# 261 High Street Walthamstow London E17

## Building Survey and Recording

**Client Name:** Henry Boot Developments Ltd.**Client Ref No:** -**Document Title:** 261 High Street, Walthamstow**Document Type:** Building survey and recording**Issue Number:** 1

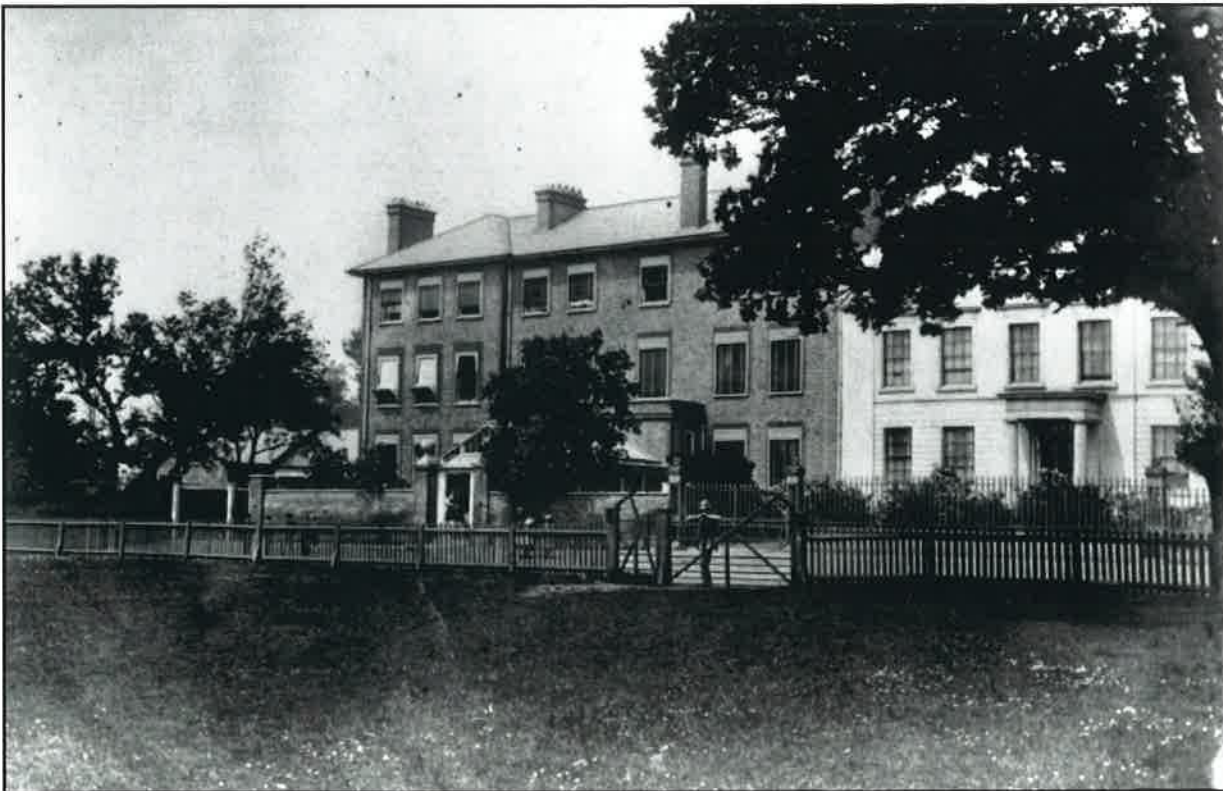
Figure 4: Langsdale House and Cleveland House, 1860 and 1865

- 1.2.3 A photograph from 1860 shows Langsdale House as a three-storey, three-bay brick house with a steep-pitched roof and dormer windows (fig. 4). There was a central front door, surmounted by a round-headed window and a dentilled pediment.

- 1.2.4 A photograph from 1865 shows the house as completely re-built, identifiable only by the remaining gateposts and Cleveland House, next door. A porch was added, with a glass gable projection extending from the porch to the front boundary wall (fig. 4). The second floor was extended to full height and the roof was raised to a shallower pitch. The blind recesses of the second floor were fenestrated, and those of either end of the first floor were filled, becoming flush with the wall. Chimney-stacks were added to either end of each bay of the building, providing each room with a fireplace.

Langsdale House and Cleveland House looking north-east, 1860

Langsdale House looking north-west, 1865

- 2.2.9 The roof is of a shallow pitch (pl. 6), dating between 1860 and 1865 and was a replacement for the original steeply-pitched roof (fig. 4). The roof was raised to create a proper second floor in the building, replacing the dormer windows. The roof extends beyond the walls of the house, and is double-hipped with the gables at the north and south ends. The roof is covered with modern slates.

- 2.8.2 By the time of the 1865 photograph, many changes had taken place in the appearance of Langsdale House, due to a comprehensive re-building of the house at this time. This rebuild formed the bulk of the surviving fabric seen in the building. The attic floor was extended, by the raising of the roof, allowing space for windows, albeit shorter than those of the first floor. The roof was made level with the top of the balustrade of Cleveland House. The blind panels of the east end and the string course above the ground floor windows were removed.

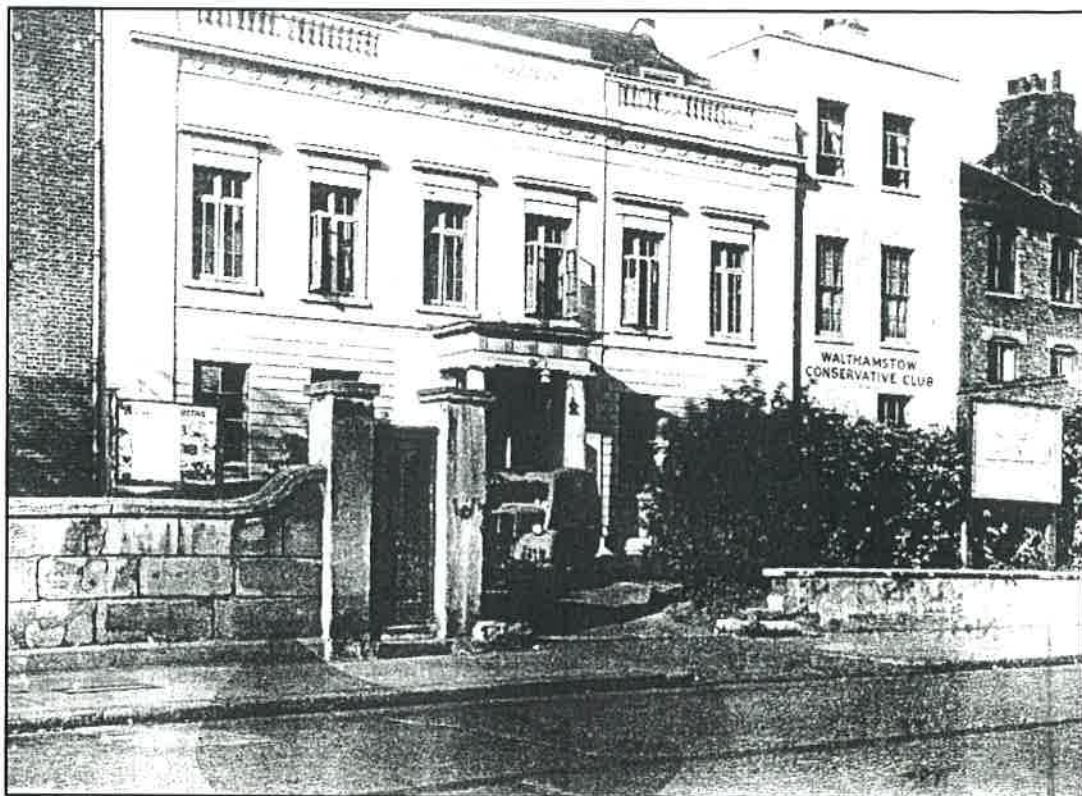
Figure 5: Langsdale House and Cleveland House, 1950

- 1.2.6 A pair of photographs from 1950 show the east bay of Langsdale House, named as the 'Old Education Offices' at 263 High Street, and Cleveland House named 'Chard Products Ltd' (fig. 5). The glass gable projection of Langsdale House has been shortened back to the porch, but the house appears largely unchanged in this view.

Langsdale House and 263 High Street

Cleveland House

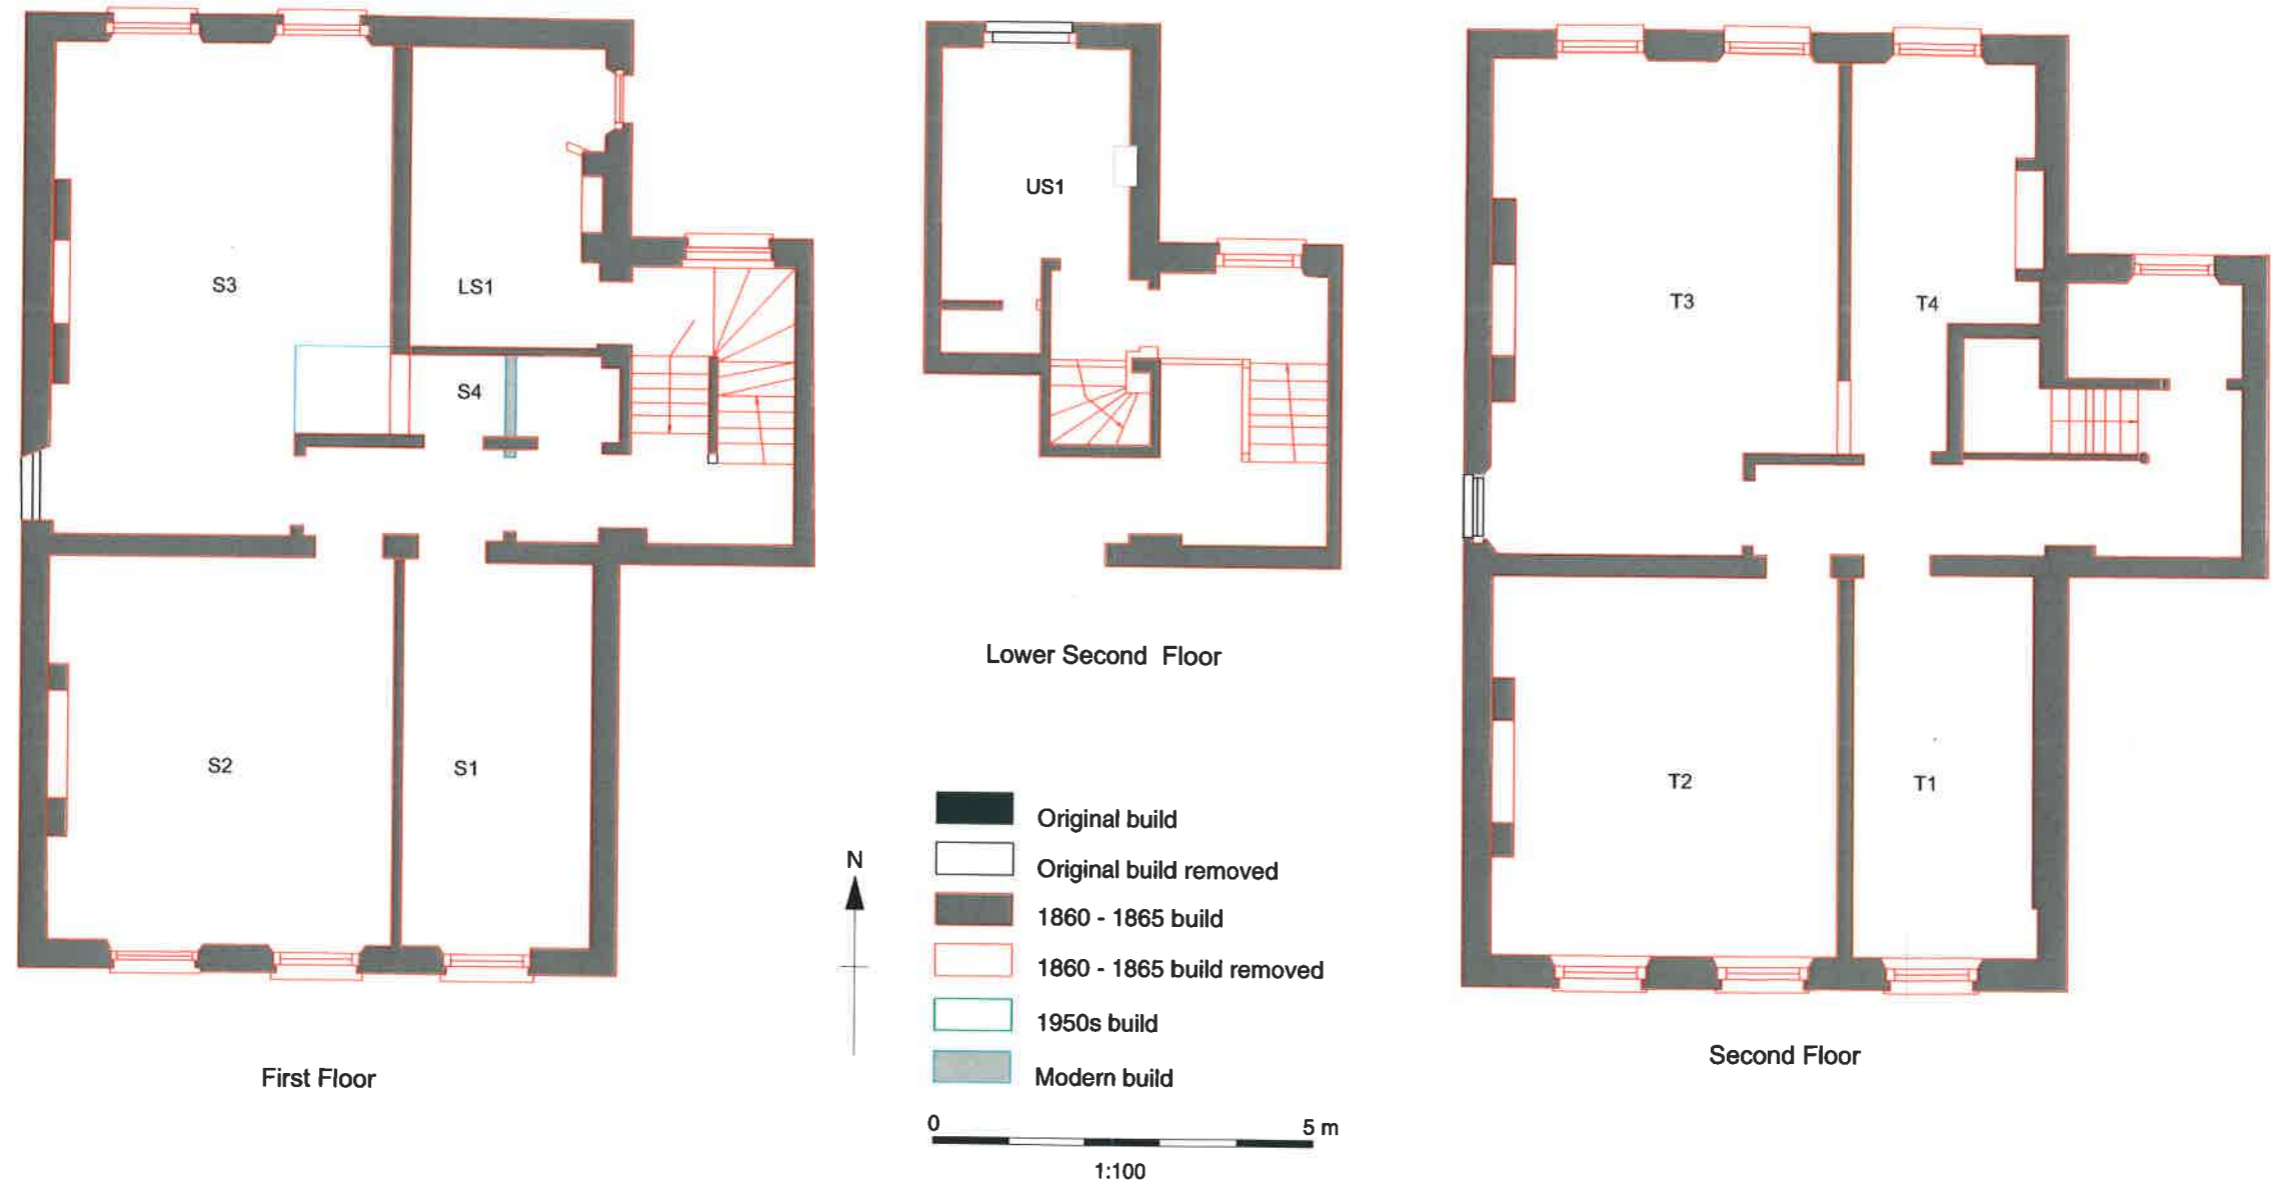
Figure 8: First and Second floor plan

- 2.5.2 Ascending the stairs in an anti-clockwise direction, the room **LS1** is reached on the west side of the stairs, at a level between ground and first floors (fig. 8). The east wall of the room has a window, visible from the outside, to the north of the stairwell, and a fireplace with marble surround (pl. 29). This flue was located between the window and the stairwell. There is a hatch in the ceiling, accessing space between the ceiling and the floor above. The fittings and exterior walls of this room are of the same style as the 1860s build of the house and may therefore have been constructed during this period.

- 2.5.4 The stairs are met by an **east-west hall**, from which room S1 is reached, on the south side of the house (fig. 8). The hall has a false polystyrene ceiling which cuts across the doorframe and window above the west end of the hall (pl. 31). Above the ceiling, complex moulded cornices are visible extending the length of the hall, and wainscoting matching those of the 1860s ground floor. The partition wall between S1 and S2 was inserted in the 1860s, together with wainscoting and cornicing. The east wall has a fireplace with a marble surround of rectangular pilasters with moulded cornices at the top and a filleted mantelpiece, inserted in the 1860s (pl. 32). The window in the south wall is preserved to its full height with the jambs of the frame extending to the floor and a coffered wooden panel beneath (pl. 33).

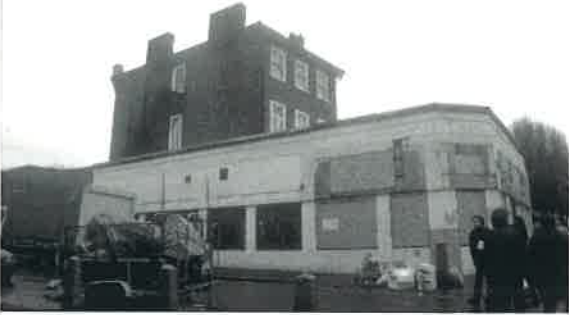
1

- 2.2.1 261 High Street is a three-storey, brick built house. The ground floor is butted by an extension which projects out to the street on the south side and also to the west, continuing to the north face of the house. The extension was built in the 1950s as a British Gas showroom. It is constructed of brick, with a flat roof and has since been covered with modern materials during its modern incarnation as a 'Kentucky Fried Chicken' outlet (pl.1).

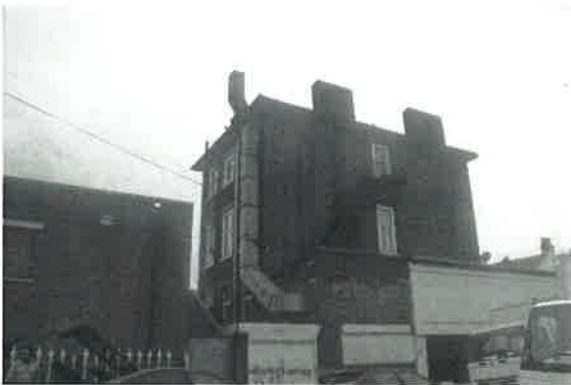
5

- 2.2.6 The **west side** of the building faces onto Cleveland Park Avenue and was re-built using dark brown brick, matching that of the south facade, during the 1860s renovations. There are two chimney-stacks at north-west and south-west corners (pl. 4). Windows are located at first and second floor level, central to the west face. The second floor window was a double-hung, four-lighted sash window; the first floor window was replaced by a modern double-glazed casement window. The ground floor was butted by the extension, which is of brick construction, partially covered by a white-painted ply-board facade (pl. 5).

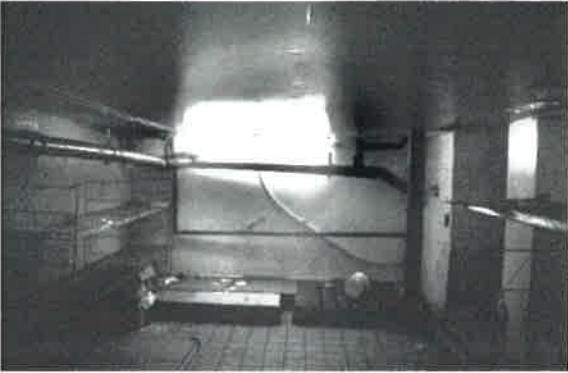
13

- 2.3.1 **Introduction** The basement of the house has largely been destroyed by the insertion of a lower ground floor to the restaurant. However the north-west corner of the house survives as one room of the store-rooms below the restaurant (fig. 7, pl. 11).
- 2.3.2 The basement of the house is reached from stairs leading down from the north end of the lower ground floor room (G2), as detailed on the 1985 plan. The west wall contains the south-west flue that served the fireplaces of the floors above (pl. 12). The presence of the flue, which was an 1860s addition, indicates that the basement may also be 1860s. Modern steps lead down from the south-west corner of the room, to a small store-room (pl. 13).

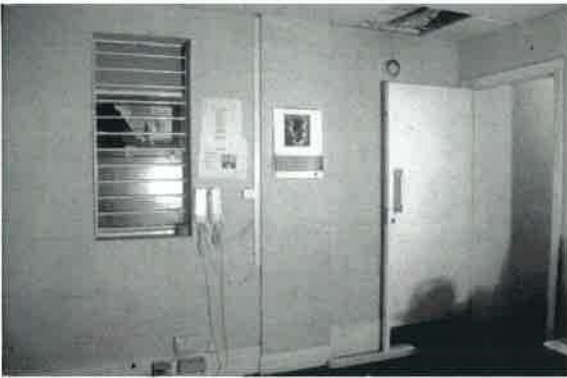
15

- 2.4.3 The ground floor of the house is reached by a flight of **20th century stairs** from the west side of the extension, ascending to the east, behind the original south wall of the house (fig. 7, pl. 14). The stairs lead into room F1. The south wall of the stairs bears the scars of four small blocked windows of the front of the house, as seen from the exterior of the south facade (pl. 14). A north-south wall existed between the east window of the group of three and the fourth window. It was an 1860s room division and was removed after the 1985 plans were drawn. The outline of the wall is present on the ceiling and a stub of the remains of a modern wall is present to the east of this, dating to the 20th century (pl. 15).

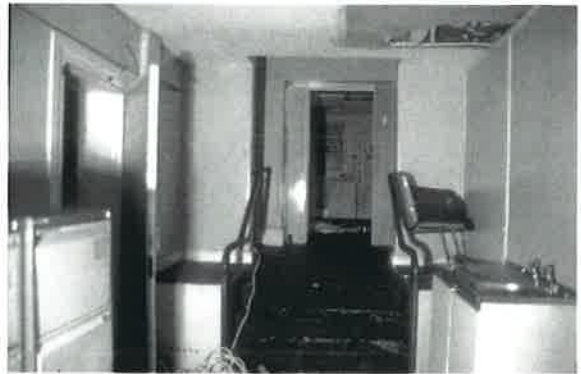
22

- 2.4.8 **Room F4** is reached by four steps descending from F1 (pl. 22), possibly inserted in the 1950s. It is separated from F3 by a C20th partition wall, which cuts across the east side of the east window (pl. 23). The north wall contains a door, which was inserted into the north-east window of the wall. The floor and ceiling levels have been dropped and the door added to form a north entrance to the building, contemporary with the 1950s extension (pl. 24). The east wall has a doorway through into the stairwell on the east side of the building (pl. 25).

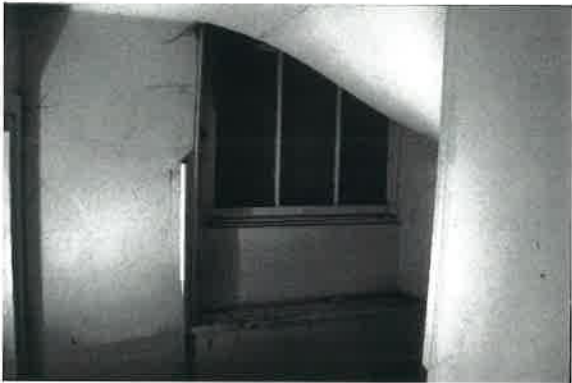
27

- 2.4.10 A double-hung sash window with six panes survives in the north wall which would have been the east ground floor window of the north facade of the building (pl. 27). The top half

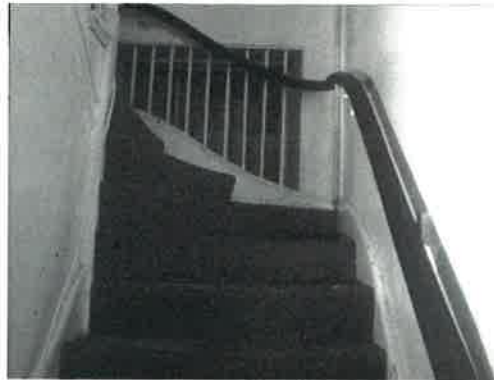
28

of the window can be seen by ascending the stairs to the first floor (pl. 28). It might reflect the design of the 1860s windows of the ground and first floors of the house (pl. 28).

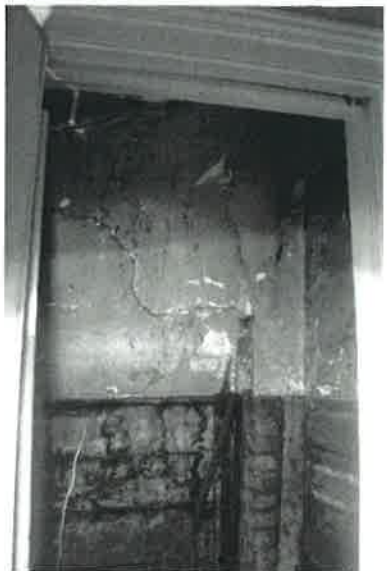
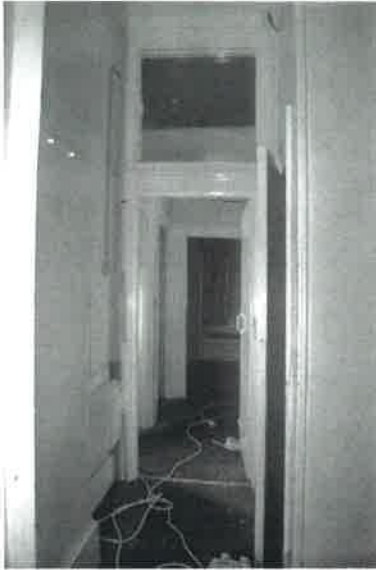
30

- 2.5.3 Ascending to the first floor, there is a small stair cupboard on the west side, in which the underside of the flight rising to the second floor can be seen (pl. 30).

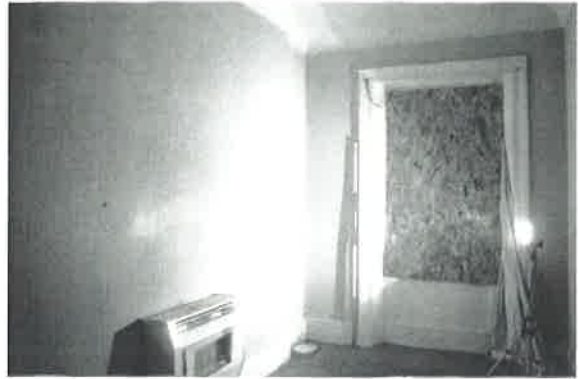
44

- 2.6.6 **T1 and T2** may have originally formed one room on the south front of the house, now divided by an 1860s partition wall. The cornicing and wainscott are complete for all four walls of **T1** and were added after the room was divided, and are of similar design to those of the rooms throughout the house. The west wall became an outside wall after the east of the house was demolished. There is no existing fireplace in this wall, but there is a break in the wainscotting and a gas fire is present, indicating that there may have been a fireplace, now removed. There is a niche at the south end of the east wall, which is not

present in the S1 below, but may be to do with the demolition of the two east bays (pl. 44).

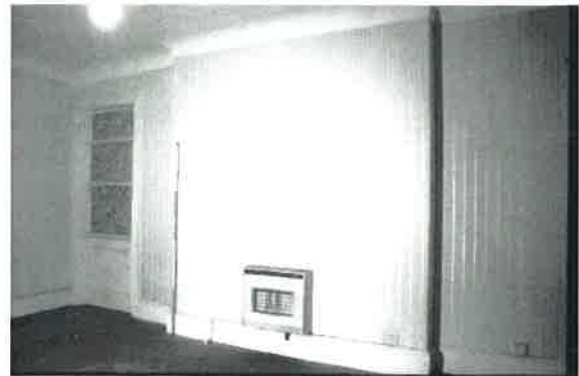
46

- 2.6.8 **Room T3**, to the north, has a window in the west wall, filled by a fitted wooden cupboard; to the north of which is a blocked fireplace (pl. 46). The cupboard is similar in style to that of S3, below. The north wall has two windows complete with their wooden surrounds, which are similar in style to the 1860s insertions. The east wall is a partition wall dividing T3 from T4 and may have been inserted in the 1860s. The south end of the wall has a door through into T4, in addition to a door in the south-east corner of the room into the hall. Both doors are panelled and may be 1860s in date as they are of a similar style to the other wooden fittings of this phase of the house (pl. 47).

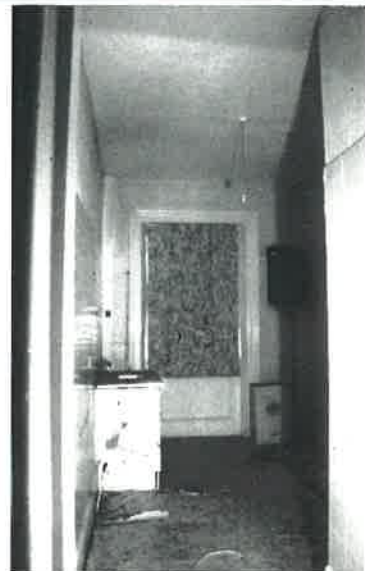
48

- 2.6.9 The south-west corner of **T4** is part of the stairwell from the second floor, giving T4 an L-shape. There is cornicing and wainscoting, matching those of the other rooms. The east wall has a blocked fireplace, served by the flue that runs up from the bathroom LS1 below. The floor slants down to the south-west corner of the room indicating a failing of a number of the floorboards (pl. 48).

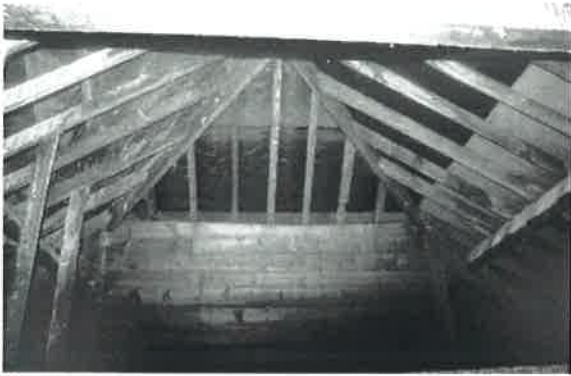
49

- 2.7.2 The roof space is reached from a hatch in the hall. The west bay of the house was fitted with a roof hipped at the north and south ends (pl. 49). The junction between the two roof types survives above the centre of the remaining building, together with a small portion of the east-west gabled roof of the rest of the house. The trusses of the gabled roof are aligned north-south and have queen struts supporting the principal rafters and the tie beam (pl. 50). The members of the gabled roof are quite substantial and square in cross-section and are dark stained soft-wood in appearance, inserted in the 1860s as part of the new shallow-pitched roof. The hipped roof contains modern slim members, pale in colour, that are modern replacements for the original 1860s ones (pl. 49). The chimney-stack of the south-east flue was seen, which retains the same chimney-pots seen in the 1865 photograph (pl. 51). The top of the skylight was not seen, though presumably there was either a skylight frame in the roof or glass tiles.
