# Zion Baptist Chapel Calne Wiltshire

## Archaeological Evaluation Report

**Document Title:** Zion Chapel Burial Ground, Calne, Wiltshire

**Document Type:** Evaluation

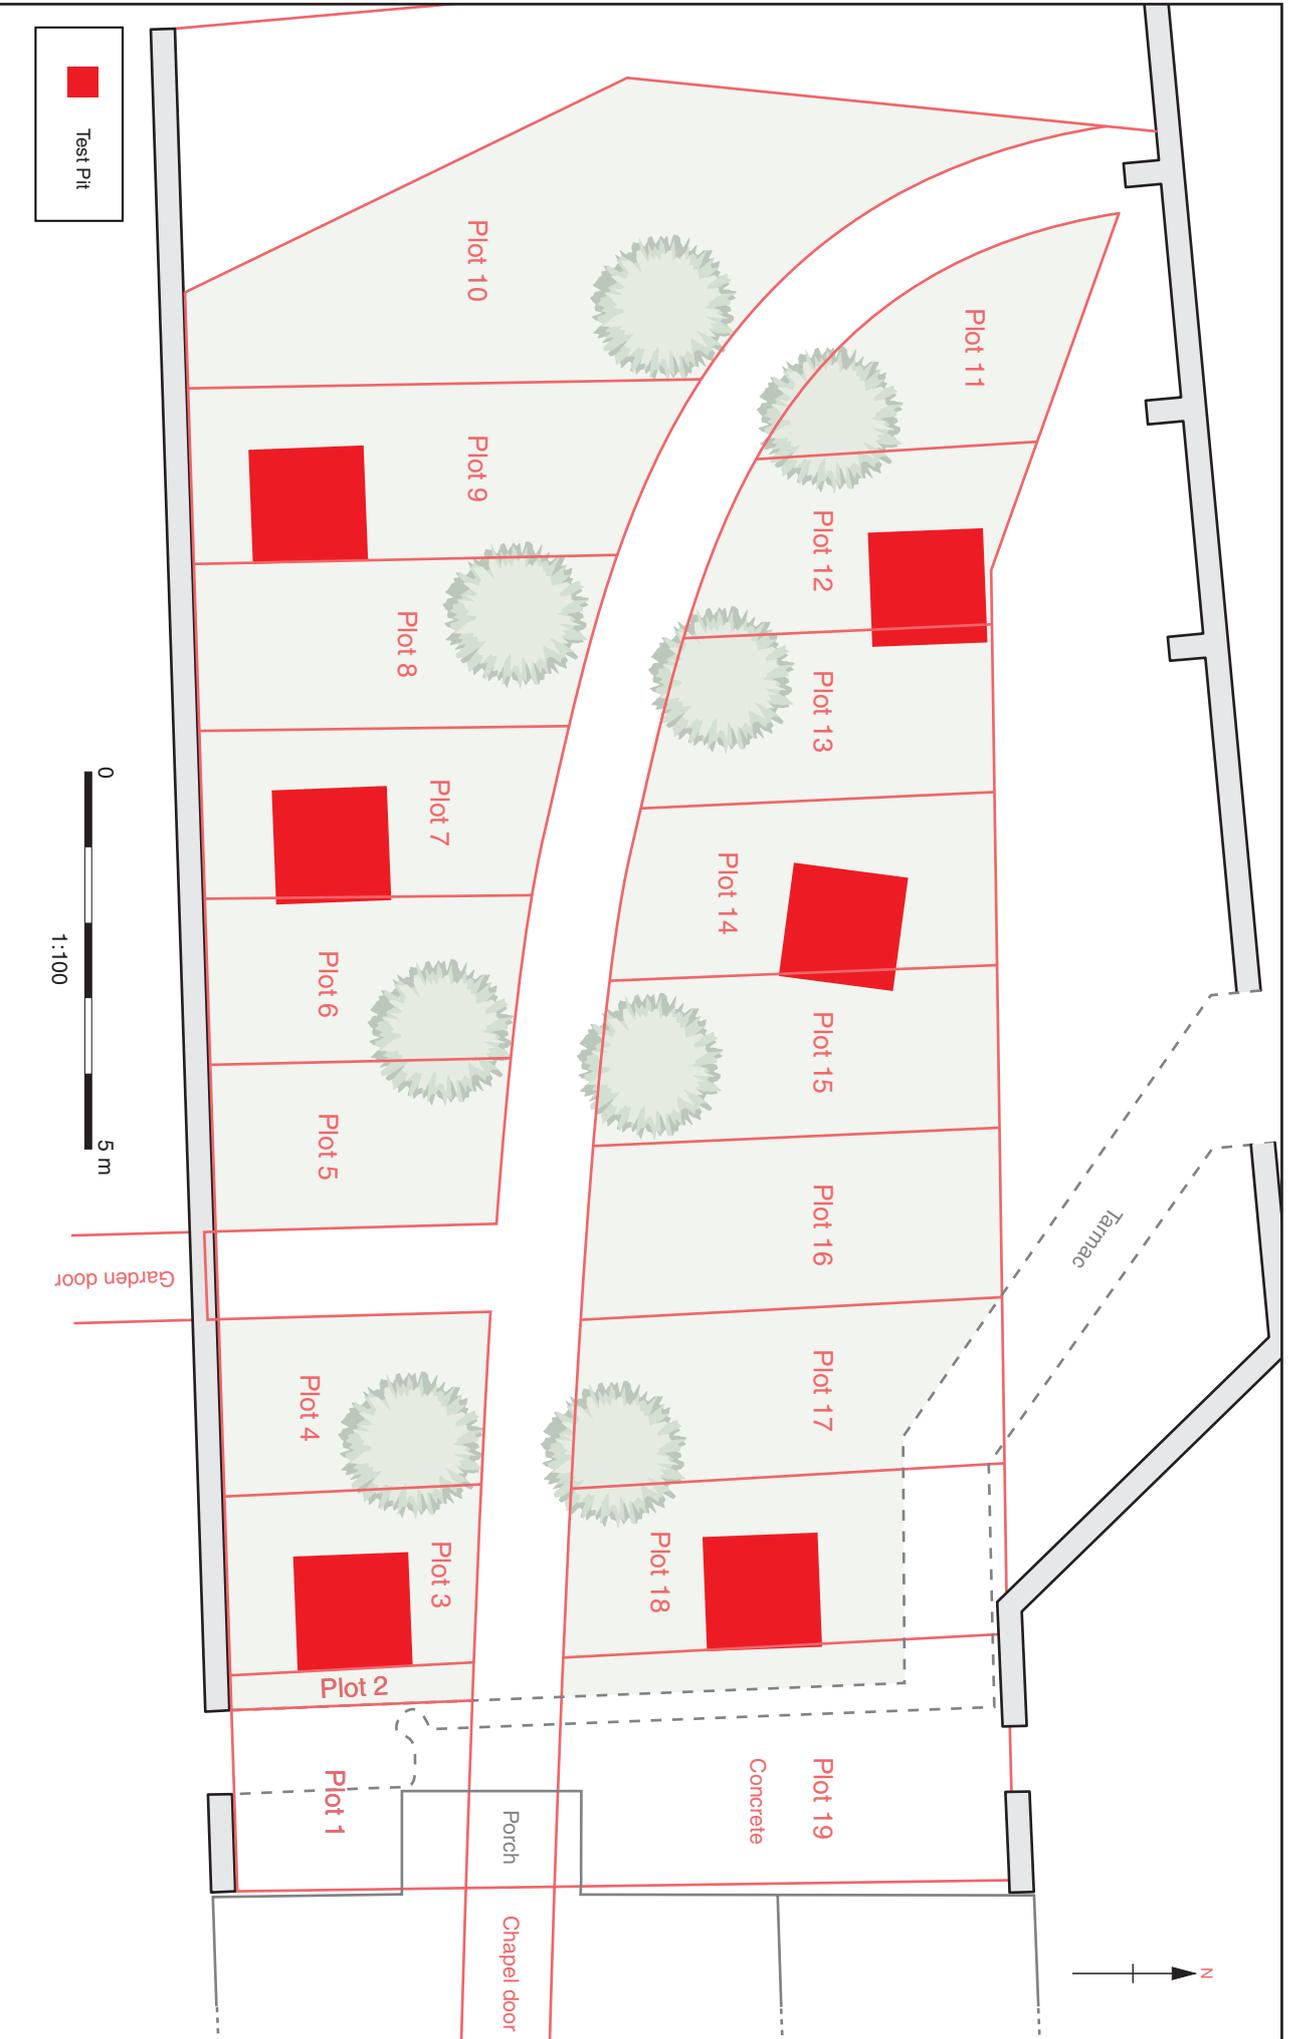
Figure 2: Location of the test pits and the original 19th century land and burial plot boundaries

3.1.1 Six burial plots, numbers 18, 14, 12, 9, 7 and 3 (Figure 2) were selected for investigation in consultation with D Faulkner. A test pit, approximately 1.5m squared and up to 1m deep, was excavated into each of these. Test pits were located by superimposing the 19th century burial plan over a modern plan of the burial ground (Figure 2). Each test pit was assigned the burial plot number with which it was associated.

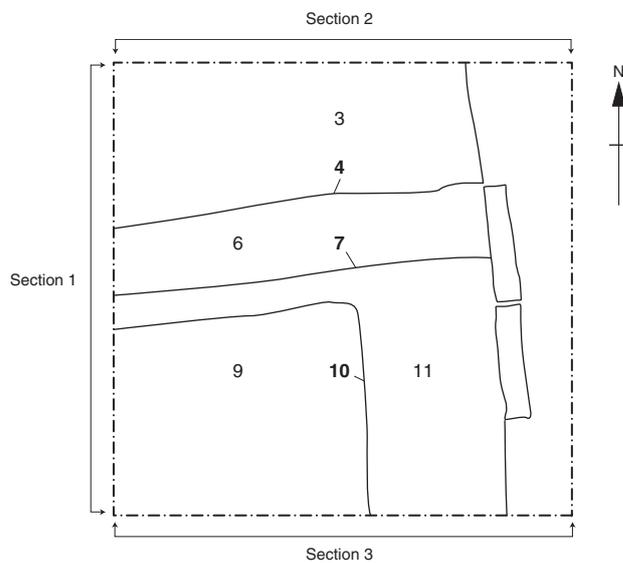
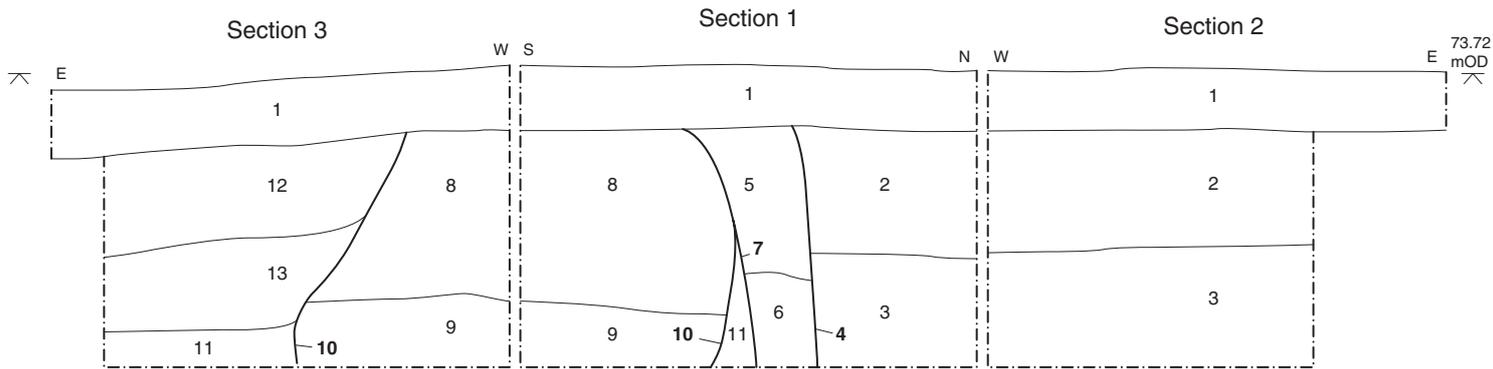
Figure 3: Plan and sections of test pit within burial plot 18

- 4.1.1 The natural (11), a yellow-brown silt-clay, with very small, sub-rounded limestone fragments, was encountered within this test pit at approximately 0.6m below ground level. Very little of this natural was seen here due to the presence of a number of intercutting features. It should be highlighted here that due to the intercutting of features within this test pit, and the often similar composition of the fills, it was difficult to define the cut features during excavation. The test pit was therefore dug to a depth of 1m below ground level, and the features recorded in section and plan, at this level. It should also be noted that at around 1m below ground level, the ground became increasingly wet, indicating the approximate level of the water table.

- 4.1.2 The earliest features (10), which cut through the natural, had steep, almost vertical sides. It was found in the south-west corner of the test pit. Only the north-east corner of this probable square or rectangular feature was revealed, but its steep sides and shape indicated that it was probably a grave cut, possibly of double width, given that it measured 0.7m, approximately N-S, and was not fully revealed. Two fills were observed within grave cut 10. The lower fill (09) (at least 0.2m thick) was a friable, grey-brown clay-silt, with occasional small limestone fragments. The upper fill (08) (0.6m in thick), was a lighter grey-brown clay silt, with charcoal flecks and more frequent stone inclusions. This fill contained fragments of post-medieval pot.

- 4.1.3 The eastern edge of grave 10 was truncated by a cut (14) for a pit, visible in section only (Figure 3, section 3). The pit was fairly flat bottomed, with a side slope of approximately 50-55 degrees. Two fills were identified; the earlier fill (13), a light grey-brown clay-silt, with charcoal and small limestone fragments (0.35m thick), and the later fill (12), a darker grey-brown clay-silt with charcoal flecks (0.3m thick). Both fills contained fragments of post-medieval pot and animal bone. The function of the pit was unclear, but it may have served as refuse pit.

- 4.1.4 The northern edge of grave 10 was truncated by another, steep, almost vertically, sided grave cut (07), aligned WSW - ENE. This grave also had two fills. The lower fill (06) was a friable grey-brown clay-silt with charcoal flecks (at least 0.3m thick), and the upper fill (05), was a darker grey-brown clay-silt, with charcoal and lime mortar flecks (0.5m thick). Both fills contained post-medieval pottery. Only 0.25m width of this grave was visible, as it was truncated on its northern side by another identically aligned grave (04).

- 4.1.5 Grave cut 04, also fairly vertically sided, was located along the northern edge of the test pit, with a width of at least 0.45m. The lower fill (03) of this grave comprised a light grey-brown clay-silt with charcoal and mortar flecks (at least 0.4m thick). The upper fill (02) was a slightly darker grey-brown clay-silt, with charcoal flecks (0.4m thick). Fill 02 contained post-medieval pot fragments.

- 4.1.6 Overlying all of the grave cuts was a 0.2m thick layer of topsoil and turf (01). Within the topsoil, at approximately 0.1-0.15m below the ground level, two *in situ* kerb stones, on a NNW-SSE alignment, were revealed, close to the eastern edge of the test pit. It is likely that these were the partial remains of the above ground grave memorial for one or more of the grave cuts identified within the test pit. The kerb stones themselves, constructed of limestone, were approximately 0.35m in length, 0.14m in width and 0.2m in height, with bevelled top edges.

- 4.1.7 At 1m below ground level, no burials had been reached. A depth of 0.8m of each of the three grave cuts was revealed.

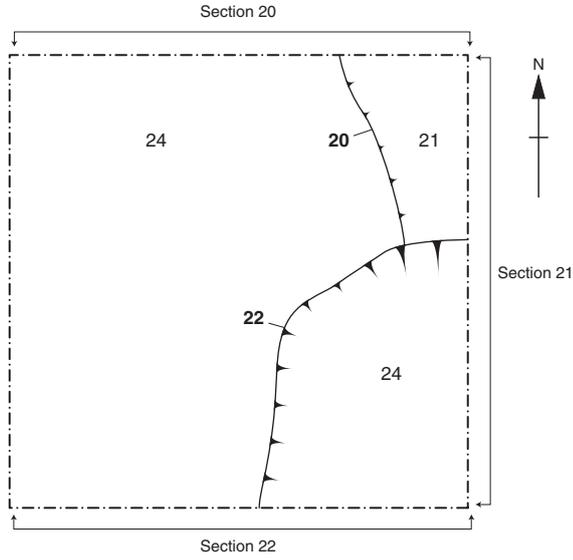
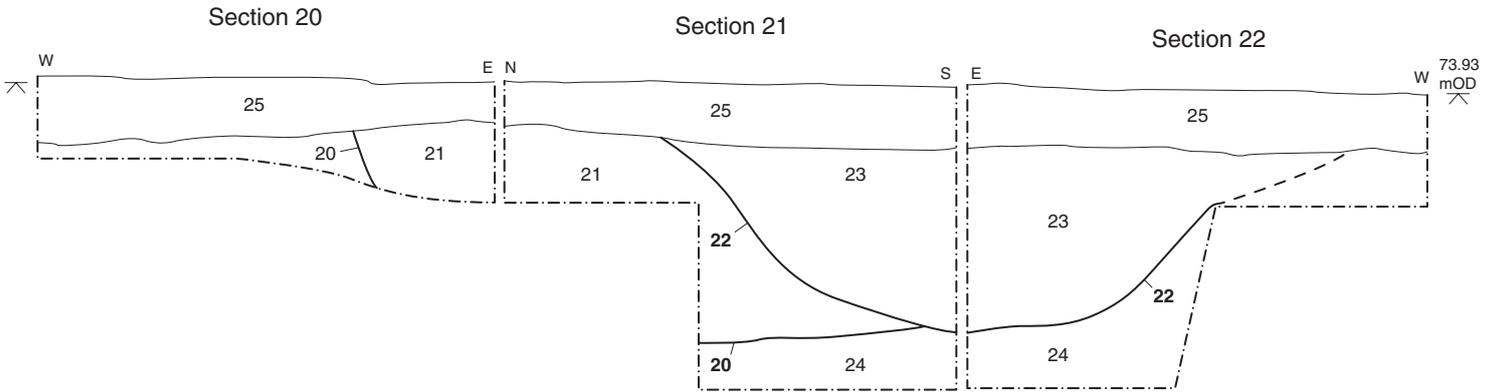
Figure 4: Plan and sections of test pit within burial plot 14

- 4.1.8 The natural was not observed within this test pit. The earliest deposit encountered (24) was a light grey-brown clay-silt, with frequent abraded limestone fragments. A thickness of at least 0.8m was observed. It is suggested that this deposit, containing

post-medieval pottery, CBM, animal bone, oyster shell and corroded iron nails, was a layer of worked, possibly garden soil.

- 4.1.9 Layer 24 was cut by a fairly steep-sided pit (20), on the eastern side of the test pit. The shape of pit 20 was not ascertained because only part of its western edge was visible in plan. It was found to be fairly flat-bottomed (Figure 4, section 21), with a maximum depth of 0.7m. The single fill of the pit was a dark grey-brown clay-silt, with very occasional small limestone fragments (21). Animal bone, post-medieval pot and CBM were recovered from this fill. It is possible that this feature represents a refuse pit.

- 4.1.10 In the south-east corner of the test pit, and truncating the southern side of pit 20, was another pit (22). Again, it was difficult to ascertain its shape in plan, as it was only partially revealed within the test pit, but it was possibly sub-oval or sub-rectangular. The sides sloped at approximately 50-55 degrees, with a gradual break of slope at the base, which itself was fairly flat (Figure 4, sections 21 and 22). The fill (23), was a slightly more reddish brown than 21, with occasional limestone fragments and very occasional charcoal flecks. Aside from a fragment of possible Tudor green glazed pot, this fill contained a fairly substantial amount of post-medieval pot, including blue and white china, CBM, animal bone, bottle glass, CTP and iron nails, as well as an iron fitting used to reinforce the heel of a shoe, known as a 'heel shoe'. The presence and quantity of these finds is convincing evidence that this was a refuse pit.

- 4.1.11 Overlying the two pits and the worked soil layer through which they were cut, was the 0.2m thick topsoil and turf.

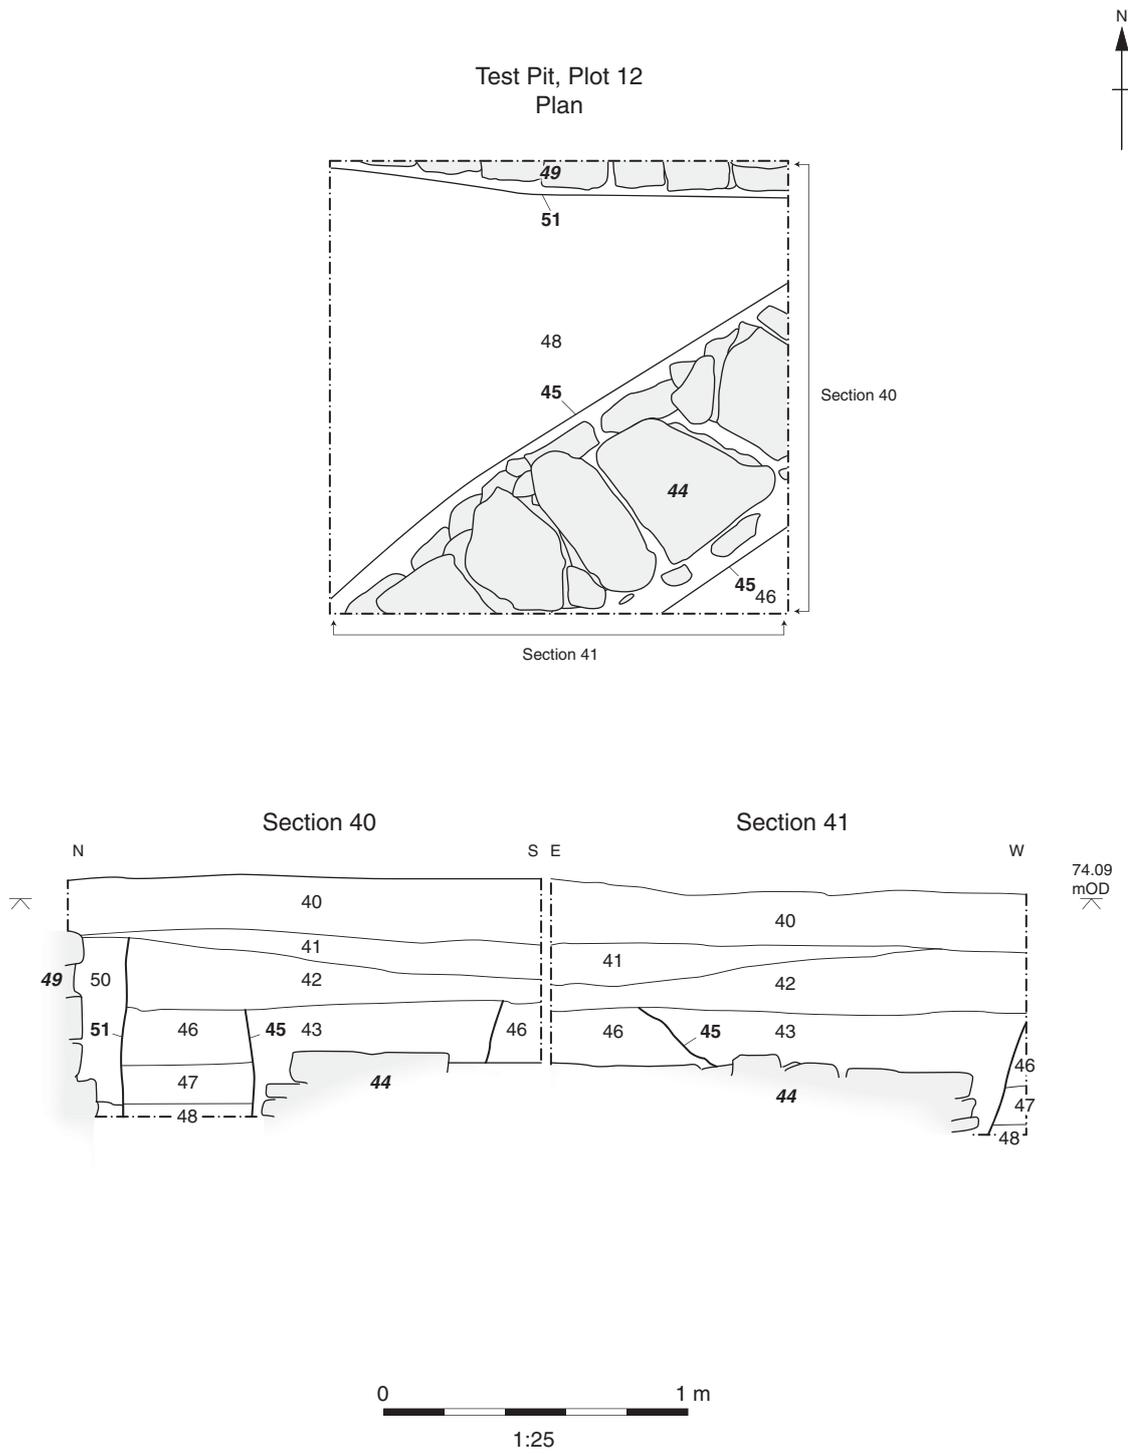
Figure 5: Plan and sections of test pit within burial plot 12

- 4.1.12 The natural silt-clay with very small stone fragments (48), was reached at a depth of 0.75m below ground level. It was slightly greyer in colour than in the test pit within plot 18. Overlying the natural was a 0.18m thick layer of light grey-brown silt-clay with very small stone fragments and charcoal flecks (47). Post-medieval pot fragments were recovered from this layer. Overlying layer 47 was a slightly darker grey-brown clay-silt layer (46), approximately 0.2m thick. This also contained post-medieval pot fragments, as well as CBM and CTP. It is thought that layers 46 and 47 represent deposits of earlier worked/garden soil.

- 4.1.13 Cut through layer 46, in the southern half of the test pit, was the construction cut (45) for a NE-SW orientated stone culvert (44). The culvert comprised sides of limestone blocks and limestone capping slabs, and had been constructed without mortar. Its overall width was approximately 0.6m, with a height of around 0.3m. A total length of 1.84m was revealed within the test pit. The capping slabs lay at 0.57m below ground level. Removal of one of the capping slabs found the culvert to be entirely blocked/silted up. It is suggested that the culvert may have served as a drainage channel for one or more of the properties, possibly workshops, that would have lined the high street frontage to the west of the site in the post-medieval period. The backfill (43) of the construction cut for the culvert was a friable dark grey-brown

clay-silt loam with charcoal flecks. This also contained post-medieval pot and CBM fragments.

- 4.1.14 Overlying the culvert was a further layer identified as worked, or garden, soil (42), a grey-brown clay-silt, with small stone fragments and charcoal flecks, approximately 0.22m thick. Post-medieval pot and CBM fragments were also recovered from this layer. Cut through layer 42, running roughly E-W along the very northern edge of the test pit, was the construction cut (51) for wall 49. The wall itself was constructed of roughly dressed limestone blocks, up to 0.25m by 0.18m by 0.12m in size. These were bonded with a lime mortar. The extent of wall revealed in the test pit was 1.5m long, 0.13m wide and 0.6m high. The top of the remaining wall was 0.18m below ground level. The backfill (50) of the construction cut (51) comprised a friable dark grey-brown silt-loam with charcoal flecks. Fragments of CTP were recovered from this deposit. It is thought that the wall revealed was part of the original 19th century churchyard boundary wall. The location of the wall corresponds closely with the western part of the 19th century north boundary wall shown in Figure 2.

- 4.1.15 Overlying the wall, was a layer of light grey silt-clay with frequent crushed and fragmented limestone inclusions (41). This layer had a maximum depth of 0.18m, in the south-eastern corner of the test pit, petering out in the western part of the test pit. It suggested that this deposit may have represented a ground surface layer, post dating the disuse of the wall (49). Overlying layer 41 was a 0.2m thick layer of topsoil and turf (40). Just below this, running along the northern edge of the test pit, a metal water pipe was encountered.

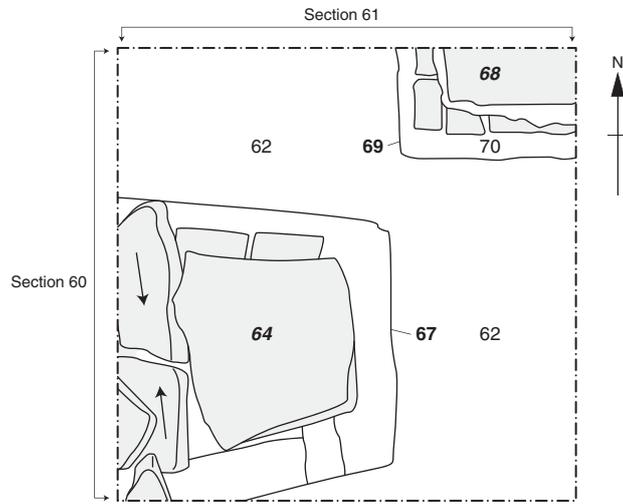
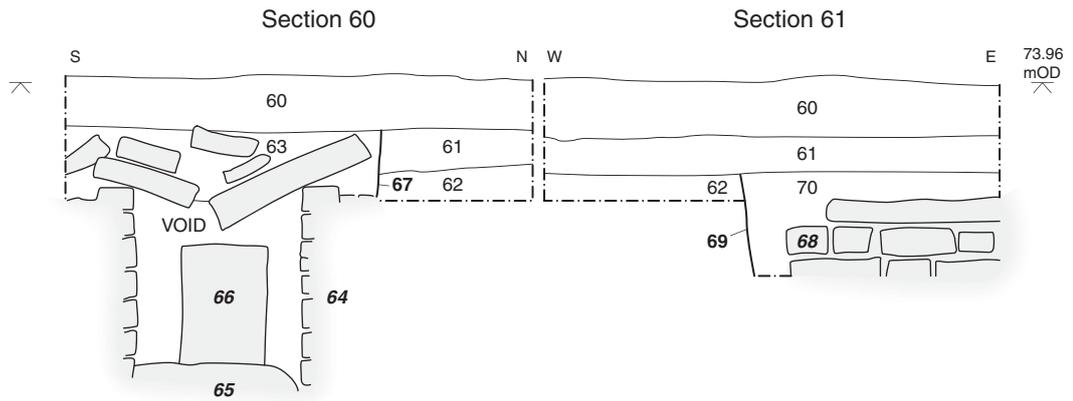
Figure 6: Plan and sections of test pit within burial plot 9

- 4.1.16 The earliest deposit revealed within this test pit was layer 62, a light grey-brown clay-silt with abraded limestone fragments and charcoal flecks, and probably a layer of worked/garden soil. A maximum of 0.4m thickness was revealed within the test pit. Post-medieval pot and CBM were recovered.

- 4.1.17 In the north-east corner of the test pit, a construction cut (69) for a W-E orientated brick shaft grave (68) was cut through layer 62. Only the very south-west corner of the shaft grave was revealed within the trench (Plate 4). The shaft grave comprised a single skin of bricks, bonded with lime mortar, and capped with limestone slabs. The top of the slabs lay at 0.4m below ground level and the upper course of bricks lay at 0.5m below ground level. Removal of one of the upper bricks allowed a somewhat restricted view into the shaft grave itself (Plate 5). It was observed to be single-break in shape and had an internal width of 0.8m, and depth of 1.4m. The base lay at around 1.9m below ground level. At least two skeletons were observed, probably both adult, at the base of the grave. At least one of the skeletons was laid supine (on the back) with the arms straight, by the sides of the body, orientated with the head in the west end and the feet in the east end. This orientation is the accepted tradition for Christian burial (McKinley 2008, 21). The fairly well preserved remains of a coffin associated with this individual, and possibly of wood-metal-wood construction, were also visible, including an iron grip at the head end of the coffin, an iron breast plate and

possible lid motif. Whilst details of patterning on these coffin fittings could not be ascertained, the complete outline of the breast plate was observable. It was not comparable to any of the types from the Christ Church, Spitalfields, or OA catalogues, and was thus assigned new type code CAZION 01 (Figure 9; Plate 5). Water was visible at bottom of the shaft grave. The backfill (70) of the construction cut for the shaft grave comprised a light grey-brown silt-clay with frequent charcoal and mortar flecks.

- 4.1.18 Overlying layer 62 and shaft grave 68 was a dark yellow-brown clay-silt layer with charcoal flecks, up to 0.2m thick (61). This was interpreted as a layer of general churchyard soil, from which post-medieval pot fragments were also recovered. In the south-western part of the test pit, the eastern end of another limestone capped, brick shaft grave (64) was revealed, the construction cut (67) for which was cut through layer 61. The capping slabs lay at approximately 0.3m below ground level, with the top course of bricks at 0.36m below ground level. As with earlier shaft grave 68, 64 comprised a single skin of bricks, bonded with a lime mortar. The dimensions of shaft grave 64 were 0.8m wide by 0.68m long (as revealed in the test pit). The capping slab running into the western section of the test pit had been broken, with the two main fragments tilting into the grave slightly. Other fairly large limestone fragments, possibly fragments of broken capping slabs from the western half of the grave (not revealed within the test pit), were also visible within the backfill (63) that had been deposited after the placement of the capping slabs.

- 4.1.19 Removal of the end (eastern) capping slab allowed inspection into the shaft grave. A well preserved wooden coffin (66), covered on all visible sides with thin tin plating, was revealed almost at the very top of the shaft grave, at 0.56m below ground level (Plate 6). There was no evidence for coffin fittings (for example, breast plate, lid motif, upholstery studs, grips or grip plates). It appeared that the coffin was orientated on its side, the reason for which was unclear. The end of the coffin - presumably the foot end if it was lying in the same, W-E orientation as the burials within grave 68 - measured 0.3m in height and 0.45m in width. These dimensions suggest that it would have fitted easily within the shaft grave had it been placed in, in the conventional way. Of course, the dimensions and shape of the western ends of the shaft grave and coffin were not revealed, and may hold information on the unusual orientation of the coffin. Underlying coffin 66 was a friable, dark grey-brown clay-silt deposit (65). The full depth of the shaft grave could not be measured due to the presence of this deposit. It was not clear whether 65 was an intentional backfill, possibly covering earlier burials, or whether it was the result of in-filling of surrounding soil either when the final coffin (66) was interred, or when the capping slabs were damaged. Of course, these events may have been synonymous. Overlying the latest backfill (63) was the 0.2m thick layer of topsoil and turf (60), seen across the site.

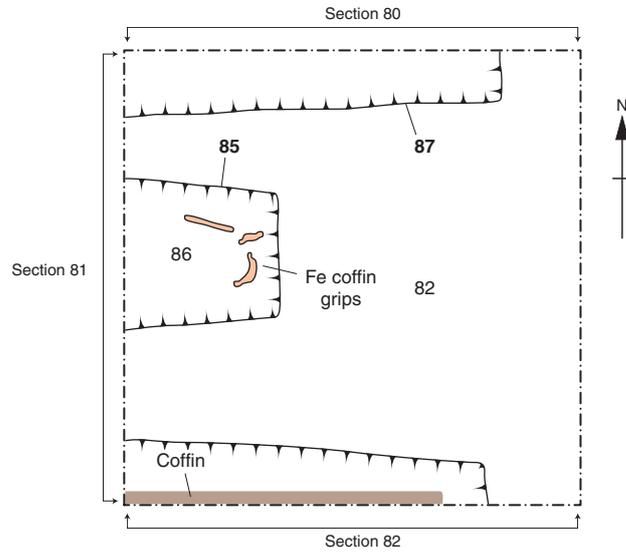
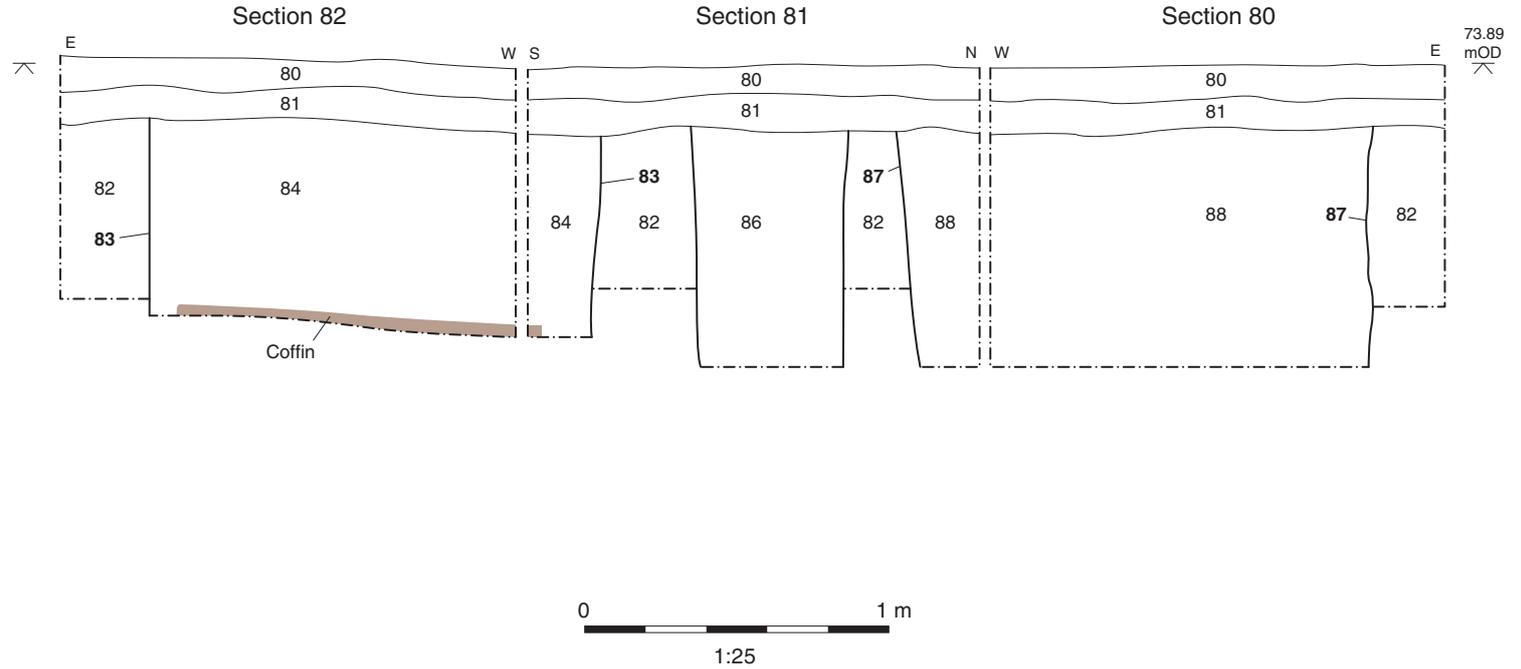
Figure 7: Plan and sections of test pit within burial plot 7

- 4.1.20 The earliest deposit within this test pit was a layer of fairly compact, grey-brown clay-silt with frequent limestone and occasional charcoal inclusions. The total excavated depth of this feature was 0.6m. Post-medieval pot, CBM, CTP, glass and

animal bone were recovered from this layer, interpreted as a worked/garden soil layer. Three W-E aligned earth-cut graves were cut through this layer. Grave cut 83 was located along the southern edge of the test pit. Only the northern edge and part of the foot end of the grave were revealed. The sides of the cut were almost vertical, with the shape in plan probably rectangular or single-break. A 1.18m length, 0.22m width and 0.68m depth of the grave cut was revealed. Against the southern section of the test pit, the very northern edge of a well preserved coffin was revealed, at 0.86m below ground level. A length of 1.1m was visible. Although the amount revealed was very limited, the structure of the coffin was found to comprise an outer layer of wood, a middle layer of thin sheet metal - probably zinc - and an inner layer of wood. Three iron fixing nails were recovered, but no coffin fittings (for example, grips, grip plates, upholstery studs) were revealed. The backfill of grave 84 comprised a grey-brown clay-silt with frequent limestone and mortar inclusions.

- 4.1.21 Another grave (85) was revealed, running into the centre of the western baulk of the test pit. Only the foot end of the grave was revealed - a width of 0.52m and a length of 0.5m. A maximum depth of 0.8m was excavated in this grave. Its shape in plan was probably either rectangular or single-break. At 1m below ground level a coffin was revealed. Fragments of degraded wood were visible, as well as two corroded iron grips, grip plate fragments, and an unidentified strip of corroded iron. The small size of the grips indicated that the coffin had probably been that of a child. The fill of the grave (86), comprised a dark grey-brown clay-silt with occasional limestone fragments. A few fragments of animal bone were observed in this fill.

- 4.1.22 The southern edge and part of the foot end of a third grave (87) were revealed along the northern edge of the test pit. Probably rectangular or single-break in plan, the extent of the grave revealed was 1.24m long by 0.23m wide and 0.8m deep were. Having excavated the grave fill to 1m below ground level, no burial was reached. The fill (88) comprised a relatively loose, grey-brown silt-clay with fairly frequent limestone fragments and occasional charcoal flecks.

- 4.1.23 Overlying all of the graves was a 0.1-0.12m thick band of dark yellow-brown clay silt (81), interpreted as a layer of churchyard soil. This was overlain by the topsoil and turf (80).

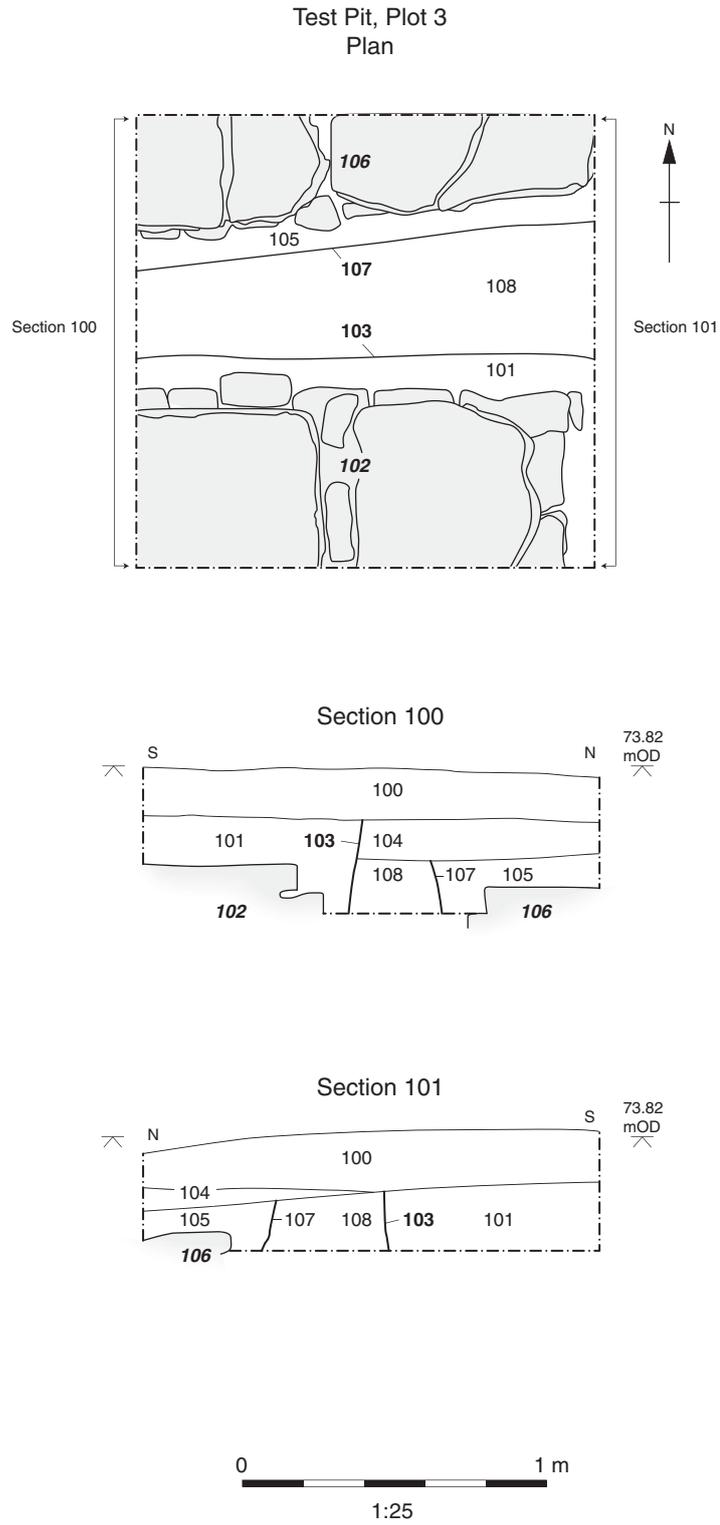
Figure 8: Plan and sections of test pit within burial plot 3

- 4.1.24 Within test pit 3, the earliest deposit encountered was worked/garden soil layer 108, a light grey-brown silt-clay with frequent limestone inclusions. Cut through this layer was the construction cut (107) for W-E aligned stone-lined shaft grave 106. Part of the southern edge of the shaft grave was revealed within the northern half of the test pit. A 1.5m length and 0.42m width of the grave were revealed, but removal of one of the limestone blocks from the upper course of stones enabled the full internal width, just past the shoulder level of the single-break shaped structure, to be ascertained - approximately 0.55m. The structure itself comprised walls of limestone blocks, and large limestone capping slabs, which lay 0.38m below ground level. The capping slabs, as seen with brick shaft graves 64 and 68, were not hewn. The limestone walls

however, were extremely well finished on the internal surfaces. The external surfaces were rough and unfinished. The depth of the shaft grave was around 1.8m, with the base at approximately 2.28m below ground level.

4.1.25 Despite the restricted view into the shaft grave a well preserved, child's coffin (wooden) could be seen. The coffin appeared to be standing on its end, with one end - presumably the head end of the coffin - facing upwards, 1.15m below ground level. Rather than having been placed deliberately in this way, which seems unlikely, it is suggested that the coffin had been resting on a metal rack (see Section 1.3.7), as has been observed in many other shaft graves (including shaft grave 102 discussed below, Section 4.1.25), and, either due to corrosion of the iron bars, decomposition of the coffin, or even an accident during interment, the foot end of the coffin had slipped away from the bar, thus tipping the coffin upright. No such iron bars were actually observed in this grave, although the view into the shaft grave was extremely limited. The position of the coffin allowed an iron grip and grip plate to be observed in detail. Neither matched any of the types seen at other sites, thus they were assigned new type codes: Grip CAZION 01 and Grip plate CAZION 01 (Figure 10). Water was observed at the base of the shaft grave. The backfill (105) of the construction cut (107) comprised a light grey-brown clay-silt with charcoal and lime mortar flecks.

4.1.26 Overlying shaft grave 106 was a layer of dark yellow-brown clay-silt churchyard soil that was up to 0.2m thick. This was cut by the construction cut (103) for W-E aligned shaft grave 102. This was also a stone-lined shaft grave, partially revealed in the southern half of the test pit. A length of 1.5m and width of 0.6m were revealed. Similar to shaft grave 106, 102 comprised large limestone capping slabs (0.32m below ground level), overlying walls of limestone blocks, the internal surfaces of which, visible after the removal of one of the upper coarse blocks, were extremely well finished. The single-break shaped structure was found to have at least two horizontal iron bars built into the walls, at 0.85m below ground level. As stated above, such bars, were used as a rack to rest coffins upon. Human bone and remains of coffin/s were visible at the bottom of the shaft grave, which was 1.4m deep, or approximately 1.8m below ground level. The base of the grave was partially filled by water. The backfill (101) of the construction cut (103) comprised a grey-brown clay-silt with charcoal and lime mortar flecks. Overlying the backfill (101) was the topsoil and turf (100).

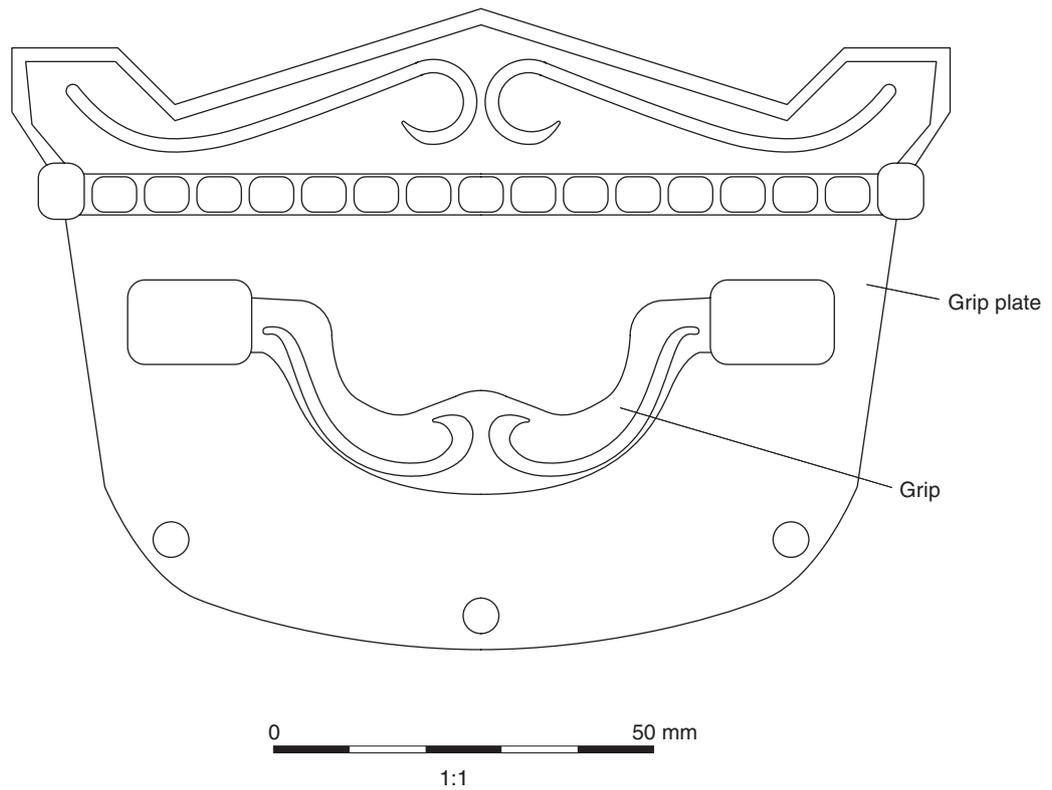
- 5.2.14 The absence of stud work at Zion Chapel does not seem to fit with the evidence for otherwise middle-class burials. In addition, whilst the decorative detail of most of the coffin fittings could not be observed, the grip plate of the coffin in shaft grave 106 had a simple decoration. At least one coffin (66), whilst apparently tin-plated, had no coffin fittings at all. These findings therefore suggest that the individuals associated with Zion Chapel, despite clearly being able to afford elaborate coffins and graves, observed the Baptists' theological emphasis on eschewing worldly values and possessions in pursuit of more spiritual goals. This practice is also reflected in the lack of decorative fittings at Broad Street, Kings Lynn and West Butt Street, Poole (Boston forthcoming; McKinley 2008, 47).

Figure 10: Grip and grip plate from child's coffin within stone-lined shaft grave 106.  
New types: Grip plate CAZION01, Grip CAZION01
