# 13 Broad Street Bath

## Archaeological Watching Brief Report

**Client: Nicholas Magniac Associates**

OA Job N<sup>o</sup>: 2792

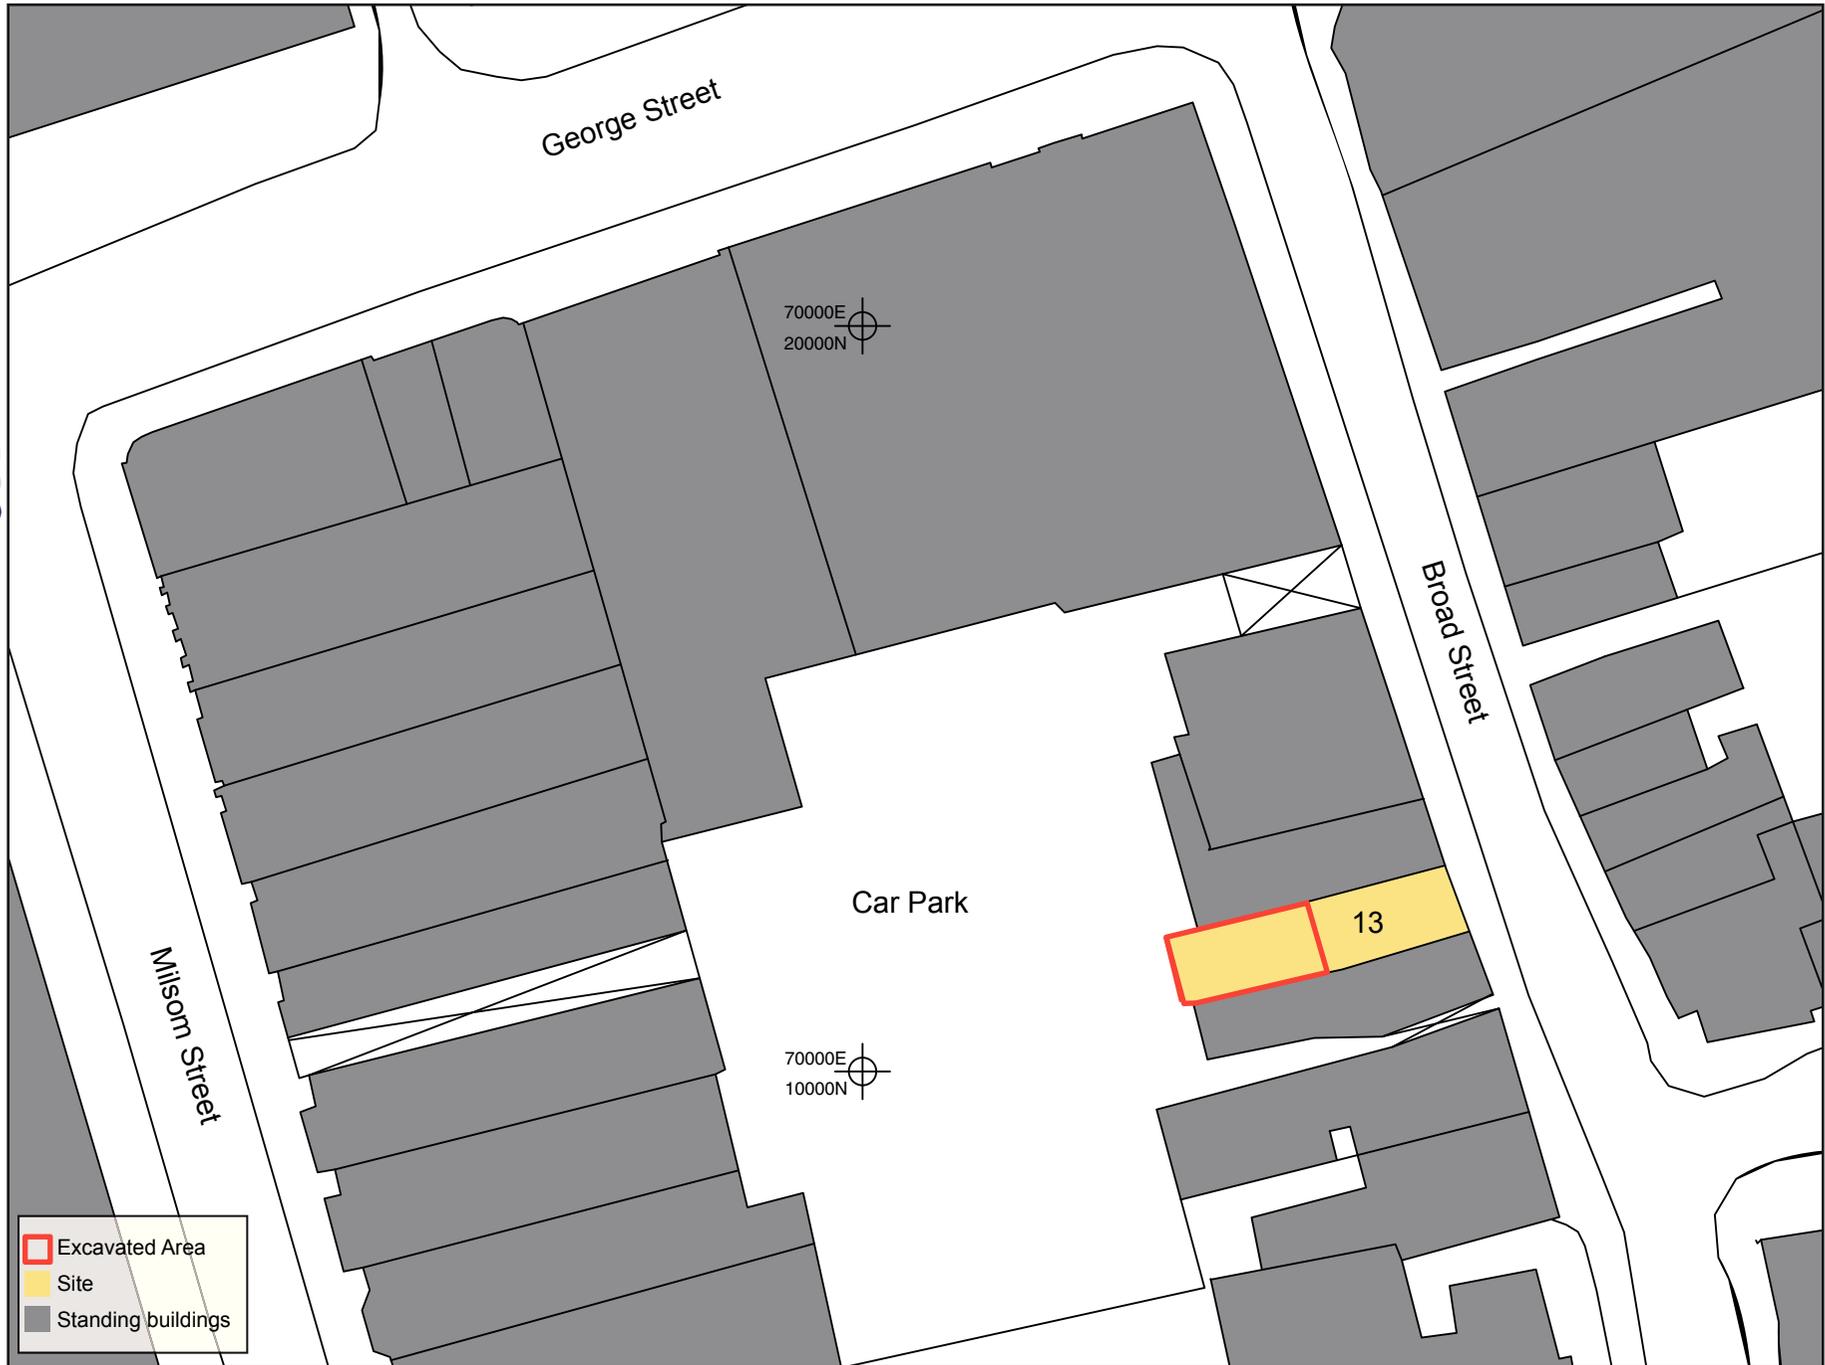
Figure 2: Location of excavation

- 2.2.3 In addition, it was possible to superficially examine temporary spoil heaps to check for artefacts.
- 2.2.4 A plan showing the location of the excavated archaeological remains was prepared at a scale of 1:200 (Fig. 2) and a plan showing the archaeological features at 1:50 (reproduced at 1:100 in Fig. 3). A section across the site at the west end was drawn at 1:20 (reproduced at 1:25 in Fig. 3). Sections and any excavated features were photographed using colour slide and black and white print film. A general photographic record of the work was also made. Recording followed procedures detailed in the *OA Field Manual* (ed. Wilkinson 1992).

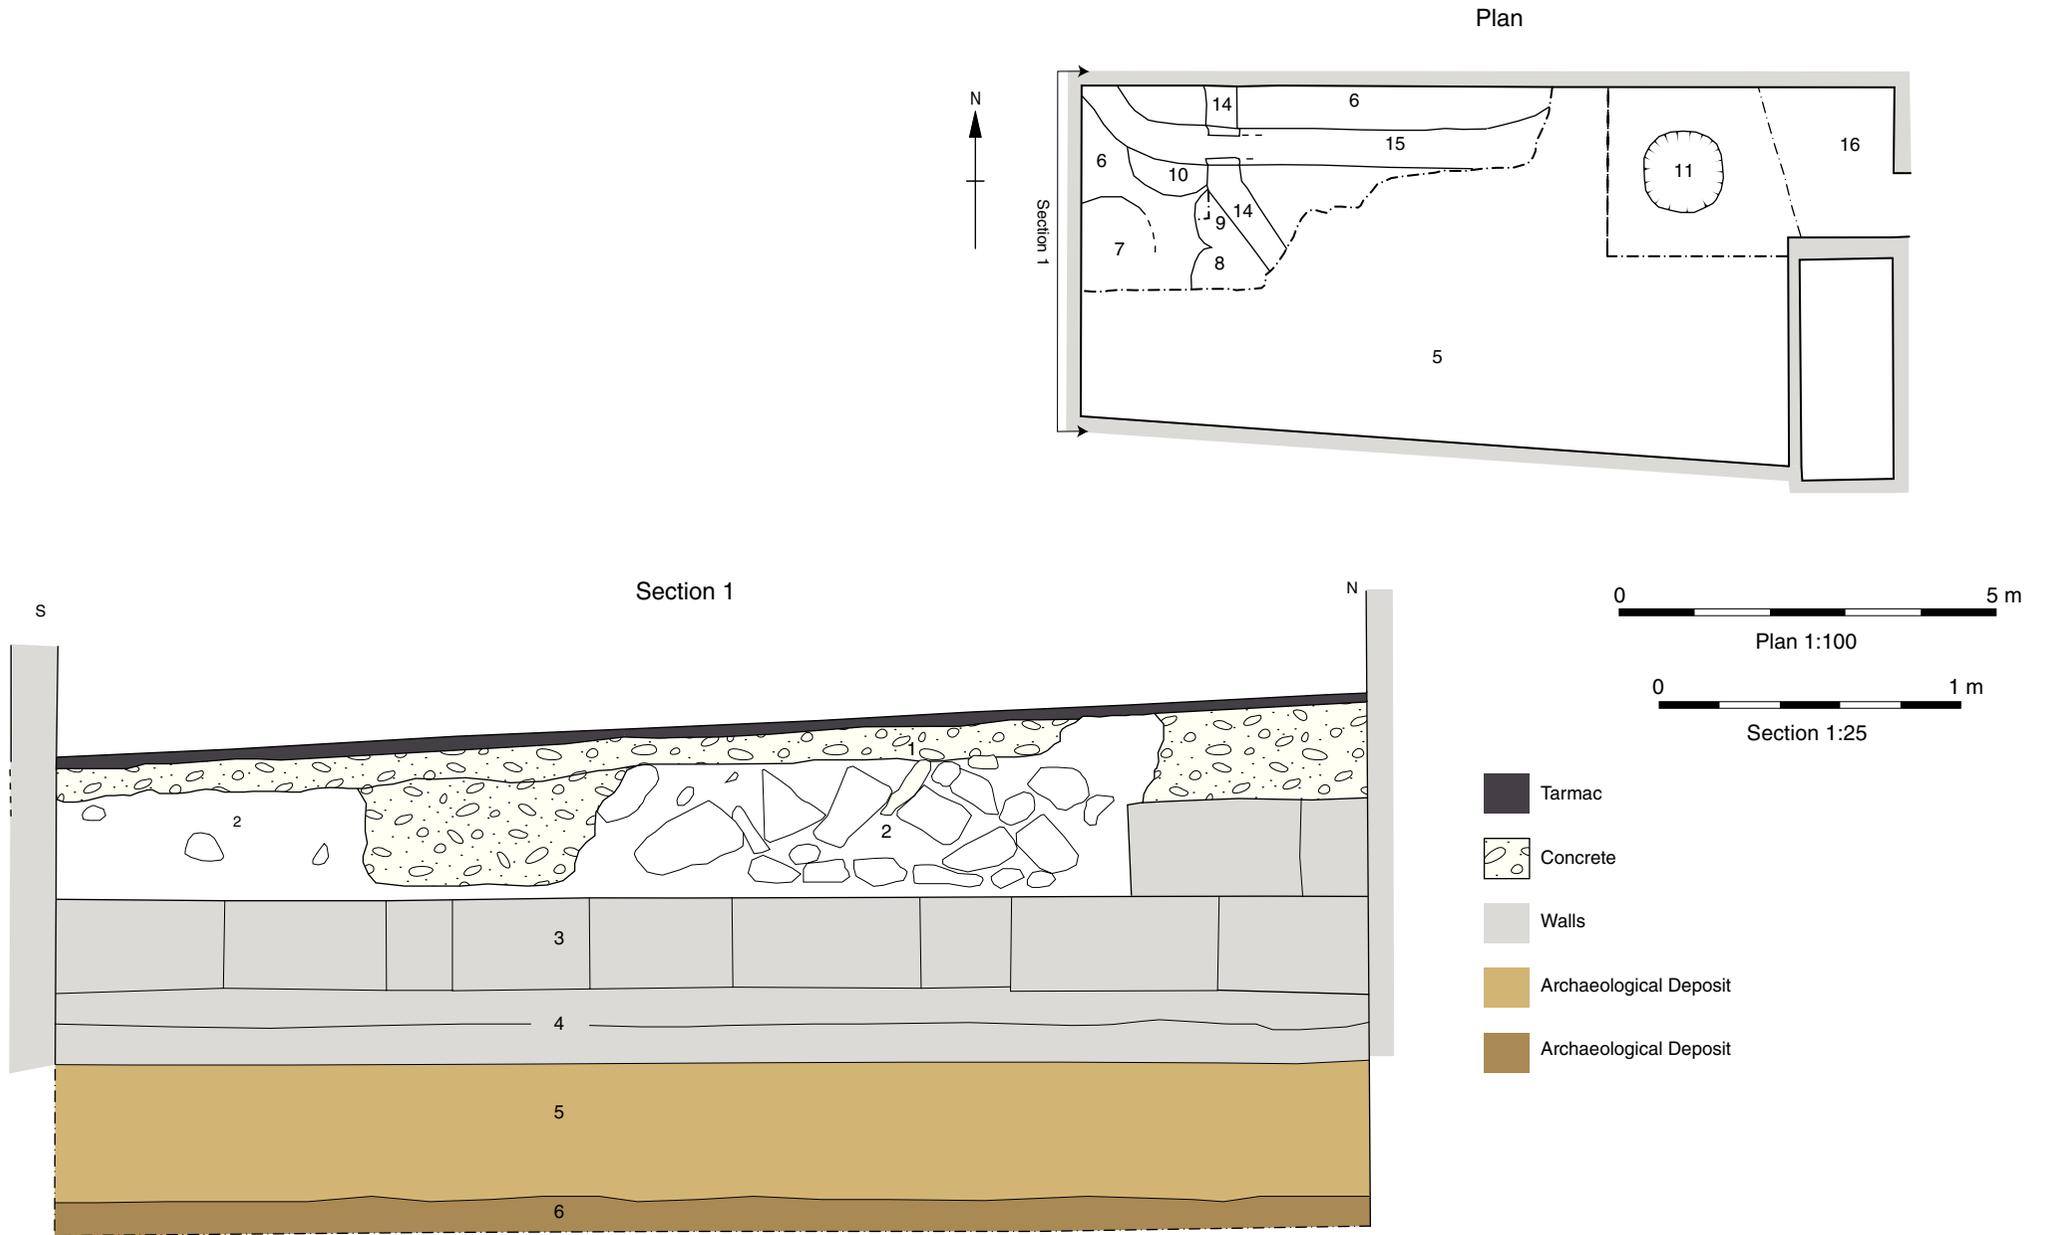
Figure 3: Plan of archaeological features and Section 1

- 3.1.3 At least four other pits were recorded at the west end of the site (7, 8, 9 & 10, Fig. 3), but were almost certainly part of a larger group of intercutting pits, whose combined fill is considered to be layer 6, originally thought to be a layer under 5 and over the natural (which was not seen at this end of the site). A small section was excavated into the top 0.15 m of pit 9 and this produced a sherd of 11th/12th century cooking pot and a sheep/goat jaw.

- 3.1.7 This had been cut into by (and probably continued to build up against) the original rear wall of the demolished extension to the existing building, which had an angled west wall. Its footings were seen as stone foundations (14, Fig. 3) which matched the scars on the north and south walls. It had been extended westwards at a later date to the position of section 1 (Fig. 3 and Pl. 2).

- 3.1.8 Contemporary with these footings and passing through them was a ceramic drain and its trench and fill (15, Fig. 3).

- 3.1.9 The rear wall of the demolished extension still survived as a single surviving course of ashlar at the west end of the site, a typical 0.31 m (or 12") high (3). It rested on two courses of Bath stone rubble, together 0.23 m (9") high, the foundation of the wall (4, section 1, Fig. 3).
- 3.1.10 The latest deposits were recorded at the west end of the site and were the surface and makeup of the adjacent car park. The tarmac (1) was laid over a discontinuous concrete raft, itself laid over a thick layer of loose, limestone rubble with lots of big voids (2). This had clearly been retained by the wall (3).

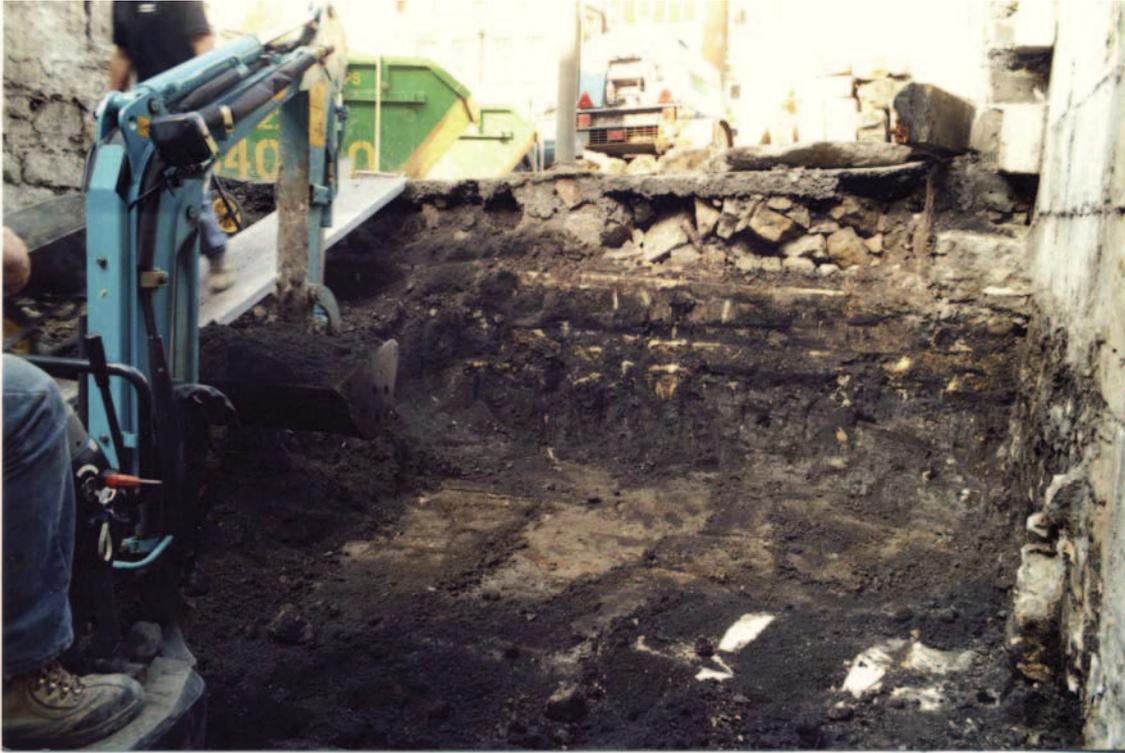
Plate 1: View westwards towards section. The ochre earth at the base is the medieval pit group fill.

- 3.1.4 The fill of the pit group (6) was a yellow-brown or ochre, firm, clayey silt. It contained the occasional bone fragment, including more sheep/goat jaws and was clearly very mixed, with 5% limestone pebbles <8 mm, limestone grit <2 mm, comminuted CBM and some pieces of slag or similar material. No further pottery was recovered. Apart from the pale colour this is a typical pit fill.

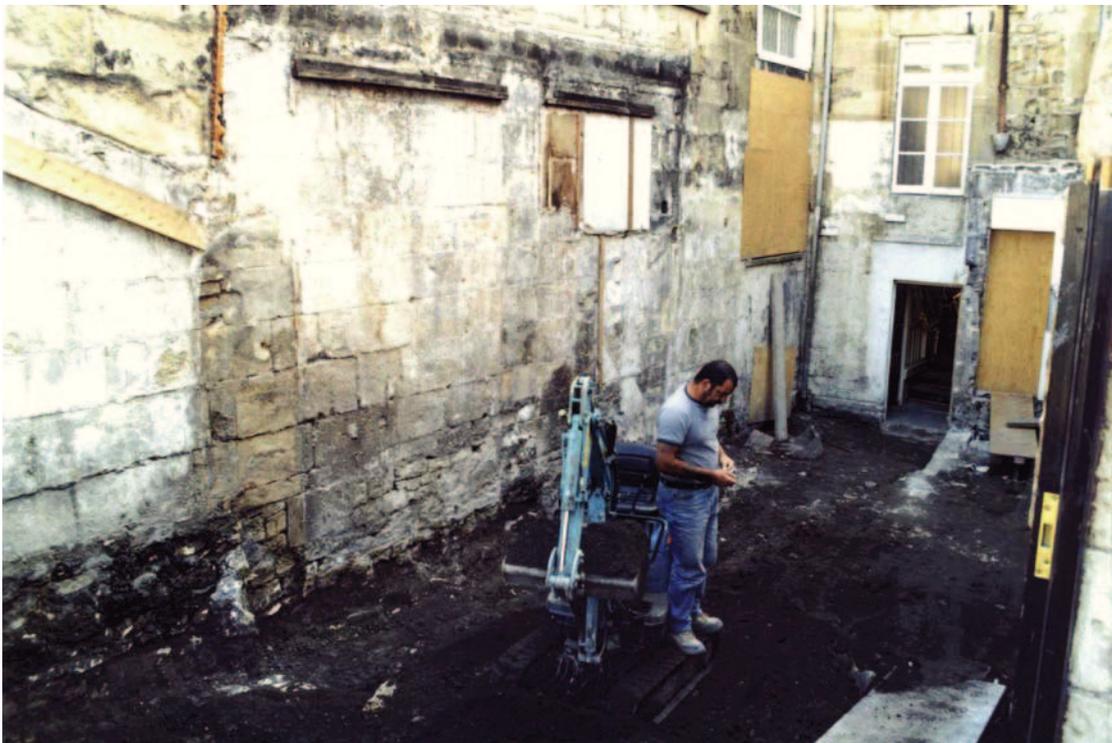
Plate 2: Looking eastwards during clearance of the post-medieval garden soil, before the discovery of pit 11, near the back door.
