Archaeological Evaluation Report

Carbon Challenge Site Glebe Court Fletton Peterborough

OA East Report No: 1372
OASIS No:
NGR: TL 195 978

**An archaeological evaluation at Carbon Challenge Site, Glebe Court, Fletton,
Peterborough**

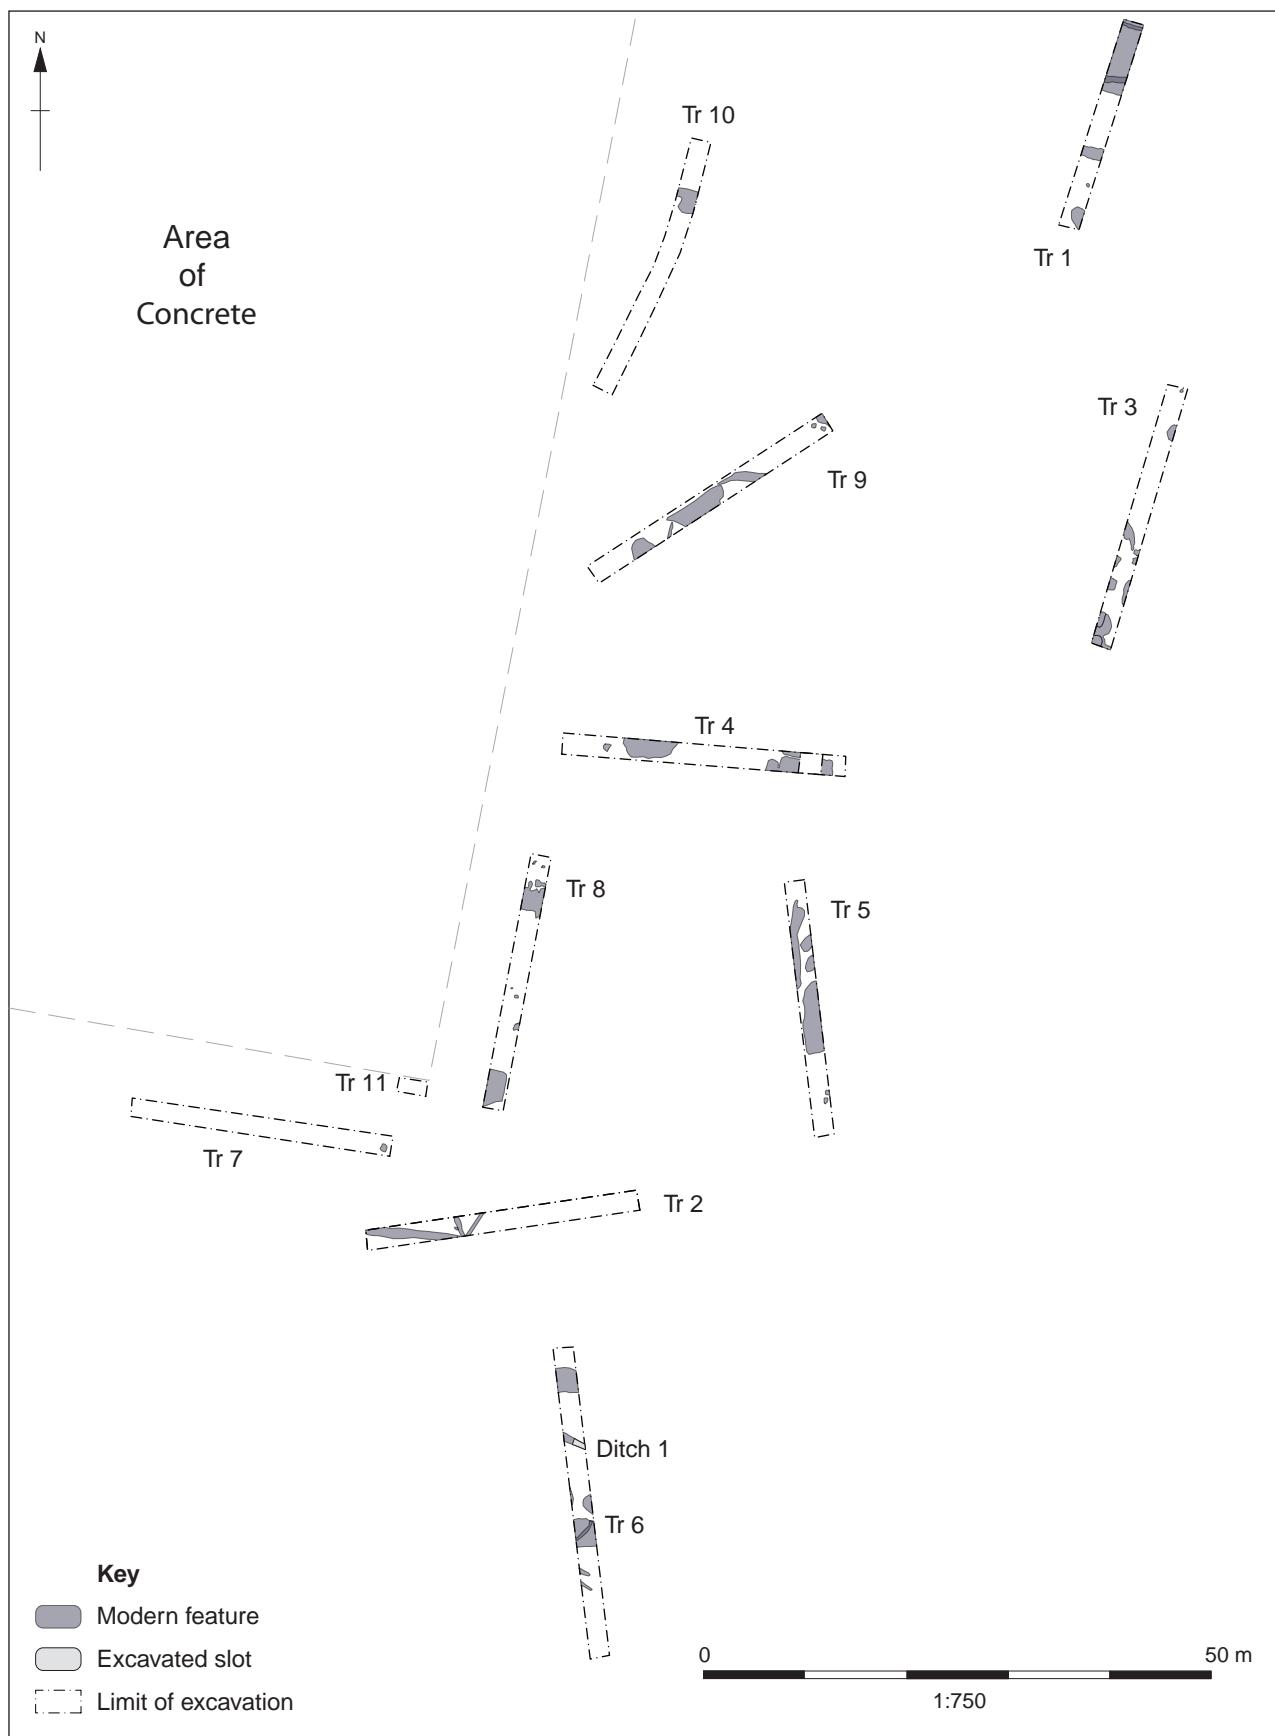
Figure 2: Trench layout showing modern features and deposits

- 3.1.1 This section is described by trench. The evaluation only found modern features with the earliest being a ditch (1) backfilled in c. AD 1800. As a consequence, only the ditch was given context numbers whilst the later features were recorded in the overall trench description sheets.

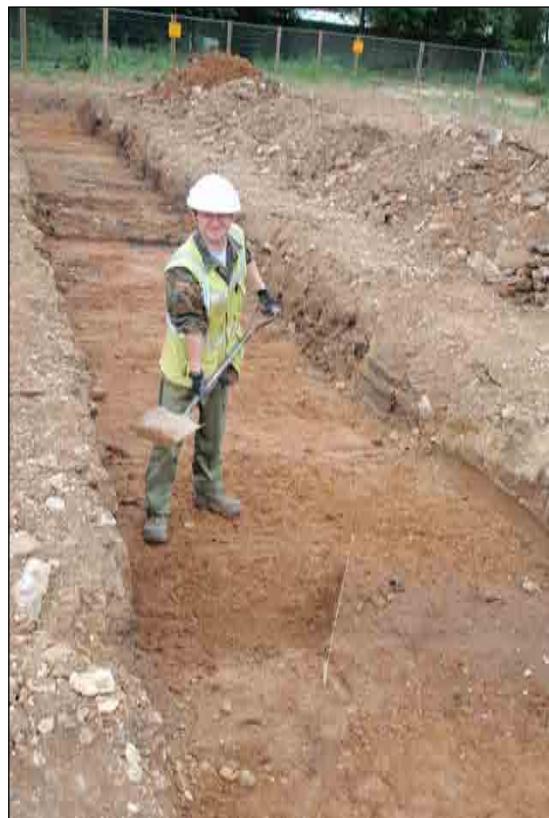
Plate 1: Ditch 1 being excavated (Trench 6)

- 3.7.1 Trench 6 , placed at the far southern part of the site, was 31m long and aligned north to south. Features were seen cutting the natural between 0.57m (northern end) and 0.66m (southern end) below the ground level. In the middle of the trench, a single north-west to south-east aligned ditch (1) appears to have been backfilled c.AD 1800 (Plate 1). It was 0.76m wide and 0.21m deep with moderate sides and a concave base. The backfill (2) was a mid greyish brown silty clay. Within this deposit there was a small collection of artefacts with four pottery sherds (two brown stoneware sherds from a bowl, a manganese glaze on a white earthenware body and a cream ware sherd from a small plate (AD 1770+)), three undiagnostic brick fragments, part of a wine bottle (late 18th to early 19th century type), a piece of iron sheet and fragments of unidentifiable animal bone. There were also two areas of modern disturbance at the northern and southern parts of the trench as well as a modern service pipe which ran north-west to south-east across the southern-middle part of the trench and was backfilled with gravel.

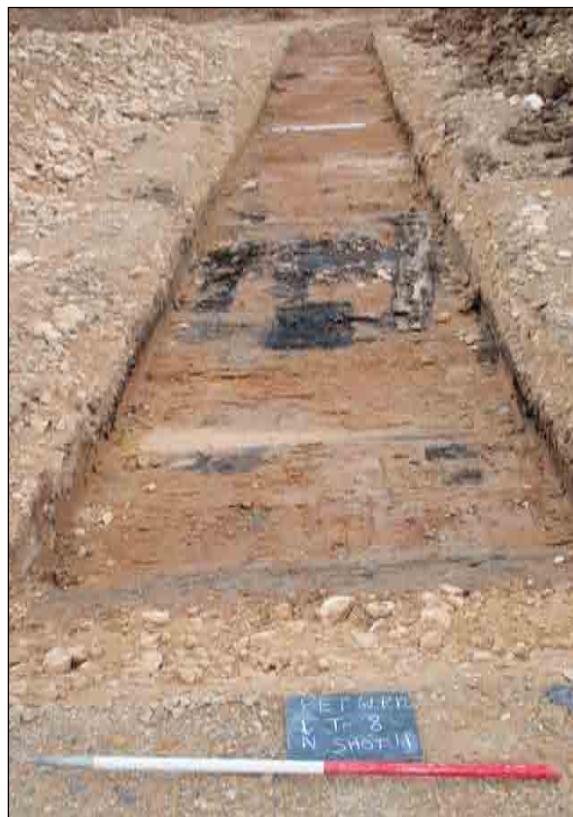
Plate 2: Trench 8 looking south with 'railway' feature within centre of trench

- 3.9.1 Trench 8 was positioned in the middle of the site, directly to the east of the concrete area, and was aligned north to south (Plate 2). A number of features were seen cutting the natural sands and gravels including what was probably part of the former 20th century railway line, within a 2m-wide area at the far northern extent of the trench. This comprised two parallel wooden sleeper planks, c.1.2m apart, inbetween which was a layer of crushed brick pieces within a black ashy deposit (Plate 2). There were also several small pits filled with a similar ashy deposit within different parts of the trench and these are also likely to have been related to the railway. An area of disturbance was located at the extreme southern extent which may have been either 19th or 20th century in date. These modern features were sealed by a 0.15 thick black layer which was in turn sealed by a 0.25m-0.3m thick deposit of hardcore.

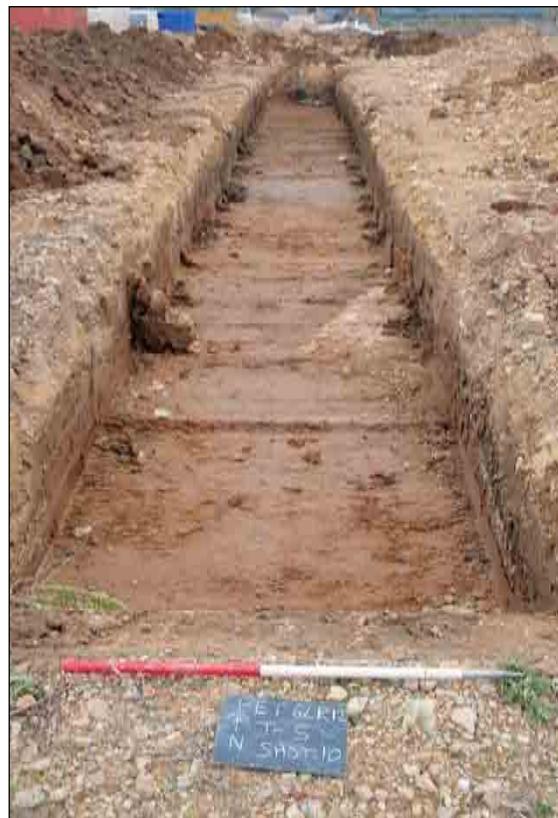
Plate 3: Trench 5 looking north showing feature comprising perforated bricks

- 3.6.1 Trench 5 was in the south-eastern part of the site, it was 30m long and aligned north to south (Plate 3). Features were seen cutting the natural orange sands across the trench. In the southern part of the trench remains of part of a brick feature either square or rectangular in shape was identified that would have been an internal floor of a building. It comprised early perforated bricks laid in rows, with the bricks having two round holes located near either ends. Perforated bricks were being patented from the c.1830s by

Robert Beart of Godmanchester and manufactured at his Huntingdon brickworks. It is likely the bricks on the site date to the mid to late 19th century and this was presumably a small structure built for the railway sidings. In the middle of the trench there was a disturbed area over 7m wide with natural recorded at 0.9m below ground level. Modern features were also recorded at the far northern part of the site.

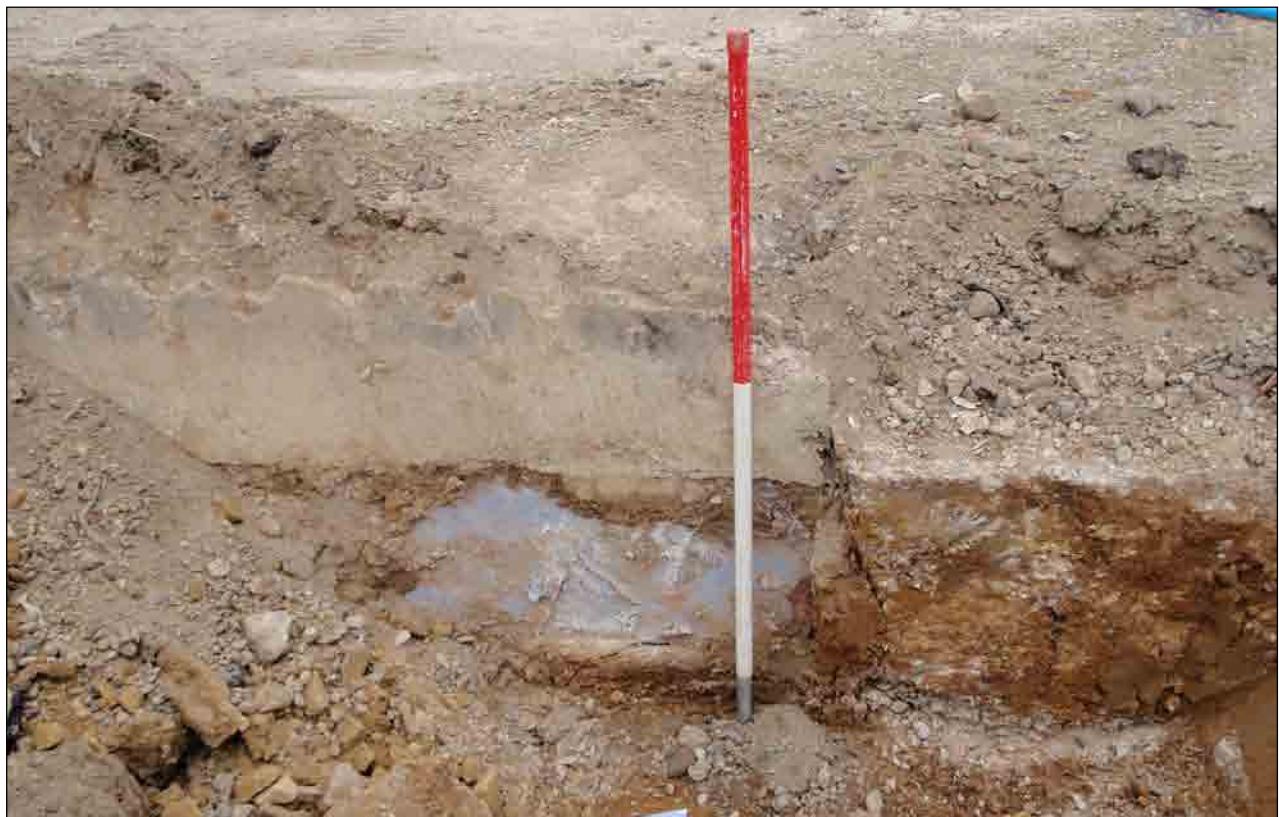
Plate 4: Trench 11 looking north showing reinforced concrete rafts and concrete pillar

3.12.1 A small trench, c.2.5m long and 1m wide, was located at the south-eastern corner of the concrete area (Plate 4). At the corner, the trench found a large concrete pillar still extending into the ground. Directly to the west there was a 0.1m thick area of disturbance sealing the natural gravel. This was overlain by a 0.35m thick concrete block which was in turn sealed by a 0.4m thick concrete slab.
