St Mary the Virgin Church
Long Crendon
Buckinghamshire

**Archaeological
Watching Brief Report**

September 2008

**Client: Acanthus Clews
Architects**

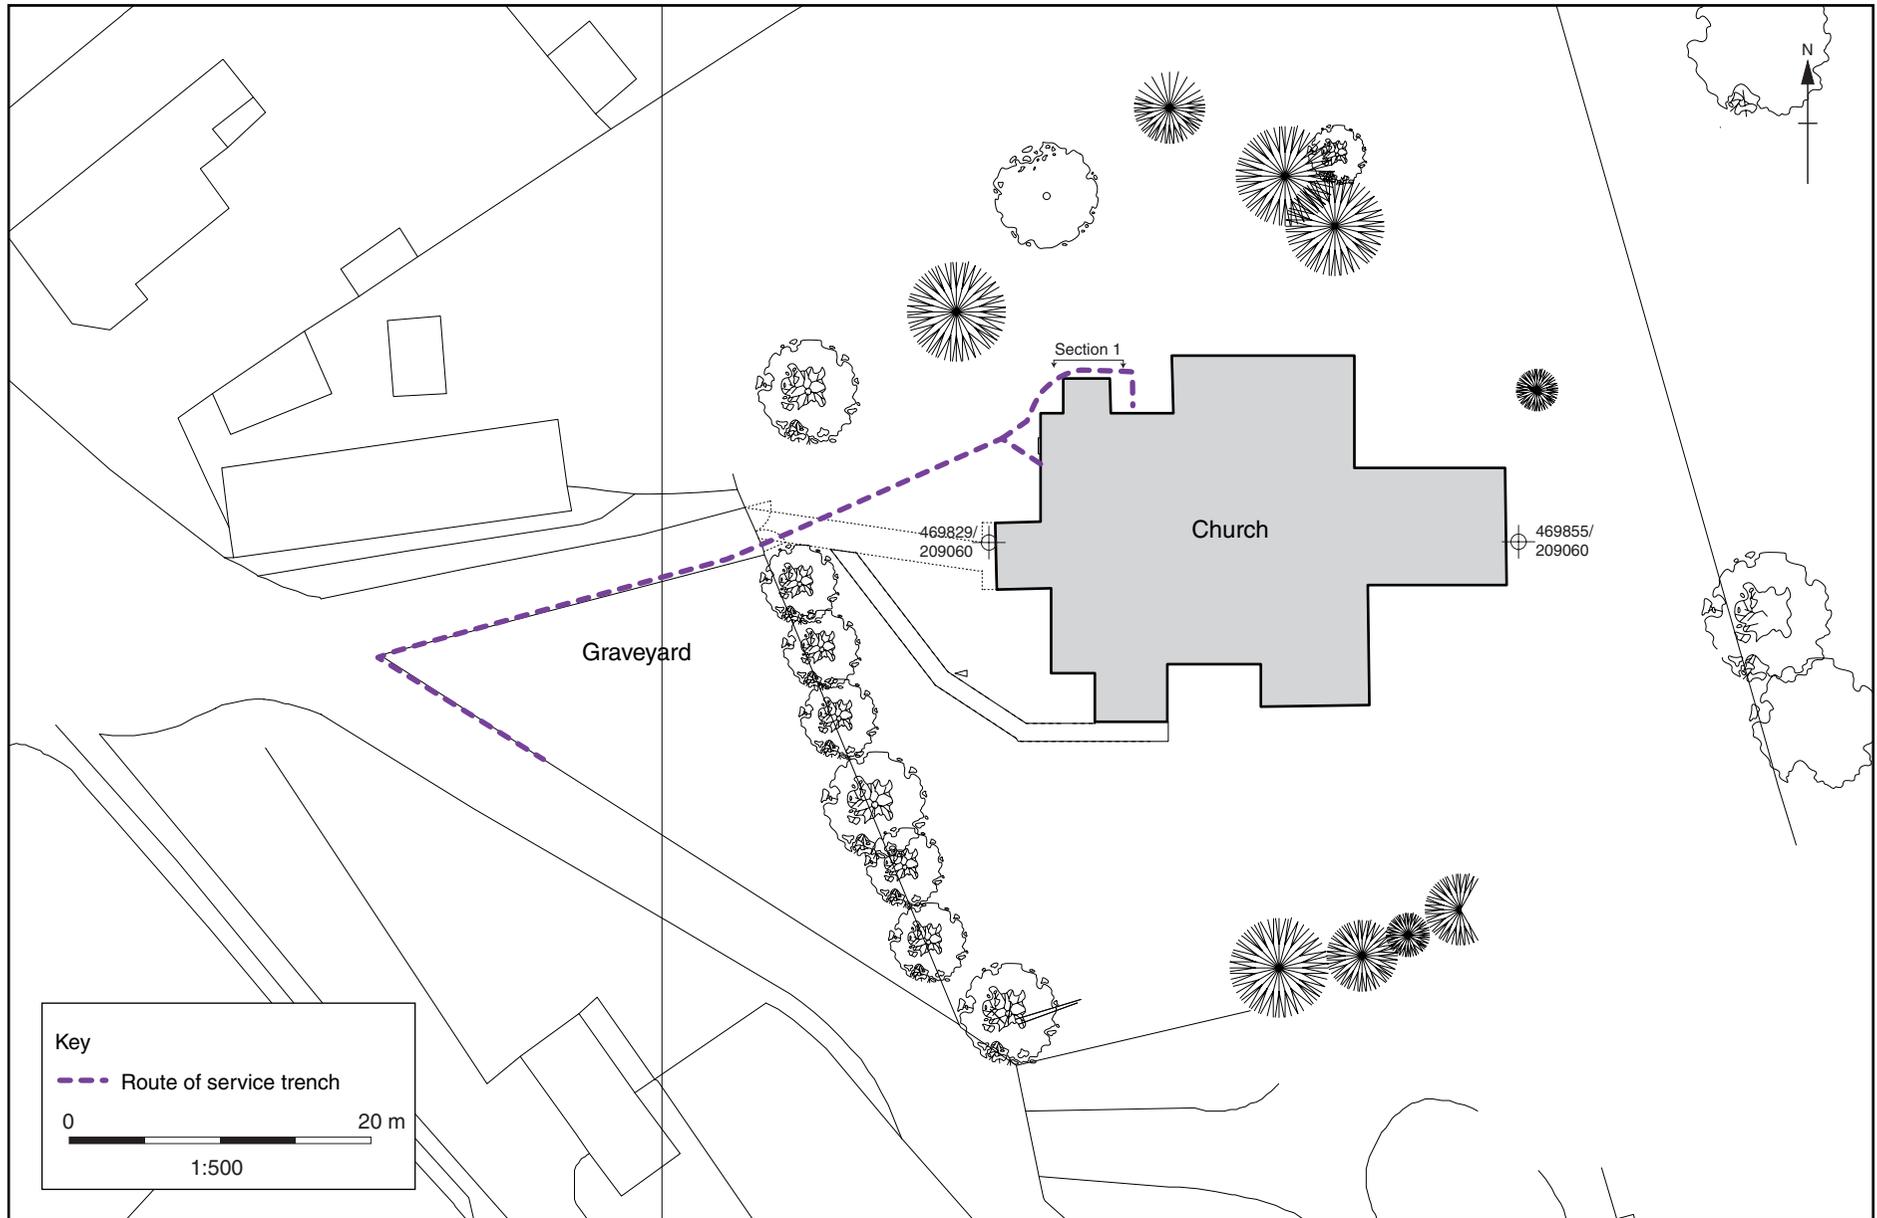
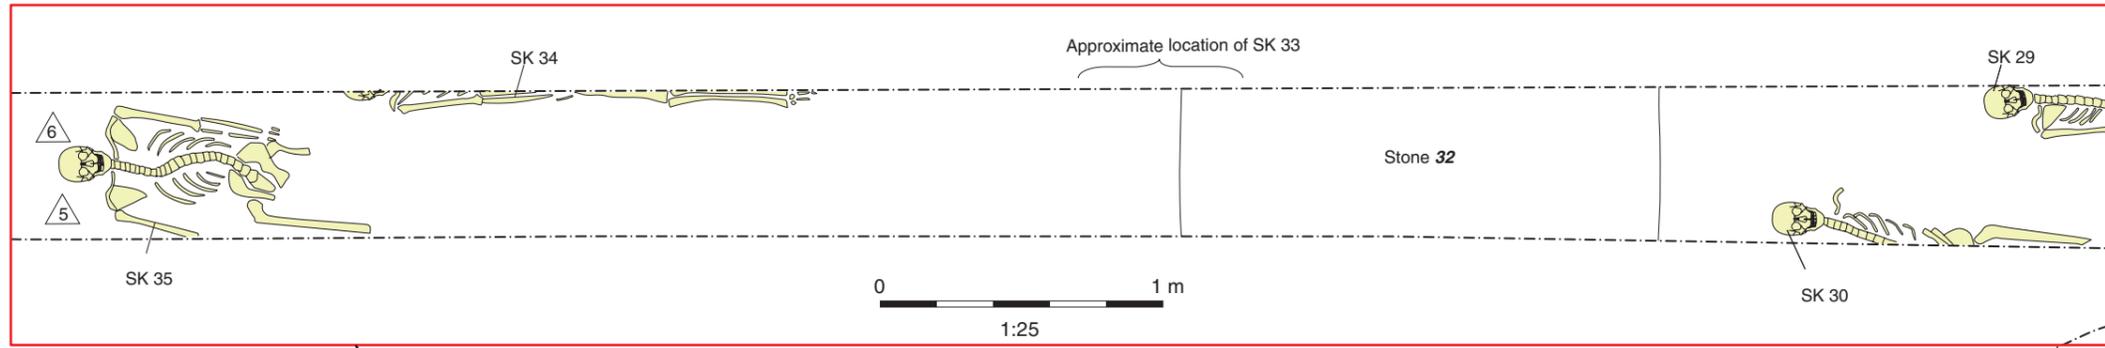
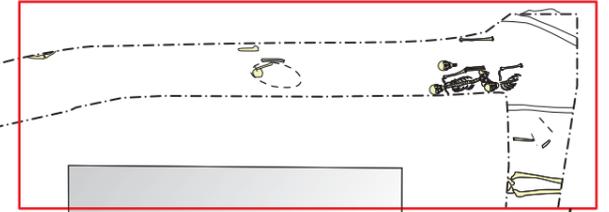
Figure 2: Plan showing Church and route of service trench

- 3.1.1 The first section of the trench (4.60 m) ran south- north and was located to the north of the church building. The trench turned south- west (c. 22.0 m) just beyond the north porch of the church, and extended to the existing entrance gate and boundary wall of the churchyard. The new drainage pipe within the trench is to connect to an existing mains foul water drain that runs along Church Road under the present tarmac surface of the road, and bordering the present cemetery (Fig. 2).
- 3.1.2 The trench was approximately 0.65 m wide throughout. Its depth was 1.40 m below the present ground level.
- 3.1.3 The underlying natural geology (31), a compact yellow clay deposit with sparse small (<2cm) inclusions, was only found in one part of the trench, below skeletons 29 and

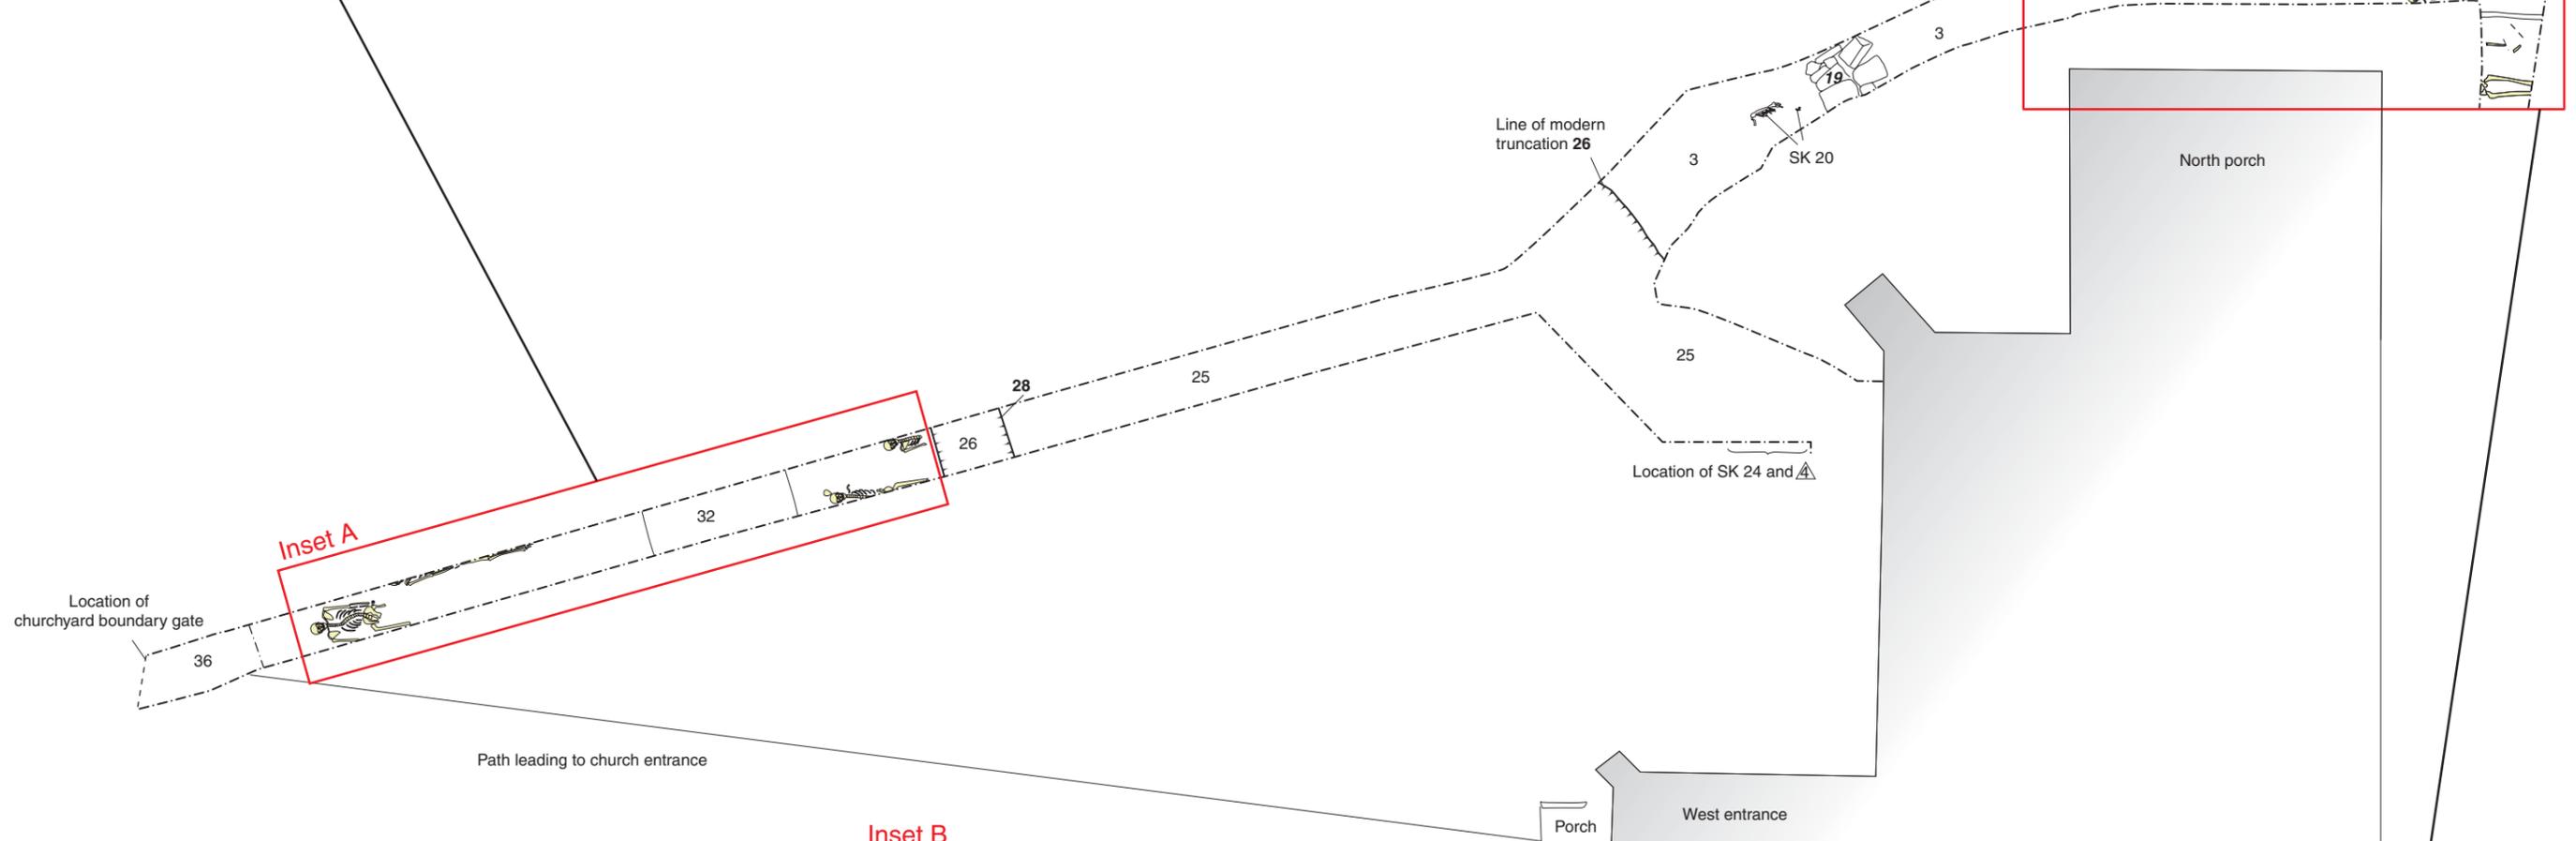
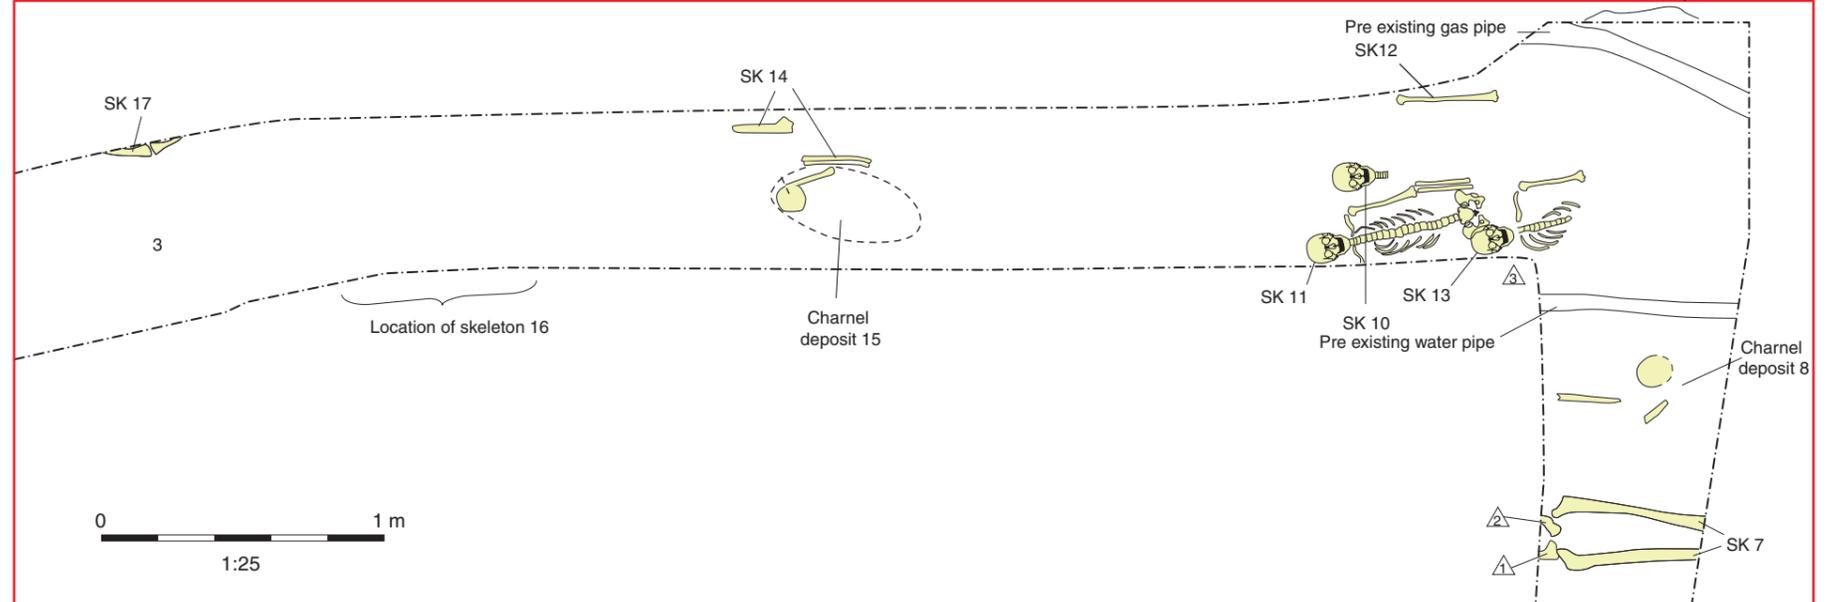
Figure 3: Plan showing the location of burials

- 3.4.2 A total of 15 skeletons were excavated and recorded (Fig. 3). For health and safety reasons (collapsing sections), three skeletons could not be recorded *in situ*. These were skeletons 16, 24 and 33. Their location is shown in Fig. 3.

3.4.11 A large quantity of disarticulated bone was recovered across the site. Several discrete channel deposits were identified (e.g. deposits 8 and 15 (Fig. 3)). These clusters of bones did not appear to have been deposited within a clearly defined cut. Most of the channel was probably the result of disturbing earlier graves when digging new ones. Modern disturbance (such as service trenches) would have also contributed to the presence of disarticulated bone.

- 4.1.4 The density of burial activity varied considerably in the trench, with areas of frequent intercutting graves (e.g. skeletons 7, 10, 11 and 13 (Fig. 3)) interspersed with areas of less intercutting. This pattern may not reflect the true distribution of graves within the churchyard, however, as it reflects only those burials that were shallower than the impact level. Due to the difficulty in distinguishing grave cuts within the graveyard soil, it was impossible to identify the location of deeper burials. Given the probable longevity of burial on this site, a much higher density of burial is probable than that reflected in this watching brief.

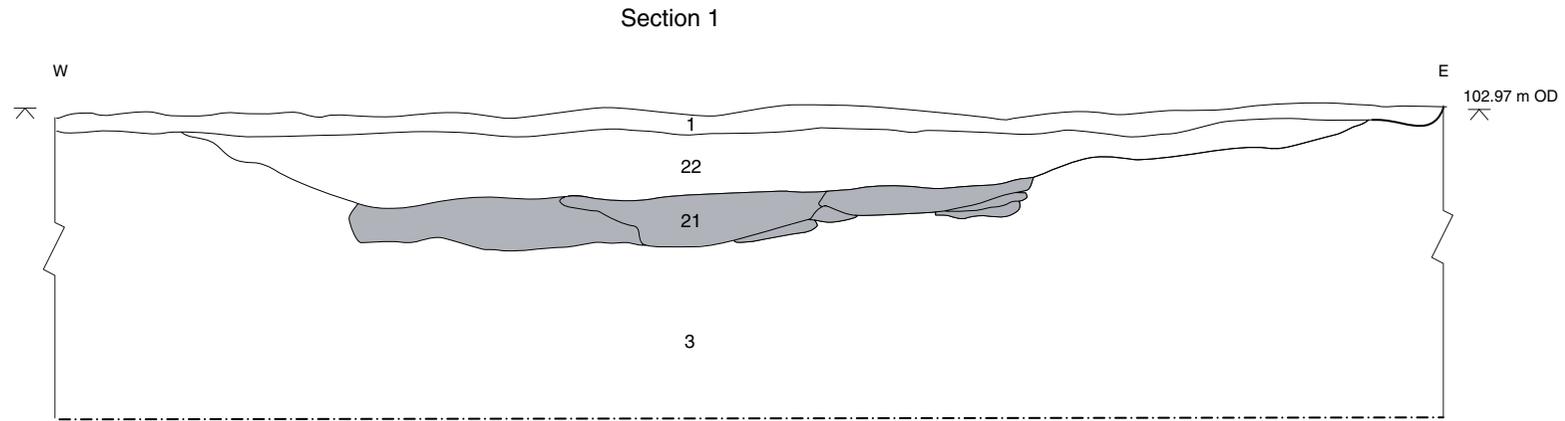
Figure 4: Section 1

- 3.1.5 A layer of irregular limestone slabs was encountered north of the northern porch of the church building (Fig. 4). This was later interpreted as a possible path leading from the northern porch aligned south- north direction.
