Linney Head Promontory Fort
Castlemartin
Pembrokeshire

Archaeological Recording

April 2005

Document Type: Archaeological Investigation Report

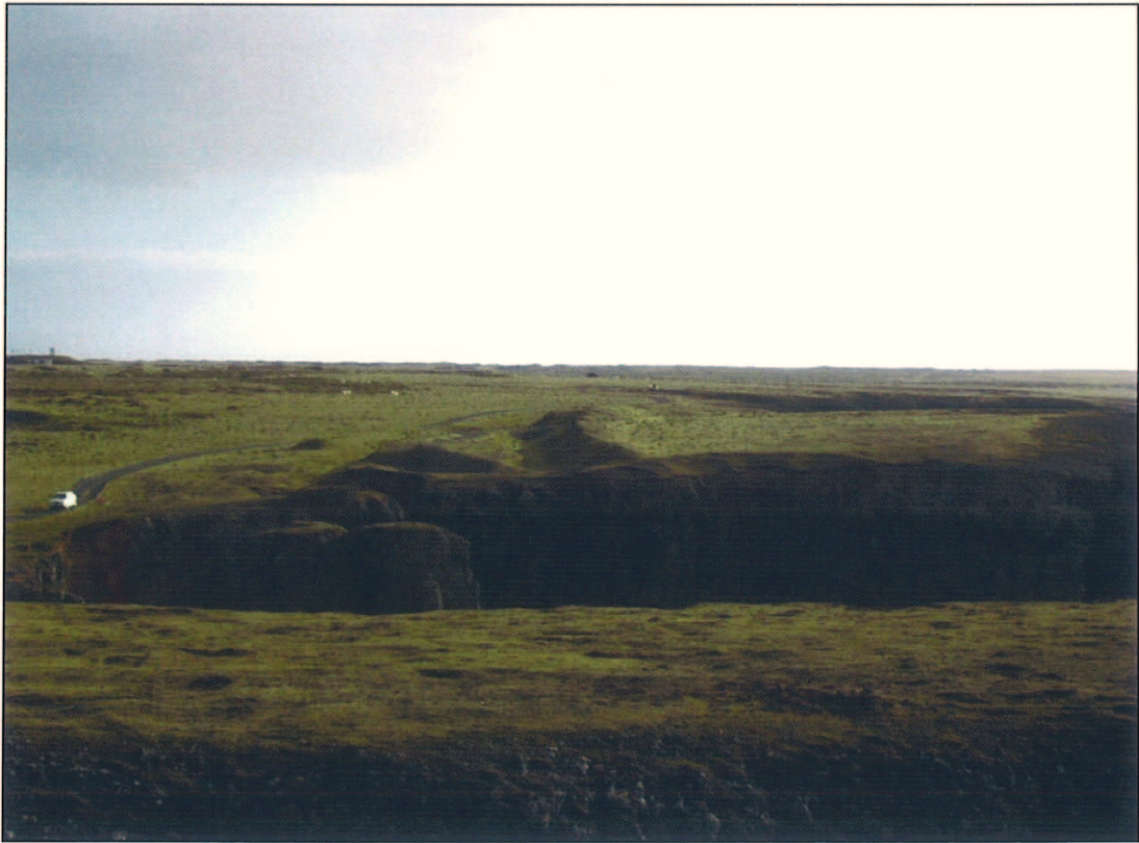
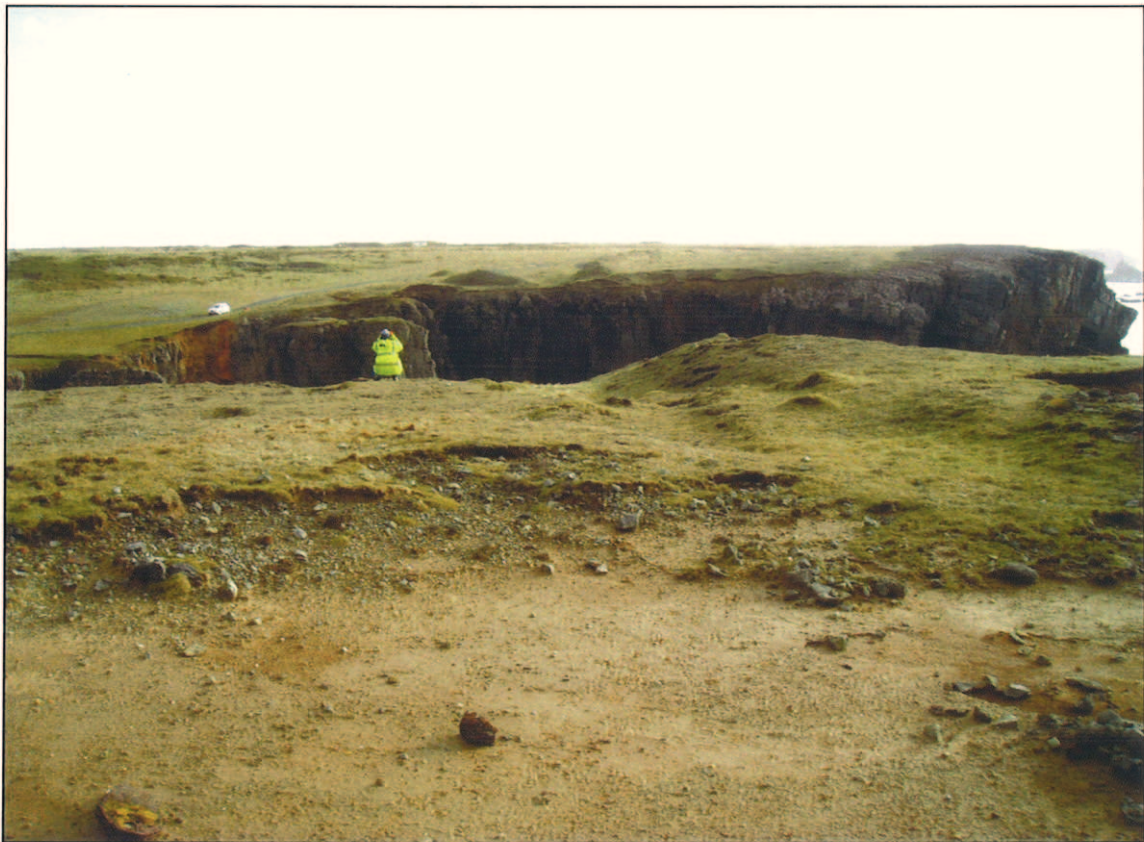
Figure 3: Linney Head fort, general site view

Linney Head main fort, outer ramparts (view to the east)

View to the east, with main ramparts in the foreground and the newly identified rampart in the foreground

- 3.2.1 The exposed section was recorded photographically, from the adjacent promontory to the west, as the section is unsafe to approach. Views were taken of the overall appearance of the structure, the area exposed by erosion, the section's relationship to its setting and particular structural and constructional details (figs 3-6).

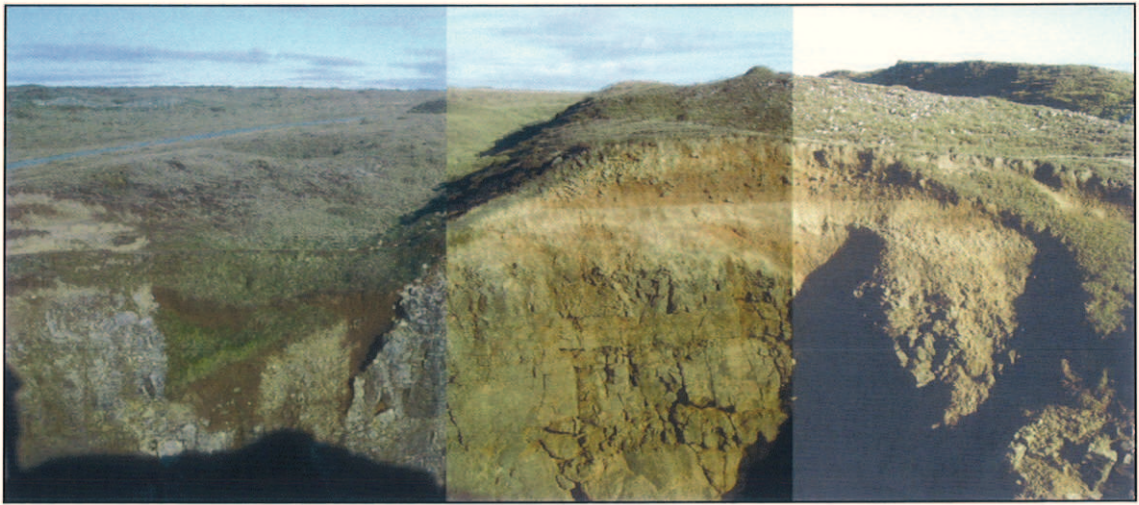
Figure 4: Close-up views of the eroded sections

- 4.2.1 The stratigraphy of the outer rampart of the fort was clearly exposed in section (fig. 4). The rock-cut ditch has steep sides and a flat base. It is filled with reddish brown soil containing some medium to large stone inclusions. There are no obvious layer

distinctions within the fill, although part of the section is obscured by grass growth. The rampart bank, immediately to the south, is composed of reddish brown soil with moderate inclusions of medium to large stones. It is revetted on its outer (northern) side by a substantial deposit of large stones with little soil visible between them. No revetment can be seen on the inner face of the rampart, although this is partially obscured by vegetation growth. The stony deposit seals a thin layer of soil identical in colour to the rampart core, but lacking stone inclusions. This may represent a pre-rampart buried soil. Below this is an earlier buried soil, forming a very distinct band of pale brown (possibly leached) material extending beneath the full width of the bank.

Close-up of outermost rampart and eroded section, to the east

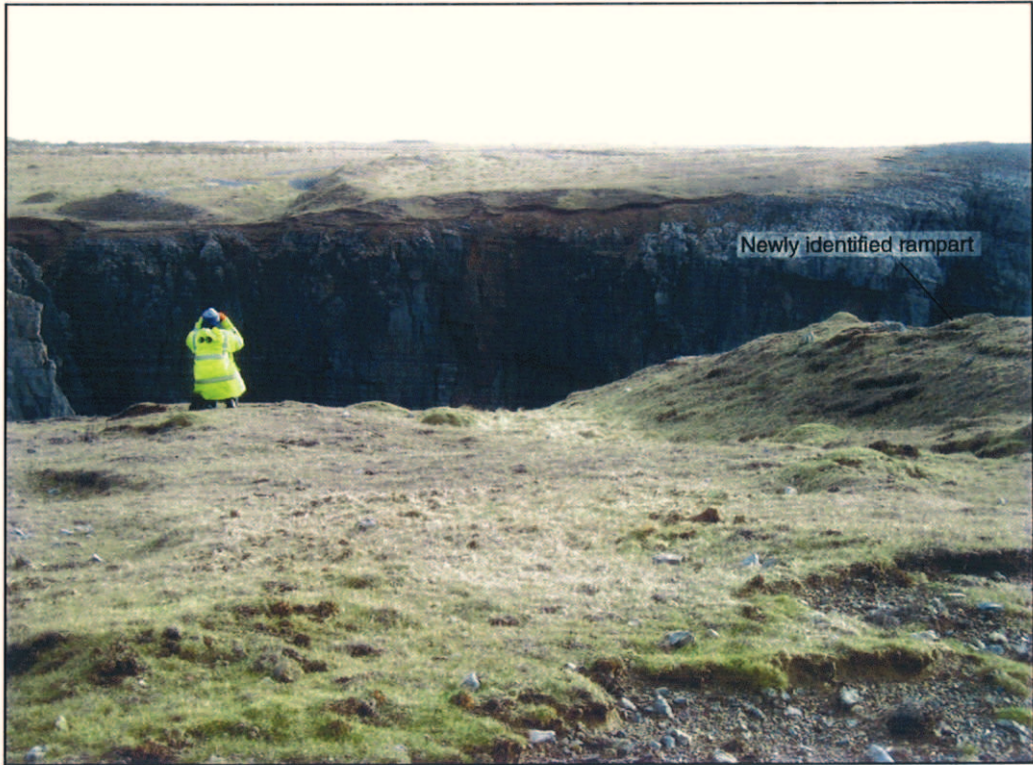
Figure 5: Newly identified rampart, photographed and rendered in 3D

- 4.1.1 The most significant result of the survey was the identification of an additional rampart on the promontory to the west of the scheduled area (fig. 5). This appears to represent an extension of the inner rampart of the fort, from which it has presumably been severed by coastal erosion. The inner rampart thus seems to have been at least 280m long in its original form, 100m longer than has previously been assumed.

Site view to the east, with the newly identified rampart in the foreground

3D models of the new rampart, results of the GPS survey

- 3.1.1 The field survey was carried out by members of OA's Geomatics Department. All survey was done using a Leica 1230 GPS rover and base unit.
- 3.1.2 The survey concentrated on geo-referencing the exposed rampart sections in advance of photographic rectification. A limited earthwork survey of the monument and the promontory to the west was also carried out. The survey results are presented in Figure 5.

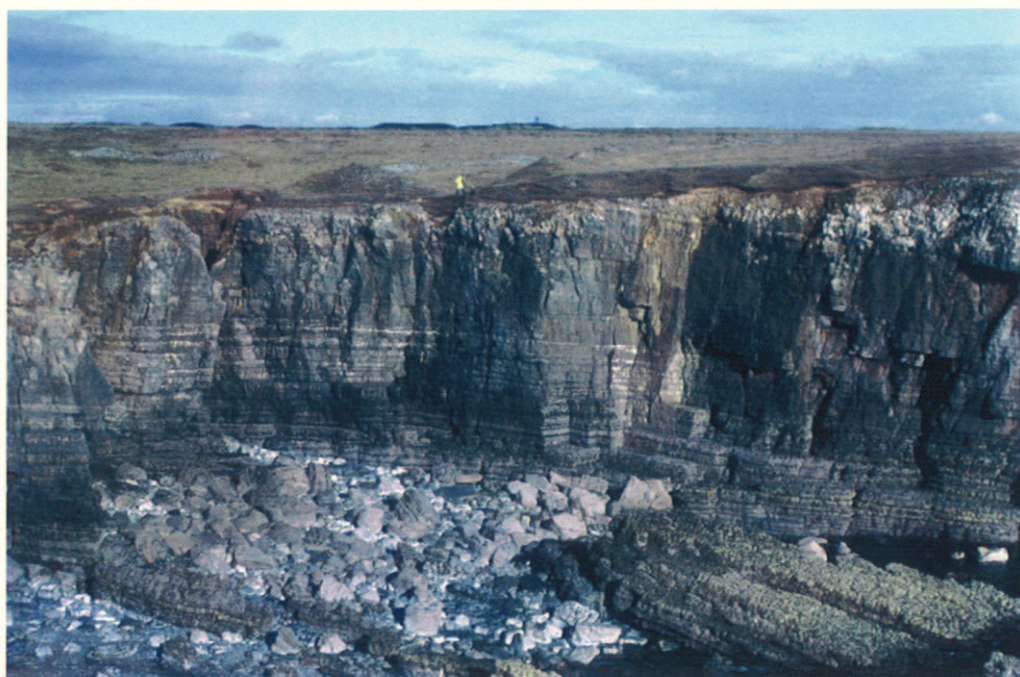
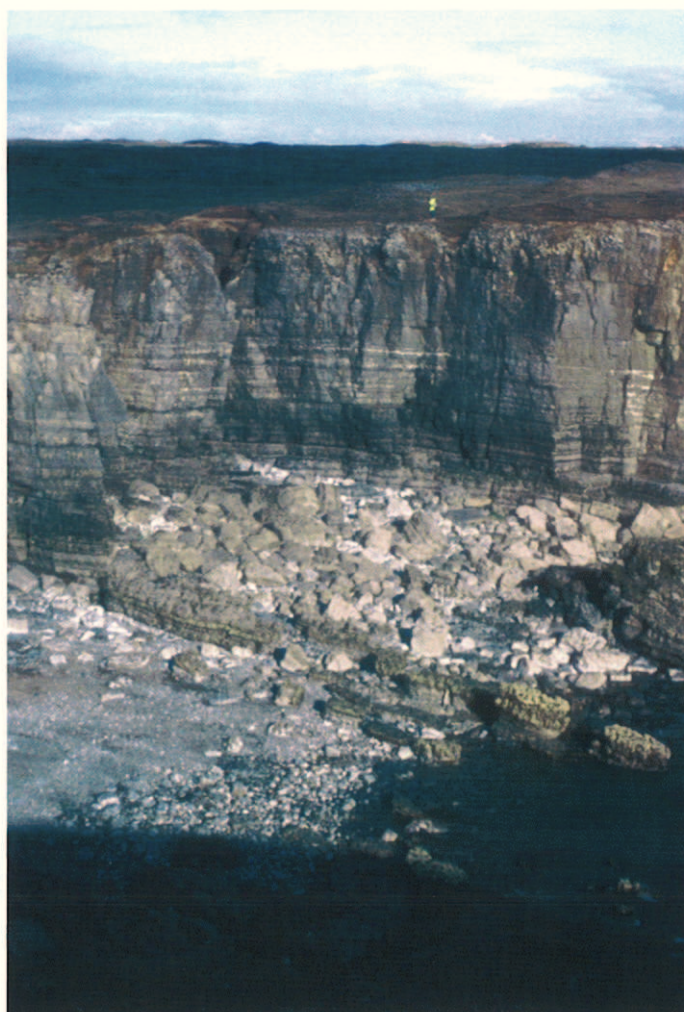
Figure 6: Panoramic view of the eroded sections, from neighbouring promontory

View of the eroded sections, looking to the east

View of the eroded sections, to the east.
