Crowback Tumulus  
Castlemartin  
Pembrokeshire

**Archaeological Survey  
and Repair**

**Document Title:** Crowback Tumulus, Castlemartin, Pembrokeshire:  
Archaeological Survey and Repair

**Document Type:** Archaeological Investigation Report

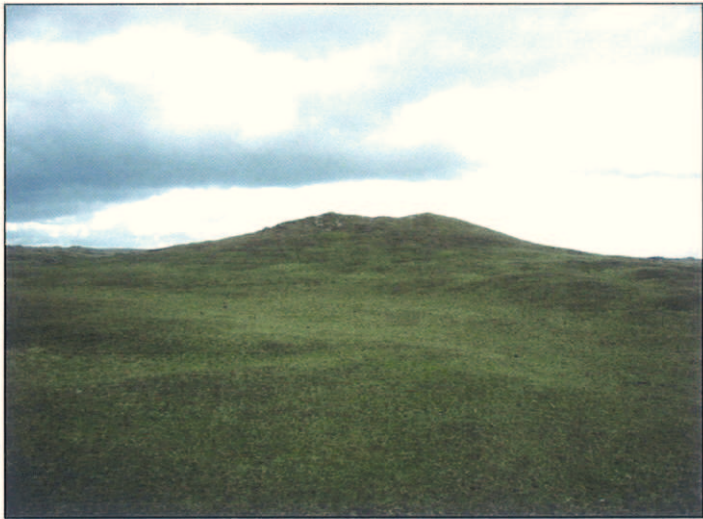
Crowback tumulus, view to the west

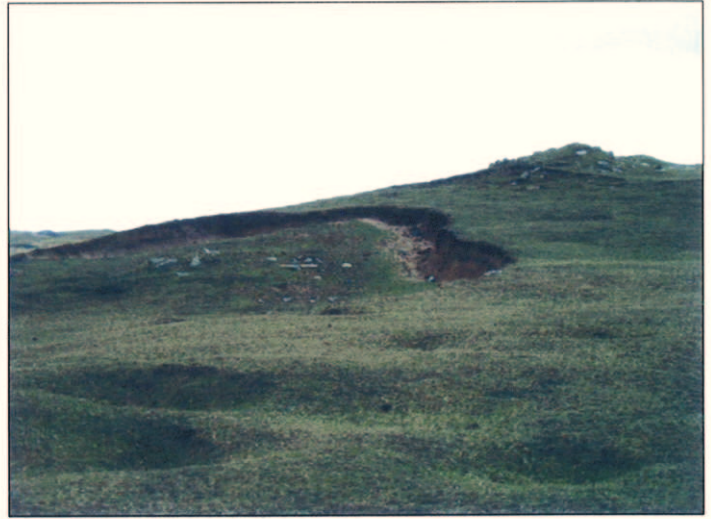
1.1.2 The work was prompted by the observation of an erosion scar on the seaward (north-western) side of the tumulus. An area of disturbance could be seen adjacent to the erosion scar, including old timbers dug into the ground, possibly the result of past military training activity. The brief called for a repair to the barrow, combined with work to record the exposed stratigraphy.

Crowback tumulus and erosion scar, view to the east

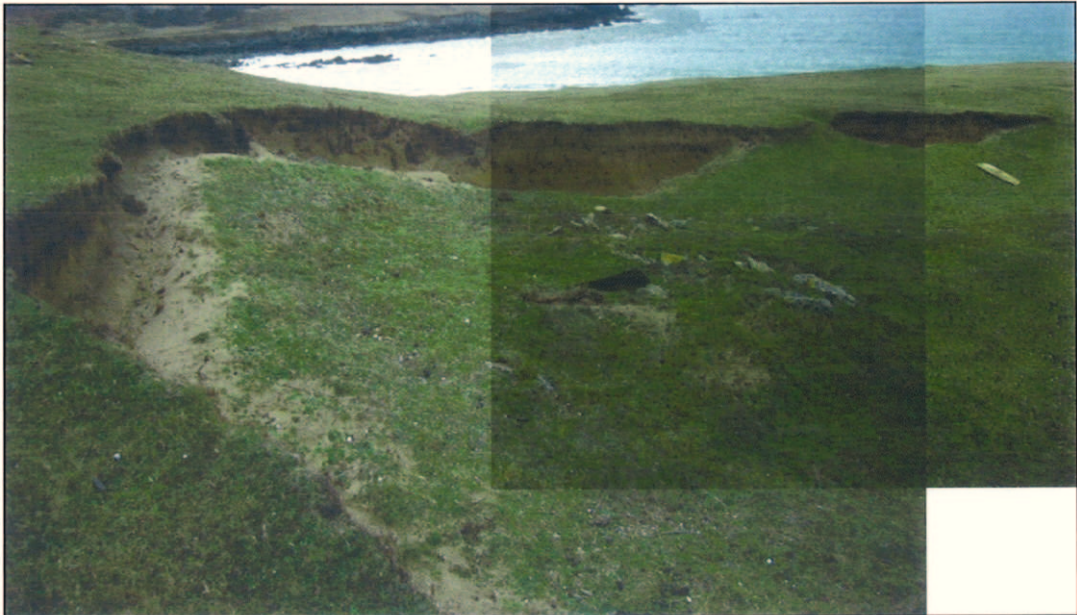
Crowback tumulus and full erosion scar, view to southwest

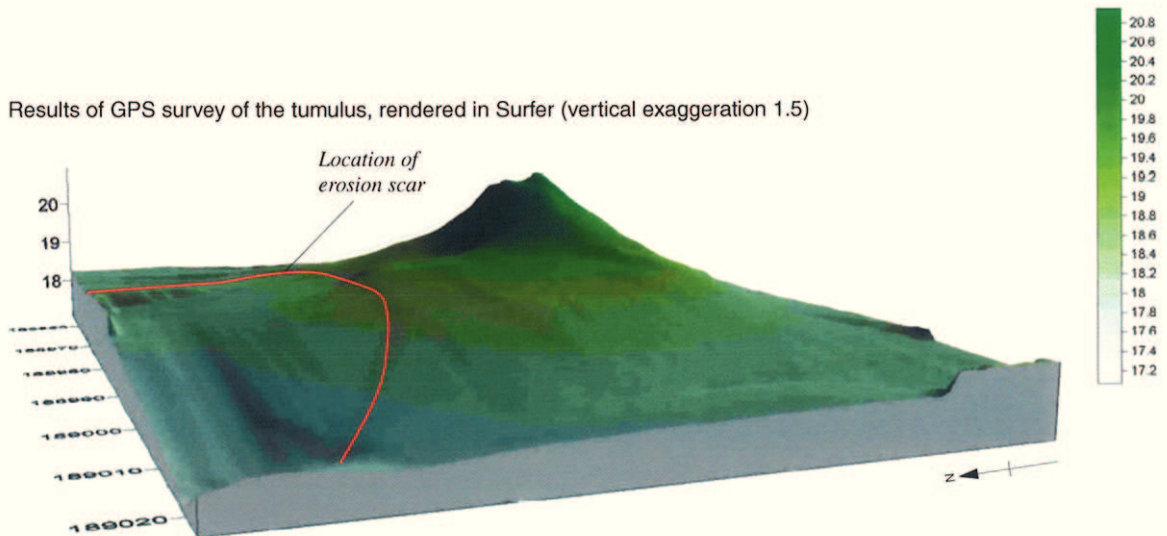
Figure 3: Crowback tumulus - general site views, showing the location of the erosion scar and the 3D survey of the site

- 3.1.1 The earthwork survey was carried out by members of OA's Geomatics Department. All survey was done using a Leica 1230 GPS rover and base unit. A static station was established at the summit of the barrow. This was followed by a walked contour survey of the monument and its environs. A spot height was recorded every 1m. The area of erosion was also surveyed prior to the repair work, as was the area authorised for soil removal (the 'borrow pit').
- 3.1.2 The condition survey results are presented in the report as a 3D contour model of the barrow (fig. 3).

Results of GPS survey of the tumulus, rendered in Surfer (vertical exaggeration 1.5)

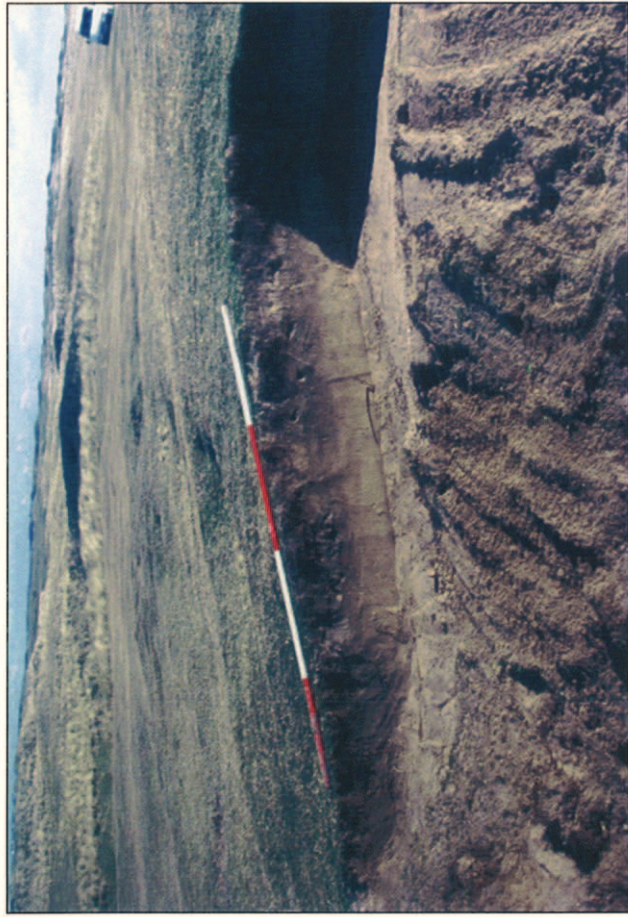
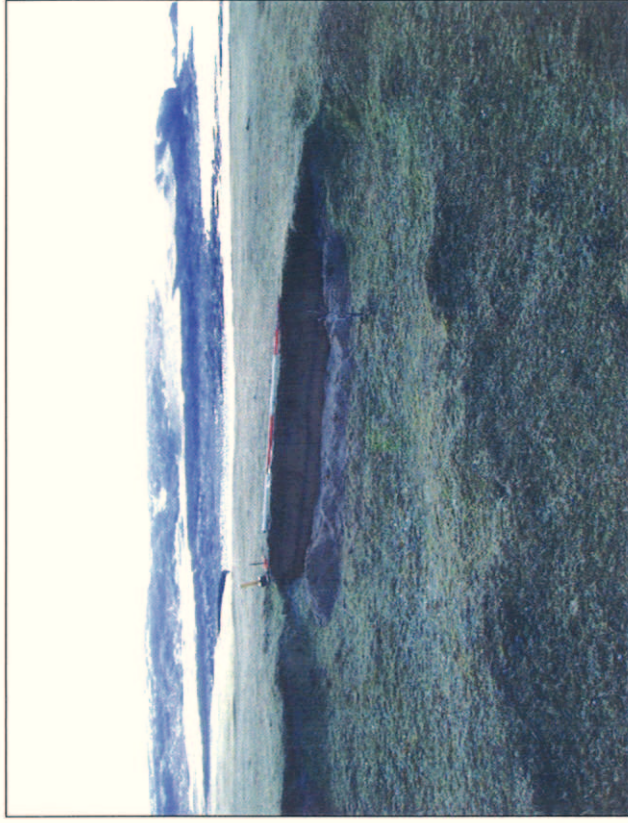
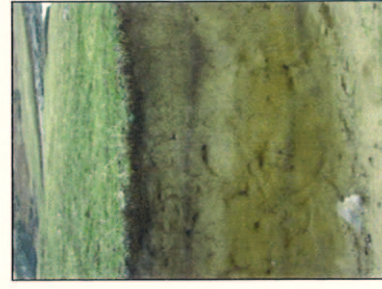
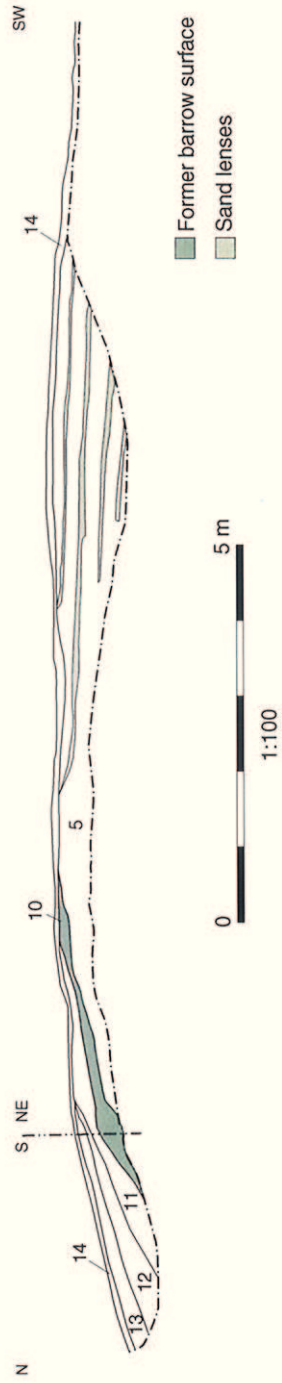
Figure 4: Eroded section, cut back and cleaned

- 4.1.1 The cleaned section was 14.75m long and up to 1.00m deep (fig. 4). The southern part of the section showed a sequence of naturally-deposited yellow sand layers separated by thin lenses of darker sand (5). These probably represent wind-blown layers, with thin turf lines becoming established between episodes of deposition. The sand deposits were overlain by a dark brown, organic-rich layer, up to 0.30m thick (10). This could well represent the turf line of the original barrow surface, suggesting that the barrow was constructed above the wind blown sand deposits. However, no horizon could be observed between the sand of the barrow 'core' and the natural sand layers beneath. The barrow turf line was overlain by three further naturally-deposited layers of sand (11-13), each up to 0.35m thick. The uppermost of these deposits lay directly beneath the modern topsoil (14).

- 5.1.1 The recorded section has revealed evidence for the probable turf line of the original barrow surface. It also showed that the monument was constructed above a sequence of natural wind-blown sand layers. As no finds were recovered, the work did not provide any further evidence as to the date of the monument.

View to southeast

View to SSW

Closeup of section

- 3.2.1 The turf was stripped from the disturbed area and kept, ready for re-use. The timbers were removed and disposed of, and the loose sand was removed and retained. The exposed section of the erosion scar was cleaned by hand, photographed and drawn.

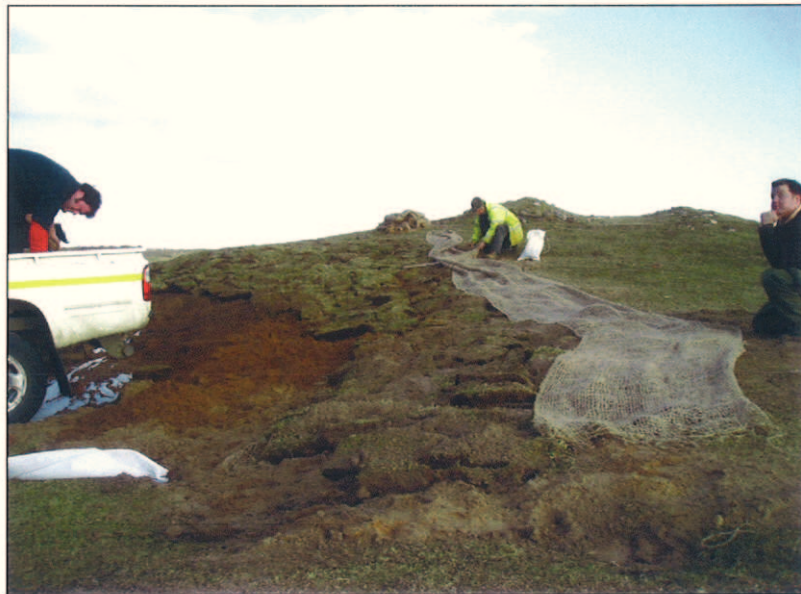
Repairs in progress - view to the east

- 3.2.2 The exposed sand area (including the vertical erosion scar) was then covered with a "Terram" geotextile membrane in order to separate the underlying archaeological horizons from the fill. The geotextile was weighted down (with stones collected from the beach) and pinned in place on the vertical slope so that it finished flush with the slope profile. No textile protruded above ground level. The disturbed sand was then replaced on top of the geotextile.

- 3.2.3 In order to provide additional in-fill material and turf, a small borrow pit was dug 50m to the south-east of the barrow (fig. 2). The turf from this pit was carefully stripped and retained for use. The pit was dug into the sand level, removing the mixed sand which was used to infill the scar in the barrow, smoothing out the profile of the mound.

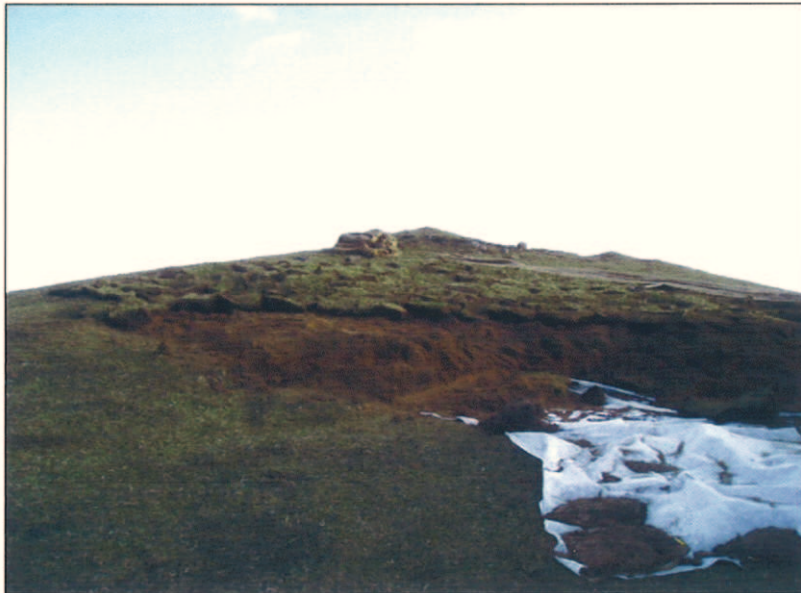
Repairs in progress - view to southeast

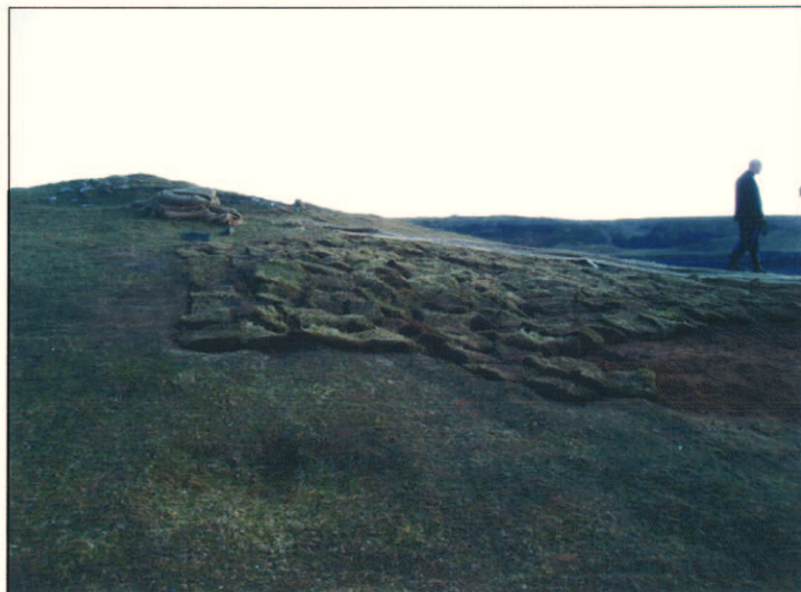
Figure 5: The repair of Crowback tumulus

Repair completed - view to south

- 3.2.4 Finally, the turf was re-laid across the repaired area. In order to encourage the vegetation to re-establish, the repaired area was overlaid with a biodegradable layer of Geojute (fig. 5).
