# Barns Associated with the former Crosse Hall, Dowgate Road Leverington, Cambridgeshire

## Historic Building Recording

**Barns Associated with the former Crosse Hall,  
Dowgate Road, Leverington, Cambridgeshire**

*Historic Building Survey*

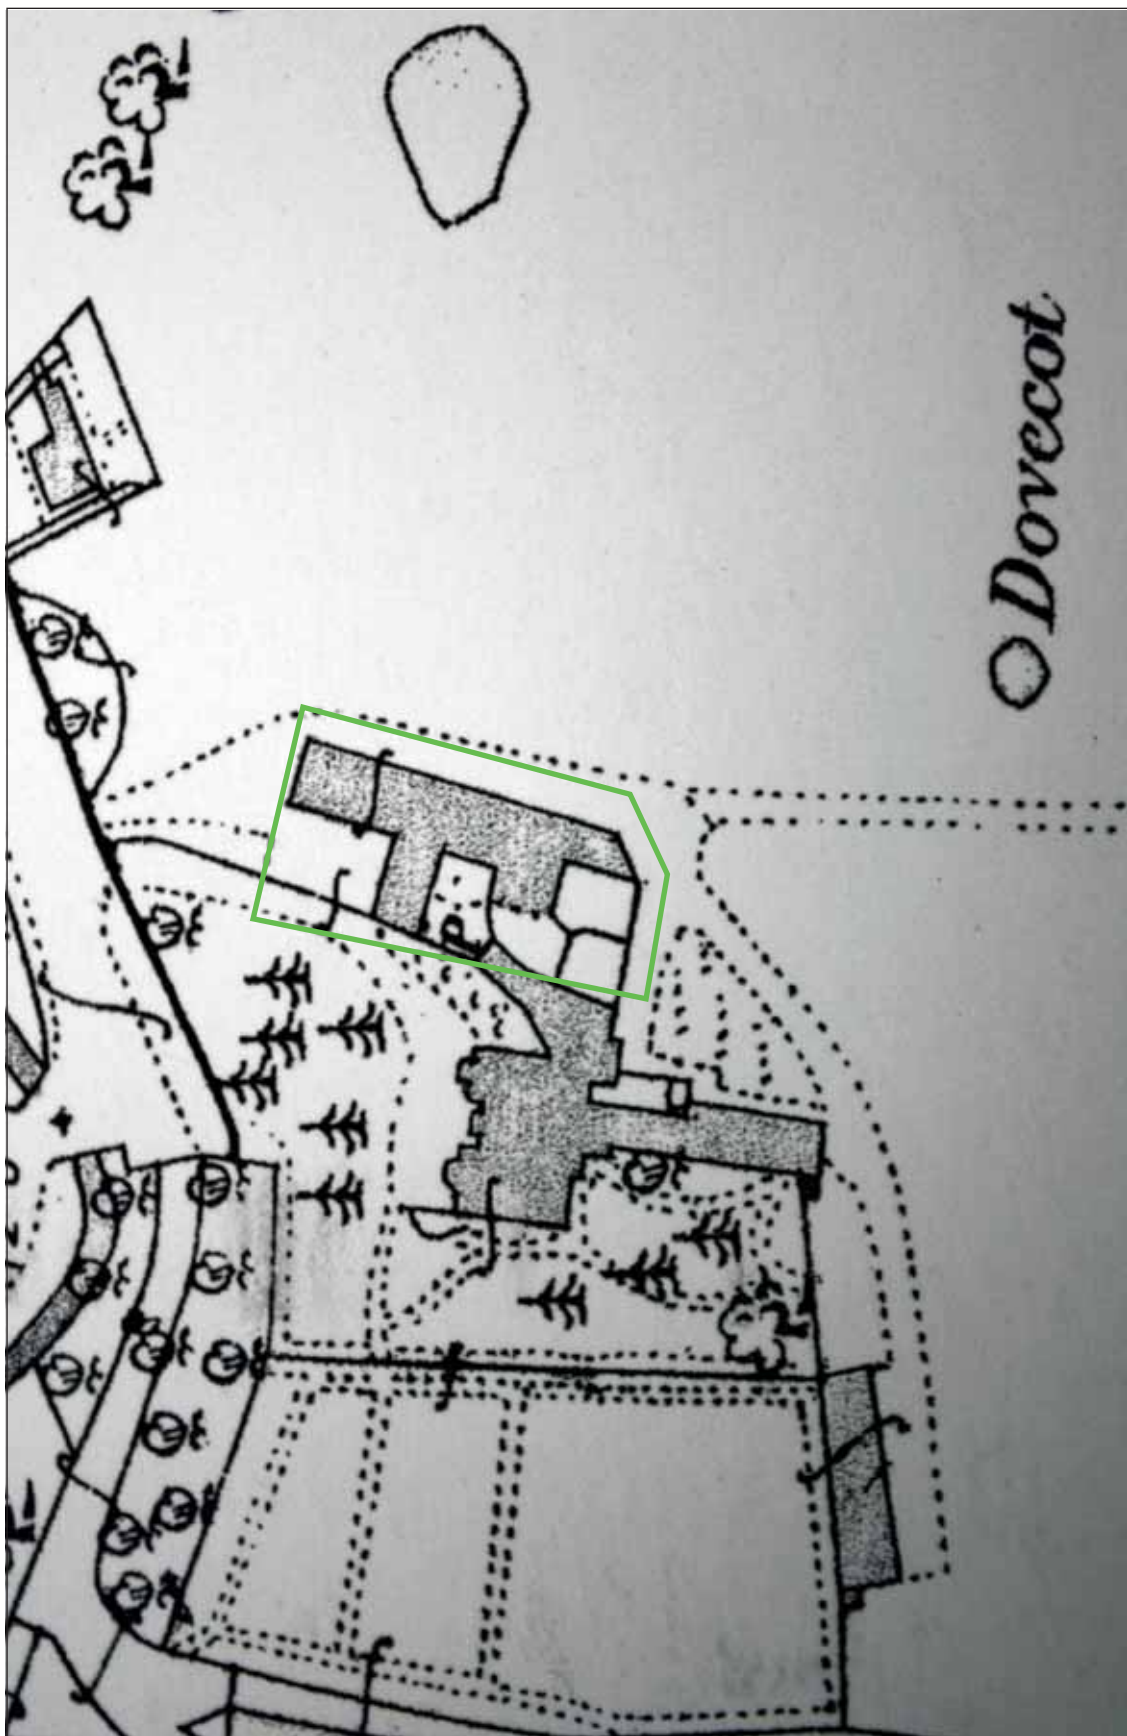
Figure 6: 1st Edition Ordnance Survey Map, 1885 showing location of buildings surveyed (green) (map reproduced with kind permission from Cambridge Archives)

- 4.3.25 The protruding "wing" on the western side which was first noted on the 1885 edition of the surveyed building range (Figure 6), has gone by the time of this map and there is no longer representation of the pump. Other than this, the surveyed buildings remain unaltered in plan.

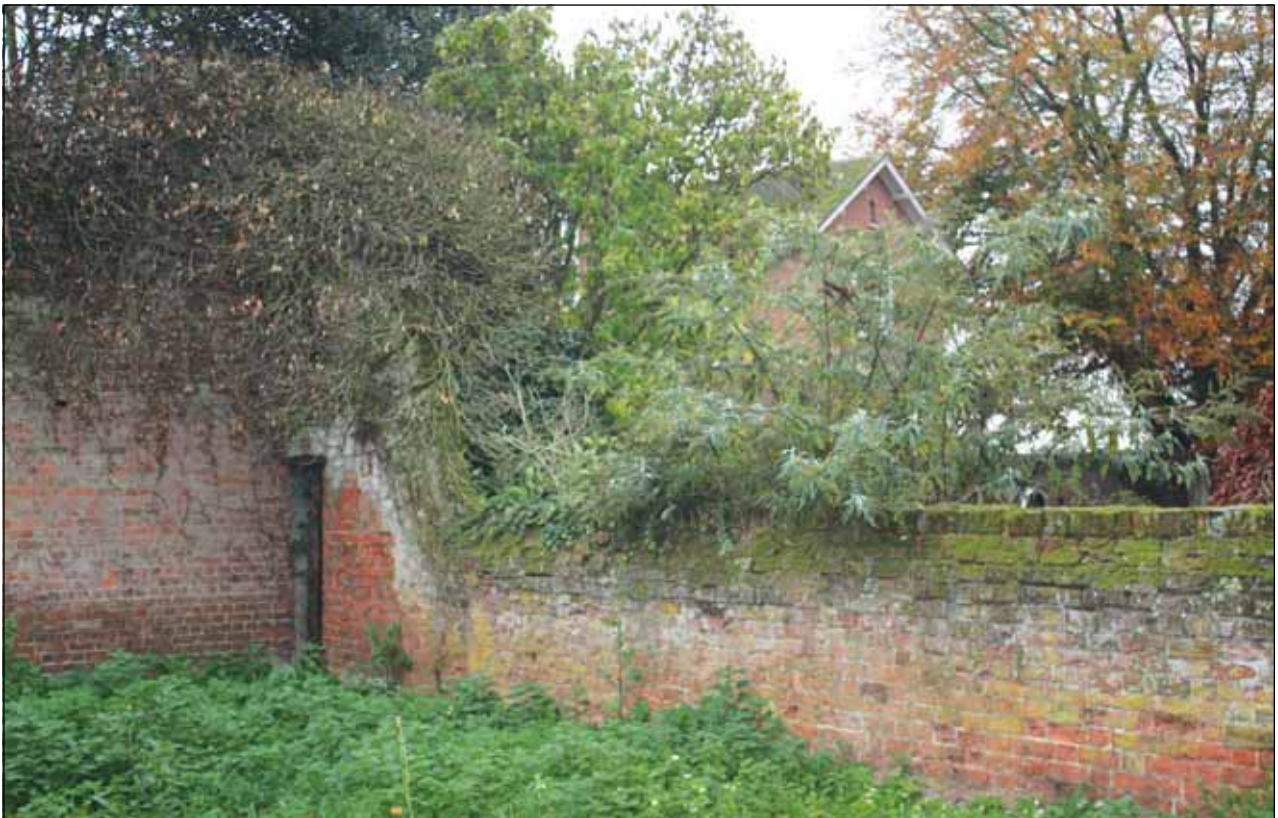
Plate 3: Garden wall

- 4.2.2 The walled garden is most likely associated with the original house and several sections survive between the buildings surveyed and Beechwood house (Plate 3).

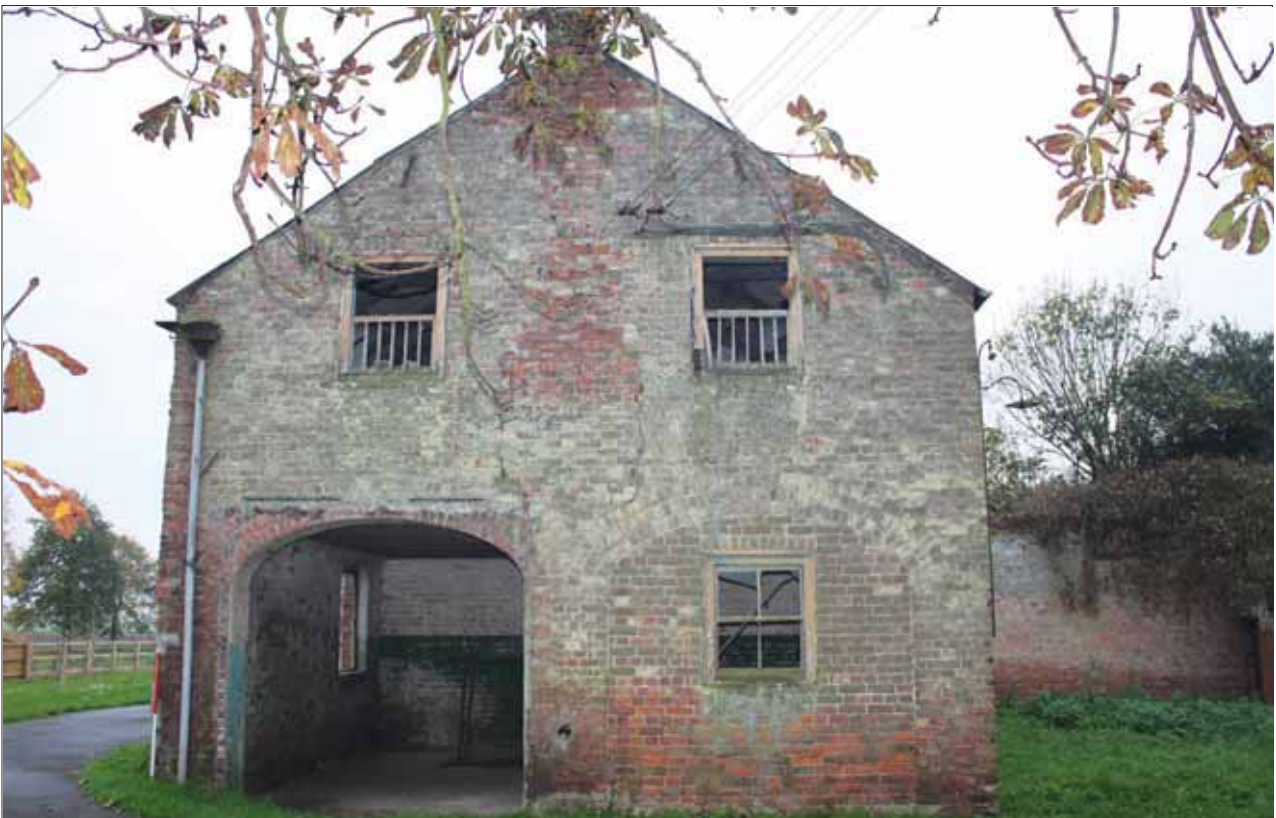
Plate 6: North-facing elevation

- 5.1.1 This elevation fronts onto Dowgate Road and contains an arched entranceway into this element of the building (Figure 9, Elevation 1; Plate 6). Evidence in the brickwork indicates it was originally built with symmetry, comprising two arches with windows above. The roof is moderately pitched and there is cracking in the brickwork in the centre of the elevation.

- 5.1.2 At ground-floor level there is an open arched entranceway on the left and a two-part wooden horned sash window comprising four panes on the right. The window is in a poor state of repair with broken and missing glass. The ground floor window has been inserted into the brickwork when the second arch was filled in.

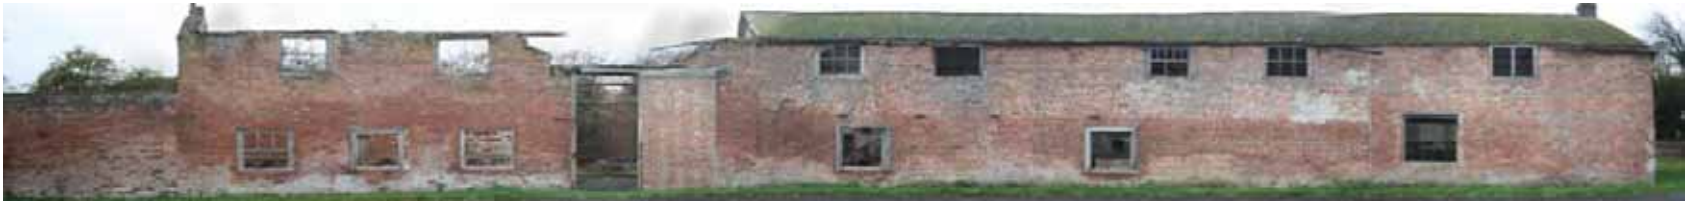
*Plate 8: East-facing elevation (created using “Autostitch”)*

- 5.2.1 The east-facing elevation (Figure 9 Elevation 2; Plates 8-10) measures approximately 40m long and encompasses several phases of construction, alteration and repair.

- 5.2.4 There is a large opening located roughly centrally in this elevation (Plate 8). Above this is a long wooden lintel above which the brick surround on the immediate right appeared to continue over, perhaps before the roof was damaged and lost. The opening and brick surround appear to be contemporary with the element recorded to the immediate left (described above in 5.2.3) as the brick on the right is the same. The opening has clearly been made smaller with the insertion of a narrow wooden frame and infill of bricks on the immediate right. The bricks used are a pale pink, laid in a Flemish bond and possibly 20th century in date.

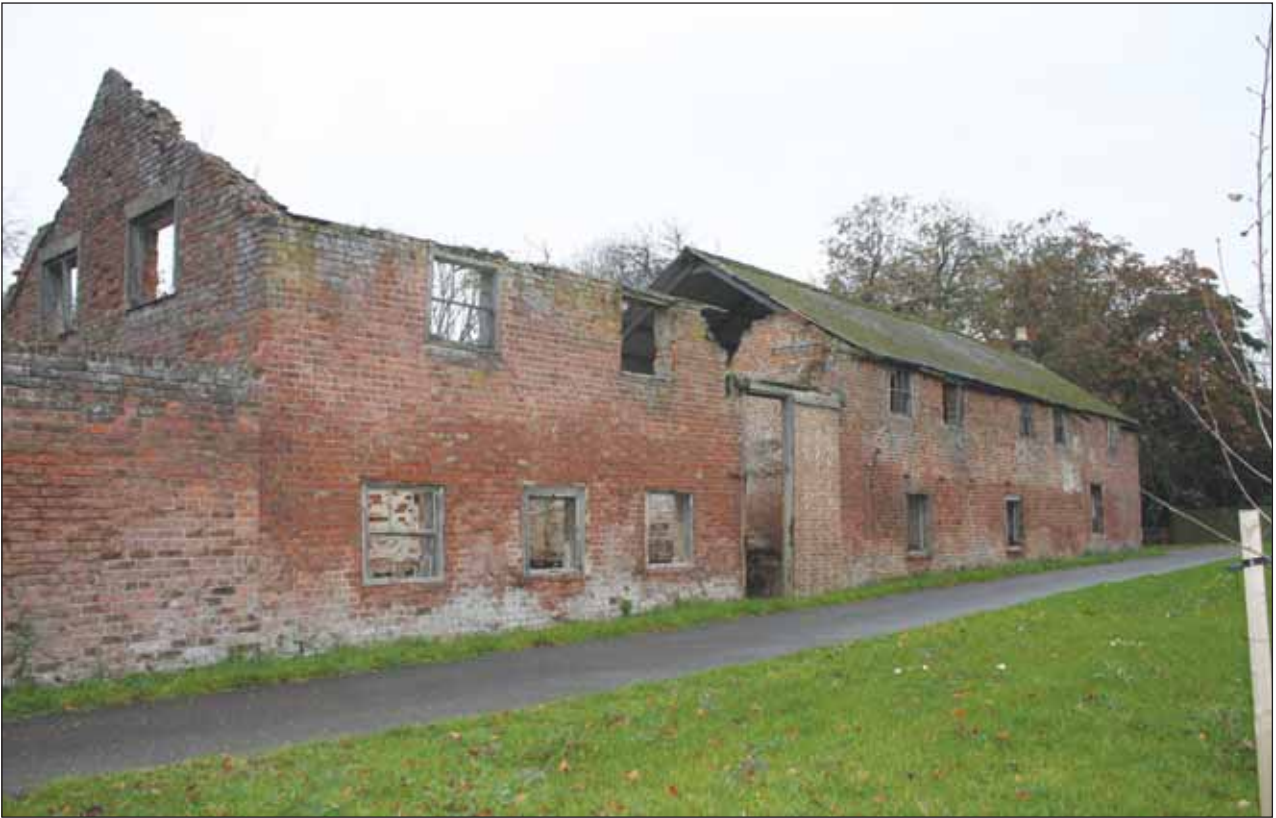
Plate 9: East-facing elevation

- 5.2.3 The next element along is a two storey building with three windows at ground level and two in the first floor (Plate 9). Like the rest of the building, this part is in a semi-ruinous state with no remaining roof cover and damaged or missing windows. This part of the building is constructed from a reddish orange brick with infrequent diagonal pressure marks and an average dimension of 22.5cm x 11cm x 6.5cm (8<sup>3/4</sup>" x 4<sup>1/4</sup>" x 2<sup>1/2</sup>"). All of the window openings appear to have been inserted after construction as the bricks in the openings have all been cut. It is possible that there were smaller openings previously. All of the wooden frames are in a poor state of repair and there is no glass remaining. The left hand ground and first floor windows are two part horned, vertical sliding-sash windows with three panes in each part. The remaining two ground floor windows have empty mortices/voids in the frame indicating a central vertical wooden glazing bar; the other first floor window could not be closely inspected.

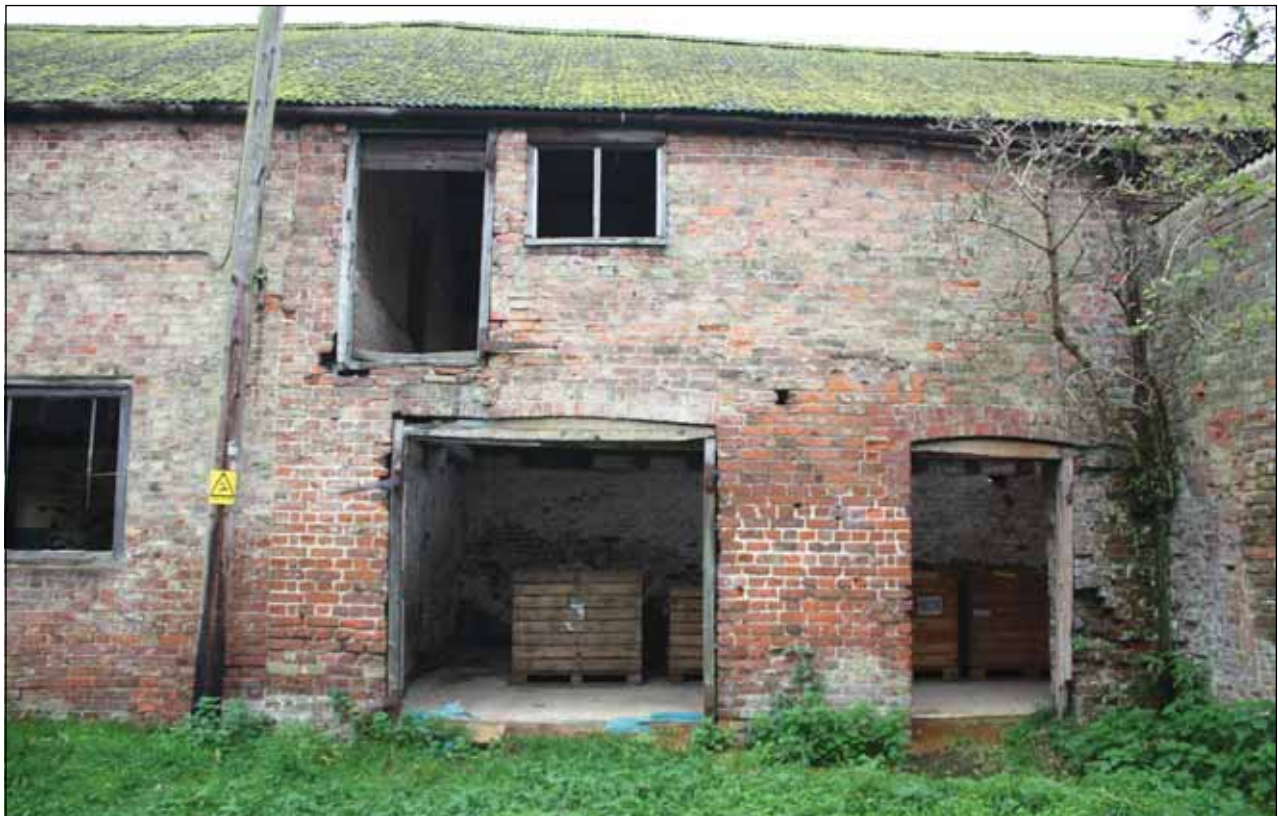
Plate 14: West-facing elevation

- 5.4.3 The next element is adjoining on the immediate right and the change in the brickwork clearly indicates a different phase (Plate 14). This element also comprises two storeys and a change in the brickwork indicates the building was raised to add a first floor as noted on the corresponding east-facing elevation. The brickwork recorded at ground floor level comprises dark orange coloured bricks with diagonal pressure marks and an average dimension of 24cm x 11.5cm x 6.5cm ( $9\frac{1}{2}'' \times 4\frac{1}{2}'' \times 2\frac{1}{2}''$ ) laid in an English bond. Those above were not accessible to measure but are a lighter, pink colour, of varying sizes and laid in a random bond. There are two openings at ground floor level; a wide wooden-framed opening with hinges for a set of double doors on the left and a door way, also with wooden frame on the right. Both have brick arches above and although the doorway opening appears to be contemporary with the construction, the wider opening appears to have been inserted into the wall and the brick headers in the arch above indicate this may be contemporary with the addition of the first floor. At first floor level there is a wooden-framed loading door and two-part window, also with wooden frame. Although close inspection was not possible, they appear to be contemporary with the first floor construction as the brickwork respects the openings.

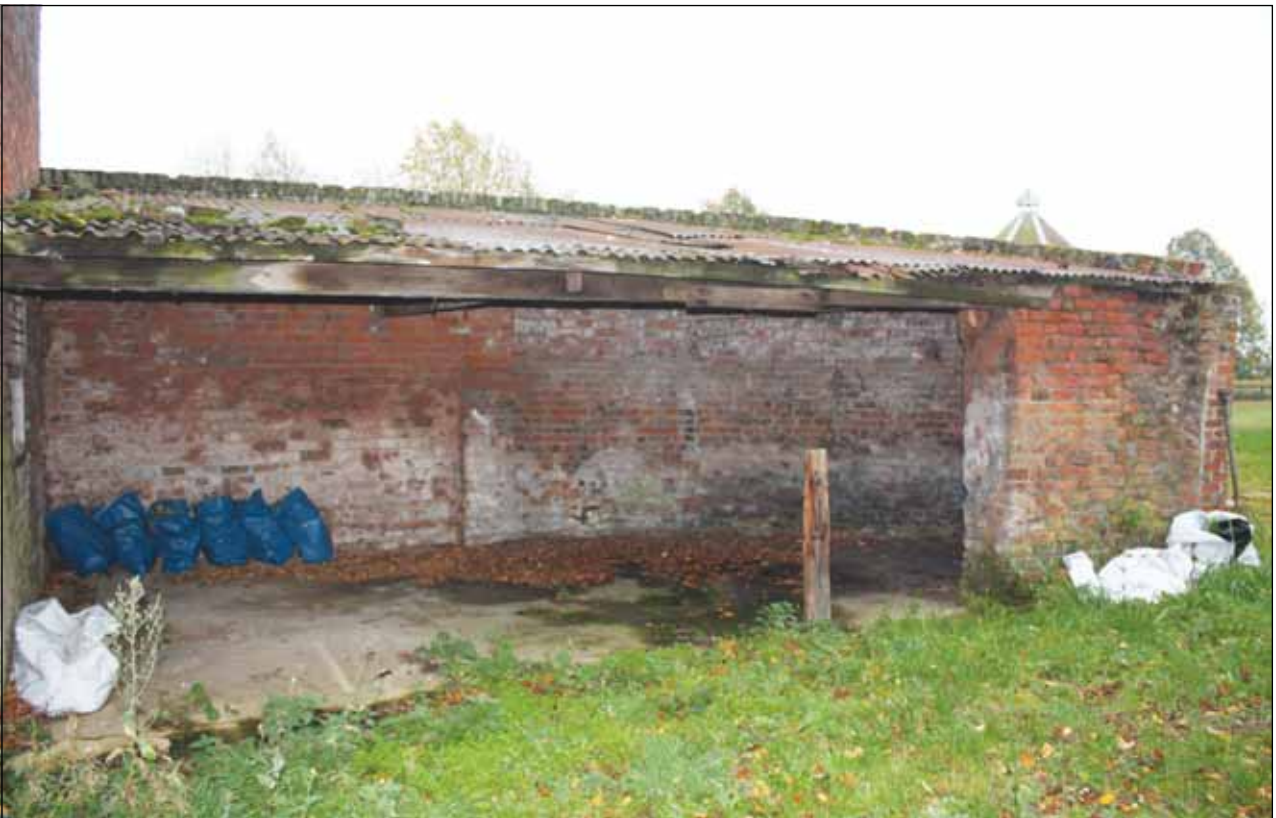
Plate 18: West-facing

- 5.4.7 The final element of the west-facing elevation is a store which has been created by utilising the curving boundary wall as noted on the east and south-facing elevations (Plate 18). This part of the building has a mono-pitched corrugated iron roof, supported by the curving wall and an additional short length of brick wall to the right of the opening.

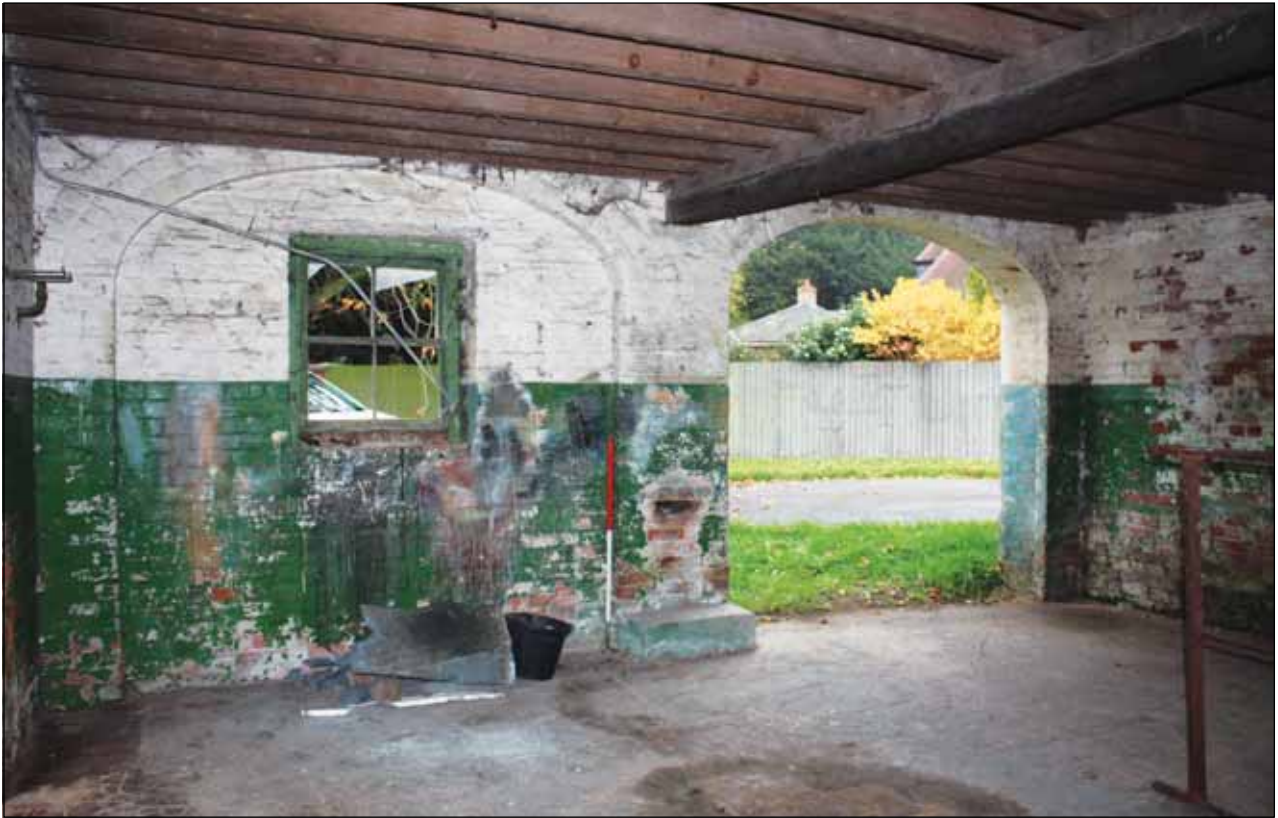
Plate 19: Internal view of workshop

- 5.5.3 There is a possibility that there was once a fireplace situated between the arches (Plate 19). Scarring in the brickwork, also visible on the external elevation, suggests some repair work has taken place here and a raised plinth may indicate the location of a hearth. There is also a fireplace in the first floor room directly above which would further support this suggestion.

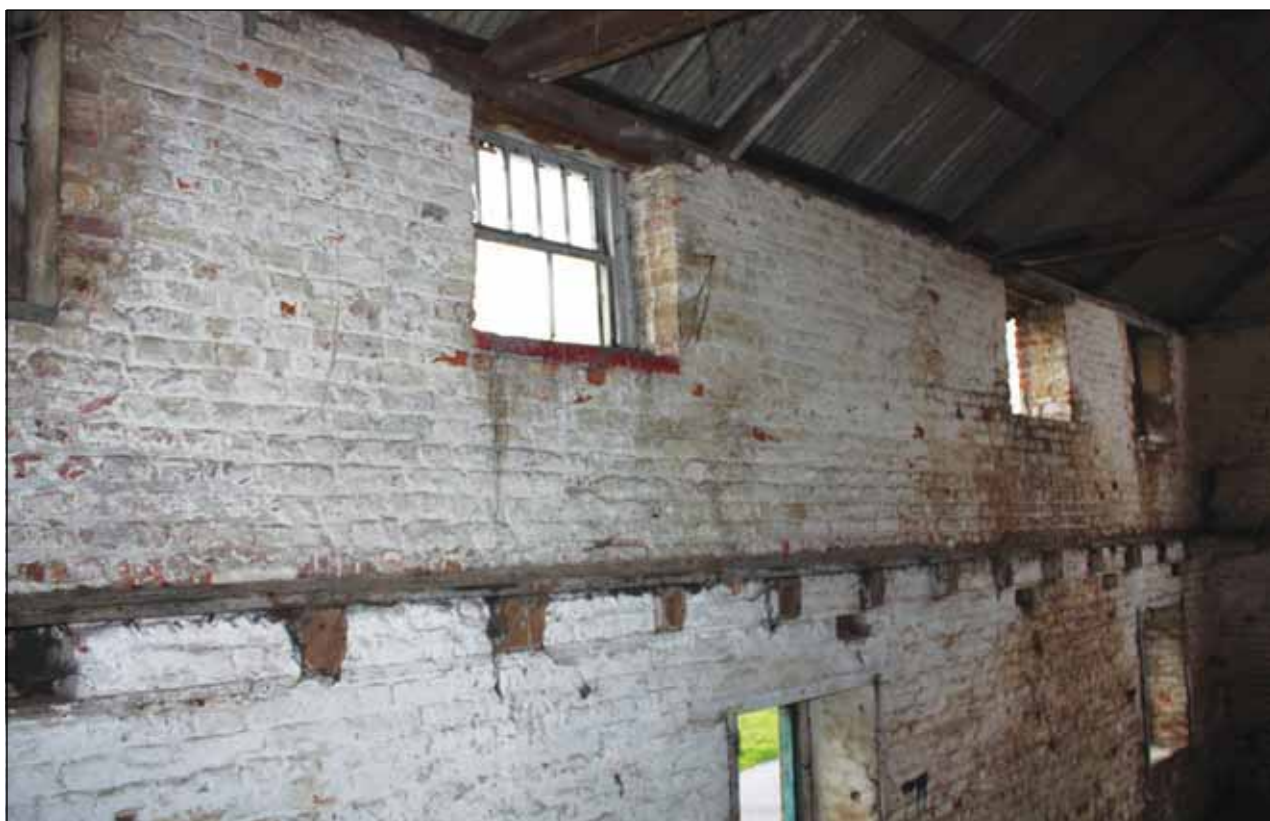
Plate 23: Detail of internal wall, Barn 1

- 5.7.4 The change in brickwork as noted on the east and west-facing external elevations is also noticeable from inside this room (Plate 23). At the northern end of the room, one beam remains which has a possible carpenter's mark or graffiti (Plate 24).

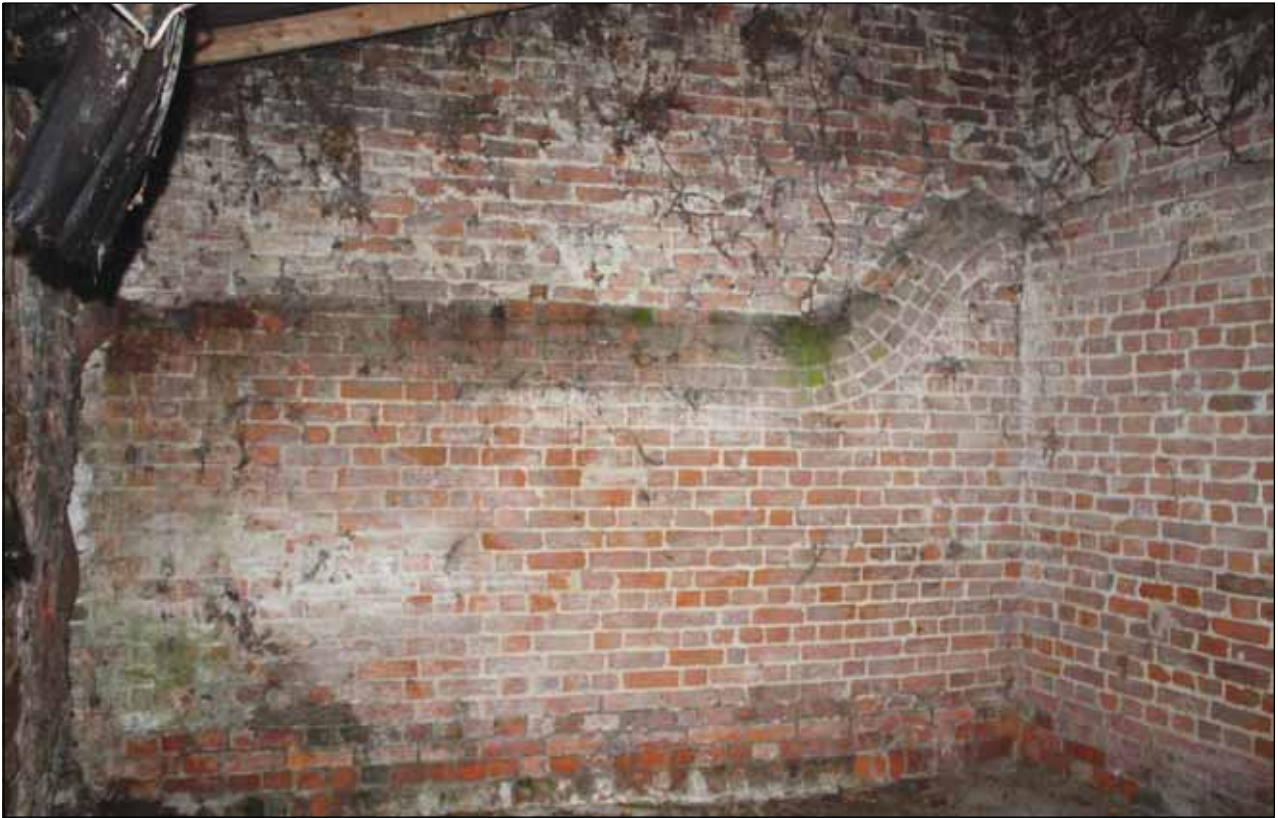
Plate 33: Detail of former garden wall from inside stable

5.9.2 This element of the building has been constructed on top of the garden/boundary wall and evidence of this is found inside on the left on entering where the curved top of the wall is visible (Plate 33).
