Ivy Farm Baldock Road Royston Hertfordshire

Historic Buildings Recording

OA East Report No: 1226

Historic Building Survey

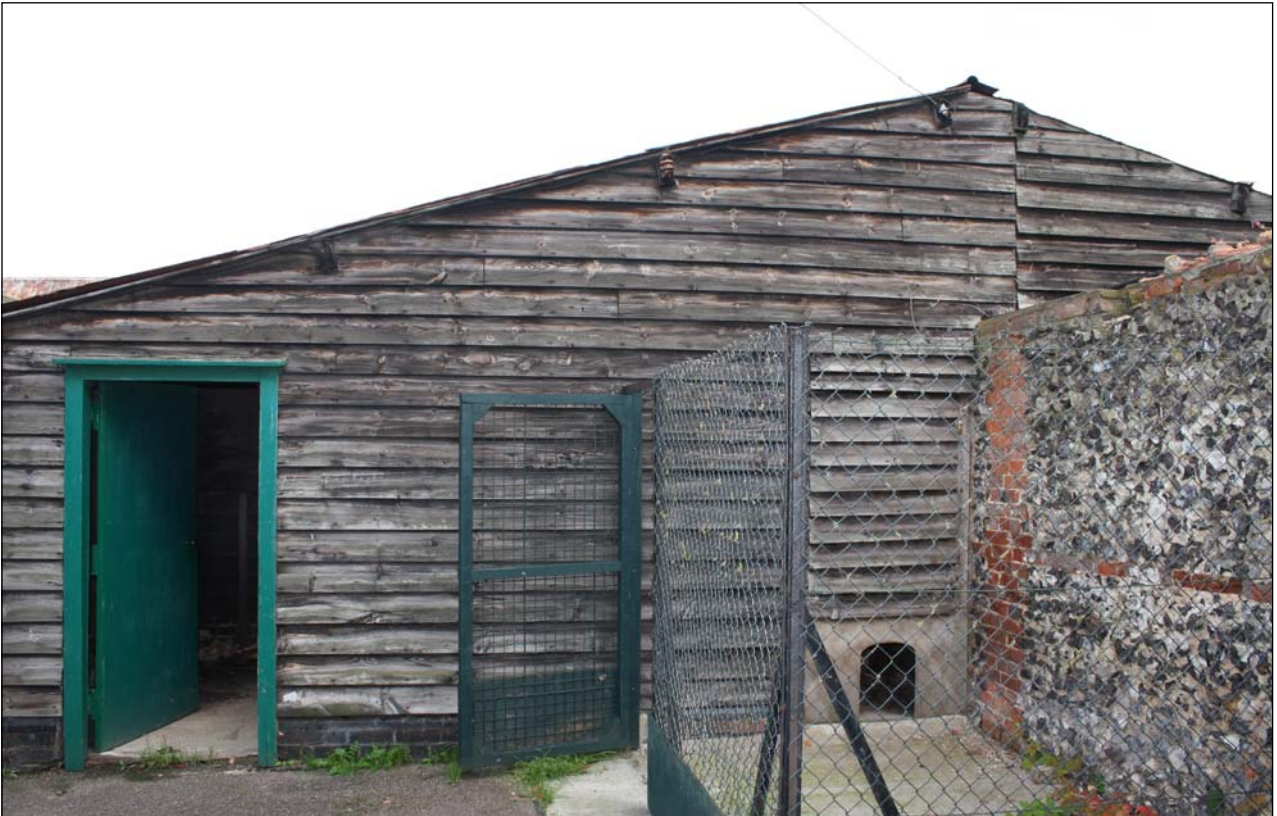
Plate 33: Building 6, southern gable end

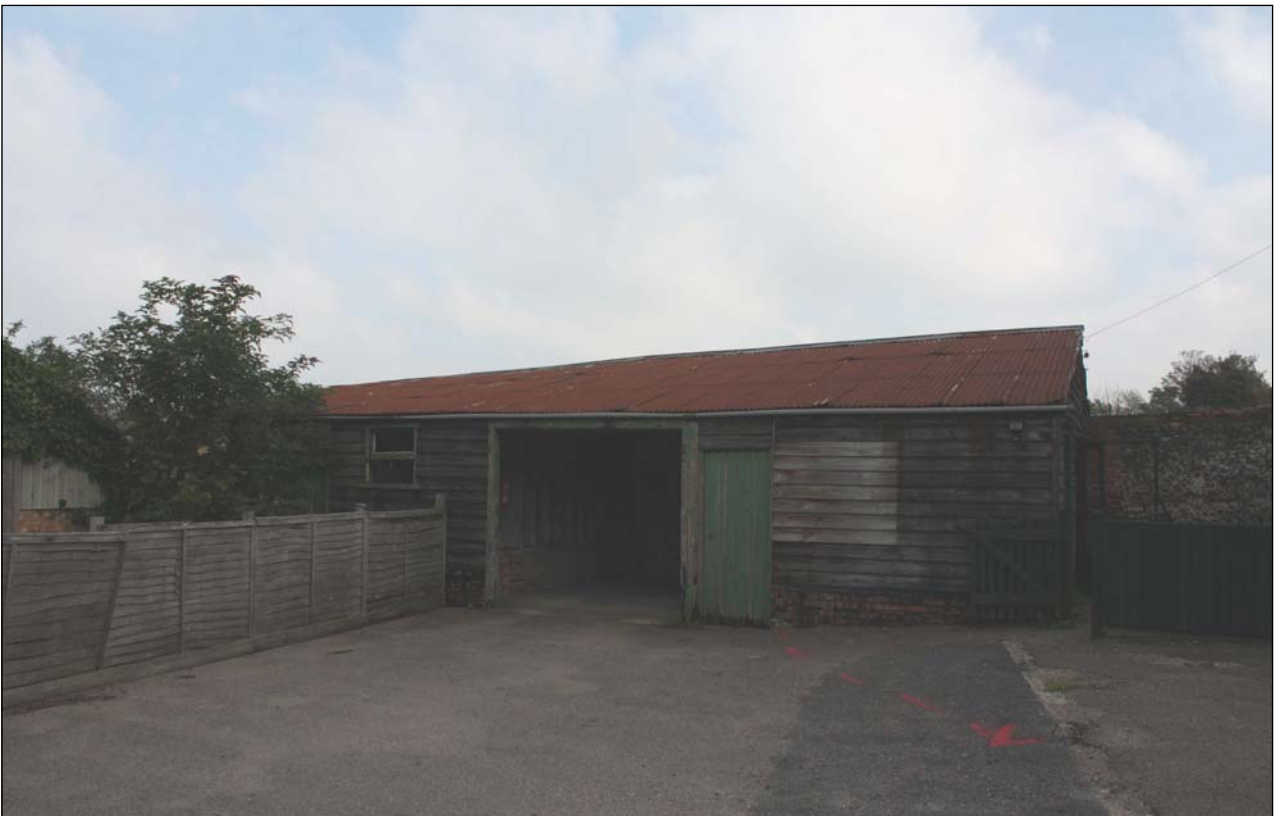
Plate 34: Building 6, viewed from west (inside farmyard)

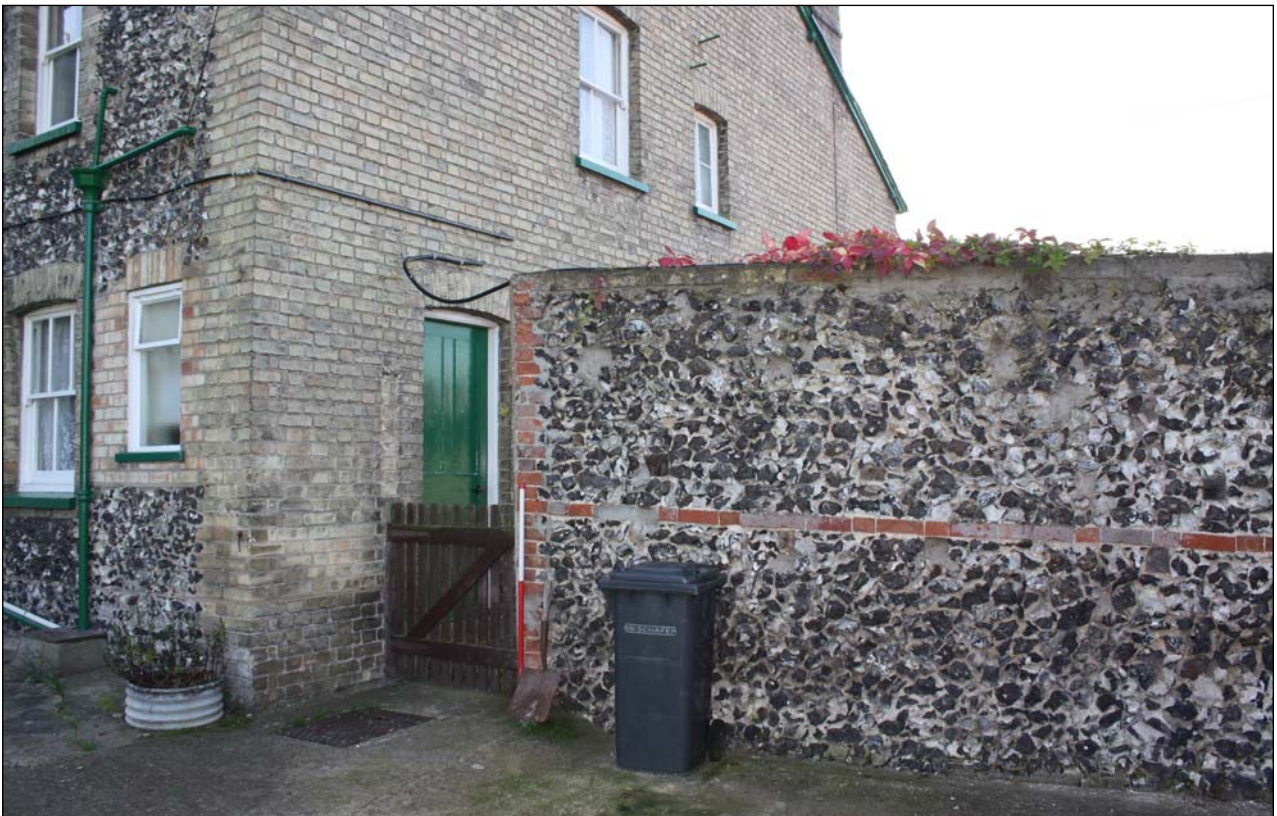
- 3.6.7 This group is much altered but formed part of the original farm complex. The structures have undergone significant alteration and adaptation to accommodate a range of later functions. Where observed, little of the original fabric survives. Although the building ranges on both sides of the wall are early to the farm and feature on the 1st Edition OS map (Figure 6), they may have been constructed a short time after the original farmyard was laid out, taking advantage of the existing early flint wall. The flint wall continues beyond the northern limit of the building (plates 33 and 36) towards the farmhouse. The wall is in-line with the eastern wall/extent of the house.

Plate 36: Flint wall and Building 1, viewed from east

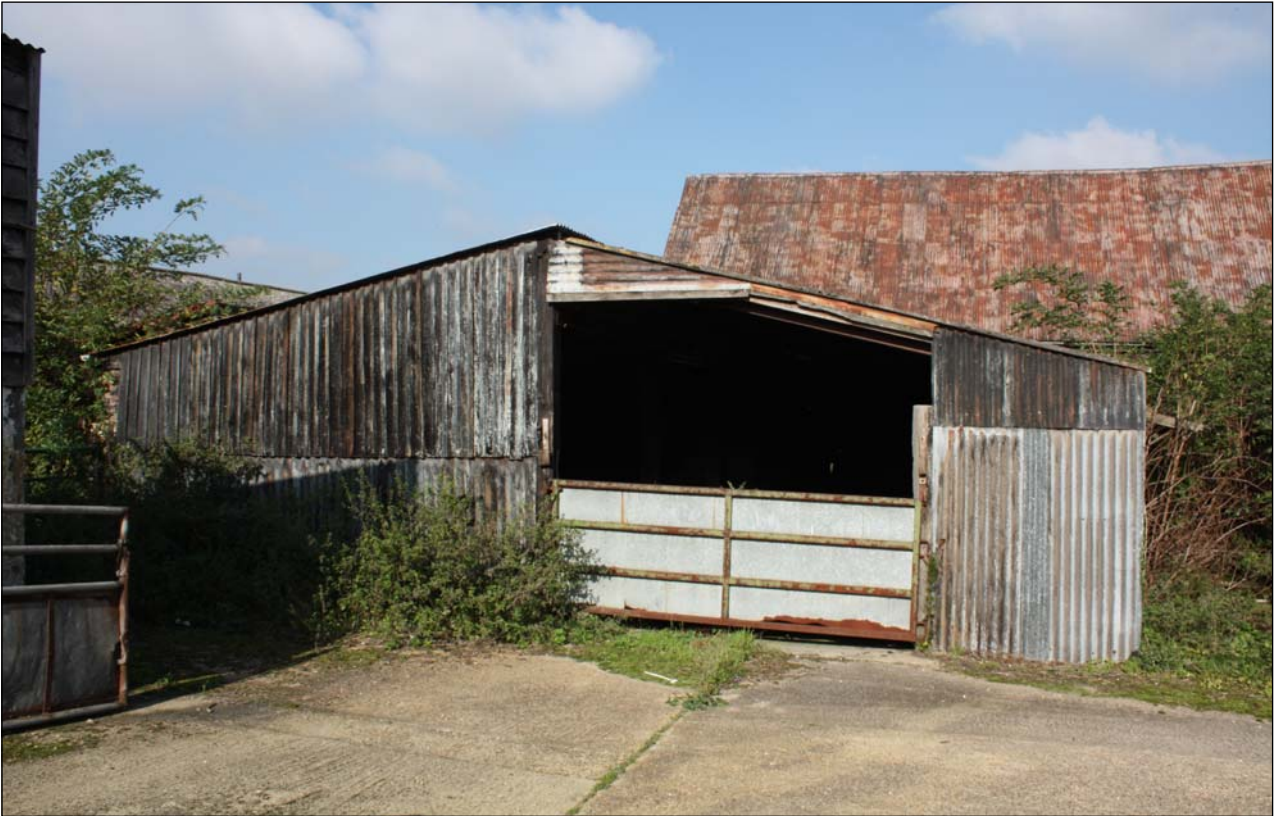
- 3.7.1 This building forms an agricultural shelter that utilises the same flint yard wall as Buildings 2 and 3 for its rear (west) side (plate 38). The building has a large open plan covered by a simple and crude timber structured roof covered in corrugated sheeting and measuring approximately 18.40m by 9.4m. At the time of the survey, this building was fully accessible and most of the floor was covered with straw.

Plate 37: Building 9, viewed from south-east

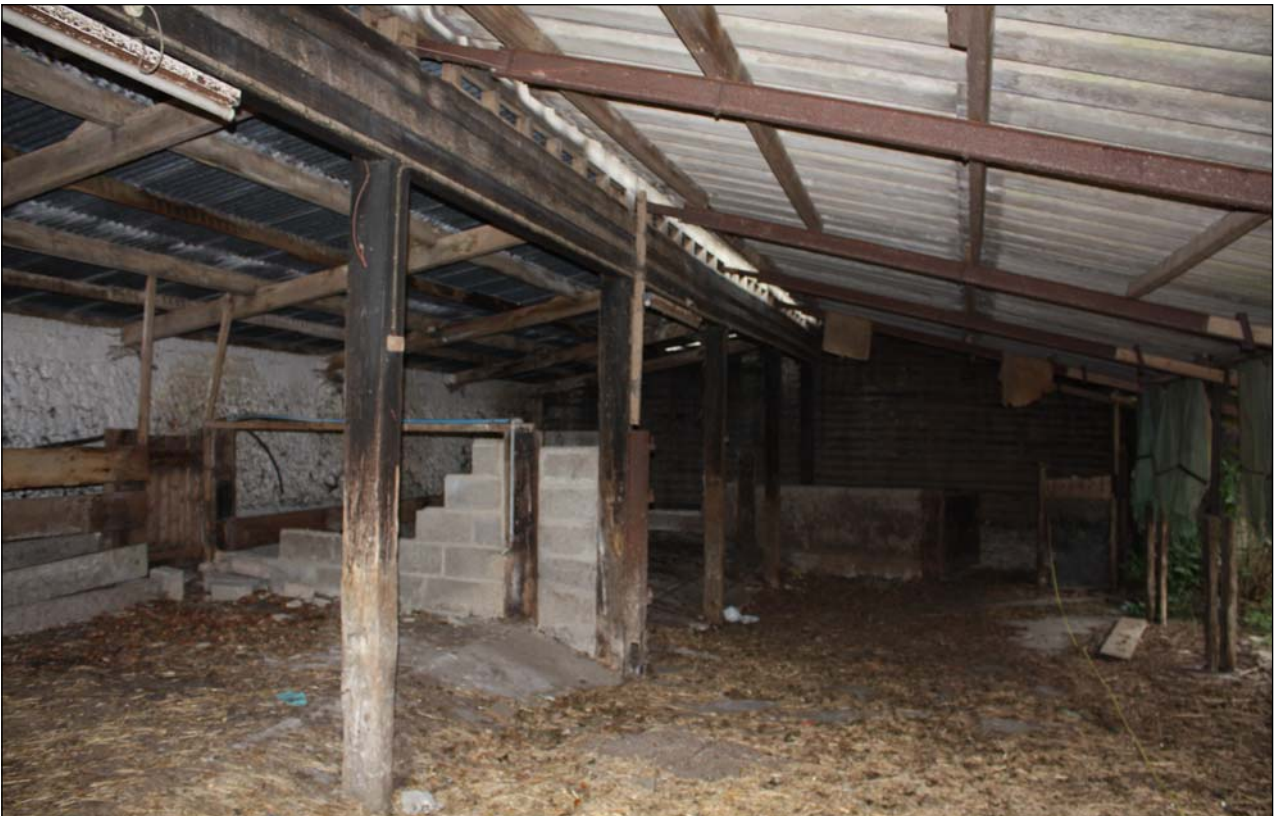
- 3.7.6 Internally, this building had two sets of support posts (Figure 2 and 15, plate 38), one set supporting the ridge of the roof, the other supporting it on the opposite eastern side. There have been a number of modern additions to this building including a concrete feeding/trough area on the western side and a raised concrete floor to provide access.
- 3.7.7 The breezeblock support wall as recorded on the eastern elevation was visible and exposed on the internal wall. Within the cement which bond the blocks the initials "K.B" and year "1959" had been inscribed. This may provide a date for the alterations of this building, research has found the farm was sold in 1957 and these alterations may have taken place as the farm was re-developed by the new owners.

Plate 38: Building 9, internal view

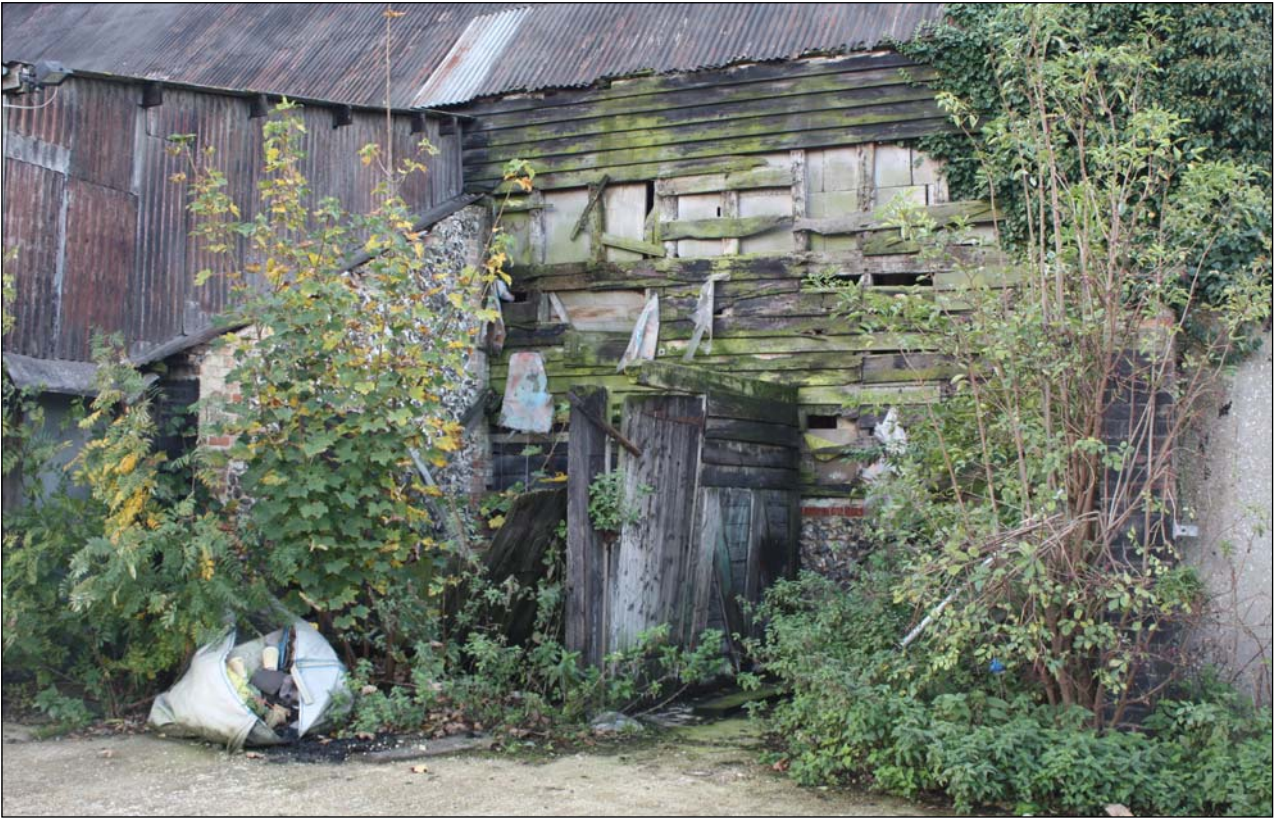
- 3.8.1 This forms the ruinous remains of a small building, possibly originally serving as an animal stall or cart shed (plate 39). The remnant building is of two bays defined by outer flint (east) and brick (west) external walls with a central dividing screen of timber frame and board. The building abuts and post-dates the principal barn (Building 4) and appears to have a mono-pitched roof covered in corrugated metal sheeting. The western wall is now abutted by a concrete block and a concrete walled structure that appears to have supported a tank.

Plate 39: Building 12 (ruined), viewed from north-west
