Four Ashes Hall
Cold Bath House
Enville
Staffordshire

**Historic Building
Investigation and Recording**

May 2012

Historic Building Recording and Investigation

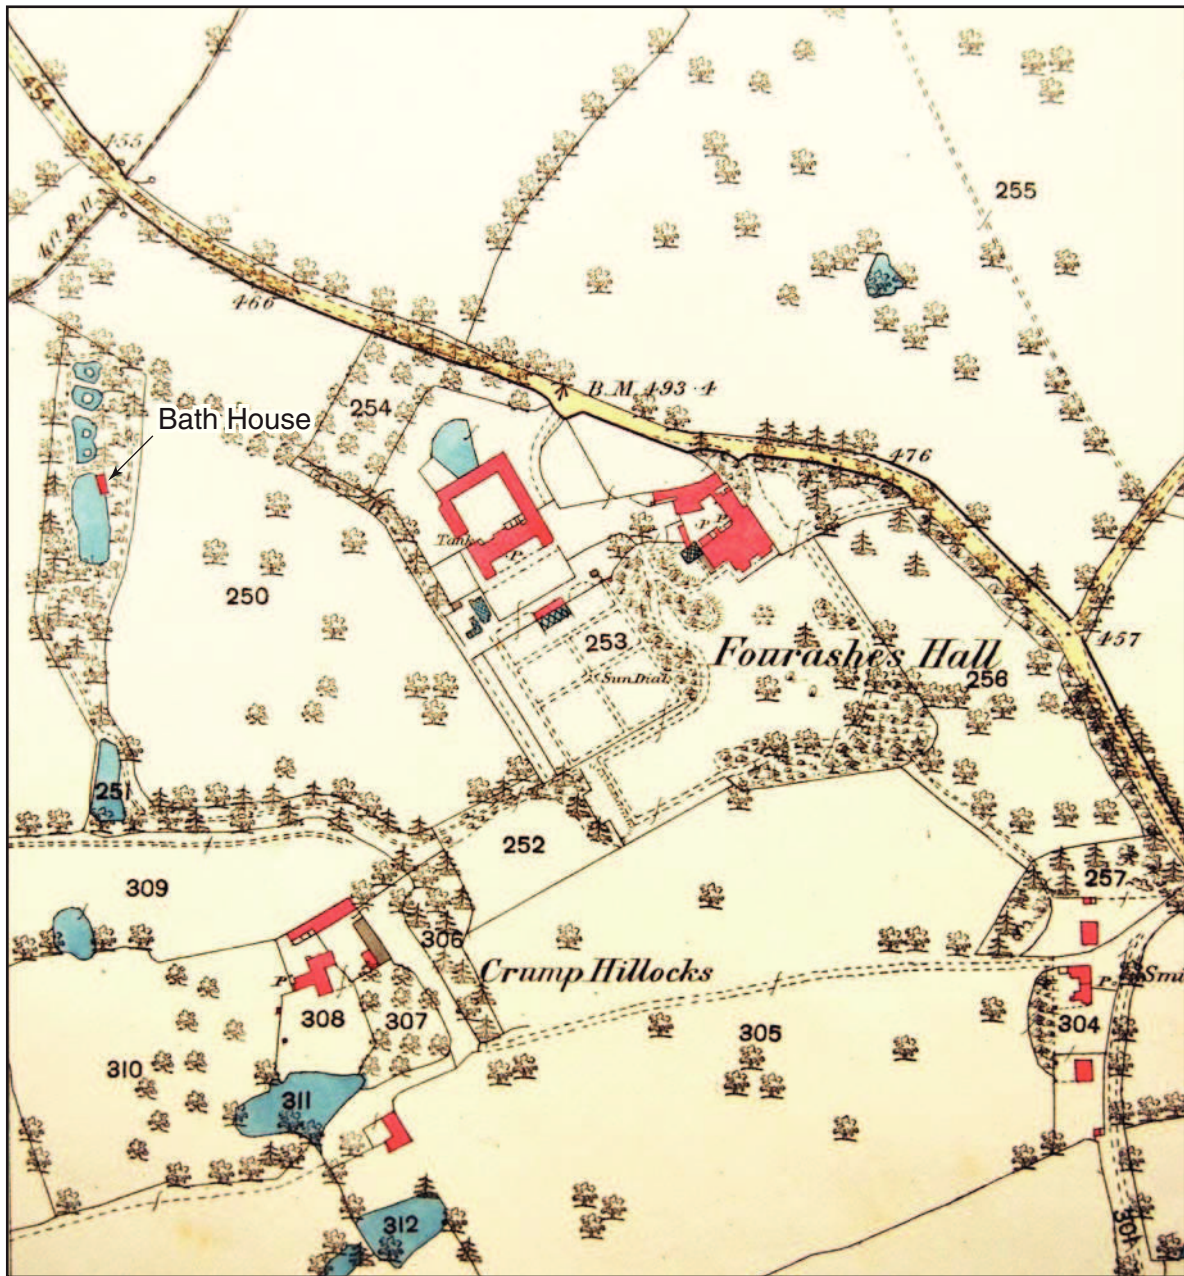
Figure 2: 1st Edition Ordnance Survey Map (1882)

- 2.1.6 The maps used in the development of the website have not been seen in the current study but four historic Ordnance Survey maps have been consulted to provide further historical information relating to the site. Each of these maps, dating from 1882, 1903, 1923 and 1961, shows a broadly similar arrangement to each other with a distinct rectangular plan wooded area c.170 m to the west of the house, containing five main connected pools or ponds. A simple network of paths extend around the ponds and each map appears to show a similar sized rectangular plan building at the north-western corner of the largest pond at the centre of the woodland. This is the location of the bath house. The three later maps label the wooded area as the *Bath Walk*. The first edition 25 inch Ordnance Survey map has been included in this report at Figure 2.

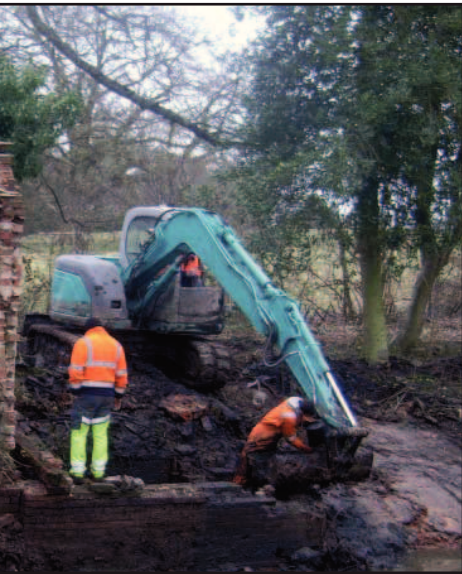
- 3.2.3 The west side of the building faces directly onto the adjacent pond and the de-watering/dredging works have exposed part of the retaining wall below floor level (see Plate 5). This has confirmed that the west wall continues down at least 8 brick courses below the floor. At its centre is an opening to allow water into the pits within this part of the building, which is covered by a secondary metal grille with very thin horizontal slits. The top of this wall, at floor level has largely been lost.

house from west during clearance works

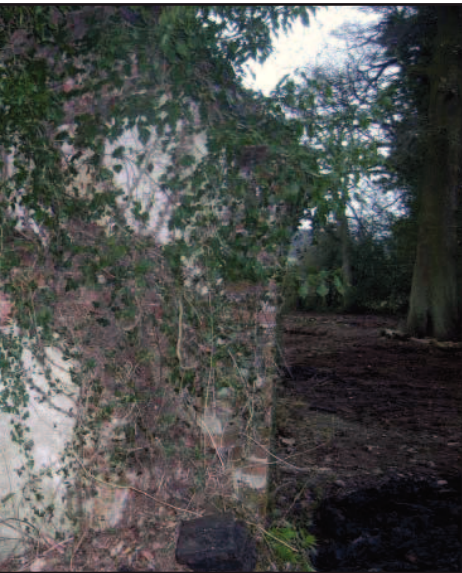
south end of surviving part of bath house

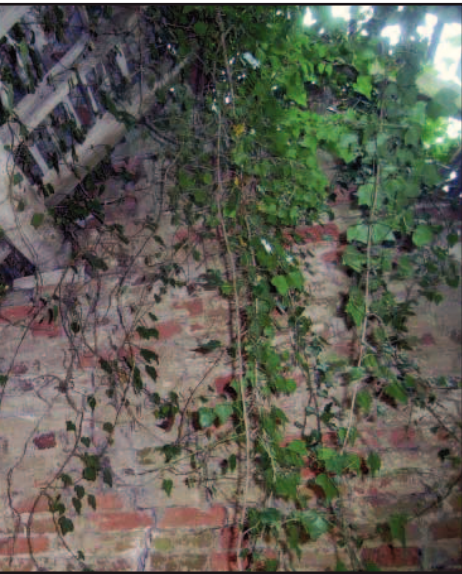
South wall in surviving part of bath house
