# Church of St Mary-Le-More Wallingford, Oxfordshire

## Archaeological Watching Brief

**CHURCH OF ST. MARY THE MORE, WALLINGFORD, OXFORDSHIRE**

**ARCHAEOLOGICAL WATCHING BRIEF REPORT**

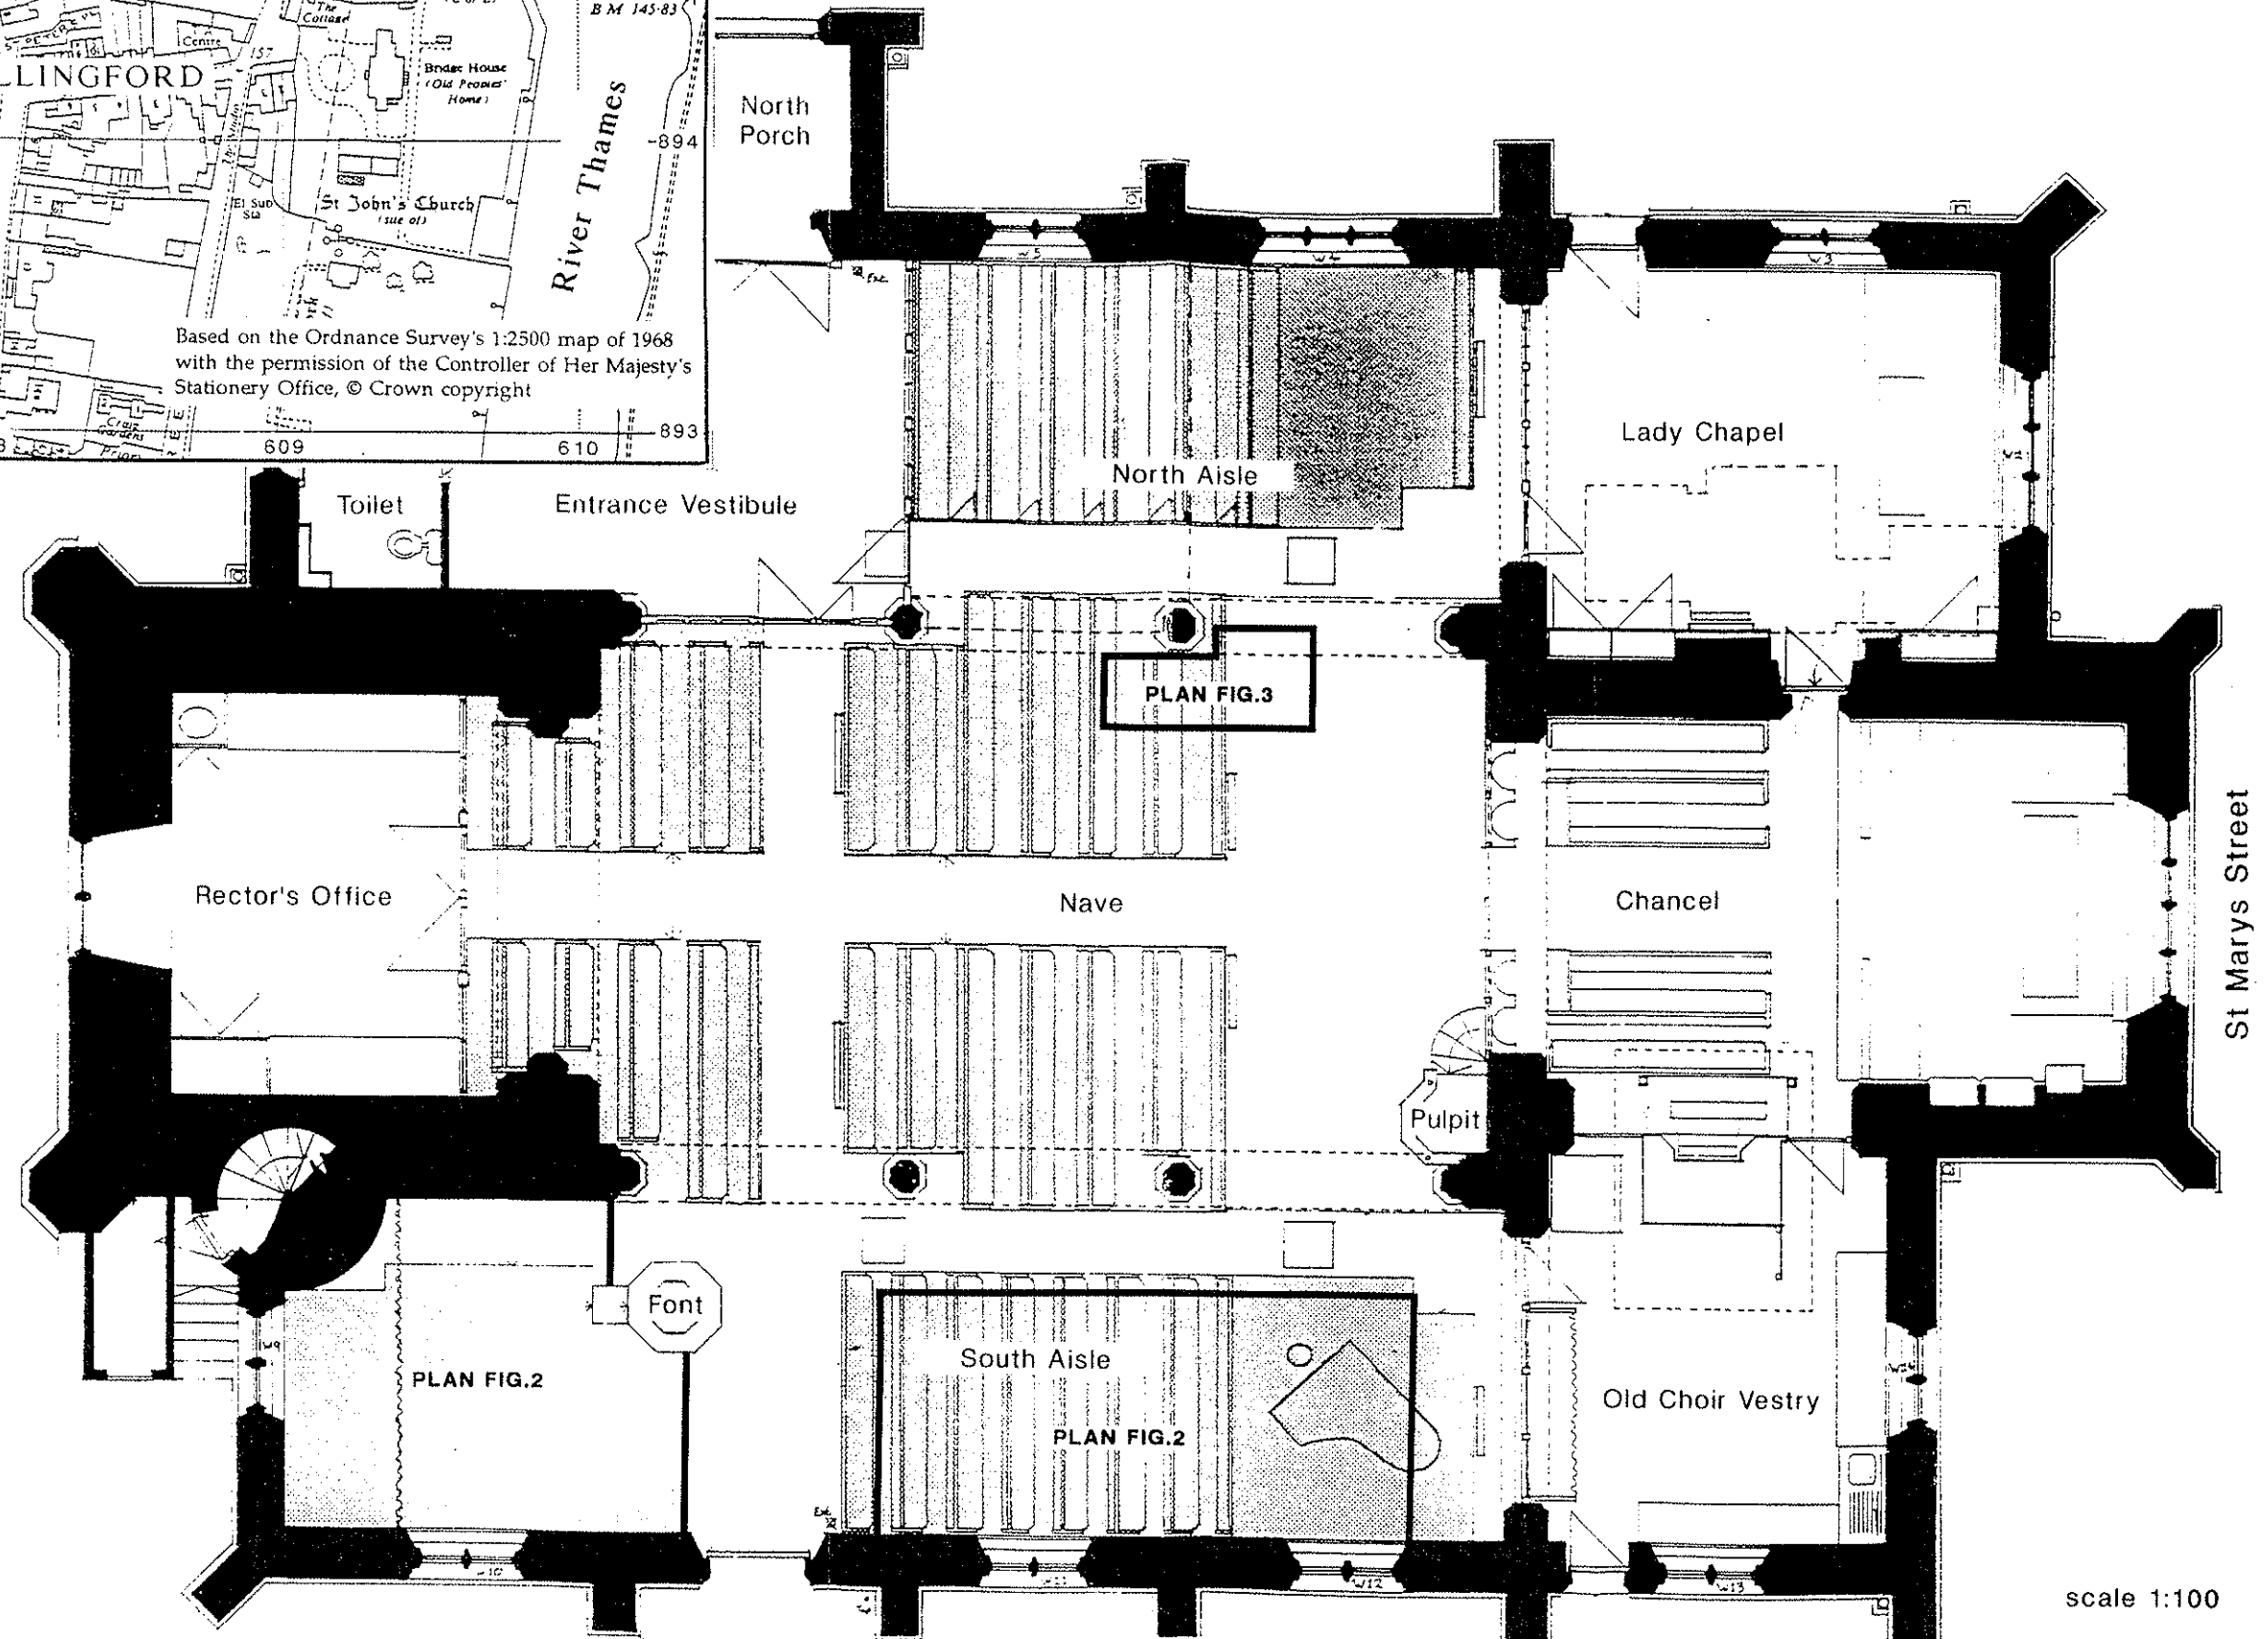
figure 1

Removal of the floorboards at the west end of the south aisle (see Fig. 1) revealed the lower portion of the west wall. This was offset from the flint masonry above and was of a completely different build, incorporating chalk and limestone as well as flint (context 6). Wall 6 had two courses of internal facing stones visible and would be 1.6 m wide if the external face of the Victorian wall was continuous with the original external face. The masonry was bonded with the lower portions of the circular stair turret attached to the south side of the tower.
