ORDSALL HALL REFURBISHMENT, SALFORD

Archaeological Watching Brief and Excavation Report

Oxford Archaeology North March 2012

Urban Vision

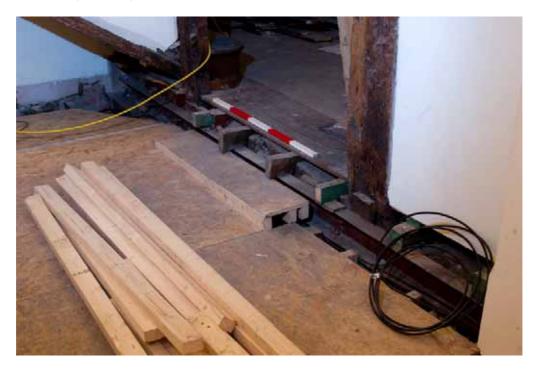
4.2.38 An I-section rolled-steel joist situated below the threshold between Room F3 and Room F1 (Plate 35), bore no makers stamp, and appears to be of mid/late twentieth century date. Whilst the timber rail of the wall-frame survived *in situ* behind it, the steel joist appears to have been inserted to carry the structural load of the floor of Room F1, which was placed at a higher level than that to the west (Plate 35).

Plate 35: Steel beam inserted to support wall frame and floor

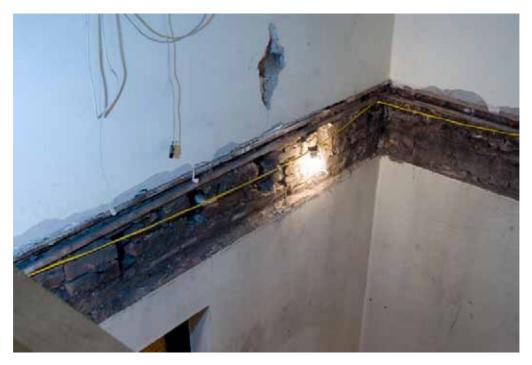
- 4.2.40 The removal of the existing floor left a wide scar, approximately $7\frac{1}{2}$ " (0.19m) wide (Plate 36), around the base of the north, south and east walls (the west side of the floor remained intact at the time of the inspection). The walls were of hand-made brick construction, typically measuring 9 x 4 x $2\frac{1}{4}$ " (0.23 x 0.10 x 0.06m), bonded with pale with lime mortar. The evenly-spaced, vertical-section joist slots for the recently removed floor were visible in both the north and south walls (Plate 36).

Plate 36: Extent of wall-strip for watching brief, Room F1

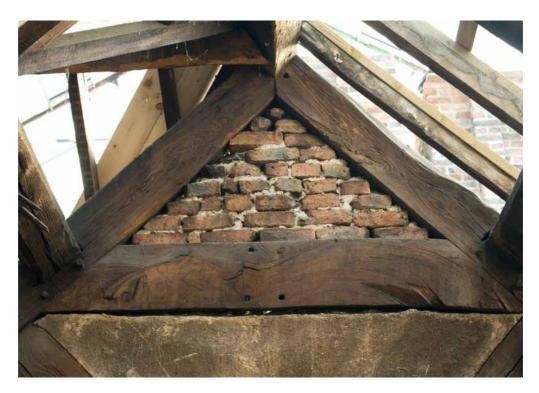
- 4.3.3 Above the tie-beams, large scantling principal rafters were quadruple-pegged into mortices, and formed a birdsmouth at their apex, clasping a more slender square-section ridge purlin (Plate 38). Two angled-braces above a collar were also incorporated into the truss, all having double-pegged mortices. However, all of the collars had two empty central mortices (Plate 38), and the joint forming the birdsmouth for the ridge appeared very untidy carpentry in comparison to other elements of the timber-framing. A peg-hole near the apex of each of the western pitch principal rafters appears to represent the remains of a mortice (Plate 38), with the rafter originally oversailing that to the east. The empty mortices in the collar were matched by a similarly positioned mortice in the tie-beam (Plate 39), and by mortices on the soffit of each of the upper principal rafters. This represents an unusual arrangement, whereby two vertical struts gave the impression of a king-post, but lacked its structural role, being broken by the collar, which provided the support.

- 4.3.4 The timber-framing within the trusses was infilled with daub, or wattle and daub panels, supported by staves (Plates 37, 38, and 39). Several of the panels were empty (Plate 40), whilst the upper panel of the central truss had been infilled with brick nogging (Plate 38), quite possibly during the construction of the present west wing.

Plate 38: Detail of truss apex, showing ridge assembly, and brick noggin

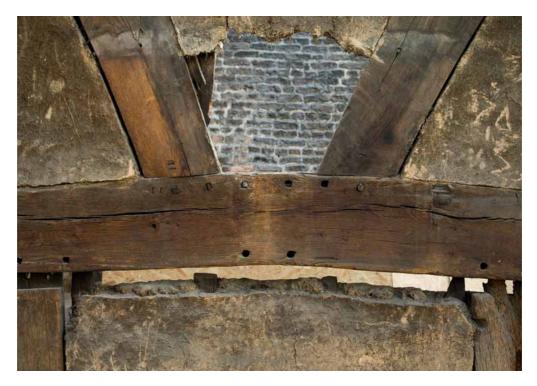
Plate 39: Assembly marks and redundant mortices, with wattle and daub panelling

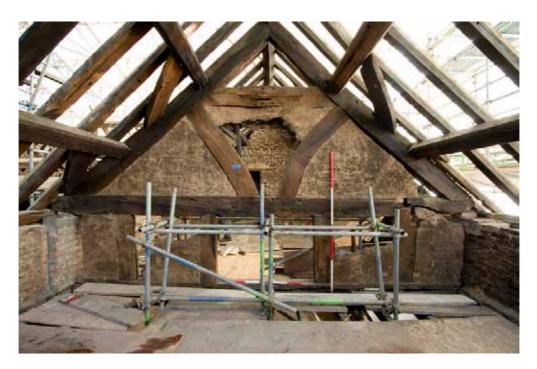
Plate 40: Southern truss of the west wing, with original wind braces

- 4.3.5 Each of the trusses had inscribed assembly marks on their northern faces, although not fully discernible, the numerals IIII and V were present with some additional tags. Chiselled I and II marks were observed on the tie-beams of each of the trusses, with corresponding marks on the arched braces from the tie-beams (Plate 39). The two purlins to each pitch were butt-ended into the trusses, and had arched wind braces from the principal rafters on both north and south sides (Plate 40).

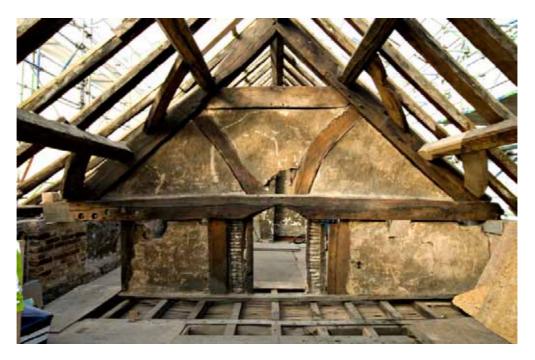
- 4.3.6 The northern truss, forming a partition between Rooms **S9** and **S8** (Fig 6), differs from those to the south, in that it has a central doorway, with a carved four-pointed arched head, being cut from the tie-beam (Plate 37). This represents a secondary feature, cut through the truss, with auger holes for the earlier staves visible in the bottom rail. The upper, northern, face of the truss was refaced either side of the door with lath and plaster panelling, containing horse-hair. This had also been applied to the other panels of the upper face (Plate 37). The lower face appears to have been left exposed, showing the post inserted to form the western door jamb, which was hung by pintels on this face (Plate 41).

Plate 41: Lower face of northern truss of west wing, with remodelled doorway

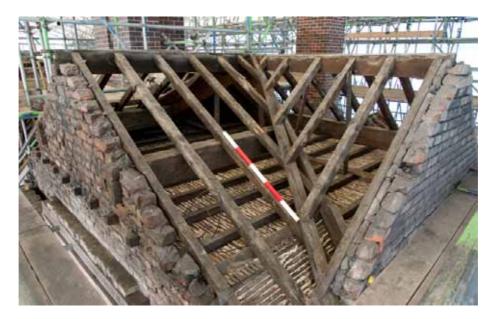
- 4.4.2 **Roof A:** this represents the roof above Room **S2**, in the south-eastern corner of the east wing (Fig 5). For the main part the roof was east/west aligned, with gables to the south and east. Both gables were of brick construction, with the ridge and single side purlins housed within the eastern gable, and passing through the smaller southern gable, which was of single-skin thickness (Plate 42). Each valley of the southern gable had two valley rafters: a full-length valley rafter, onto which the rafters of the gable were nailed; and a shorter rafter, with a splayed scarf onto the valley rafter, which in turn housed the feet of the rafters of the steeper eastern gable (Plate 42).

Plate 42: Roof A, with timbers projecting through single-skin southern gable (left)

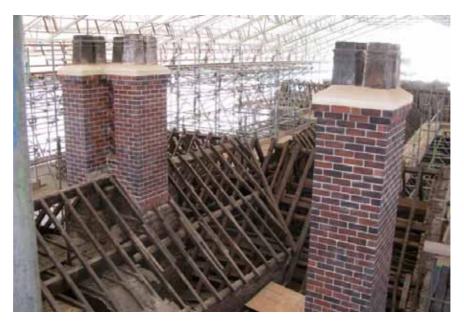
4.4.3 The roof contained a large rectangular chimney-breast, with a triple-pillared chimney-stack rising through the ridge, in a T-shape plan arrangement (Plate 39). Each contained two flues within stretcher bond stacks, and was tied into the adjacent pillar at both the crown and the mantel (Plate 43). The internal faces between the stacks were infilled with decorative brickwork arranged in a zigzag pattern (Plate 43). The pots were squared, with diamond panels, above a chamfered crown cap (Plate 43). The ridge purlins of the roof were socketed into the chimney stack. To the west the ridge was supported purely by the attached rafters, the western end resting only partially on the lower scantling northern valley rafter, which overlay Roof C (Plate 43). The southern valley rafter terminated prior to the ridge, where it butted an adjacent rafter.

Plate 43: Roof A, with triple-pillared chimney-stack and remodelled purlins and rafters

- 4.4.4 Internally, the second floor had a suspended ceiling of lath and plaster construction. The eaves were undersealed to the height of the purlin on each pitch, which had runners nailed to their soffits, and also to the rafters supporting the ceiling beams below (Plate 43). Hanger timbers nailed to the ridge purlin supported a further central runner.

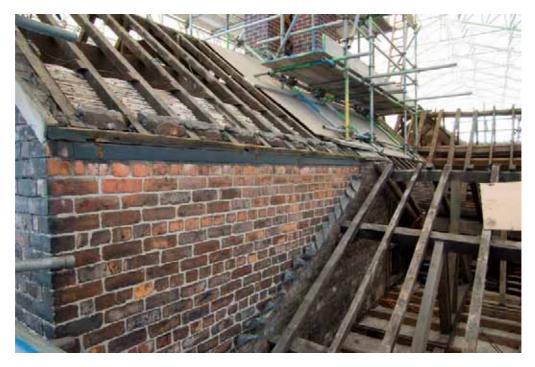
Plate 44: Relationship between Roofs A (left) and B (right)

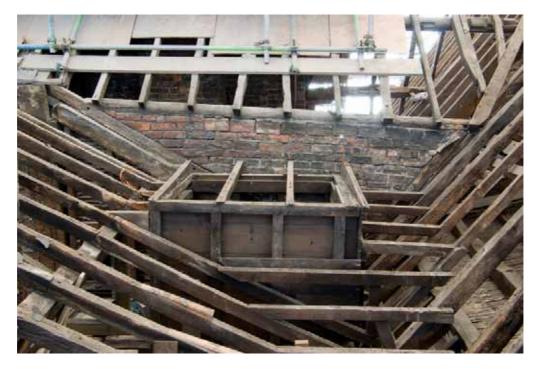
tank, which was housed in the valley between Roofs B and C (Plate 45). At their base, the rafters on this pitch were also strengthened, being sprocketed onto the wall plates at the northern end, and onto the lower purlin of Roof C, further to the south (Plate 45).

Plate 45: Timber water tank between Roofs **B** (left) and **C** (right)

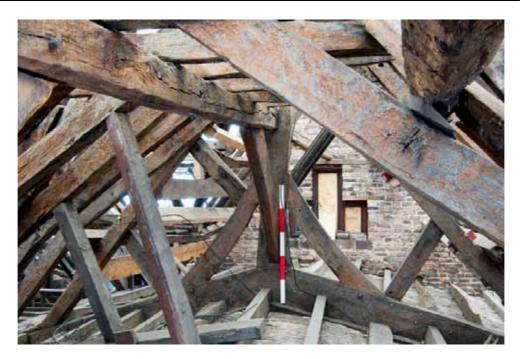
- 4.4.9 The roof retains two cranked tie-beams, each carrying a central crown-post, held in position by down-braces. Those on the southern truss are convex, whilst to the north they are concave (Plate 46). The foot of each crown-post is splayed to accommodate a straight longitudinal brace to a collar purlin, which is clasped by the jowled head of the crown-post (Plate 46). Both crown-posts retained evidence for tenons at their heads, for jointing to a collar above. At the northern end of the roof the collar purlin is socketted into the brick gable. However, it retains a notched lap joint adjacent to the wall (Smith 1995, Fig 12), denoting the position for a further arched brace, which would have been attached to a crown-post in the position of the present brick gable.

Plate 46: Northern truss, clasping crown post, Roof C

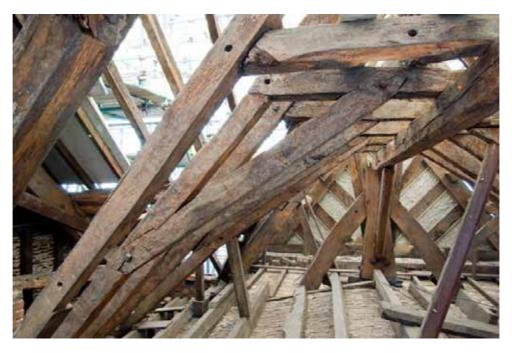
4.4.10 Between the two trusses the roof retains its original form, comprising seven lower scantling common rafter trusses, the collars of which were carried on the collar purlin (Plates 46 and 47), but were also braced to each rafter by straight 'soulaces' (Plate 47). These are joined with notched oblique lap joints, on differing faces (Plate 47), with the collars having similar joints to the rafters, whilst the rafters of each pitch have a simple halved lap joint at the apex of the roof (Plate 48), all joints being single-pegged (Plates 47 and 48). It is noteworthy that this original form of the roof had neither a ridge nor side purlins, with the longitudinal stability being provided solely by the collar purlin.

Plate 47: South truss, with detail of rafter, collar, and soulace construction, Roof C

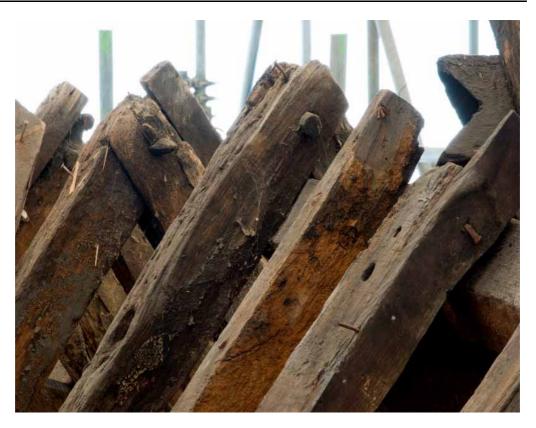
Plate 48: Halved and pegged common rafters, Roof C

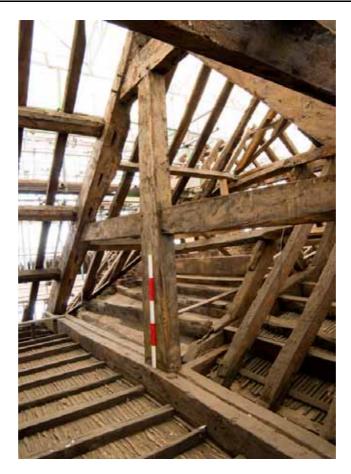
- 4.4.11 The northern two rafters appear to have been cut too short for their intended role, and had small extensions added, presumably prior to the erection of the frame, using stop-splayed scarf joints (Plate 49). Many of the timbers of the common trusses bear carpenter's assembly marks. It would appear that the series was numbered from the southern end, with the trusses having their upper faces on the northern side. However, the trusses appear not to have been arranged in the order that they were numbered, with the sequence apparently being I, II, VII, VIII, V, X, and VIIII. These trusses could easily have been positioned once the wall frame below had been erected, and it is therefore likely that their final position was unimportant. The wall plate was jointed immediately beneath the northern extant crown-post truss, using a splayed scarf, with over-squinted abutments (*ibid*).

Plate 49: Eastern truss, Roof **D**, with scarfed common rafters of Roof **C** behind (bottom right)

- 4.4.18 Unfortunately, no access was possible to examine the detail of the joint between this truss, and the perpendicular truss of the earlier Roof C to the immediate east (Plate 49). However, it appears to comprise a relatively large-scantling trimmer to a ceiling joist of Roof C (Plate 49).

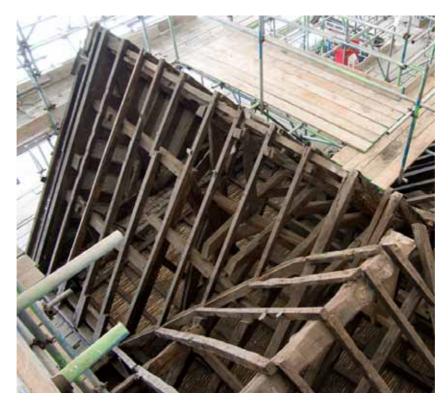
- 4.4.12 The southern three rafters between the trusses have been remodelled with late jack rafters replacing the upper elements, and forming part of a southward extension of the roof, which had a low-scantling ridge and two side purlins added to the earlier structure (Plate 50). These were trenched into short principal rafters which were added to the crown-post truss (Plate 51), rising to only the height of the upper purlin. Additional braces to the upper purlin and ridge were also bolted with an iron plate to horizontal timber pads below (Plate 51). The northern part of the roof also had been heavily remodelled, again with two side purlins and a re-used ridge purlin being inserted. The replaced square-section rafters were attached to the ridge with large round-headed nails (Plate 52).

Plate 50: Remodelled southern part of Roof C

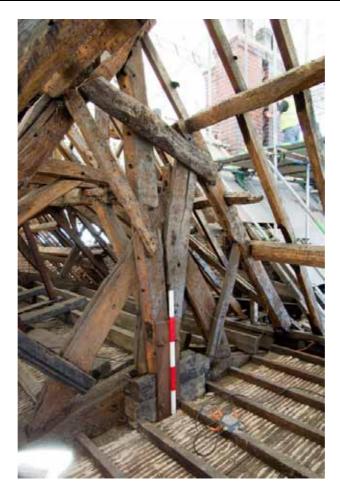
Plate 51: Remodelling of southern truss, Roof C, with inserted short principal rafters

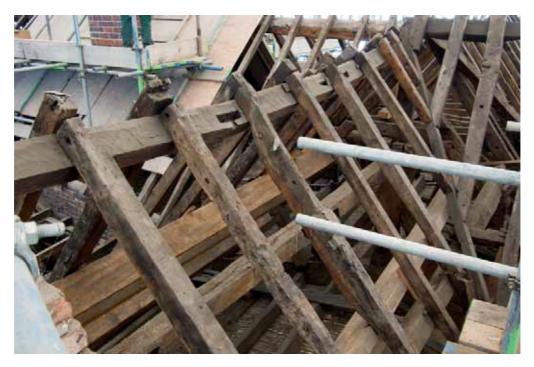
Plate 52: Re-used ridge purlin and common rafters, northern part of Roof C

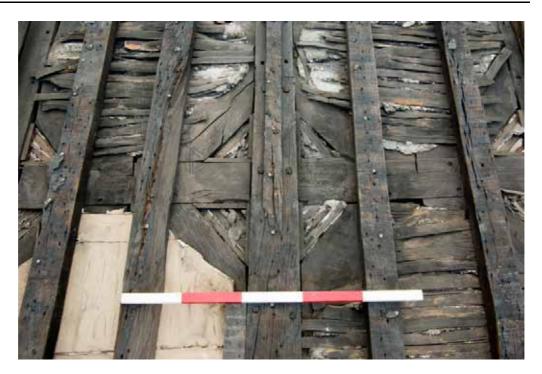
4.4.15 The carpentry of the purlins and panels comprised single-pegged mortice and tenon joints (Plate 54), with the exception of the longitudinal joints between purlins. That observed on the ridge purlin had a splayed scarf joint with bridled and squared abutments, the evidence for the bridle comprising a peg below the splay, which would have been redundant without the internal bridling (Plate 55).

Plate 54: Pegged jointing of decorative timber panels on Roof D

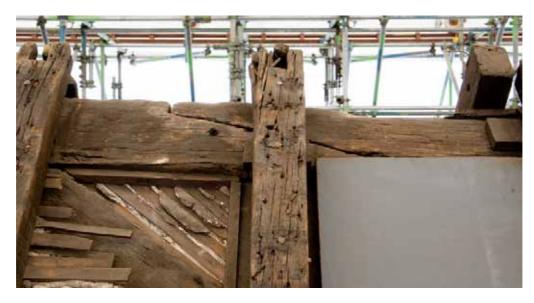
Plate 55: Bridled scarf joint in ridge purlin (Roof D)

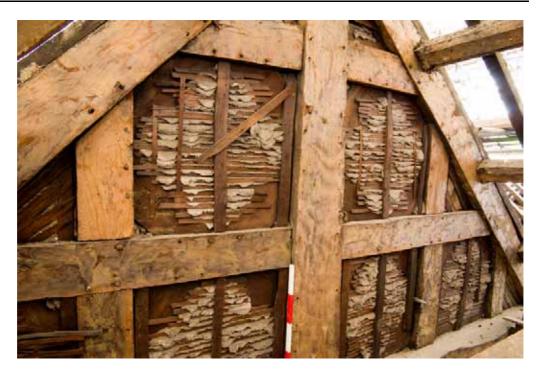
Plate 57: Lower face of truss forming Dais in Great Hall (Roof D)

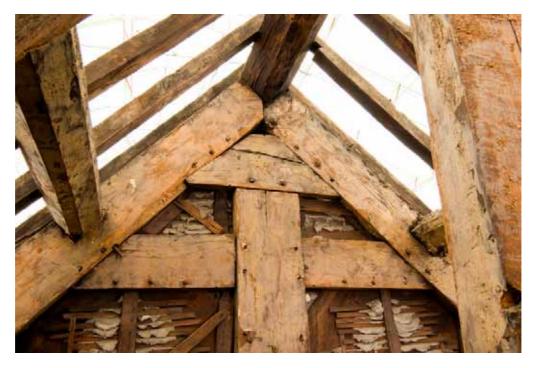
Plate 58: Saddle within truss construction, and pegging of decorative panelling (Roof **D**)

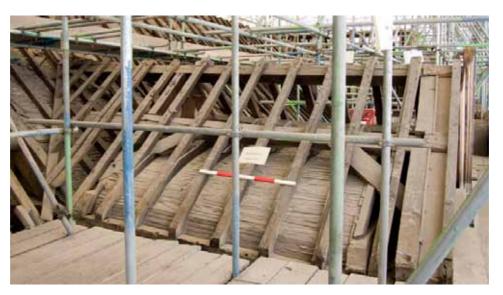
4.4.20 Each truss had double-pegged principal rafters, and a single, rectangularsection trenched purlin was present to each pitch. Each king-post had a birdsmouth apex, clasping the square-section ridge purlin, whilst each principal rafter had a notched oblique lap-jointed straight wind brace, which was tenoned into the purlin (Plate 60). The rafters, which were arranged in pairs, were nailed onto the wall plate, purlin, and ridge, with square-headed

Plate 59: Roof E, with king-post truss either end, and vaulted ceiling

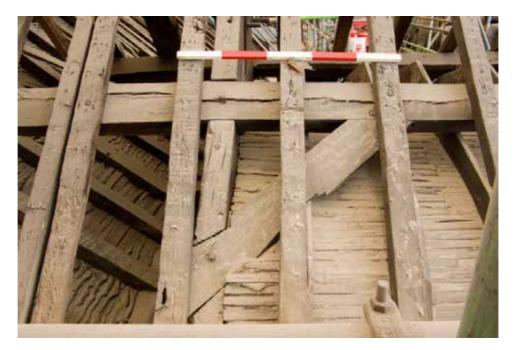
Plate 60: Detail of wind-brace jointing (Roof E)

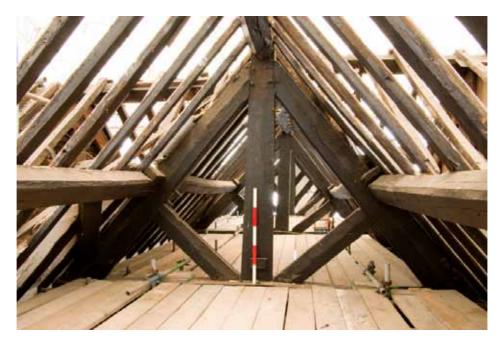
4.4.22 *Roof F:* this roof was aligned perpendicular to the roof of the Great Hall (G4), projecting beyond it to both the north and south, and finished with jetties at these ends (Fig 5). Its construction comprised king-post trusses, with slightly cambered tie-beams, and with straight braces from the tie-beam to below the single trenched purlin on each pitch (Plate 61). The purlins had straight wind

Plate 61: Truss detail, Roof F

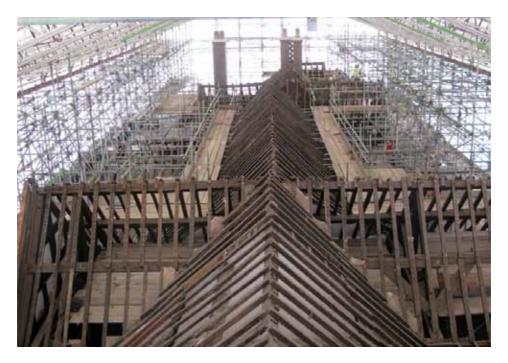
braces, with notched lap-joints to the principal rafters, although several had been removed. The king-posts had birdsmouth apexes, clasping the square-section ridge (Plate 61), which in turn comprised several members, each with splayed scarf joints with square vertical abutments (Plate 62).

Plate 62: Aspect of roofs from west. Note bridled scarf joints on ridge of transverse Roof F

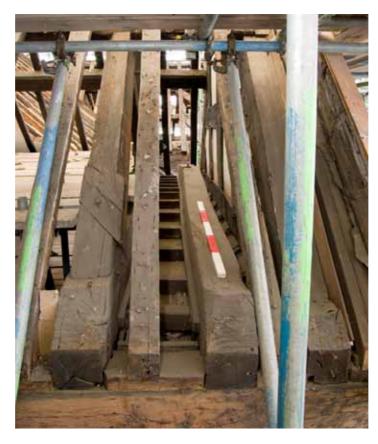
4.4.23 All of the joints were double-pegged, except for the wall-plates, which were triple-pegged onto the wall-frame post (Plate 63), suggesting normal assembly with an internal upstand. The jetty bressumer at the northern end of the roof was single-pegged to the wall-plate (Plate 63). It was rather unusual in that it did not house the studs for the gable façade, instead having only a central wrought-iron bolt (Plate 64), and this probably to strengthen the rail supporting the jetty coving located approximately 3' (0.91m) below (Plate 61). The façade of the southern gable was placed against a repositioned truss, located approximately 2' (0.61m) to the north of the façade (Plate 65). This was presumably originally positioned further out to the south, with a bladed scarf joint immediately below this truss in the eastern wall plate (Plate 64), also suggesting that the roof originally continued for a considerable distance to the south.

Plate 64: Jetty bressumer and trusses, northern end of Roof F

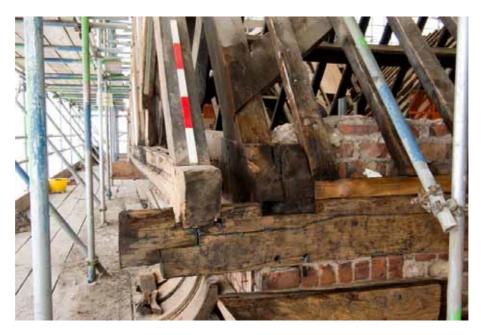
4.4.24 The jettied north gable comprised a king-post above a moulded beam, supported on decorated console brackets. The infill comprised double-pegged studs and rails forming quatrefoil panels, matching those of the Great Hall (G4). The southern jettied gable reflected the style of the truss behind it and had a series of raking struts forming the decoration either side of a central stud (Plate 65).

Plate 65: Repositioned truss and scarf-jointed wall-plate, southern gable, Roof F

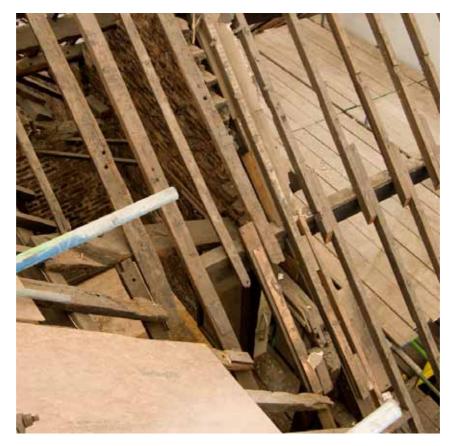
- 4.4.26 **Roof G:** this short and wide roof linked the east and west wings of the hall. It was asymmetrical, with the ridge offset to the south, forming a continuation of that of Roof **D** (Fig 5). The present roof structure appeared to replace an earlier structure. Evidence for this was the tie-beam being incorporated into a brick wall at the western end of the roof. This was jointed onto a wall-frame post at the south-western corner of the roof. Although the wall-plate was missing, the joint appeared to represent normal assembly with the outside upstand almost certainly chamfered in line with the eaves at a later date (Plate 66).

Plate 66: Brick gable, incorporating tie beam with normal assembly to wall post (Roof G)

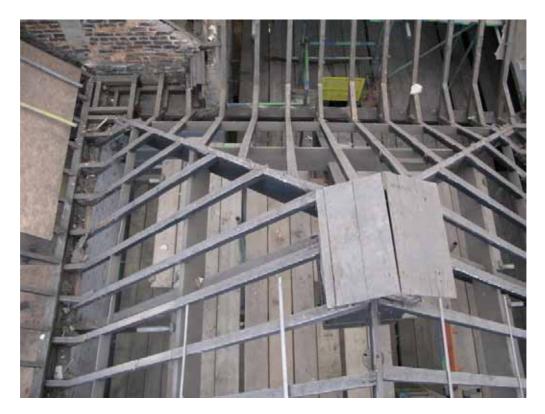
4.4.28 **Roof H:** this short gable roof was hipped on its northern side, creating an internal valley within the overall roof structure (Fig 5). The valley was drained by a channel along the west side of the roof, adjacent to the wall below Roof I. The roof structure comprised a single king-post truss of machine-cut rectangular-section, with hip purlins on its north side. This was augmented by a principal rafter which was placed perpendicular to the truss, and which supported the trenched purlin of the hip (Plate 67). The north-eastern hip rafter was of larger scantling than the other timbers, and was a re-used timber from an earlier roof. The king-post had a jowled head, clasping the slender ridge board, with the principal rafters being attached by bolts. The jack rafters were trenched into the hip rafters, with the common rafters being nailed onto the purlins, ridge and wall plates. The rafters were also sprocketed onto the wall plate of Roofs F and G. A small planked louver spanned the ridge board adjacent to the truss (Plate 67), but detailed examination was not possible.

Plate 67: Late hipped Roof H, with raised timber louvre

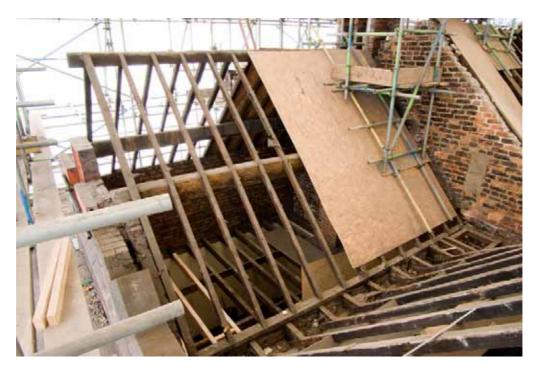
4.4.29 **Roof I:** this was also a short-gabled structure, narrower and steeper than Roof *H*, and with higher walls to Room **S3** (Fig 5). The roof was supported on the north and south walls of Room **S3**, and comprised a ridge and a single purlin to each pitch (Plate 68). The ridge was square-sectioned, and probably from an earlier roof. The purlins were of larger-scantling rectangular-section softwood; the eastern one displaying Baltic shipping marks (Plate 69), suggesting a nineteenth-century date for the roof. The opposing pairs of common rafters were trenched into the purlins, and nailed to the face of the ridge, and onto the narrow wall plates (Plate 68).

Plate 68: Roof I, looking west

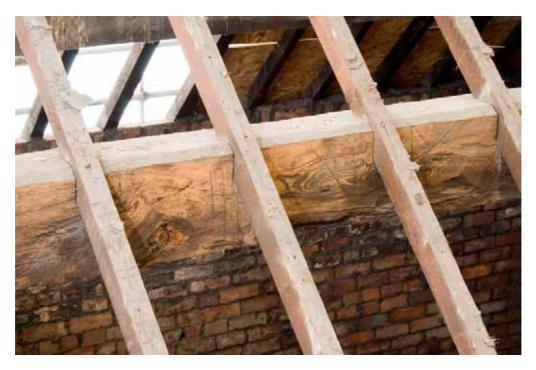
Plate 69: Baltic shipping marks on eastern purlin, Roof I

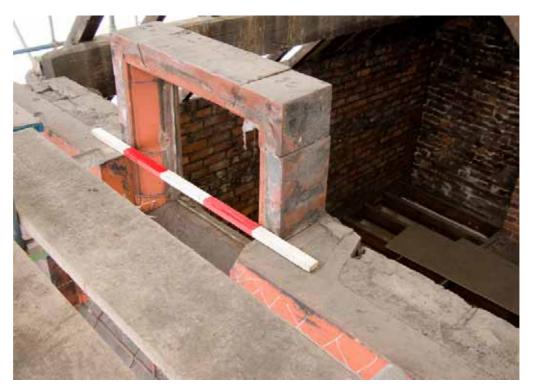
4.4.30 The southern gable had a joggled terracotta window surround (Plate 70), the removal of the wall around the window revealing it to be stamped with the letters O.H and AX (Plate 70). The O.H clearly stood for Ordsall Hall, whilst the AX possibly represents a style or numbering system. A facing brick located in the wall nearby was stamped with the name 'Whittaker's Darwen'. The brick was a hard-glazed engineering brick, and the Victoria County History of the County of Lancaster (Farrer and Brownbill 1911), catalogues a glazed-brick manufacturer in Darwen at this time. Thus the brick almost

Plate 70: Joggled terracotta window surround, with maker's stamps 'O.H.' and 'AX' (Roof I)

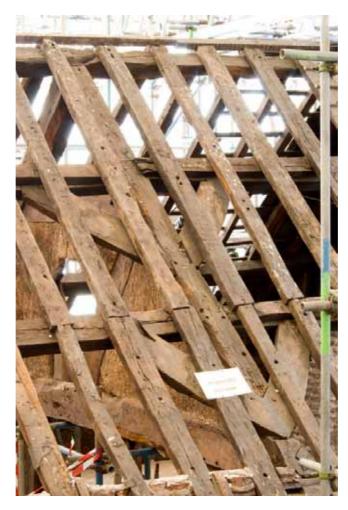
- 4.4.32 The two square-section purlins of each pitch were butt-ended into the trusses (Plates 40 and 41), and the similar scantling ridge purlins were jointed with simple splayed scarf joints (Plate 71). Those to the south of the brick cross-wall between rooms **S5** and **S4** bore redundant mortices and peg holes, demonstrating their re-use. Replacement common rafters in offset pairs were nailed to the purlins and ridge. The ridge itself is capped with a smaller scantling member, presumably to carry later ridge tiles. The common rafters were jointed over the lower purlins, and were trenched into the wall-plates. The wall-plate at the north end of the west pitch had a bridled scarf joint (Plate 72) suggesting its re-use. Other wall-plates exhibited redundant mortices, again demonstrating their re-use.

Plate 71: Simple splayed scarf joint in ridge purlin above truss, Roof J

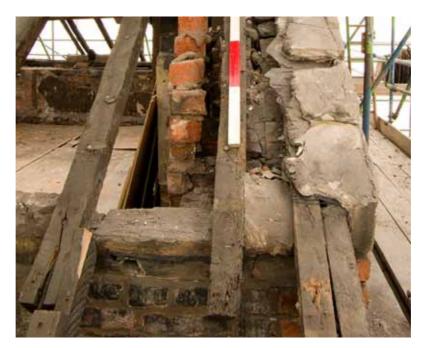
Plate 72: Bridled scarf joint in wall-plate, adjacent to north gable, Roof J

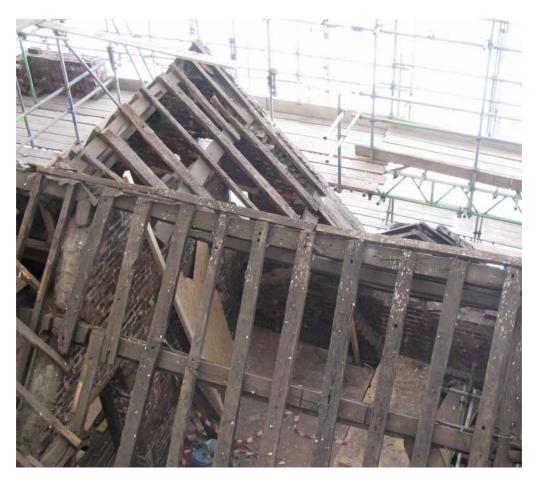
4.4.33 **Roof K:** this small roof above the kitchen bay window comprised a squaresection ridge purlin, and two similar scantling side purlins to each pitch. These were notched onto the purlins of Roof **J**, and were overlain by jack rafters of various scantling, suggesting that it comprised re-used timbers from various phases (Plate 73).

Plate 73: Small pitched gable of western tower (Roof **K**)

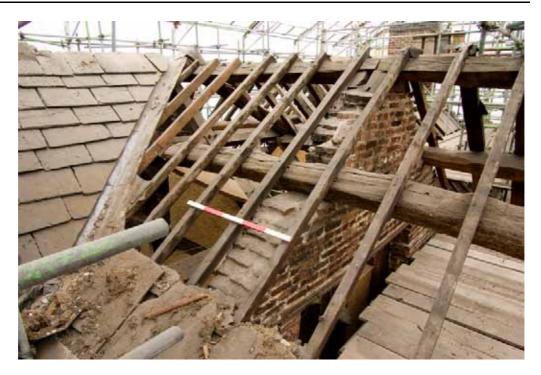
4.4.34 **Roof L:** this was the roof to the stair tower projecting out from the west wing (Fig 5). The square-section ridge purlins were butt-jointed above the west wall of the stair tower, which was capped with timber saddles on each face (Plate 74). The single purlins to each pitch were re-used square-section timbers, the southern example having a notched lap joint for a wind brace (Plate 74), whereas the north side comprised two separate members trenched into the cross-wall (Plate 75). The square-section common rafters were nailed to the ridge (Plates 74 and 75) and birdsmouth-jointed onto a slender southern wallplate, whilst those on the northern side were re-used rectangular-section short rafters, butt-jointed above the purlin (Plate 75).

Plate 74: Timber saddles below butt-jointed ridge purlins, and redundant lap joint in purlin below, Roof L

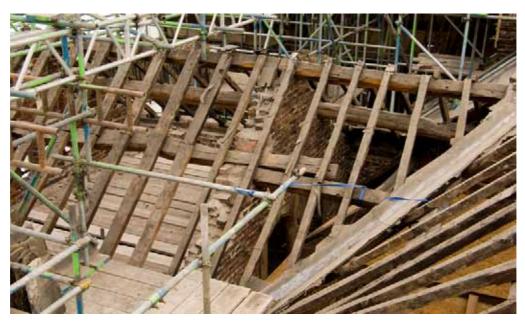
Plate 75: Trenched purlins and butt-jointed jack rafters, Roof L

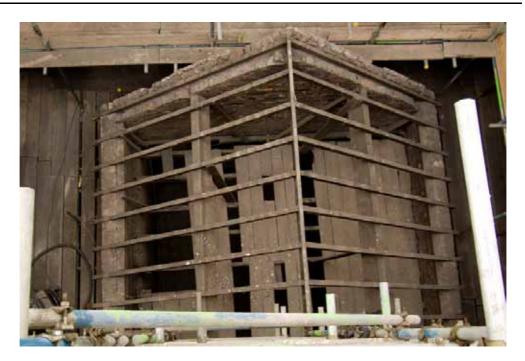
4.4.35 **Roof M:** the original roof above the annexe to the northern end of the west wing was replaced when the annexe was reduced to single-storey height. The roof comprised machine-cut rectangular-section softwood purlins to each pitch, with a slender ridge board, all socketed into the brick gables. The straight, rectangular-section rafters were trenched through the side walls and wall plates, and the opposing pairs clasped the ridge board (Plate 76). Hangers from the purlins stabilised the ceiling joists below, the northern of which had slender braces to the purlins (Plate 76).

Plate 76: Slender timbers of late Roof M

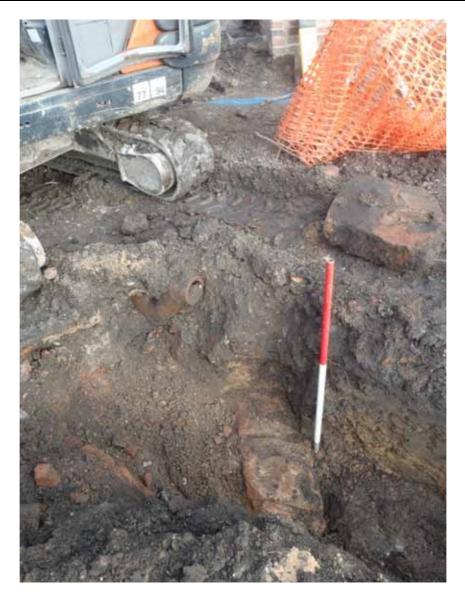
- 4.6.3 Two stone walls (29 and 37) and a stone culvert (30) were partially exposed. Wall 29 (Plates 79 and 80) followed a vague east/west alignment, and appeared to be truncated by the northern end of the west wall of the hall. It comprised a single course of unbonded, worn, yellow sandstone blocks, surviving for a length of 0.75m. These were set on red sandy-clay, which was exposed 1m beneath the modern ground level. A large block, measuring 0.8 x $0.6 \times 0.4m$ was removed from loose deposits above the wall, and was likely to have formed part of an upper course. The projected approximate length of the wall measured 3.30m. It would certainly appear that this wall pre-dates the northern annexe to the west wing

Plate 80: Wall 29

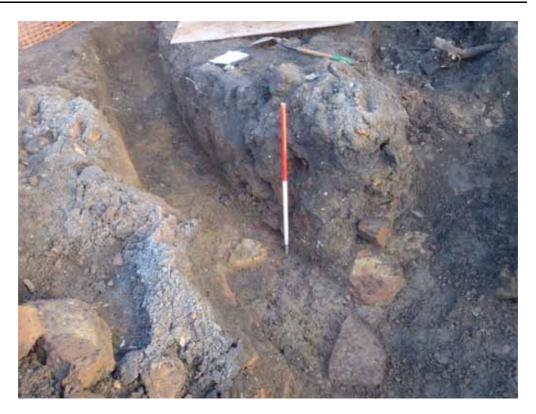
- 4.6.4 A stone culvert (30) comprising a single row of stones was aligned adjacent to, and to the north of wall 29 (Fig 8; Plate 81). It was encountered at a depth of 1m beneath the modern ground level, and sealed beneath modern dumped debris. The space between the culvert and wall 29 was filled with a sticky silty-clay (31), which yielded no artefacts. This was 0.2m thick and overlay the remains of the stone base of the culvert. Due to the limited exposure of 30, it is unclear whether wall 29 was part of the culvert, or alternatively, if the culvert was positioned so as to drain alongside the wall.

Plate 81: Wall 29 and the culvert, 30, with silty-clay between (31)

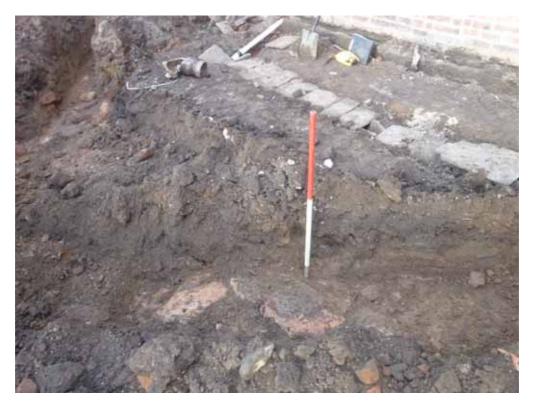
- 4.6.5 Wall 37 was exposed for a length of 1m (Fig 8) to the south of wall 29. It survived to two courses in height. The core of the wall comprised roughly-hewn small sandstone blocks, with the outer faces being of large stone blocks (Plate 81). The upper surface of the wall was exposed beneath a 0.5m thick deposit of levelling clay, and was cut into a reddish-brown clay. It is possible this small section of wall is related to the truncated remains of wall 25 (*Section 4.6.6*, below) seen to the west, although there was no physical evidence to this effect.

Plate 82: Wall **37**

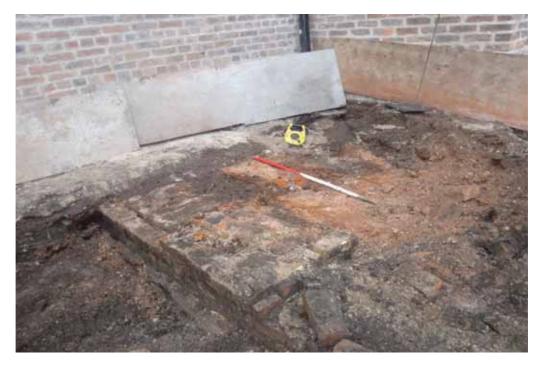
- 4.6.16 On an north-west/south-east alignment, and positioned to the east of wall 26, a further brickwall (24), was seen to extend into the footings of the hall, immediately adjacent to the location of the bread ovens within the kitchen (Plate 86). It measured 3.1m in length by 1.3m in width, and was exposed to a height of three courses (0.40m), with a single step foundation. The wall was charred along its northern face and its outer skin was lined with fire brick. Within the core of the wall was a 0.2m wide ash-pit (Plate 87) sealed beneath an iron plate. This is almost certainly part of the construction and flue for the Jennison bread ovens present in the west wall of the kitchen (*Section 4.2.14, above*).

Plate 86: Upper courses of Wall 24, adjacent to the kitchen

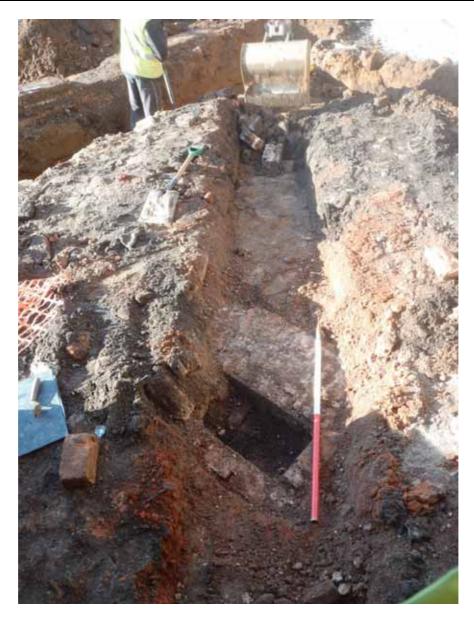
Plate 87: Ash pit within the base of Wall 24

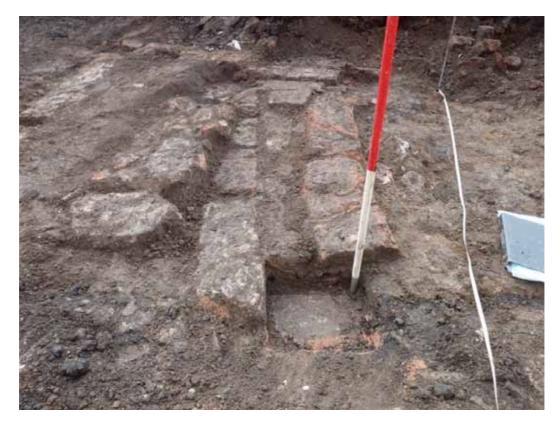
- 4.6.21 The best preserved of the drains were 13 and 21. Drain 21 was the most southerly and of brick construction. It survived for a distance of 2m in length by 0.45m wide. It was capped by thin sandstone tiles. The stone-lined drain, 13, to the north (Plate 88) comprised two parallel, and slightly curving single course (0.3m high) masonry walls. It survived for a length of 1m by 0.5m in width. It was capped with thin (<0.5cm) sandstone tiles, and filled with dark brown silty-clay (14) containing pottery dating to no later than the early nineteenth century. It would seem there was a secondary phase to the drain as represented by the addition of a stone and brick wall (18) located along the southern wall of the drain.
- 4.6.22 The coal store comprised brick walls (19 and 20) and a coal-covered brick surface (23). The walls were unremarkable and a single skin in width.

Plate 88: Section through Drain 13

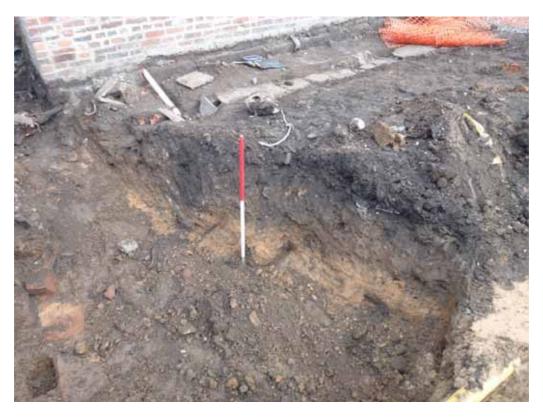
Plate 89: North-facing section showing pit 34, and layers 35, 36 and 27

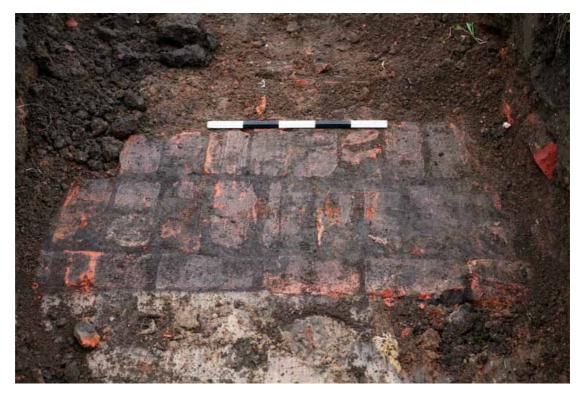
Plate 91: Wall within Trench 3 of the Proposed Formal Garden

4.7.6 *Trench 3*: contained a brick wall with a row of paving stones present along its eastern edge (Plate 93). The wall measured 0.63m wide and was located 1.2m from the western limit of excavation.

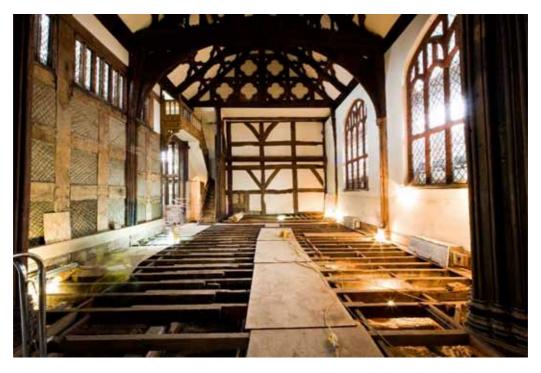
Plate 92: View of the Great Hall looking north-east

5.1.1 Following the removal of the floorboards within the Great Hall (G4), the deposits visible below the joists were cleaned and recorded (Plates 3, 91-92). Several features of archaeological significance relating to the development of Ordsall Hall were revealed (Fig 10). These included evidence of a hearth, a brick surface, and a brick channel. Most of these features were truncated by twentieth-century services and were overlain by sleeper walls that ran north-east/south-west across the hall.

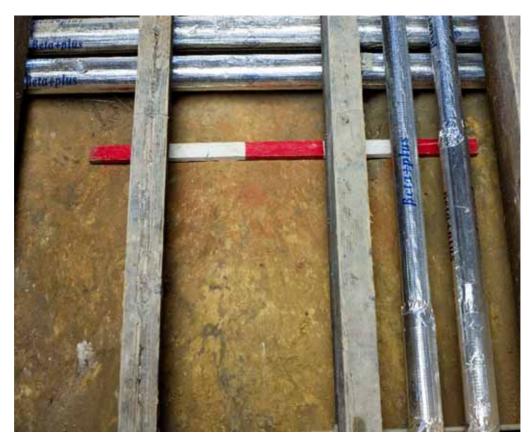
5.2.1 The earliest encountered material comprised naturally deposited mid-orangebrown sand. A sub-ovoid patch of the sand that was situated within the centre of the eastern, or 'high', end of the hall was seen to have been burnt and to have become discoloured to a pinkish-red hue (Fig 10; Plate 94). This burnt patch measured 2.6m long and 2m wide, and was was situated beneath a former louvre in the apex of the roof, which has now been boarded over. The discolouration is, therefore, clearly evidence of the former presence of a hearth in this area, and the intense heat that this would have produced. The central part of the heat-affected patch had been truncated by modern services and it is likely that horizontal truncation had removed the former upper surface of the deposit and any associated deposits, such as charcoal and ash, or structural remains.

Plate 94: Area of burnt sand (101) resulting from the former presence of a hearth

- 6.2.3 Due to a lack of dating evidence it was not possible to ascribe a date of origin to the hearth, however, the alignment of hearth and louvre would certainly suggest that the hearth was still in use when the current hall was constructed c 1513. The brick channel observed beneath the padstone for the spere post had very obviously undercut the padstone, and is not suggestive of an earlier phase of work to the hall.

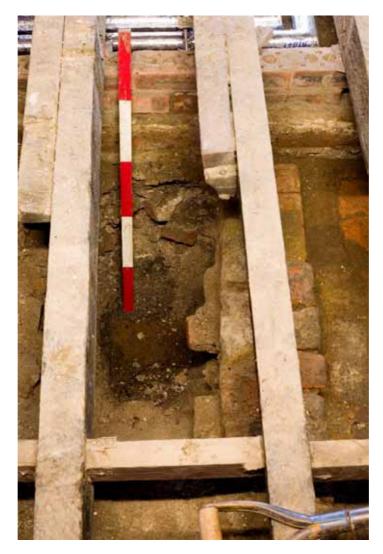
5.2.2 A dumped deposit of building rubble comprising fragments of ceramic bricks and mortar, in addition to sherds of late-nineteenth-century pottery (111), was located at the south-western side of the hall (Plate 95). This deposit was 0.7m deep and extended over a sub-rectangular area measuring 2.42m wide and 3.22m long. The northern extent of the spread was defined by a single row of mortared bricks (110) that was traced for 2.42m. Only the upper surfaces of these bricks, which was level with the natural sand (100), were visible and it is not known whether lower courses were present. The relationship between the row of bricks (110) and the dump of rubble (111) suggests that they were possibly contemporary. A linear cut (106) measuring 0.44m wide and 2.16m long was filled by a single course of bricks (109). These had the appearance of being the remaining portion of a linear feature, such as a wall foundation, constructed to a width of three bricks, or 0.35m. This brick feature (109) shared the same alignment as the brick row (110), and it is possible that they represent discontinuous portions of a single structural element that was truncated by the installation of later services.

Plate 95: Exploratory sondage through a dumped deposit of building rubble (111) facing south-east. The overlying brick channel (108) is visible at the right of the image

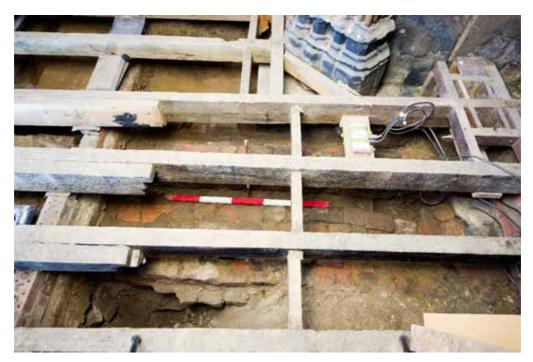
5.2.3 A linear foundation trench (102=107) with vertical sides measuring 1.2m wide at the western end and 0.65m wide at the eastern end, was aligned southeast/north-west across the entire exposed width of the hall. The trench cut natural sand (100) to the south and the deposit of rubble infill (111) to the north. An apparent brick channel (108=104) had been constructed within the trench comprising parallel double-thickness walls sitting two courses higher than a brick base that lay between them.

Plate 96: Brick channel (108) facing south-west

5.2.4 The overall width of this structure varied between 0.88m at the western end (Plate 96), and 0.65m at the eastern end (Plate 83). The western end appeared to have been further widened by a stretch of wall (103) that ran parallel to the southern side of the structure (108=104). Wall 103 was a single brick wide and might have formed a second channel. It extended beneath a stone pad that supported the south-western spere post, and it is likely that this was simply a consequence of the insertion of the wall, as it extended for a further 1.7m beyond the stone pad. The foundation trench and the brick channel were truncated in the centre and at the eastern end, by the sleeper walls that supported the most recent floor joists above, and was overlain by a sleeper wall at the western end. As the channel overlay the deposit of building rubble (111) that contained pottery of late nineteenth-century date, this provides a relatively tight date range for the construction of the channel, lying between the late-nineteenth and early-twentieth centuries.

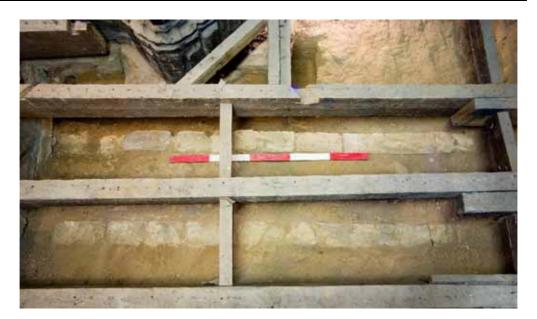
Plate 97: Brick channel (104) facing south-west

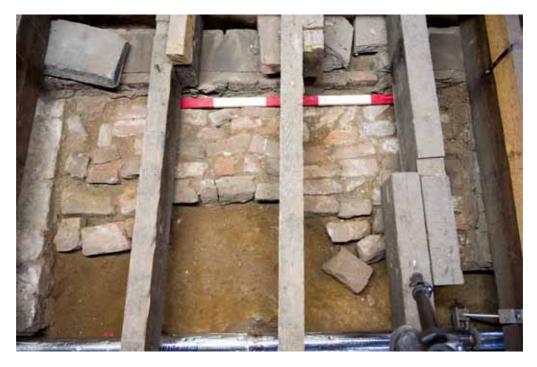
5.2.5 A crudely-formed brick surface (105) lay at the northern end of the hall (Plate 98). This was mainly constructed from reused broken bricks that had been laid on edge and did not include the use of bonding material. The surface measured 1.64m long and 0.7m wide and appeared to have abutted two sleeper walls that supported joists for the latest wooden floor and were of twentieth century date. This suggests that the surface was of modern construction and was used temporarily, perhaps in association with a phase of repair or modification to the hall during the twentieth century.

Plate 98: Brick surface (105) facing north-east
