Church Farm Lewknor Oxfordshire

Historic Buildings Recording and Investigation

October 2009

Document Type: Historic Building recording and investigation

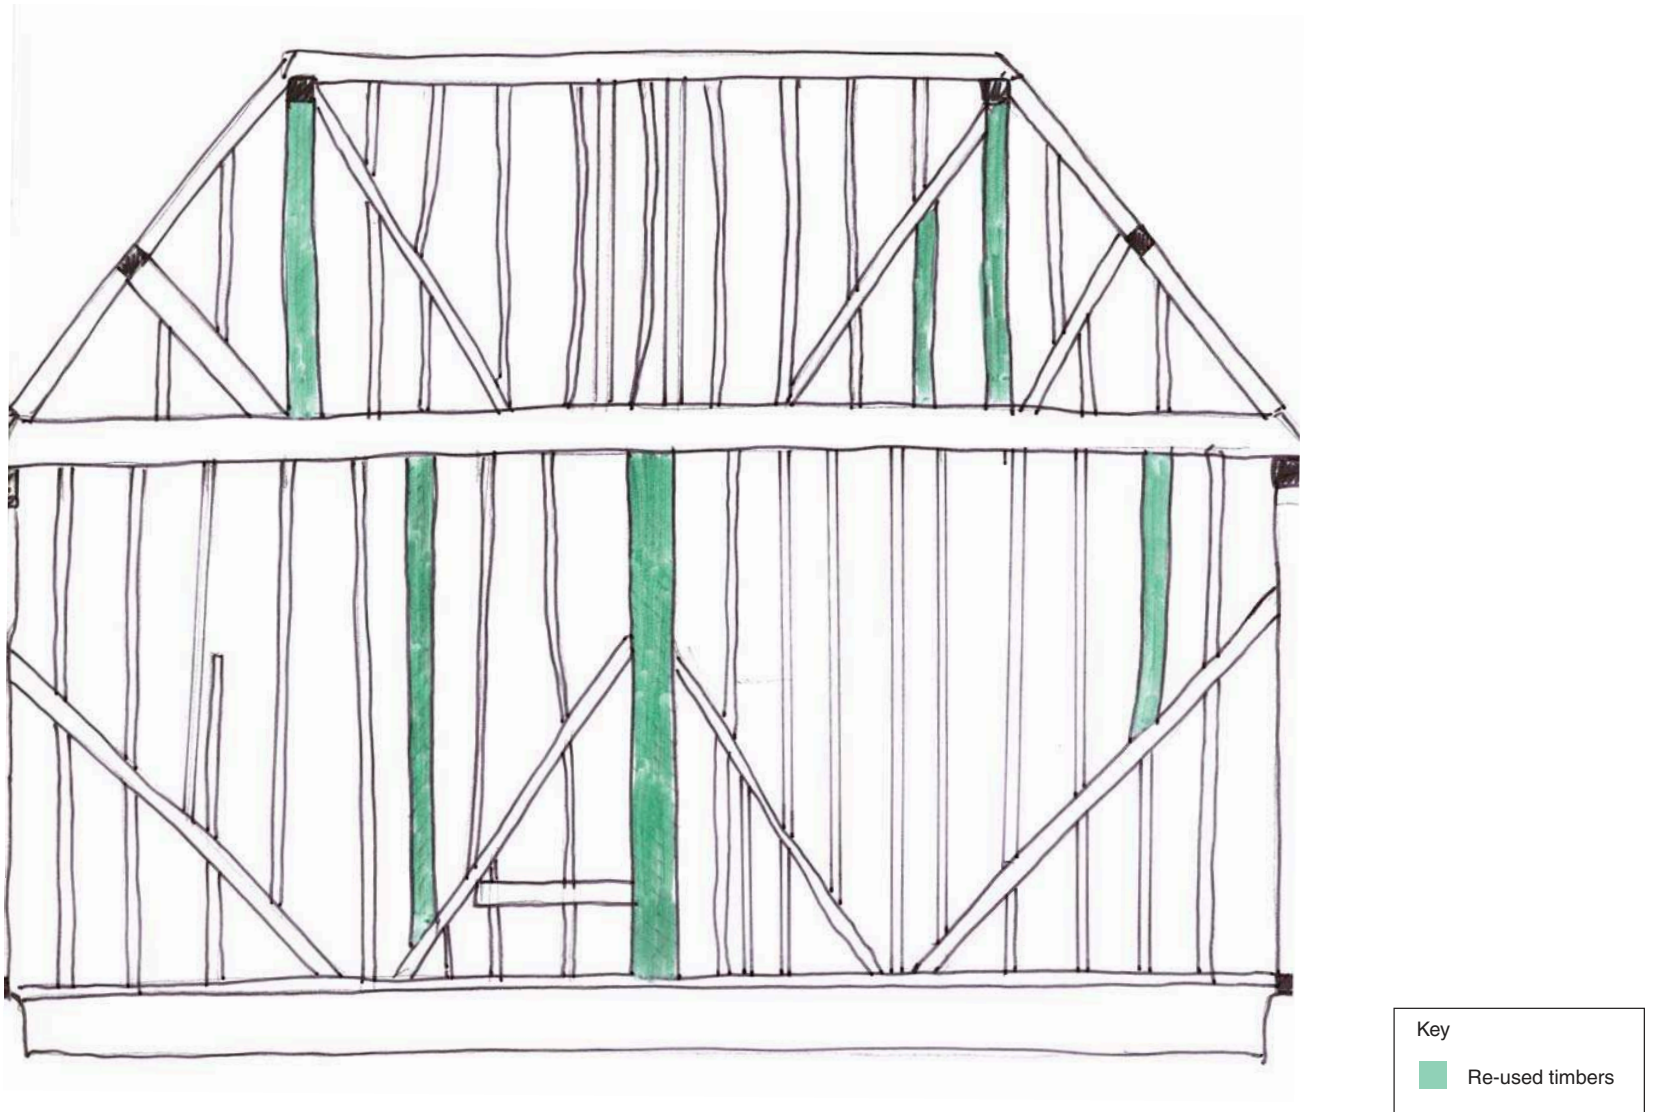
Figure 8: Sketch elevation of west wall showing re-used medieval timbers, (approx 1:50)

- 3.6.16 West end Frame 4**
- 3.6.17 The west end wall has been entirely reconstructed (together with the western ends of the north and south walls) and we know very little about the original form of this end of the building (Fig. 8). The primary structure may have had a similar footprint to that existing today or it may have extended further west. Alternatively it may have ended further east, a short distance west from Frame 3 if the construction of the building was unexpectedly curtailed at this point (possibly for example by the Black Death) or it may have adjoined a separate (or proposed) building at this point.

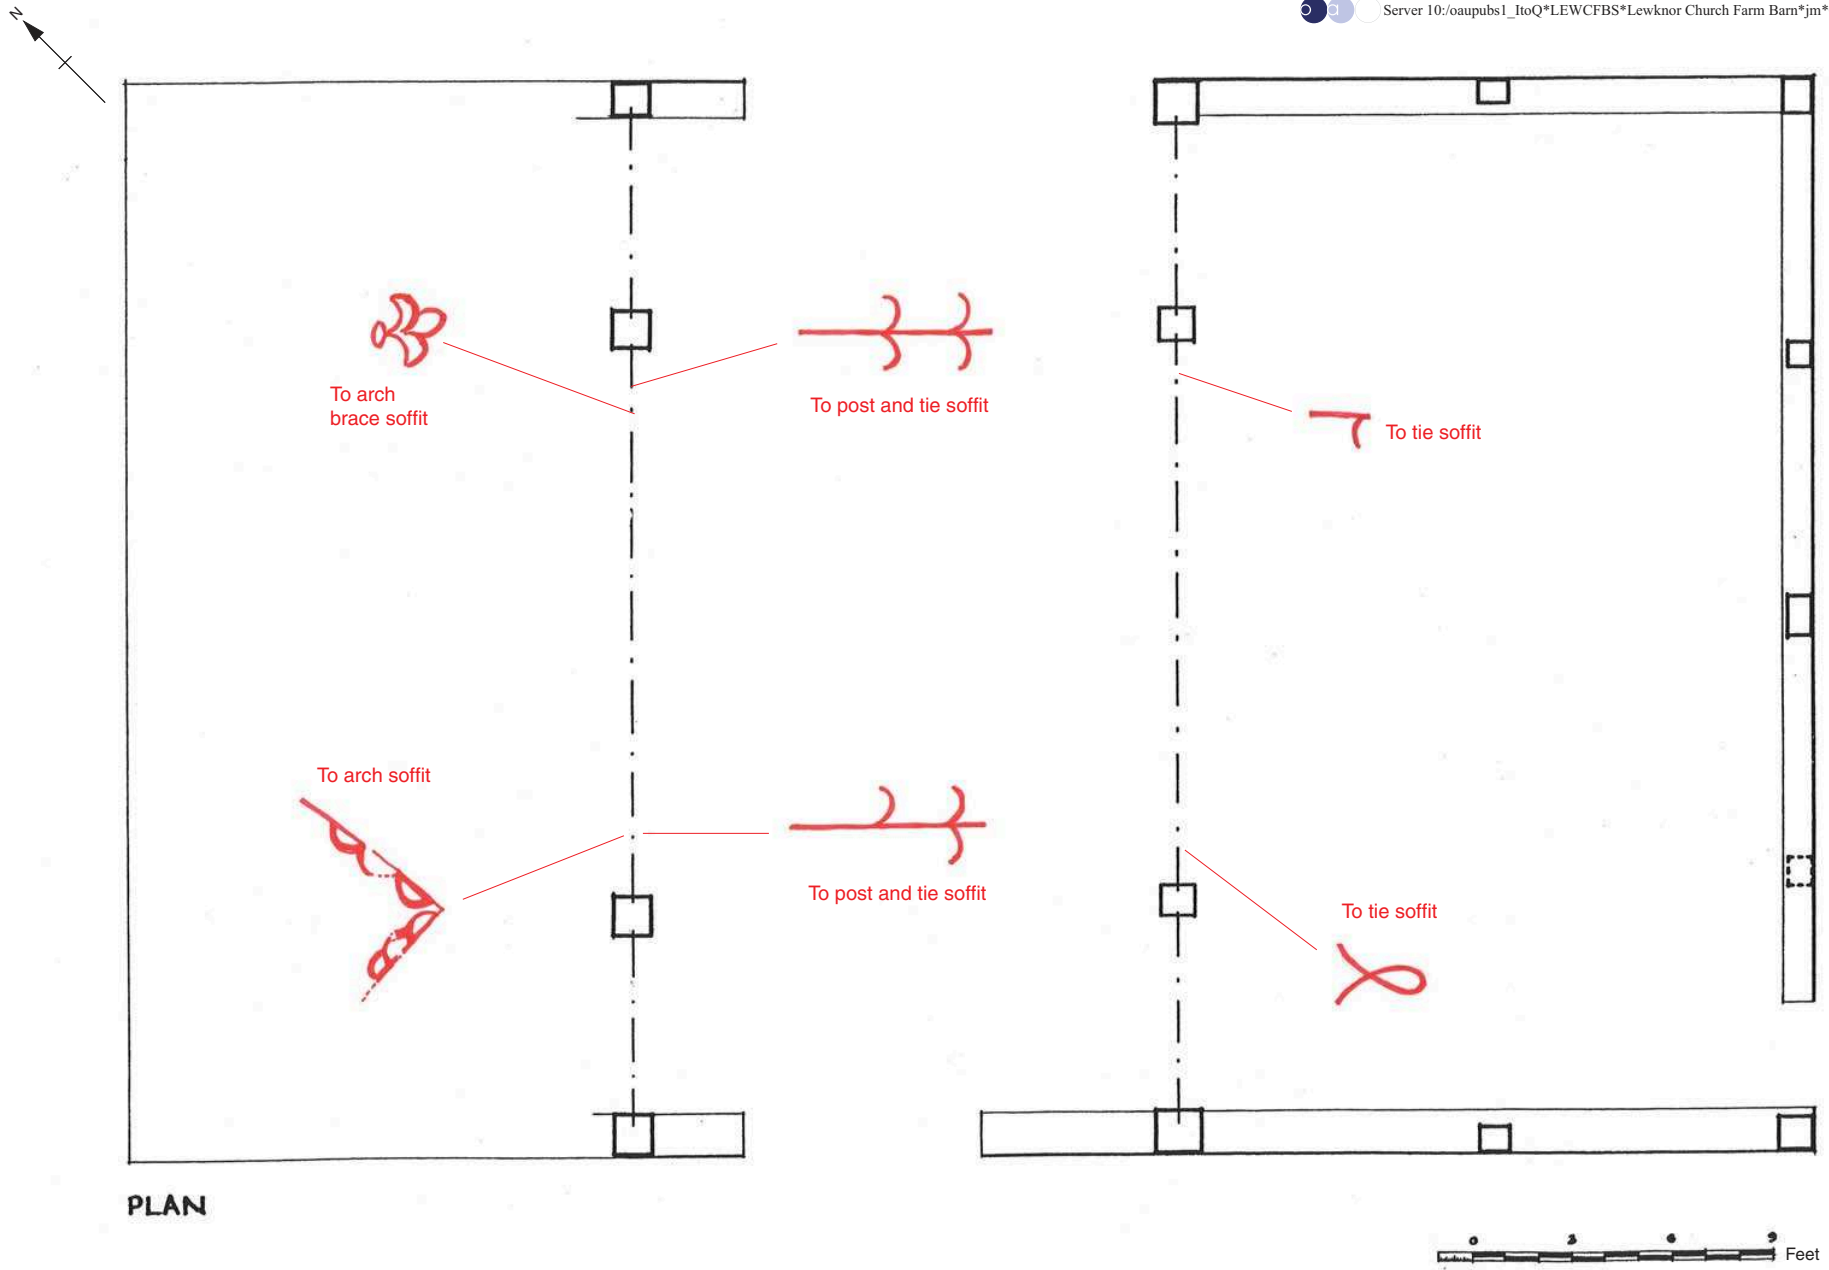
Figure 9: Plan of barn showing carpenter's marks (based on RCHM survey)

3.8.2 Among the interesting features of the barn identified during the current works have been a number of unusual and distinctive carpenters marks (Fig 9). At the east end of the building there are a series of Roman numeral marks (Fig. 3) scratched to the underside of the tie-beam and these are interesting but conventional setting out marks whereas on the two main trusses of the hall (particularly the spere truss) there are a number of more individual marks which may have had symbolic value or formed a carpenter's 'signature'.

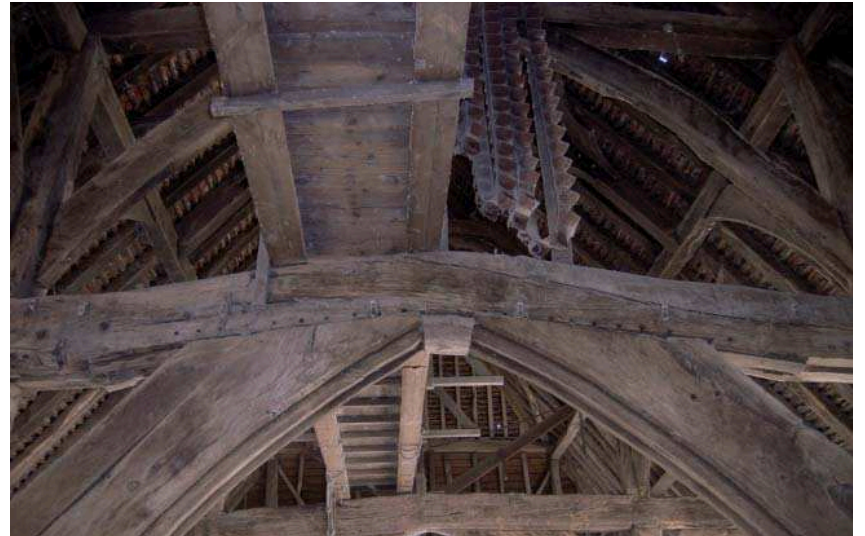
Plate 9: Detail of Frame 2 and 20th-century gantry

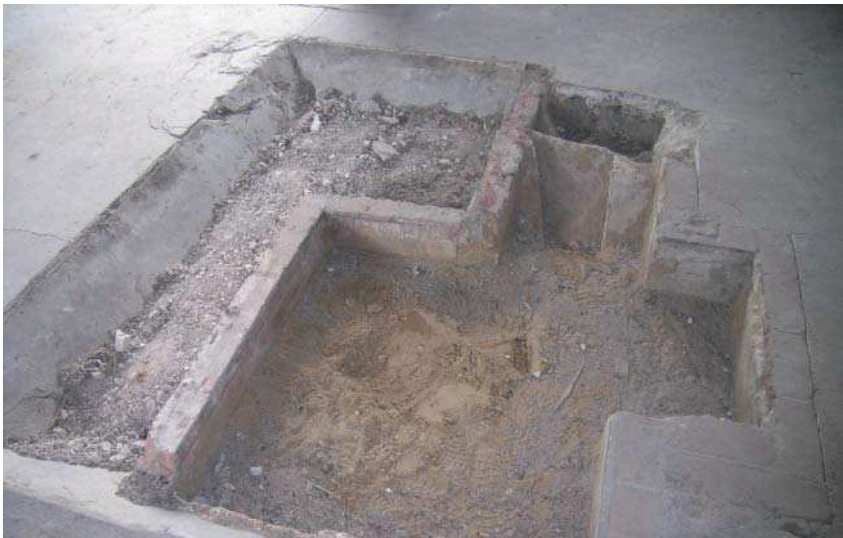
Plate 18: Modern trough/chute in floor of barn

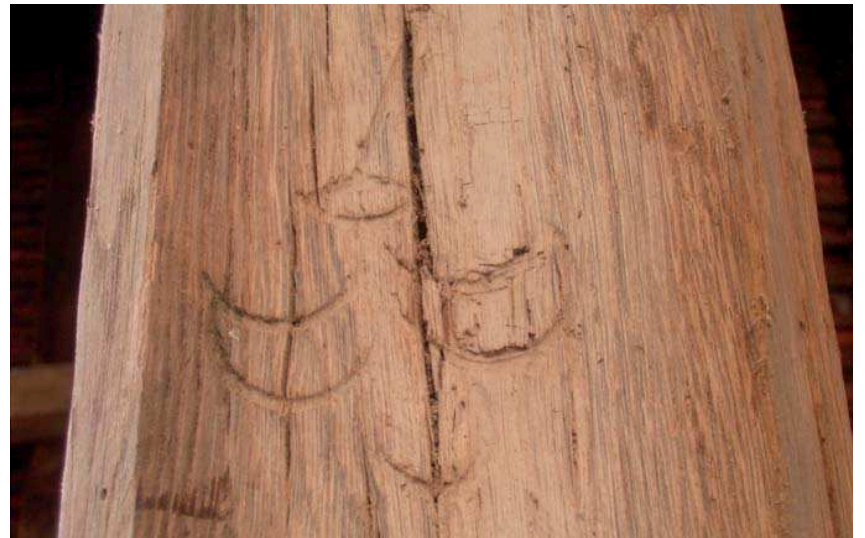
Plate 19: Fleur de Lis carpenters mark

- 3.8.4 The marks at Lewknor include a *Fleur-de-lys symbol* on the soffit of the northern arched brace of the spere truss (Frame 3). This had been scribed with a circular race knife with approximately 40mm diameter on the circle. The central point can clearly be seen on photographs (Plate 19 and Fig 5). This is an unusual mark and probably an individual piece of decorative graffiti or with some symbolic purpose rather than forming part of a series of assembly marks.

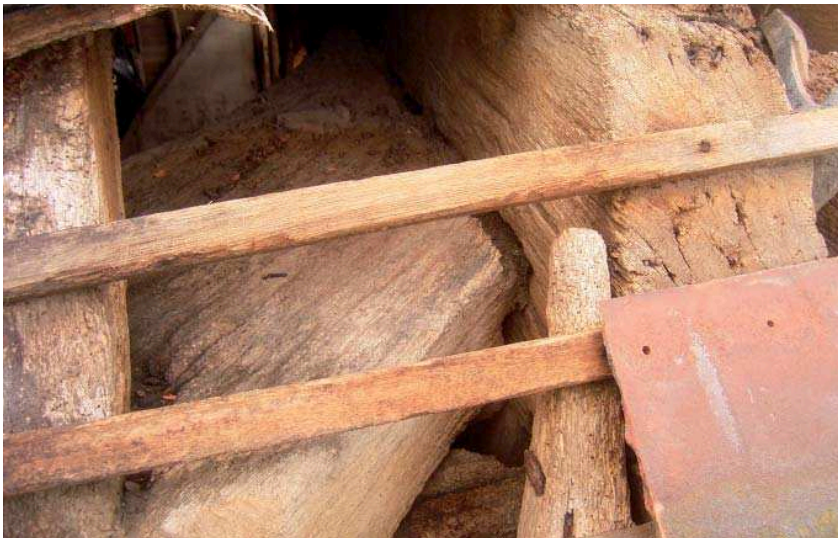
Plate 22: Curved corner brace and end of tie beam at E end of barn
