Site/Project Name: **Lewknor Church Farm Barn**

**Church Farm, Lewknor, South Oxfordshire
Written Scheme of Investigation for Building recording**

Church Farm
Lewknor
Oxfordshire

**Historic Buildings Recording
and Investigation**

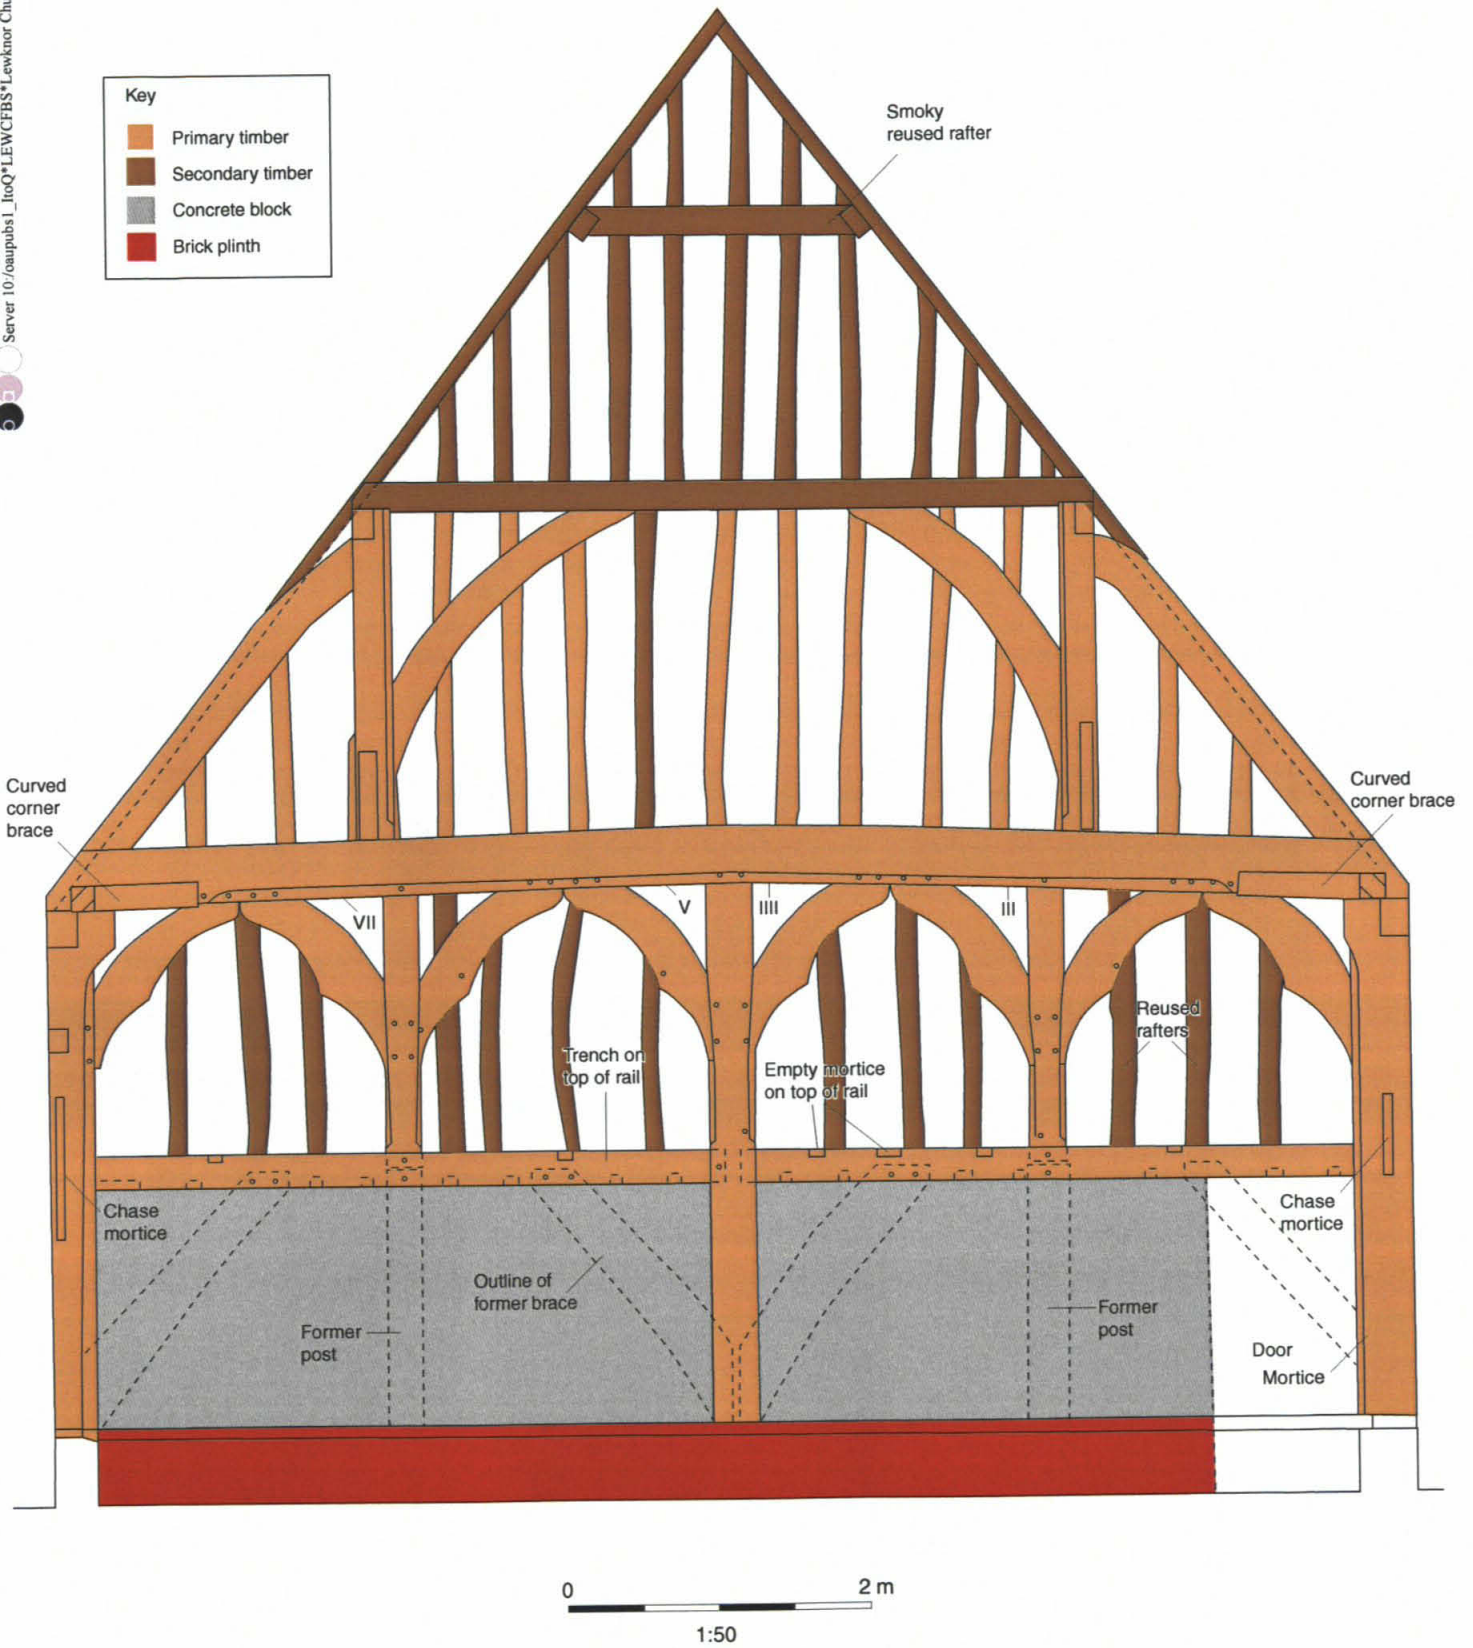
Figure 3: East end wall, internal elevation

- 3.6.2 The east wall (Frame 1) of the barn would have formed the upper (dais) end of the open hall and it is an attractively decorated frame with cusping and mouldings which were clearly intended to impress visitors to the hall (Fig 3, Pl. 12). The wall divides into two main elements: i) the truss and half hipped gable; ii) the wall beneath the truss.
- 3.6.3 The truss comprises tie-beam, principal rafters, lower collar (or upper tie), upper collar, raised aisle posts and curved struts between raised aisle posts and lower collar. Unlike in

3.8.2 Among the interesting features of the barn identified during the current works have been a number of unusual and distinctive carpenters marks (Fig 9). At the east end of the building there are a series of Roman numeral marks (Fig. 3) scratched to the underside of the tie-beam and these are interesting but conventional setting out marks whereas on the two main trusses of the hall (particularly the spere truss) there are a number of more individual marks which may have had symbolic value or formed a carpenter's 'signature'.

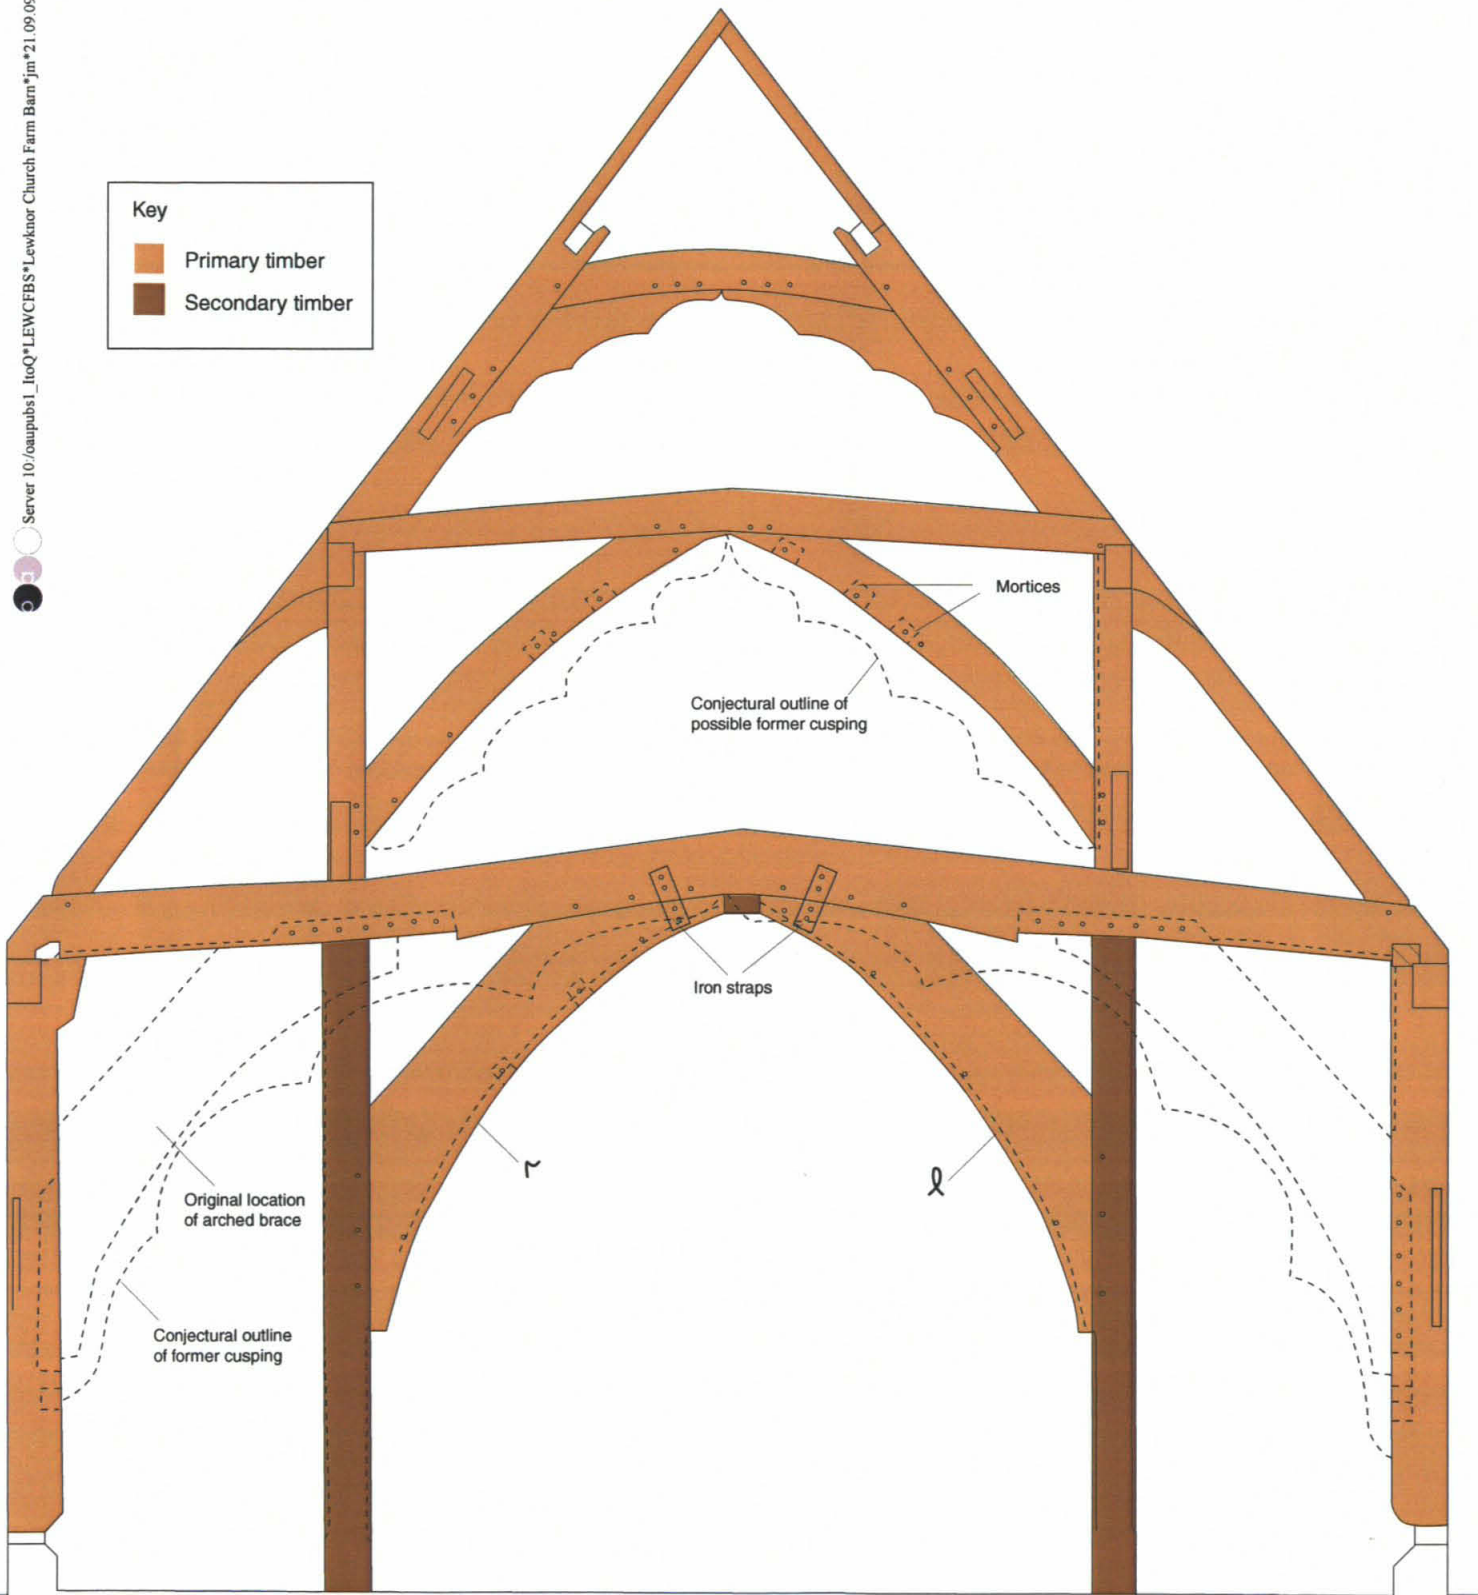
Figure 4: East central truss from west

- 3.8.7 The formerly open truss (Frame 2) also has some marks but they are smaller and less distinctive. They included a small looped shape on the western arch and an 'r' shape to the east (Fig 4).

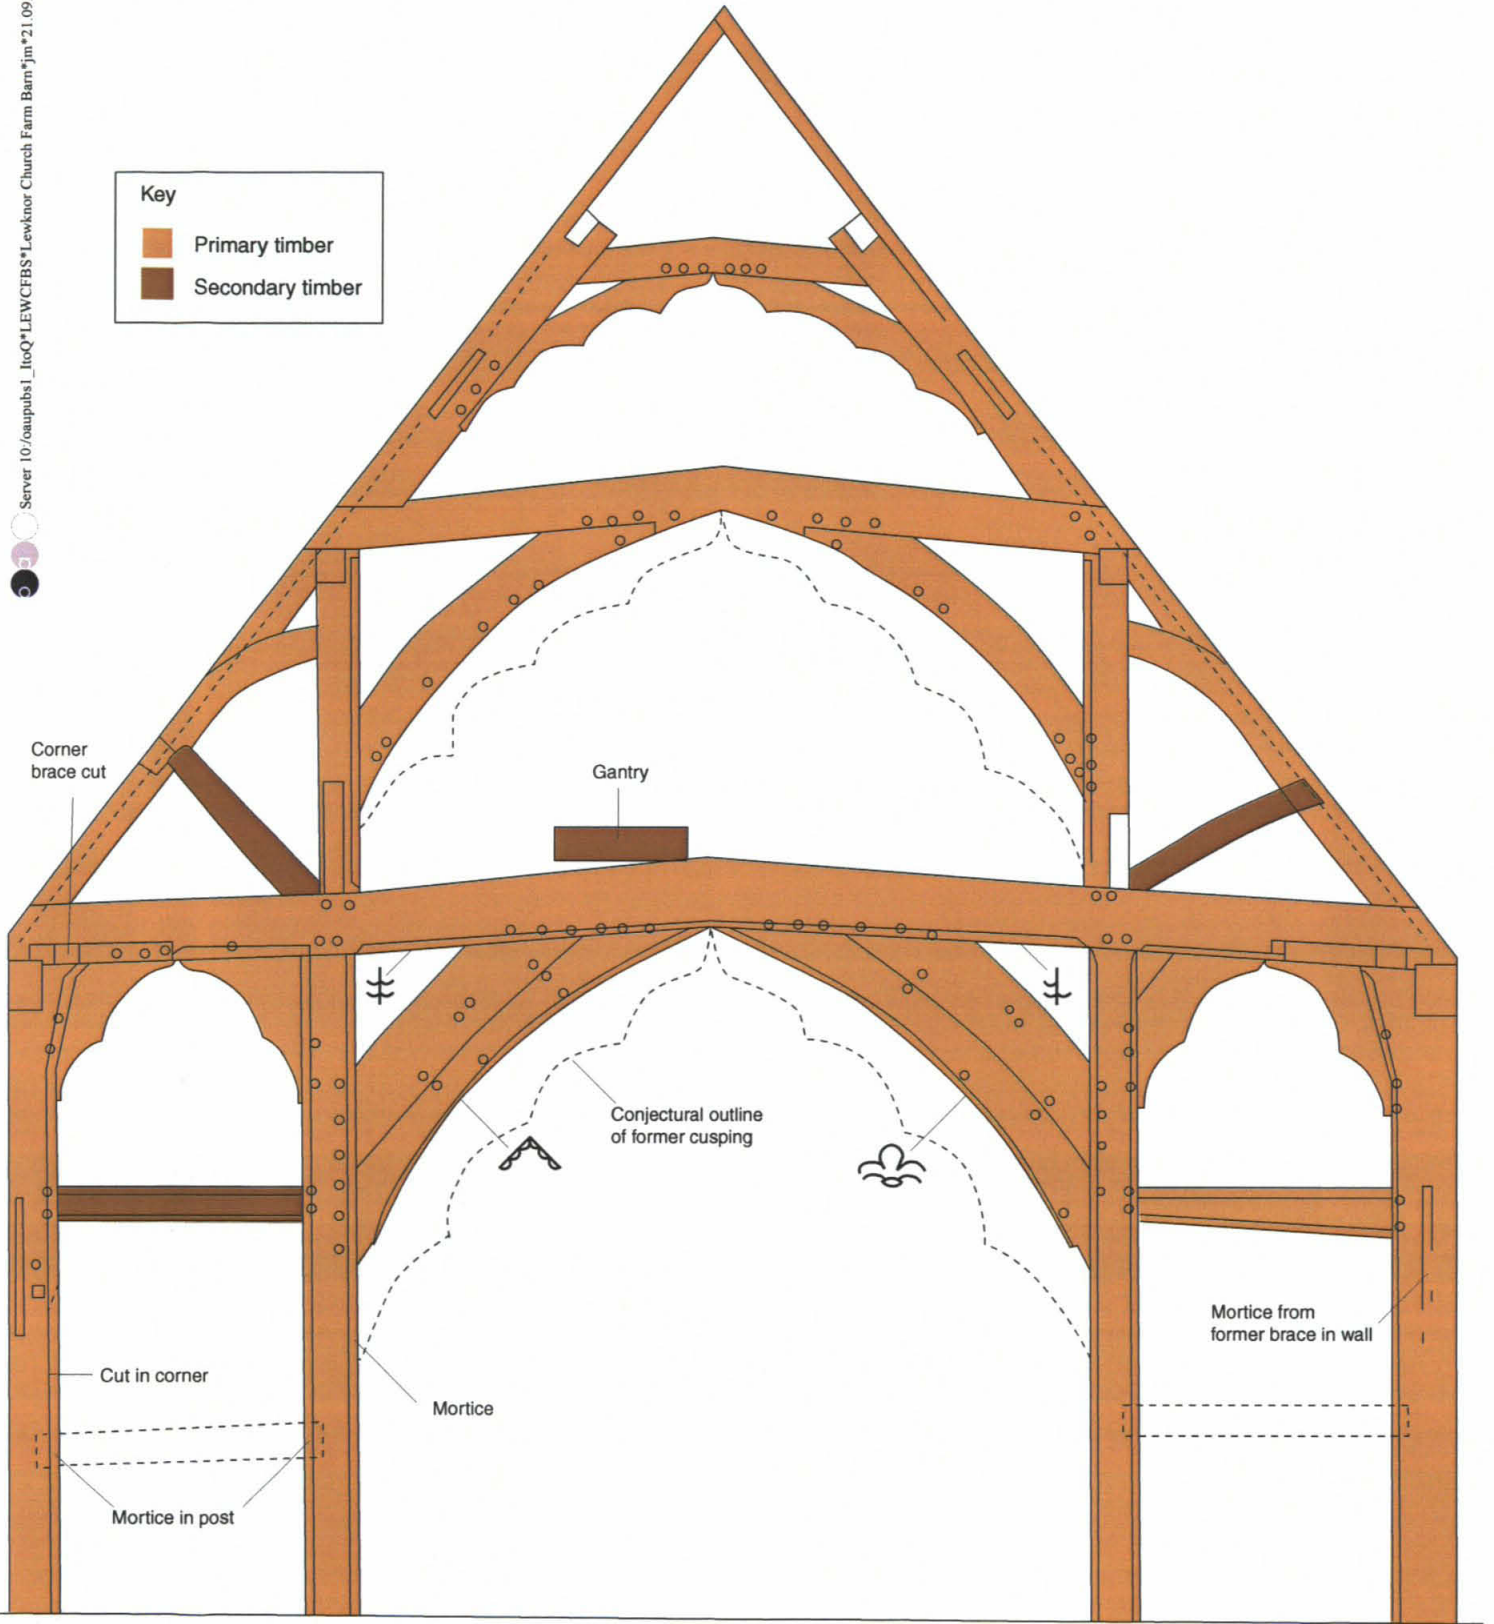
Figure 5: West central truss from east

- 3.8.4 The marks at Lewknor include a *Fleur-de-lys symbol* on the soffit of the northern arched brace of the spere truss (Frame 3). This had been scribed with a circular race knife with approximately 40mm diameter on the circle. The central point can clearly be seen on photographs (Plate 19 and Fig 5). This is an unusual mark and probably an individual piece of decorative graffiti or with some symbolic purpose rather than forming part of a series of assembly marks.

- 3.8.5 On the corresponding soffit of the southern arched brace in the spere truss is an unusual *V shaped mark with half circles (two to one side and three to the other)* and again this was scribe-cut with a race knife (Fig 5). It is likely that the race knife had a central point that enabled the user to make circular shapes of approximately 40mm diameter. This central point is not found on post 18th century race knives. It is again unlikely that this is an assembly mark and is probably a graffiti or decoration.

- 3.8.6 Also on the spere truss a number of similar marks were identified with *half circles and lines* and these do form part of a pattern of assembly marks (Fig 5, Pl 20). Each mark includes a straight central line and half circles branching to either side from this line. On one set of marks there are two half circles to either side while another set has a single half circle to one side and two to the other. Corresponding marks are found to either side of the truss on the tie beam soffit and side of the post. This mark is very similar to arrow style markings seen elsewhere (eg. moulded roof truss in the Chapel Royal Hampton Court Palace c. 1536). It would appear that the lower two half circles denote whether the frame goes on the left or right with only one half circle on one side of the barn and two on the other. This appears to be made with the same size (40mm) circular race knife as the two marks above suggesting they are all of a similar date.

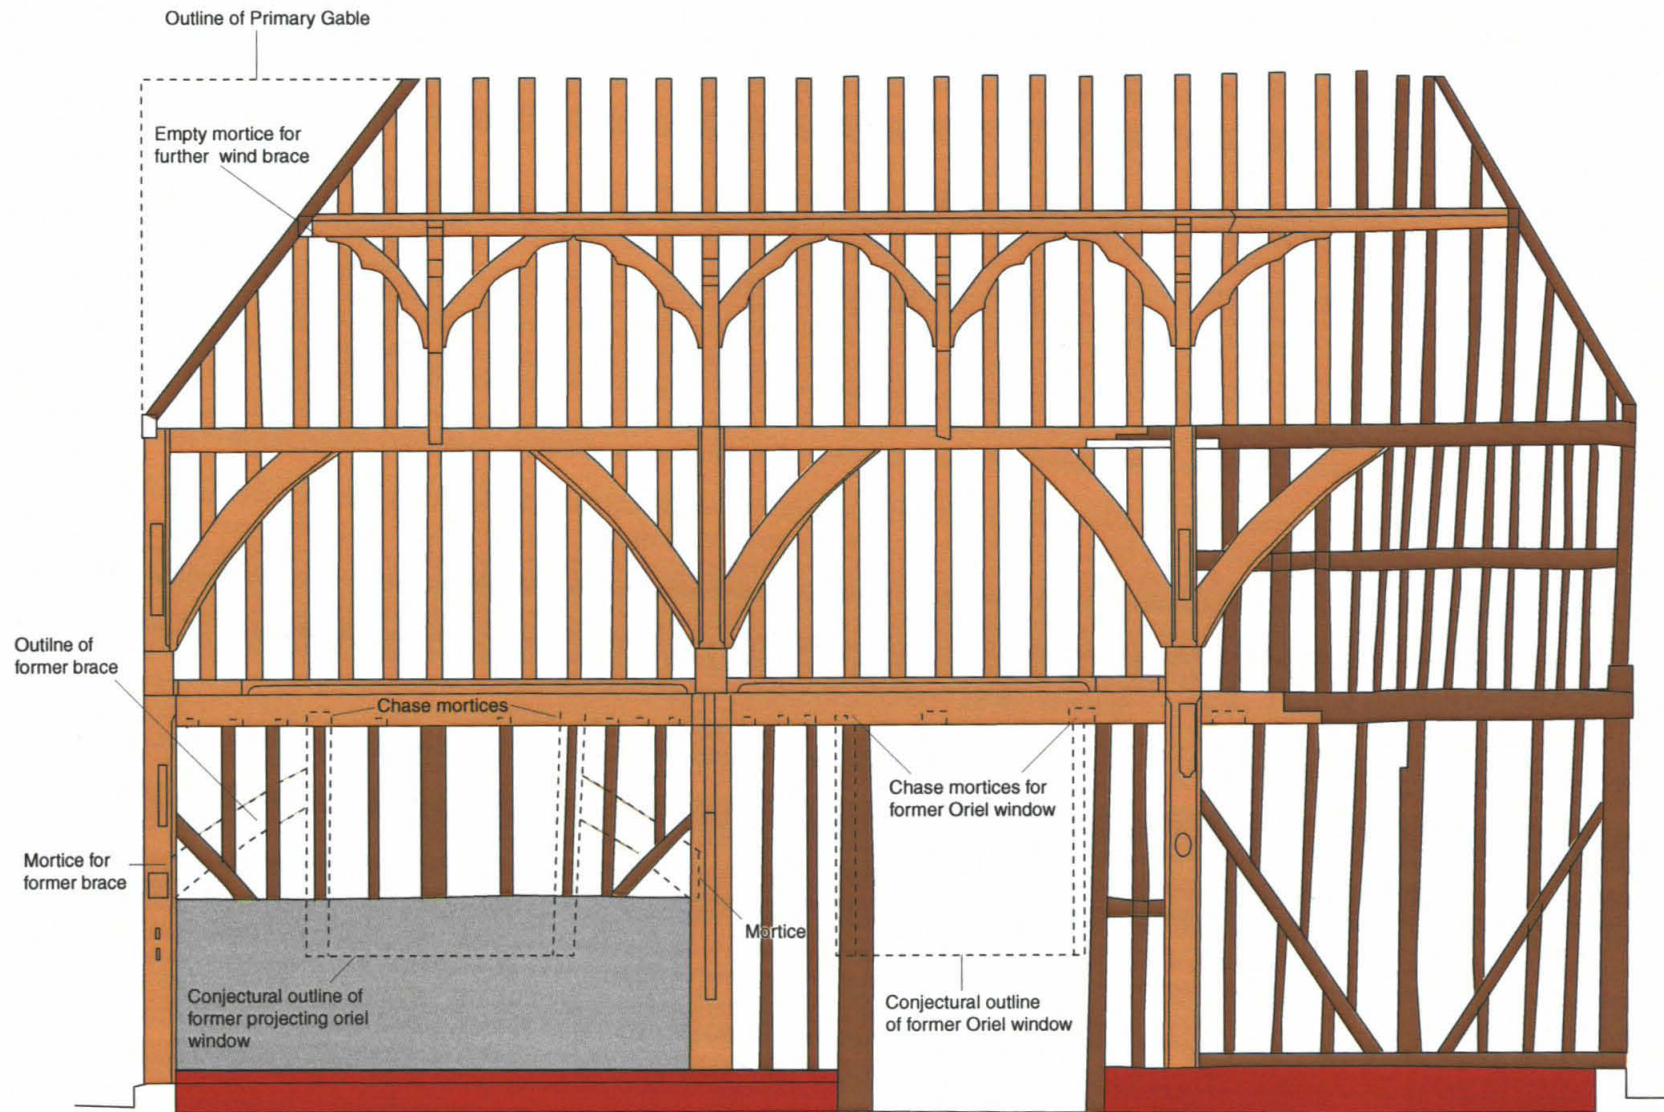
Figure 6: South wall internal elevation

- 3.5.2 The phasing of the south wall divides into the largely primary eastern two bays and the western bay which has been entirely reconstructed, possibly in the 18th century (Fig 6).

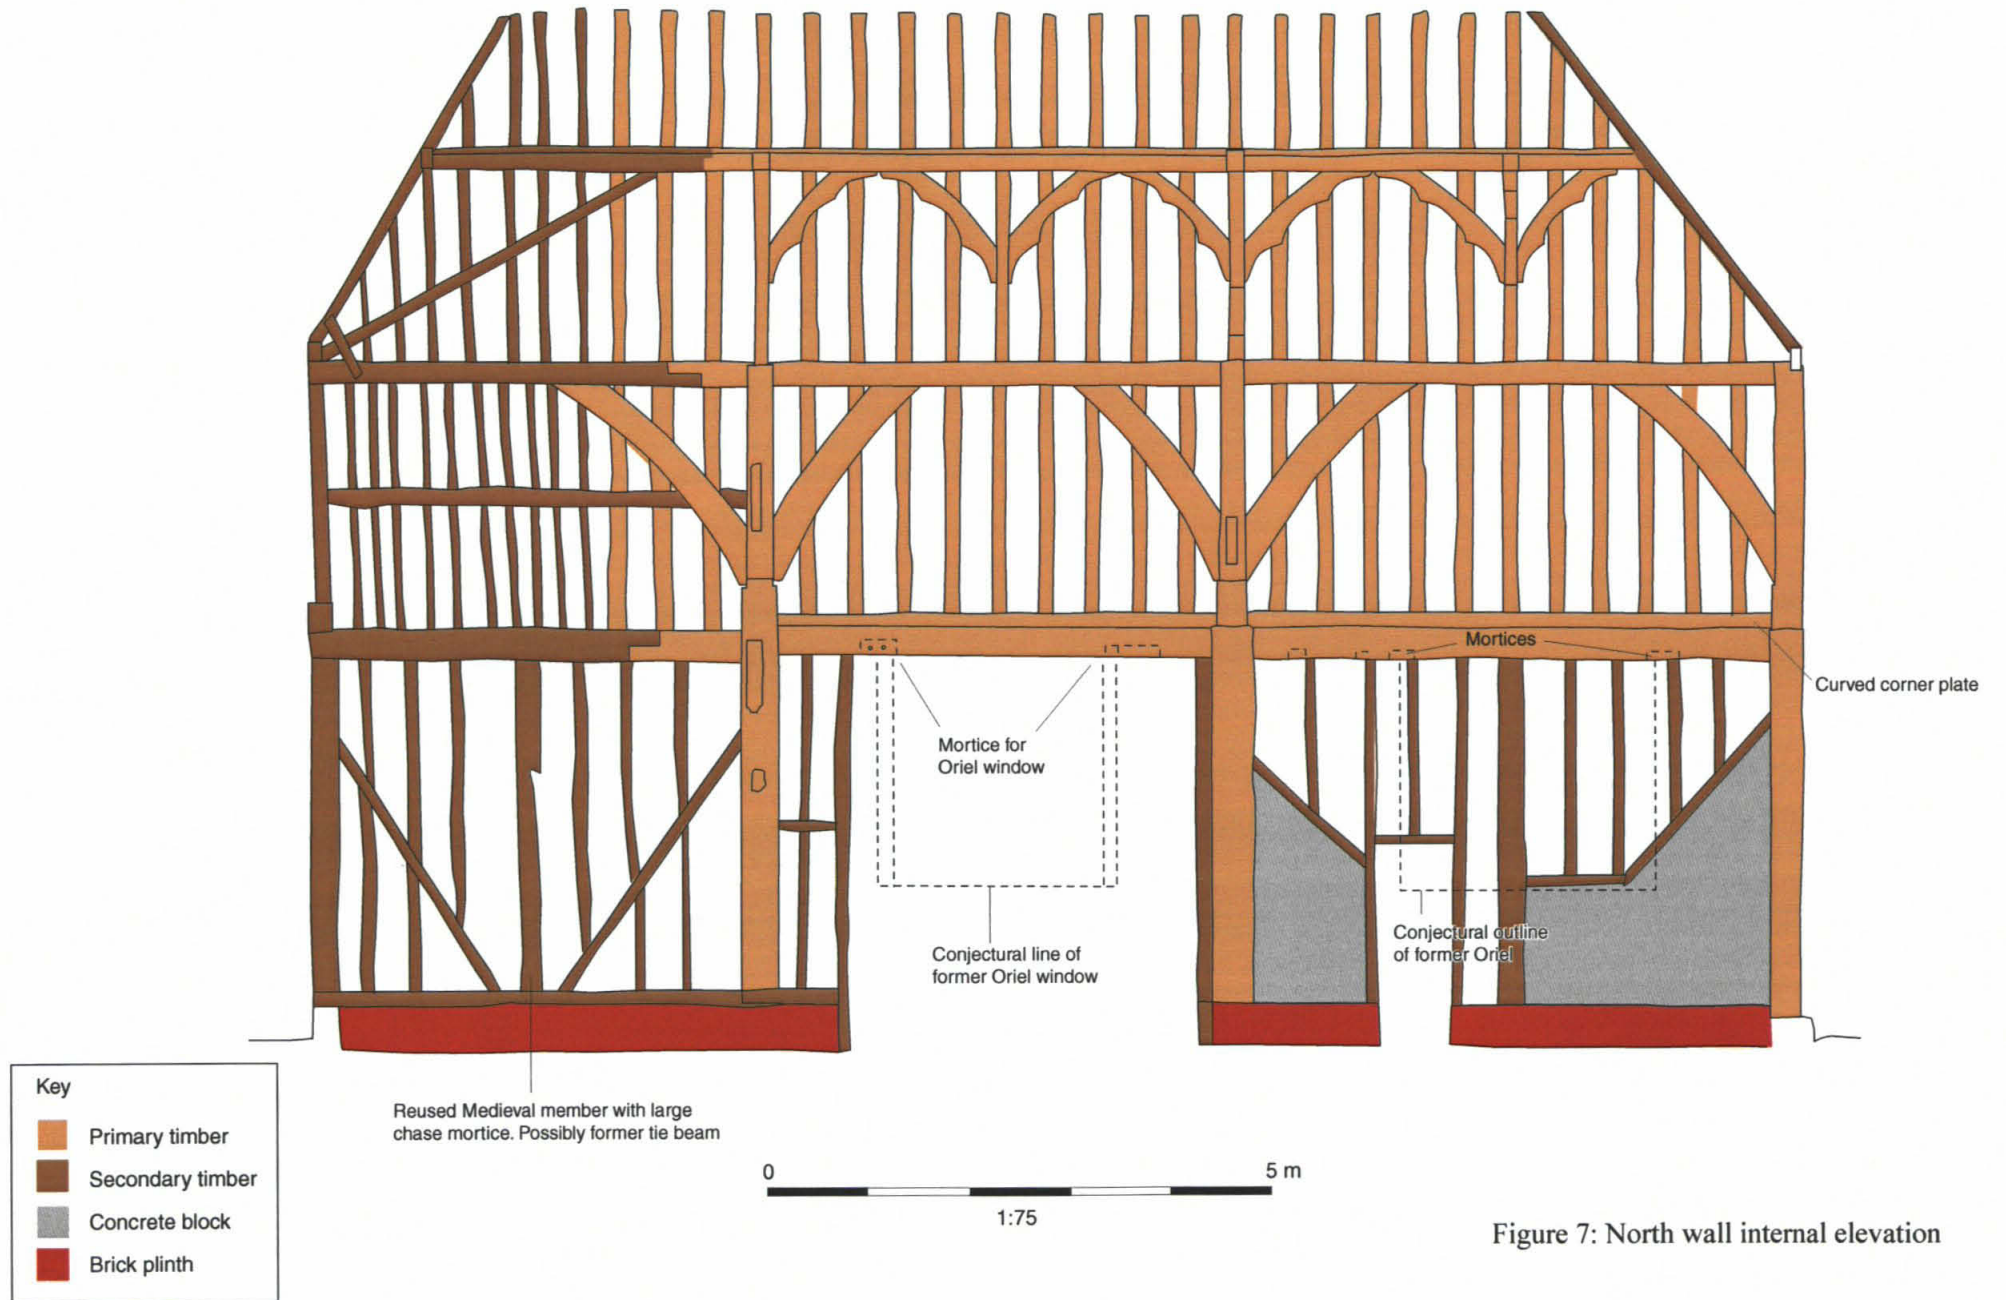
Figure 7: North wall internal elevation

- 3.5.8 **North wall (recorded by OA)**
- 3.5.9 The north wall framing (Fig 7) is also broadly similar to the south wall. The eastern bay of the north wall incorporates concrete blockwork (post 1972) to the lower section and secondary elm stud framing above. One of the members in this frame (the sloped eastern bearer or plate) may be a reused medieval member.

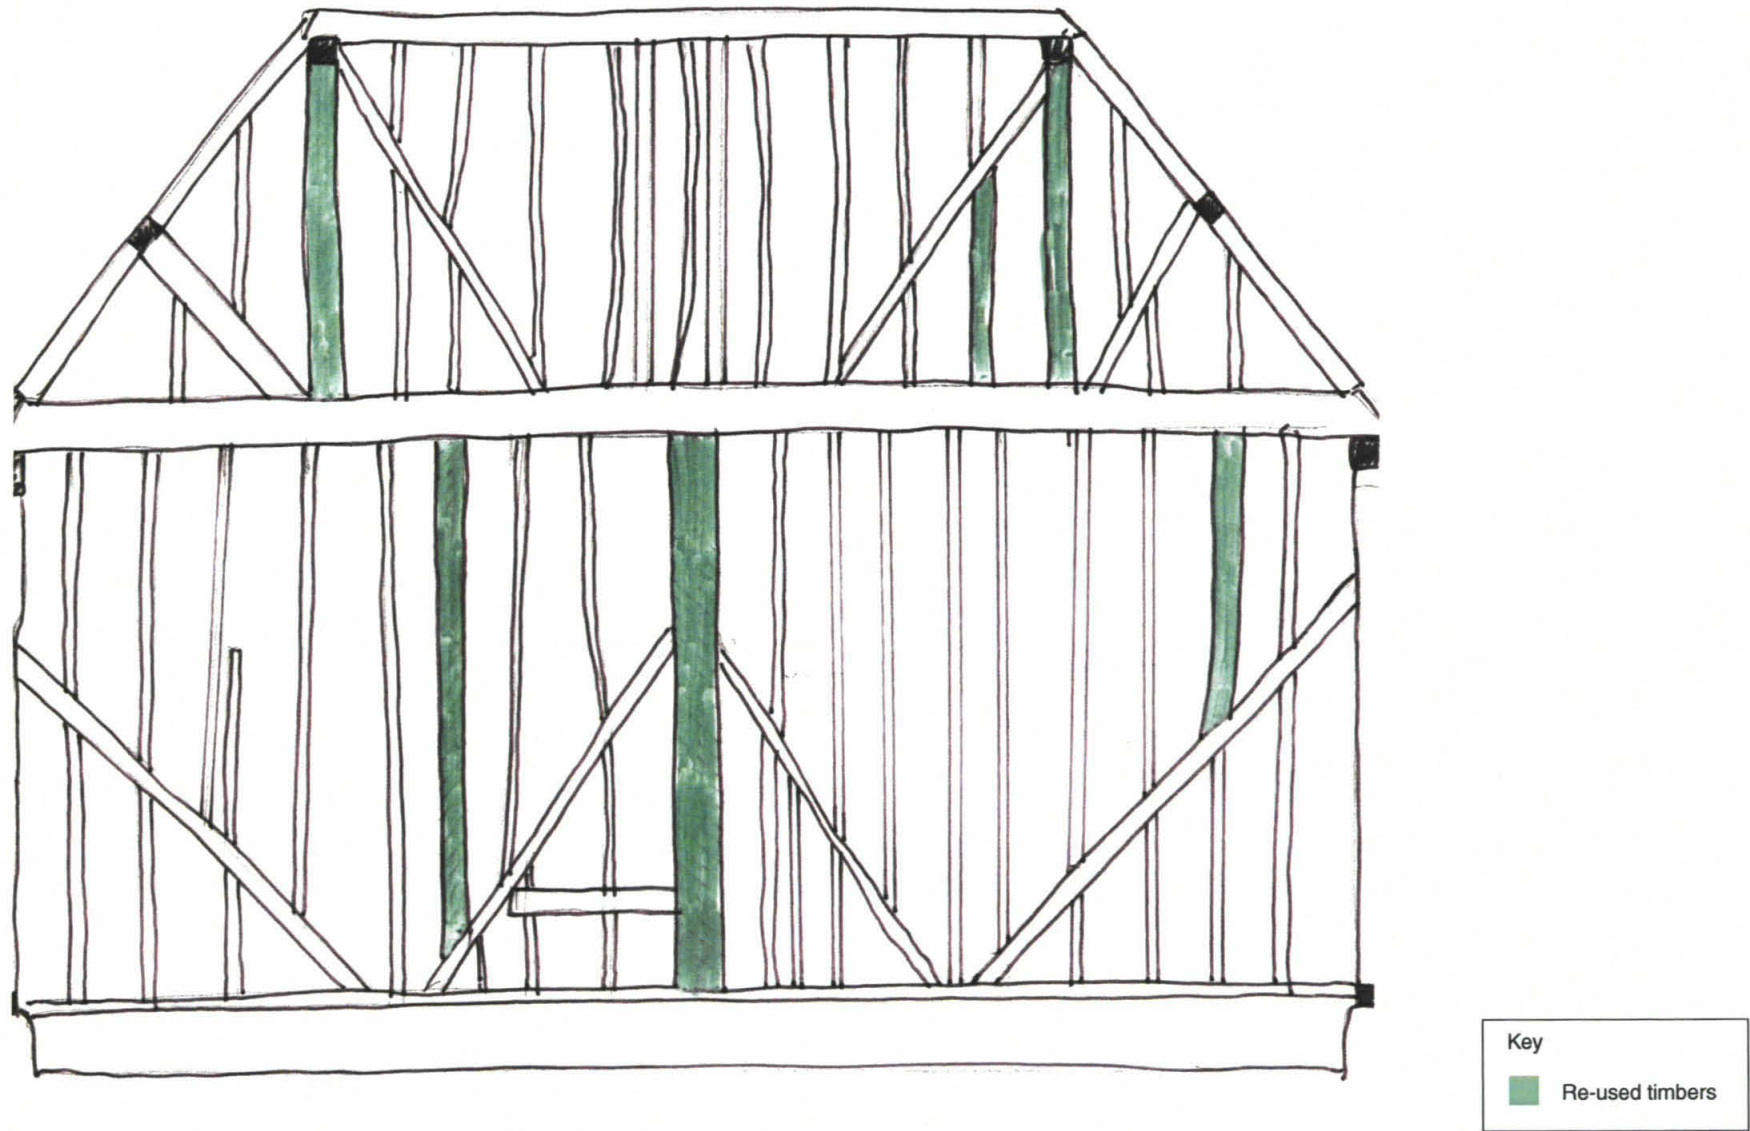
Figure 8: Sketch elevation of west wall showing re-used medieval timbers, (approx 1:50)

- 3.6.16 West end Frame 4**
- 3.6.17 The west end wall has been entirely reconstructed (together with the western ends of the north and south walls) and we know very little about the original form of this end of the building (Fig. 8). The primary structure may have had a similar footprint to that existing today or it may have extended further west. Alternatively it may have ended further east, a short distance west from Frame 3 if the construction of the building was unexpectedly curtailed at this point (possibly for example by the Black Death) or it may have adjoined a separate (or proposed) building at this point.

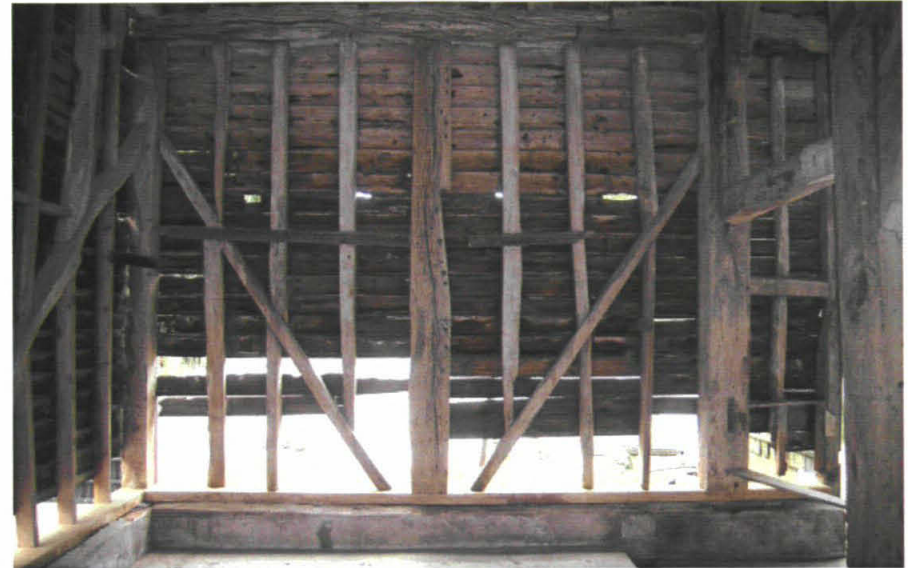
Plate 13: Secondary framing and possibly reused tie at W end of N wall

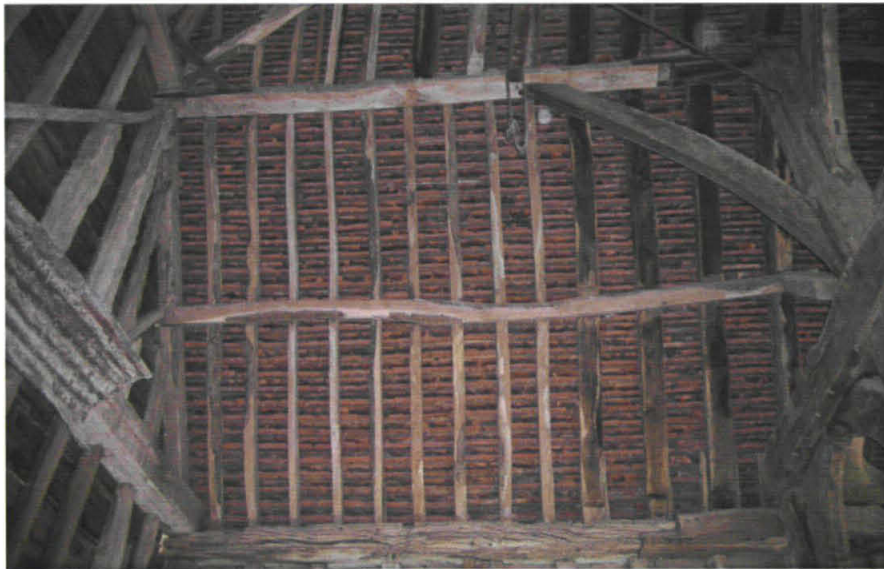
Plate 14: Roof at W end. Rafters to left secondary. Primary smoke blackened rafters to right

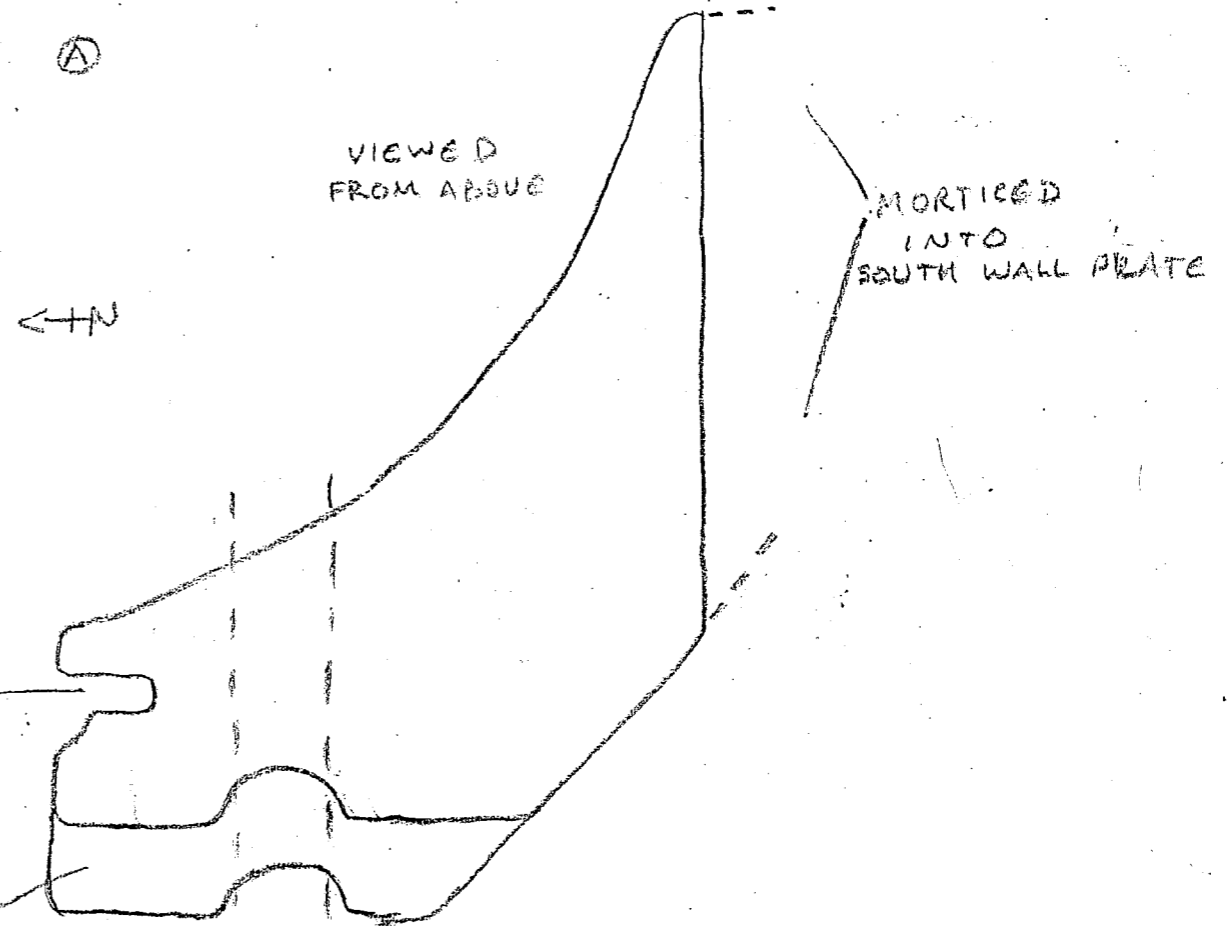
CHURCH FARM - LEWKNOR
 LEWCF
 SOUTH EAST ELBOW JOINT
 D.F.
 SCALE 1:20

DIFFICULT TO TELL IF THIS IS MOULDED OR SUBJECT TO ROT

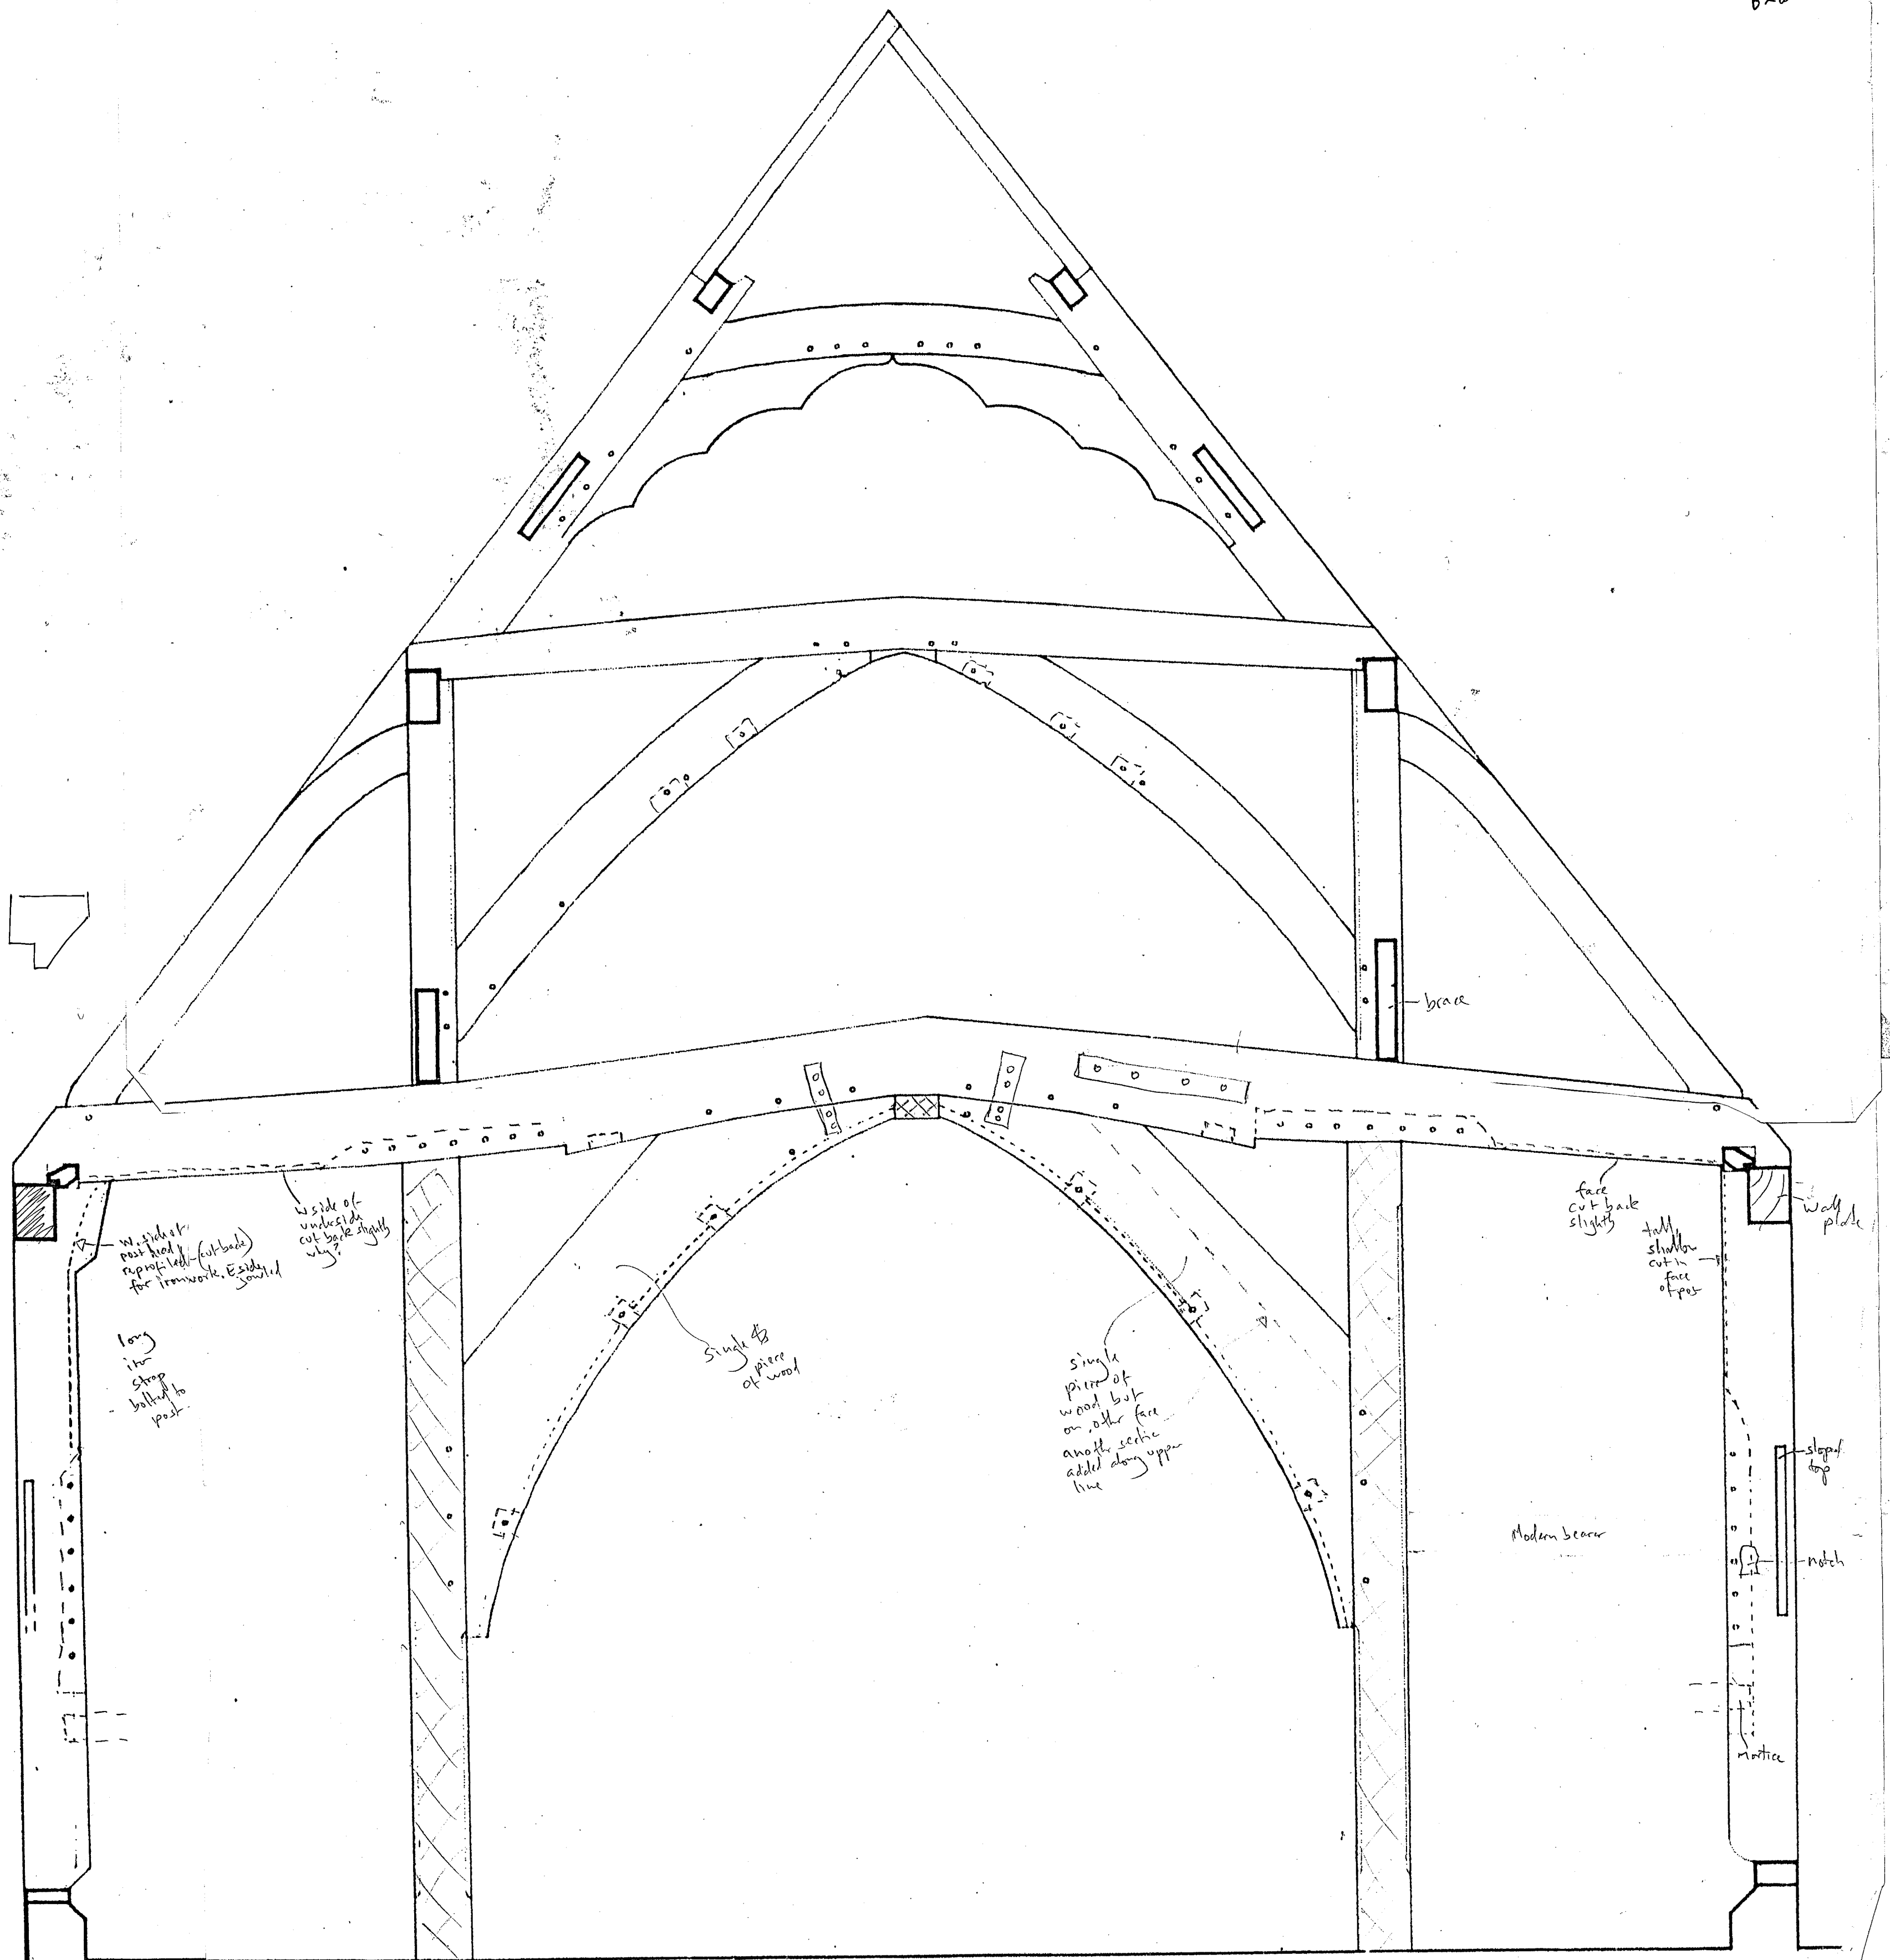
EAST CENTRAL TRUSS FROM WEST

Beam deflected and cracked where centre post supported

Hip rafter damaged

Damaged horizontal knee
