# TOWNSIDE FARM PILLING LANCASHIRE

## Archaeological Building Investigation

**Document Type:** Archaeological Building Investigation

**Issue Number:** 2005-6/444  
**OA Job Number:** L9614  
**Planning Application Number:** 02/03/00471

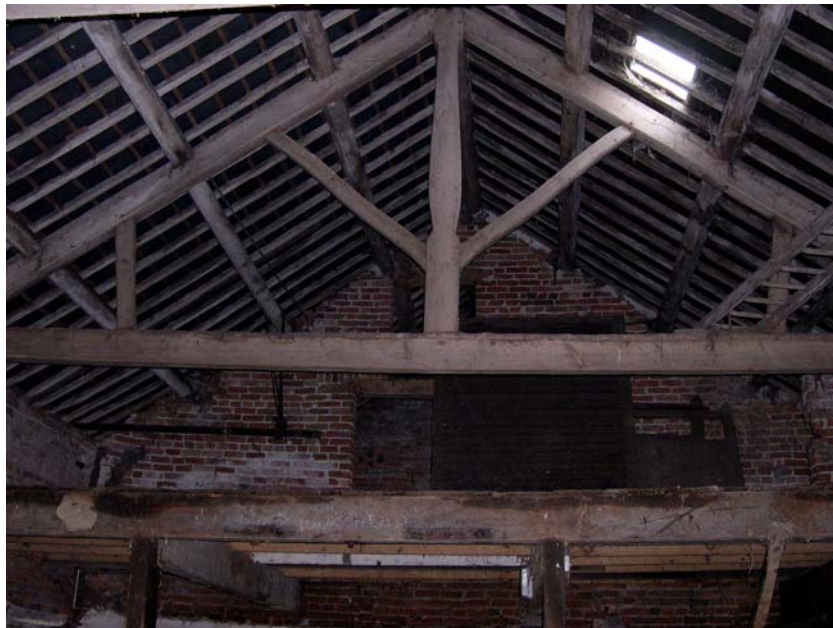
Plate 8: The southern truss within the barn

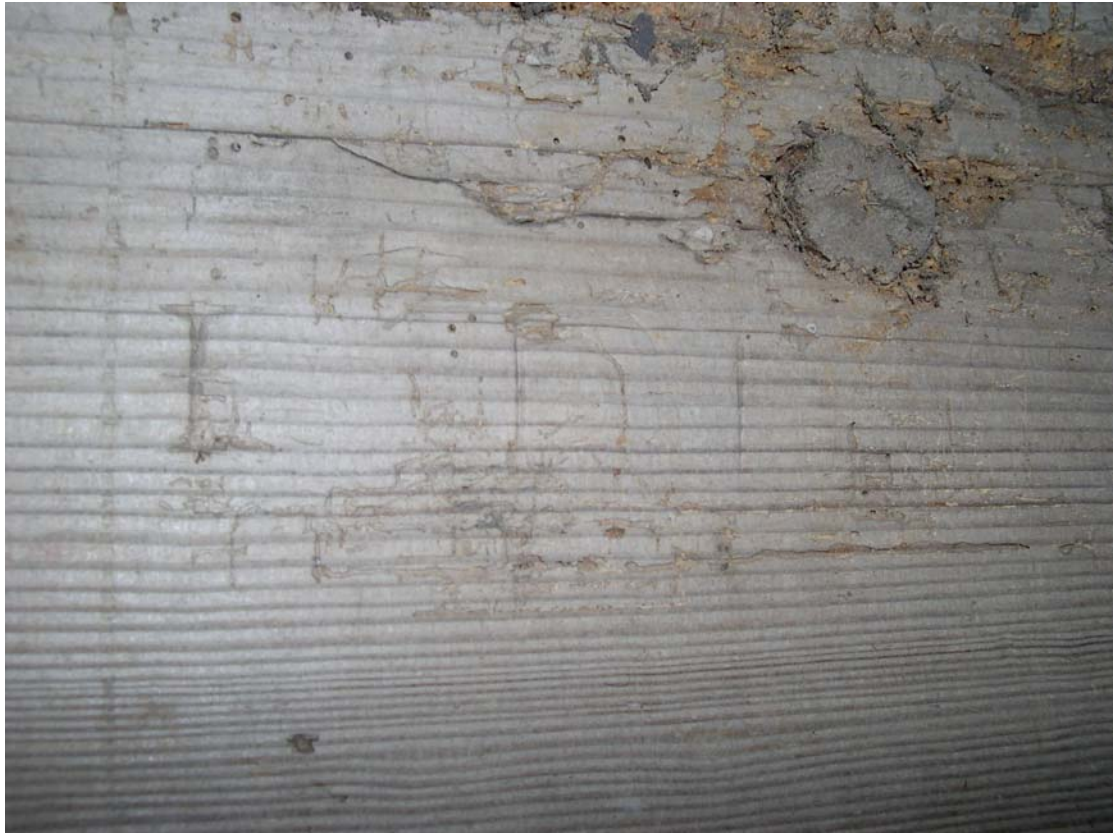
ventilation slots being blocked, perhaps suggesting that the southern shippon went out of use for a while. Curiously the archaic 'I' scored into the southern truss of the barn (Plate 9) is of a much earlier style, typically of the late seventeenth century (see examples in Garnett 1994). It is not clear whether this means that this timber was also re-used or that the mark was simply using a very old-fashioned style. The baluster-style king posts are also anachronistic, and suggestive of a late seventeenth century date (Alcock and Hall 2002), that might suggest that a deliberately antiquated style was being used.

Plate 9: Carved 'I', possibly part of date, in the tie beam of the northern truss

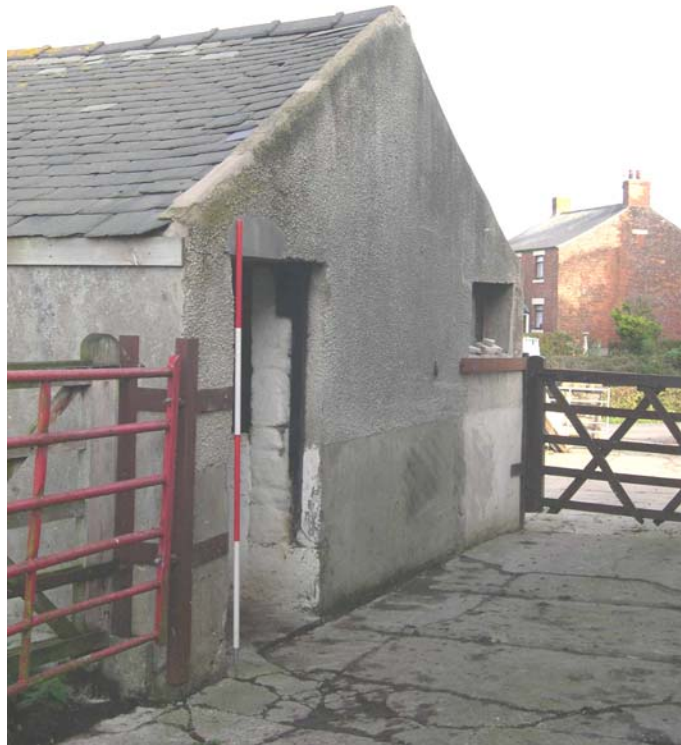
- 4.6.3 ***South elevation of the north south axis:*** (Plate 17) the south gable end has a roughcast render with a smoother finish towards the base of the wall. There is a small casement window, originally a door, towards the east end, and a doorway with a stone lintel and timber gate at the west end.

Plate 17: The south elevation of the north/south axis of the cow sheds

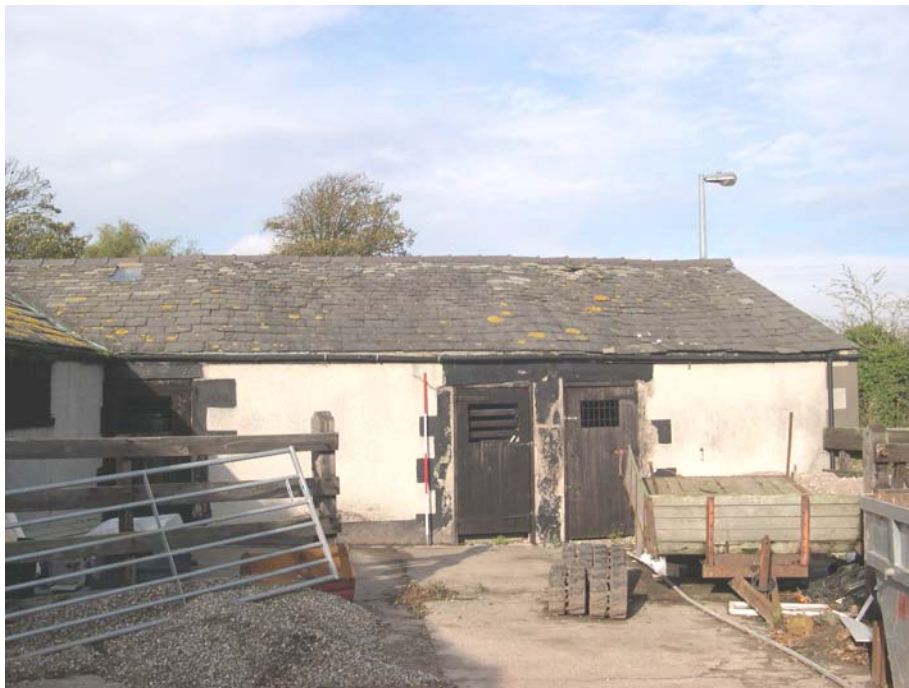
- 4.6.4 ***South elevation of the east west axis:*** (Plate 18) in keeping with the character of the east elevation, and indeed the rest of the structure, the walls are roughcast rendered with quoins to the east end. In addition, there are three matchboard doors, the two end doors are dressed with quoins and feature stone lintels, whilst the central door differs in its concrete lintel.

Plate 18: The south elevation of the east/west axis of the cow sheds

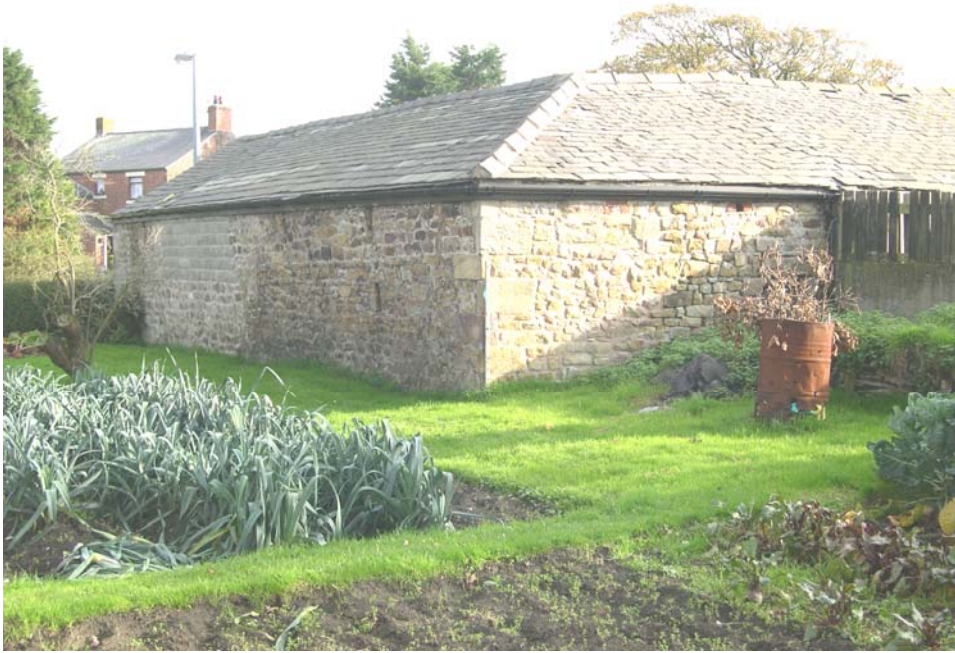
- 4.6.5 ***North elevation of the east west axis:*** (Plate 19) the north elevation of the east/west axis lies within the garden of the adjacent property. It is similar in character to the east elevation of the east/west axis. It has the same unrendered stone walls and is dressed with similarly exposed quoins. There is a blocked aperture very reminiscent of the opening in the centre of the long east elevation, and there are four vent holes underneath the guttering.

Plate 19: The north elevation of the east/west axis of the cow sheds

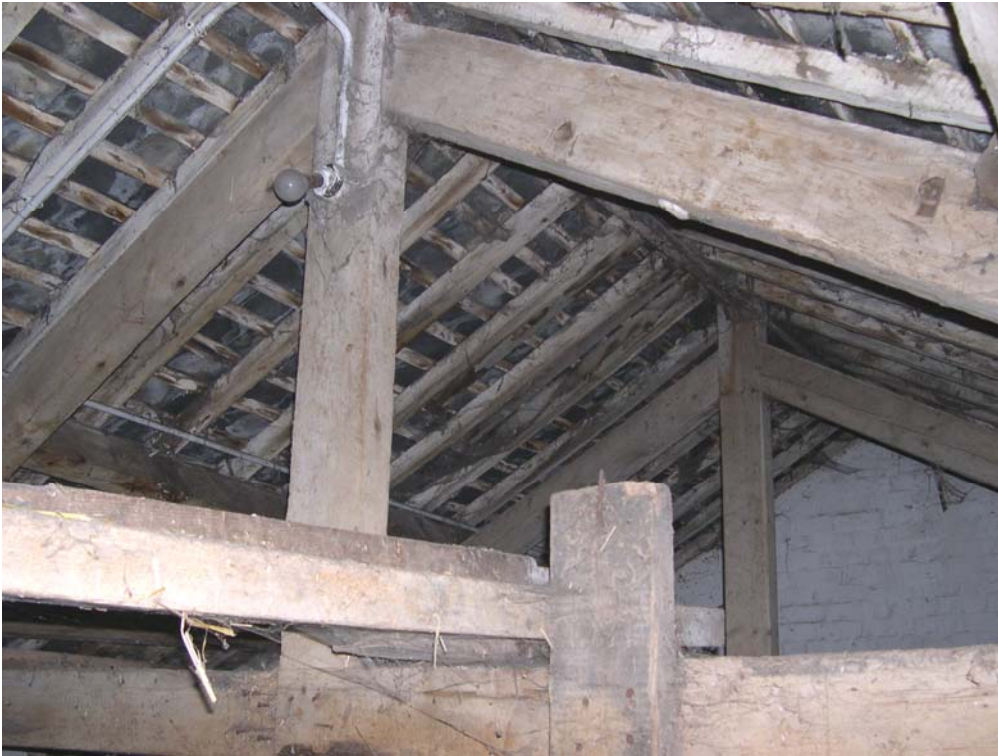
Plate 21: North-west-facing view of the central kingpost truss in *Box One*

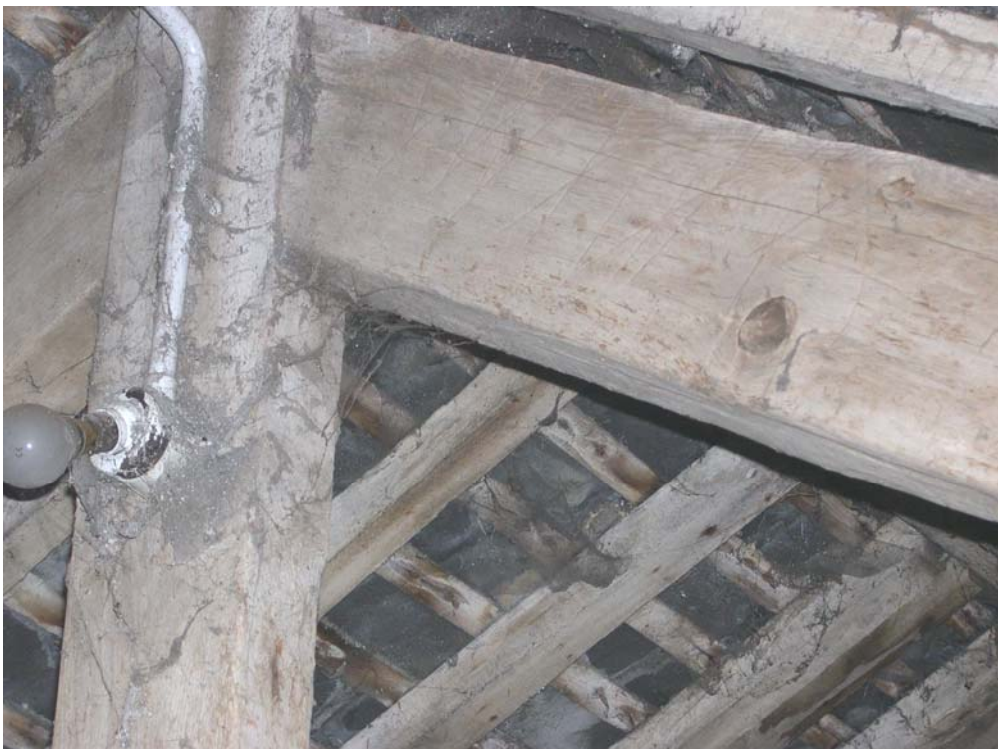
Plate 22: Detail of the Baltic timber marks on the central truss
