The Dye House, Hallthwaites, Millom, Cumbria

Archaeological Building Investigation

Oxford Archaeology North

November 2005

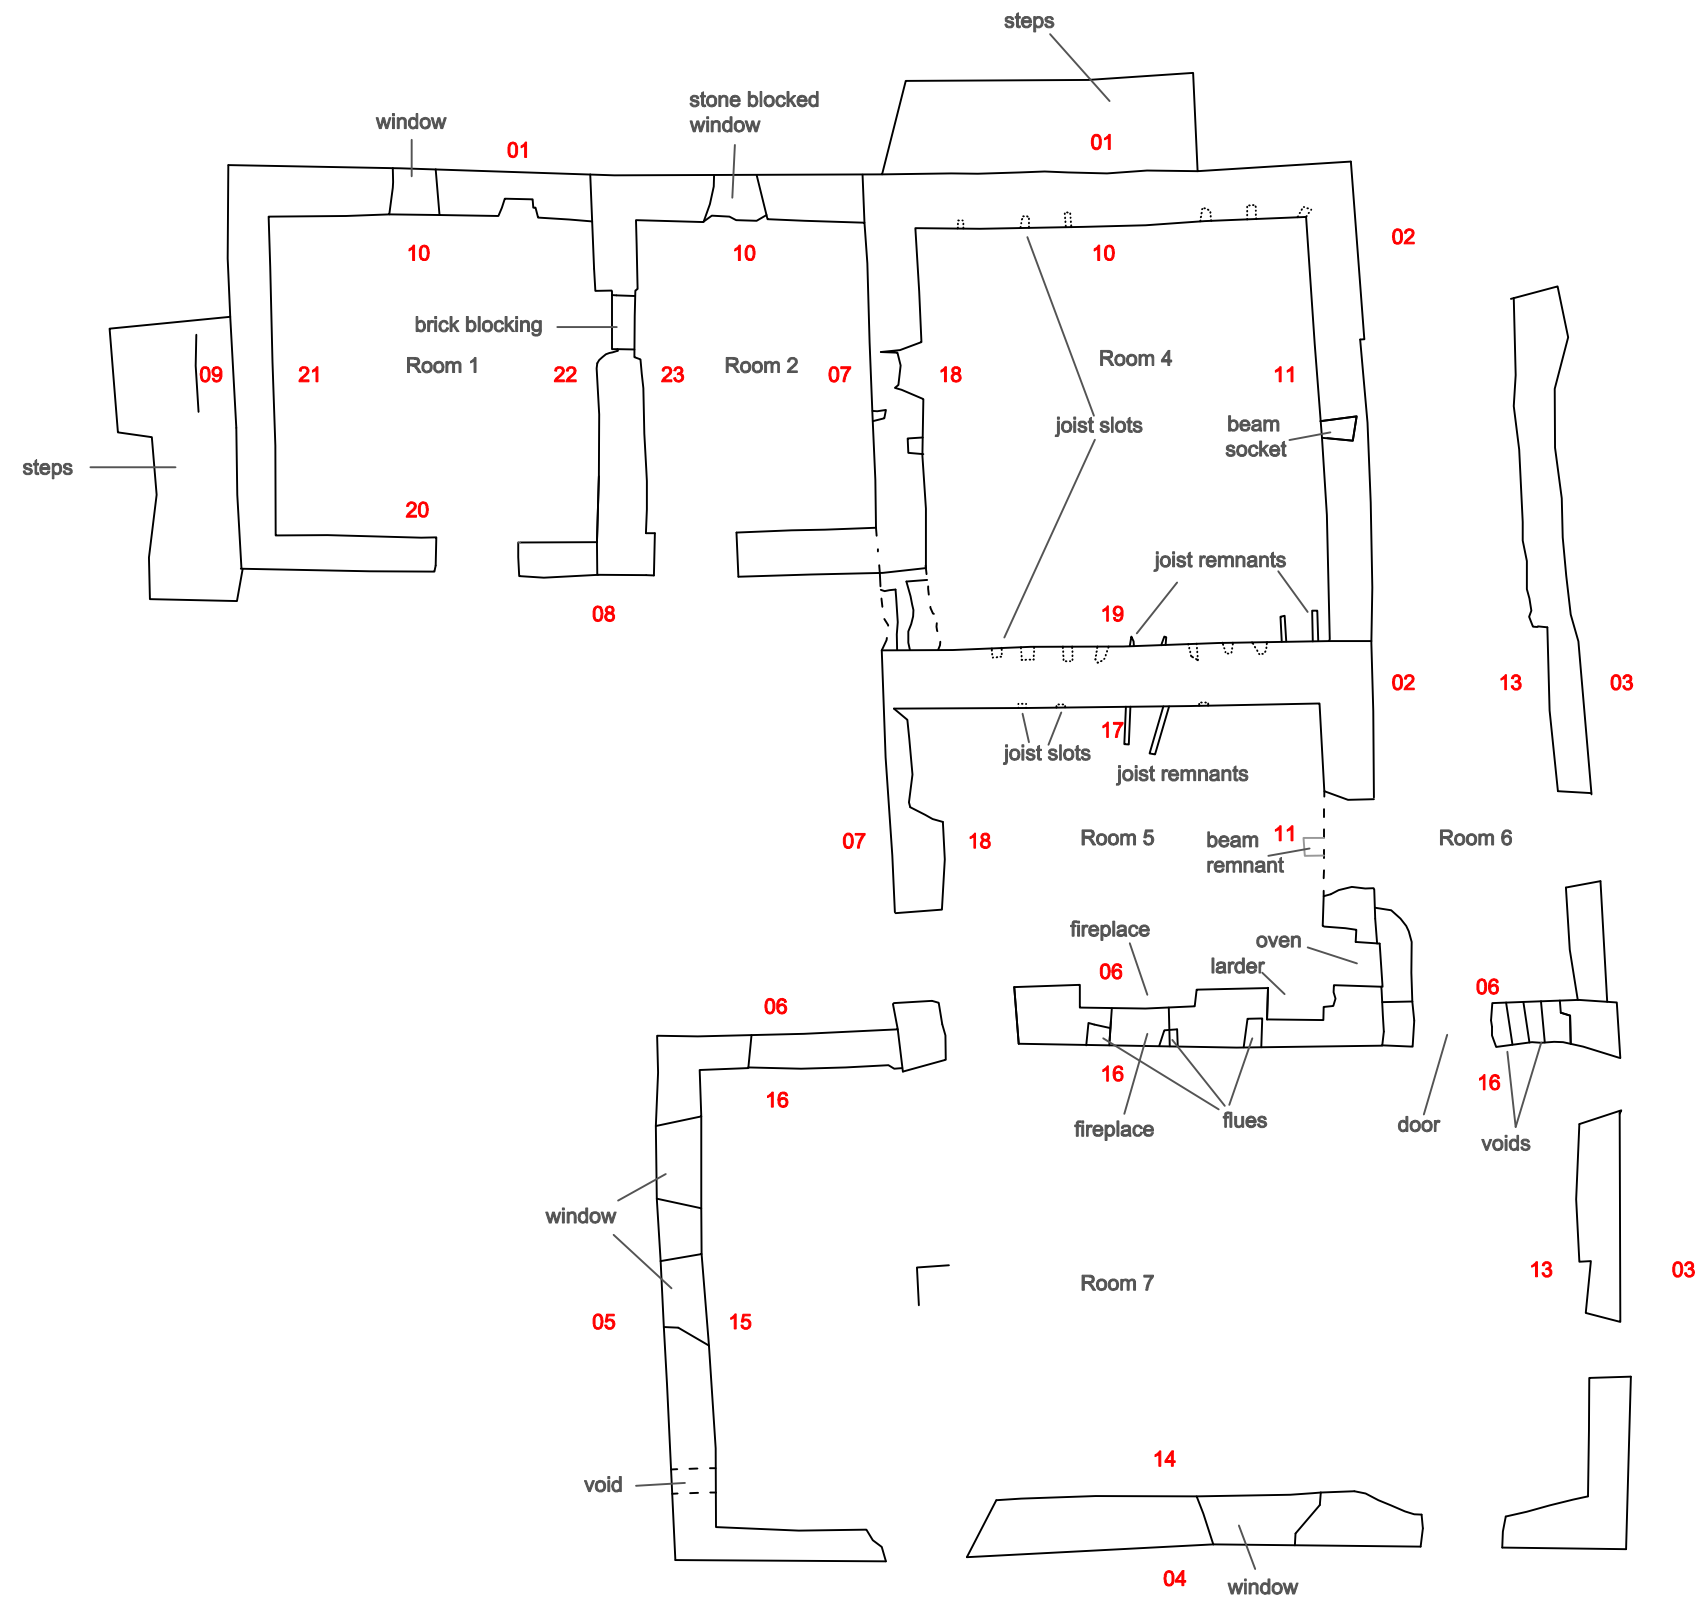
Figure 3: Ground floor plan

4.2.1 The whole complex comprises seven rooms and is set out in an asymmetrical 'C-shape' with the long axis of Rooms **1**, **2**, **3** and **4** aligned east/west (Fig 3). Rooms **1**, **2**, **3**, **4** and **5** form an 'L-shape' and rooms **6** and **7** appear to have been built on to this. Most of the rooms are able to be accessed from a central area, which almost forms a small (grassed) courtyard. The Black Brook runs to the east of the building. Rooms **1** and **2** are situated below Room **3**, while Rooms **4**, **5** and **7** extend through both the ground and first floors.

4.3.2 The remaining roof (above Room **3**) has a pitch of approximately 25 degrees, has slightly projecting eaves and comprises local slate laid in diminishing courses with a stone ridge. The remains of a brick-built chimney are present below the eaves of this roof on the north side (Fig 3). There are no rain water goods present. The rest of the complex is unroofed, but it reasonable to assume from the surviving evidence that it was roofed in a similar manner to the remaining roof. There is evidence to suggest (see *Section 4.4.1*) that the surviving roofed building (Rooms **1**, **2** and **3**) was constructed in more than

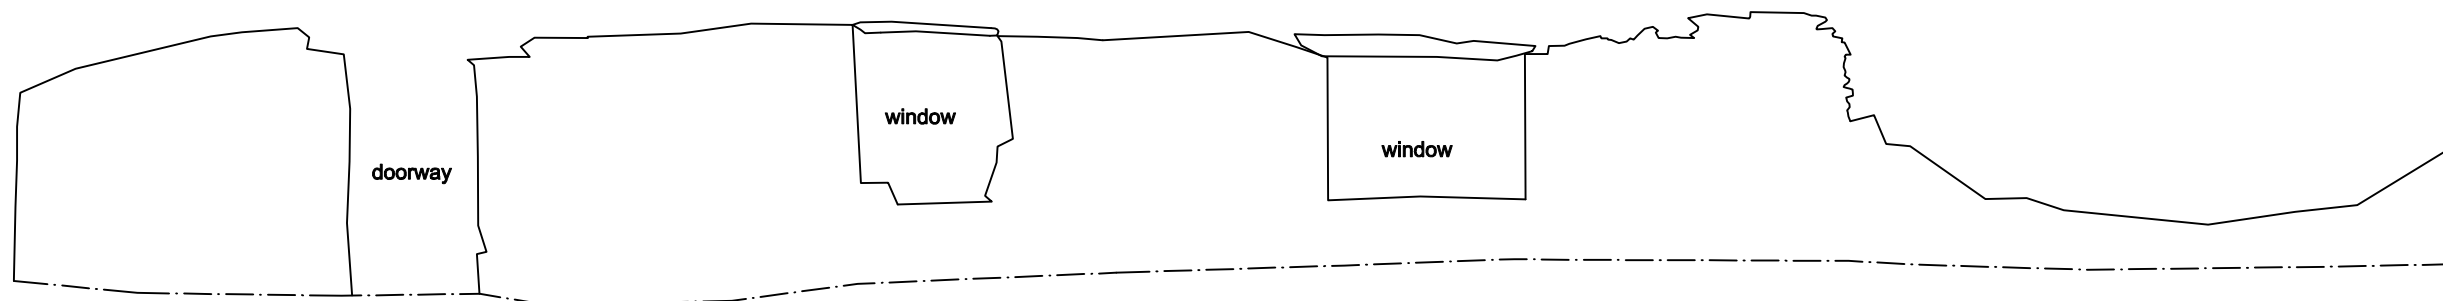
Figure 9: Elevation 3

- 4.4.3 *External Elevation 3:* (Fig 9; Plate 6) surviving to a height of approximately 1.3m, this elevation comprises the east walls of Rooms **6** and **7**. The wall of Room **6** is constructed from a mixture of split stone and river cobbles of varying sizes, while that of Room **7** is of similar construction to the rest of the room. The rest of the building. There are three openings, two in Room **7** and one in Room **6**. The north opening in Room **7** has a stone lintel, while that in Room **6** has a timber lintel and both were probably windows (no trace of glazing survives). The southern opening in Room **7** may have been a door and

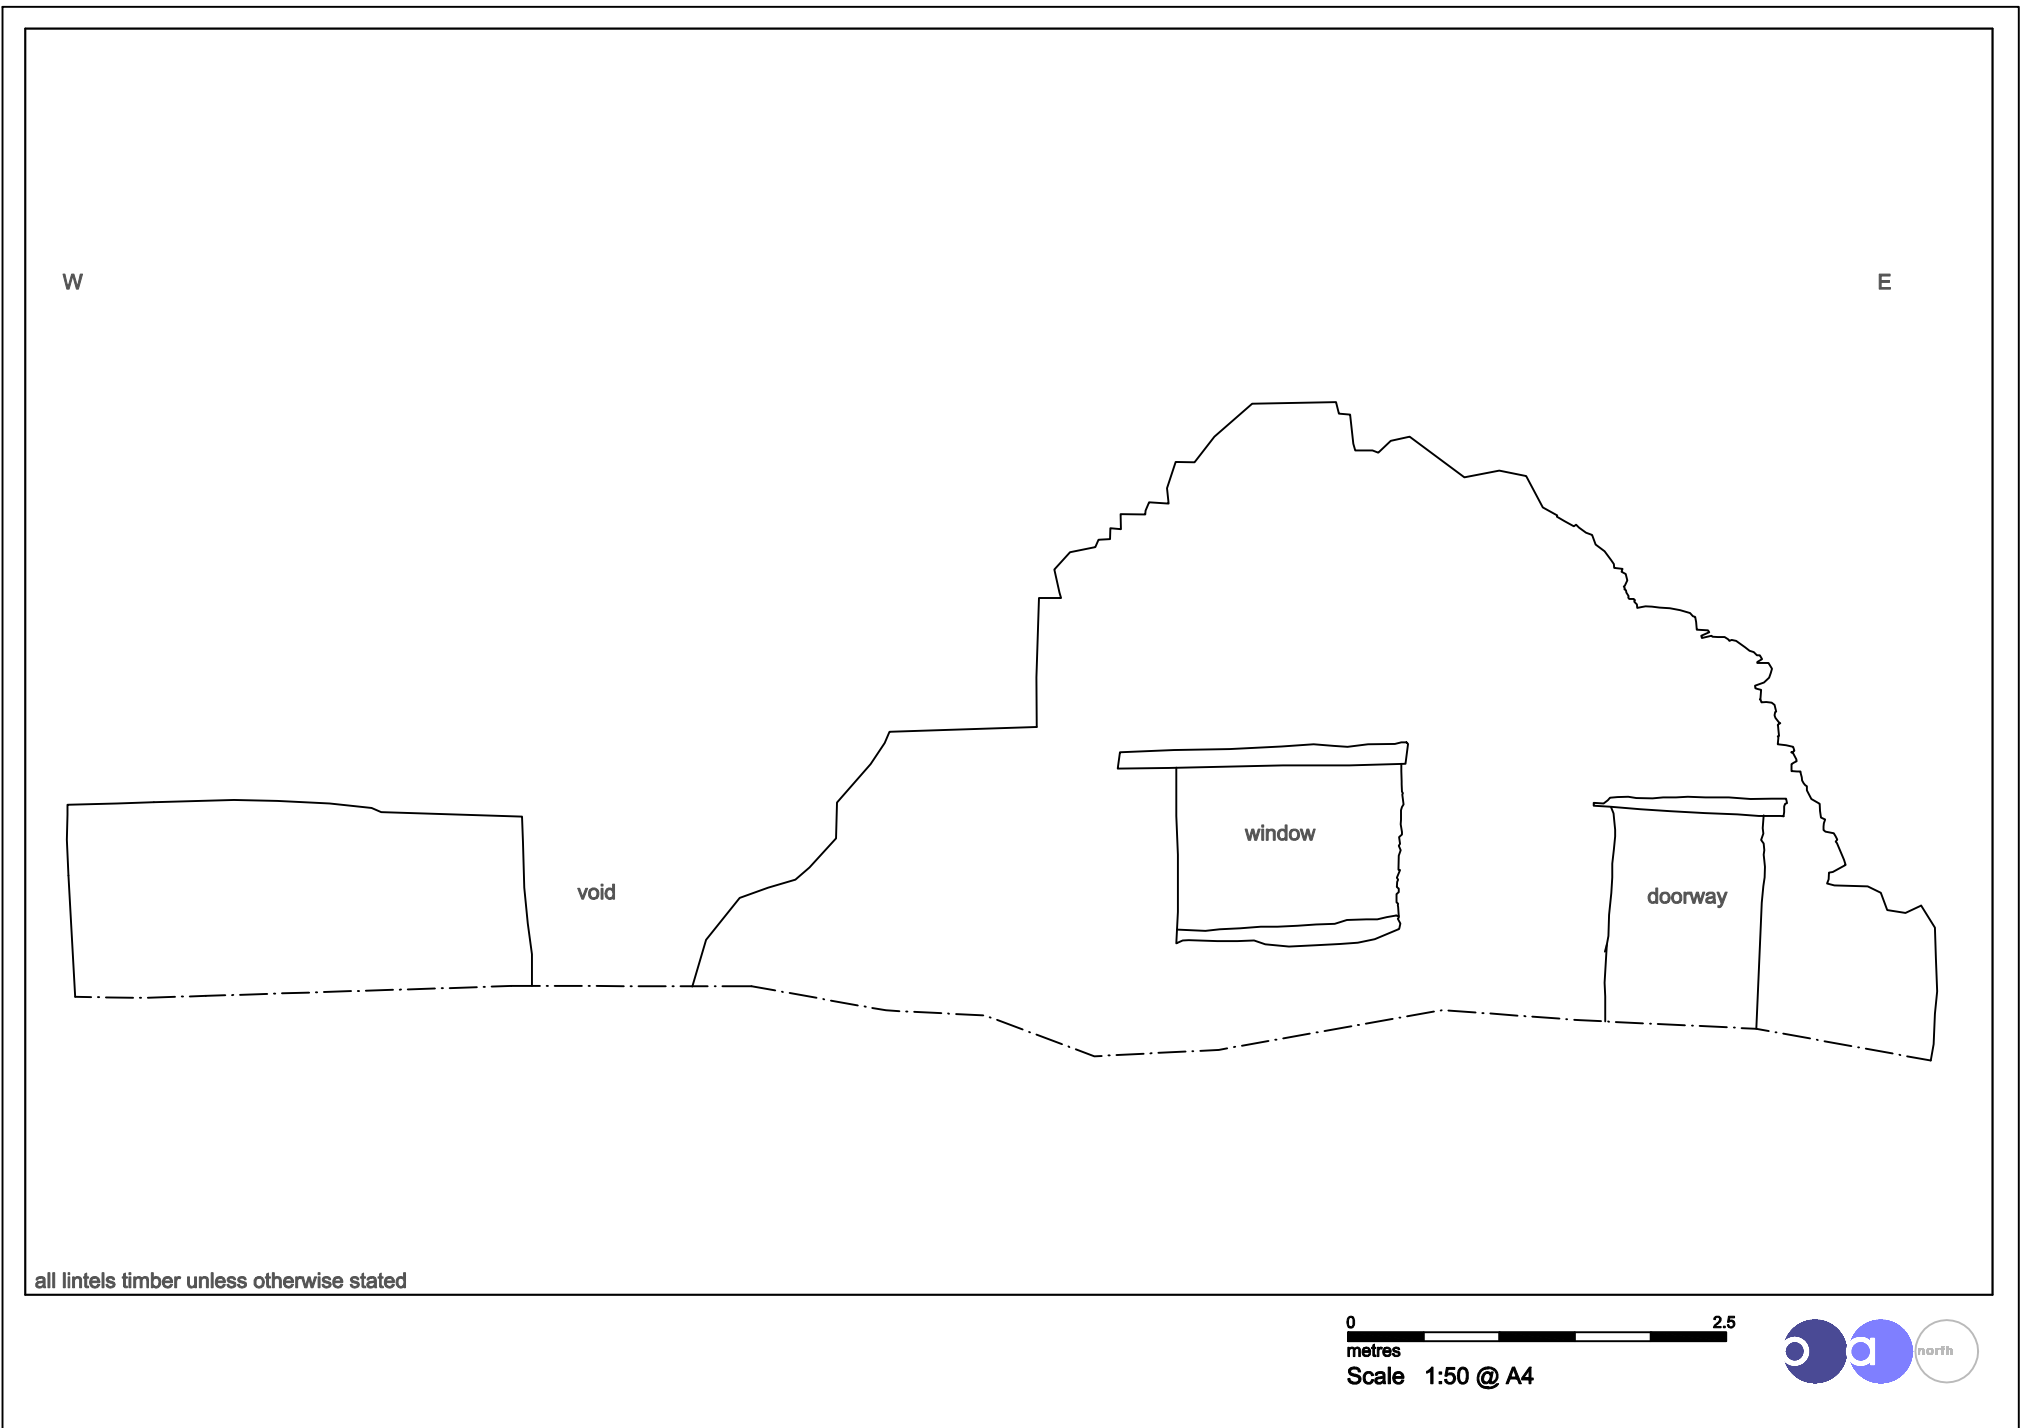
Figure 10: Elevation 4

- 4.4.4 **External Elevation 4:** (Fig 10; Plate 7) this elevation comprises the south wall of Room 7, which, at the time of survey, was unable to be inspected. This was due to the elevation forming part of the boundary of a private garden, through which access was not permitted. Photographs were taken from the road in order to permit a brief description of the elevation. In most details, the elevation is similar to the south internal elevation (Elevation 14; Fig 19) of Room 7 (Section 4.5.20).

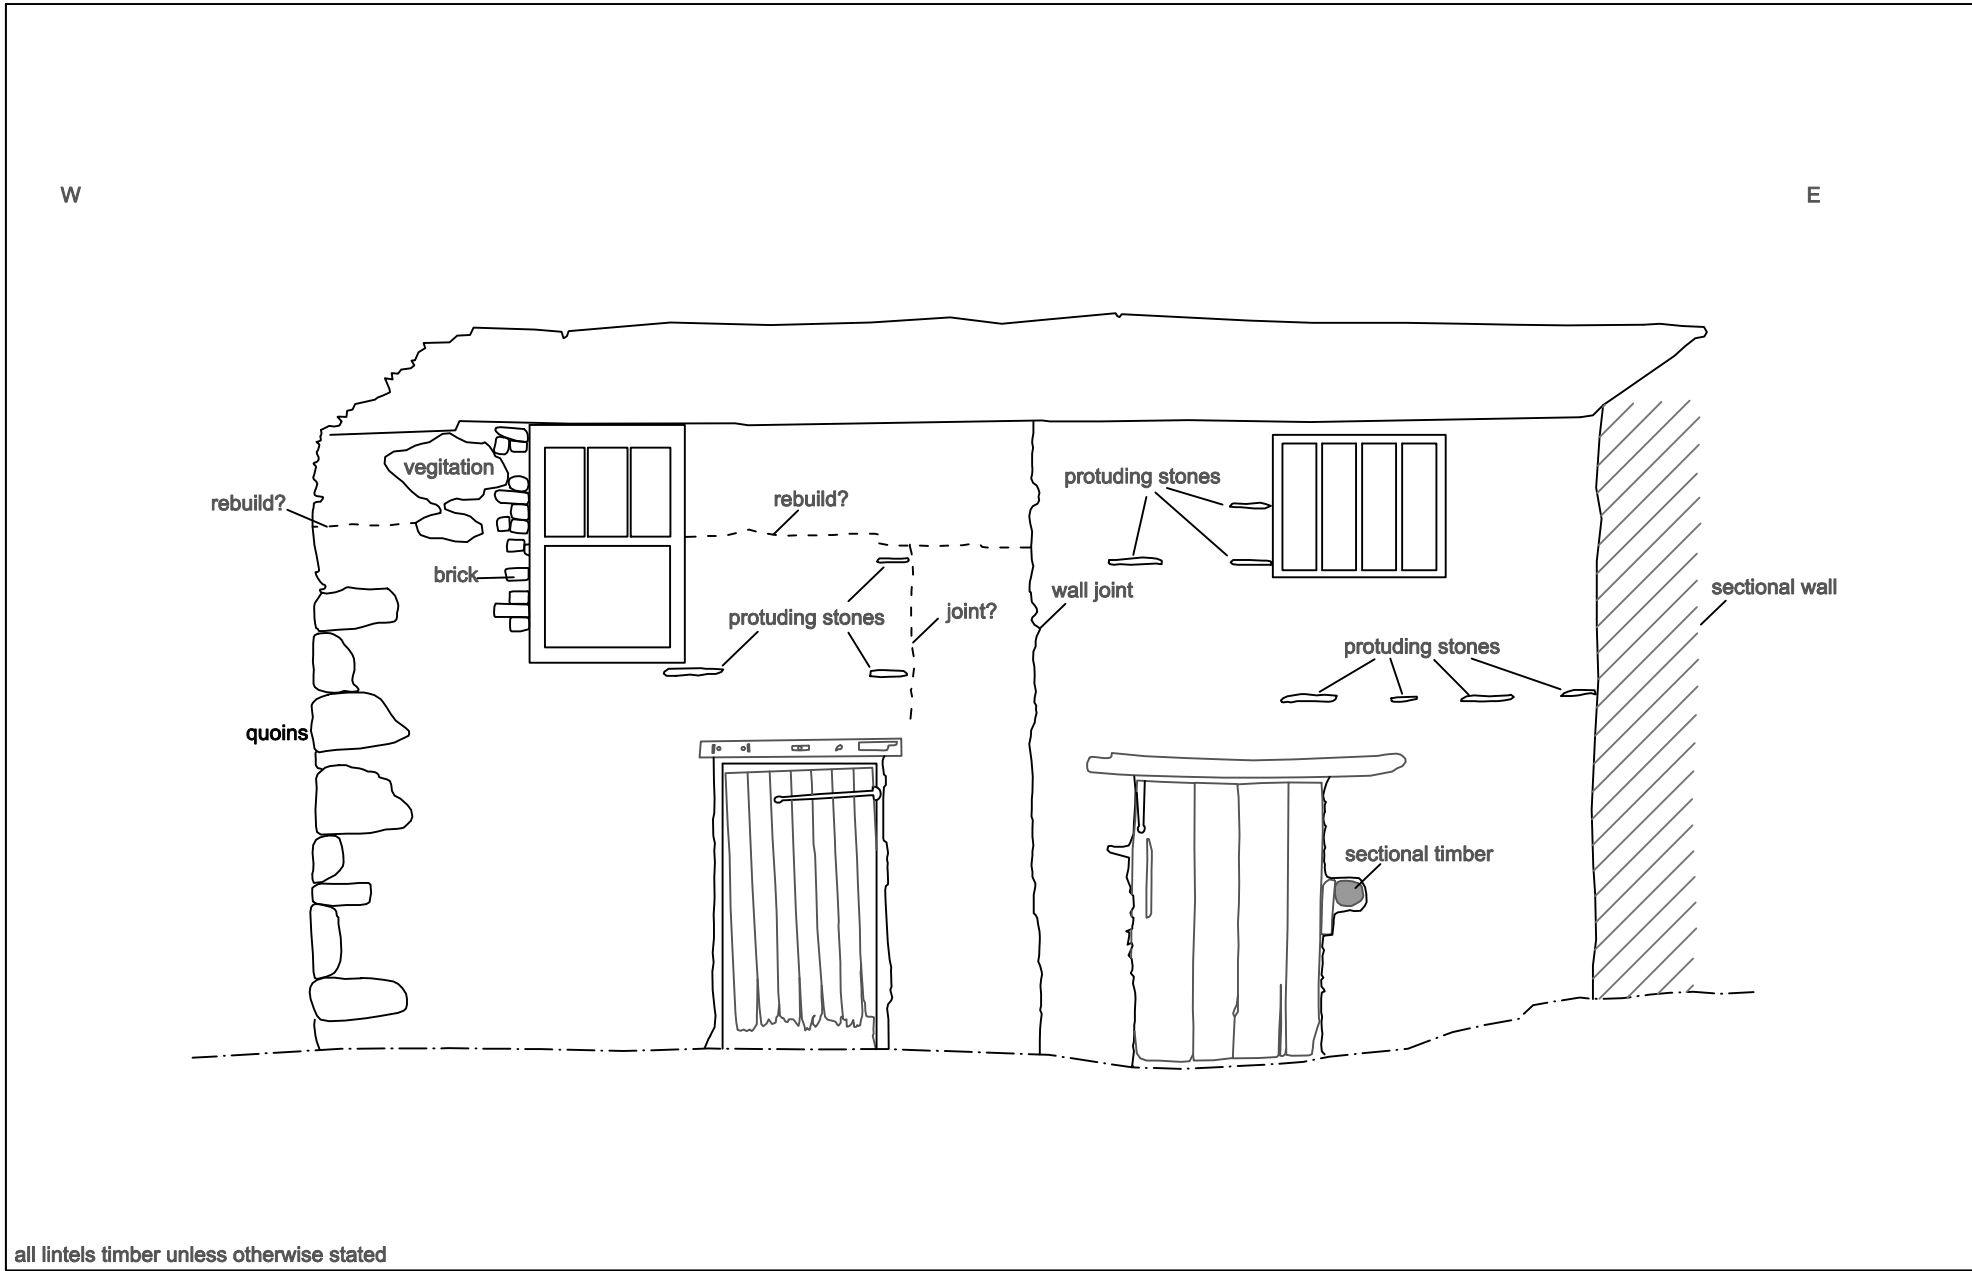
Figure 14: Elevation 8

- 4.4.9 **External Elevation 8:** (Fig 14; Plate 10) this is the south-facing exterior elevation of the main roofed building which contains Rooms 1, 2 and 3. It is

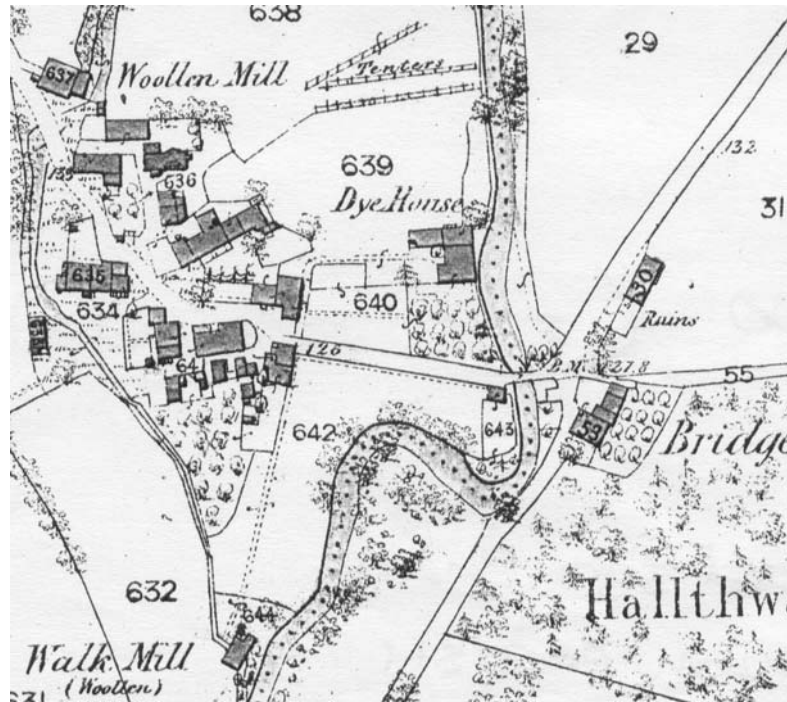
- 3.6.2 *Ordnance Survey 1865-7*: these are the earliest detailed maps of the site, and by this time the entire complex has been constructed, including the woollen mill, walk mill and Dye House (Plate 1). The buildings appear much as they do today, although the east side continues to the north-east corner, rather than stopping short as it now does. The tenter frames to the north of the Dye House are also clearly shown.

Plate 1: Part of the Ordnance Survey map of 1865 showing the Dye House and related buildings

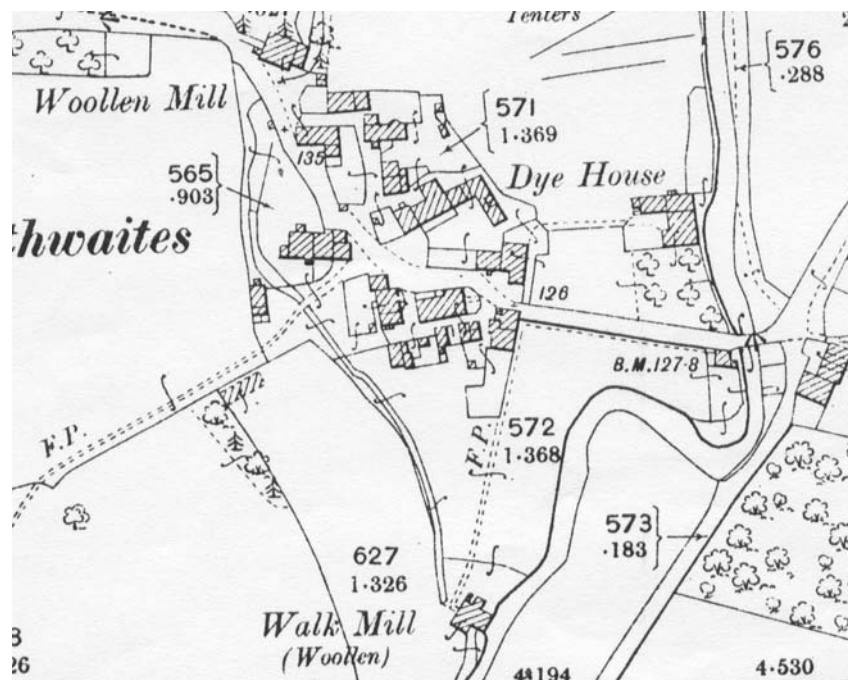
- 3.6.4 *Ordnance Survey 1899*: the buildings have essentially the same form, and the tenter frames to the north are still present (Plate 2). The west end is shown with two small outshuts attached to it, although these may have been present before and not shown.

Plate 2: Part of the Ordnance Survey map of 1899 showing the Dye House and related buildings

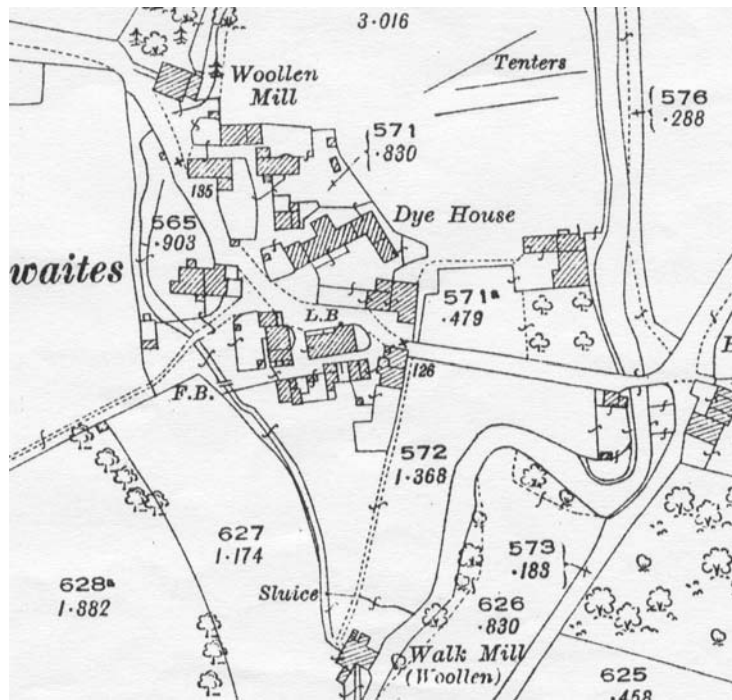
- 3.6.5 *Ordnance Survey 1924*: the buildings have essentially reached their present form by this time (Plate 3). The north-east corner has been shortened to its present dimensions, but the outshuts on the west end are still present, as are the tenter frames to the north.

Plate 3: Part of the Ordnance Survey map of 1924 showing the Dye House and related buildings

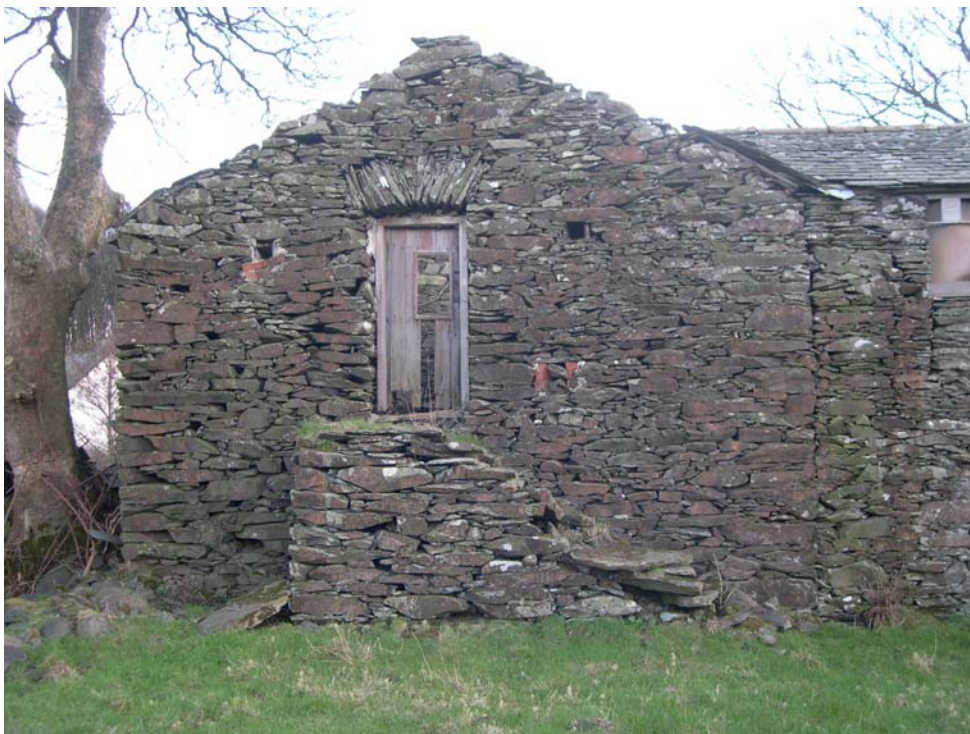
- 4.4.1 *External Elevation 1:* (Fig 7; Plates 4-5) this forms the long north external wall of Rooms **1**, **2**, **3**, and the gable wall of Room **4**, and is constructed from random uncoursed local stone, most of which is unworked. There are traces of lime mortar and lime render present particularly in the centre section of the wall (Room **2**). There are four window openings, two providing light for the upper floor (Room **3**) and one each for Rooms **1** and **2**. All the windows differ in size and there is evident rebuilding corresponding to the remodelling of each opening, particularly the west windows. The first floor windows were glazed with simple multi-light frames (now much degraded). The east ground floor window is blocked, the west is boarded. All the openings have slate sills and the first floor windows have timber lintels (formed from the wall plate). A doorway with a distinctive arched head is present in the gable of Room **4** which once gave access to the (now gone) first floor. This is reached via a flight of degraded steps (possibly with eight steps originally) of the same construction as the rest of the building. A door with a single light is still present, as is the door surround (although both are much degraded). Either side of the door are two apertures (Fig 7) which may have supported a porch. A similar aperture (lined with brick) is located to the west of the door at low level. These are also visible internally.

- 4.4.2 It is evident that the wall was not constructed in a single phase, as shown by the two, very clear, vertical butt joins visible in the elevation (Fig 7). These correspond to the dividing walls between Rooms **1**, **2** and **4**. It would appear that Room **4** was the first to be built followed by Room **2** then Room **1** as Rooms **1** and **2** only have quoins on their western sides. The elevation of Room **1** is quite distinct in that it contains numerous large rounded boulders similar to those visible in the bed of the Black Brook. An inserted chimney (stack missing) constructed from hand-made brick is present just to the east of the western window on the first floor.

Plate 5: East end of Elevation 1

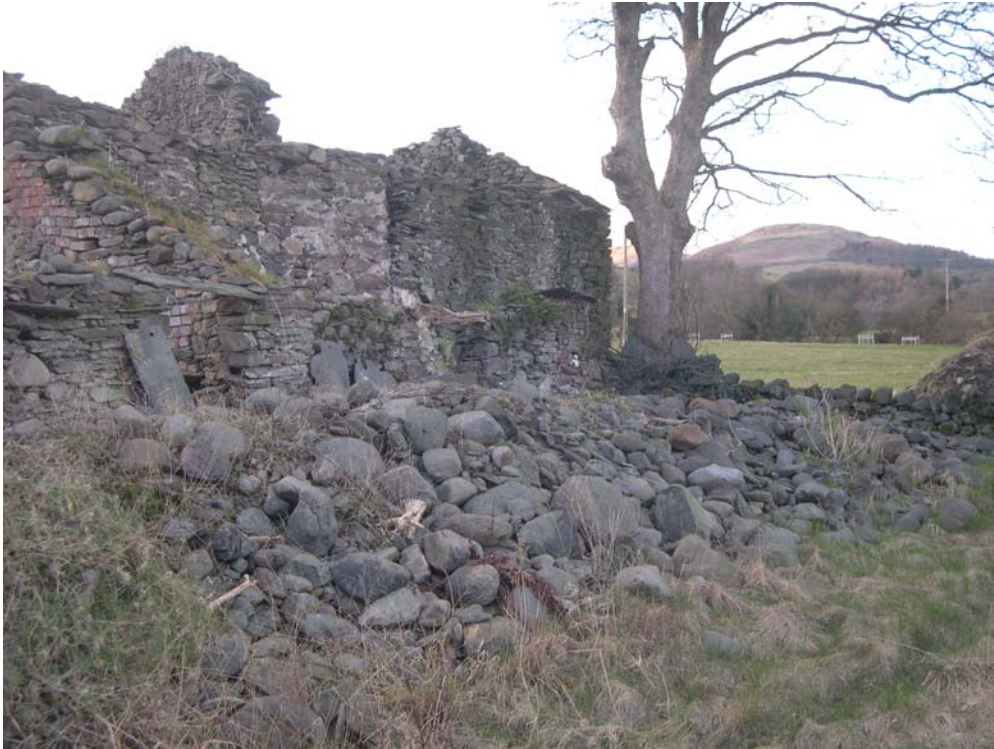
Plate 6: North-west-facing view of Elevation 3

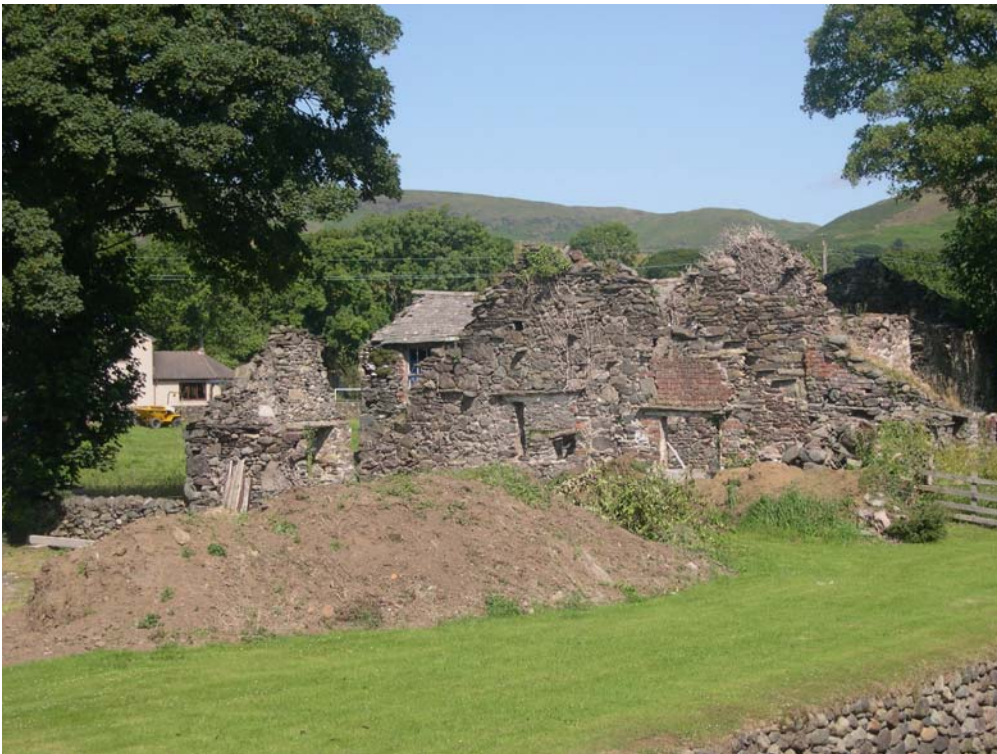
Plate 7: North-west-facing view of Elevation 4

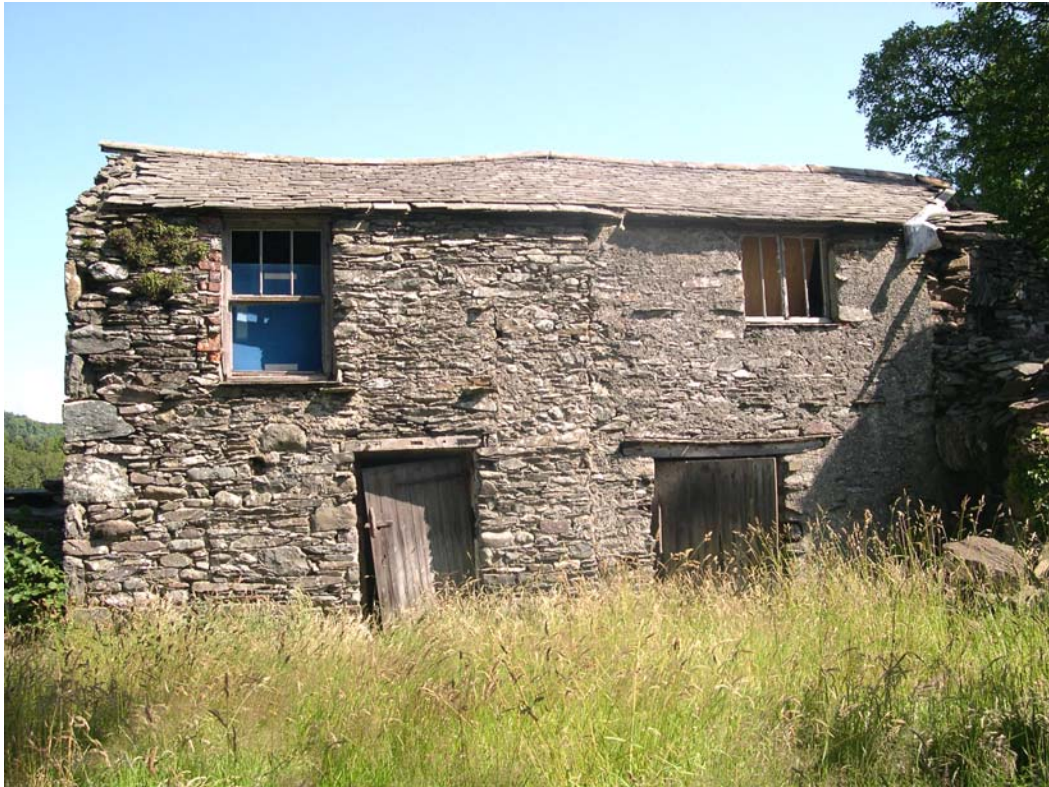
Plate 10: North-facing view of Elevation 8
