MERLEWOOD, GRANGE-OVER- SANDS, CUMBRIA

Historic Building Investigation, Topographic Survey and Archaeological Evaluation

Oxford Archaeology North

March 2008

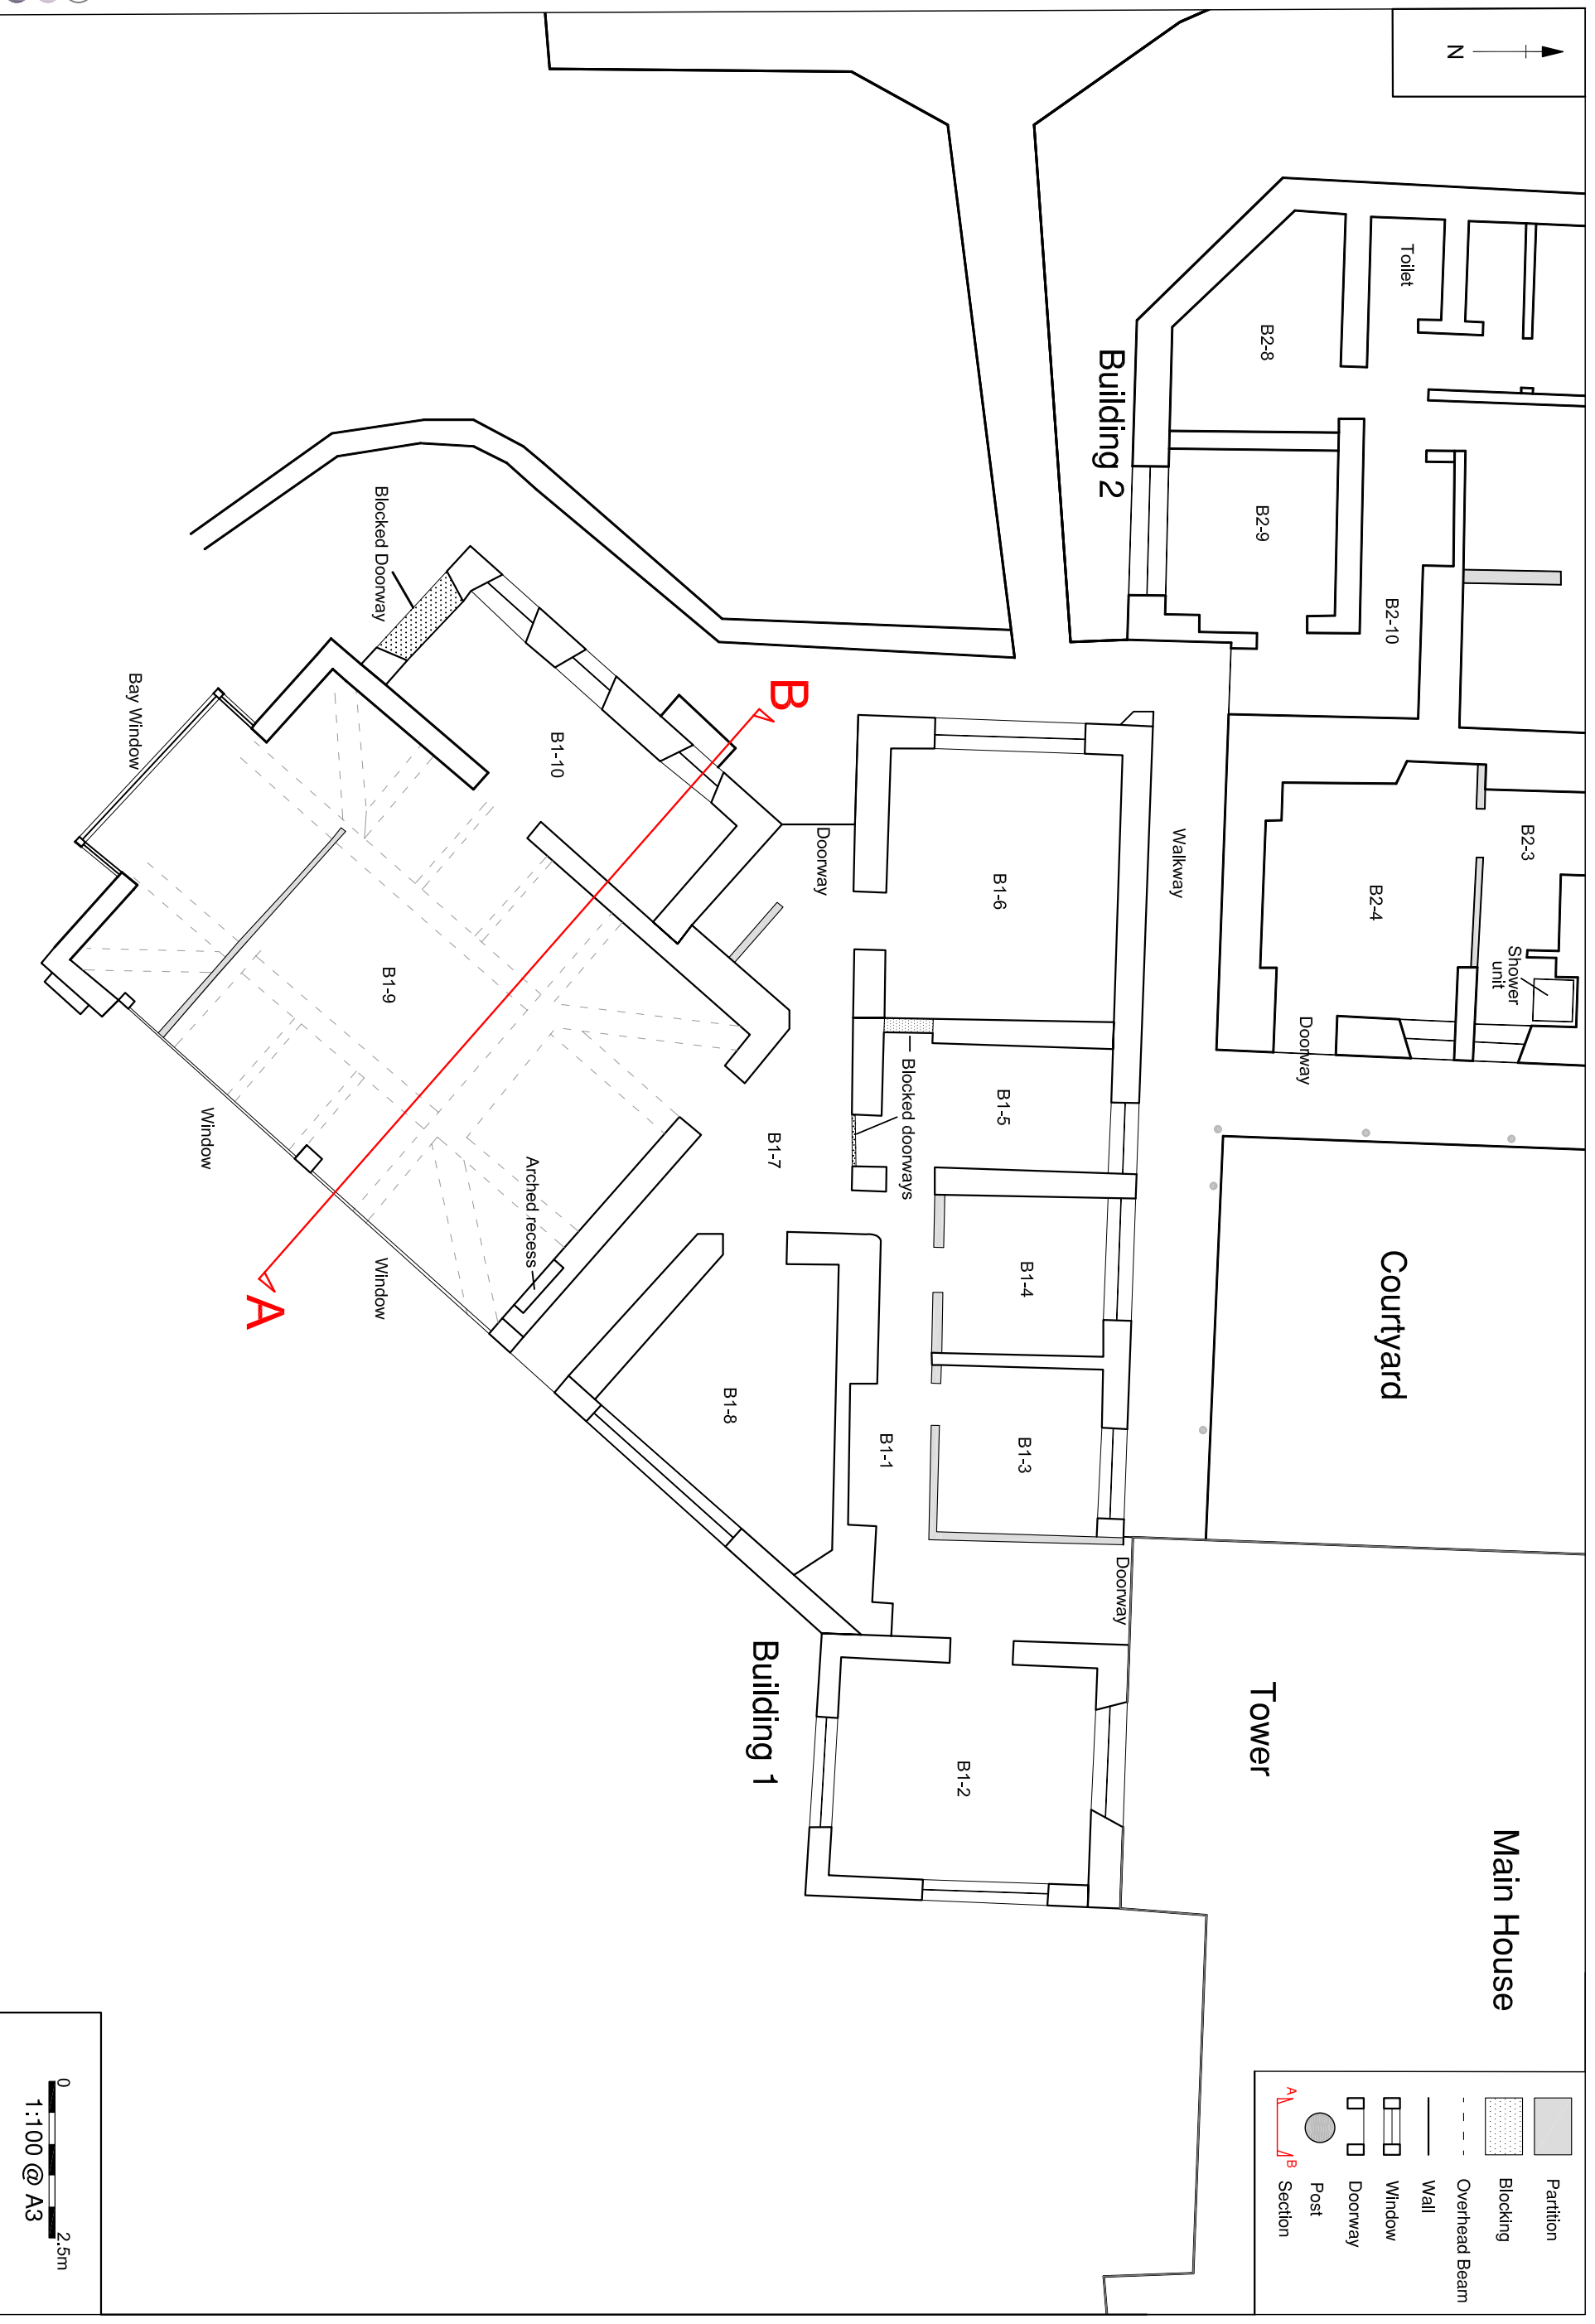
Figure 3: Building 1 Floor Plan

- 4.2.2 The northern part of the building follows the same alignment as the main house whilst the southern part is canted and lies on a north-east/south-west orientation (Fig 3). Internally, the building is divided into eight rooms accessed via two corridors, although some of the rooms are only accessible through other rooms. Two doorways provide external access to the north-west and south-east elevations of the building.

- 4.2.8 **Internal Details:** as already mentioned, there are eight rooms accessed via interconnecting corridors from the rear of the main house (Fig 3). Most of the rooms in Building 1 (in common with the other buildings) are of plain appearance and are empty. Each room will be described in turn, commencing with Room **B1-1**.

- 4.2.9 **Room B1-1:** this L-shaped corridor is accessed via a doorway located in the ground floor of the tower at the rear of the main house and allows access and egress to Rooms **B1-2**, **B1-3**, **B1-4**, **B1-5** and **B1-7** (Fig 3). It is plain in appearance with the south wall being of solid construction and containing recesses of unknown function; all the walls are painted (Plate 8). The north wall which divide the corridor from Rooms **B1-3** and **B1-4**, is of plasterboard construction and has been inserted to create these rooms; the corridor, together with Rooms **B1-3** and **B1-4**, was once probably a single large room. All the doors and surrounds are of late twentieth-century appearance. The floor is laid down to vinyl tiles and the ceiling is plain with modern strip light fittings.

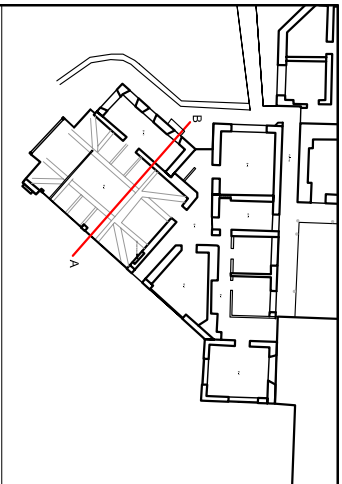
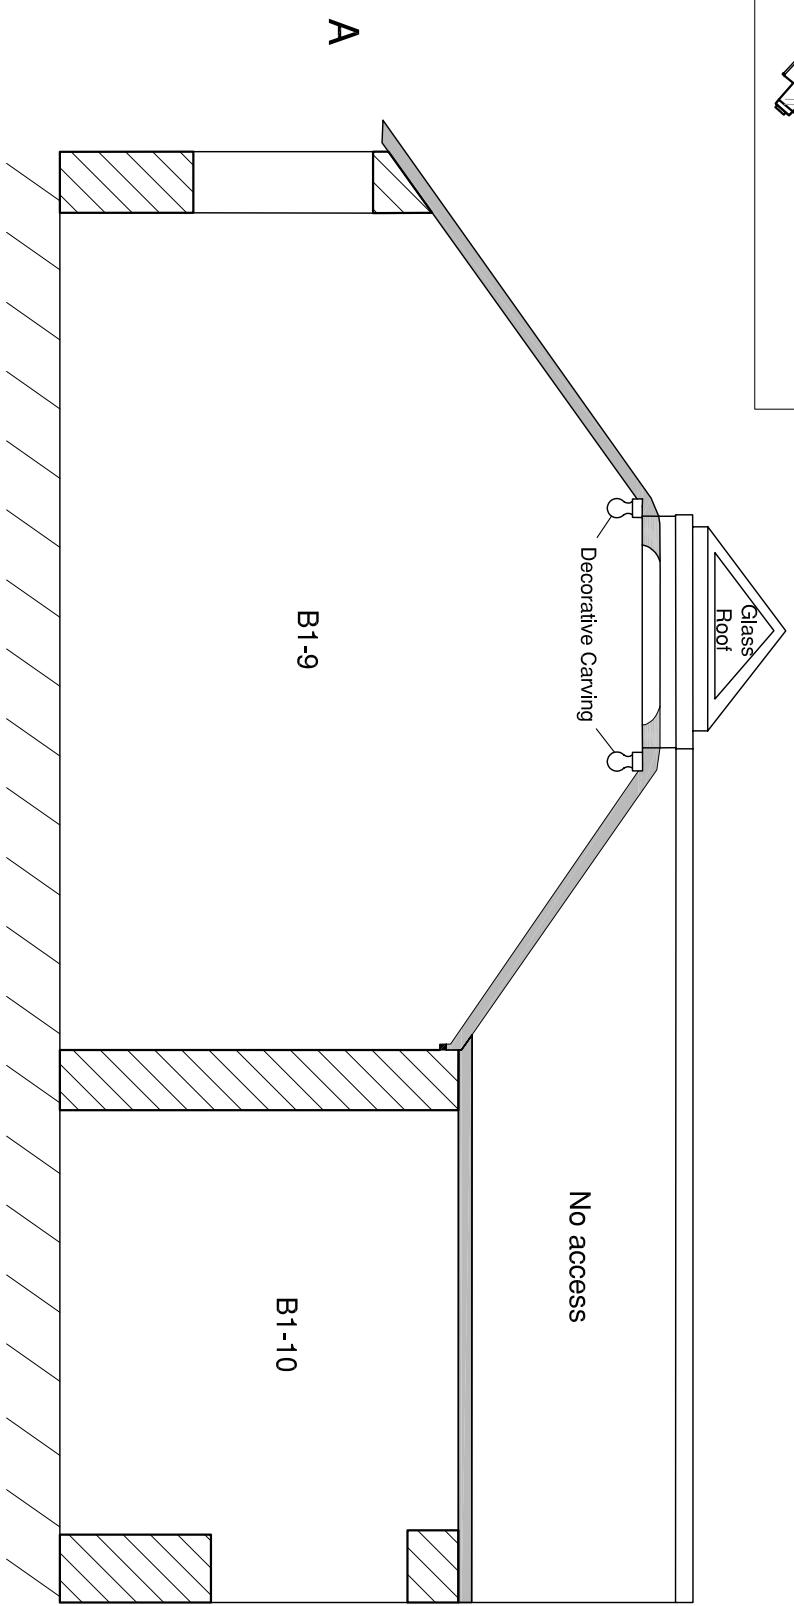
Figure 4: North-Facing Section through Building 1

- 4.2.7 The roof of the entire building is of slate laid in diminishing courses with clay ridges and lead valleys. Most of the rain water goods are of plastic, although some cast iron down pipes survive. The canted part of the building has a lower eaves line than the northern part and the south end is hipped. Double-glazed skylights are present at the south end of the roof. The north slope of the roof meets the east-facing slope of the roof of Building 2. The bay window in the south-west-facing elevation has a small additional gablet roof. The roof of the west side of the building (comprising Room **B1-10**) lies at a ninety-degree angle to the main part of the room (Fig 4).

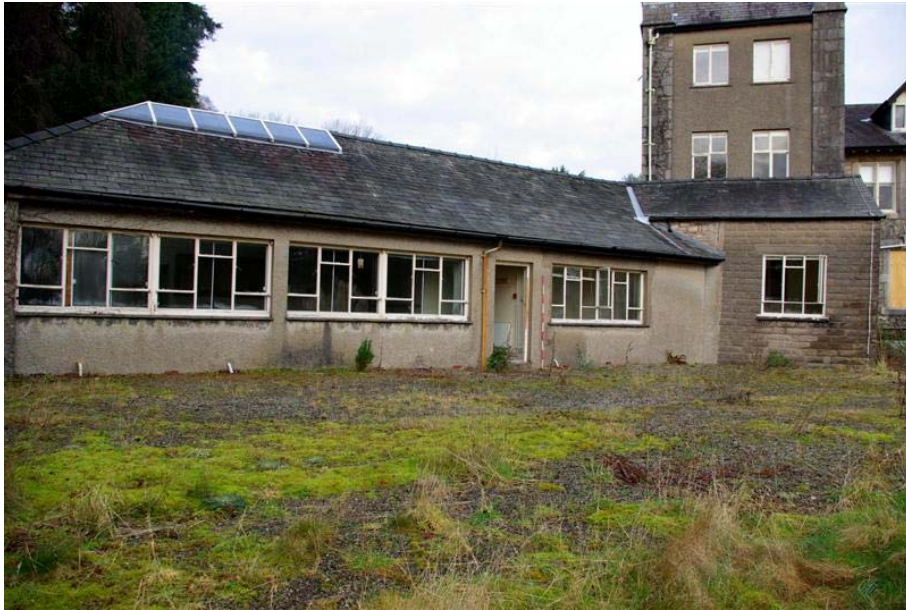
- 4.2.4 The south-east-facing elevation of the canted section of the building is faced with harling and contains fenestration similar in appearance to that on the northern part of the building (although wider and more squat), together with a modern glazed timber door (Plate 1). The south-west elevation of the canted part of the building is constructed from random coursed rubblestone with large quoins and smeared cement mortar (Plate 4). The fenestration consists of a timber bay window and, to the north-west, a casement unit with chamfered sandstone surround and decorative carved lintel (Plates 4 and 5). This appears to be a blocked doorway.

Plate 1: General view of Building 1, facing north

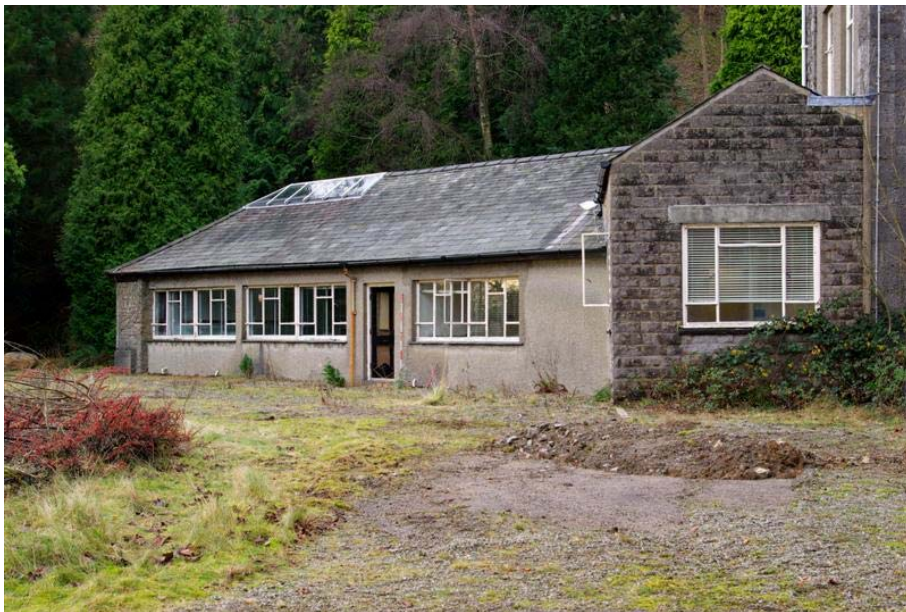
- 4.2.3 ***Fabric and External Details:*** the building exhibits differing construction details, suggestive of several phases of alteration. The northern part of the building, which is visible from the east side (comprising Room **B1-8**), consists of a gable and short section of wall and is constructed from coursed rock-faced sandstone with cement mortar (Plates 2 and 3). There is an obvious vertical butt joint and section of lead flashing where the gable meets the south wall of the tower. There is a second obvious butt joint where the north-east/south-west canted elevation of the building meets the east/west aligned northern part, comprising Rooms **B1-1** to **3** (Plate 3). The fenestration on the east side of Building **1** consists of steel-framed single-glazed casement window frames with concrete lintels and sills (Plate 2 and 3).

Plate 2: General view of Building 1, facing west

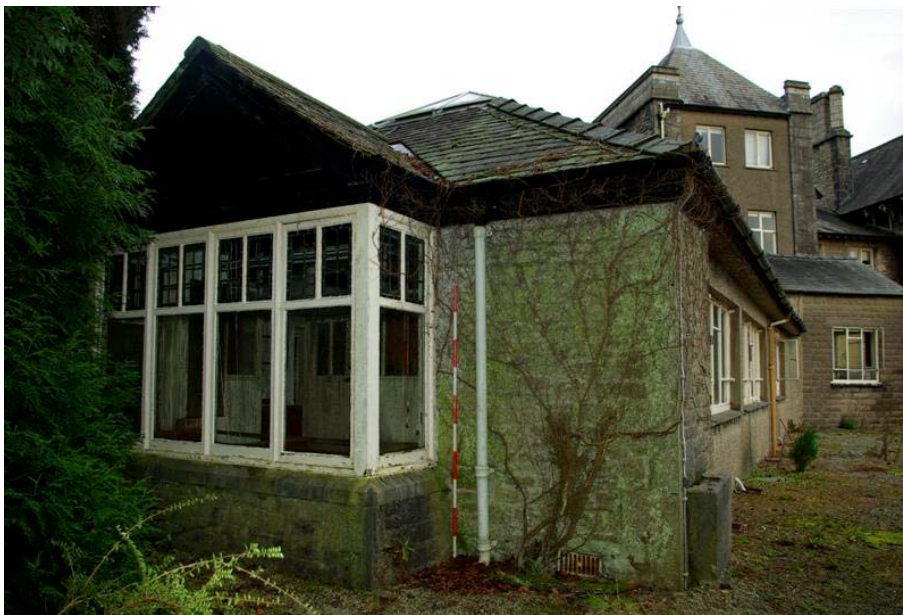
Plate 4: Bay window at the south-west end of Building 1

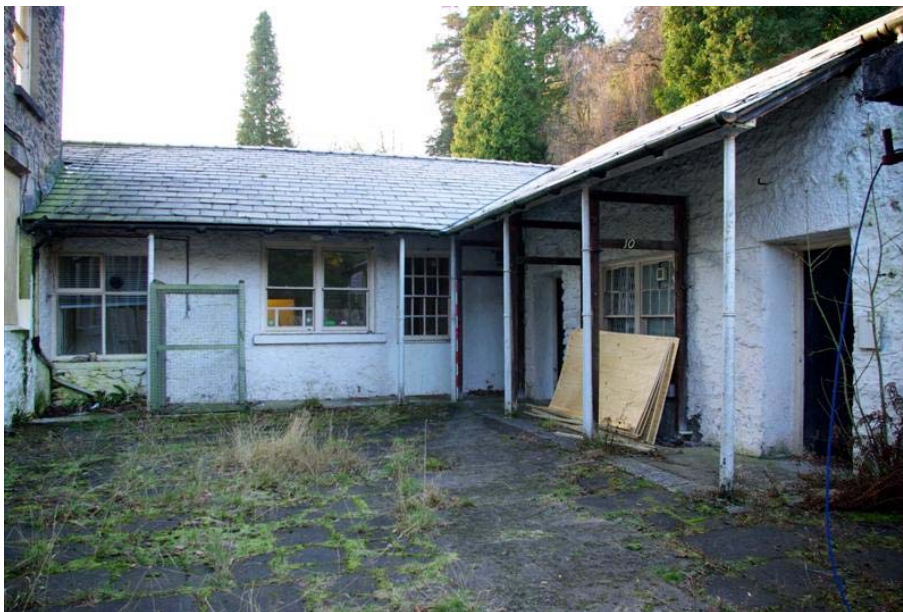
- 4.2.6 The north-facing elevation of the north part of Building **1** is whitewashed and is of random rubblestone construction (Plate 6). It forms the south wall of the small courtyard between the main house and Building **2**. A walkway is present between Buildings **1** and **2** which is roofed-over and allows access to the east side of Building **1** (Plate 7). It is evident that Buildings **1** and **2** are separate structures and that the roof of Building **2** extends to cover the walkway. Both the north slope of the roof of Building **1** and the east slope of the roof of Building **2** project out somewhat to form covered walkways which are supported on cast iron columns (Plate 6). The fenestration of the north elevation of Building **1** consists of three windows, which are all of different types (Plate 6). One is of steel-framed casement construction of similar manufacture to those on the east-facing elevations of the building, a second window is a timber mullioned twin one-over-one sliding sash without horns

Plate 6: Courtyard between Buildings 1 and 2

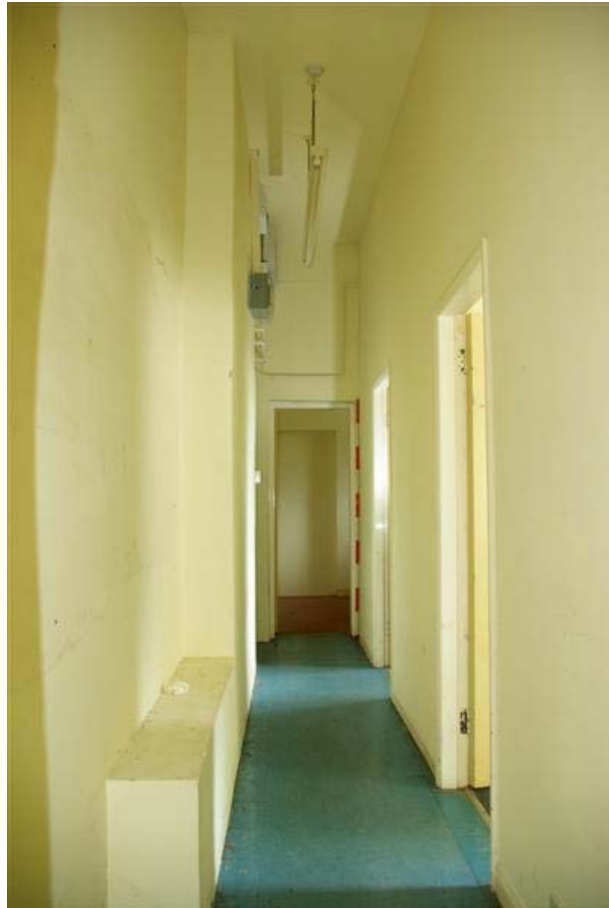
Plate 8: Corridor **B1-1** in Building 1, facing west

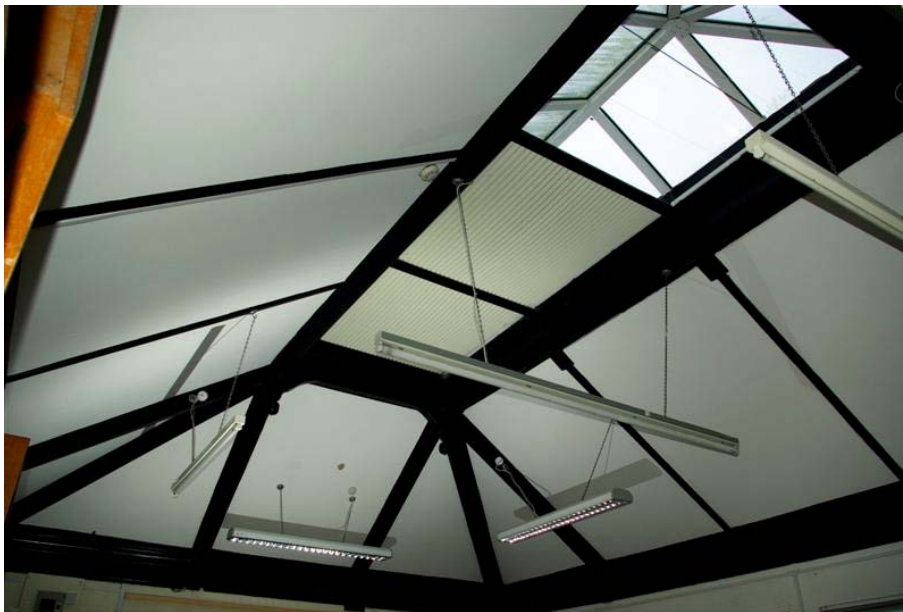
moulding and run-out stops (Plates 14 and 16). Four turned bosses are present at each corner of the frame for the roof light (Plate 15).

Plate 14: View of the roof in **Room B1-9**

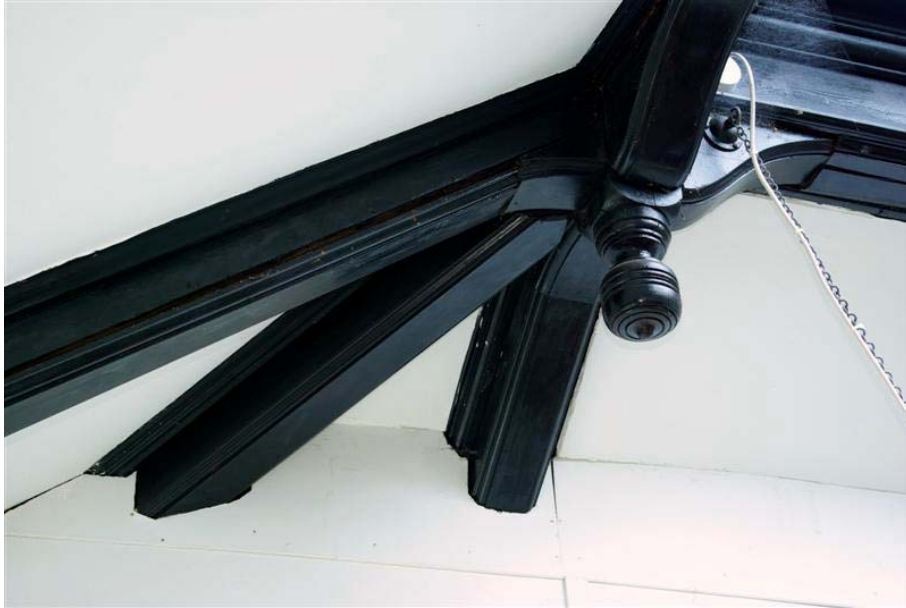
Plate 15: Detail of a boss in Room **B1-9**

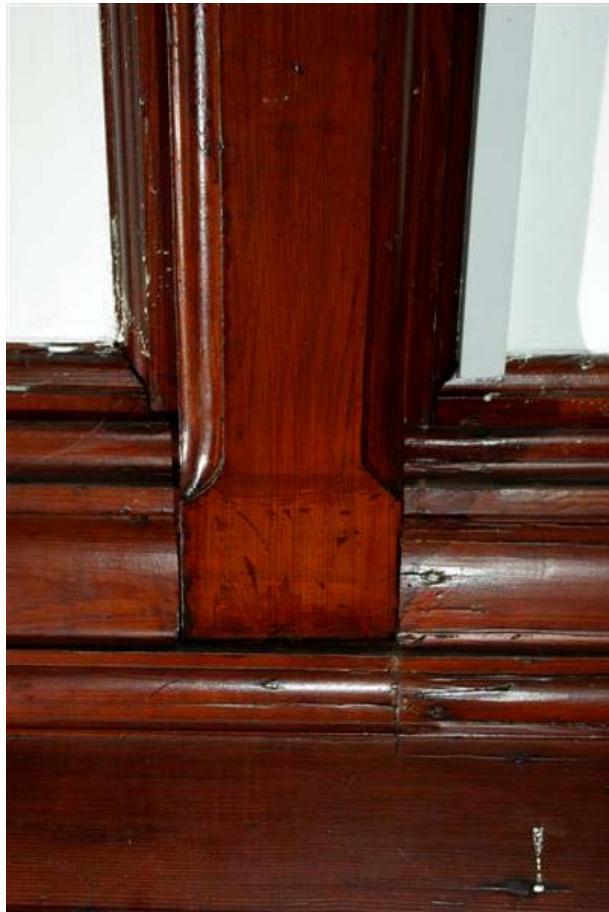
Plate 16: Detail of chamfer on unpainted roof beams in Room **B1-9**

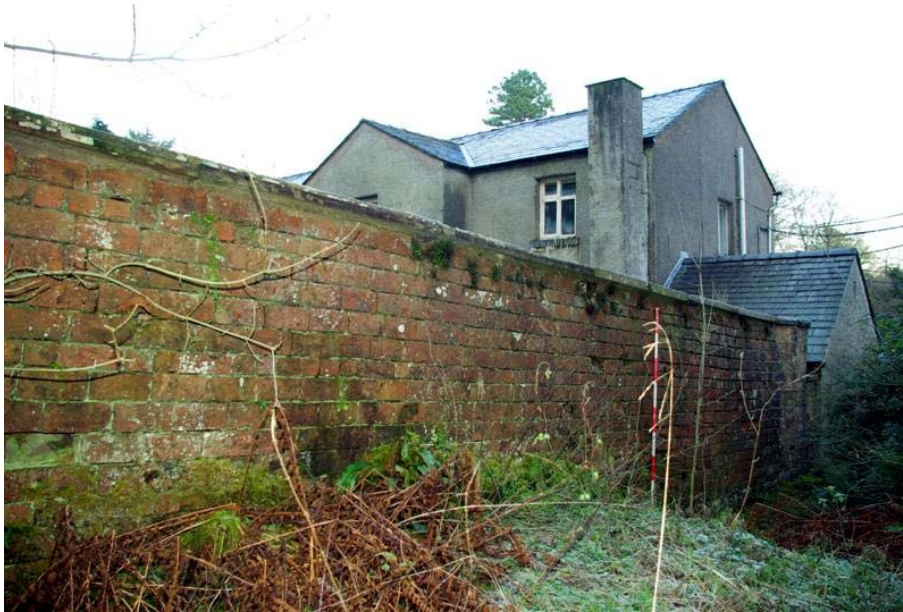
- 4.5.3 The south wall is constructed of machine-made red brick externally (Plate 41) and random rubblestone internally. A doorway with rough limestone quoins is located at the west side. Concrete and flagstone copings rest atop the wall.

Plate 41: Eastern part of the south boundary wall of the walled garden

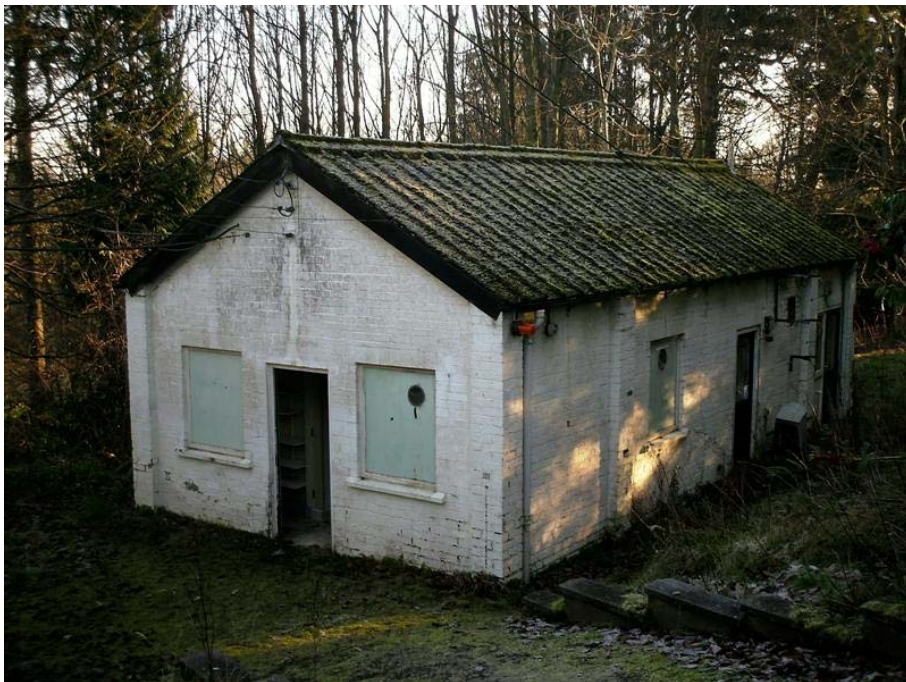
- 4.6.8 **Building 9:** the building is very similar in appearance to Buildings 7 and 8 and is of identical construction details (Plate 52). There are eight windows, which are all single panes with timber frames. Four doorways allow access to the interior, all of which are of modern appearance. A small timber porch is attached to the south west corner of the building.

Plate 52: View of Building 9

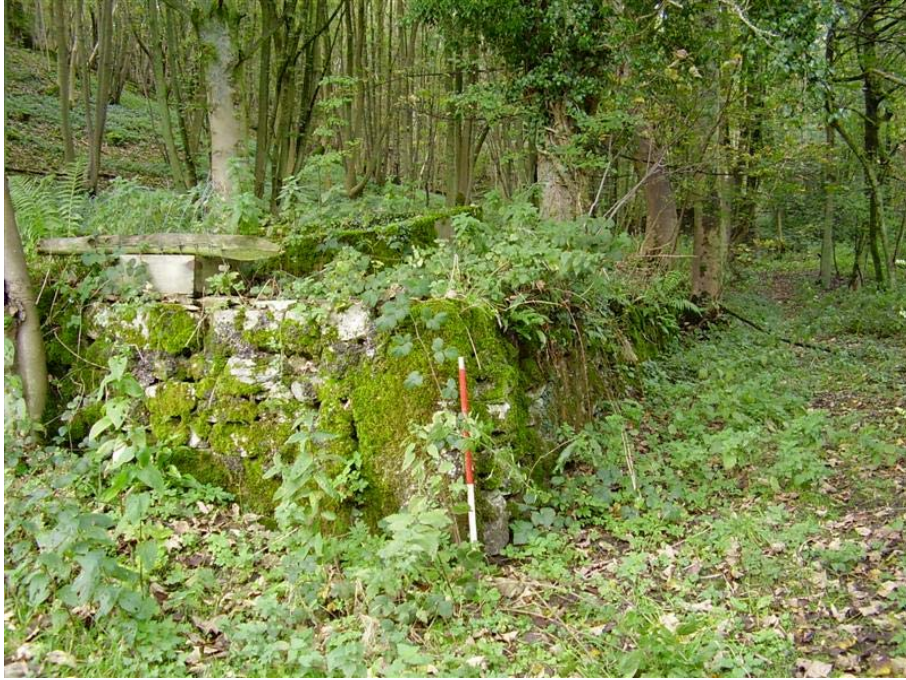
5.1.3 **The Terrace:** this area lies between the northern end of the walled garden and Building 5 (Fig 17). It comprises a slightly sloping terrace area bounded to the west by the steep slope of the wooded bank and to the east by a low revetment wall (Plates 56 and 57). The wall is of random rubblestone construction and follows the contour to the north almost as far as Building 5. It also follows a course to the west towards the base of the slope. At the south-west corner of the wall and located on the terrace is a rectangular concrete foundation of unknown purpose (Plate 58) and a stone 'tank'. No other remains of significance were discovered during the survey.

Plate 56: Revetment wall of the terrace looking north

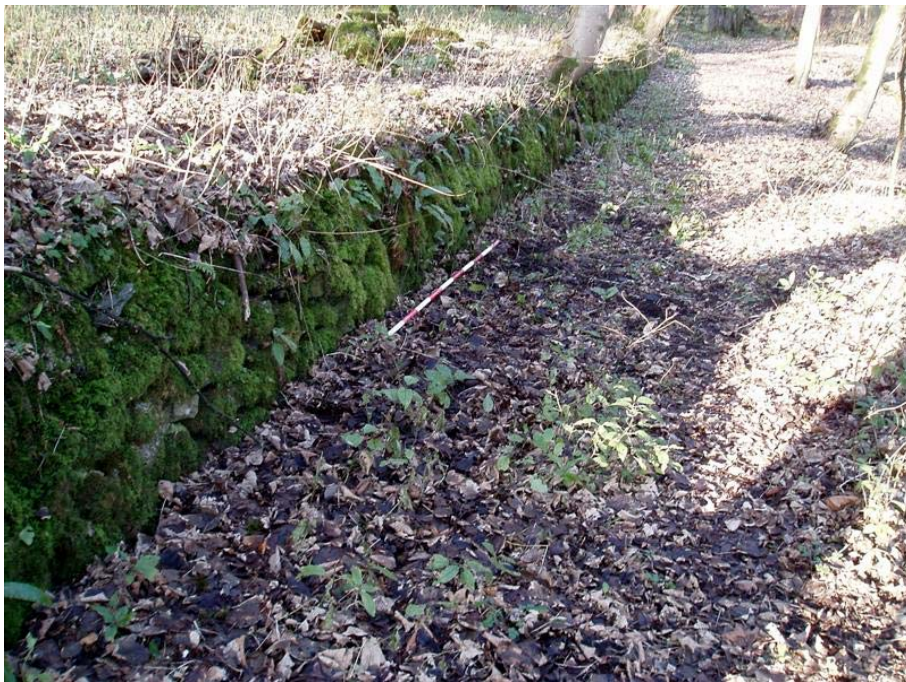
Plate 57: Revetment wall of the terrace looking north
