TY NANT A5 GLYN BENDS IMPROVEMENTS

Archaeological Survey

September 2007

Issue No: 2007-08/716 OAN Job No: L9788 NGR: SH 9930 4430

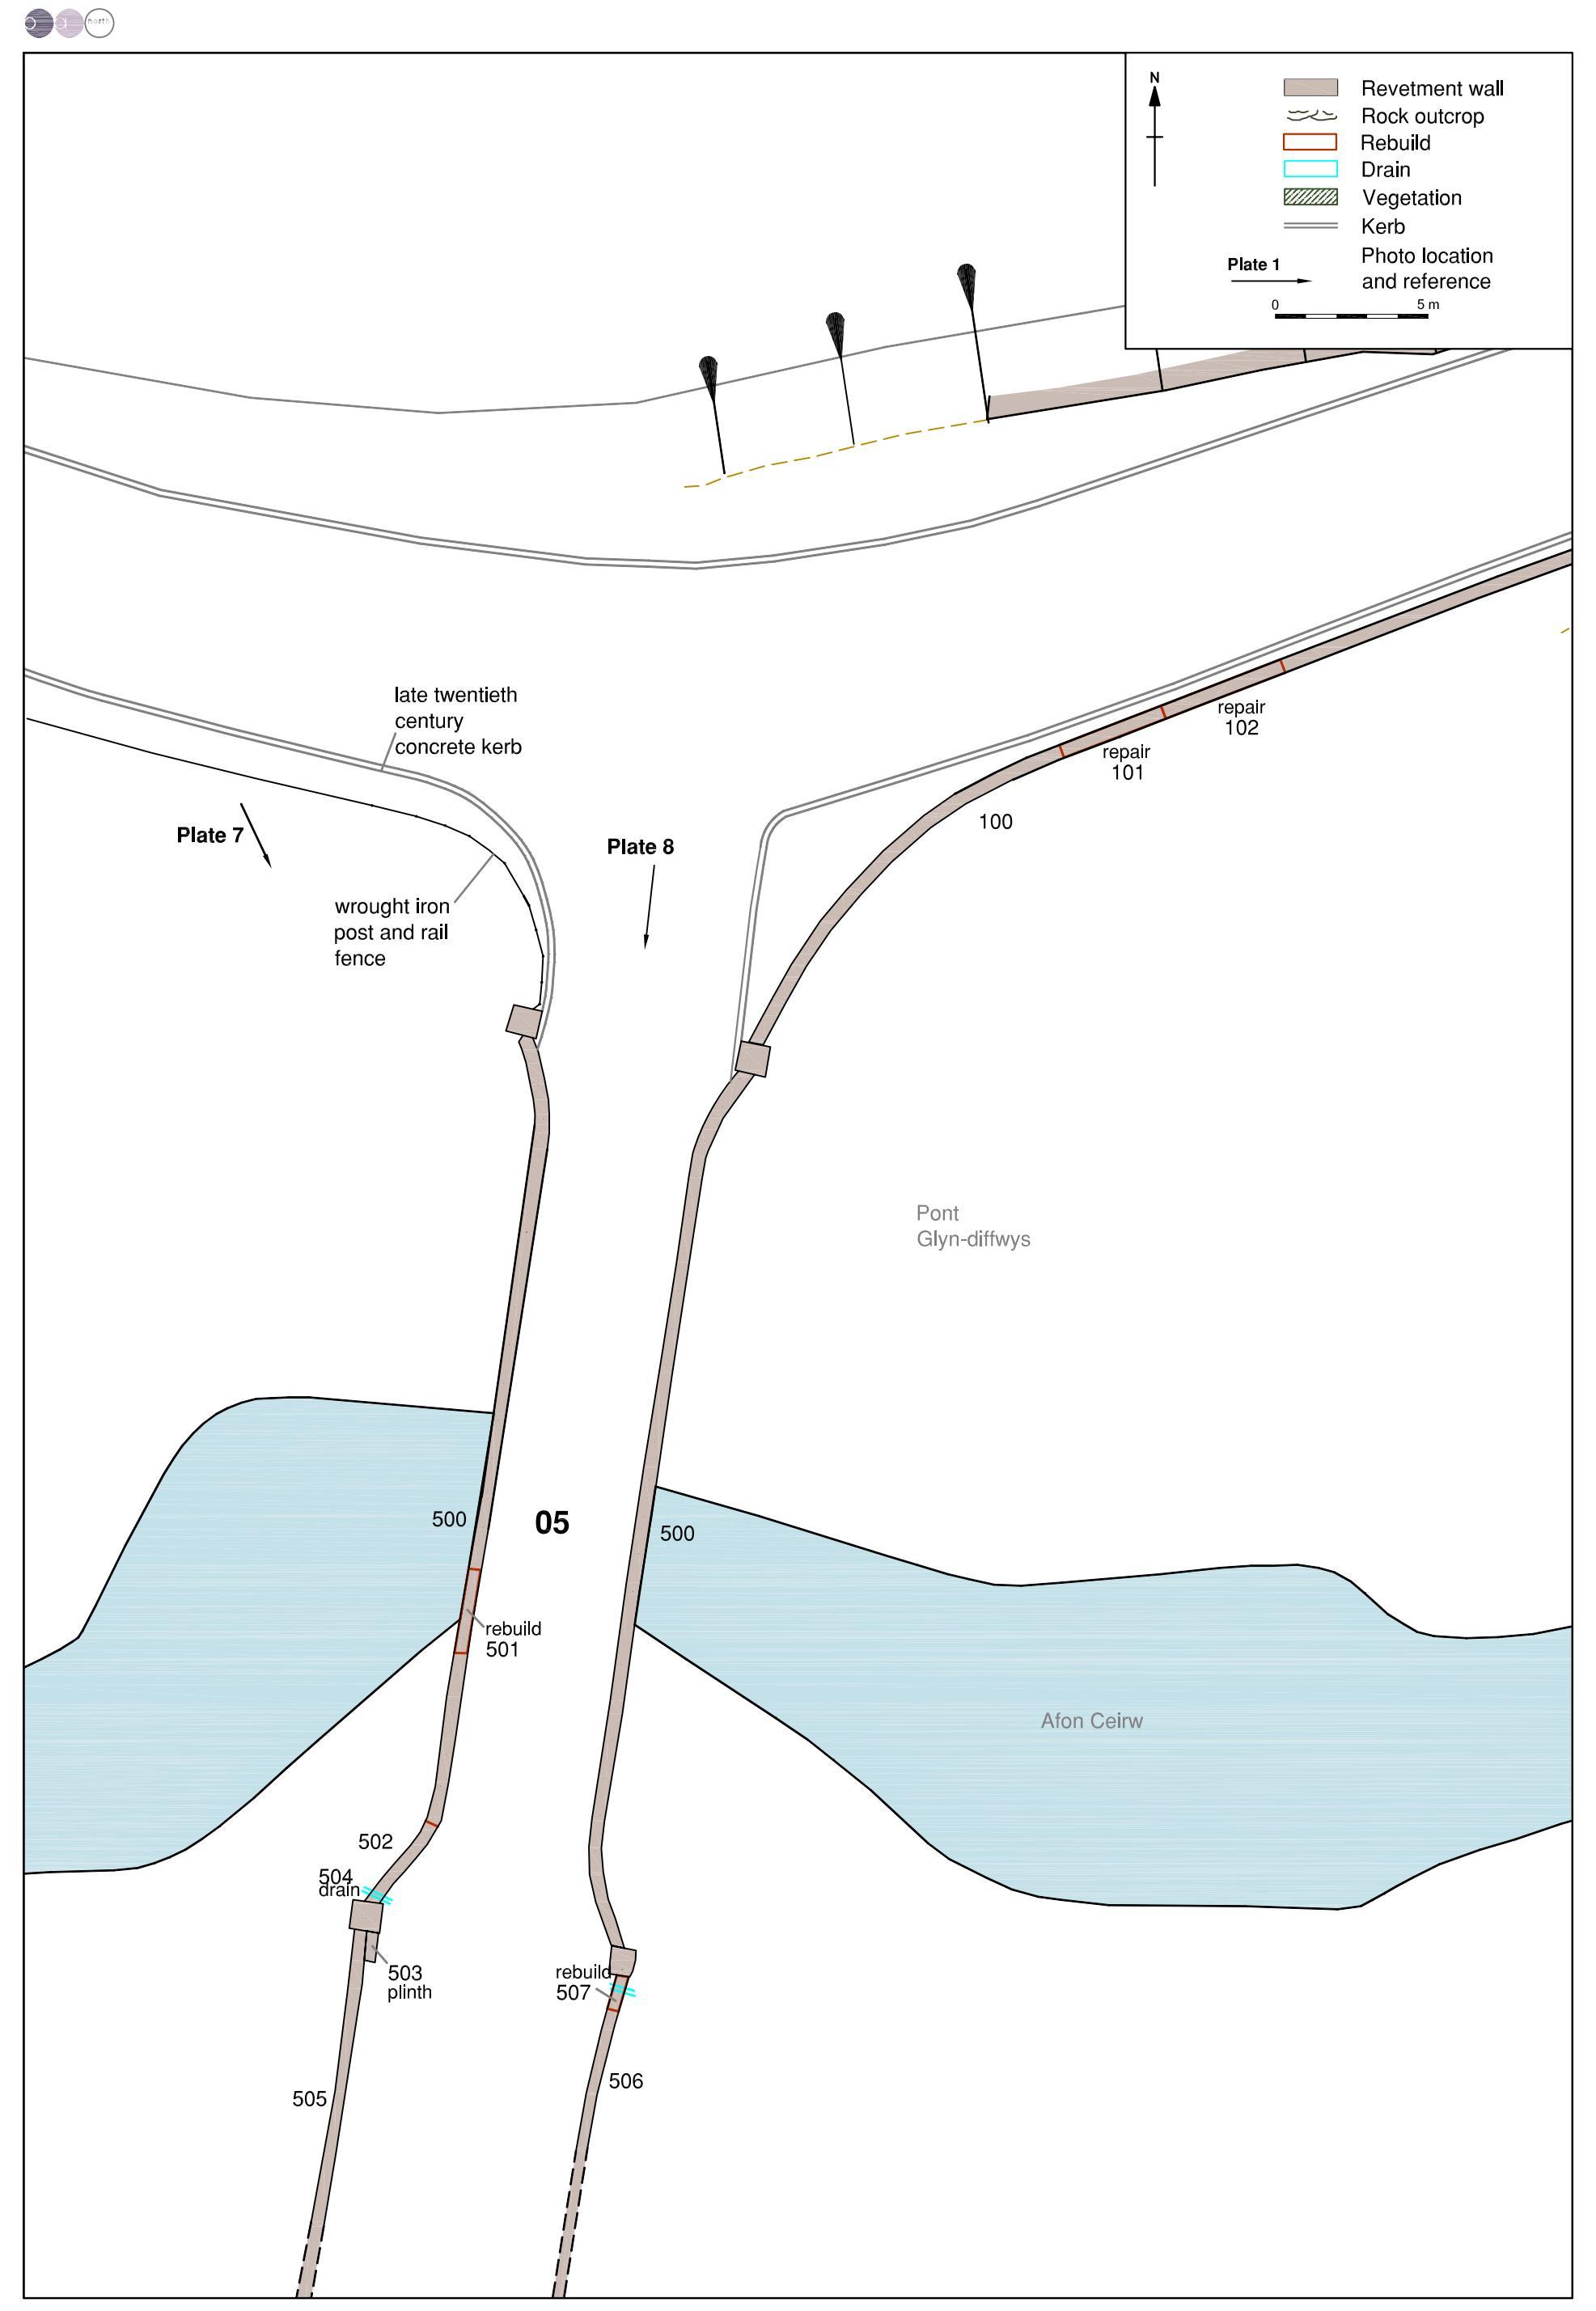
Figure 3: Detail of bridge 05

- 4.3.1 Feature 05, Road Bridge across Afon Ceirw (Fig 3): beyond the western retaining wall (01), the parapet continues along the southern side of the road, returning south, approximately 25m beyond the embankment wall, joining it to the eighteenth century turnpike road bridge across the deep Afon Ceirw gorge (Plate 6). The bridge is also of local slate construction, and is similar in coursing and bonding to the embankment walls, with a string course at road bed level on the external face (Plate 7). The road is supported on a single span of edge-set larger slates. This springs from two large natural rock outcrops, at differing height on either side of the gorge, but providing a stable base for the bridge footings. Beyond the arch at either end, the bridge splays slightly (Fig 3), and the angled bridge parapet (500) is joined to the road parapet by 0.5m x 0.5m posts, which are of similar height to the bridge parapet (Plate 8). This appears to have been entirely rebuilt, although the original slate topstones have been re-used on both sides of the bridge. Two further phases of repairs were also observed in the western parapet (501 and 502). The bridge parapet has a row of 24 wrought-iron posts along both parapets, each with a 2 x ¹/₂" profile. These are set into the top of the topstones, and secured with lead seals, and were probably contemporary with the wrought-iron post and rail fence which borders the section of the Holyhead Road to the immediate west of the bridge. Road-side retaining walls (505 and 506) butt the southern face of the bridge, continuing along the road to the south, both are of similar fabric to the parapet walls of the bridge, but are of drystone construction. The present road bed is cambered and is drained through the parapet wall on either side at the southern end of the bridge. That on the western side (504) is positioned immediately to the north of the bridge post (Fig 3), whilst that on the eastern side (508) is positioned below the northern end of the retaining wall, immediately to the south of the bridge itself.

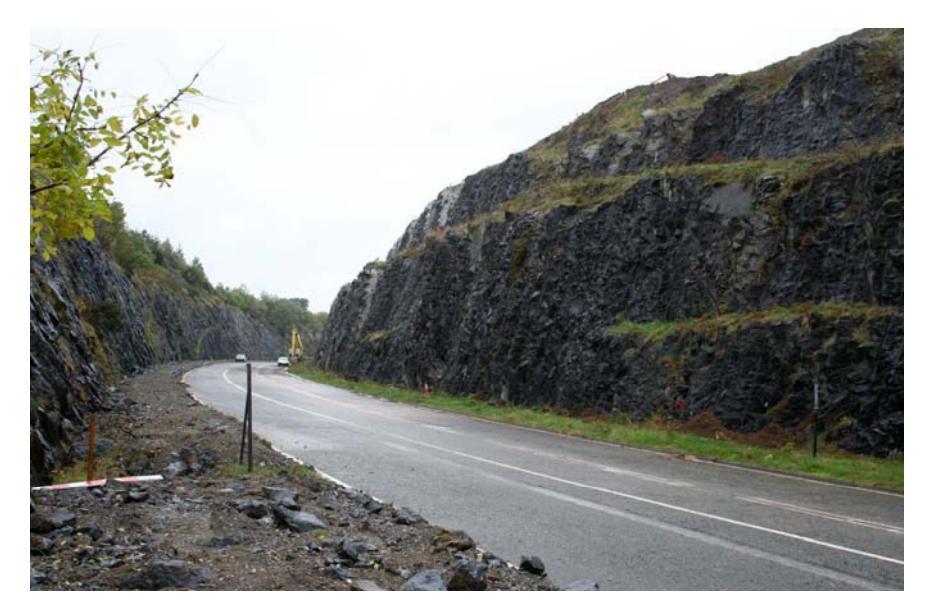
- 1.1.1 The Ty Nant section of Thomas Telford's Holyhead Road, through North Wales, had formerly been detrunked, as a result of the construction of the Glyn Bends Bypass in the 1990's (Plate 1; Fig 1). However, when instabilities in the embankment of the bypass became apparent, it was necessary to close the road and divert the traffic back along the original Ty Nant section of Telford's road (centred on SH 9930 4430), while stabilisation works were undertaken to the bypass.

Plate 1: The Glyn Bends Bypass before stabilisation works

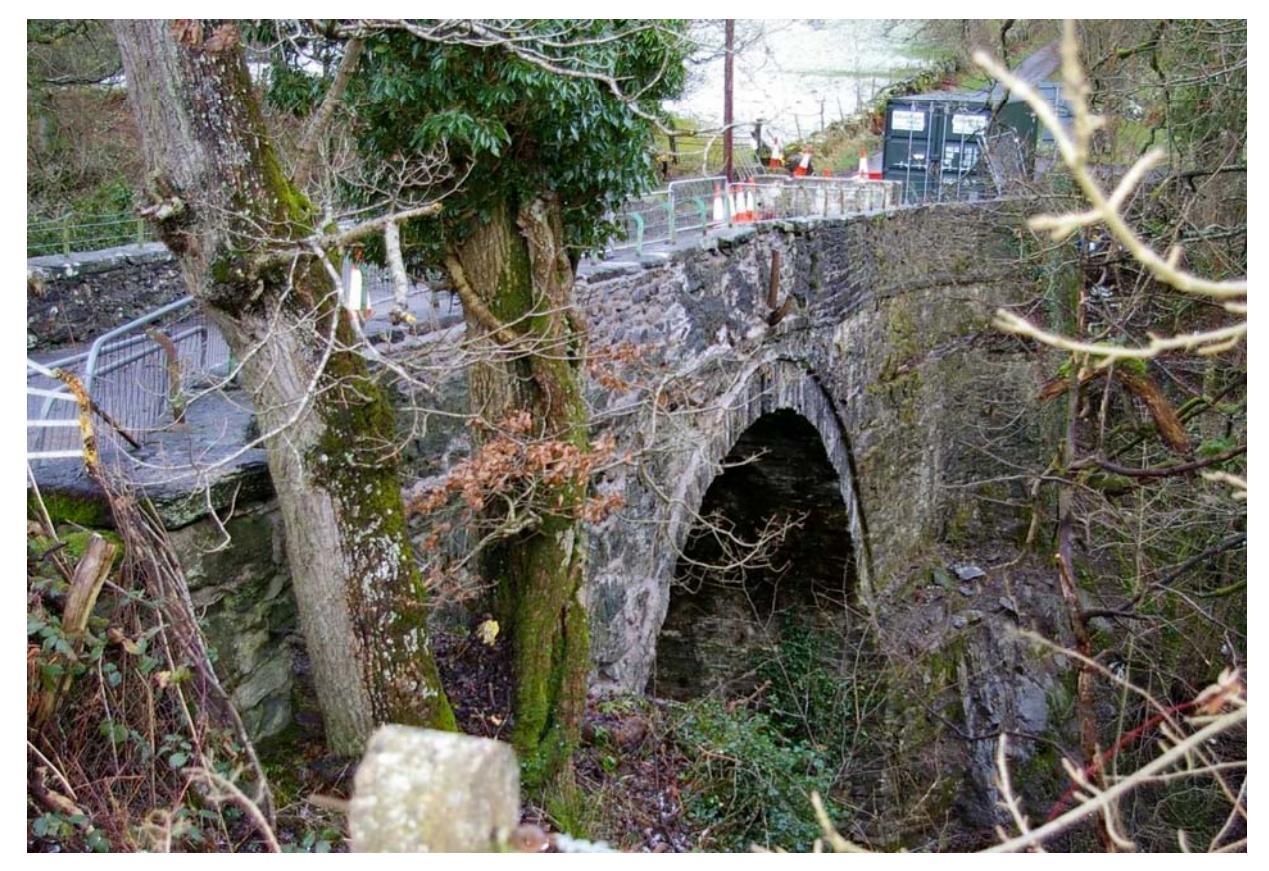
Plate 7: The eighteenth century turnpike bridge across the Afon Ceirw looking southeast (Site **05**)

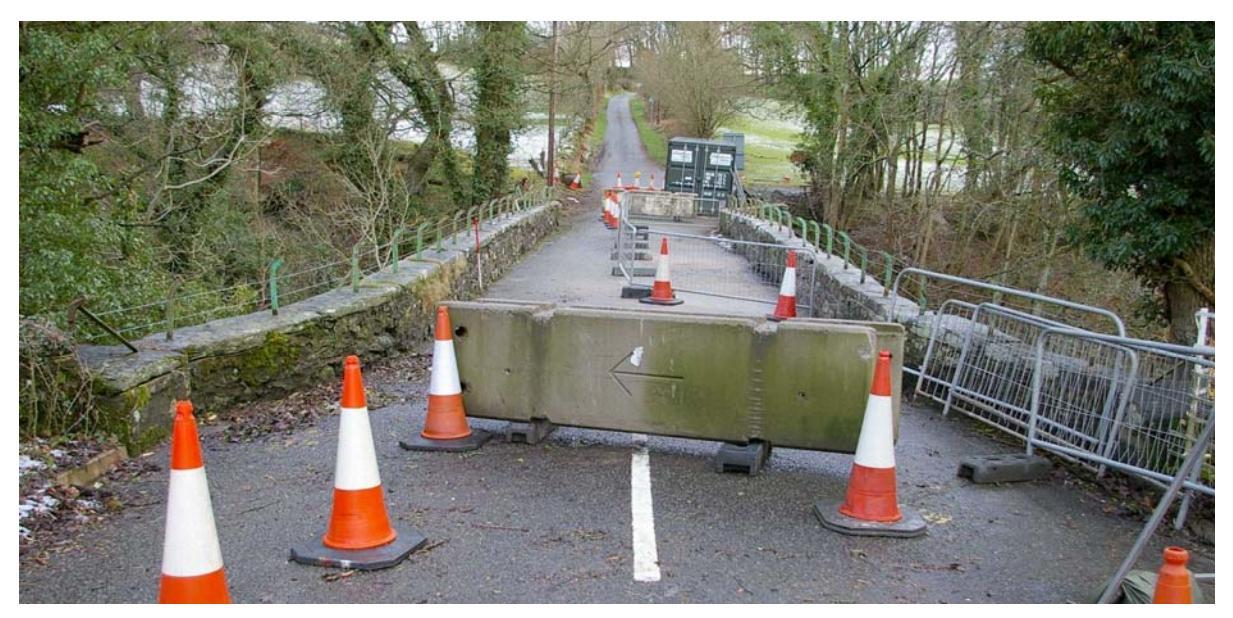
Plate 8: The top of the turnpike bridge (Site 05), looking south

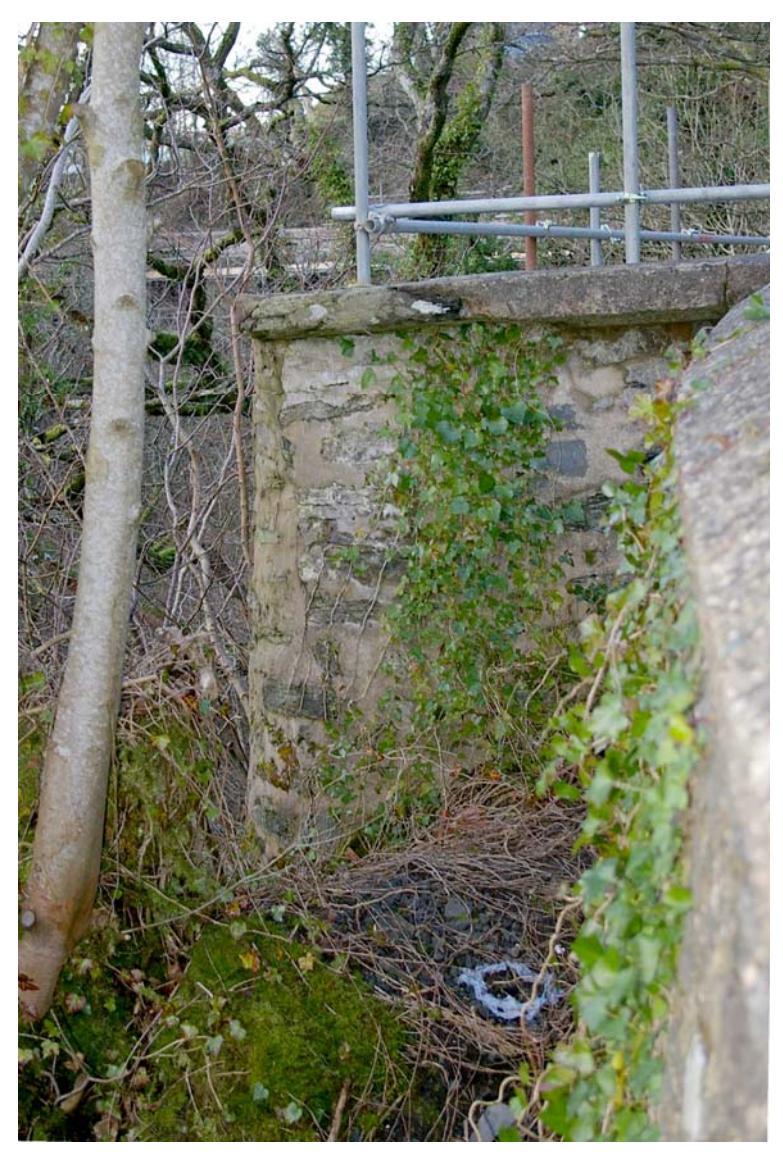
- 4.3.2 *Feature 10, western Viewpoint Turret:* within the western retaining wall (01), a viewing turret was constructed, affording views of both the Glyn Dyffwys gorge and the bridge constructed over it (05). Positioned 11m from the eastern end of this section of the embankment wall, at the northern end of the most pronounced bend in the road, it gave the traveller the best view of the bridge (Plate 9), and the waterfall in the Glyn Dyffwys gorge below. The turret has a horse-shoe shaped plan, open on the road side, with externally battered walls, and was constructed on a natural projection of bedrock, and would also have served to buttress the embankment wall. It was built to the same height as the adjacent parapet walls, and has a single original, slightly projecting, dressed sandstone capping surviving on its southern side (Plate 10).

Plate 9: Western viewpoint turret (Site 10) looking north

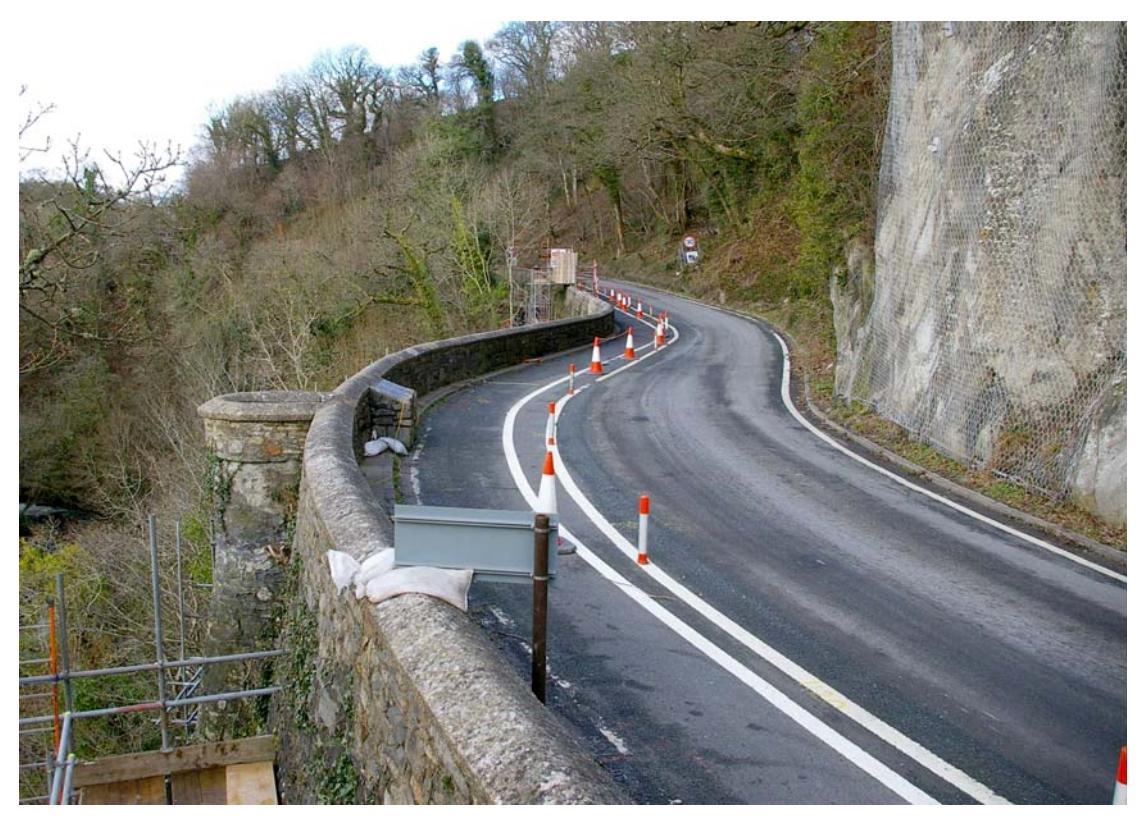
- 4.3.3 *Feature 23, eastern Viewpoint Turret:* the eastern viewpoint turret is similar in construction and style to that to the west (Plate 11), but is considerably taller, and the retained height of the wall is 5.35m at this location. The feature makes considerable use of the local topography, being sited on a natural outcrop of slate, which is partially incorporated within the construction of the turret, not only saving on materials, but also providing a firm foundation. This is most especially noticeable on the western face of the turret, where the almost vertically-bedded outcrop has been incorporated into the turret from 3.5m below its top (Plate 12). The turret is footed on the outcrop from around 4.9m below the parapet, but this footing has been bolstered on the southern and eastern sides by a layer of concrete, comprising a 2.1m height of concrete-filled sandbags laid around the base of the

Plate 11: Turret Site 23, opposite the worked rock outcrop (Site 22), looking west

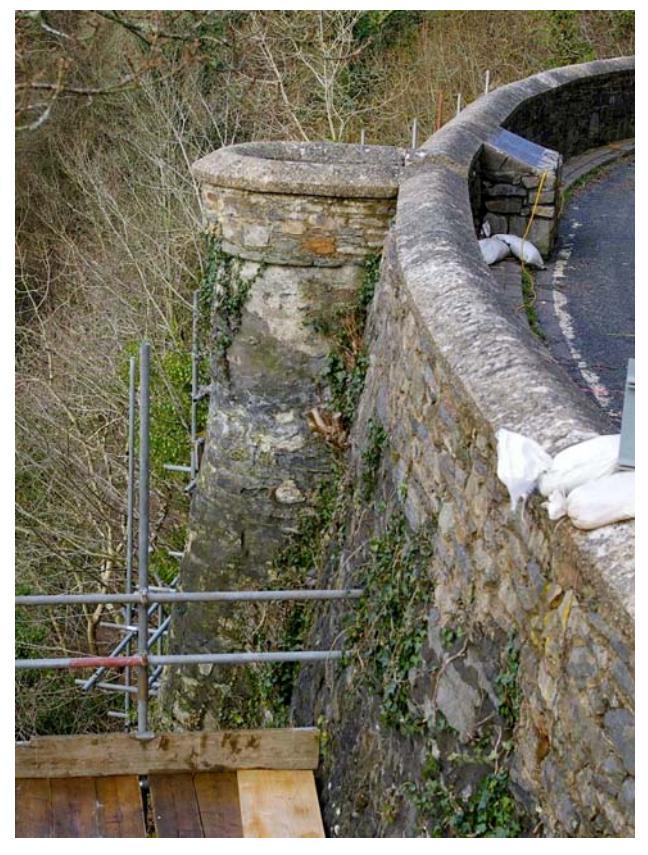
Plate 12: Turret 23 viewed from the east

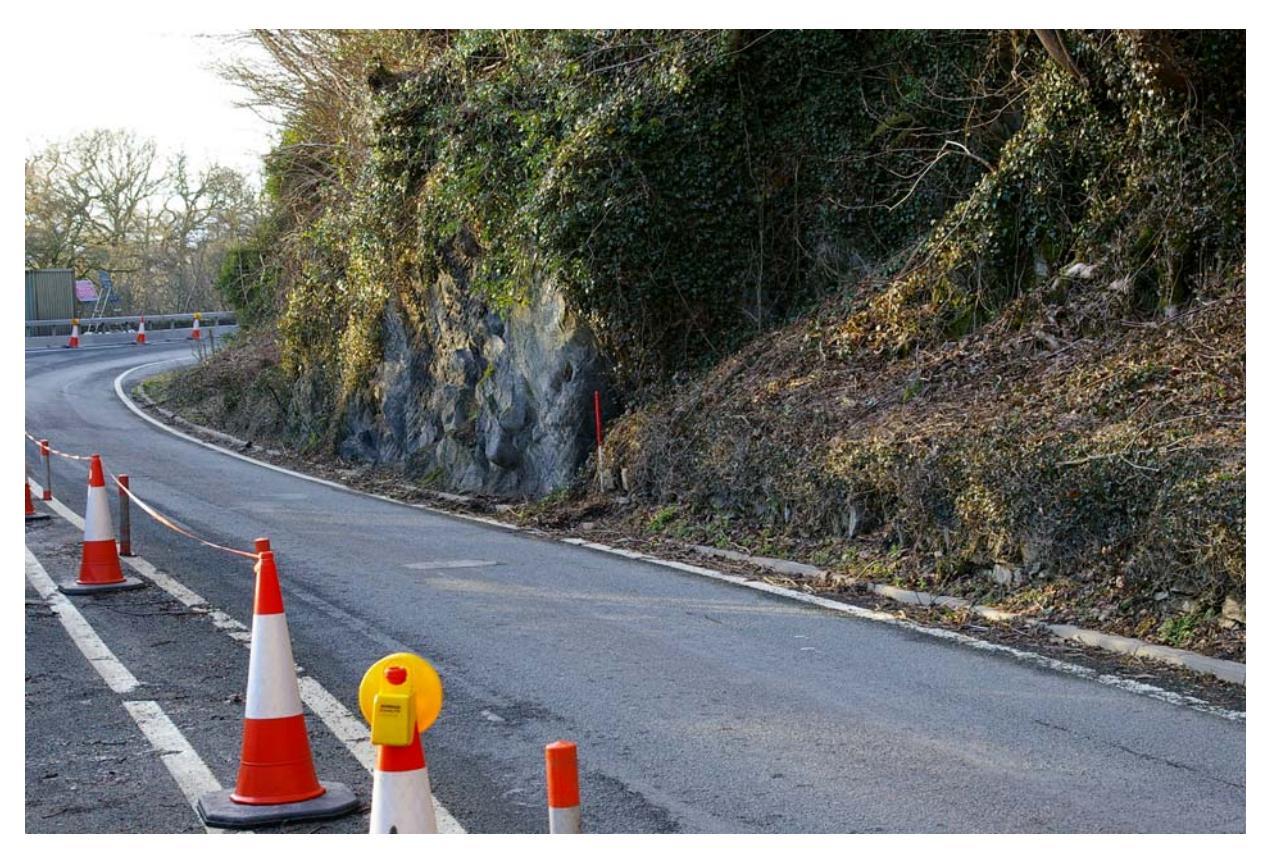
Plate 15: Retaining Wall 16, set against a section of worked outcrop

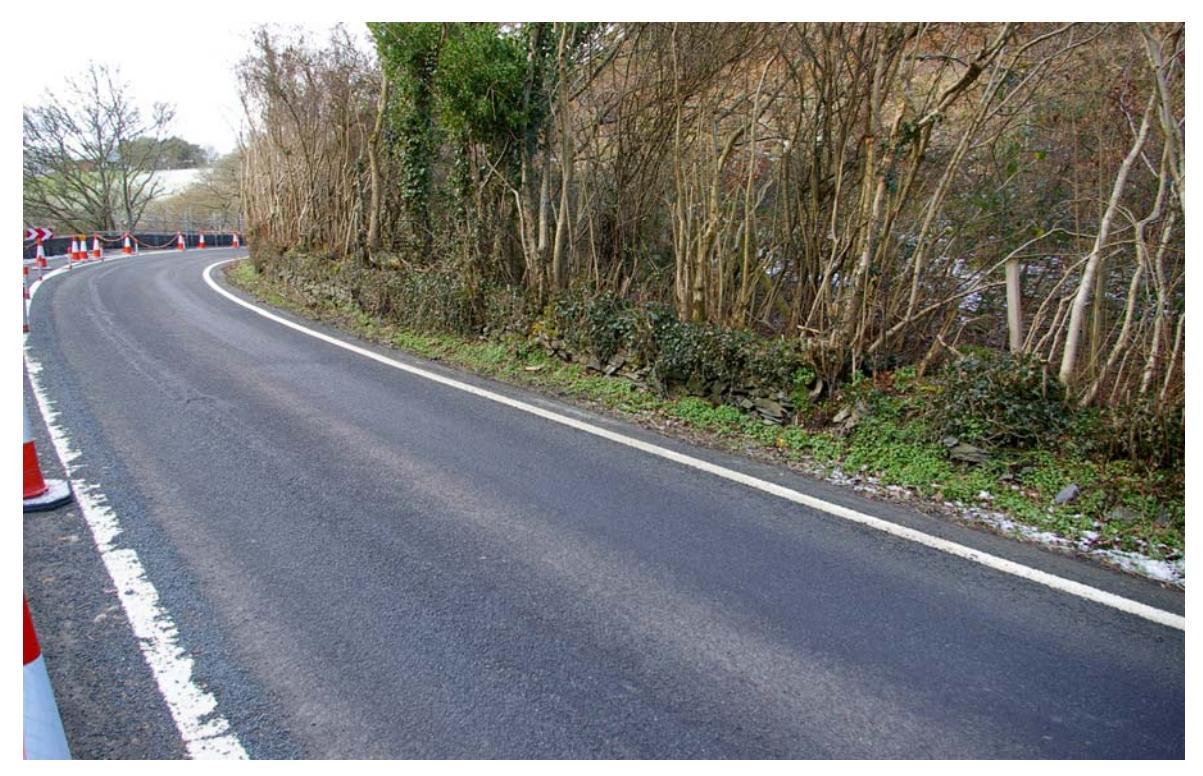
Plate 18: The longest section of retaining wall (Site 24) at the eastern end of the embanked road section
