Valentines Park Ilford

London Borough
of Redbridge

**Historic Building Recording and
Archaeological Watching Brief**

April 2009

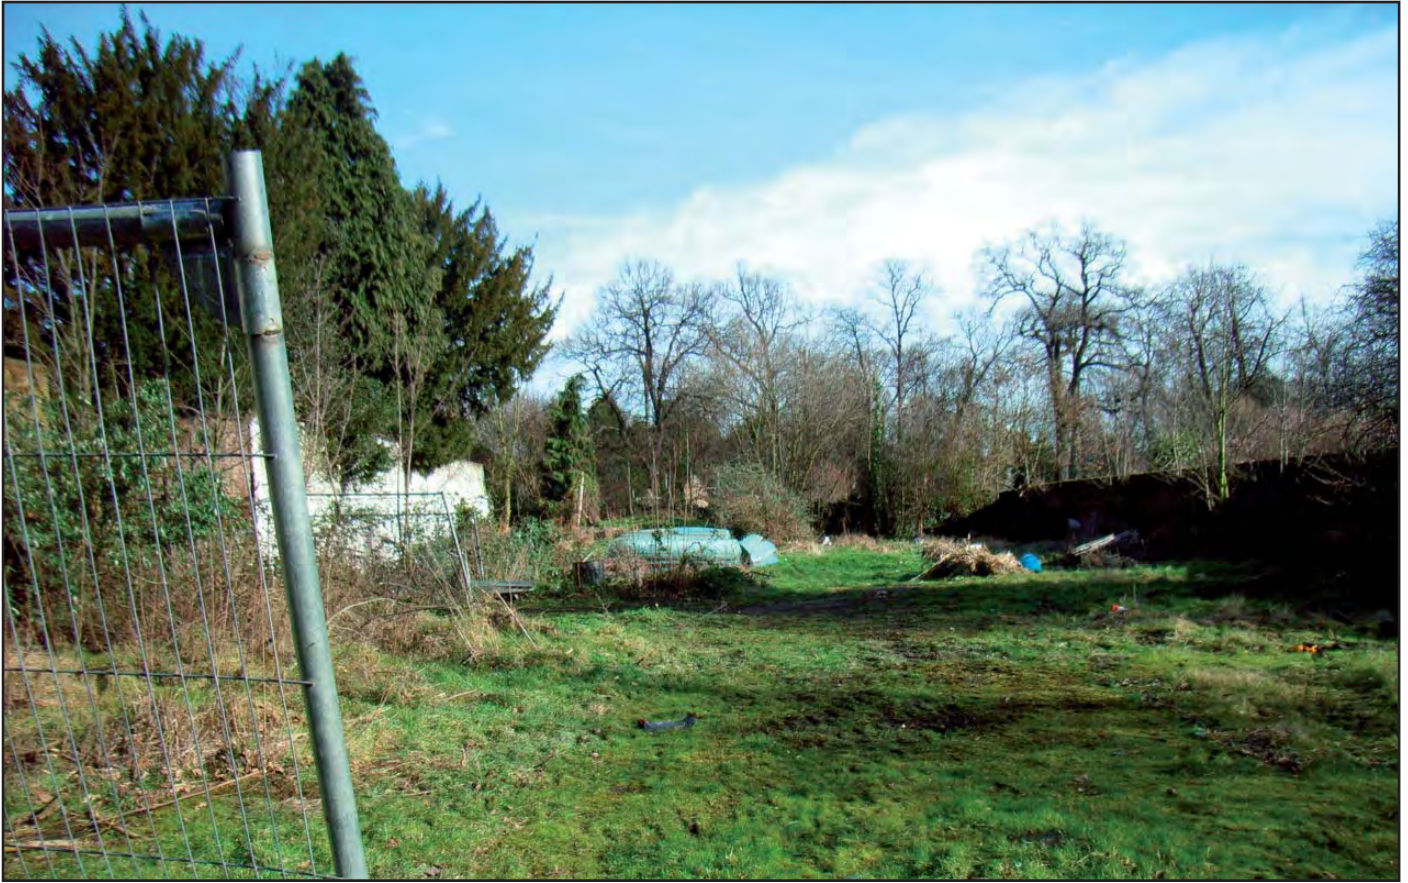
Plate 1: General view of Kitchen Garden from SW prior to start of works

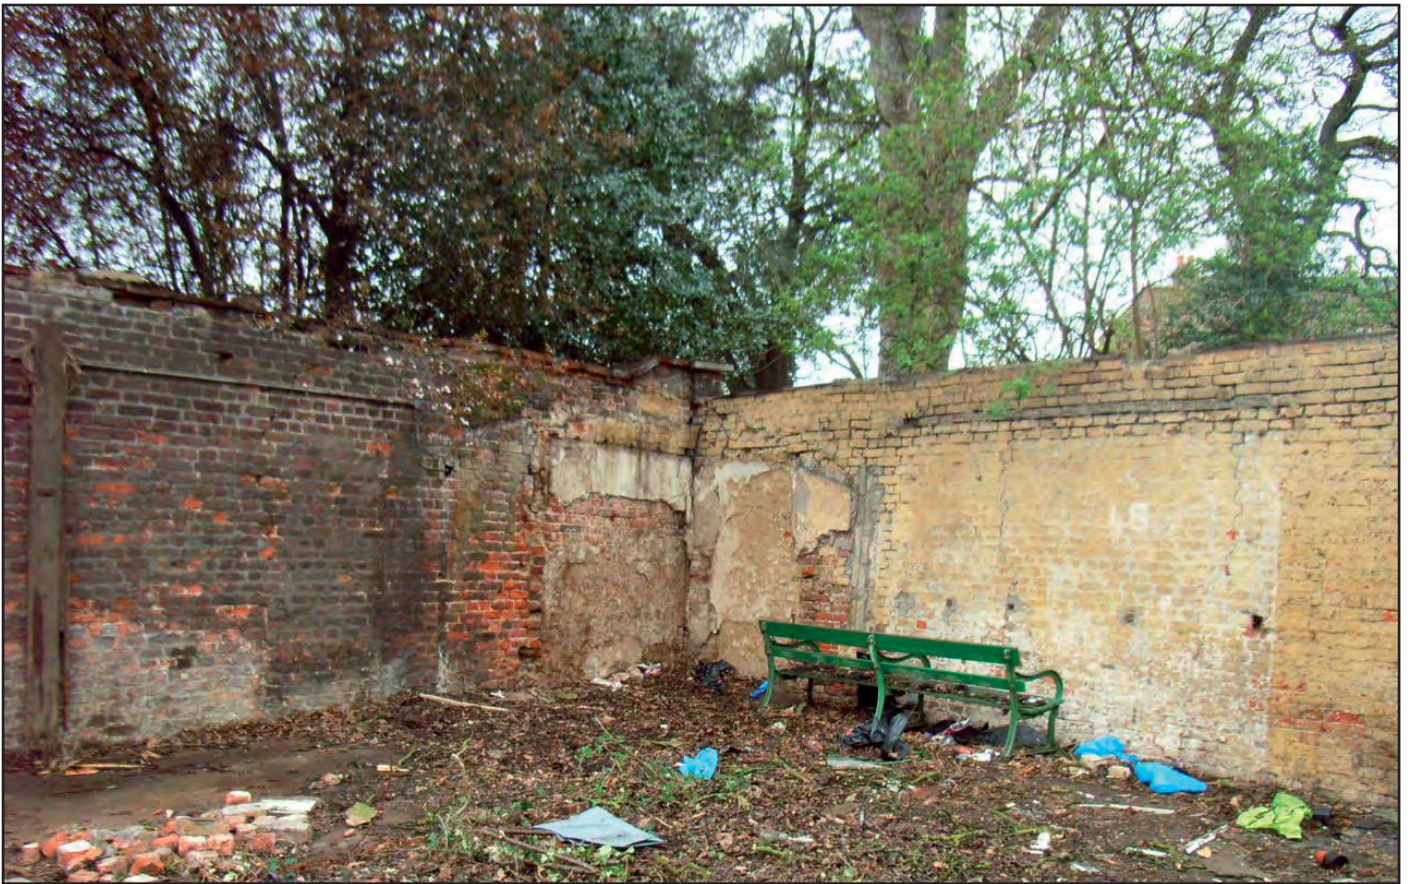
Plate 3: South corner between Walls 2a and 3

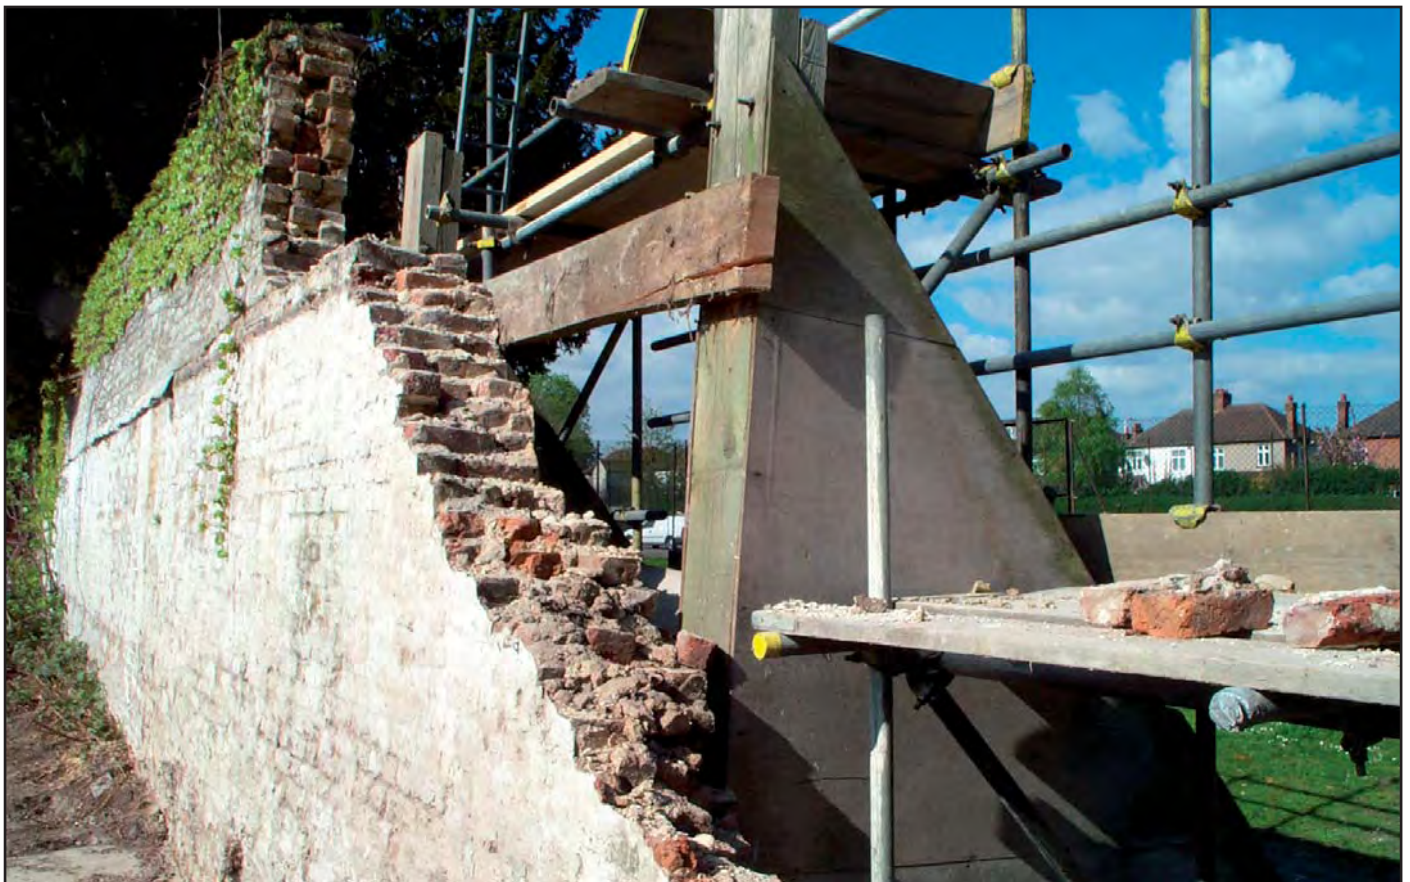
Plate 8: Wall 1 (NE end) during reconstruction

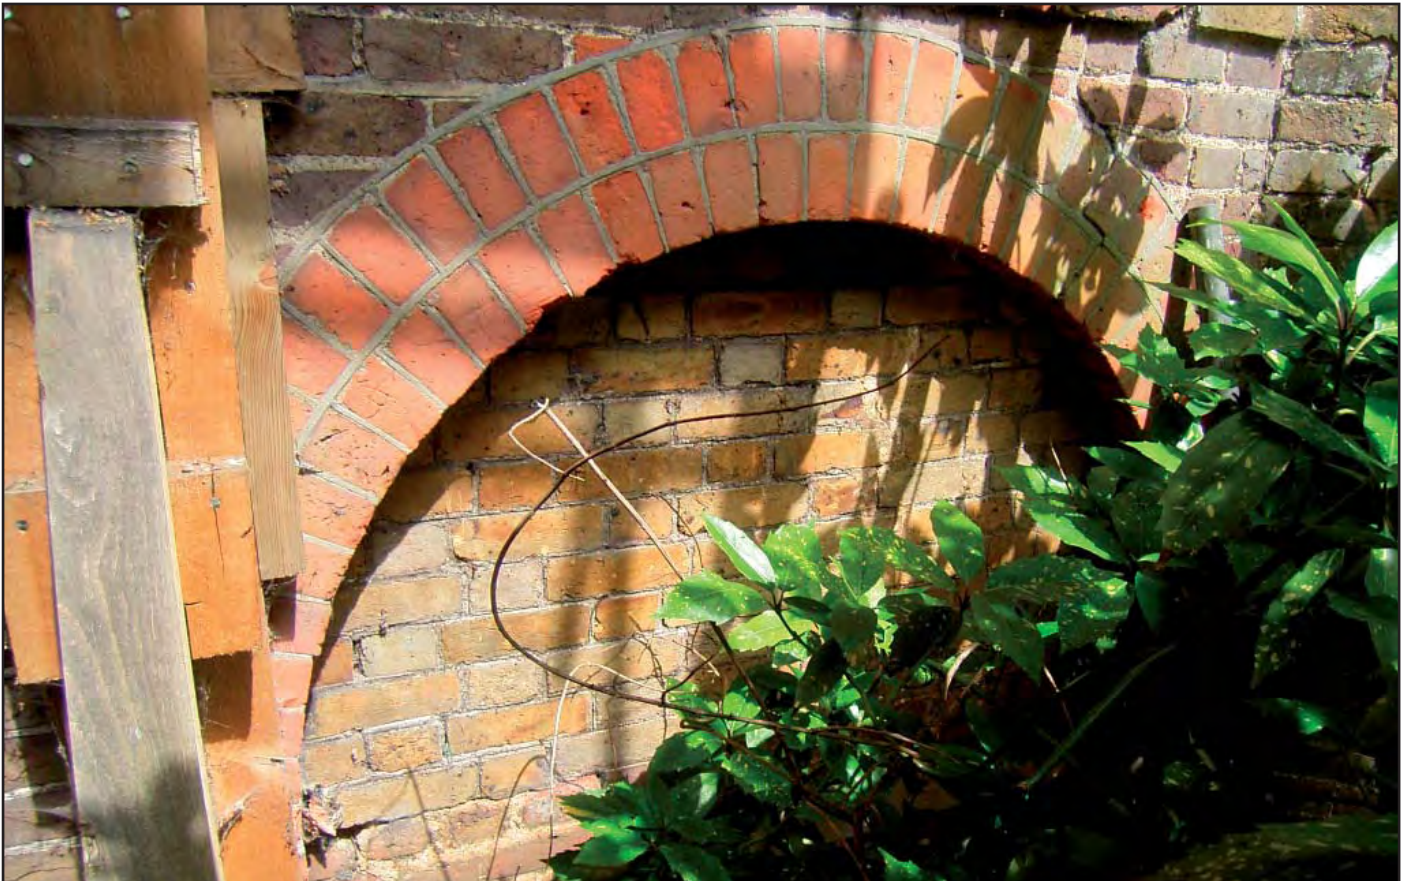
Plate 14: Blocked arch in SW elevation of Dovecote

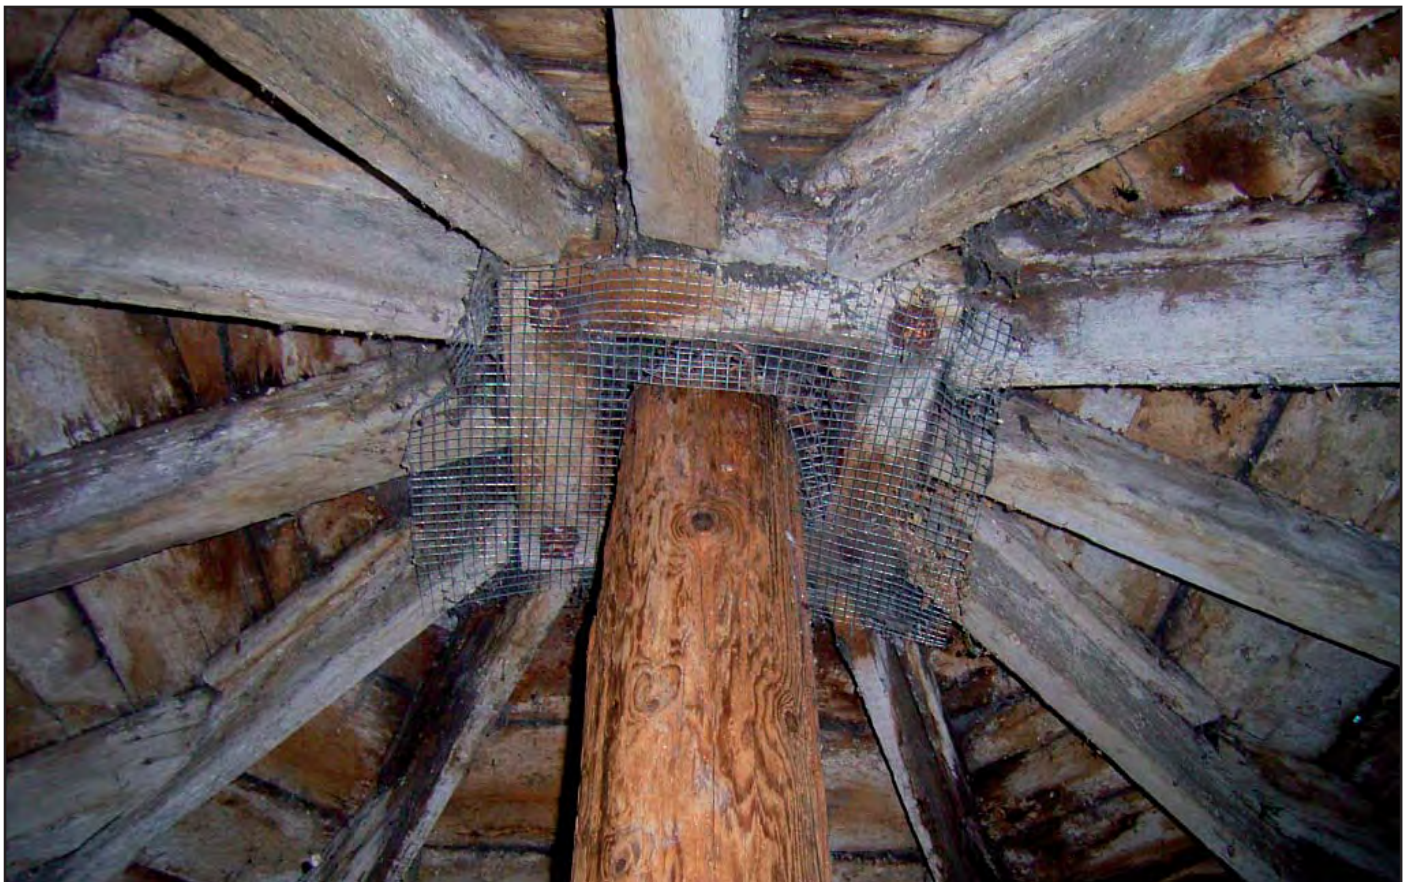
Plate 28: Apex of roof in Dovecote

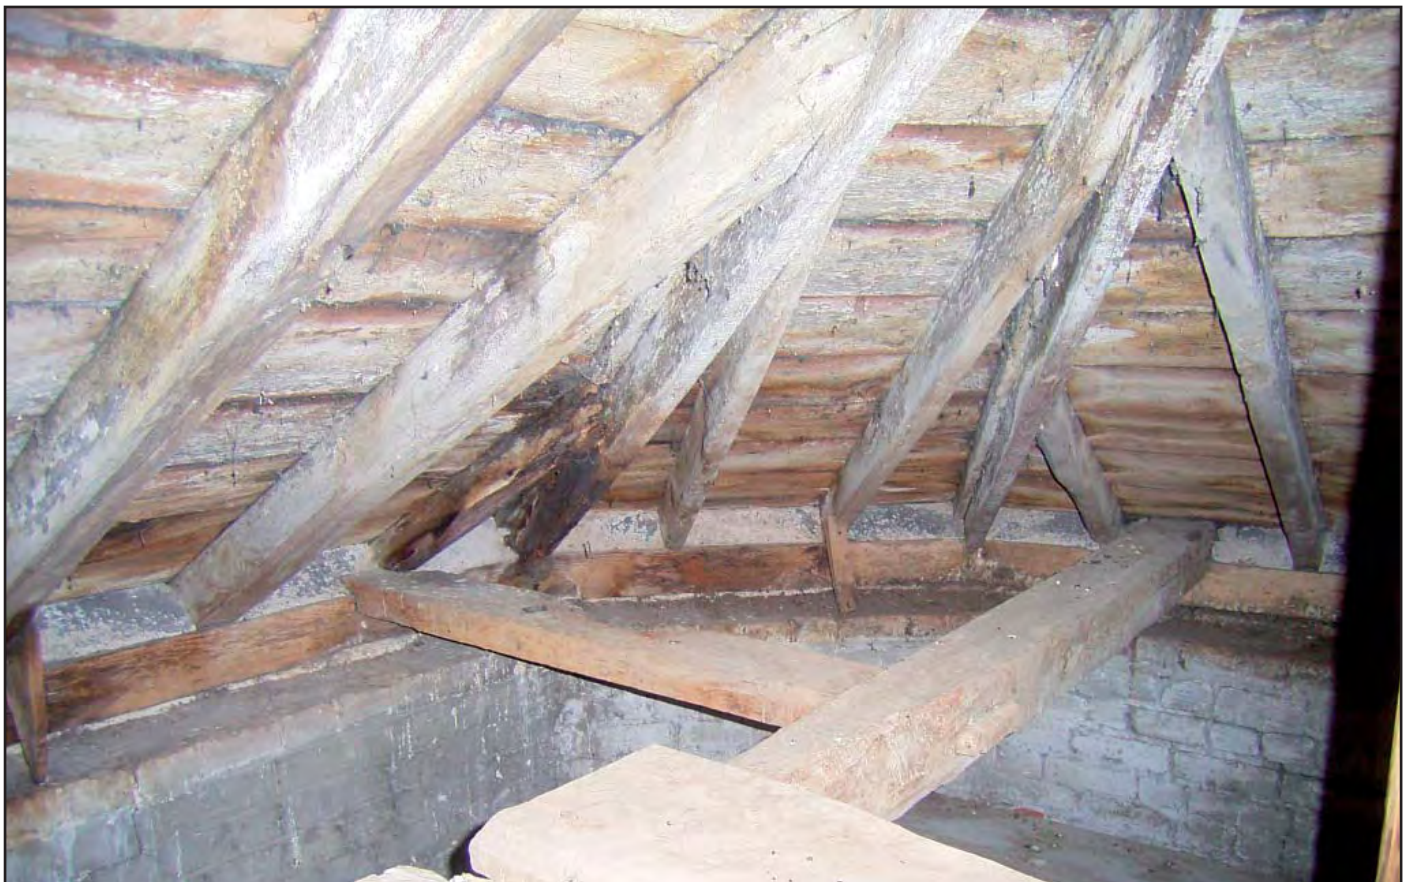
Plate 30: Roof detail in Dovecote

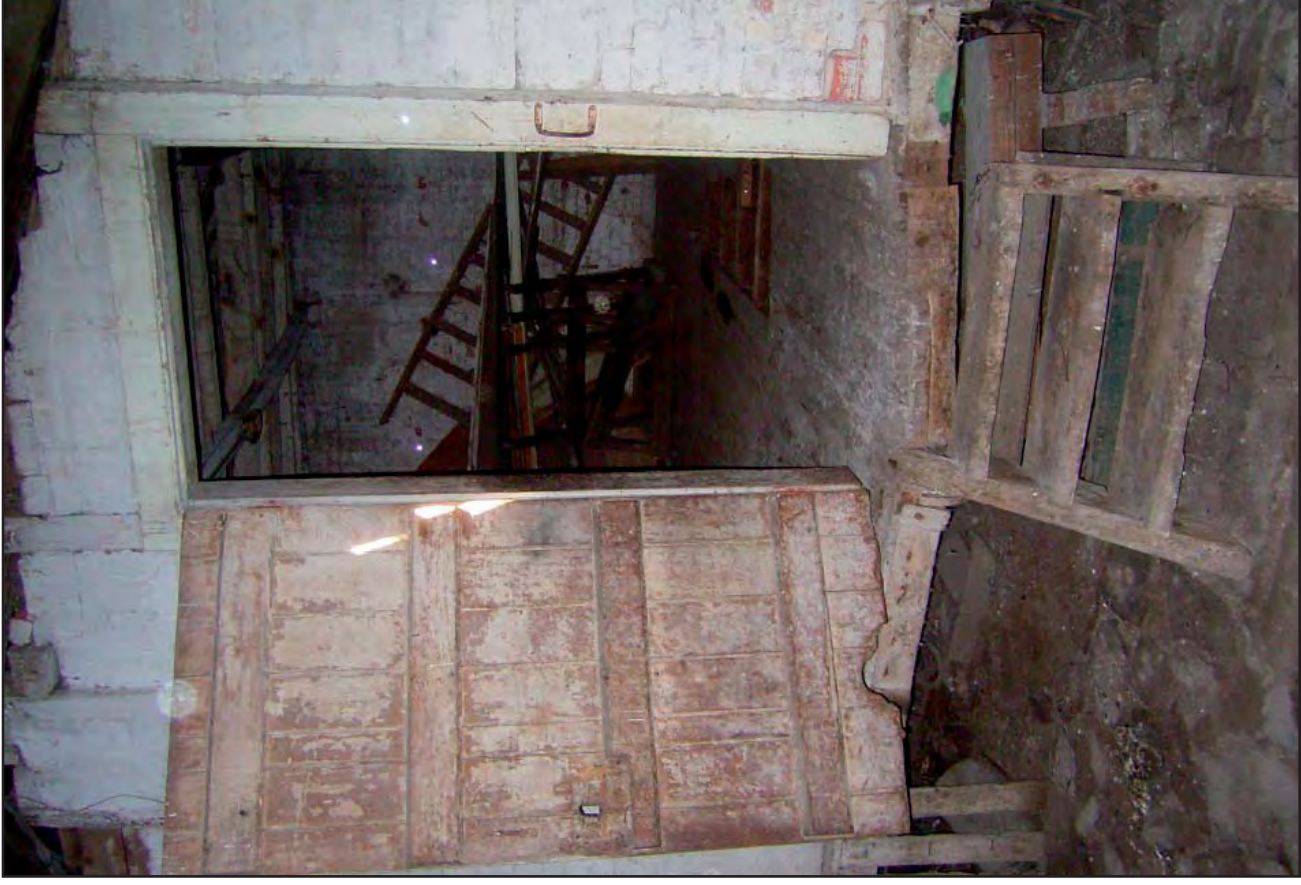
Plate 36: Access door to Granary

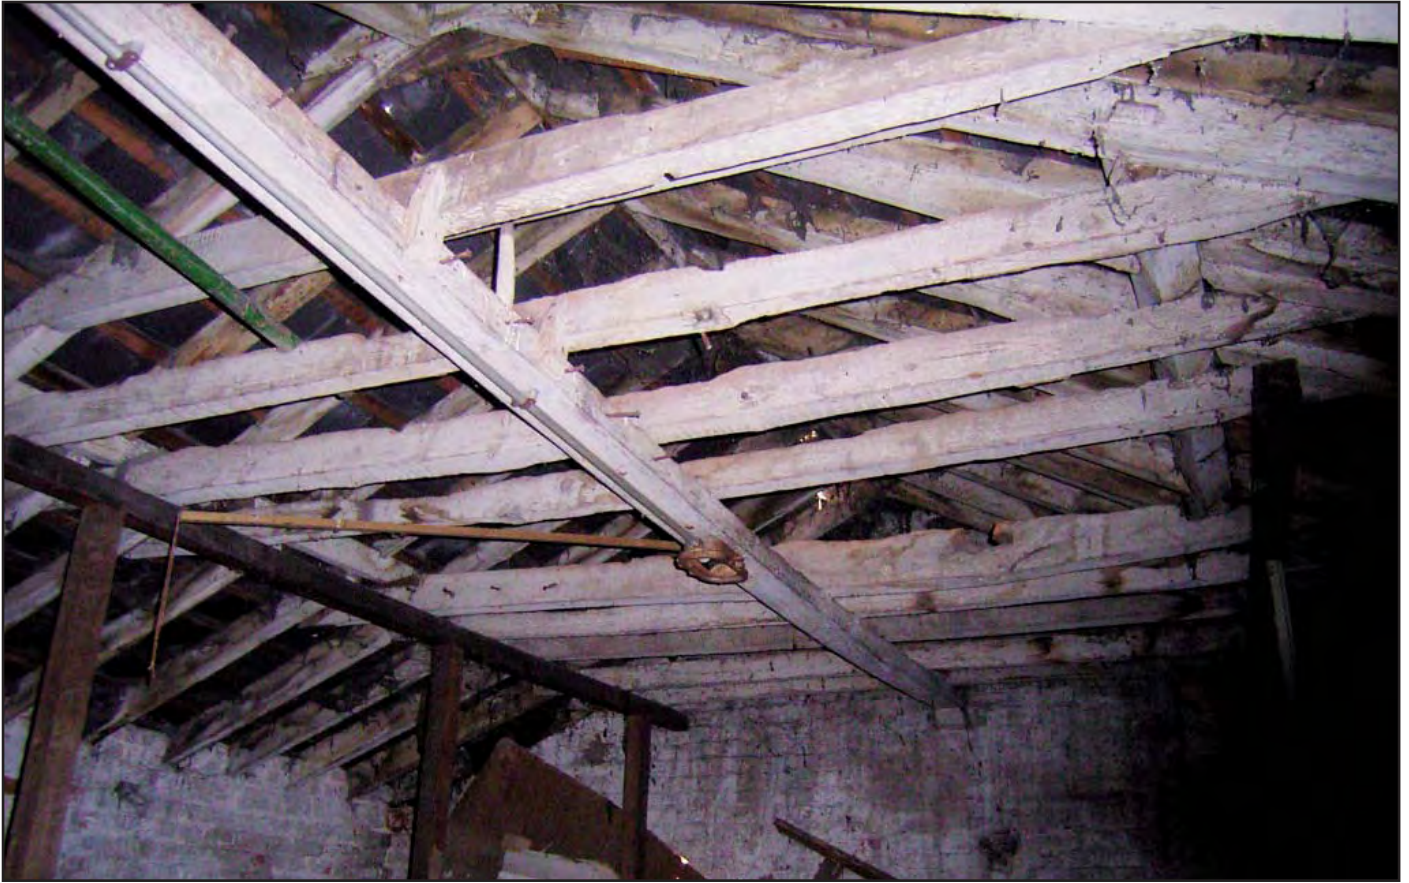
Plate 39: Roof in Granary

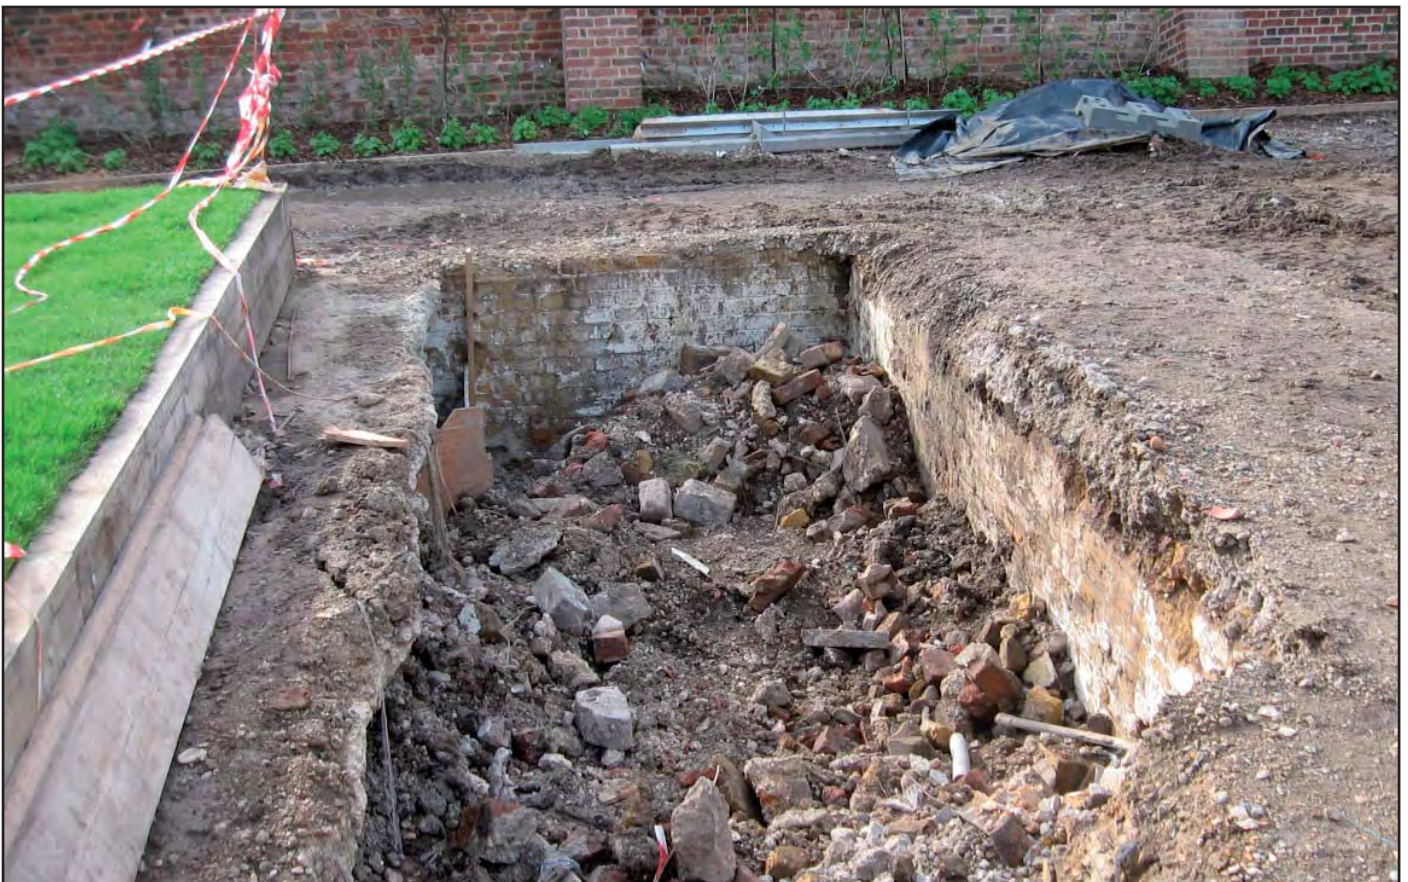
- 6.4.13 Hole number 4 which was located centrally within the Kitchen Garden, towards Wall 2, revealed a substantial wall, comprising of the same hard yellow later 19th-century bricks with cement mortar seen elsewhere on the site (Plate 50). The wall initially exposed within the tree pit was approximately 10 courses high, a single brick (c.10 cm) thick and aligned with the south-east edge of Pit 4. An area of 1.5 m wide and 1 m high was uncovered within the Pit but this excavation continued for a short distance beyond the line of the pit and this revealed that the wall exposed formed the corner from a larger feature. Two similar walls were exposed, at right angles to each other forming a corner just to the south-west of Pit 4. One wall was aligned SE-NW and although the visible section was c.4 m long the wall appeared to continue beyond the line of the excavation. The other wall was c.3 m long, orientated SW-NE and again it appears to have continued beyond the line of the excavation.

Plate 50: Brick (later 19th century) walls exposed in Tree Pit 4 in Kitchen Garden

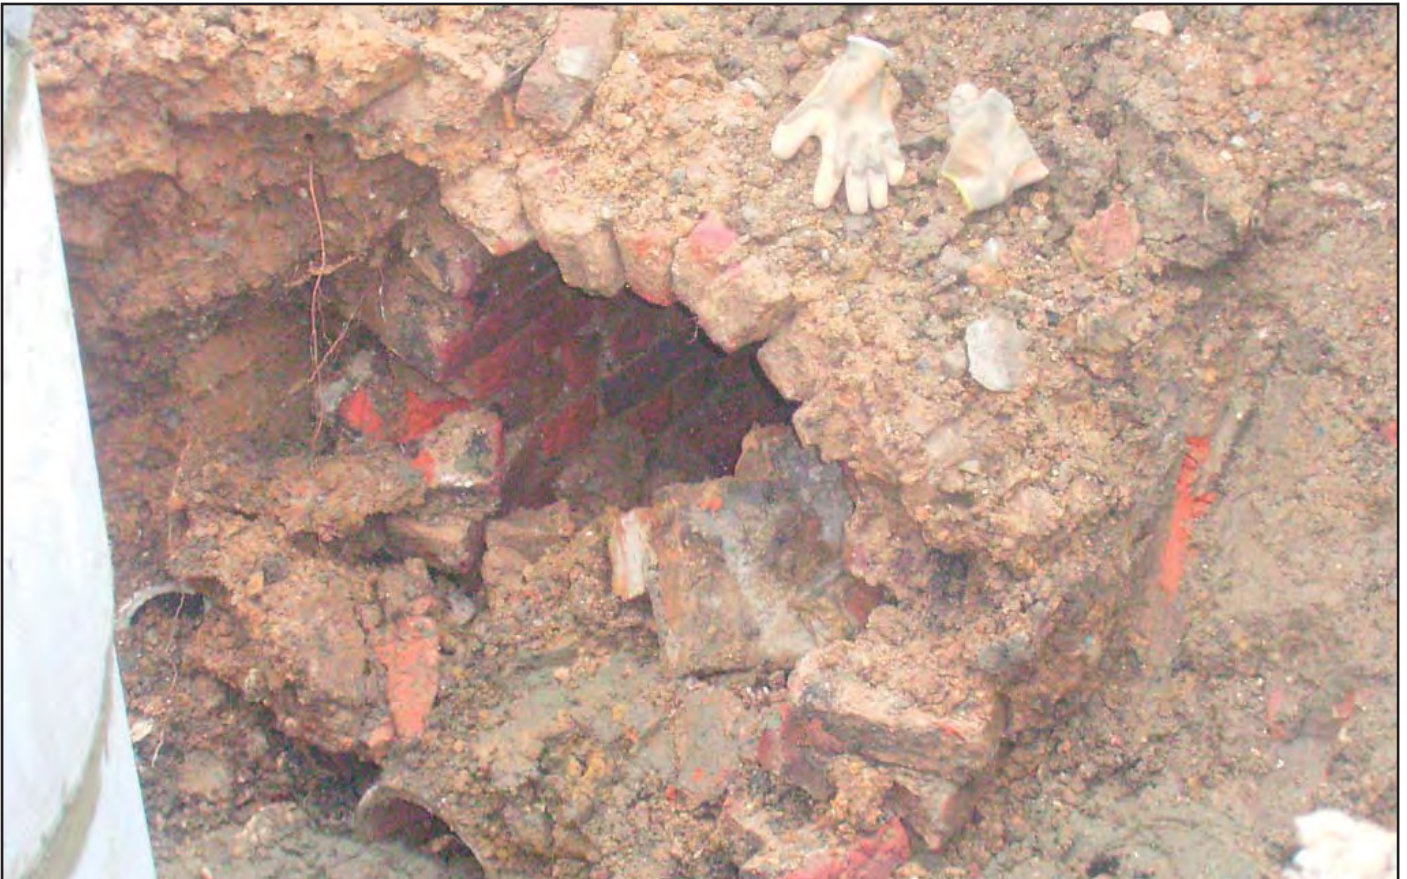
6.4.25 **Trench 33** was located 1m to the south east of Trench 32 and approximately 4m to the north of the main house (Fig. 15, Plate 52). It contained a large brick culvert (5033) which appeared to

Plate 52: Culvert (5035) in Trench 33 adjacent to house

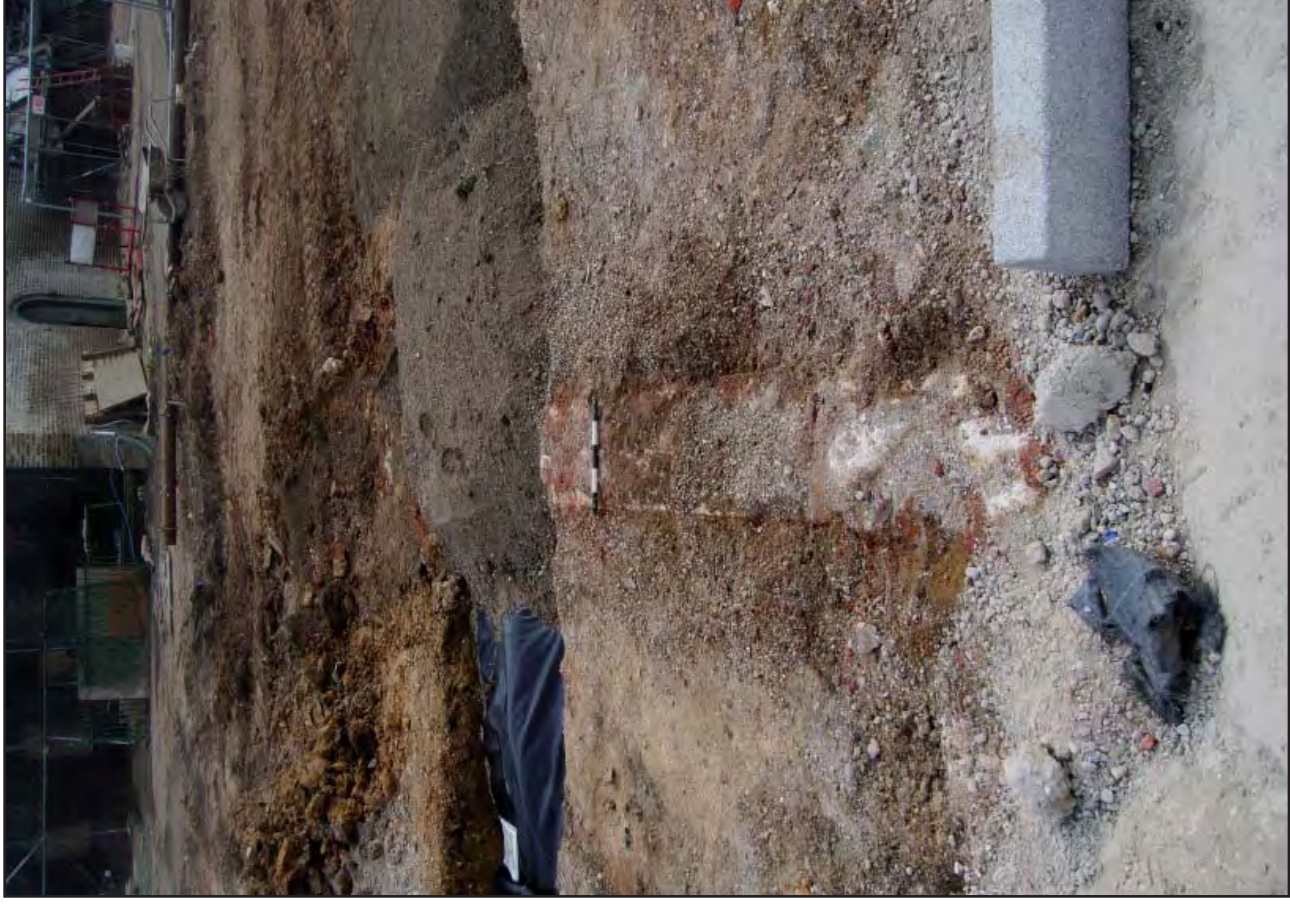
- 6.4.31 In the same general area service trenching revealed the footings from a 6.8 m length of brick wall, 0.5 m wide and 0.4 m tall (Plate 56, Fig. 15). The south-east end of the exposed section of this wall was located c.17 m to the north-west of the cottage and c.10 m north-west from the end of the screen wall adjacent to the cottage. The exposed wall was orientated NW-SE and the fact that it was closely aligned with the straight section of screen wall suggests that it may have been a continuation of this wall. The bricks within the wall were red, 23 cm x 10 cm x 7 cm, and with a coarse light-brown sandy mortar.

Plate 56: Wall exposed by works to north of Cottage/Dovecote
