Priory Wall Ham Lane Lewes East Sussex

Archaeological Recording

Oxford Archaeology

October 2004

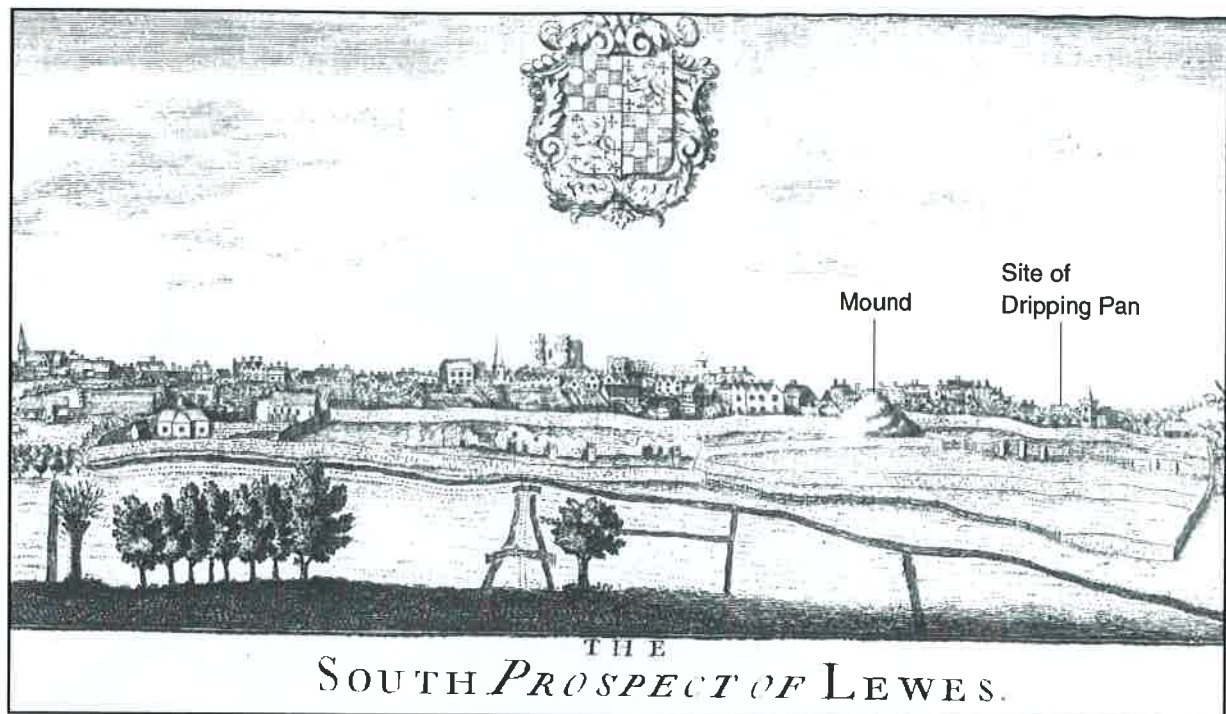
Figure 2: South Prospect of Lewes by R. Budgen (1724)

- 2.4.3 The next available source is a particularly useful view of **The South Prospect of Lewes by Budgen dated 1724** (Fig 2). This view clearly shows the ruins of the Priory, the mound to the east of it, a series of walls and fences within the Priory precinct and the town of Lewes on the raised ground in the background. Although there is doubtless a degree of artistic licence employed in the view and it should not be assumed that every detail is fully accurate it does provide very useful evidence on the form of the area in the early 18th century. Neither the flat, shallow Dripping Pan nor the earth banks which enclose it are shown but the mound, which has been assumed to have been constructed from the earth excavated from the Dripping Pan, is shown. The northern wall of the precinct is clearly shown as a masonry structure together with a wall on the alignment of the current wall flanking Ham Lane and the east side of the Dripping Pan. A further wall is also shown on the current alignment of the southern boundary of the Dripping Pan (passing in front of the mound) although this wall is shown partly masonry (with buttresses) and partly as a fence. The fact that fences are shown along this alignment suggests that the earth bank which is now retained by the wall in this location may not have been constructed at this date and must be an argument against the common theory that the Dripping Pan was a medieval salt pan (discussed further below). As stated above too much reliance should not be placed on the details of the view but the lack of any earth banks in the current area of the Dripping Pan and the undulating nature of the site (which is now very flat) is clearly a suggestion that the Dripping Pan in its current form may post-date this view. If this was true it would mean that the wall flanking Ham Lane, which now retains the bank, must have been rebuilt since 1724 but this cannot be viewed as definitive and the view does confirm that there was a wall along this alignment from at least the early 18th century.

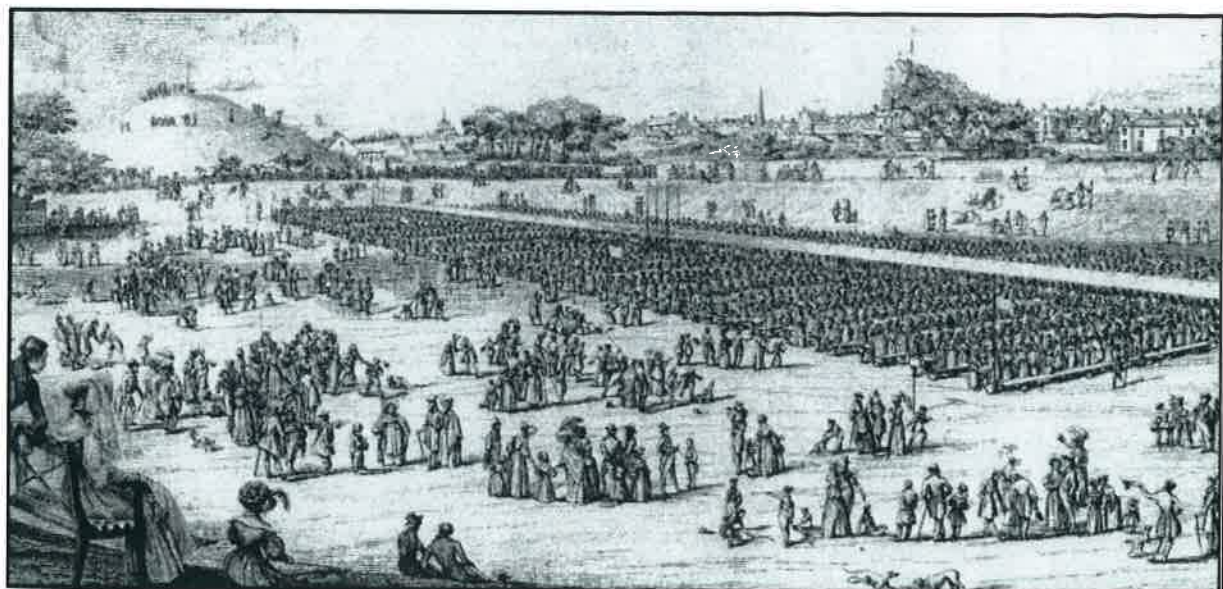
Figure 3: Banquet in the Dripping Pan in Honour of Queen Victoria's Coronation (1838)

- 2.2.6 Subsequent to this ownership of the site changed several times but the house does not appear to have been replaced and the surviving elements of the Priory remained as ruins. One area of the Priory precinct which is known to have been put to later uses is a large flat, sunken area in the north-eastern corner of the precinct known as the 'Dripping Pan'. This area (which is adjoined by the wall which forms the current study and is detailed further elsewhere) is rectangular in shape with earth banks enclosing it and it appears to have been formed by extracting earth for an adjacent mound. In the later 19th and 20th centuries the Dripping Pan has been used as cricket and football pitches (and is currently the home of Lewes FC) and in 1838 it was used to host celebrations in honour of Queen Victoria's coronation. This consisted of a dinner given for 3900 poor people of the town with 612 gentlemen officiating as carvers and attendants. An illustration of this event, showing the flat Dripping Pan, the mound and banked enclosures, is included in this study as Figure 3.

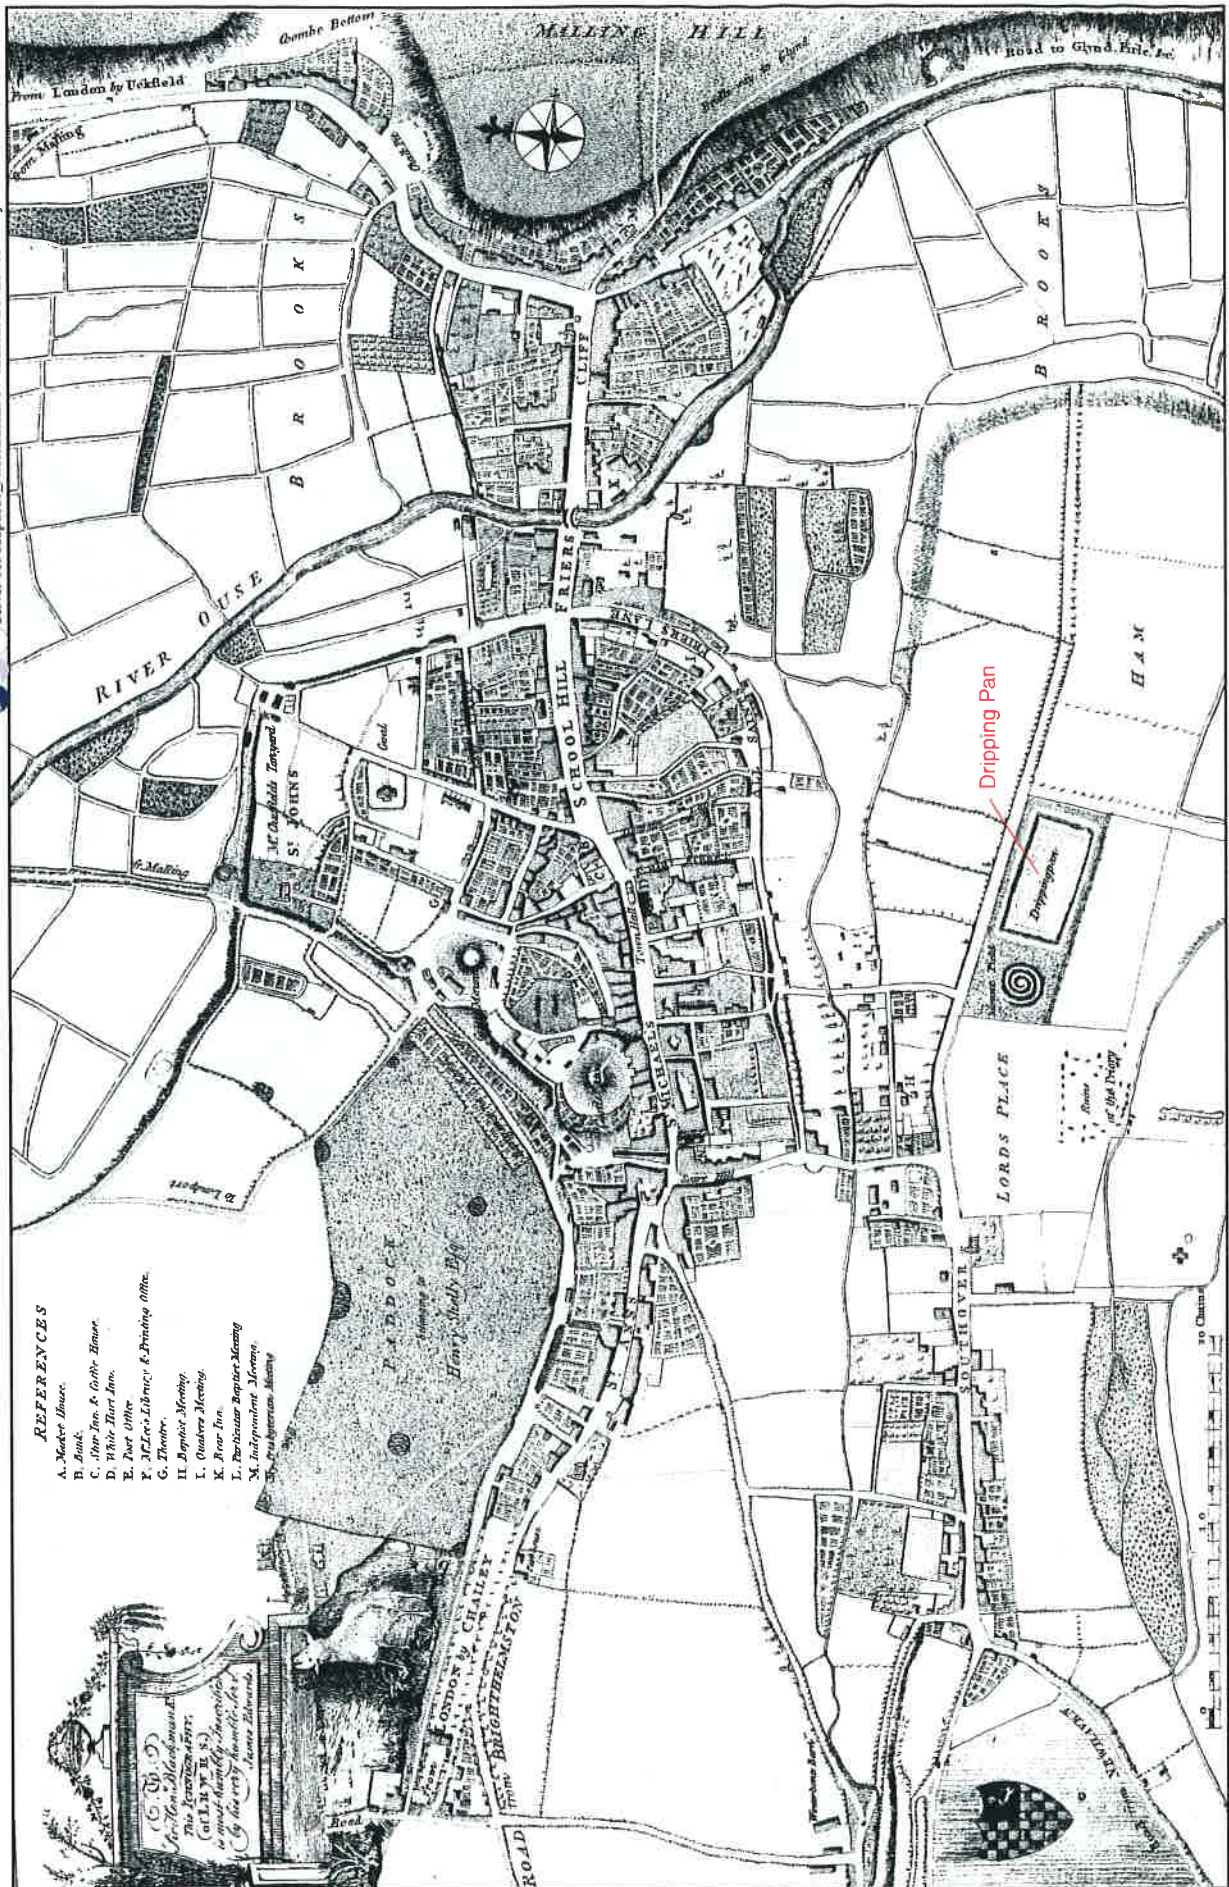
Figure 4: James Edward's Map of Lewes (1799)

- 2.4.5 **James Edwards' Map of Lewes, 1799** (Fig. 4) shows much of the Priory precinct and the area that is the subject of the current study. This is the first plan to show the Dripping Pan (and labelled as such on the plan) with what appears to be a rectangular sunken area surrounded by four earth banks. The area to the west of the sunken enclosure is labelled *Mount Field* and shows the mound with spiral pathway to the top. A short distance to the south of the Dripping Pan is a wooden fence clearly constructed with regularly spaced posts supporting horizontal slats. This appears to be on the alignment of the current retaining wall which encloses the Dripping Pan and the eastern part of which is the subject of the current study. Although, as with any historical map such as this, one should be cautious of assuming that the detail of what is shown is accurate the fact that a fence is so clearly indicated, when walls are shown elsewhere, strongly suggests that there was indeed a fence in this location at the turn of the 19th century, rather than the current wall. Ham Lane is shown (although not labelled) although the map is inconclusive on the form of the wall which flanks it to the west immediately adjacent to the Dripping Pan (ie the subject of the current study). There is a line of trees shown to the east of Ham Lane and a single line shown to the west of it. Elsewhere on the map, such as along the northern boundary of the former precinct, walls are shown as a double line which suggests that along the single line there may not have been a substantial wall. Again however, this evidence is merely suggestive rather than conclusive.

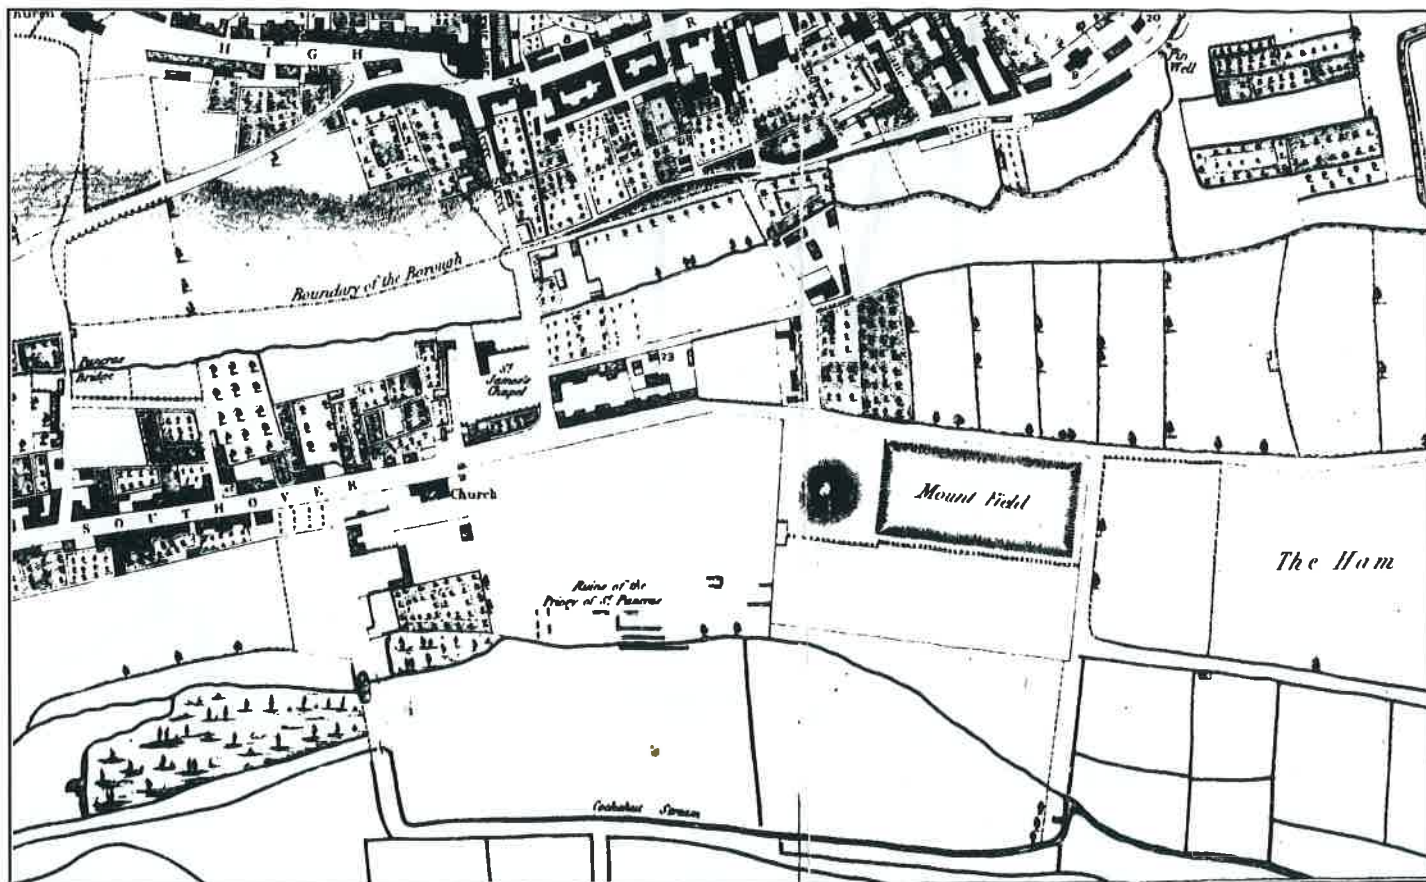
Figure 5: William Figg's map of Lewes (1824)

- 2.4.6 **William Figg's map of Lewes, 1824** (Fig 5) is broadly similar to the 1799 map in the area under consideration except that the sunken area of the Dripping Pan is labelled *Mount Field*. The boundary immediately to the south of Mount Field and the mount itself (which was shown as a fence on the 1799 map) appears to be shown on the 1824 map as a hedge, possibly a fence with a hedge alongside it, and clearly not a masonry wall. The east side of the Dripping Pan flanking Ham Lane is again shown as a single line but it is impossible to surmise from this what type of boundary structure this indicates.

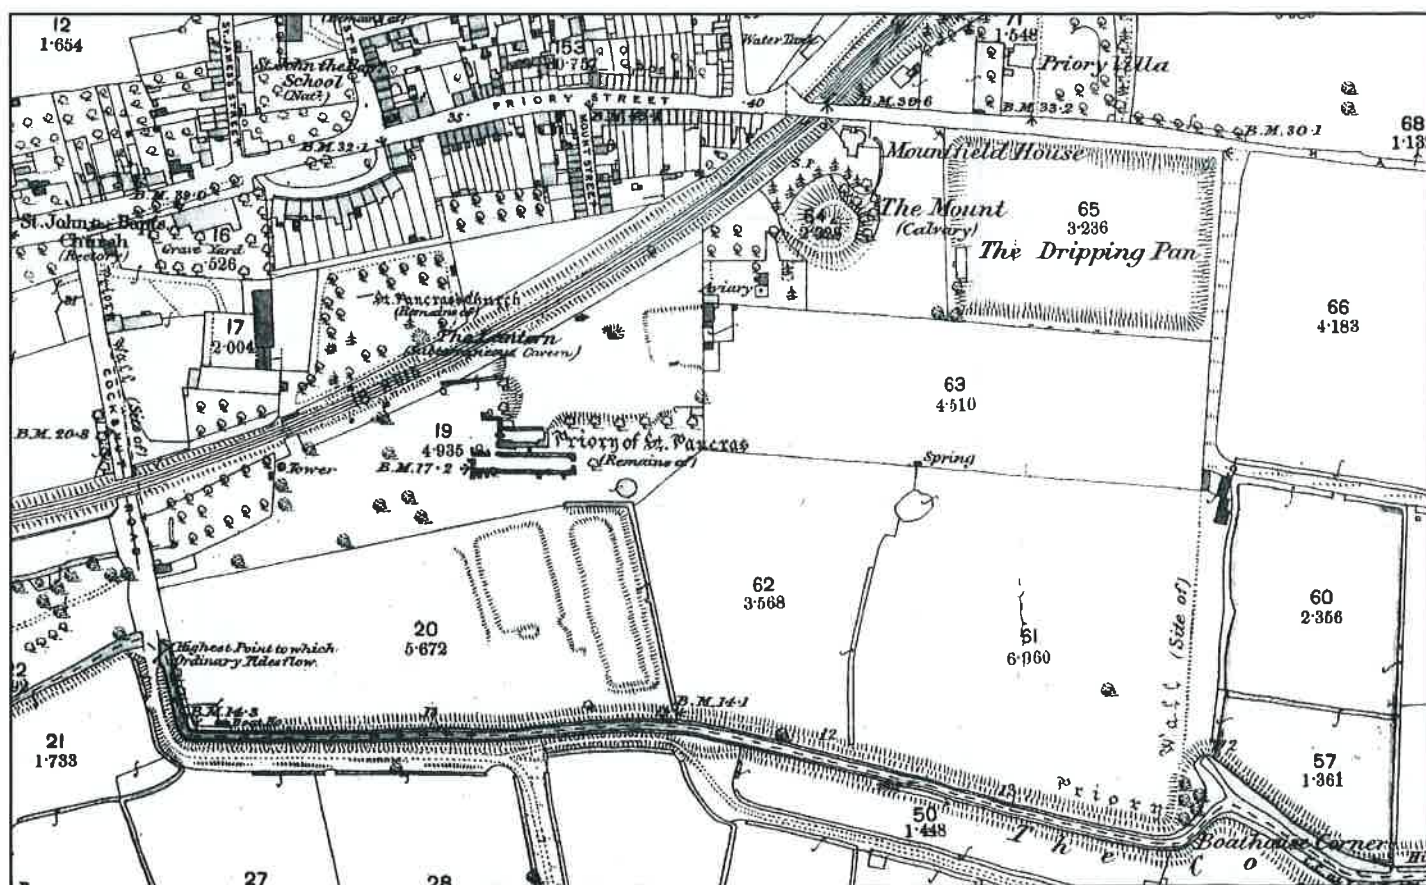
Figure 6: First Edition Ordnance Survey map (1873)

- 2.4.7 The next map is the **first edition Ordnance Survey 25" map of 1873** (25 inch: 1 mile. Fig 6) which is the first map to show the railway cutting through the precinct just to the north-west of the mound. The sunken area is once again labelled as *The Dripping Pan* and there is a single line shown to the south and east sides on the line of the current walls. On this map (unlike the 1799 map and to a lesser extent the 1824 one) the line of the wall is immediately adjacent to the bank and this strongly suggests that the line was a retaining wall for the bank. It is significant to note that there is a broad arrow shown at the north-east corner of the Dripping Pan (at the junction between Ham Lane and Priory Street) indicating that there was a survey bench mark in this location and clearly showing that the structure on which the bench mark was located must have been permanent (eg a flint stone wall). It is a safe assumption that the walls shown on this plan (both the south and east walls) are essentially the same as the structures

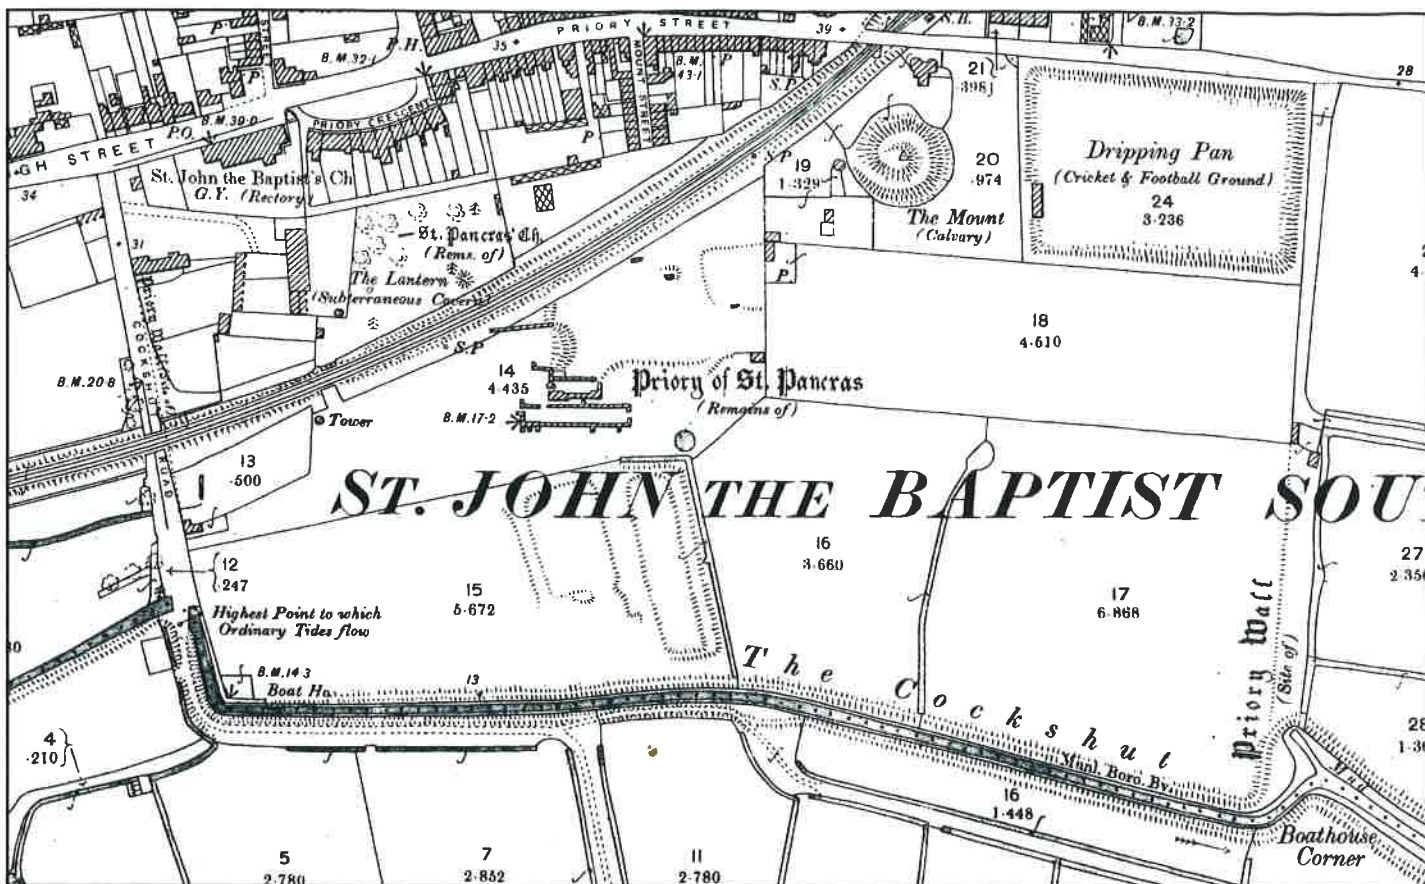
Figure 7: Second Edition Ordnance Survey map (1899)

- 2.4.9 The **second edition OS map, 1899** (Fig. 7) is very similar to the first edition in terms of the evidence it provides relating to the current study. The two sections of wall in the current study (to east and south of the Dripping Pan) are again shown as solid lines immediately behind the banks of the Dripping Pan. The north - south line to the south of Ham Lane is again shown dotted and labelled *Priory Wall* (site of) and the mound is again labelled *The Mount (Calvary)*. A label shows that by this date the Dripping Pan was being used as a *Cricket and Football Ground*. One possibly significant difference with the first edition map is the fact that on the second edition map the bench-mark arrow is no longer shown at the junction between Ham Lane and Priory Street although there are many others shown elsewhere on the map. One possible reason for this is that the section of wall on which the bench mark was situated (part of the current study) was taken down and rebuilt between 1873 and 1899 thus removing this bench mark. No surviving bench mark was seen in this location in the current study although part of this section of wall was heavily overgrown and it is possible that a bench was obscured.

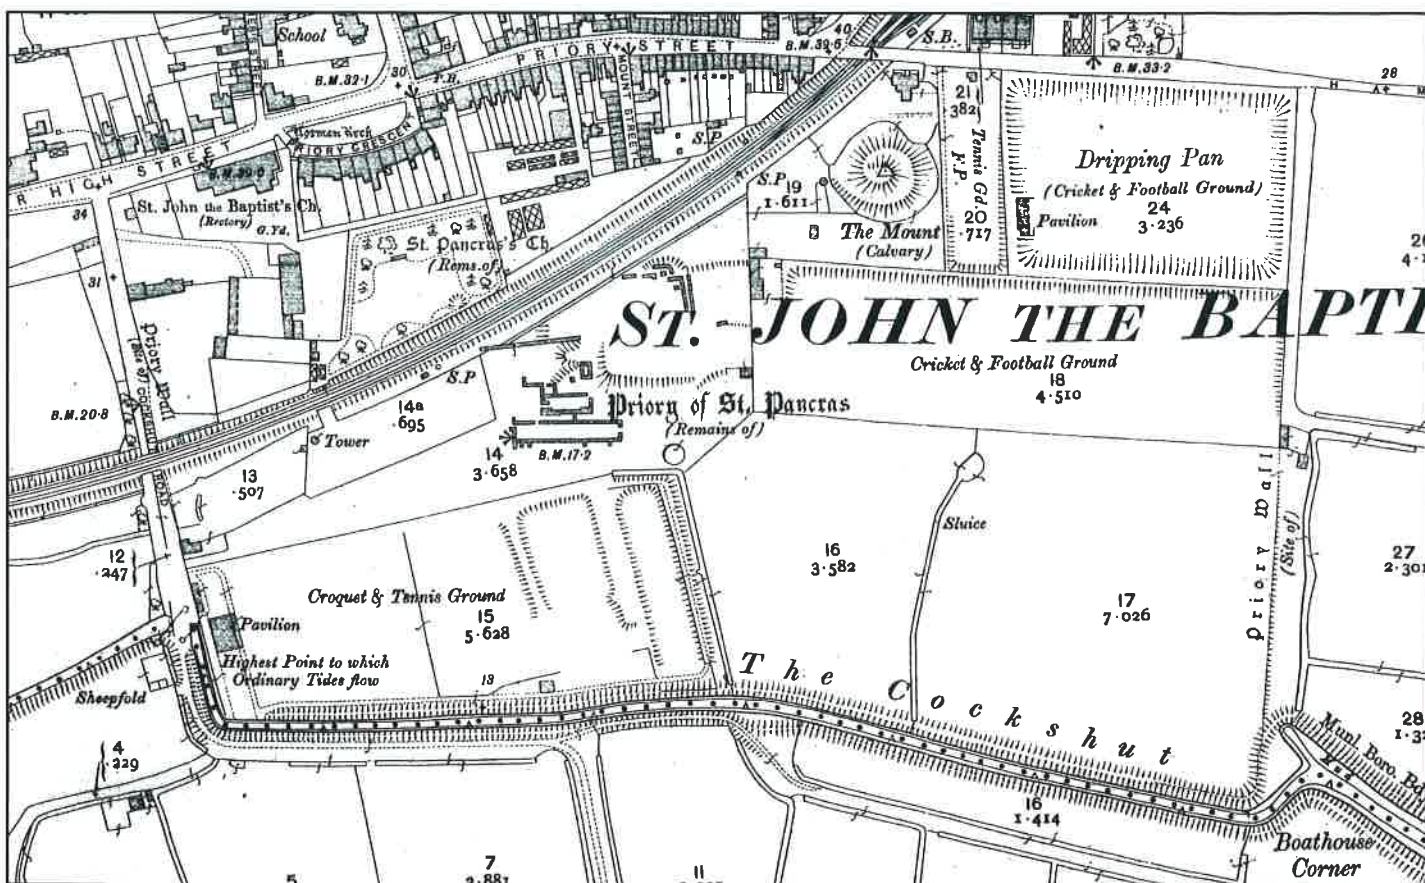
Figure 8: 1910 Edition Ordnance Survey map

- 2.4.10 The **1910 edition OS map** (Fig. 8) is again similar to the previous two OS maps. The two sections of wall in the current study are solid lines behind the Dripping Pan banks, The sunken area is again labelled *Dripping Pan (Cricket and Football Ground)*, The Mound is again *The Mount (Calvary)* and the southern section of the former east wall of the precinct is *Priory Wall (site of)*. One minor difference is that an embankment is now shown on the south face of the south wall of The Dripping Pan as well as on its north side. It is likely that this simply indicates that the large area to the south, which on this map is first labelled *Cricket and Football Ground* was levelled off and the earth spread to the sides.
