HEST BANK JETTY, LANCASHIRE

Archaeological Survey Report

Oxford Archaeology North

July 2010

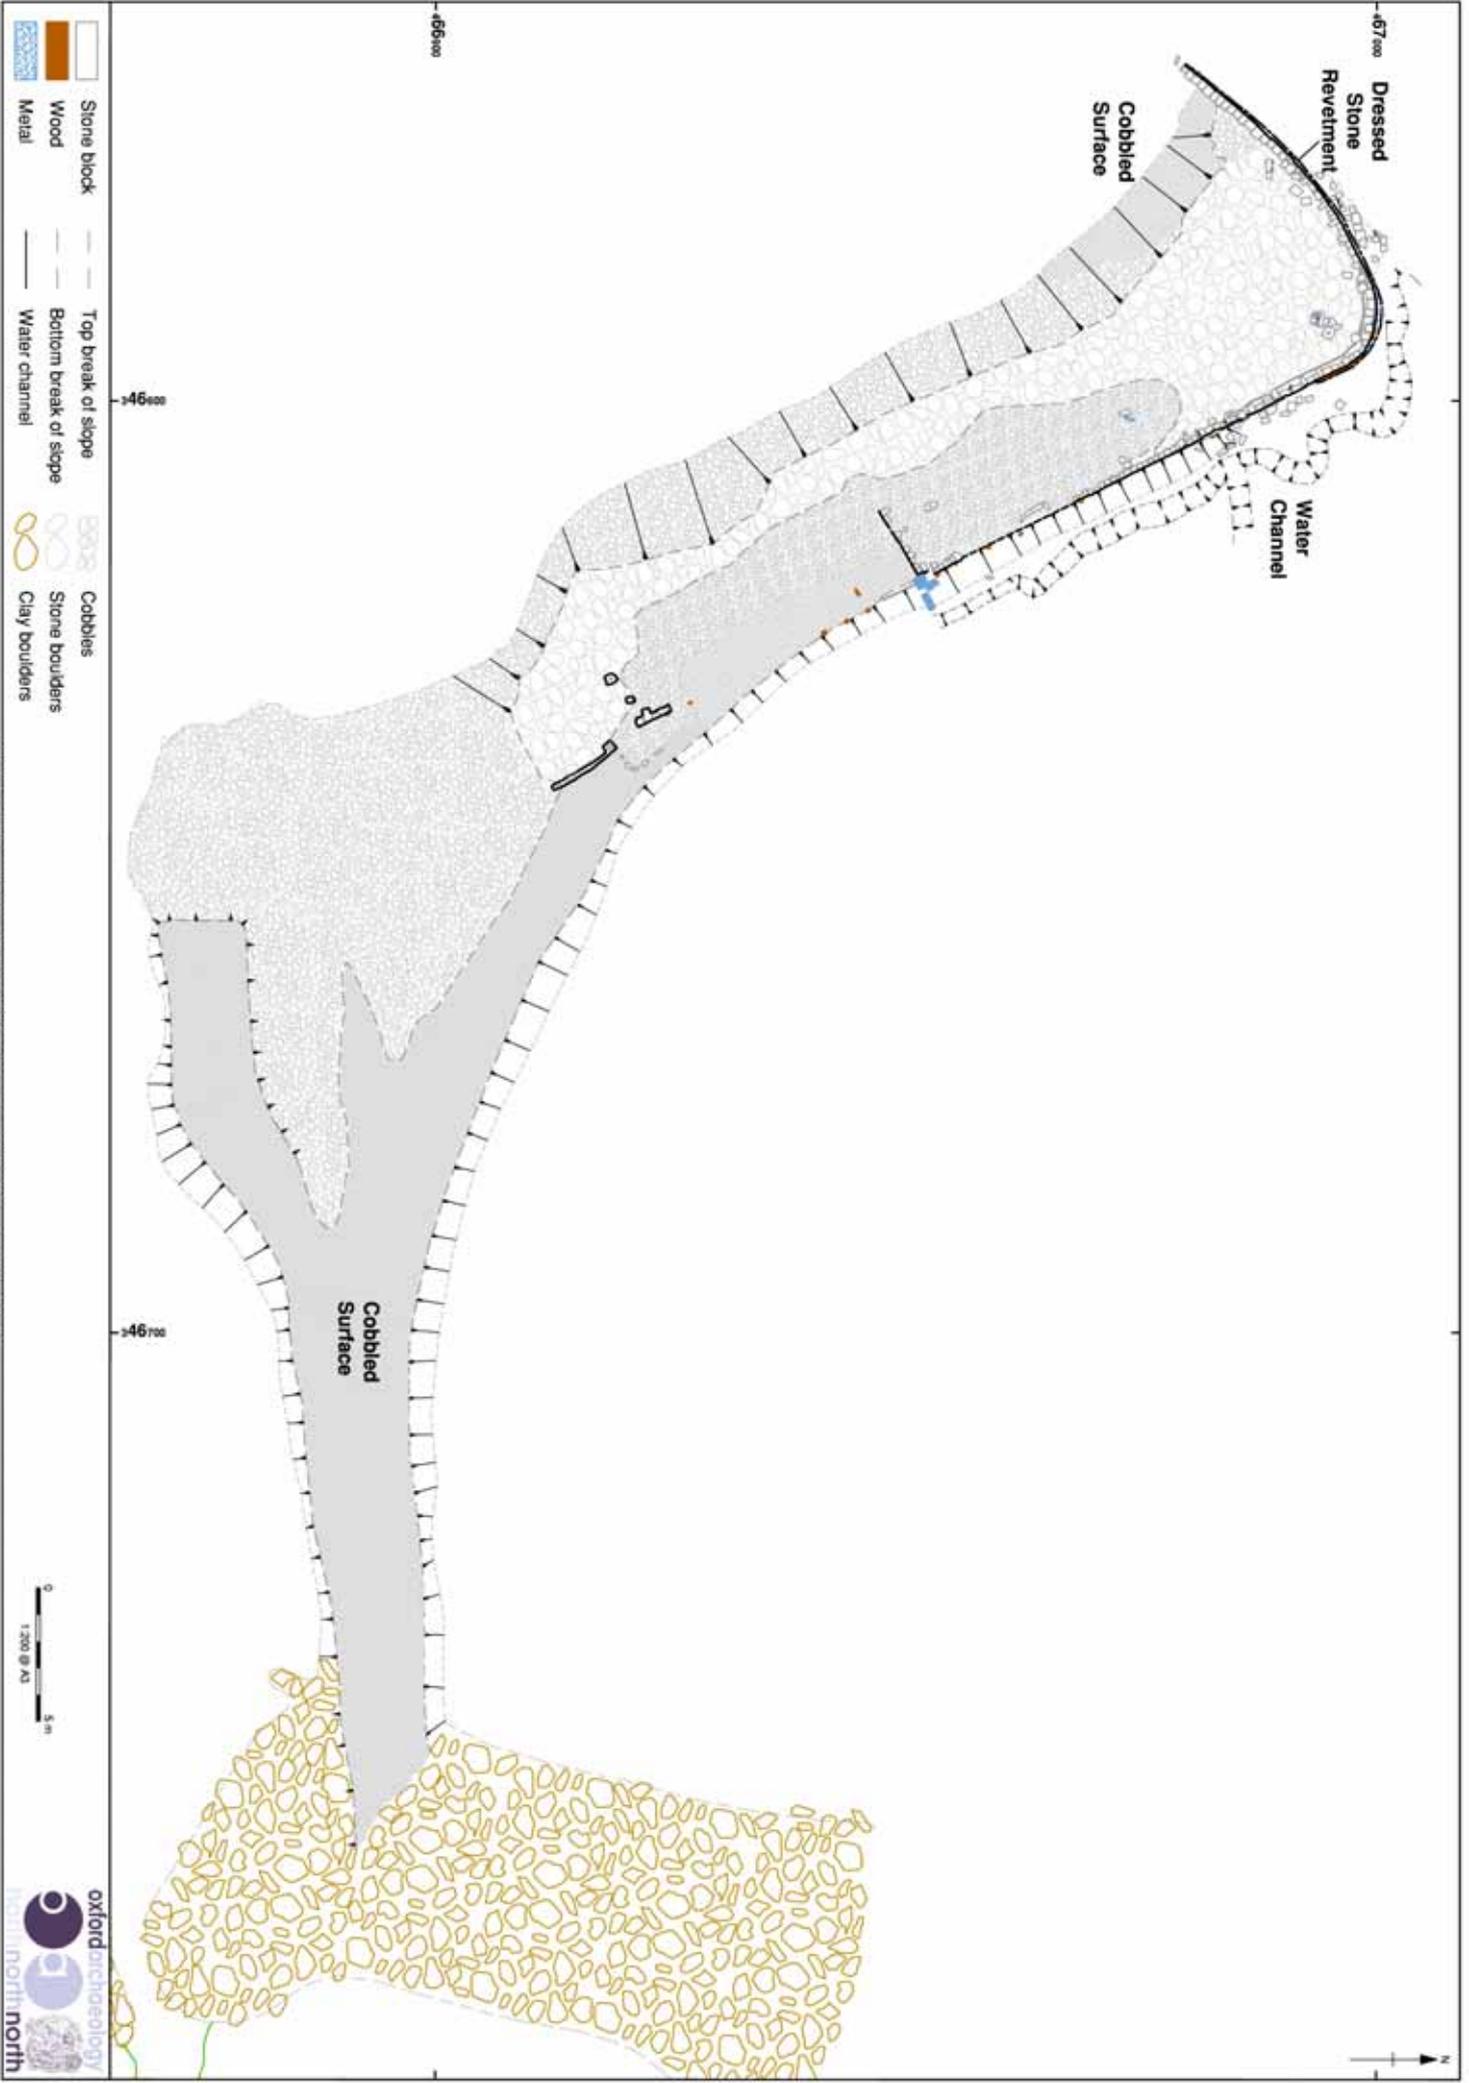
Figure 3: The extent of the Hest Bank Jetty remains - survey results

3.2.1 The jetty consists primarily of a linear cobble-constructed, relatively flat, platform running on a diagonal angle (orientated north-west/south-east) at a little distance from the present coastline forming what would have originally been an isolated breakwater (Plate 9) (Fig 3). The southern end of the structure is less well defined and consists of a curvilinear bank of cobbles that run to the shoreline and would have originally formed an access causeway at low tide (Plate 10). The main part of the structure has a shallow-sided, curved profile on its seaward side in order to dissipate the effects of storm waves, and there is evidence of partially surviving elements of a layer of densely-packed set cobbles (Feature 1) forming the northern end of the outer seaward face of the jetty (Plate 11). The inner construction of the jetty is of large beach cobbles with a packing of smaller cobbles on the outer surfaces, much of the latter has been eroded away over years of storms and tides leaving a slightly uneven upper surface with much of the finer material having been stripped away (Plate 12).

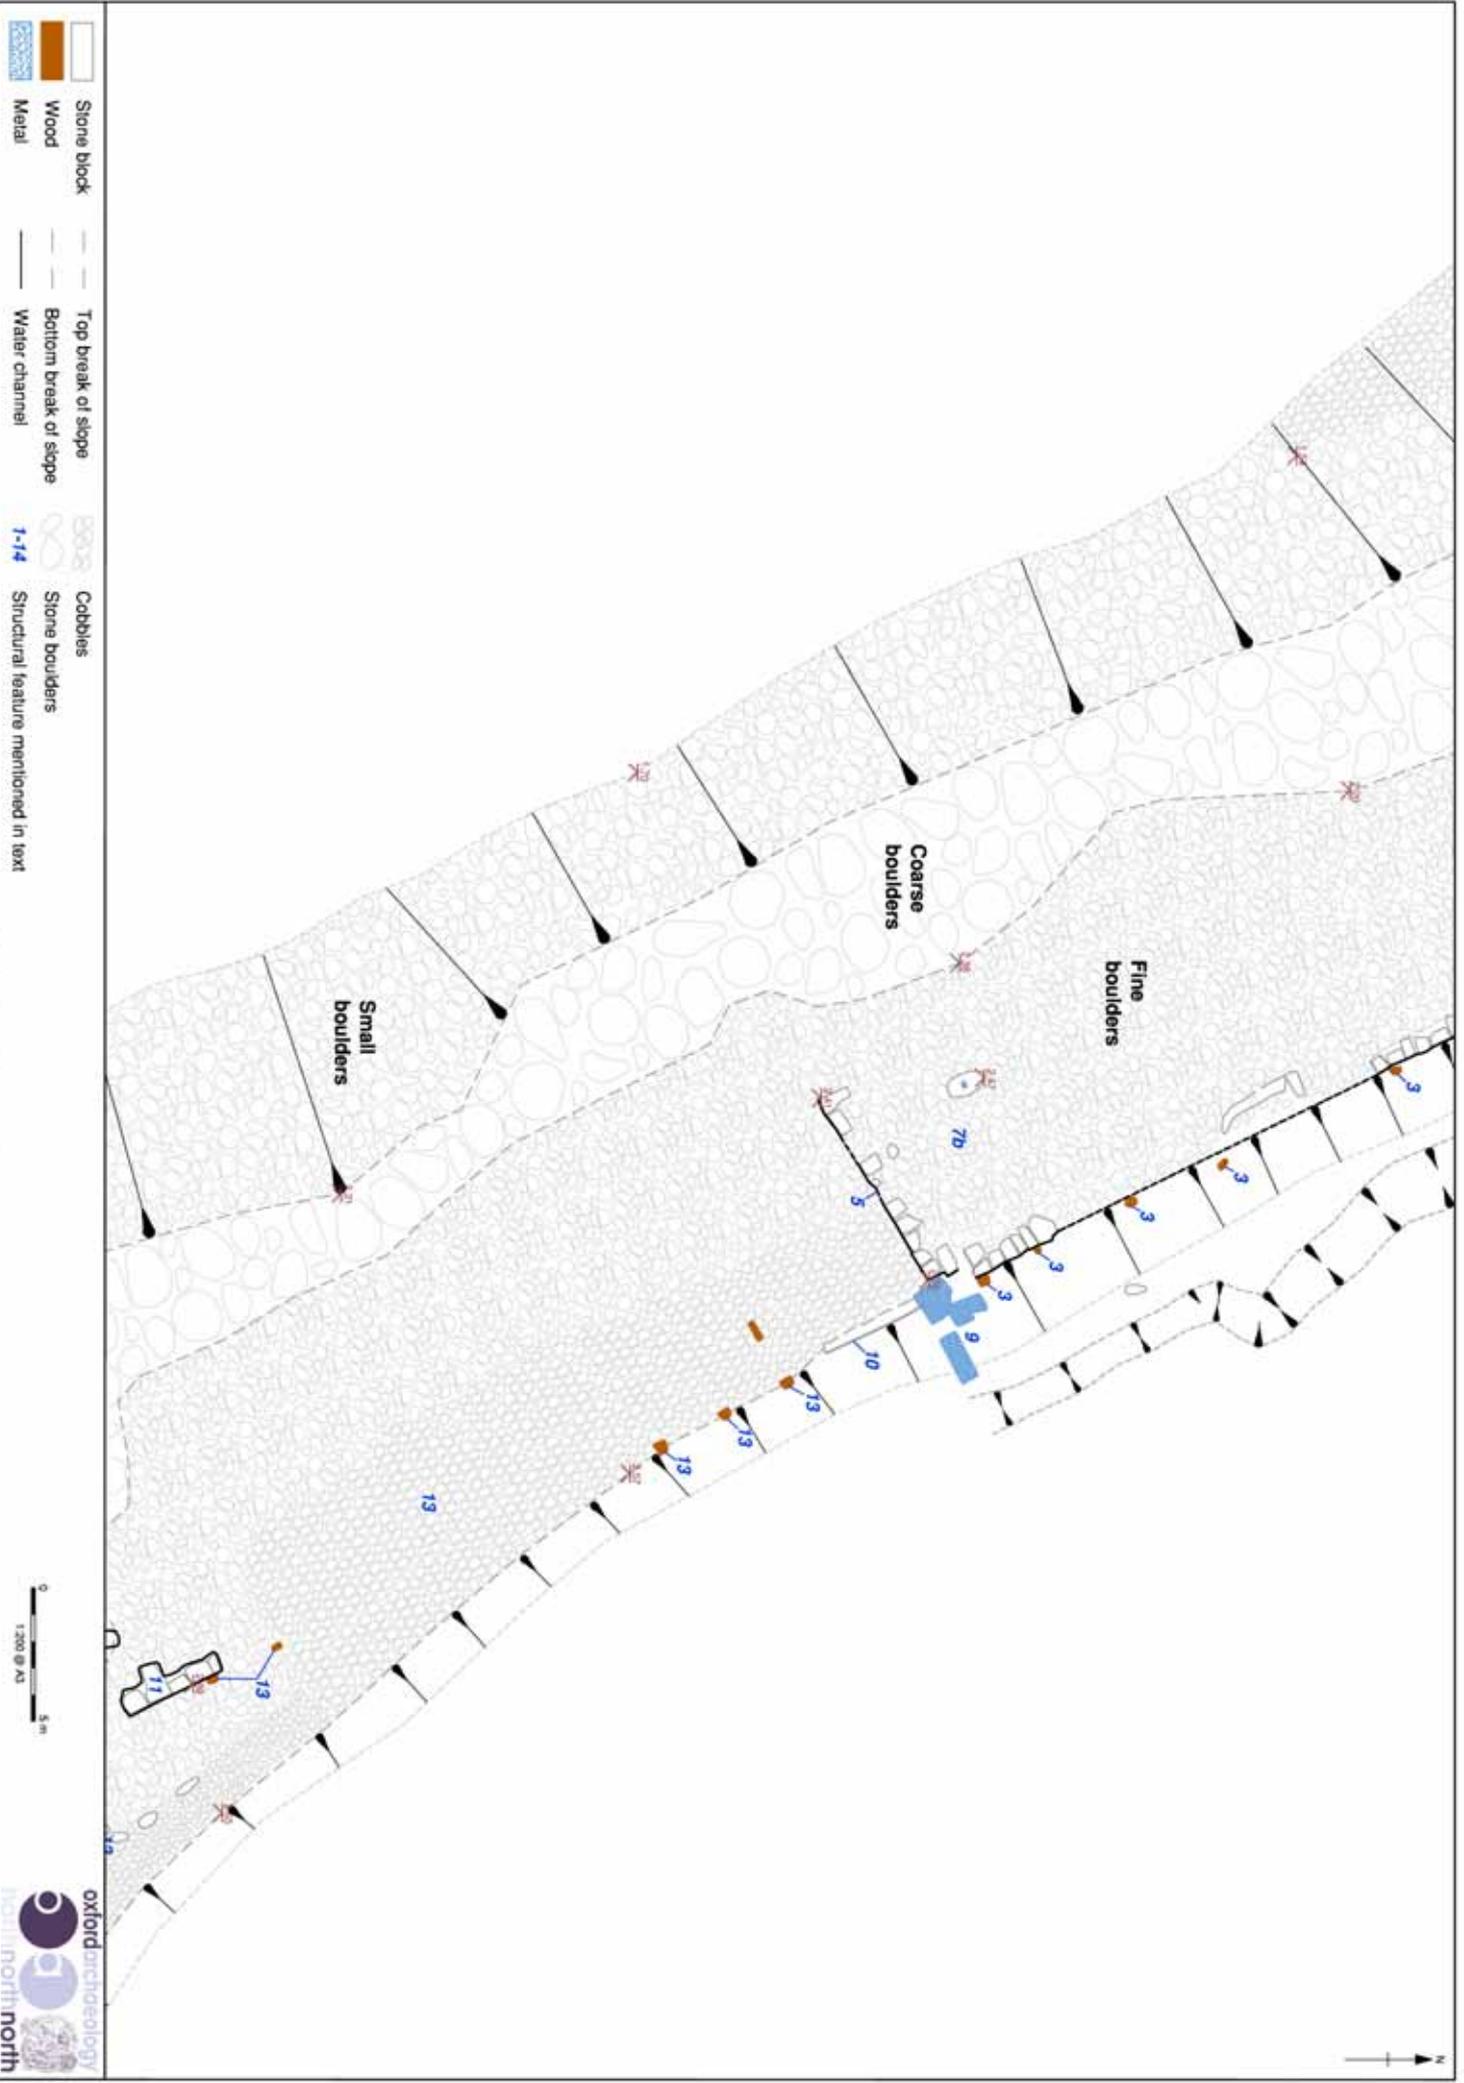
Figure 5: Topographic survey - central part of the jetty

southern end of the main jetty structure has a return of a linear wall (Feature 5) of dressed sandstone blocks visible running from the landward side of the structure, making the original breakwater approximately 58m long by up to 37m wide (Fig 5).
