Harts Hill Farm Thatcham Berkshire

Historic Building Investigation and Recording

January 2006

HISTORIC BUILDING INVESTIGATION AND RECORDING

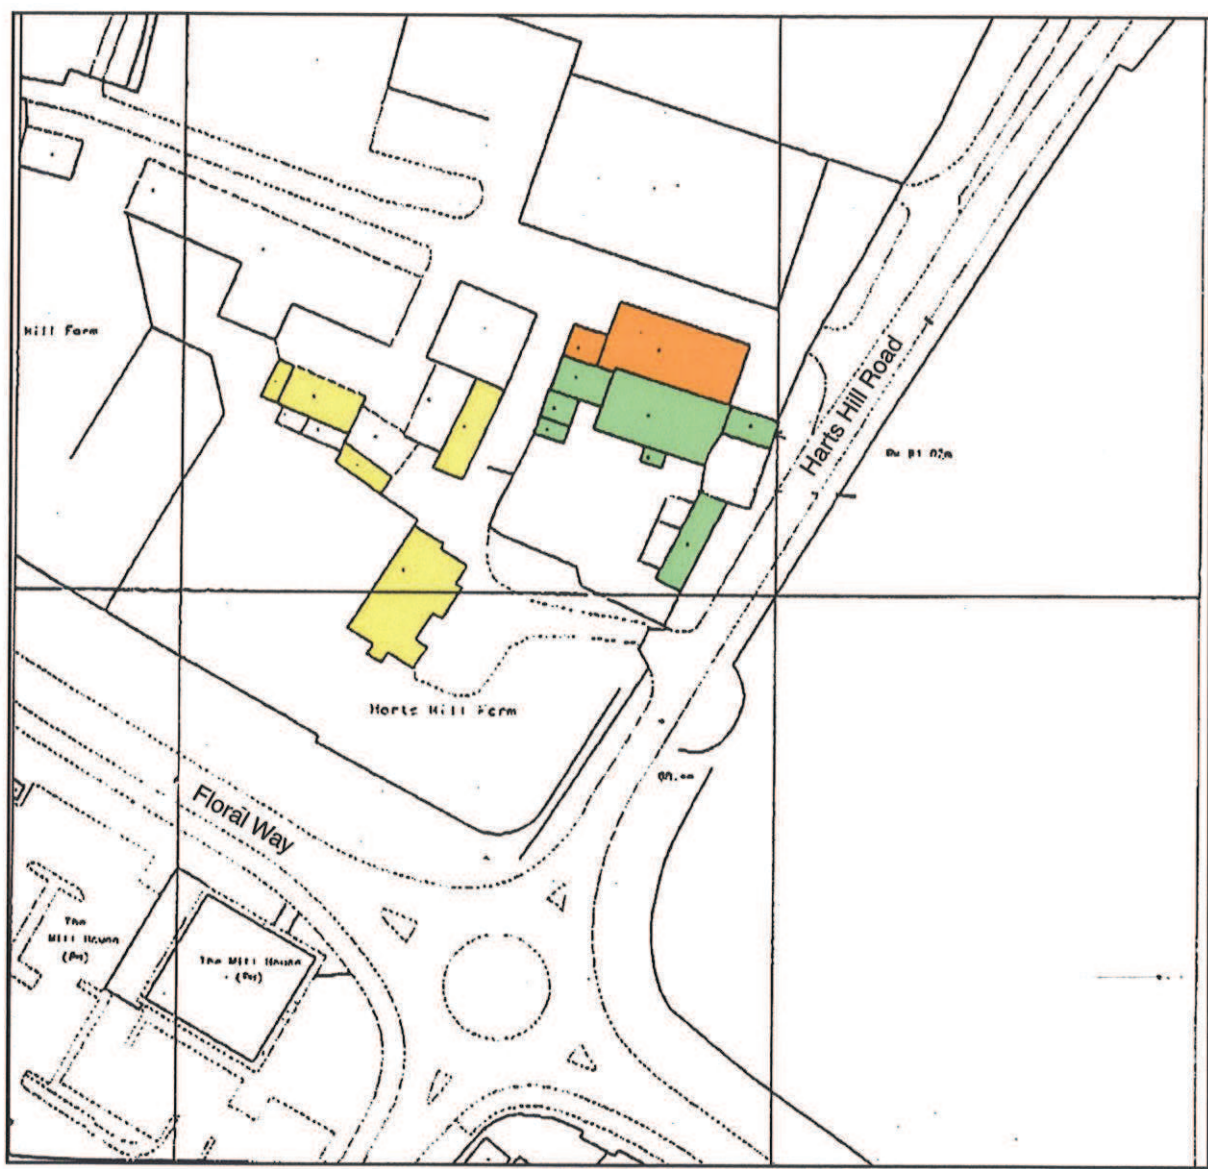
Figure 2: Site plan

- 2.1.7 The modern siteplan (see fig. 2) shows the buildings as they were shortly before development of the separate plot north of the barn began. A large modern building attached to the north side of the barn with a smaller structure in the angle of this building and block D are shown. These were demolished prior to the present survey. An arrangement of enclosures or extensions are shown on the west side of block B and these had also been removed before the present work.

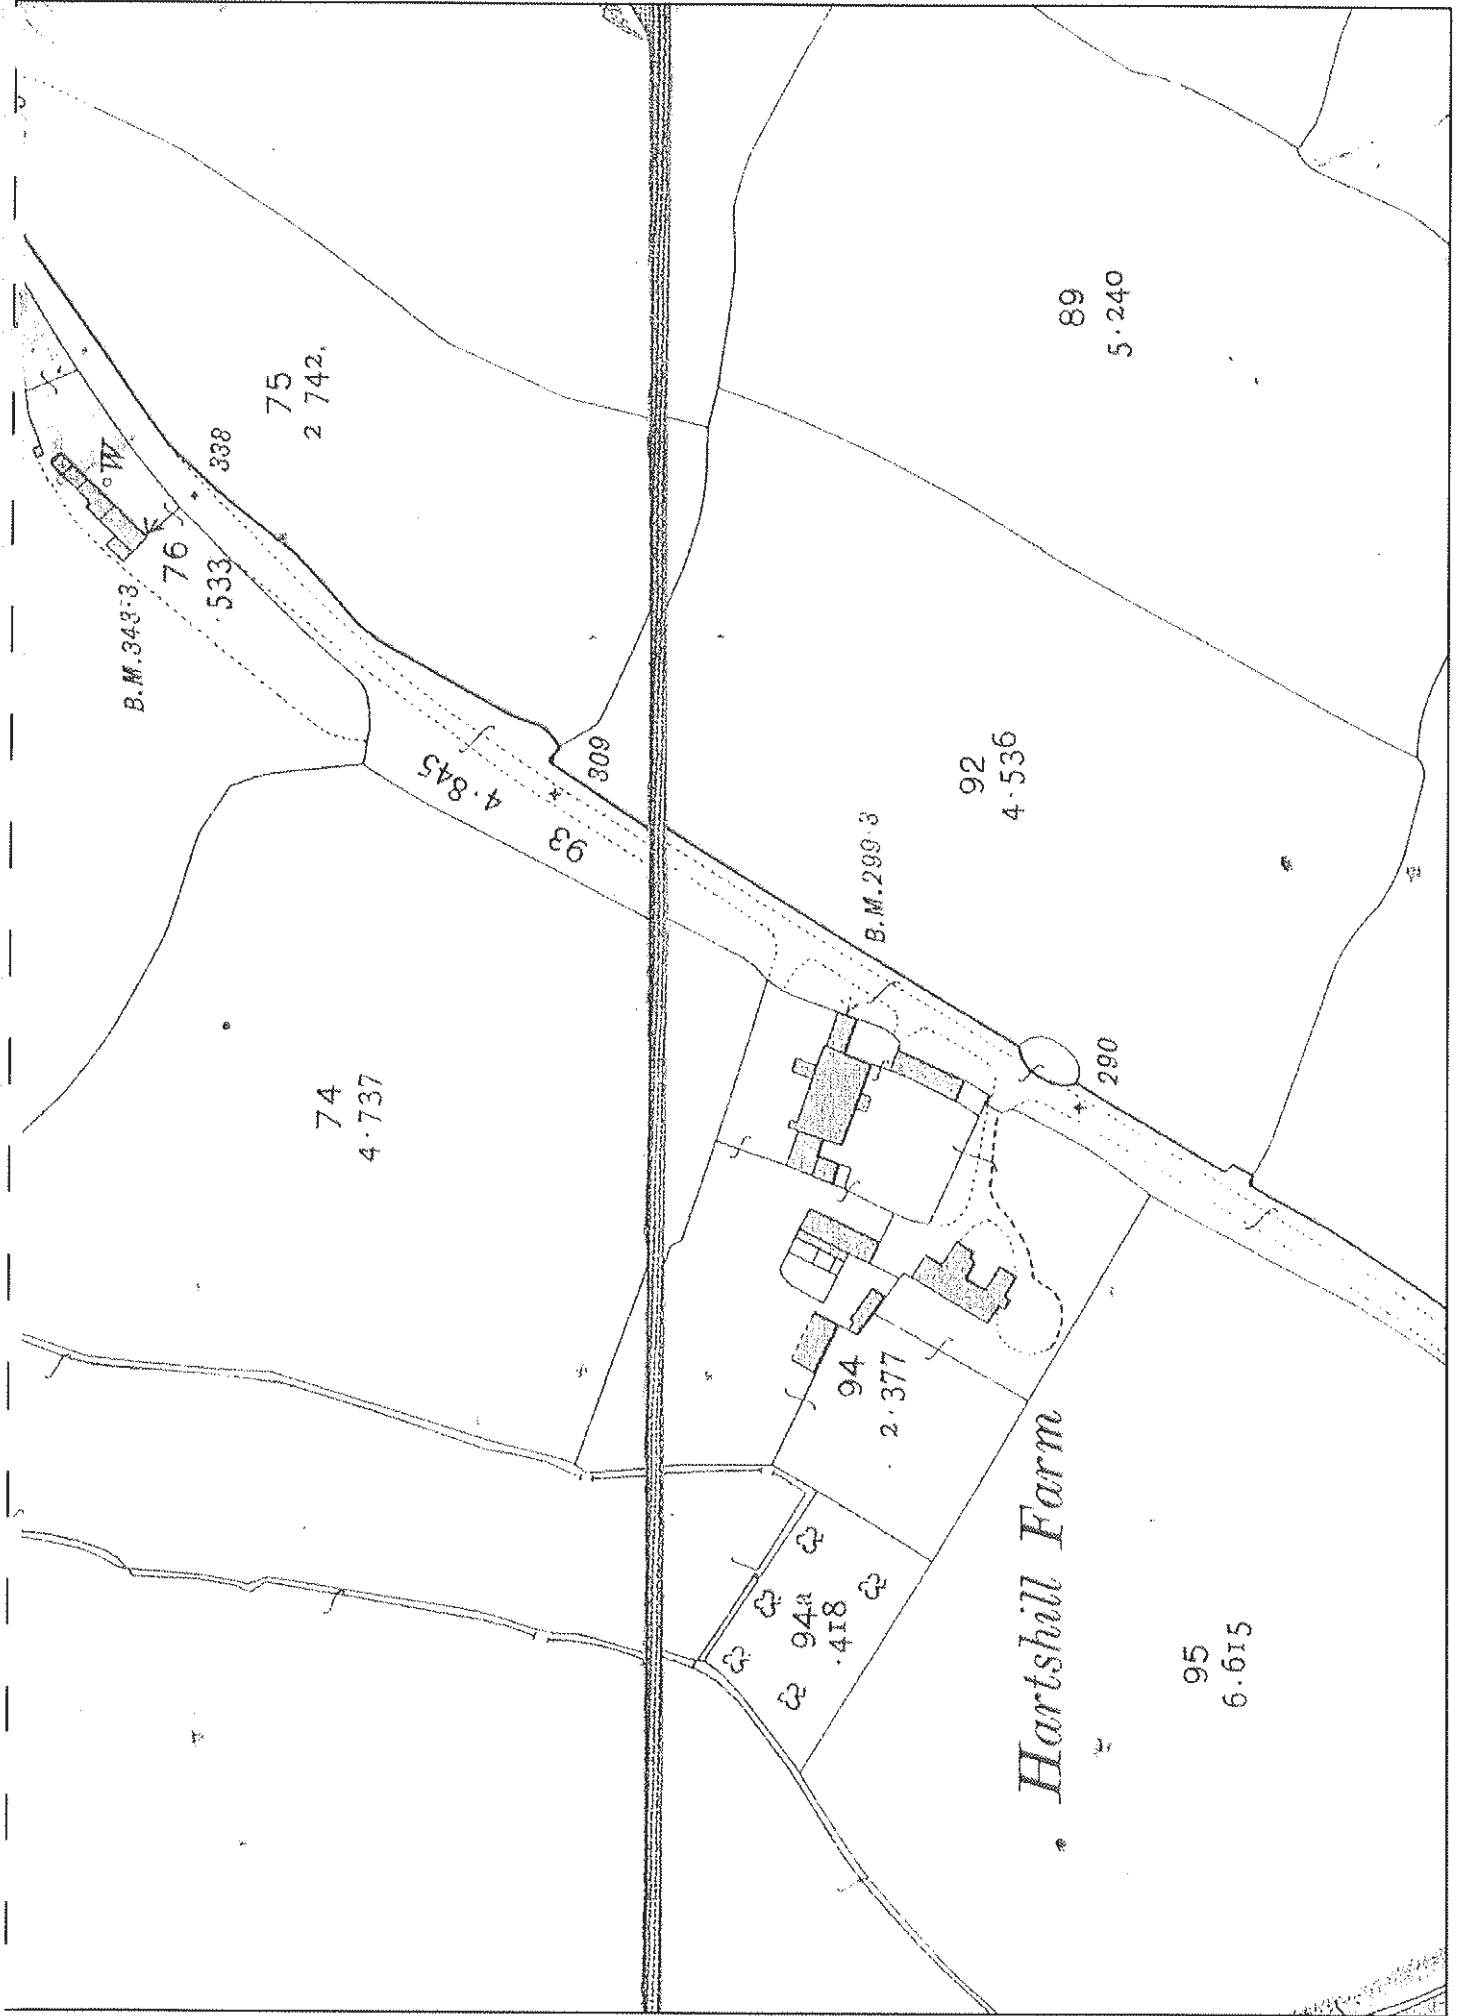
Figure 4: 1911 OS Map

- 2.1.5 The 1911 OS map (fig. 4) shows all the buildings of 1883 still in existence apart from the last mentioned long narrow north range which has been demolished. The fact that this has gone by 1911 tends to imply that it was not part of the 19th century improvements but an earlier range that was replaced by them.

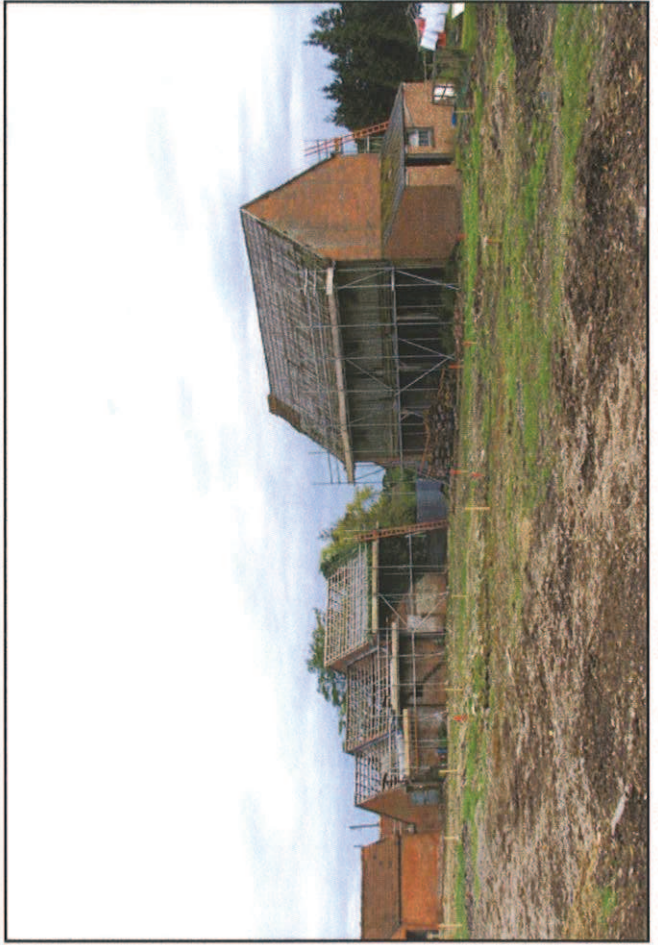
Plate 28: General view of the 19th century buildings (Block D on extreme left)

part of a programme of farm improvement and are quite typical of the sort of development taking place on estate farms in the 19th century (plate 28).
