LOWER FARM BARN  
WASING  
WEST BERKSHIRE

HISTORIC BUILDING RECORDING

OXFORD ARCHAEOLOGICAL UNIT

October 1999

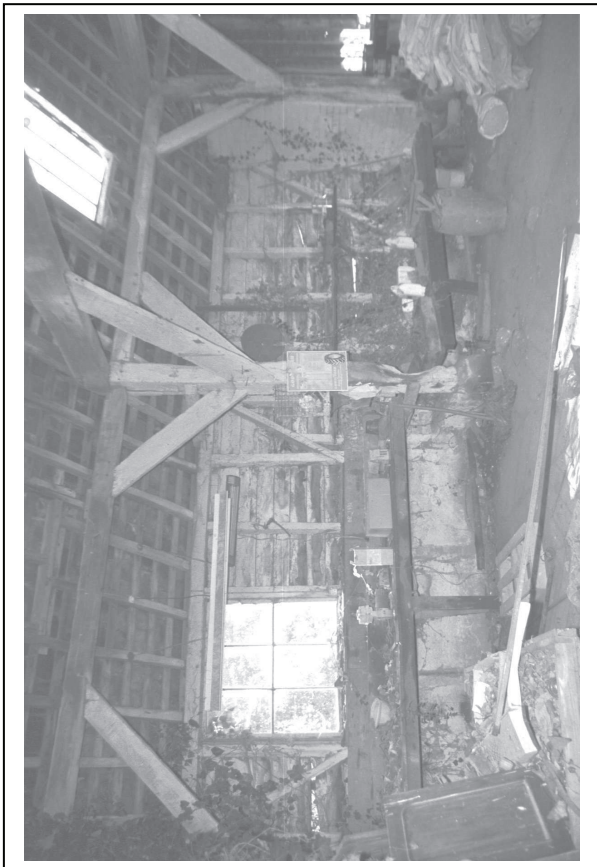
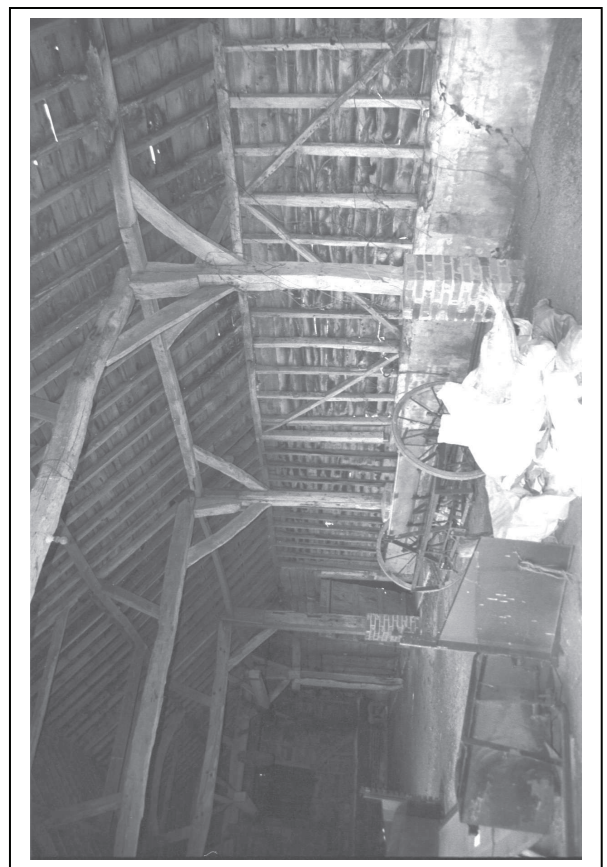
Plate 9: South wall of Area 1

2.4.3 Each of the three main rear posts (including that supporting Truss 8) was supported by a timber sole plate set on an apparently primary brick plinth projecting from the rear (south) wall. This was almost certainly the detail which was removed from within Area 2 and replaced by modern freestanding brick piers.

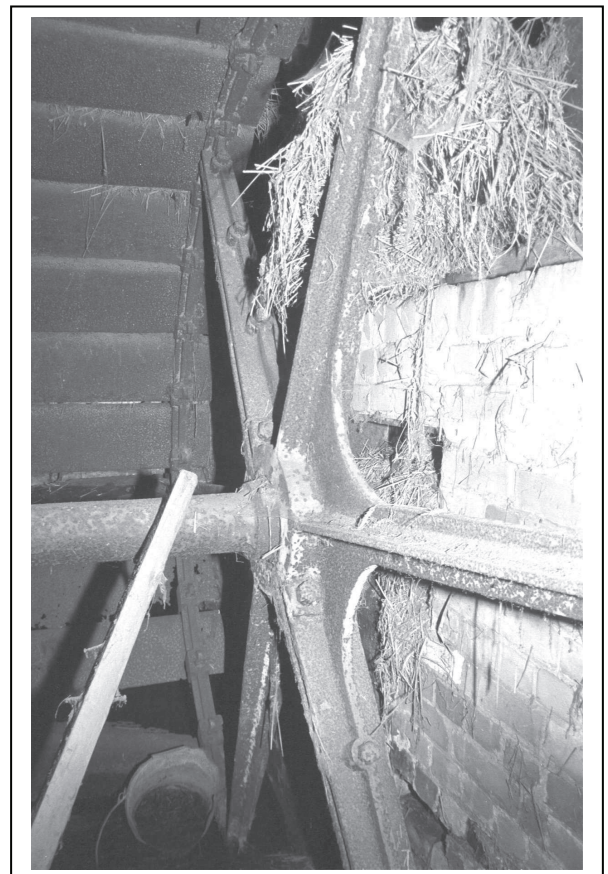
Fig. 1.1. The wheel of the machine.
