# Parterre Gardens Witley Court Great Witley Worcestershire

## Archaeological Investigation Report Volume I

Oxford Archaeology

May 2004

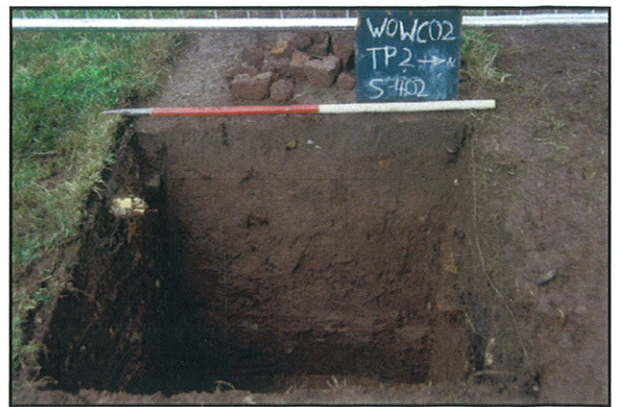
7.9.4 The two hand excavated trial-pits were dug to a maximum depth of approximately 1 m (Plates 3 and 4). No evidence of surviving below ground archaeological features were recorded as had been suggested by the results of the geophysical survey. The trial-pits did however reveal that extensive levelling had been carried out by Nesfield during the gardens construction, and potentially this ground preparation has led to the disturbance/clearance of any potential earlier features/deposits in this area. The recorded soil profiles within the test pits comprised three compacted silt deposits with fragments of building material to a depth of a c. 850 mm from ground surface. Beneath this level in Trial-pit 1 was the remnant of what has been interpreted as a pre eighteenth century soil horizon that overlay the natural geology. In Trial-pit 2 this earlier soil horizon appears to have been removed. Bulk samples for environmental analysis were taken of this earlier soil horizon.

Plate 5 - Trial pit 1, excavated along course of new disabled access path. Looking south.

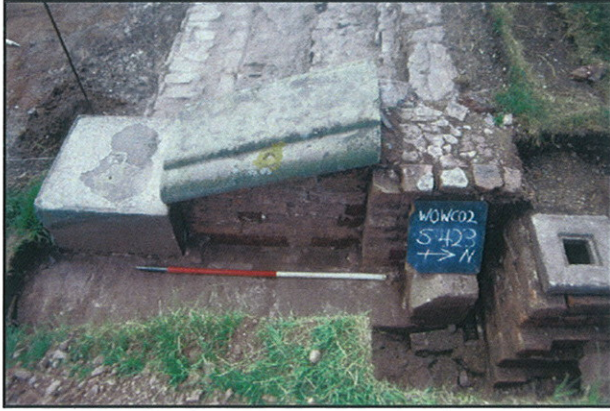
Plate 24 - Trench 5, detail of surviving stringer S4. Looking west.

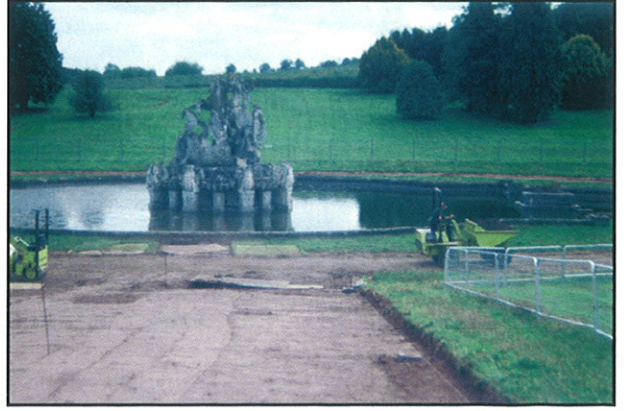
Plate 25 - Trench 5, surviving eastern stringer of steps S4. Looking west.

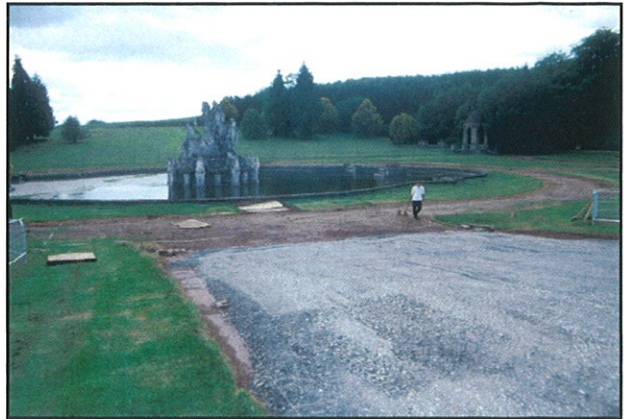
- 7.8.8 Monitoring and recording works were further maintained during the excavation of a sondage along the edge of the fountain circuit (Trench 11). This was excavated by the Principal contractor (Capps and Capps) to examine the drainage in this location and assess whether or not the installation of new soakaways would be viable. The sondage uncovered evidence of a twentieth century repair to the earlier drainage system, characterised by the presence of a ceramic glazed male to female pipe, thus illustrating further the problems created by the silting up of the original system (Plate 27). In addition, further evidence of levelling deposits for the construction of Nesfield's garden were recorded as was a buried soil horizon.

Plate 27 - Trench 11, trial pit excavated by garden contractor to examine drainage. Looking south west.

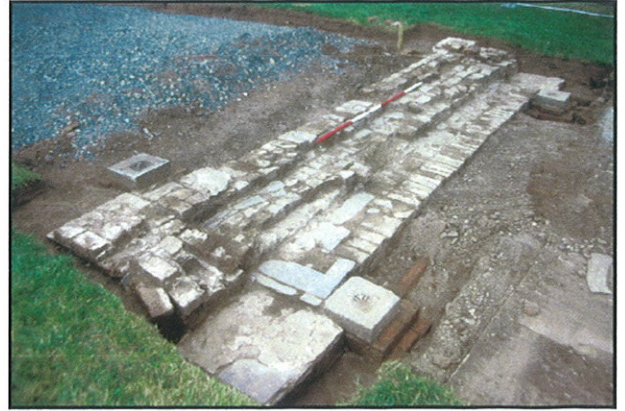
- 7.5.5 Further evidence of probable pre-Nesfield garden features were recorded during the excavations carried out over steps S12 (Plate 31). A sandstone structure was recorded beneath steps S12 and this may possibly represent the remains of an earlier balustrade or viewing platform as suggested from map evidence of 1817 and 1838 (Hughes, P. 1997; SY9 and SY12). Additional evidence of this structure is thought to have also been recorded at the bases of steps S2 and S4 suggesting that this earlier feature has been incorporated as part of Nesfield's northern east-west terrace that lies immediately to the south of the house. It may further be conjectured from this evidence that the upper terrace of the East parterre, immediately east of the house, may have utilised a continuation of this structural feature.

Plate 31 - Trench 17, wall footing 527 exposed beneath step foundations S12. Looking north.

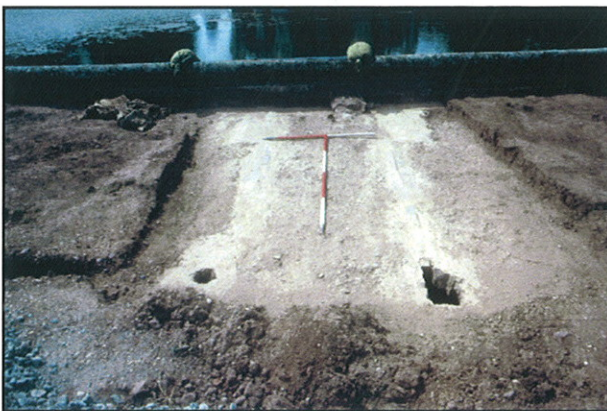
Plate 34 - Trench 16, detail of surviving stringer of steps S6. Looking north.

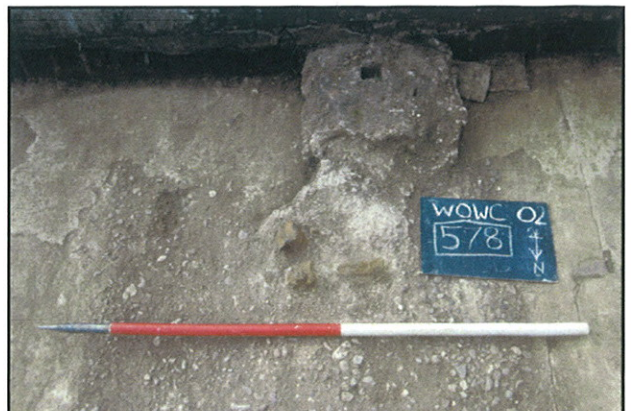
Plate 35 - Trench 9, excavation of fountain outfall area. Looking south.

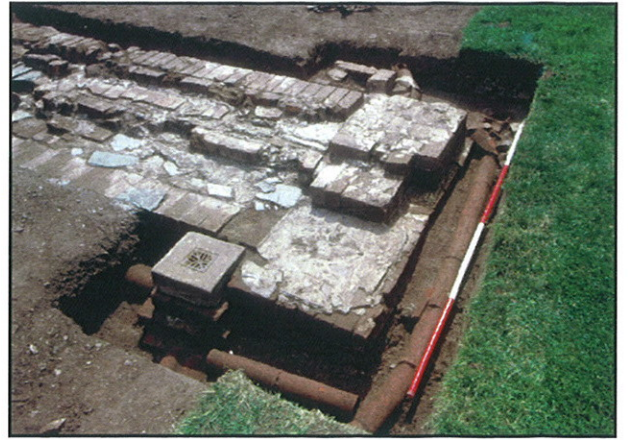
- 7.5.3 Two additional flights of steps (S30 and S31) were revealed approximately 10 m to the north of the West and East pavilions during turf removal for the reinstatement of the main north-south aligned paths within the South parterre garden. Steps S30, located to the north of the West pavilion had been heavily damaged (Plate 42), whilst Steps S31, situated to the north of the East pavilion, appear not to have been subject to such similar disturbance (see Fig. 6; Plates 37-38 and 40).

Plate 37 - Trench 22, excavation of step foundations S31. Looking south.

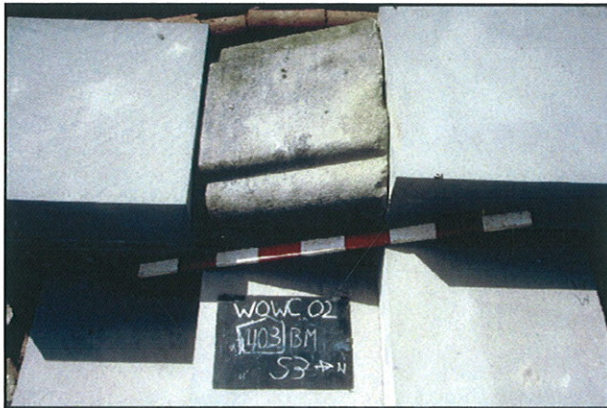
Plate 38 - Trench 22, detail of surviving stringer and drainage of steps S31. Looking south.

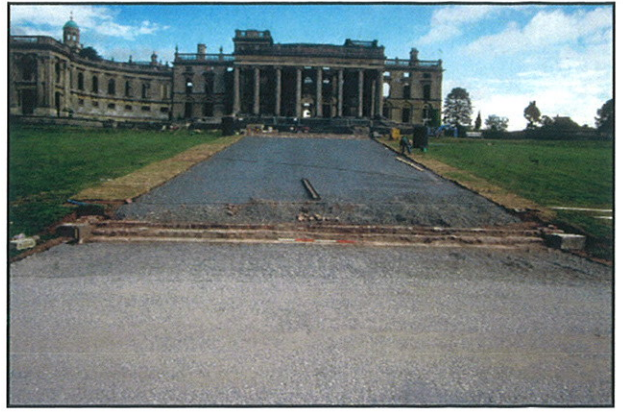
Plate 50 - Preparation of paths for re-surfacing with steps S5 in foreground. Looking north.

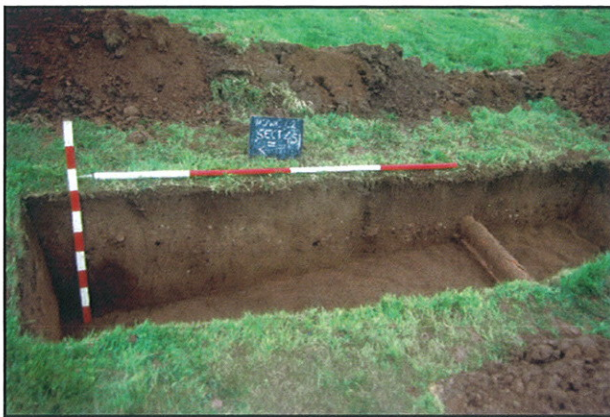
Plate 51 - Trench 26, examination of former South Parterre terrace. Looking east.

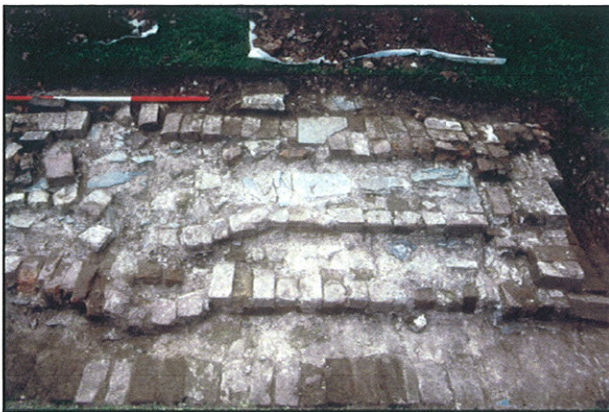
Plate 57 - Trench 101, excavation of step foundations S18b. Looking east.

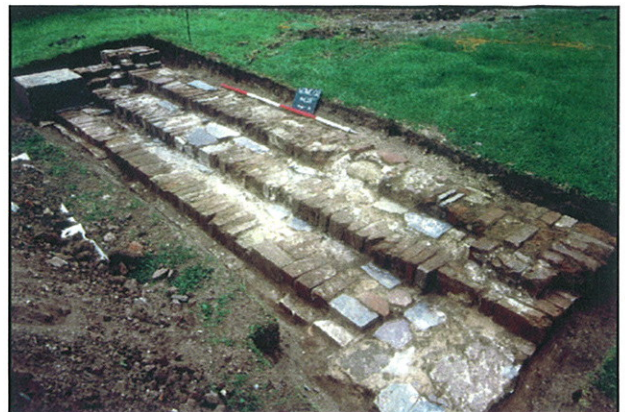
Plate 58 - Trench 104, excavation of step foundations S18a. Looking south west.

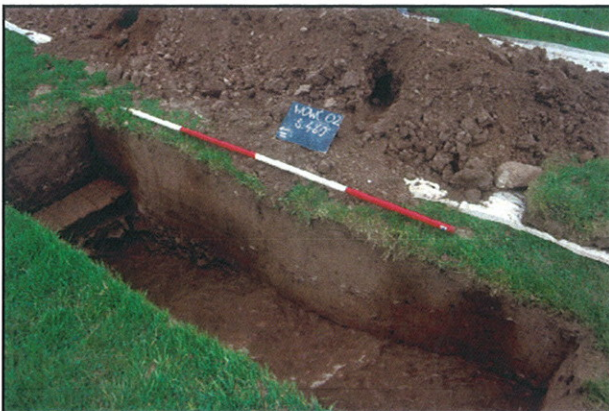
Plate 59 - Trench 33, showing excavation of trench to examine surviving terrace. Single course brick footing exposed. Looking north east.

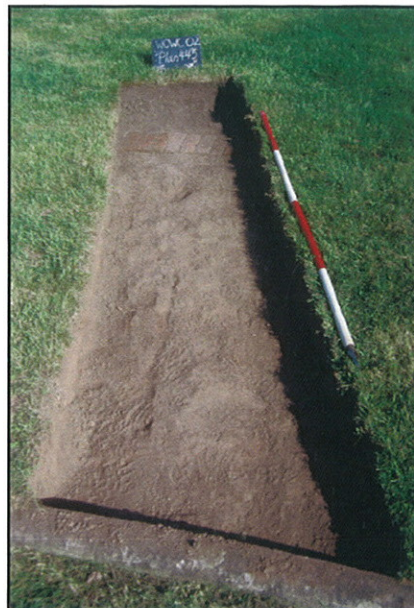
Plate 60 - Trench 18, excavation to reveal inner edge of north west quarter bed. Single course brick footing exposed. Looking north west.

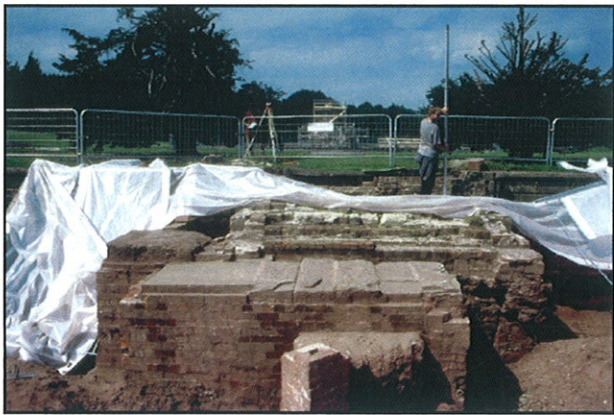
Plate 63 - Trench 20, fountain tunnel entrance exposed. Looking west.

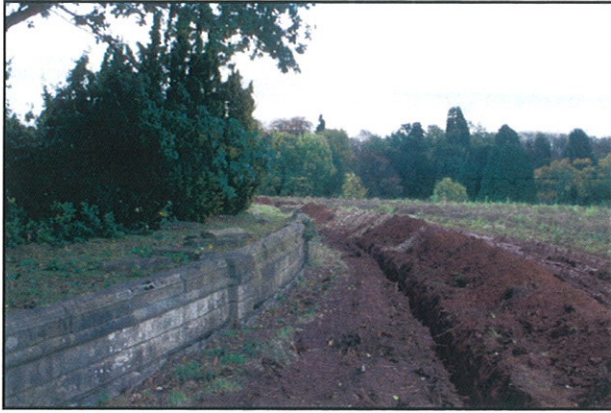
Plate 67 - Service trench excavated along east side of eastern balustrade of gardens for new pumphouse. Looking north.

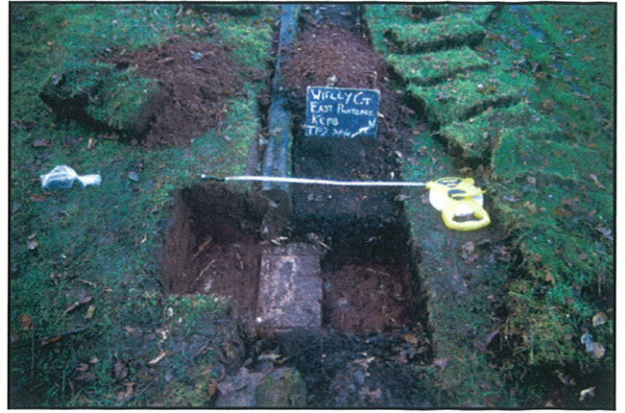
Plate 68 - Trial Pit 1 (East Parterre), examination of construction and survival of bed kerbing in east parterre. Looking north west.

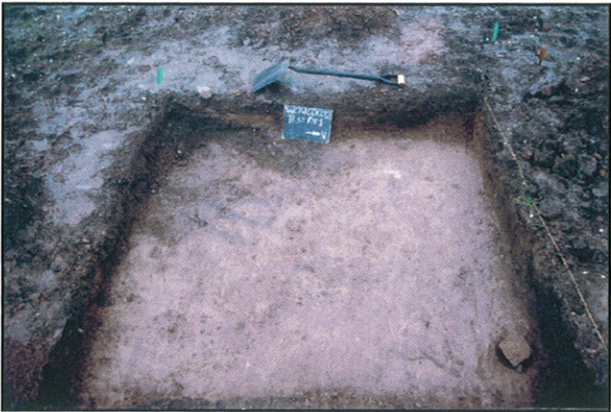
Plate 69 - Trial Pit 3, excavated in north west oval bed that revealed no evidence of former inner design. Looking west.

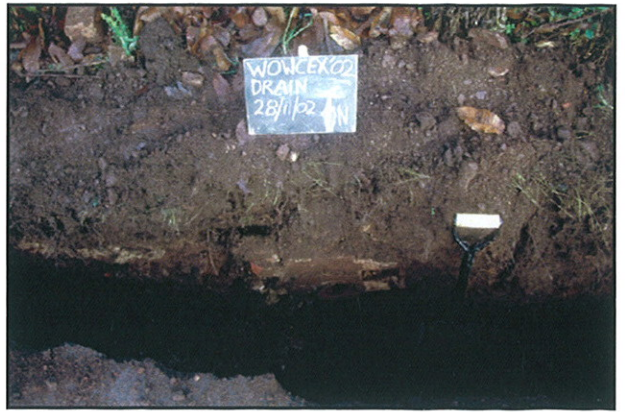
Plate 70 - Drain recorded during monitoring works carried out along service trench excavated to the north of the house. Looking north.
