All Saints Vestry

Kingston Upon Thames

**Historic Building Investigation
and Recording**

December 2006

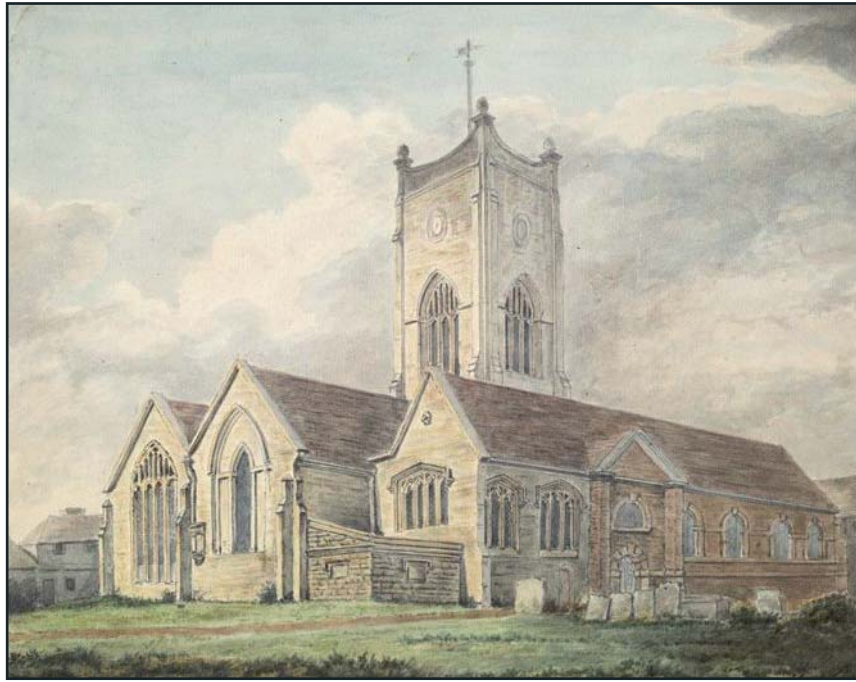
Figure 2: All Saints Vestry, Kingston: 1787 sketch
'View of Kingston church in the county of Surrey'

- 1.1.18 During the 19th century a doorway was inserted into the eastern elevation of the vestry. There is no evidence in the building fabric of an earlier doorway prior to this date and early sketches of the church confirm this (Figures 2 and 3).
