St Mary's Church, Shudy Camps A Survey of the Upper Stages of the Tower

Ben Robinson and Anthony Baggs

June 1999

Report No. 160

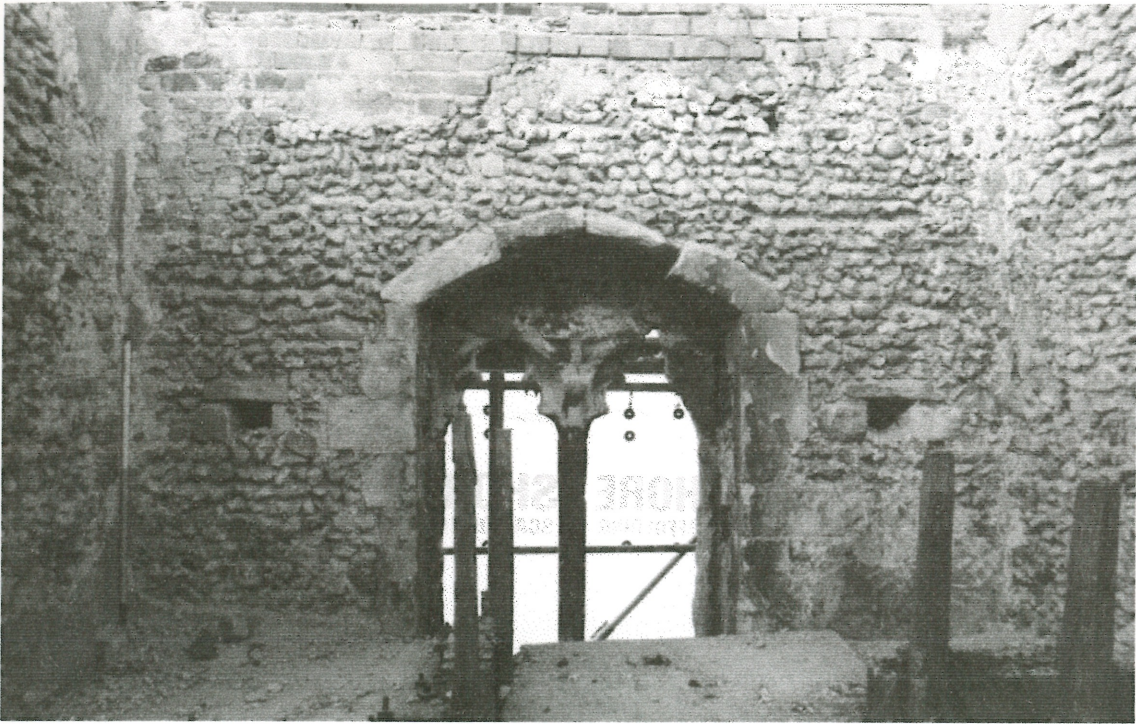
Plate 6 North wall interior at belfry level

A repair of up to four courses of nineteenth century brick (type B1) replaced the outermost course of flint rubble just below the wall plate on the internal face. This was reduced to three courses mid-way along the wall and two courses at its east end. At the west end of the wall, extending to about 1m below the wall plate (and forming part of a repair which had been concentrated on the west wall's internal face) was a small area of uncoursed brick rubble patching (type B5).

Two lift lines could be seen on the external face of the north wall. The first was 12 flint courses above the belfry level string course. The second was nine courses above the first to the east of the window and ten courses higher to the west. A lift line could be seen on the internal face extending across the wall at the level of the topmost ashlar of the window jamb.

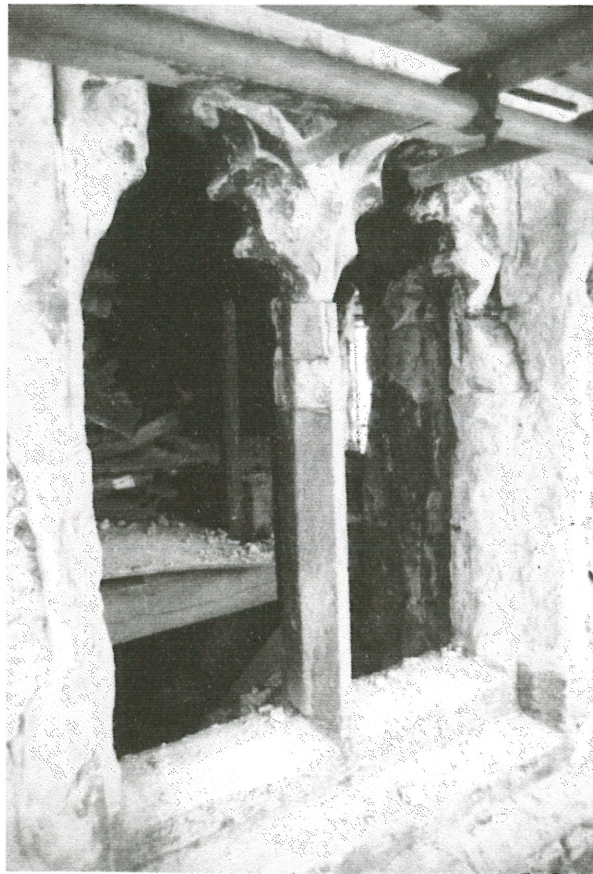
Plate 7 North wall belfry level light

The central, cusped, two-light window was of perpendicular form. All jambs and tracery were of clunch. The two end pieces of the lintel and the entire mullion were limestone replacements. The sill was also of limestone.

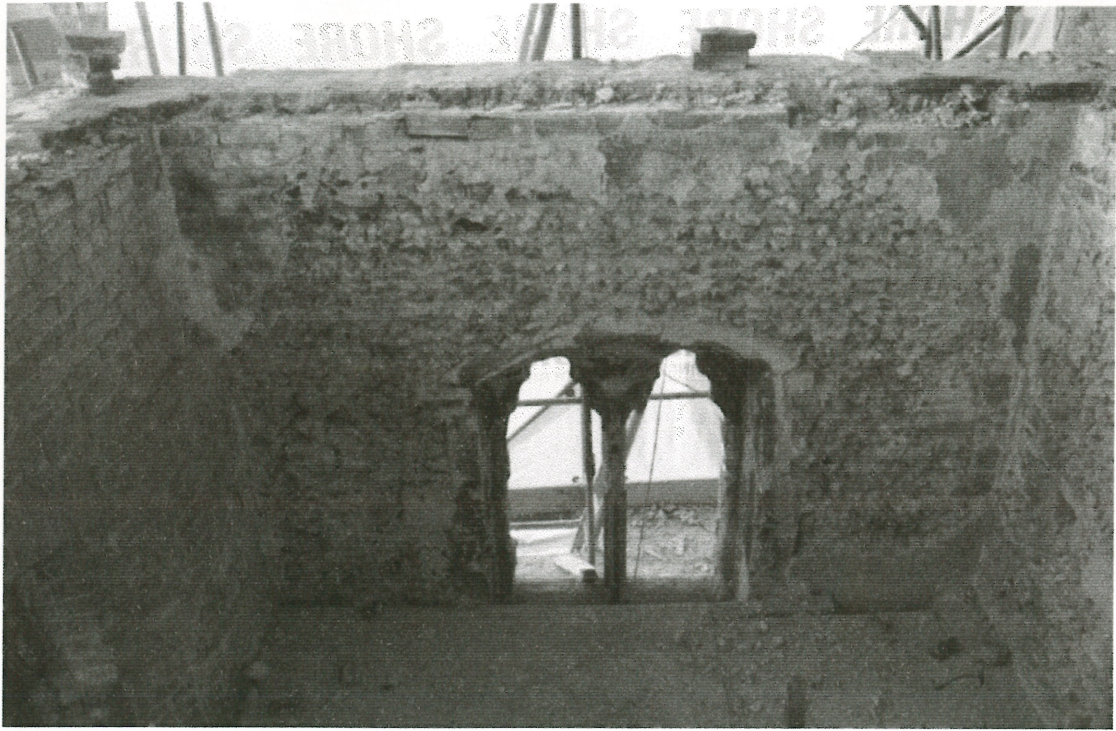
Plate 9 West wall interior

All the render had been removed from the external face before survey, but plaster (type P1) covered most of the internal face. This sealed two courses of brick (type B1) below the false tie beam, and a crude rubble repair (of brick type B5) at the north end.

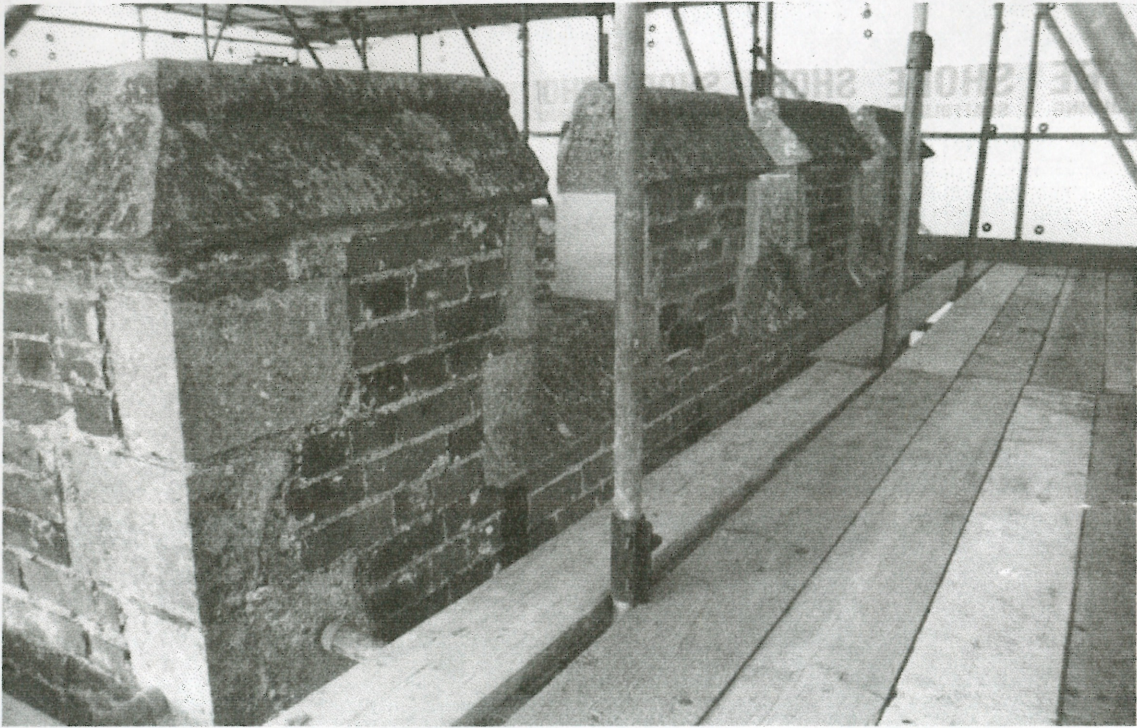
Plate 12 South east corner of parapet

A small brick patch (11 courses of type B2) had replaced all but two fragments of the lowest south-east quoins.

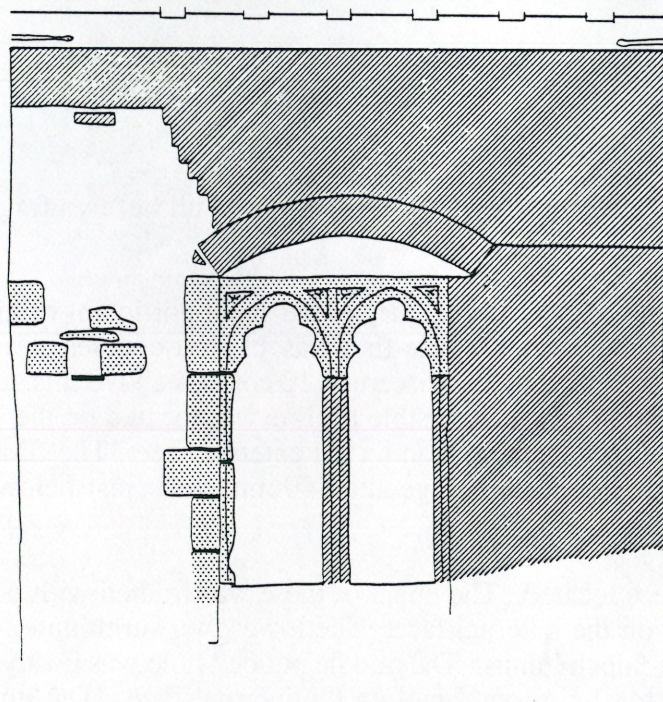
Figure 8 South wall internal elevation (Drawing by A. Baggs)

The west jamb, east jamb and mullion of the central two-light window were of brick (type B6). The cusps, sill and lintel were of badly weathered clunch. Moulded bricks (as type Bx) formed the shape of the replaced mouldings and jambs. Render had been applied to both brick and clunch to further mimic the form of the original mouldings. The internal relieving arch of the window was segmental and formed of two courses of headers on edge (also B6).

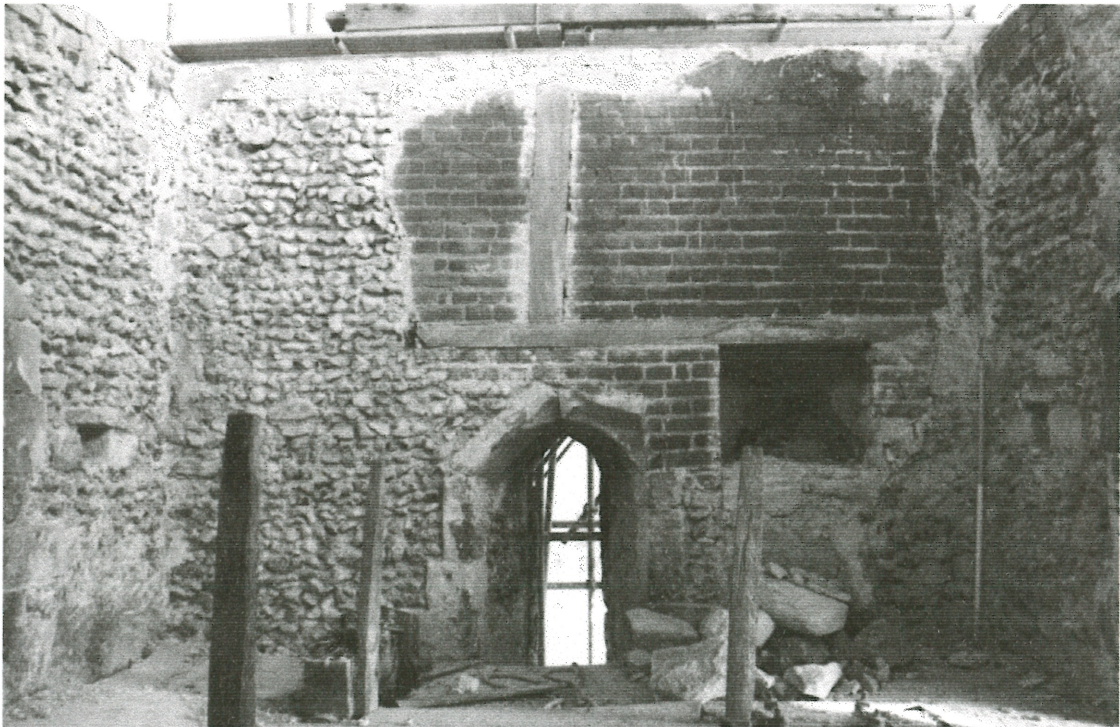
Plate 13 East wall interior at belfry level

All render had been removed from the external face before the survey. Plaster P1 covered most of the internal face and overlay a thick, hard plaster, P2, which in turn overlapped brickwork of type B2. P1 also sealed P5, a thin layer of plaster characterised by small rounded chalk granules and of similar consistency to the mortar bonding flint rubble courses. This plaster was confined to a patch on the lower portion of the north end of the face but also covered the reveal of the small central lancet. Here it ran out to leave the ashlar of the lancet reveal exposed. The third from bottom ashlar on the south side of the reveal bore the graffiti '1684 G.B.' on its north face.

A large expanse of brick patching incorporating peg-tile fragments (12 courses, English bond, type B2 bricks – the upper two courses were inclined and separated from the lower course by half a course at one end), was encountered just below the parapet-level string course. Another smaller patch (11 courses, English bond, also type B2) abutted the north-east clunch quoins.

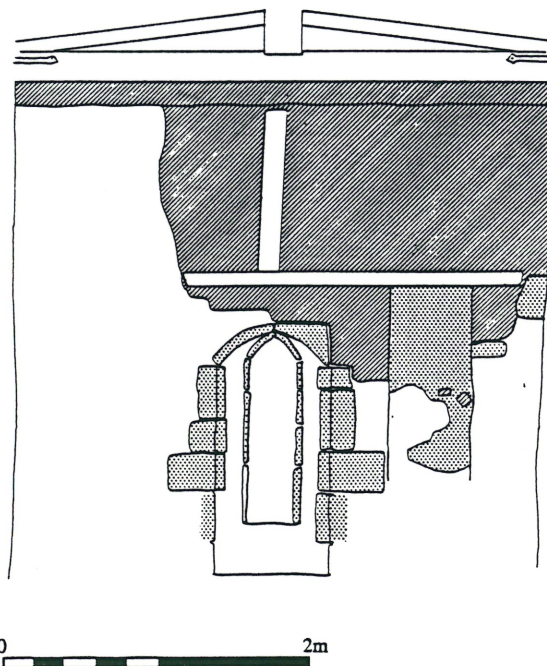
Figure 10 East wall internal elevation (Drawing by A. Baggs)

patch and timber work described above) and partly of flint. The blocked reveal of this curious opening was packed with clunch blocks, including one with moulding similar to that of the sides of the two main two-light windows. It had been sealed with plaster P1.
