## GAWTHORPE GREAT BARN, PADIHAM,

## **LANCASHIRE**

# **Historic Building Survey Report**

Issue No: 2014-15/1531 OA North Job No: L10668

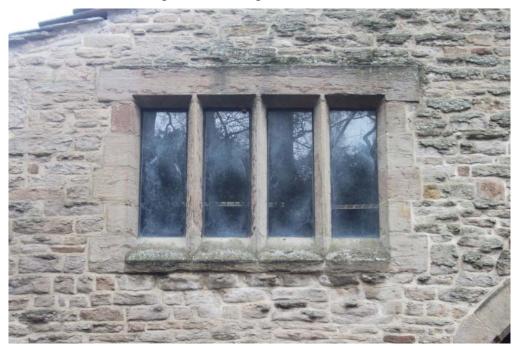
- 4.3.4 The mullion windows are all identical in construction and have sandstone surrounds and mullions. Each window contains four glazed lights each with plain single glazing set within timber frames (Plate 25). The mullions are chamfer moulded externally and internally. Located on either side of the central mullion windows are iron tie rod ends (four in total, Plate 22). Three of these are quite decorative, being of a square foliate design, whilst the fourth is round and ribbed; they are not visible internally. Above the windows, located centrally just below the apex of the roof, is a further small opening that is directly accessible internally from the mezzanine floor above the stable. This

Plate 25: Example of a mullion window set within the principal elevation

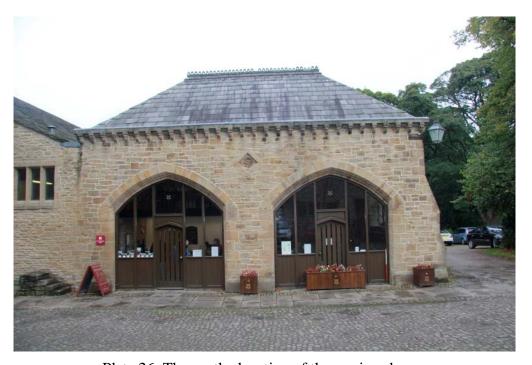
4.3.5 Carriage house: the east side of the principal elevation comprises the south, long elevation of the carriage house (Plate 26). There is an obvious change in the stonework between the carriage house and the main barn but there is no butt join between the two (Fig 22); however, the eaves of the carriage house are raised up slightly above the eaves level of the barn. The stone work of this elevation of the carriage house consists of random squared un-coursed stonework of varying sizes, and is bonded with lime mortar. Both the stonework and the mortar are in good condition with no visible signs of patching or rebuilding. This elevation of the carriage house mainly comprises two large openings which are in-filled with late-twentieth-century timber and glazed panels. Within these panels, pedestrian doorways allow access to the visitor reception and café. The openings have sandstone arches of similar appearance to the small opening in the apex of the barn gable (Section 4.3.4)

Plate 26: The south elevation of the carriage house

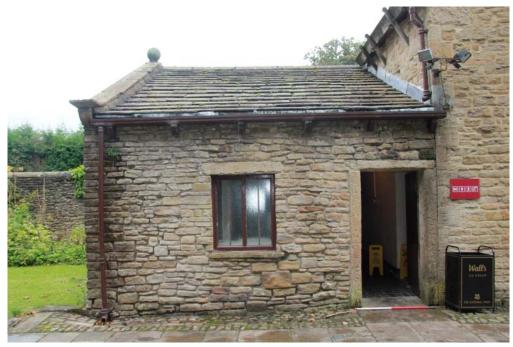
Plate 27: The south elevation of the toilet wing

4.3.8 Store/ Toilet Wing: the west side of the elevation comprises the south-facing elevation of the toilet wing. There is an obvious vertical join where the toilet wing meets the main barn, indicating that it is of a later phase (Plate 27). The stonework of this elevation consists of roughly coursed, squared and flat randomly sized sandstone with lime mortar. There is a single pedestrian door which has a simple sandstone surround exhibiting visible pick-marks. The door is of plank and ledge construction, with six distinctive vertical ventilation slits set into the upper half of the planks (Plate 28). To the west of the door is a window with simple sandstone lintel and flat sandstone sill; the glazing is of late twentieth-century origin. At the top of the elevation is a simple ogee timber gutter supported upon six timber brackets. To the west of the elevation is a single iron down pipe.

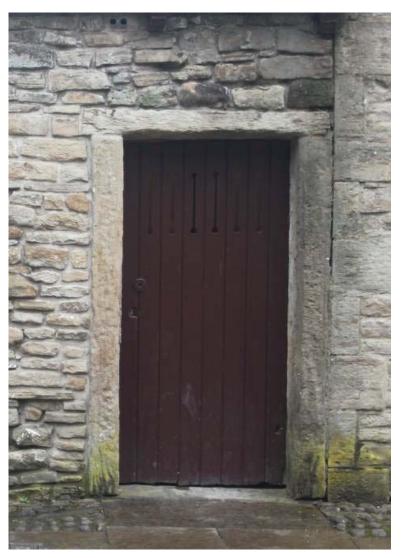
Plate 28: Door on southern elevation of store/toilet block, with ventilation slits set into the upper half

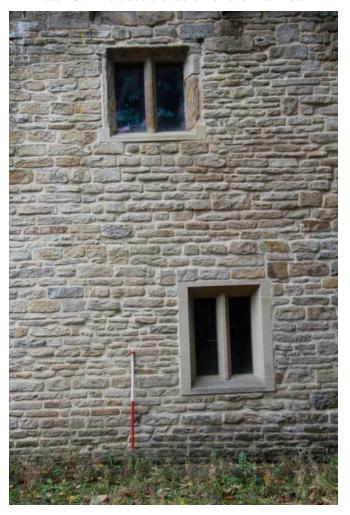
Plate 30: Example of fenestration on the east elevation

- 4.3.12 The fenestration of the elevation, as already outlined, comprises five stone mullion windows (two at a lower level and three at a higher level), arranged without obvious pattern or symmetry (Fig 23). Each of the windows is of a similar style, being a square, deep opening with single mullion dividing it into two lights. The mullions are chamfer moulded both internally and externally; they are roughly the same size and measure approximately 0.9m tall by 0.85m wide. The two at a higher level are slightly narrower at 0.8m wide; the reveals are splayed and they all have sloping sills and lintels. Four of the windows have been repaired, the two lower windows being constructed of very recent looking stonework (probably dating to the 1980s) (Plate 30). The stonework of the upper windows appears to be earlier and possibly contemporary with the rest of the elevation. Only the southernmost window is un-restored, the others having been repaired with replacement stonework. The surviving earlier stonework has weathered considerably.

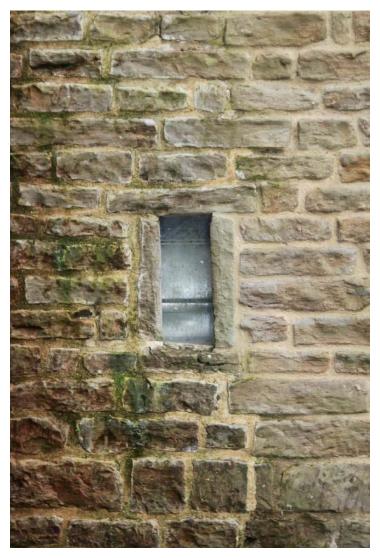
- 4.3.13 The six ventilation slits present in this elevation do not, in common with the fenestration, appear to conform to any particular pattern, there being no conclusive evidence of former, or blocked ventilation slits within the stonework (Fig 23). The surviving slits are all roughly the same size (approximately 0.4m tall by 0.15m high) and have weathered sandstone surrounds (Plate 31). It is probable that further ventilation slits were once present, although there is no evidence for this.

Plate 31: Example of a ventilation slit on the east elevation

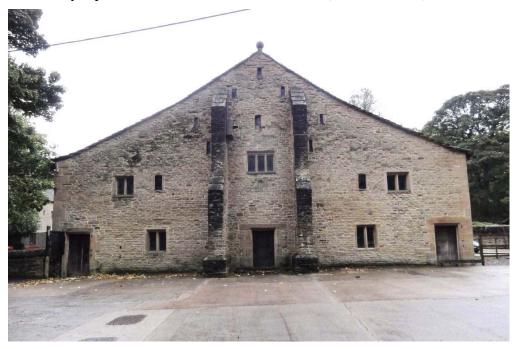
- 4.3.19 Of the five mullion windows set within this elevation, two are located at ground floor level, two are on the level above and offset, with the fifth being centrally placed at a higher level with its sill being at the same level as the lintels of the upper two (Plate 33). The ground floor and upper level windows are all similar in design, construction and dimensions to the windows set within the east elevation described in *Section 4.3.12*). Two of the windows have been repaired, the upper west window apparently being completely rebuilt. The centrally placed top most window is unique across the whole

building, in that it is a three-light mullion. Its general appearance, however, is the same as the other mullion windows on the main barn building; the window measures approximately 1.55m wide by 0.97m tall. Although, one of the windows appears to be a replacement (west upper) most of the mullions are weathered and were obviously part of earlier phases. They have not been as extensively repaired as those in the east elevation (Section 4.3.12).

Plate 33: The rear (north) gable elevation of the main barn

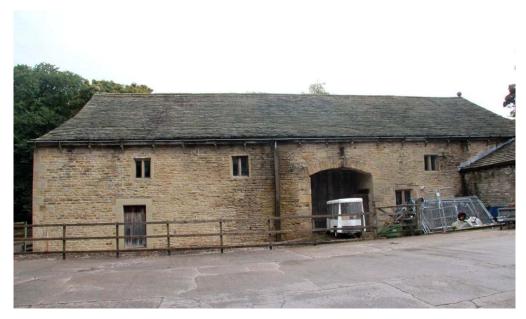
- 4.3.22 *The West Elevation:* in common with the east facing elevation described in *Section 4.3.10*, the north and west elevations of the store/ toilet block extension are visible and will be described in the following section. At the time of the survey, parts of the elevation were obscured by materials such as steel fencing etc (Plate 34). The southern part of the elevation is obscured by the store/ toilet block extension.

Plate 34: The west facing elevation of the main barn

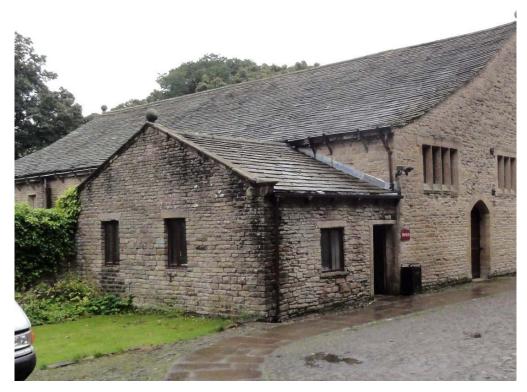
4.3.27 The west facing elevation of the toilet extension block forms the gable and contains two rather plain window apertures with stone lintels (Plate 36; Fig 25). The stonework of the elevation is distinctive, being laid in very slightly diminishing courses toward the apex; whether this was the intention or not is unknown. Sandstone copings with projecting cornices are present on both verges and fairly plain sandstone kneelers are located at the foot of each slope.

Plate 36: Gable elevation of the toilet extension

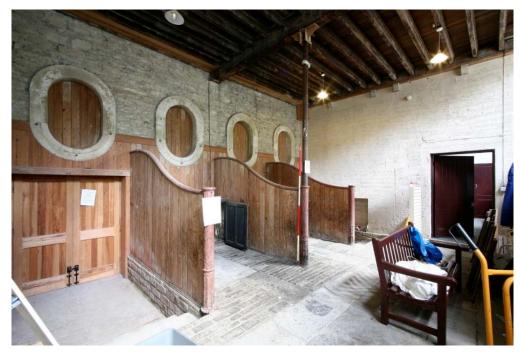
- 4.4.3 **Room 1:** this room is entered via the central sliding door located in the centre of the principal elevation of the barn and contains evidence of its former use as stabling accommodation for horses together with later modifications (Plates 37 and 38). The room is rectangular and it is through this room that access to the main space of the barn (Room 6), the adjacent kitchen (Room 5) and a further room on the opposite side (Room 2), is available. This room was probably created during the alterations of *circa* 1870 (*Section 3.3.13*).

Plate 37: General appearance of Room 1

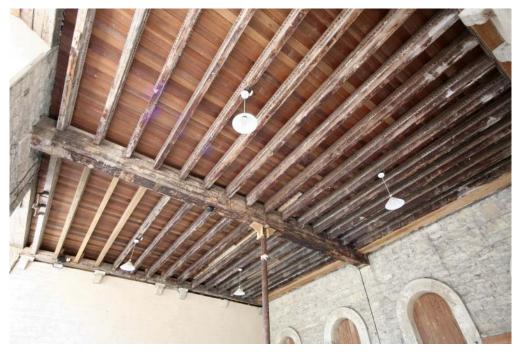
Plate 38: The ceiling in Room 1

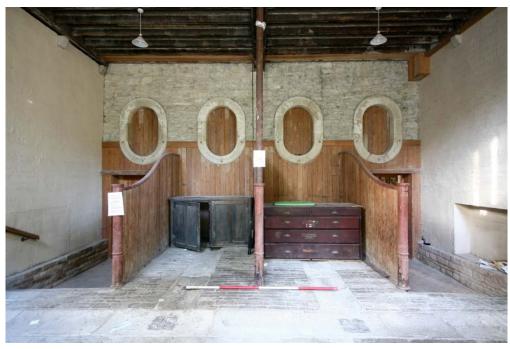
- 4.4.9 As already outlined, this room contains evidence for accommodation for horses in the form of two surviving and two altered stalls (Plate 42). The stalls are divided by timber panelled partitions with curving iron top rails, each stall measuring 1.9m (6 feet) wide by 2.6m (8.5 feet) long. The dividing partitions are some 1.3m (4 feet 3 inches) high at the front rising to 2.3m (7 feet 5 inches) at the rear. They terminate in a vertical iron post that has decorated fluting and geometrical designs. Set in to the north wall, within each of the stalls, is a panelled feature of half-circle top and bottom shape with a square sandstone surround. Set into the bottom half-circle of each of the surrounds are three bolt holes. These are probable evidence for former wall mounted hay racks that were most likely to have been of wrought iron construction. These are not visible on the other side of the wall in the main barn. The presence of these suggests that the horses stood facing the wall. There is no evidence for any tethering arrangements or any sort of restraint or guard over the entrance to each of the stalls. A small hole in each of the outside iron posts is the only evidence suggestive of a guard or chain.

square features in the lateral channel may have once accommodated the collection of manure. The two flanking stalls adjacent to the east and west walls of the room have both been converted into steps and doorways to allow access to the main barn (Plate 42). The steps and the floor in front of the doors are concrete and probably date to recent 1980s alterations. Both sets of doors are of late twentieth century appearance. On the other side, within the barn, both openings have large sandstone lintels.

Plate 42: Horse stalls in Room 1

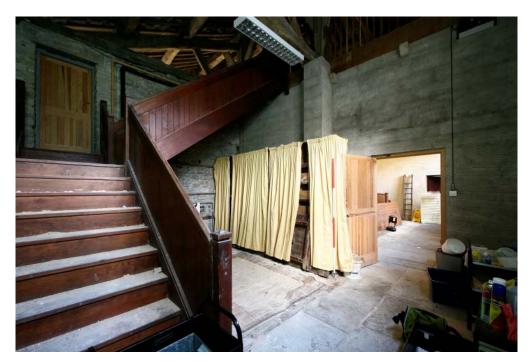
Plate 43: General appearance of Room 2

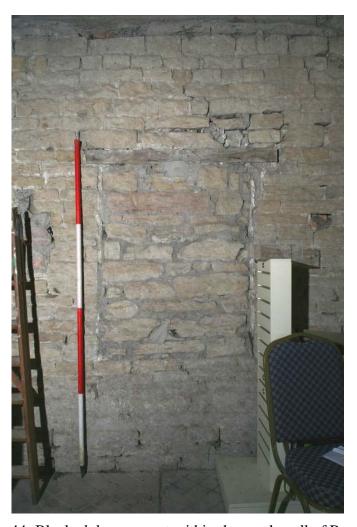
- 4.4.12 In similar fashion to Room 1, the south wall of Room 2 contains evidence of a former doorway that is visible as a low (approximately 1.3m wide by 1.7m high) blocked aperture with a substantial lintel (Fig 26; Plate 44). To the east of this is a doorway allowing access to the south external elevation (Plate 45). This differs from the door in Room 1 (Section 4.4.6) and has a splayed reveal with a shallow pointed segmental sandstone arch; the west jamb does appear to have been rebuilt. The door is a heck door with substantially constructed stable door of chamfered, framed ledged and cross braced construction with a two-centred head. It is hinged via iron pintles at the east side. Further repair to

Plate 44: Blocked doorway set within the south wall of Room 2

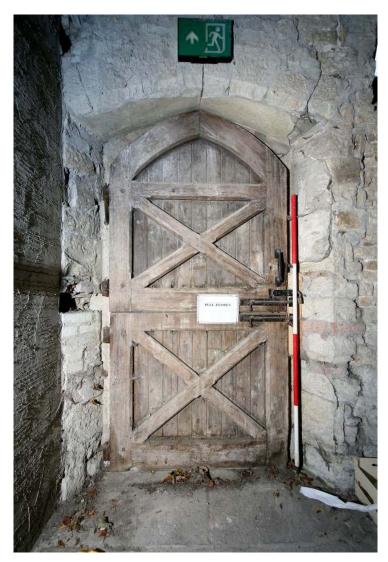
Plate 45: Internal face of the doorway leading to the courtyard from Room 2

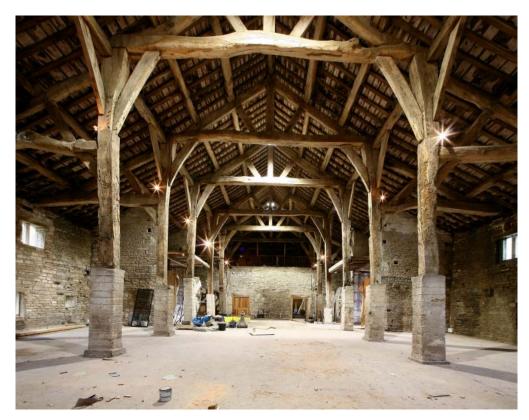
- 4.4.18 *Room 6:* this is the largest space in the whole building and comprises the main large open space of the barn. Upon entering the barn from any of the access points the magnificent structure of the aisled barn is visible (Plate 46). The barn is nine bays long with a threshing bay, each bay being around 2.6m (8.5 feet) wide. The bay occupied by the threshing floor is 3.7m (12 feet) wide; the southernmost two bays being occupied on the ground floor by Rooms 1, 2 and 5 (Fig 18) and on the upper floor by Room 8 (Fig 19). As Room 8 is an integral part of this space it will be discussed in this section. There are two internal porches that house each of the two barn doors together with Rooms 3 and 4 (*Section 4.4.15* and *4.4.16*) as well as an internal shippon (*Section 4.4.29*).

Plate 46: Interior view of the barn showing the aisled construction

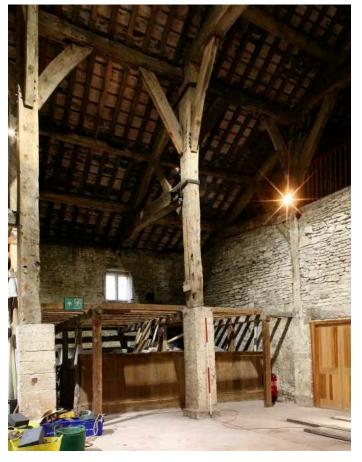
- 4.4.19 The bays are divided by sixteen aisle/ arcade posts (eight on each side) (Plate 47) upon which the roof trusses are supported (Figs 20, 30 to 39). Wall ties extend on either side spanning the aisles (Plate 48). There is no evidence to suggest that the barn was ever timber-framed and the principal rafters and wall ties are supported by the stone long walls; there is no evidence of a wall plate. For this description the assemblies are labelled 1 to 8, assembly 1 being at the southern end (Figs 18 and 30-39). The span between the aisle posts (the nave) is approximately 7.4m (24 feet).

Plate 47: Example of an arcade post

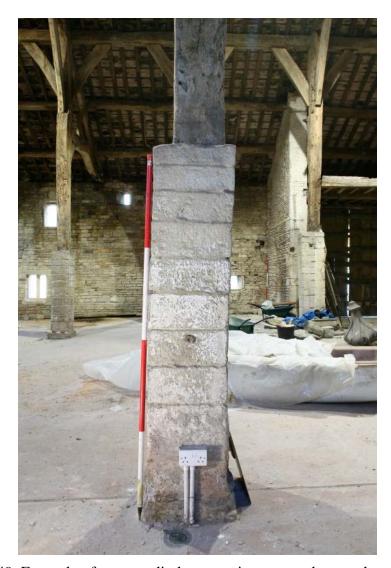
4.4.20 The construction of each arcade post truss assembly is identical, there being a post on either side upon which the upper truss is supported (Figs 30 to 39). The base of each post stands upon a square stone plinth or pad (Plate 49), each one varying in height from 1.1m on the west side of truss assembly 4 (Fig 33), to approximately 2.4m high on the east side of truss assembly 5 (Fig 34). The top of each post thickens out, to form what is called a 'jowl', which helped to provide additional support to the tie beam and was usually created by placing the post, obtained from a tree, upside down. The truss assemblies are similar to those within Wycoller, Lancashire the barn at (www.greatbarns.org.uk/wycoller\_barn), the barn at Shibden Hall, Halifax (www.greatbarns.org.uk/shibden\_hall\_barn) and the Great Barn at East Riddlesden Hall, Yorkshire (OA North 2009); Gawthorpe Barn, however, is much taller than these other examples. Truss assembly 2 is built into the stone wall that forms the north wall of Rooms 1, 2 and 5 (Plate 50) and the base of truss assembly 1 is plastered over (Sections 4.4.14). It appears that each of the timber arcade posts is fitted into its corresponding plinth via a vertical mortice and tenon joint as there are wooden pegs visible on some of the plinths indicating that the post continues down into the plinth (Plate 49). At the base of some of the plinths is a further square pad stone/plinth.

Plate 49: Example of a stone plinth supporting an arcade post showing the wooden peg

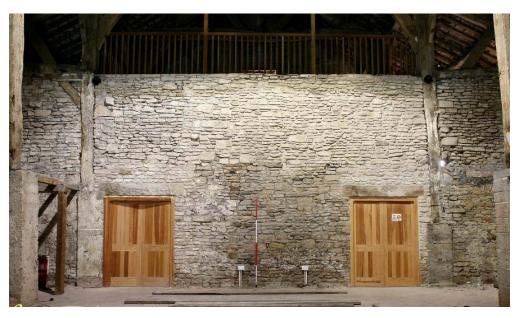
Plate 50: Stone wall forming the north wall of Rooms 1, 2 and 5

- 4.4.32 *Partition wall between Bays 7 and 8:* at the south end of the barn, the stone wall forming the north walls of Rooms 1, 2 and 5, is visible (Fig 31; Plate 50); the wall is of random rubble construction with large variation in stone sizes. This has clearly been inserted later as evidenced by the way in which the wall is built around the aisle posts and stone plinths of truss assembly 2; the wall butts against the long walls of the barn at each side.

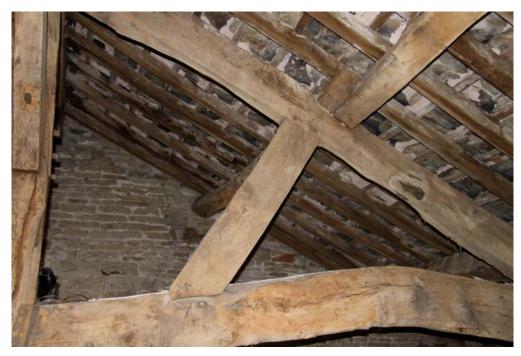
- 4.4.23 The purlins support common rafters onto which battens are fixed that support the roof covering (Fig 20). The horizontal spaces between the battens are torched with lime putty, some of which is missing or degraded. Other details visible on some of the truss assemblies include both assembly marks on the timberwork and masons or banker marks on some of the plinths (Figs 30 to 39). Inevitably the restrictions imposed by inspecting the roof timbers from the ground will have resulted in the overlooking of some assembly marks. However where visible it appears that the trusses are marked up with a hybrid roman numeral system, commonly in use in traditional carpentry from the medieval to Victorian periods (Plate 52). The southern truss is marked at the joint of the tie beam and King Post as 'I' with the trusses ascending in order up to VIII at the northern end. Each truss is marked up on its fair face, reflecting the side of the truss that faced upwards prior to its raising (Brunskill, 1999, 34) and in each instance the fair face has been designed to look towards the threshing bay. The individual joints within each truss are also marked up using the roman numeral system, although without closer inspection it is unclear whether this system relates to the wider numbering system. The marks will require further recording/ inspection in order to work out the sequence, an opportunity to do so may present it self during forthcoming repair work to the roof (Jamie Lund pers comm).

Plate 52: Example of assembly marks on the truss assemblies

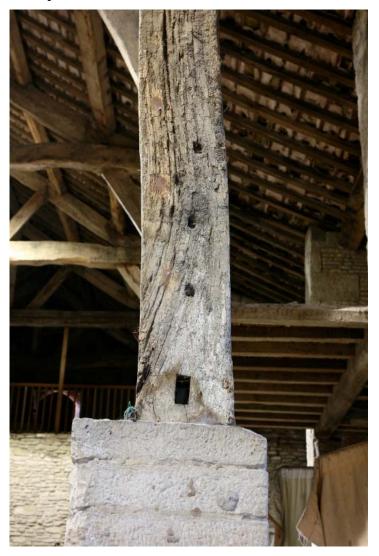
Plate 53: Example of stave/peg holes on an aisle post

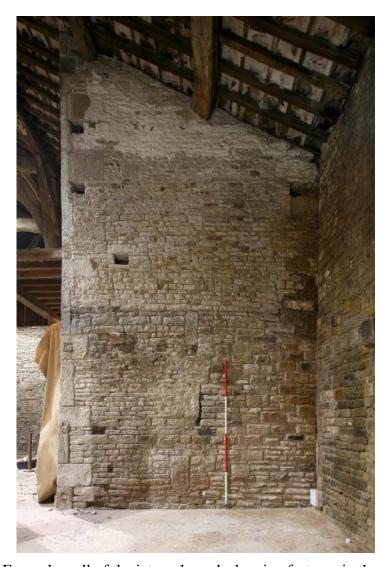
- 4.4.27 There is a vertical alignment of stones visible in all the outward facing walls of the porch that coincide with the jambs of the wain doors (Plate 56). These are probably needed for structural integrity, although on the internal side, they appear to be more reminiscent of quoins; however, there is no evidence to suggest the walls have ever been extended inwardly. Other than this, the walls are fairly plain. The doors are large wain doors overlapping horizontal ledges (Figs 23 and 25; Plate 57); an additional central ledge, on the north side, overlaps to allow for the locking mechanism which consists of a pivoting timber. When closed, the doors are very secure. The ledges are tennoned into a vertical hinge post which is hung on harr hinges top and bottom; the top hinges slot into a substantial timber lintel. Curved iron braces support the bottom hinges. The planks are fixed to the rails with large iron nails with externally projecting heads.

Plate 56: Example wall of the internal porch showing features in the stonework

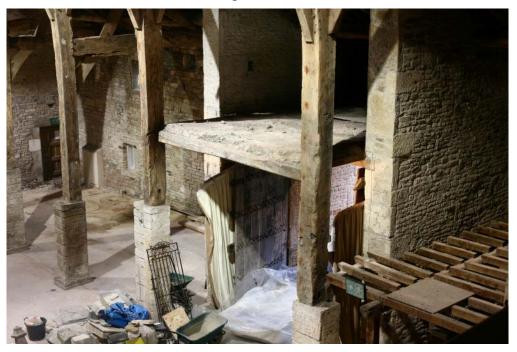
Plate 60: The appearance of the east ceiling

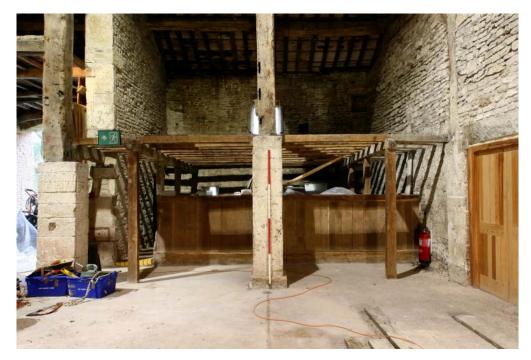
planks. At the time of the survey the stalls were being used as storage that obscured much of the detail. Some of the timberwork appears to have been replaced, particularly the ceiling joists, which are trenched into the frame. It is probable, however, that the shippon was roofed at some point although no trace of this survives. Parts of the floor of the shippon are visible, and were observed to be laid down to flags, cobbles and bricks (Plate 62); a short corridor leads to the main area of the barn.

Plate 61: Surviving shippon on the east side of the barn

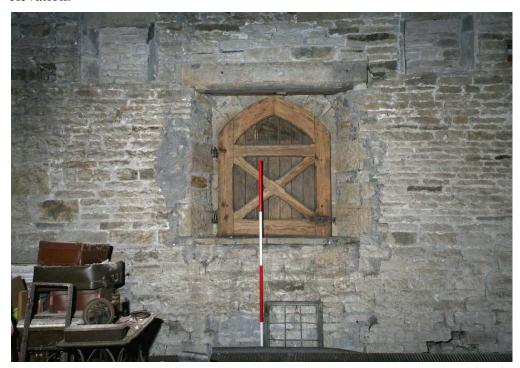
Plate 65: Opening in the south wall of the main barn showing rebuilding

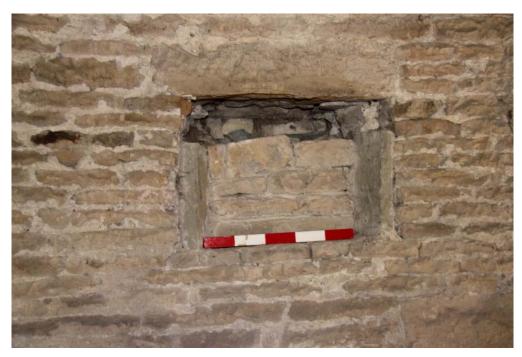
- 4.4.39 There are other blocked openings in the central upper part of the elevation that are arranged in a similar layout as those open apertures in the north elevation (Plate 66, Figs 26 and 28; *Section 4.4.32*). They all appear to be covered over by the outer wythe of the principal southern elevation and none are visible

Plate 66: Example of a blocked aperture on the south internal elevation of the barn
