# **Kirk Mill, Chipping, Lancashire**

## **Archaeological Building Investigation**

**Oxford Archaeology North**

August 2013

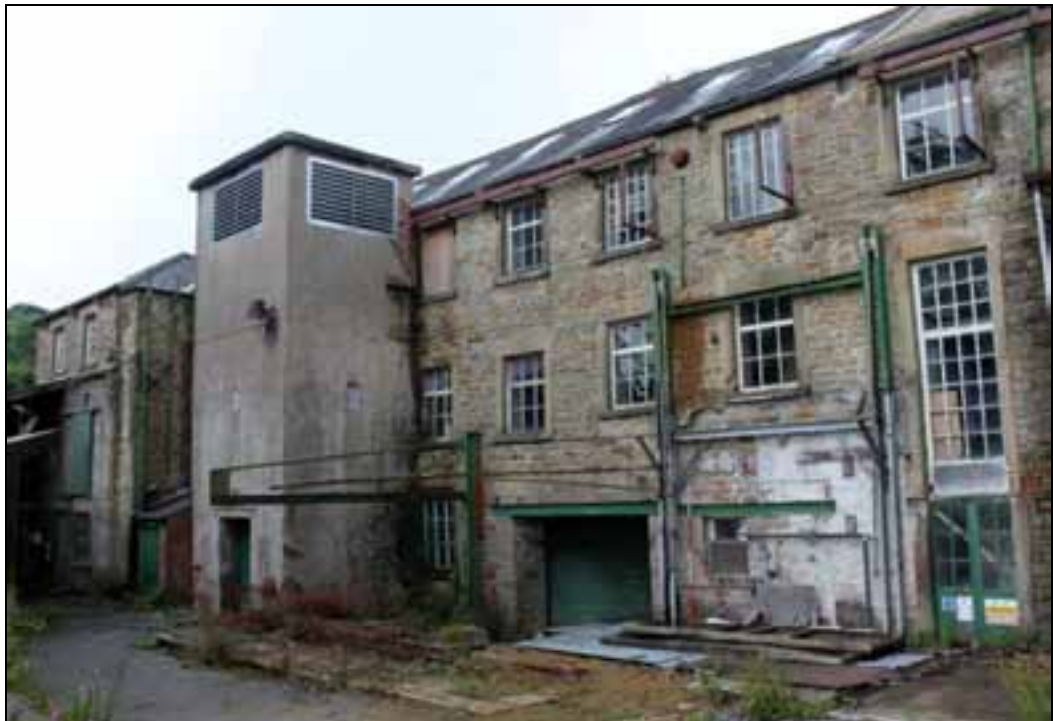
*Plate 4: The south-facing elevation of Kirk Mill*

- 3.2.1 The front, southern elevation represents the only surviving external wall of the original Arkwright-type mill (Plate 4), the eastern elevation now being an internal partition, and the western and northern walls having been removed in all but the wheel house, which was located in the eastern two bays, and projected beyond the north wall of the original structure. The wall is approximately 3' (0.91m) thick, diminishing to 2'6" (0.76m) at first-floor level, and 2'3" (0.68m) on the upper floor. The fenestration comprises vertical windows of 4' (1.21m) width, with dressed sandstone surrounds, flush with the wall face (Plate 4), and with slightly projecting plain sills. Several of these retain small-paned 25-light timber windows, which if not original, represent early replacements, whereas elsewhere nine-light timber-framed replacement windows of a probable late nineteenth-century date, make up the majority of the extant fenestration (Plate 4).

- 3.2.2 At ground-floor level, two windows were remodelled into a large loading doorway, with only their lintels surviving above, whilst a narrow window to the east represents a later insertion (Plate 4). This has an I-section steel beam lintel, extending beyond the window, and having a 'FRODINGHAM IRON & STEEL CO LTD' rolling stamp, suggesting a date of insertion in the early twentieth century. The wider wall space to the right denotes the position of a free-standing, square-section tapering chimney, depicted on a photograph of 1924 (Plate 2), which would have partly blocked the light into the windows of the eastern two bays.

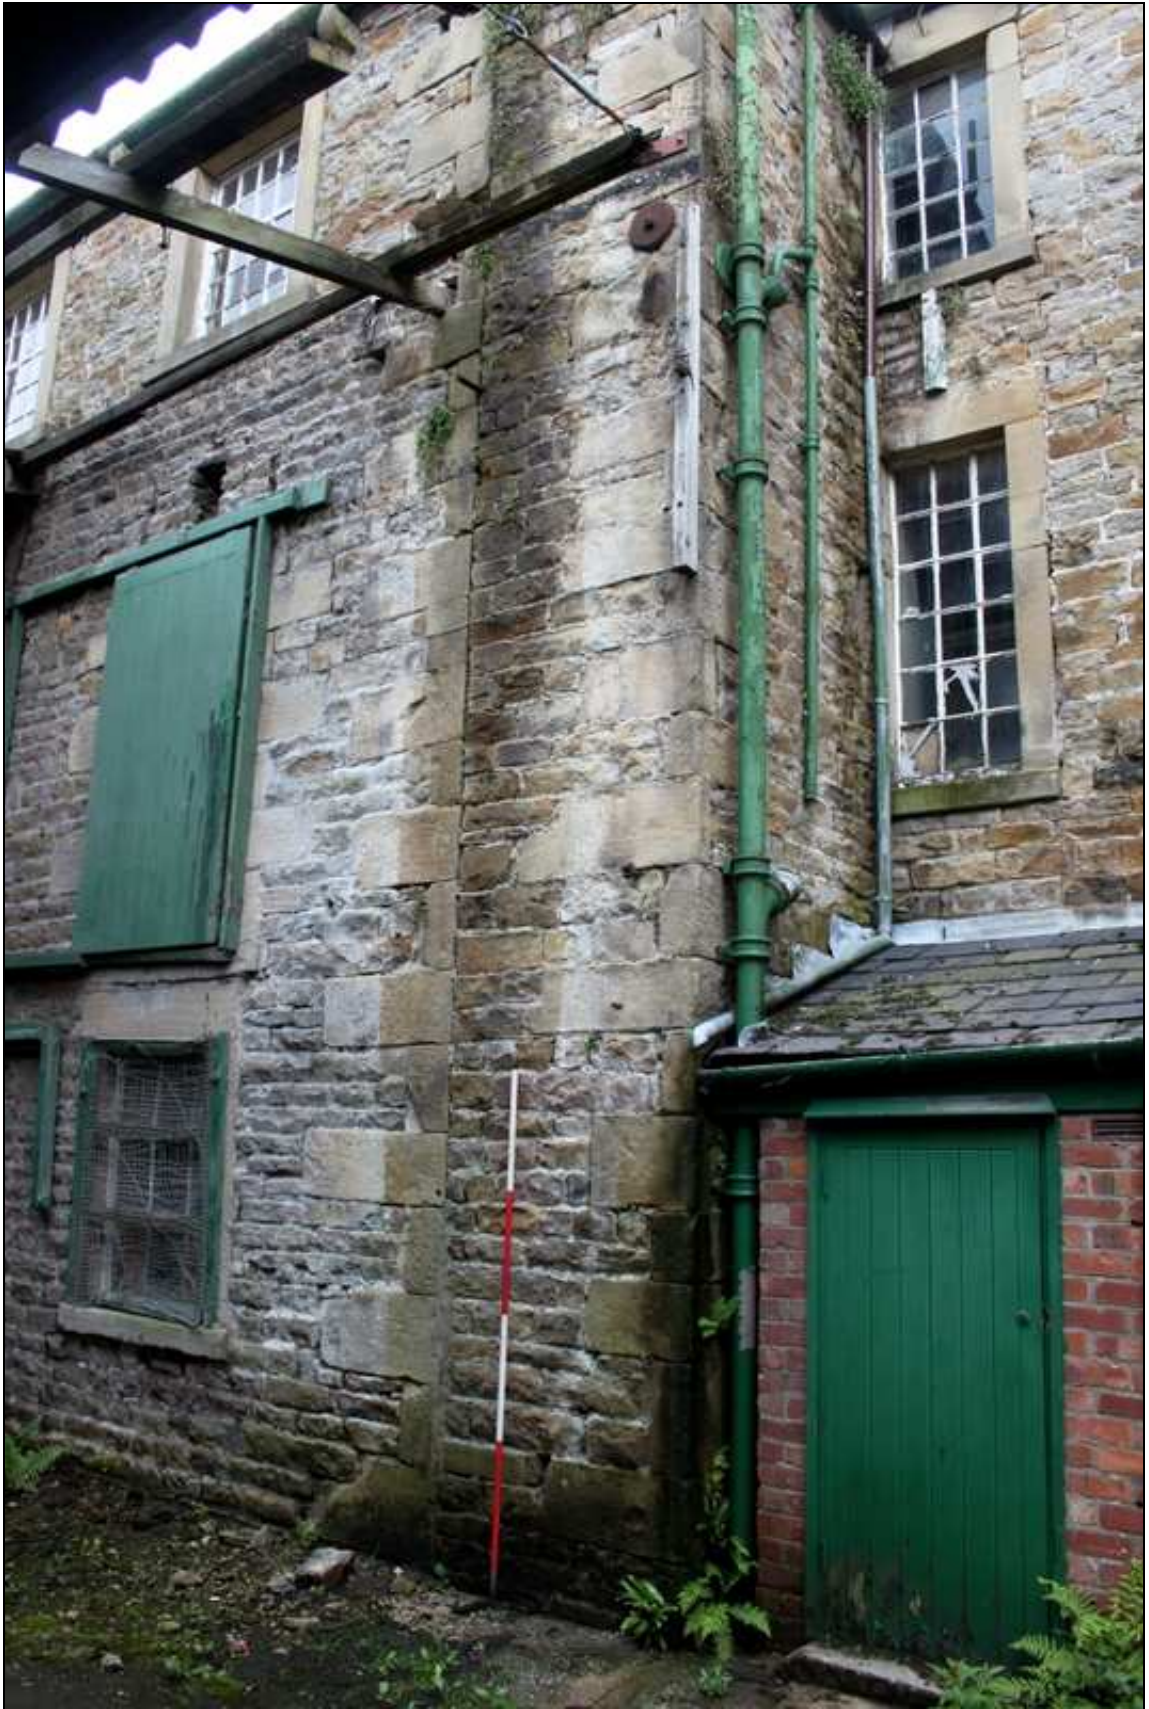
Plate 5: Quoined returns of west wing and privy tower

- 3.2.7 At its south-eastern corner, the west wing was butted by a small rectangular privy tower, which was of similar construction, but with slightly differing course levels (Plate 5). This had narrow slit windows adjacent to the main façade in the eastern wall, which were presumably originally unglazed, providing ventilation, and a minimal amount of light to each privy.

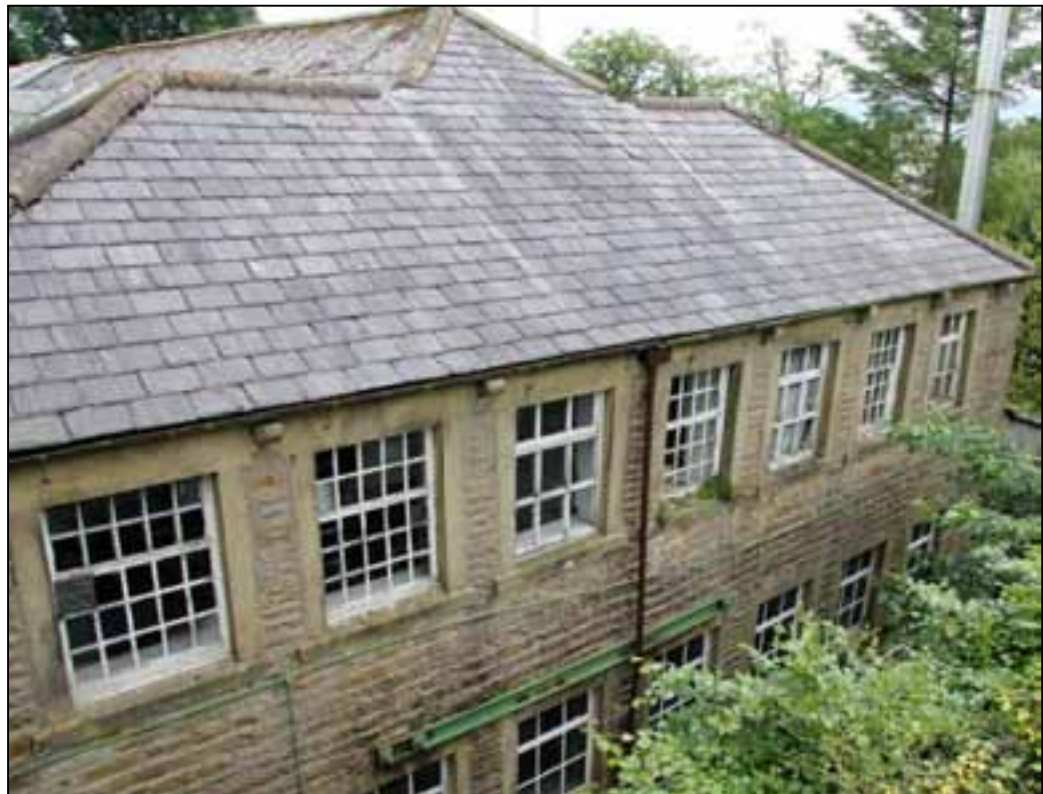
*Plate 12: External west elevation of the west wing*

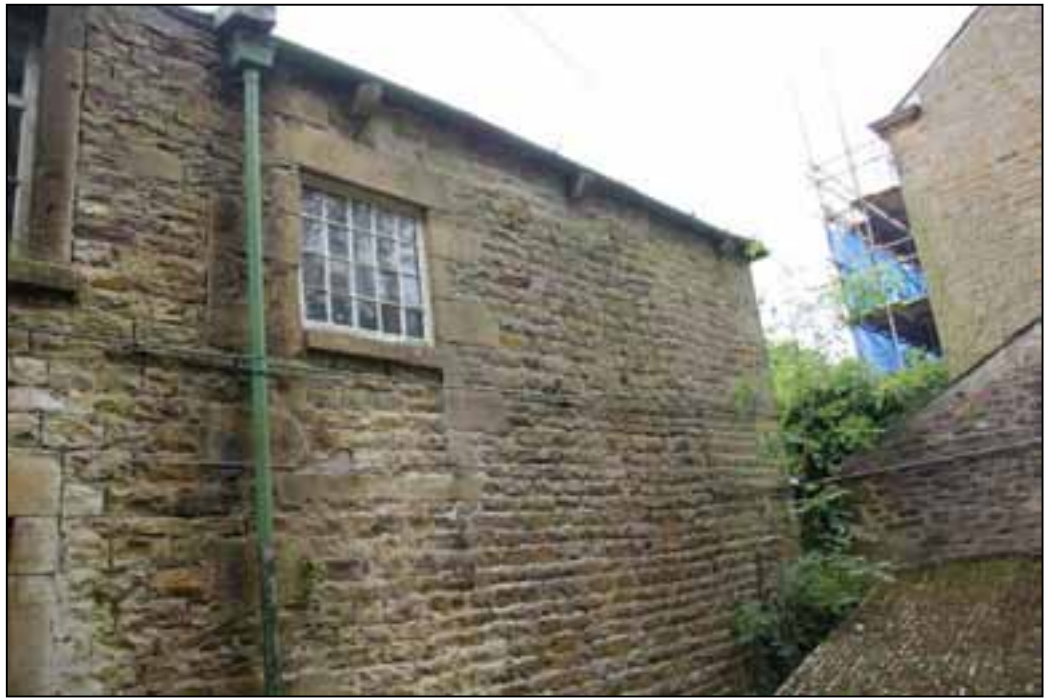
*Plate 13: Butt joint between the west wing and the north wall, with blocked doorway*

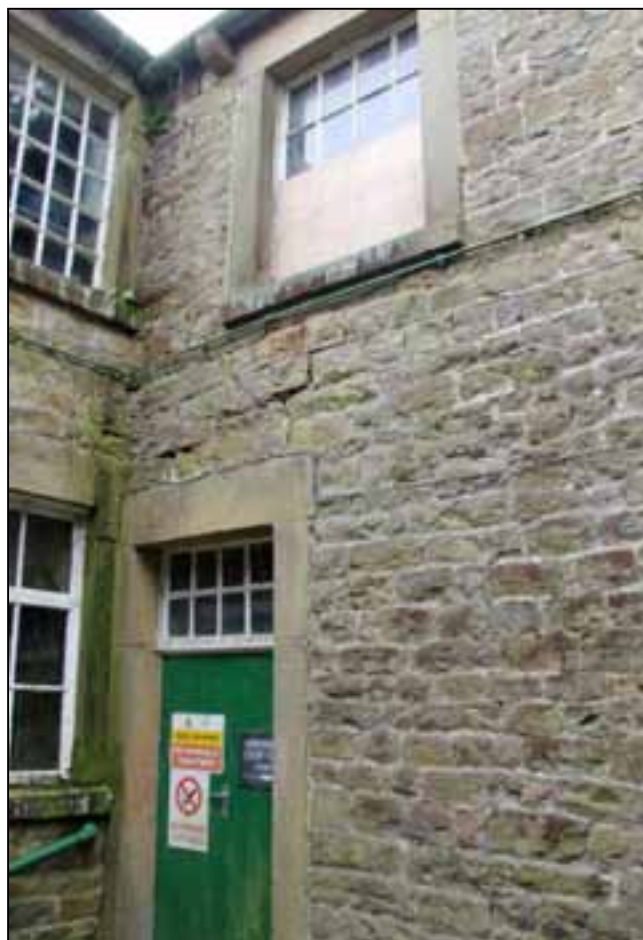
- 3.2.9 A rectangular stair tower was also added to the northern side of the mill. It is unclear whether this represented a contemporary construction to the repositioning of the north wall, or was a subsequent remodelling, as the western joint was obscured by a downpipe and vegetation, and the eastern joint comprises only five keyed courses between the window and door apertures that were placed at the junction of the two walls (Plate 15). The fact that the courses are not aligned in this position does suggest different dates of construction, with facing stones from the north wall possibly being removed in order to key the two structures together in this small area. The sill of the second-floor level window is also partially overlain by the stair tower wall (Plate 15), whereas it would more likely end at the joint between the two walls in a contemporary construction.

*Plate 15: East wall of stair tower*

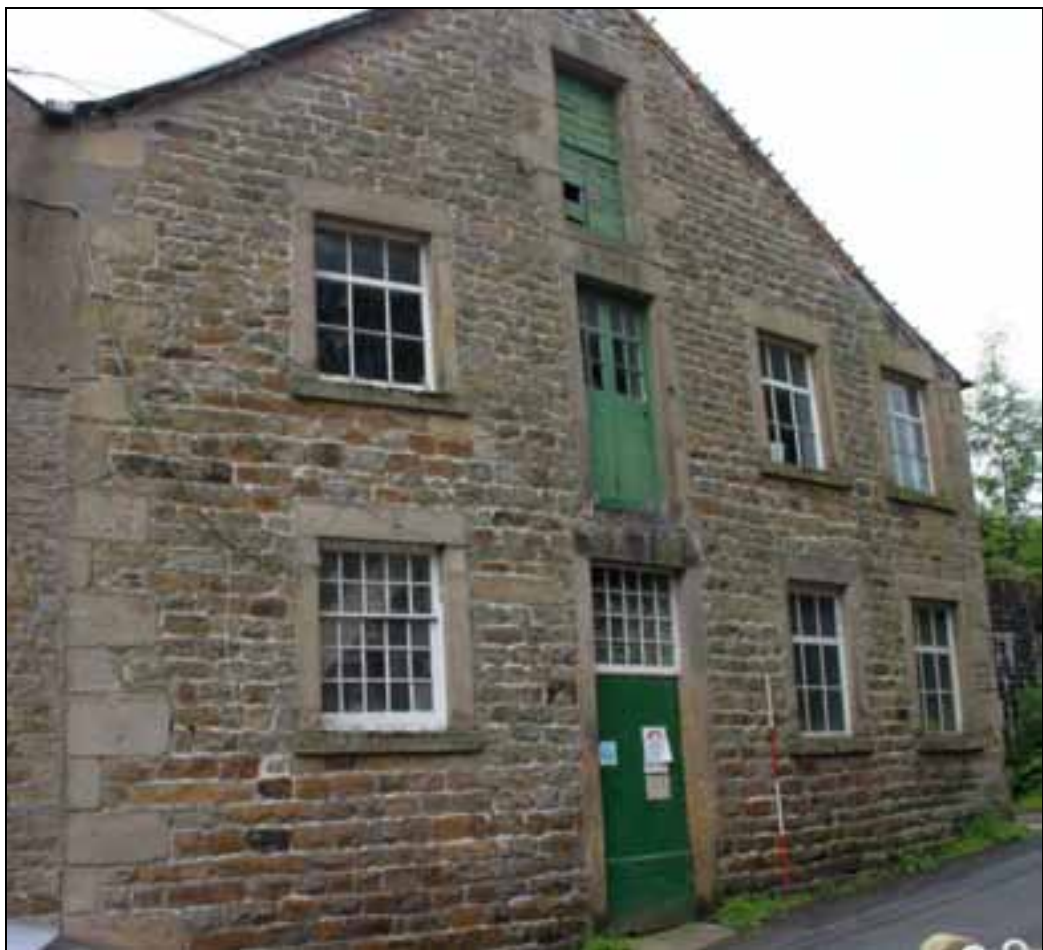
- 3.2.12 A further extension was added to the east of the waterwheel. It was constructed in similar style to those to the west, in coursed local sandstone rubble, and again with quoined returns (Plate 19). It comprised 4 x 2 bays, angled around a slight bend in the road, and has a pitched roof with a loading loophole to both above ground-level floors and to the attic (Plate 19). This was originally placed centrally within the eastern façade, flanked by vertical windows to both floors, with all but the lower southern window having nine-light windows. That in the southern bay retained a 25-light vertical sash (Plate 19), which is probably an original aperture, being retained when it was partially blocked internally by the insertion of a staircase.

*Plate 19: East wing*

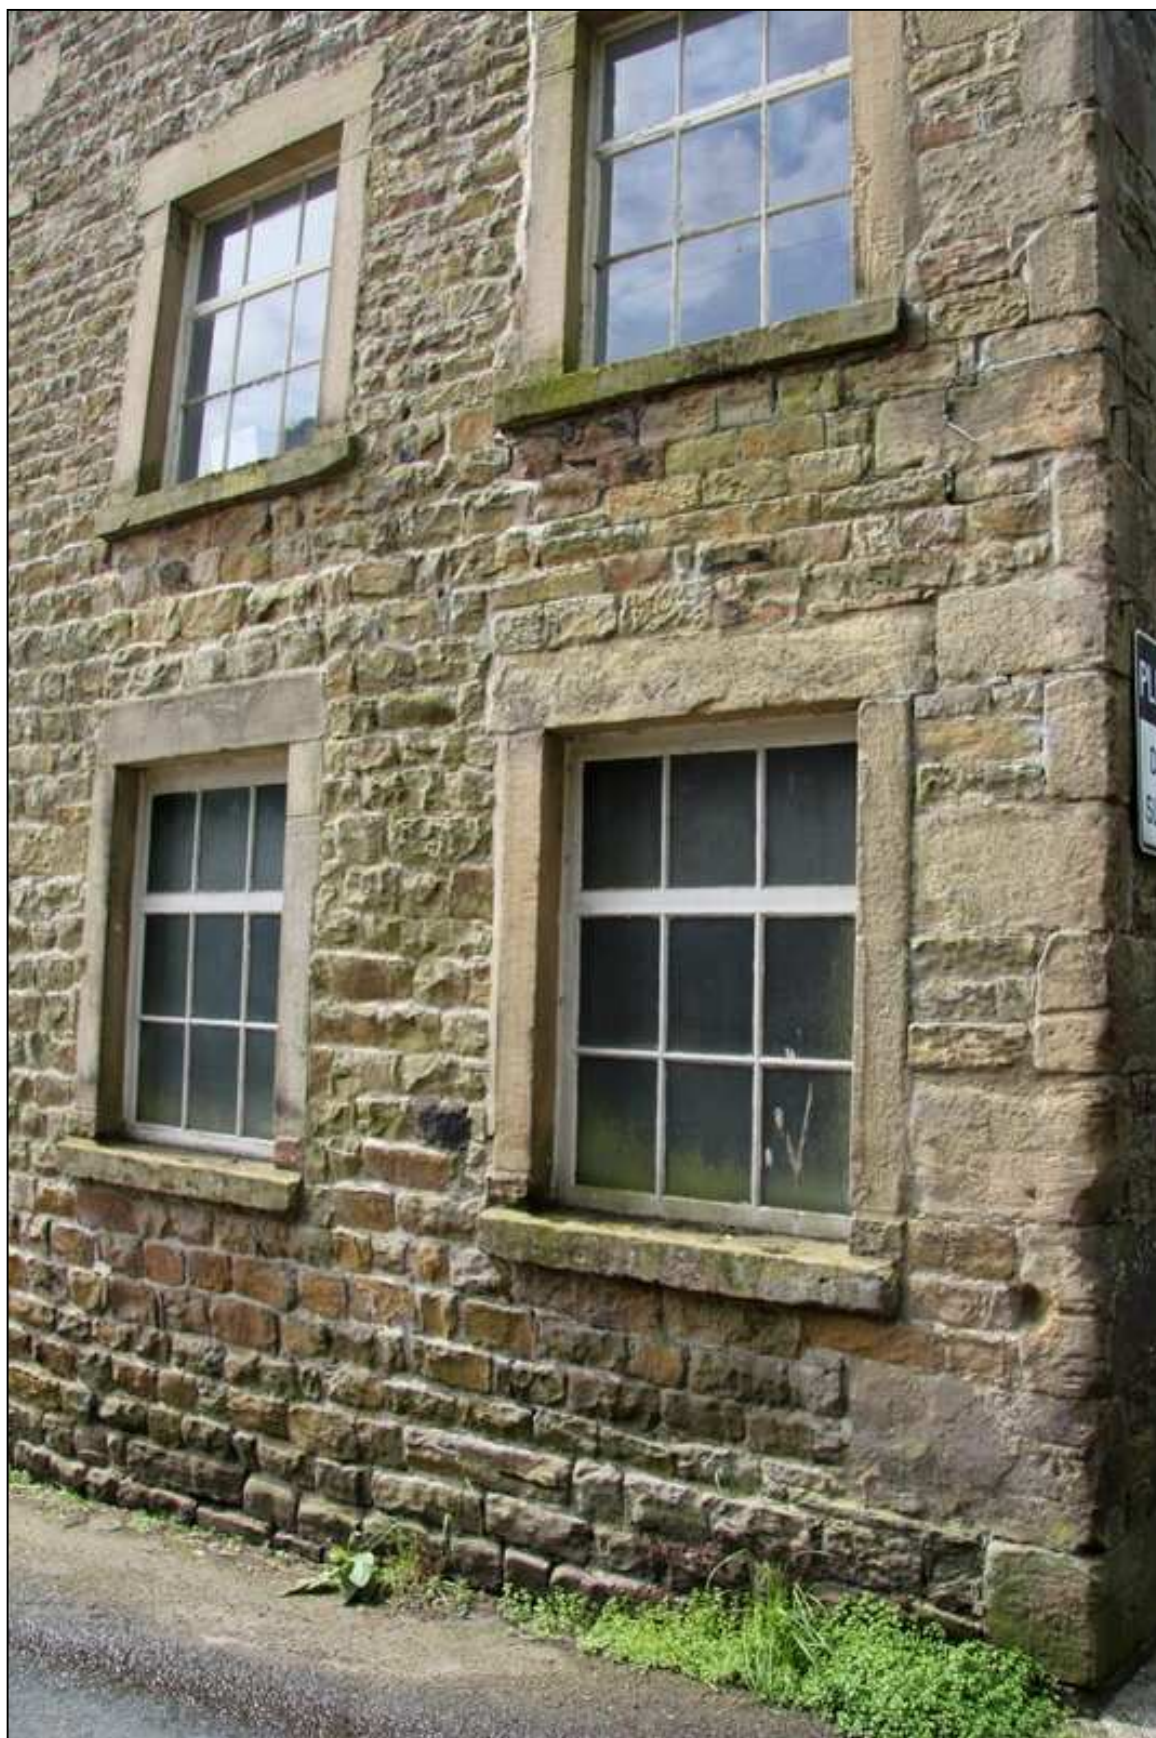
- 3.2.13 The northern wall was also repositioned subsequently, moving it flush to the wheel house, which had earlier been extended, as demonstrated by the quoins around its eastern return (Plate 11). This allowed for an extra window to be inserted at first- and second-floor level (Plates 19 and 20). The rebuilding of the wall can be seen within a subtle change in coursing and stone dressing at the northern end of the elevation, and a subtle change of gradient in the pitch of the roof (Plates 19 and 20).

*Plate 20: North return of the east wing, showing rebuilt wall and inserted windows*

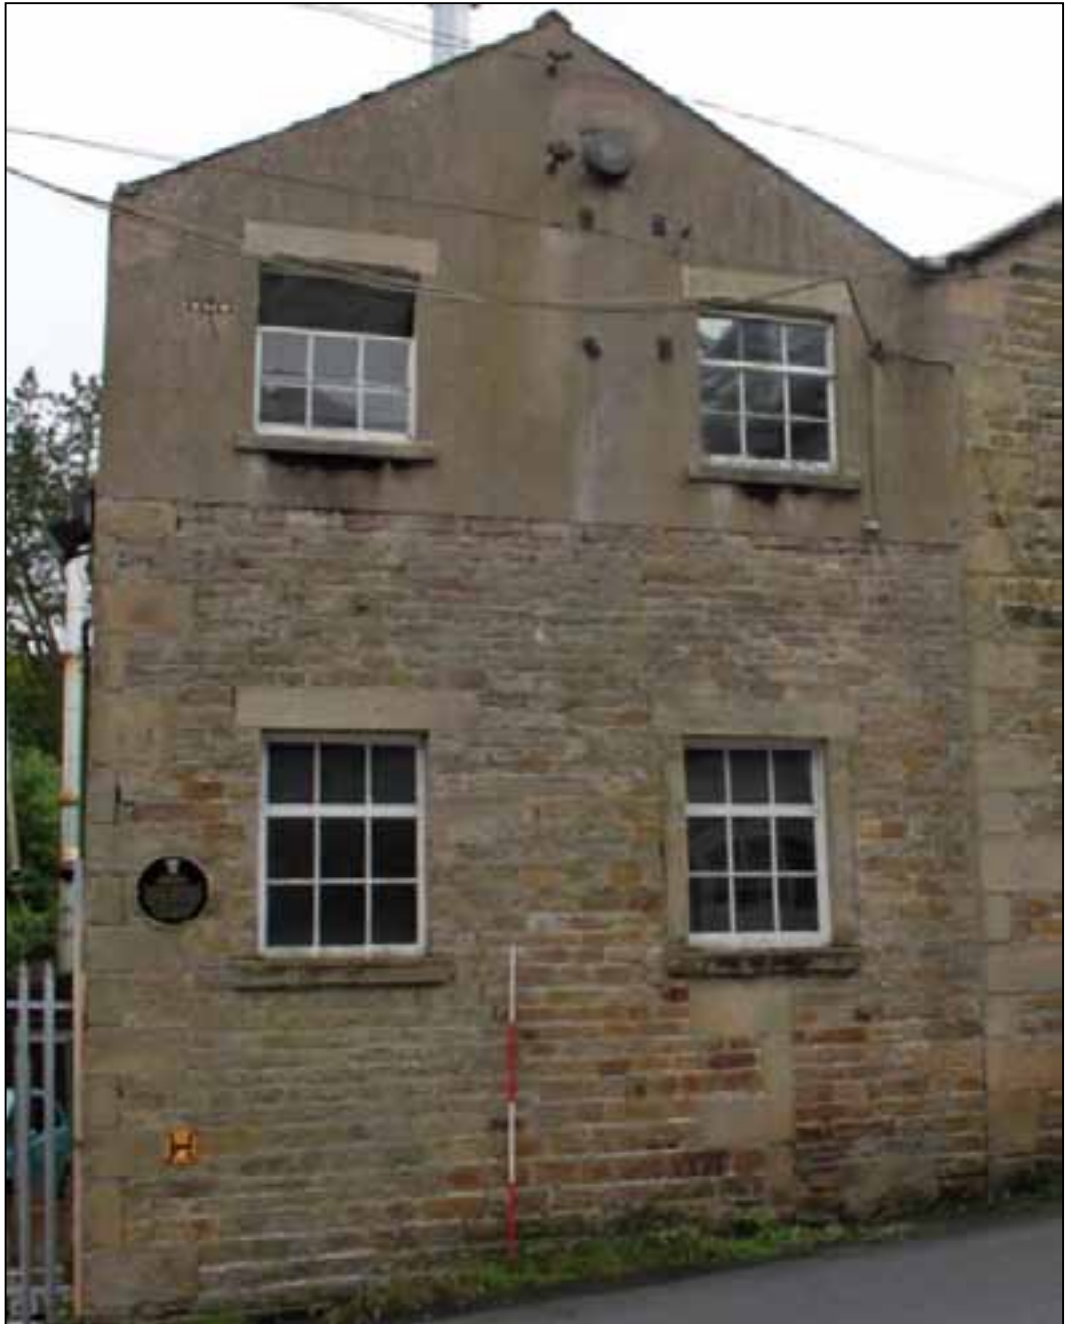
*Plate 21: Southern extension to the east wing*

- 3.2.15 A column of quoins in the east wall indicate the position of a former aperture at road level, blocked subsequently in stone (Plate 21). This possibly afforded access into a boiler house that was probably placed at ground-floor level within this extension. A sandstone block immediately above road level within the blocking (Plate 21) represents the lintel of a coal chute, suggesting that the boiler was retained after the blocking of the doorway. This may relate to the remodelling of the south-western corner of the extension, where the wall at ground-floor level was removed to produce an open-fronted bay (Plate 22), affording access to both the boiler / waterwheel axle bearing, and a store beneath the eastern bay. An aperture at ground-floor level was blocked with sandstone rubble, and represented an original doorway, and being the only aperture shown on a photograph of 1924 (Plate 2). An additional window with a rubbed sandstone cambered lintel (Plate 22), was inserted subsequently at first floor-level, and is depicted on a photograph of 1933 (Plate 3), taken following the removal of the chimney, itself shown on the Ordnance Survey plan of 1932.

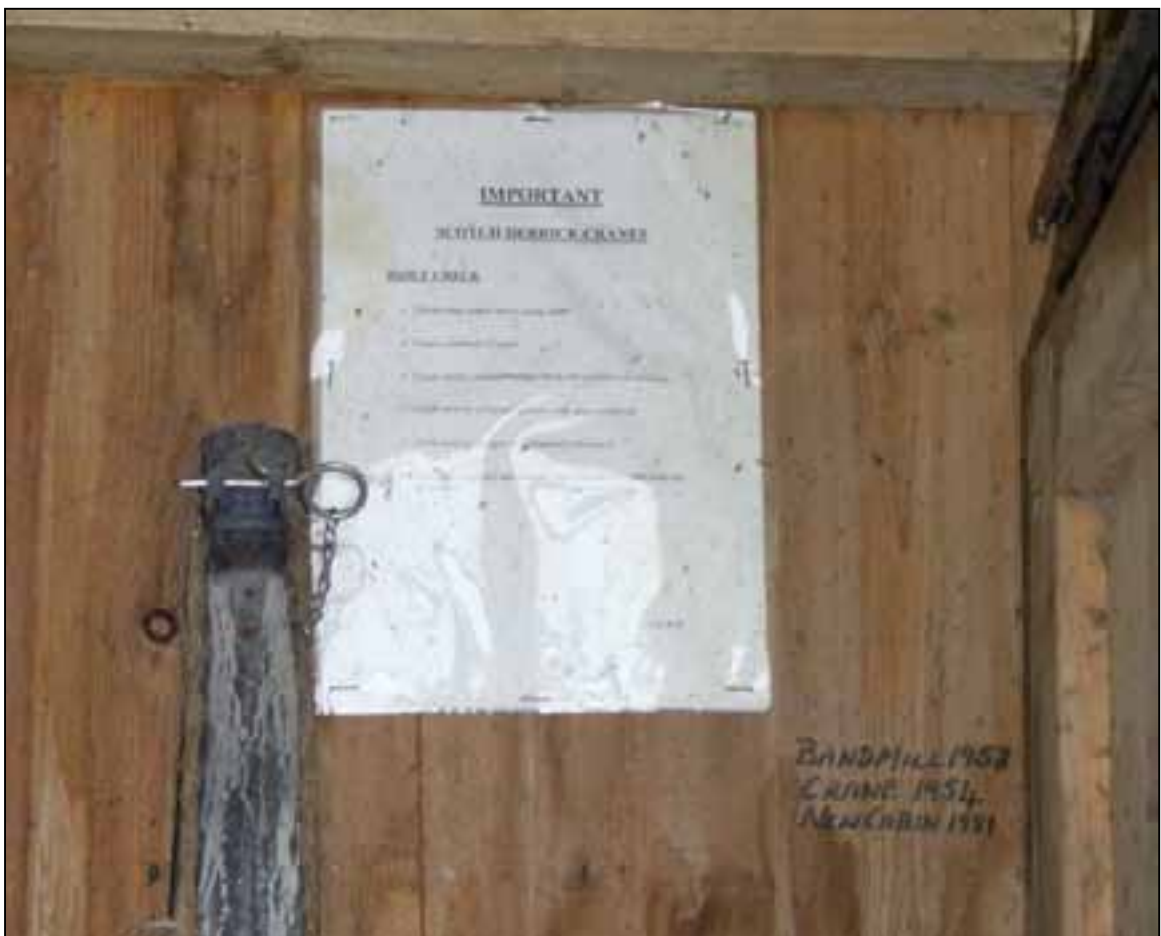
- 3.2.19 To the east, placed adjacent to the canalised brook, is a derrick crane (Plate 25). Although similar in appearance to that depicted in the photographs of 1924 and 1933 (Plates 2 and 3), the crane legs were renewed in 1954, and a new sheltered cabin was added in 1981 (Plate 24). It is probable that the gearing forms part of its original construction.

Plate 24: Dating of crane features within cabin

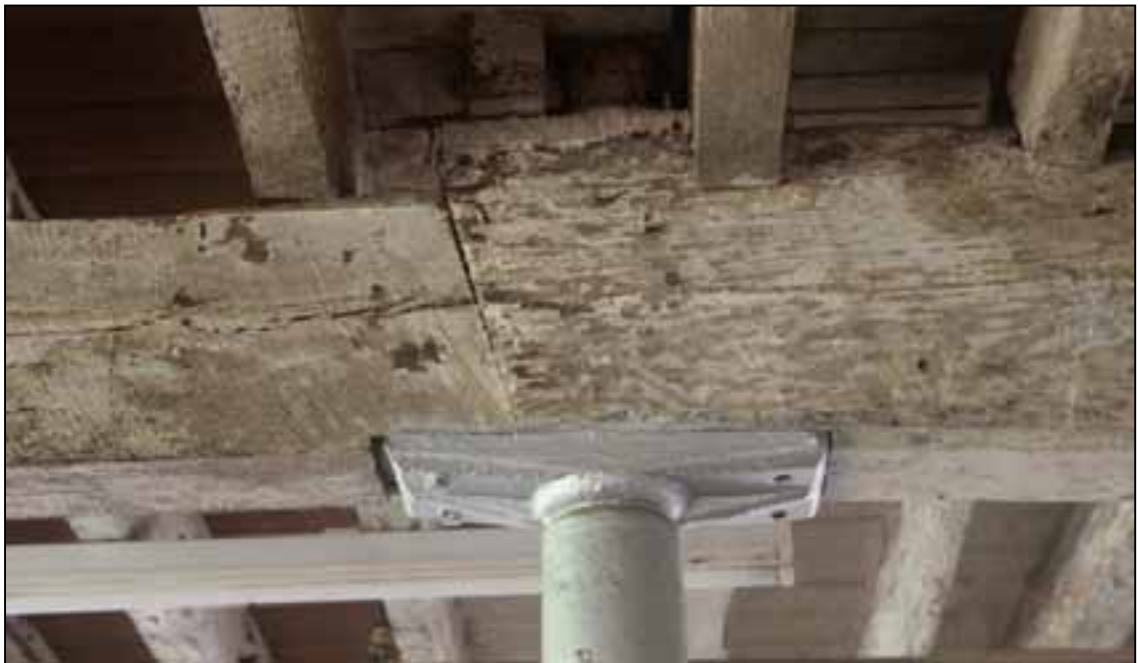
- 3.3.2 Each scarf joint is carried on a cast-iron column (Plate 27). In the western three bays, these comprise 5" diameter columns with mid-height astragals and further astragals 15" above the 10" diameter foot (Plate 28). The diameter of the column head reduces to 4" diameter and fits into a separate cap, which is bolted to the soffit. The adjacent two columns are 3¾" diameter and have octagonal section feet of 6 and 13½" height respectively (Plate 29). The final column appears to be a combination of the two styles, being 5" diameter, but octagonal section below the lower astragal above a rectangular foot (Plate 30). It also has an integral head plate, unlike those to the west.

*Plate 27: Simple scarf joint in ceiling beams above ribbed capital*

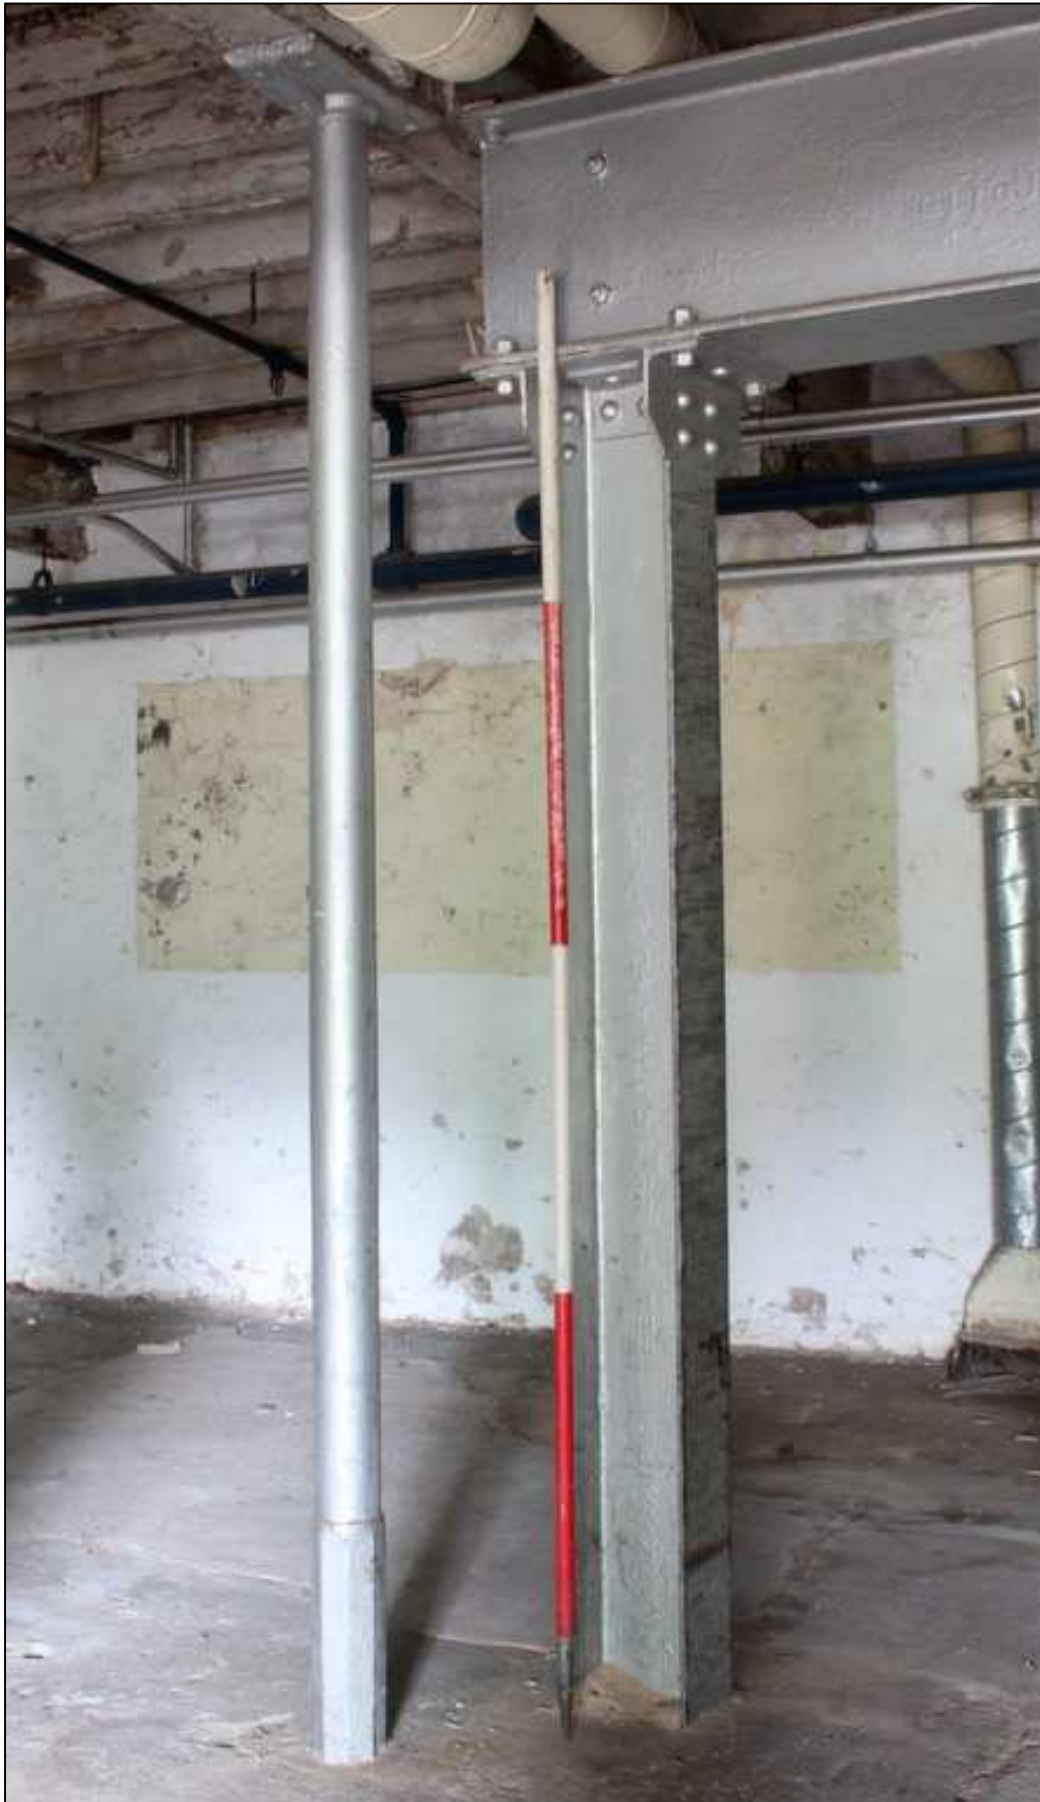
Plate 29: Detail of octagonal-section column foot

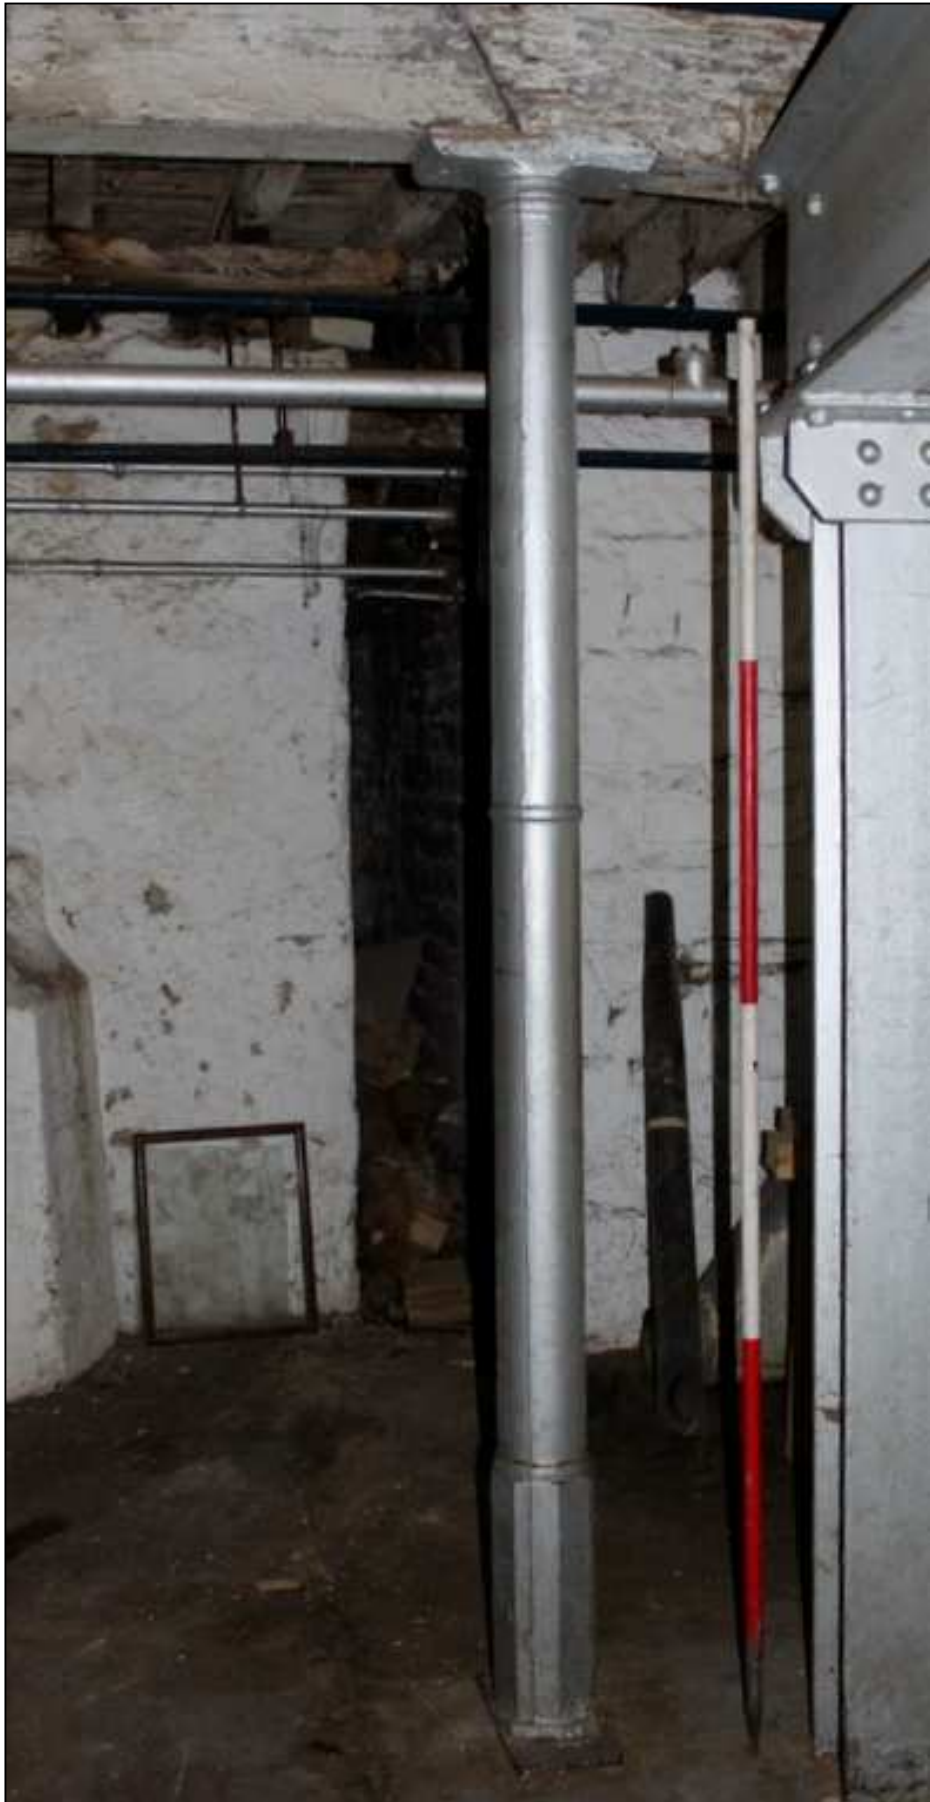
Plate 30: Column with astragal in shaft

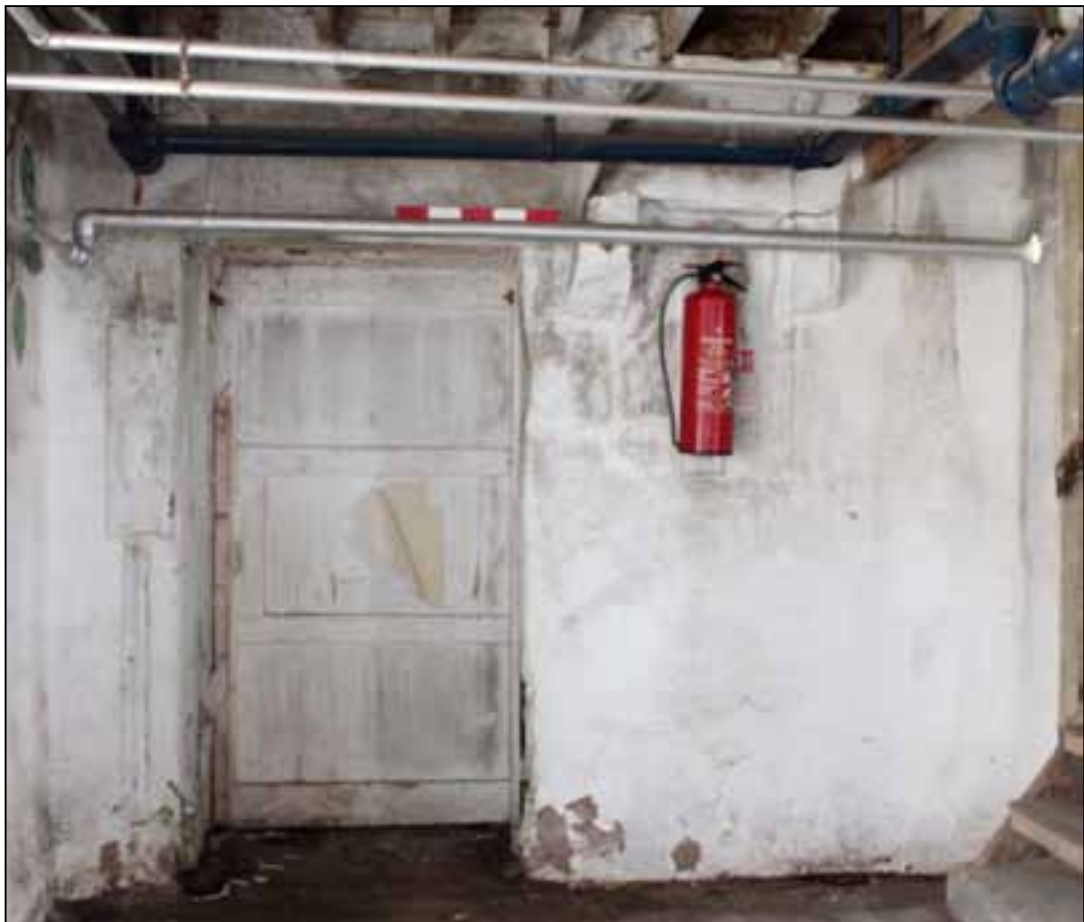
- 3.3.7 The western bay of the north wall of the extension also contains what appears to be an original doorway (Plate 34), with the corbelled footings of a hearthstone placed immediately to the east below ceiling level providing the only evidence for a fireplace on the floor above (Plate 34). An extant doorway in the adjacent bay within the west wall was inserted through a window aperture. The window to the east in the north wall had a flat sill, unlike those in the west wall, but was similarly placed 3' (0.91m) above floor level, terminating 8" (0.21m) below ceiling height.

*Plate 34: Door in north wall of west wing, and corbels carrying hearth of fireplace above*

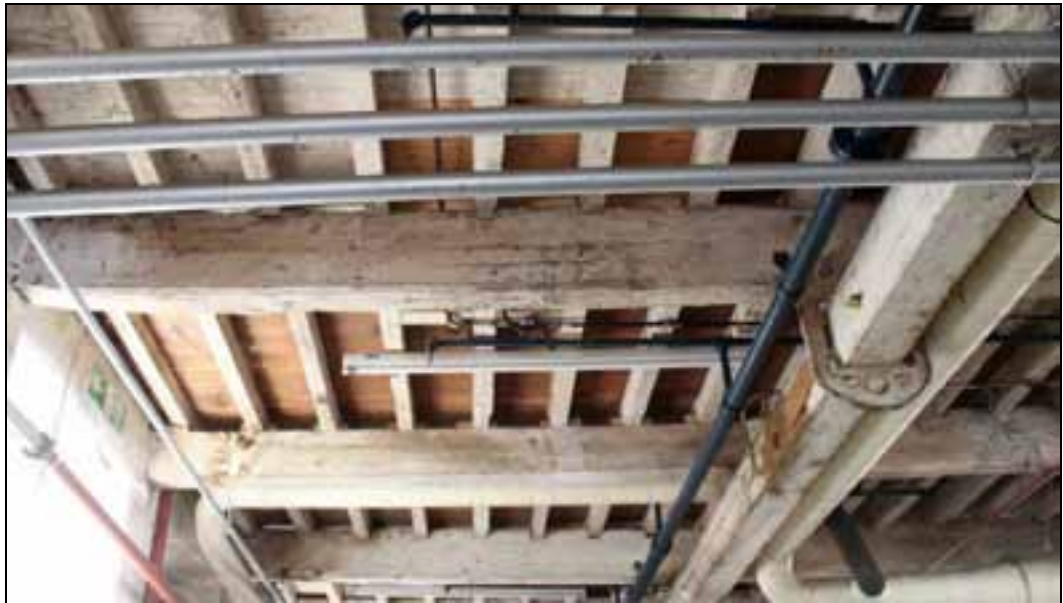
- 3.3.8 The ceiling of the extension comprises north/south-aligned 3 x 4½" (0.08 x 0.11m) joists carried on 6½ x 13" (0.16 x 0.33m) beams, the third from the southern end having Baltic timber marks at its western end. All beams, with the exception of the fourth beam from the southern end, which is a circular-sawn replacement, are stop-chamfered at either end, but not above a central north/south-aligned 8 x 10" beam with rolled-edged soffit (Plate 35). This suggests that this beam represents an insertion, originally being supported at either end by a 3½" diameter, cylindrical column with octagonal section foot. That at the southern end was removed subsequently, leaving only the scar of the column head (Plate 36). The beam was also strap-jointed to alternate beams with cast-iron brackets (Plate 35).

*Plate 35: Additional longitudinal ceiling beam in west wing*

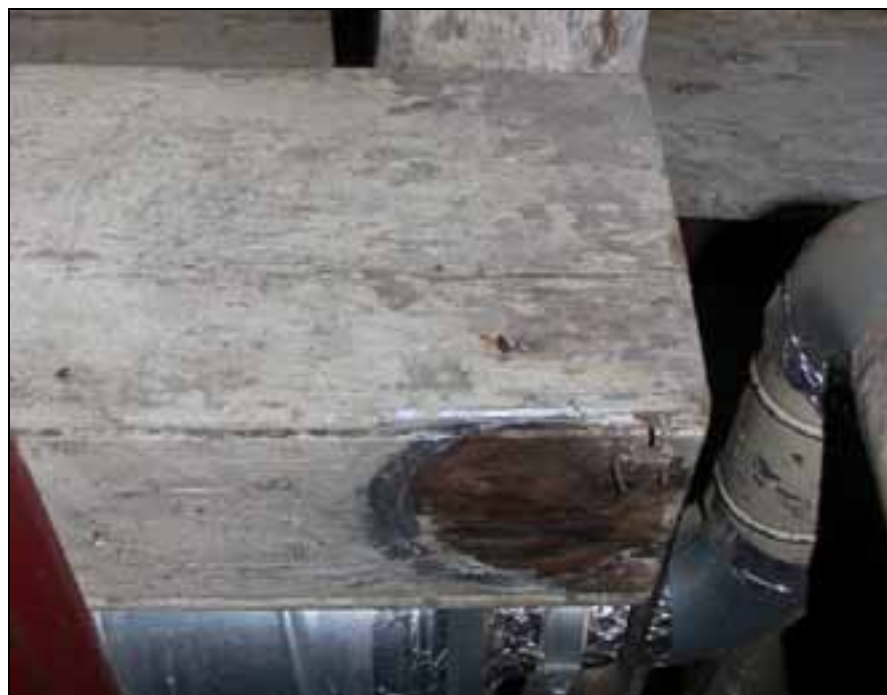
*Plate 36: Scar for column capital*

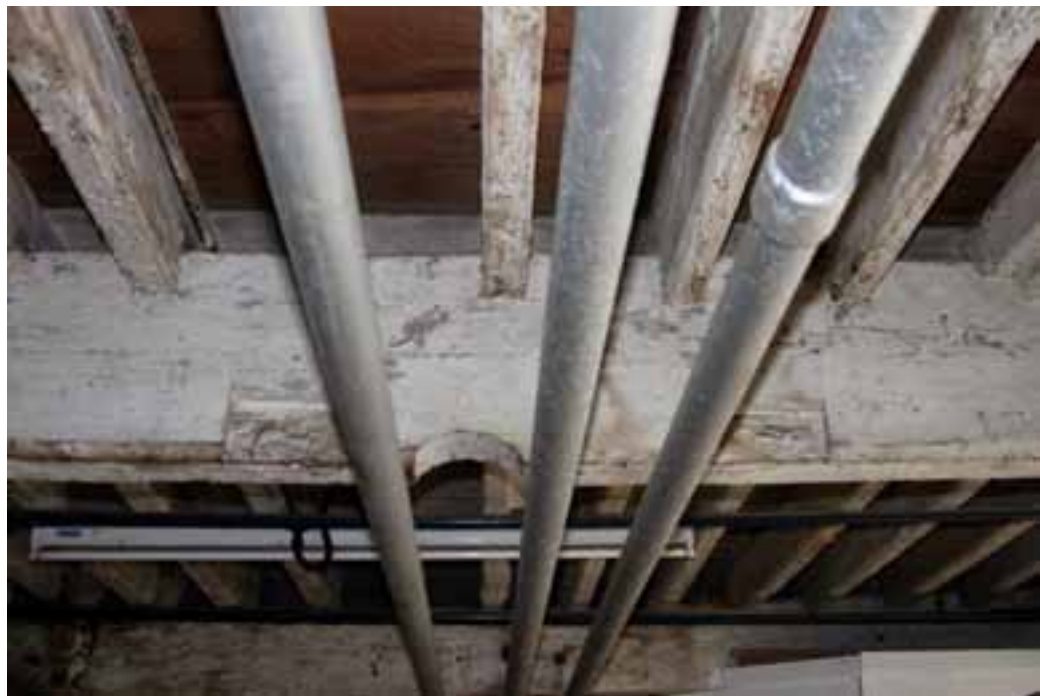
3.3.10 The beams house evidence for three distinct power systems. The earliest was placed in the second bay from the north wall of the original structure and comprised semi-circular cut-outs, presumably for timber shafting (Plate 32). The fourth beam from the west end has the cut-out for this shaft only on its eastern face, whilst the cut-out in the beam to the east is shallow, and offset to the north, suggesting jointing in the shafting. The adjacent beam has no evidence for this shaft, whilst that in the penultimate beam lies significantly to the south, flanked by 8¼ x 4x1½" cut-outs at the base of the western face (Plate 38). In the eastern bay, the cut-out is placed slightly north of the centre line.

*Plate 38: Semi-circular cut-out in ceiling beam soffit for original line shafting*

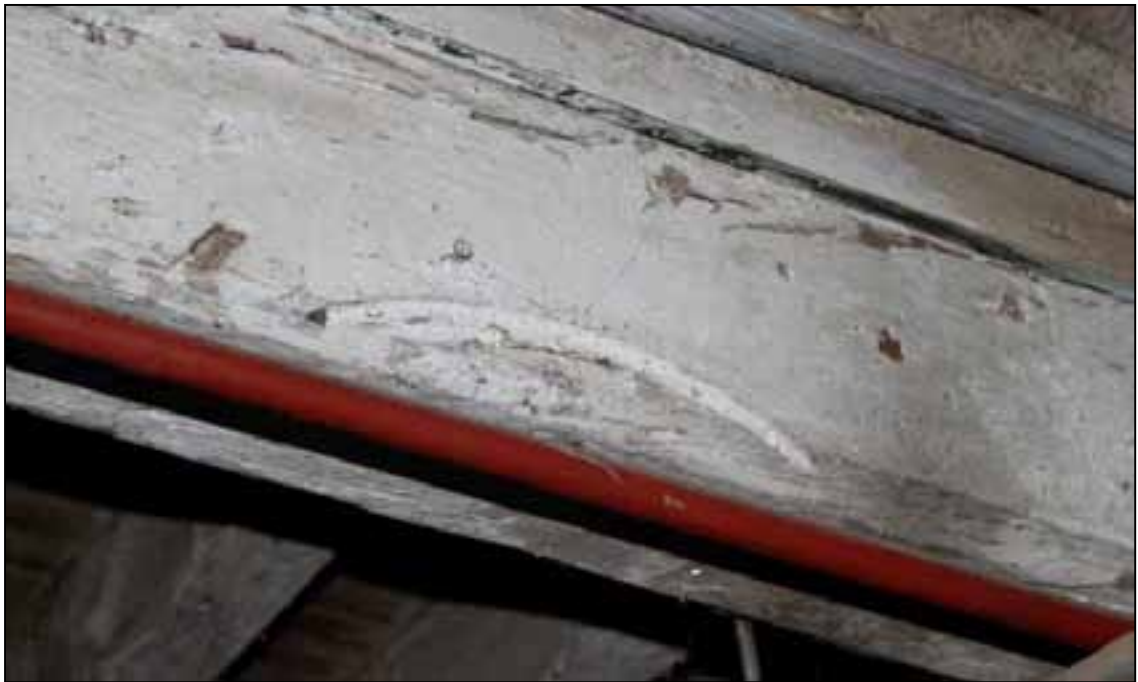
*Plate 39: Scar of drum attached to line shaft*

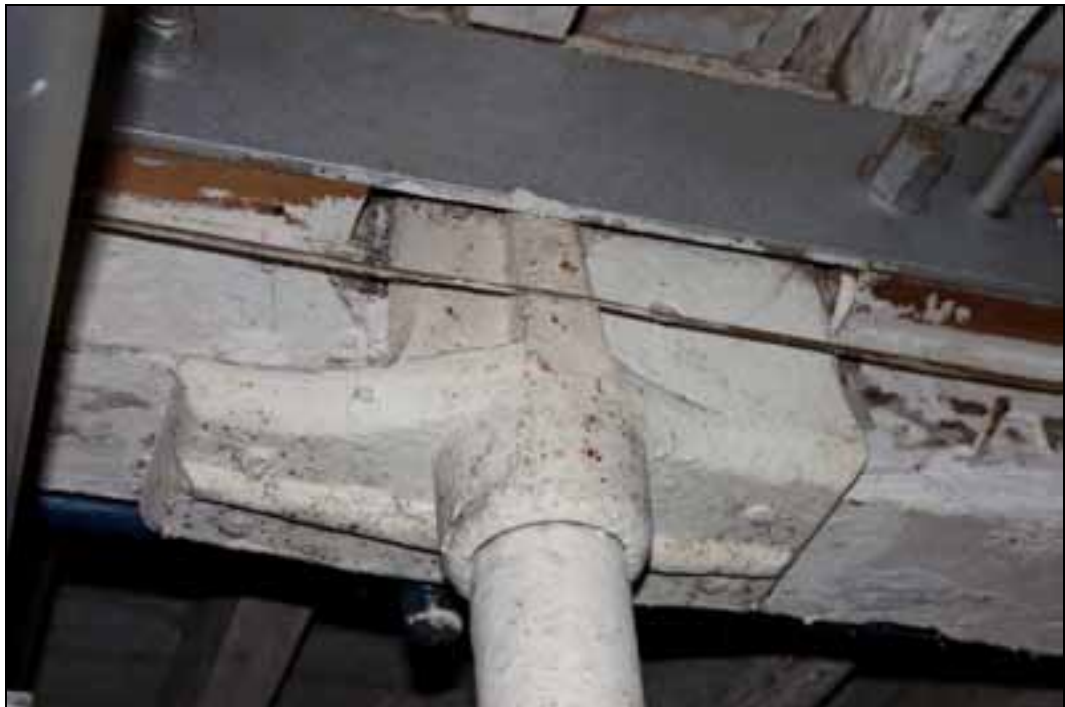
- 3.3.23 All beams have narrow cast-iron columns placed below the scarf joint, with that below the fifth beam having an L-section head plate, offsetting the column to the western side of the beam (Plate 53). Many of the other columns have significant lean, particularly the eastern three bays (Plate 54). The flooring of the main mill at first-floor level comprises 5½" and 4½" north/south-aligned boards.

*Plate 53: L-section column head plate*
