# **Kirk Mill, Chipping, Lancashire**

## **Archaeological Building Investigation**

**Oxford Archaeology North**

August 2013

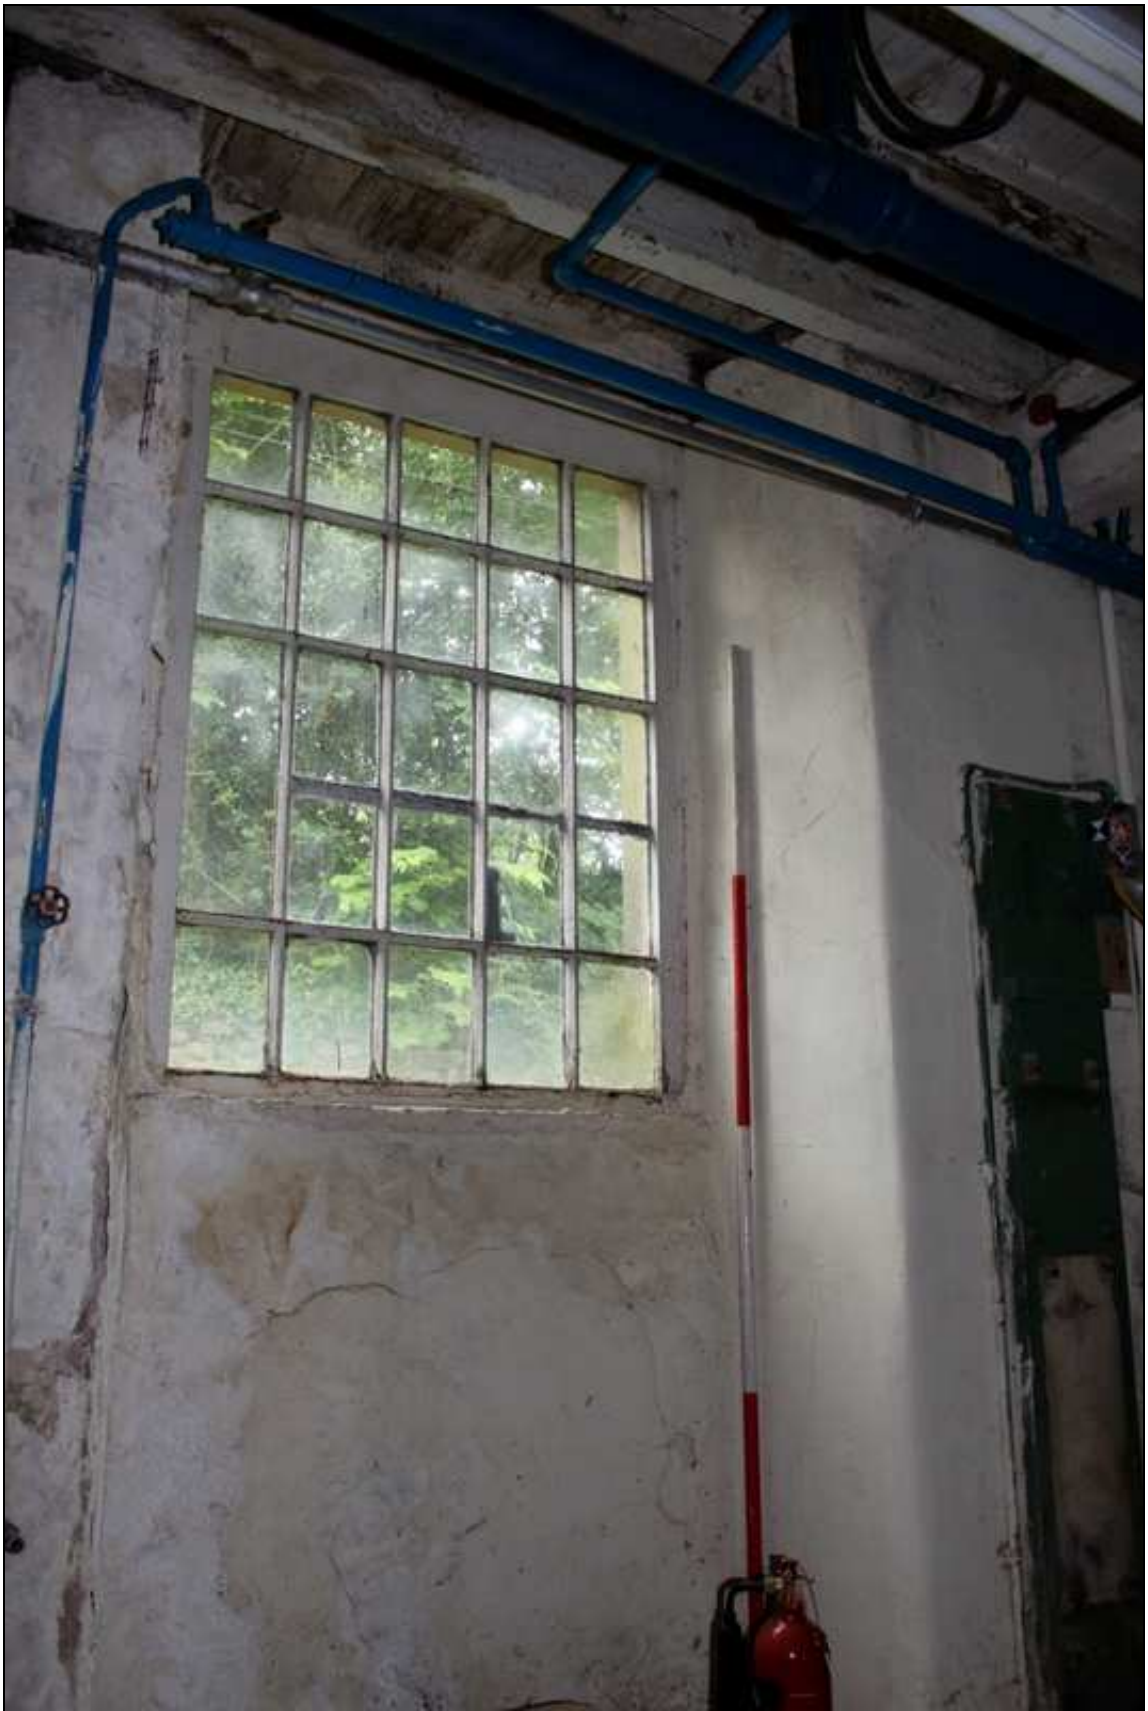
*Plate 55: 25-light window in north wall, first floor*

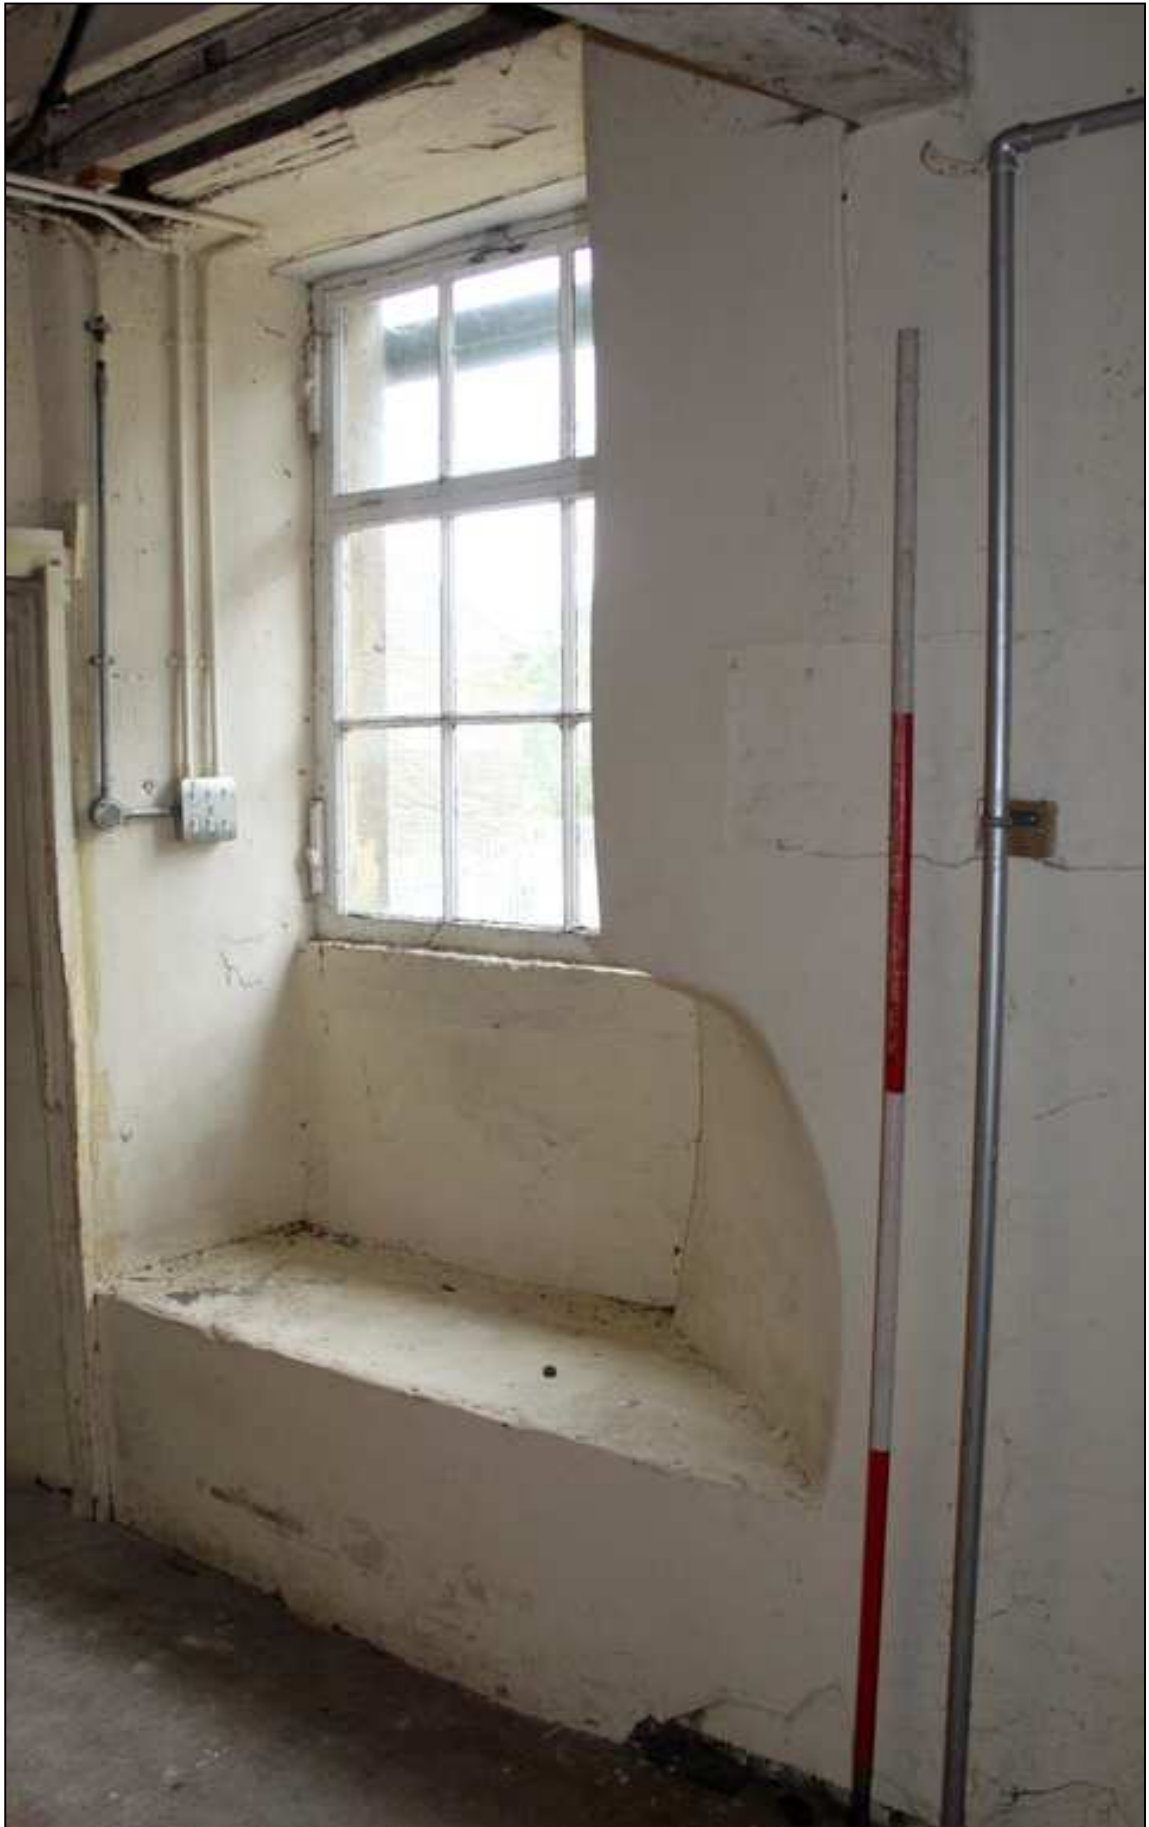
- 3.3.24 The extension to the western end of the mill has a door in the eastern bay of the south wall, with a dressed surround, and apparently representing an original loading door from the yard. All windows throughout the floor in all but the west wall, and the east bay of the south wall are recessed to floor level, with those in the north wall again being offset to a higher level (Plate 55), as at ground floor level. Several retain 25-light small-paned timber windows. The window aperture of the east bay of the south wall has a 20" high sill and a curved 30" high rebate in its western jamb (Plate 56), possibly cut away to allow for the headstock of a wider mule.

*Plate 56: Rebate in south wall, possibly for mule headstock*

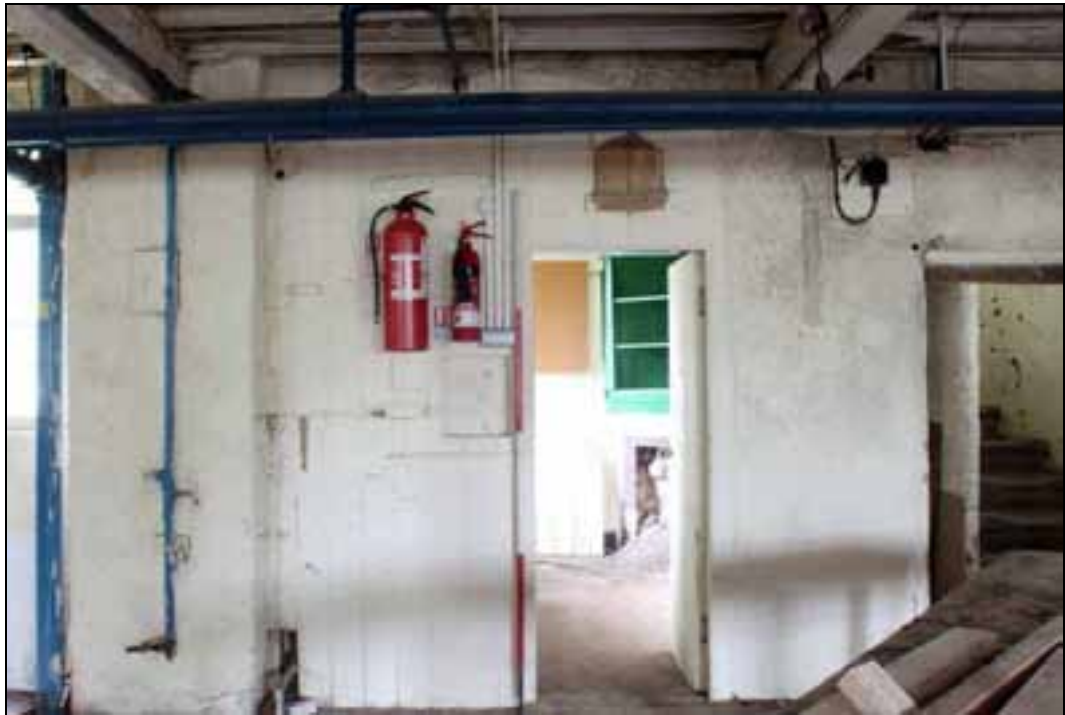
3.3.27 At first-floor level, a full width, full-height stone-arched aperture (Plate 60) afforded access into the west bay of the stair tower, which had a brick fireplace in its north-east angle (Plate 60). This formed part of an office which had a timber panel partition to the main structure (Plate 60), with the second floor landing being carried on a T-section fish-bellied beam (Plate 61). Within the main body of the mill, the main control valve, or 'Christmas tree' for the Mather and Platt sprinkler system was placed adjacent to stair tower (Plate 62), with a rare survival of an associated replacement sprinkler-head cabinet, mounted on the wall nearby (Plates 62 and 63).

*Plate 60: Wide arched opening into office within western side of stair tower*

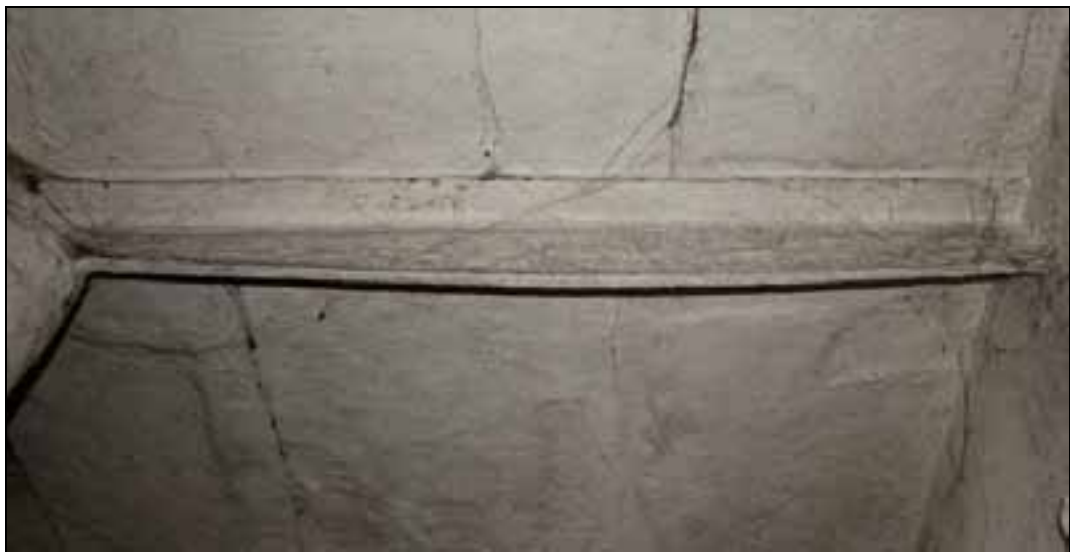
*Plate 61: Fish-bellied T-section beam carrying stair tower landing*

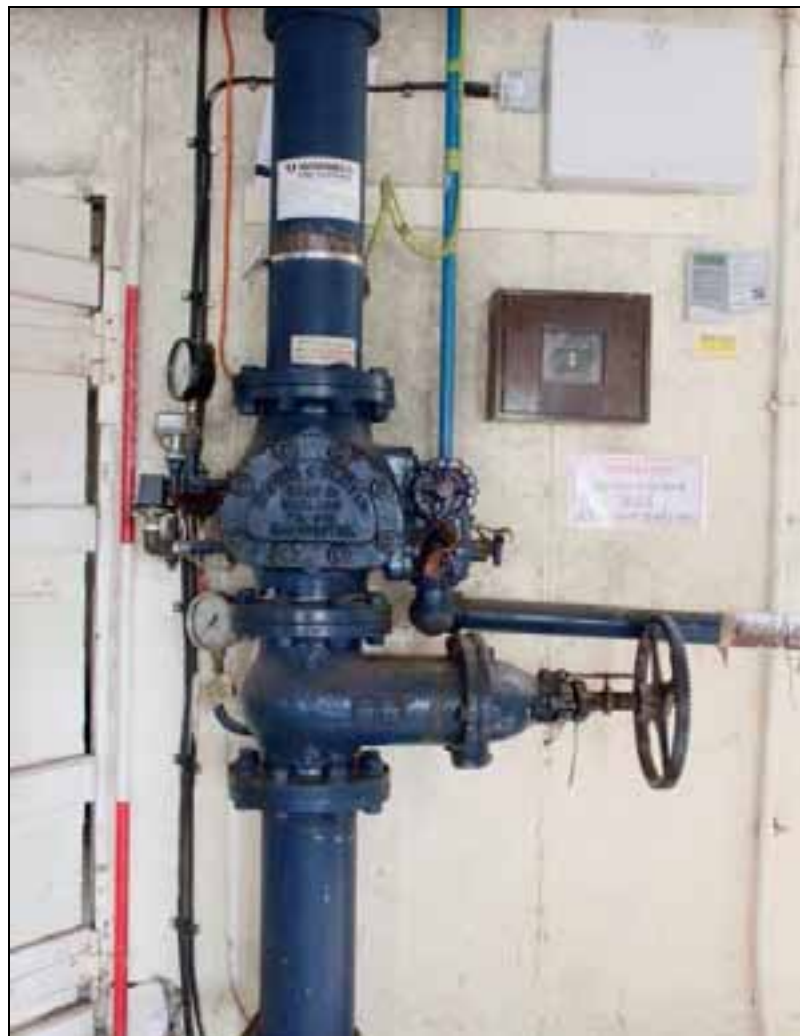
Plate 62: 'Christmas tree' control valve of sprinkler system

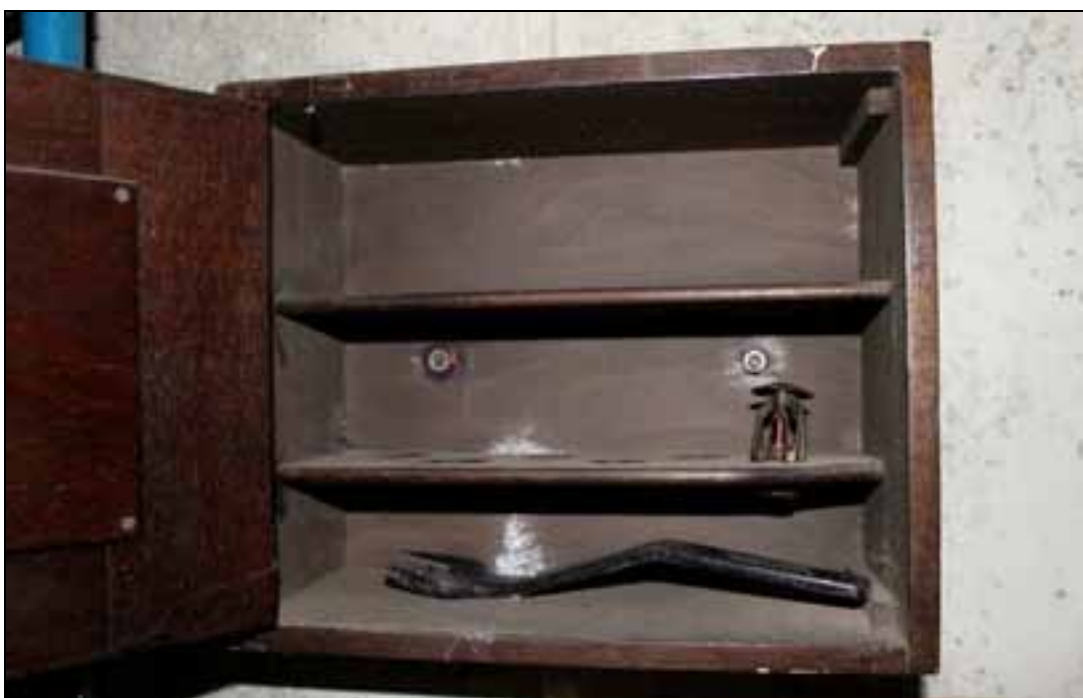
Plate 63: Cabinet housing spare parts for sprinkler system

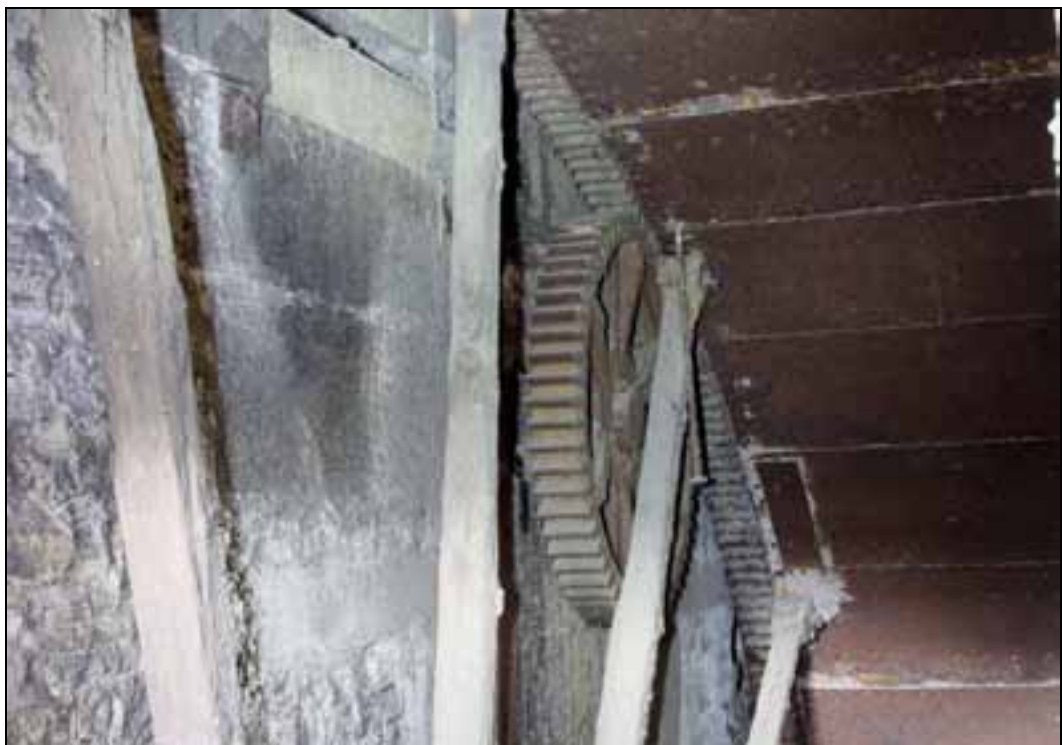
*Plate 64: Pinion wheel on rim gear of waterwheel*

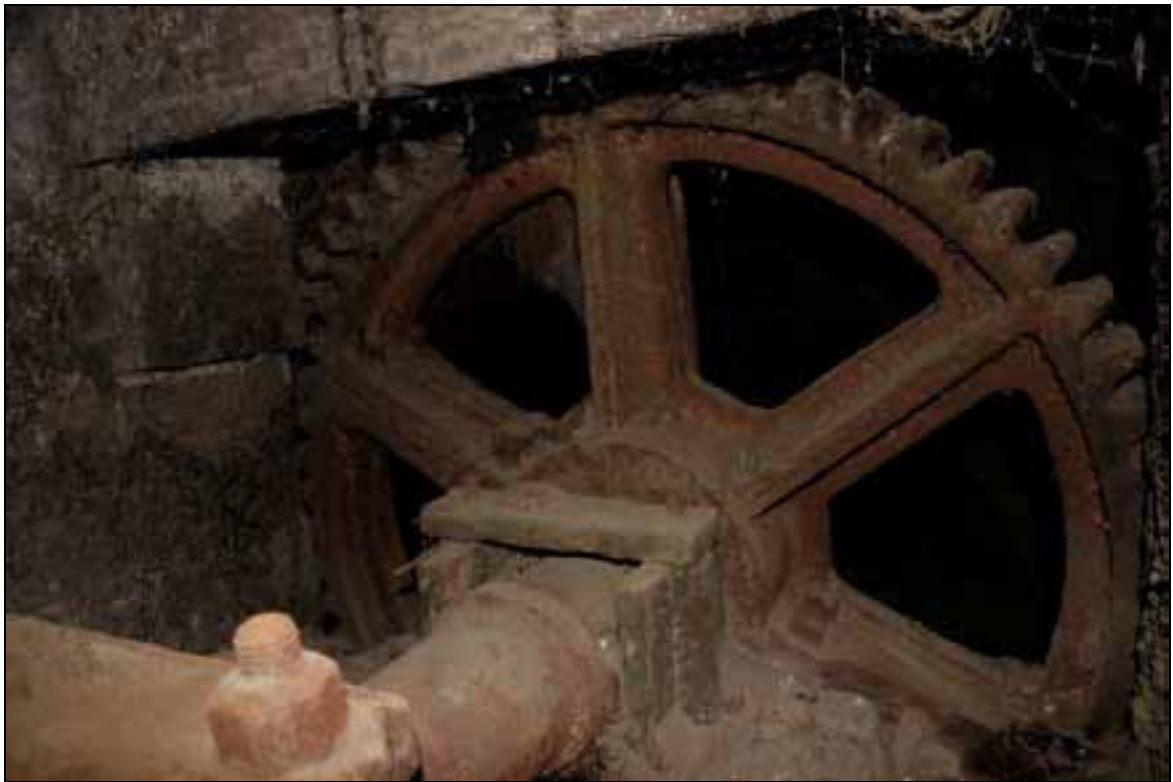
*Plate 65: Axle and bearing of pinion wheel*

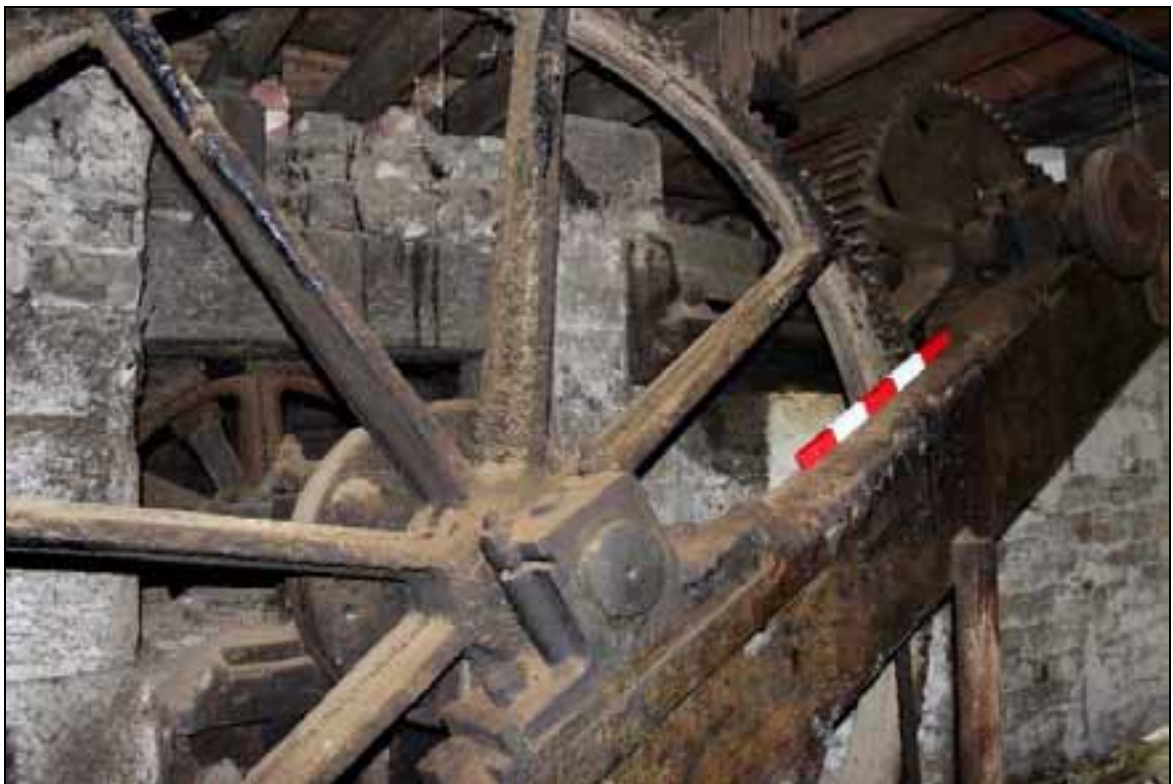
*Plate 66: 8' gearing wheel on pinion wheel axle*

- 3.3.29 A shaft driven by the 2' wheel extended immediately below the ceiling beam towards the spinning room to the west, and terminated in what appears to have been a clutch plate, almost adjacent to the gear wheel (Plates 66 and 67). The great difference in size between the two wheels would have given a massive increase in the rotational speed of the line shaft, in comparison with that of the primary motion shaft, which again rotated at a much greater speed than the waterwheel itself. The clutch afforded the ability to disconnect the waterwheel gearing from the primary motion shaft, allowing it to be powered by the supplementary steam engine.

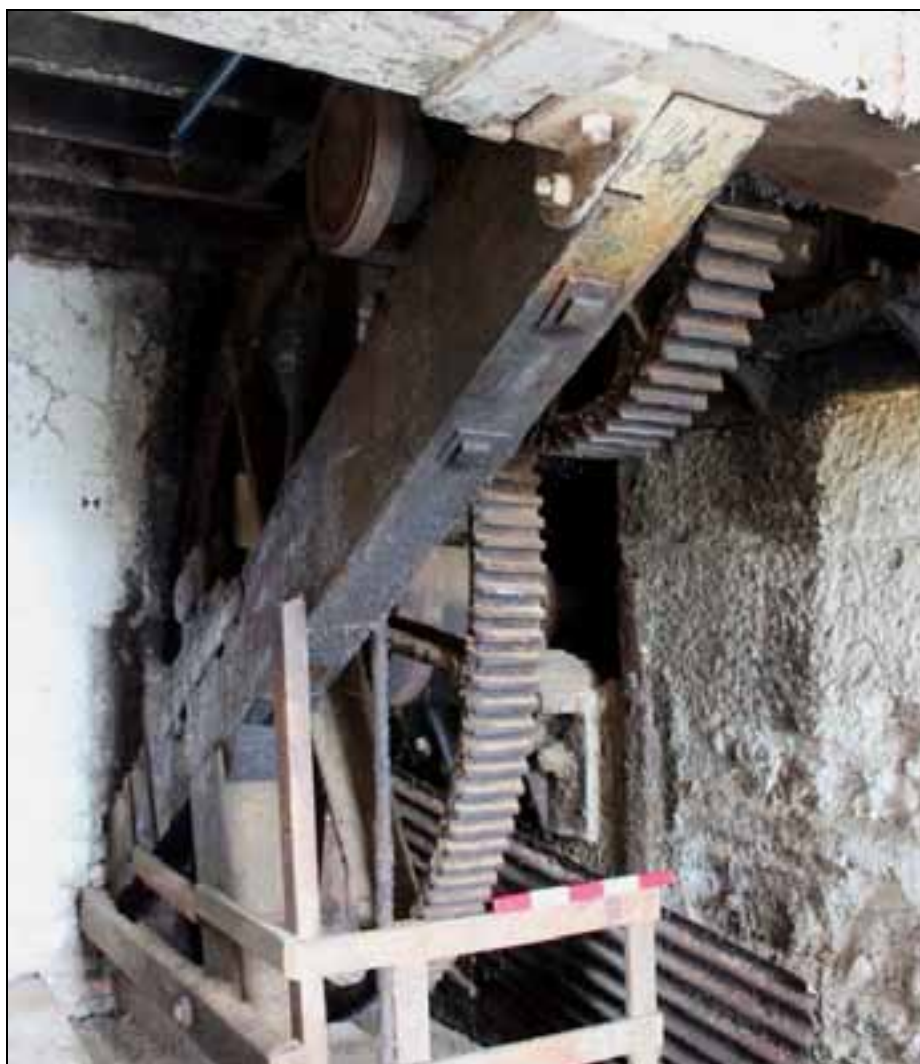
*Plate 67: Gearing driven by pinion wheel, with clutch-plate on drive shaft*

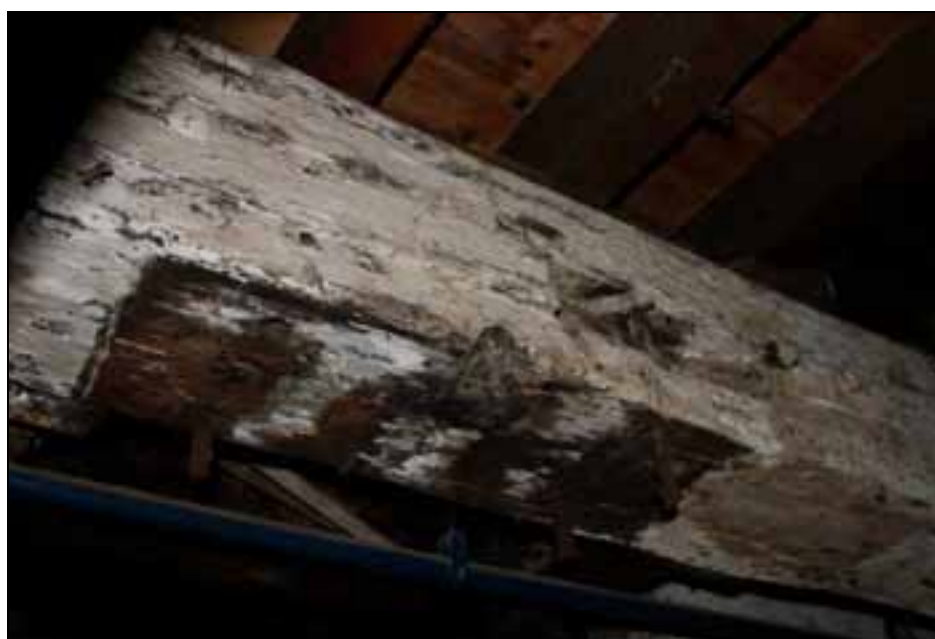
*Plate 68: Compression scar and bolts associated with vertical shaft from steam engine*

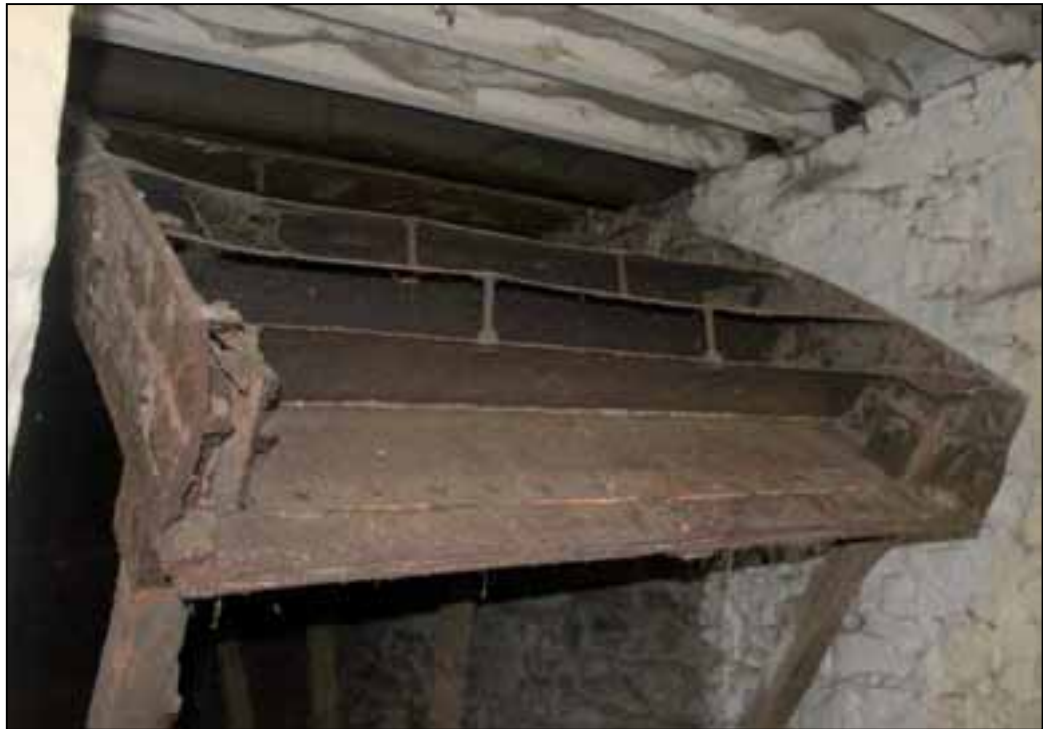
- 3.3.32 The current waterwheel is the full height of the ground and first floors, and almost the full 7' width of the bay in which it is housed (Plates 69 and 70). This represents an extension to the original mill, with this waterwheel probably being erected whilst an original waterwheel continued to function in the adjacent bay to the west. The high breast-shot wheel has cast-iron rims housing metal sheet elbow-buckets (Plate 71), supported by slender timber spokes socketed into a small diameter cast-iron hub (Plates 69 and 70).

*Plate 71: Detail of buckets and spoke sockets*

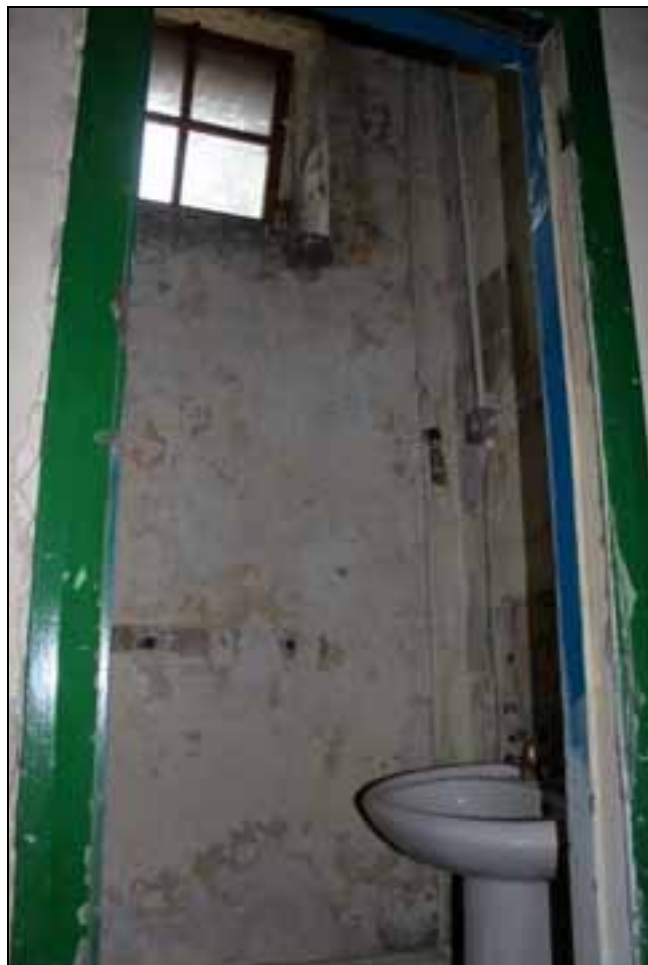
- 3.3.36 At first-floor level the extension comprised a lobby, adjacent to the earlier extension, with three doors to a privy and two further offices (Fig 3). The privy had a small four-light tilt window at the top of the west wall (Plate 75), and a modern toilet suite, whilst the floor in the western of the two larger rooms was raised by 2'6" (0.75m) in the southern part of the room, above the open-fronted bay below. The larger eastern room had two nine-light top-vented timber windows in the eastern wall, both probably original to the construction of the extension. The north wall had a fireplace cut into the 2' (0.61m) thick wall of the earlier extension (Plate 76), possibly placed in a window aperture of the earlier structure. Two convex sandstone corbels below the ceiling almost certainly carried a wall plate associated with the roof of the extension, prior to a brick-built second floor being added, at which point, the ceiling height also appears to have been increased to its present level.

*Plate 75: Privy in southern extension of east wing*

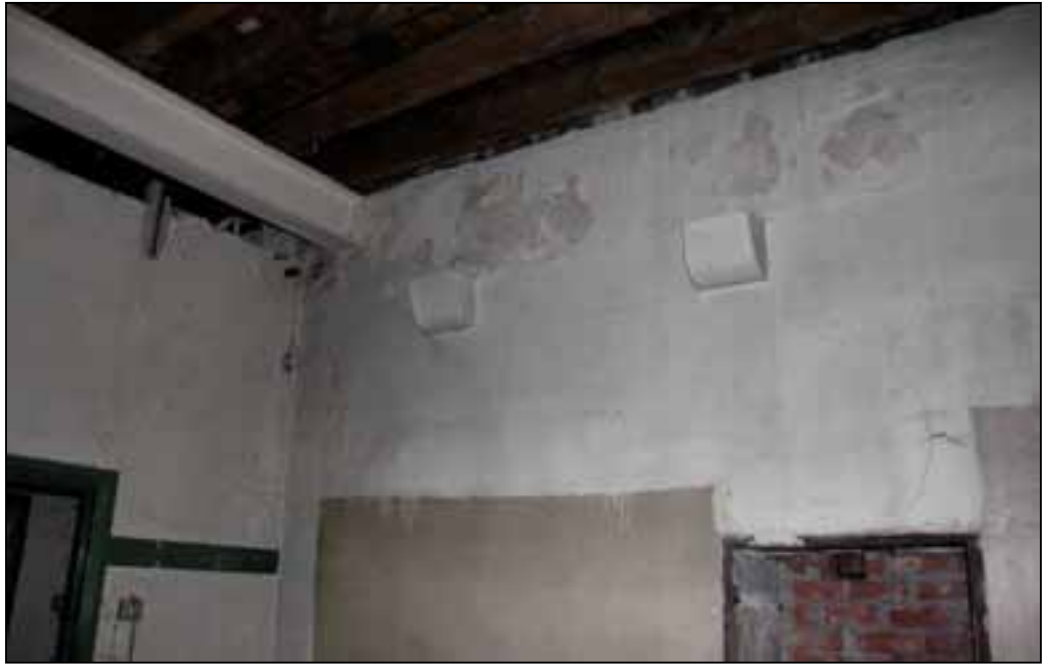
*Plate 76: Sandstone corbels in south external wall of original eastern extension*

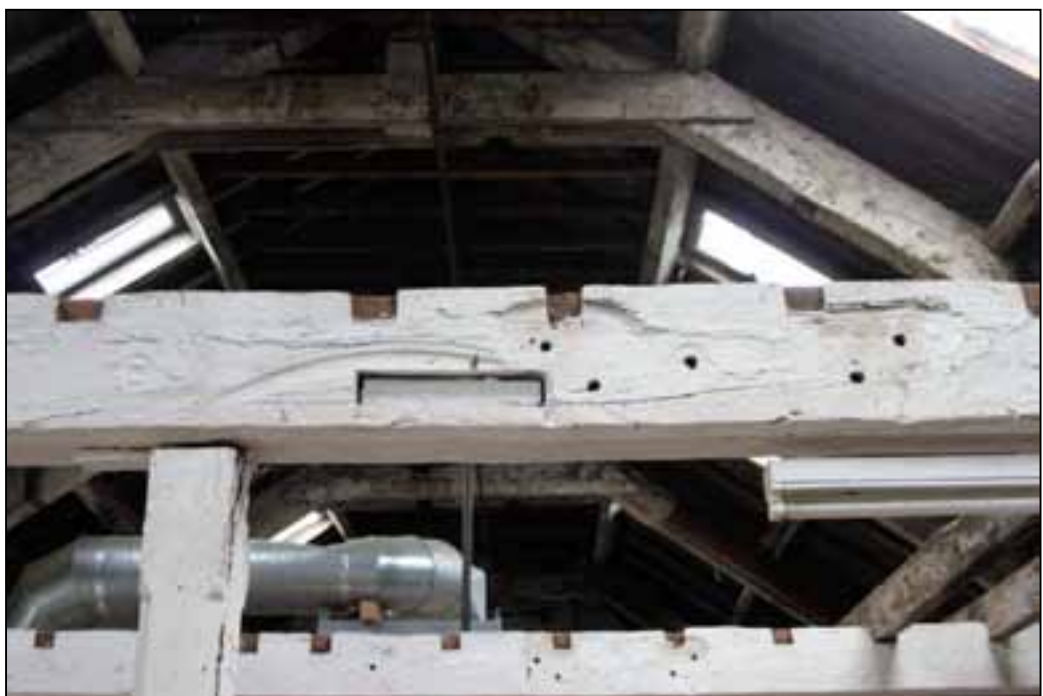
3.3.37 **Second floor:** the second floor of the spinning block was similar to that below, with timber props supporting the original beams at their midpoint. Whilst most were plain, that in the eastern bay of the original spinning block was lamb's tongue-chamfered (Plate 77). The original beams were, however, not scarf-jointed into timber beams extending to the wall of the northern extension of the original mill, as on the floors below, but instead remained short of the repositioned wall (Plate 78), their exposed ends being supported on hollow cylindrical, cast-iron columns of varying type, having either a flat or a ribbed head plate (Plates 78 and 79), and a plain, or octagonal-section foot (Plate 78).

*Plate 77: Drum scar and line shaft bolt holes, second floor*

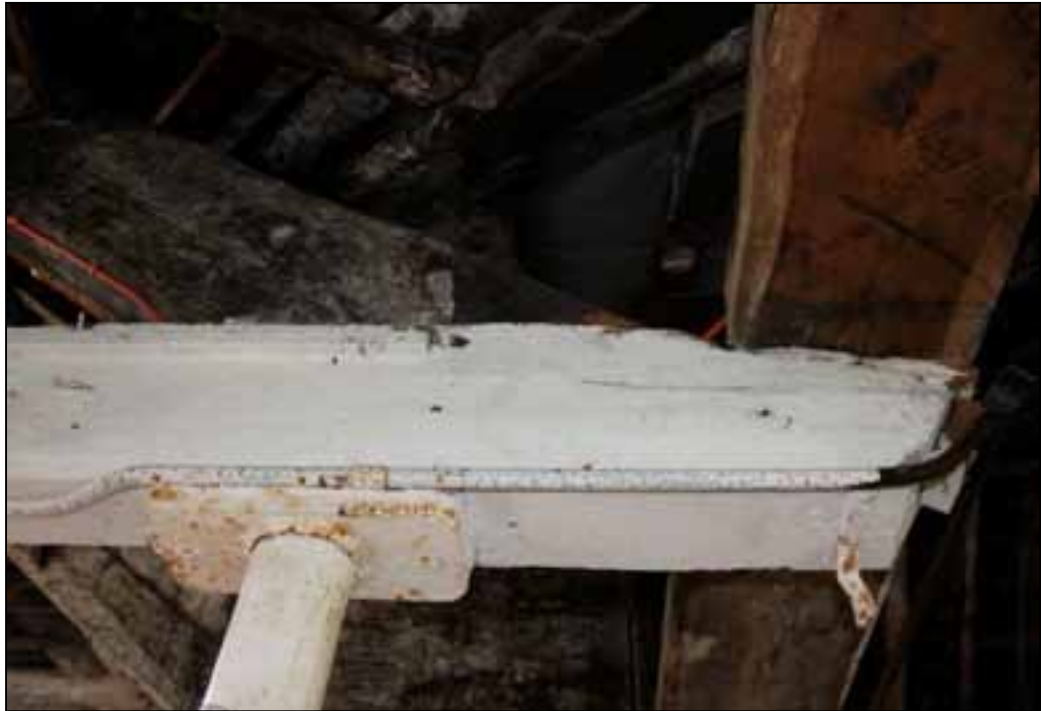
*Plate 79: Plain column capital, second floor*

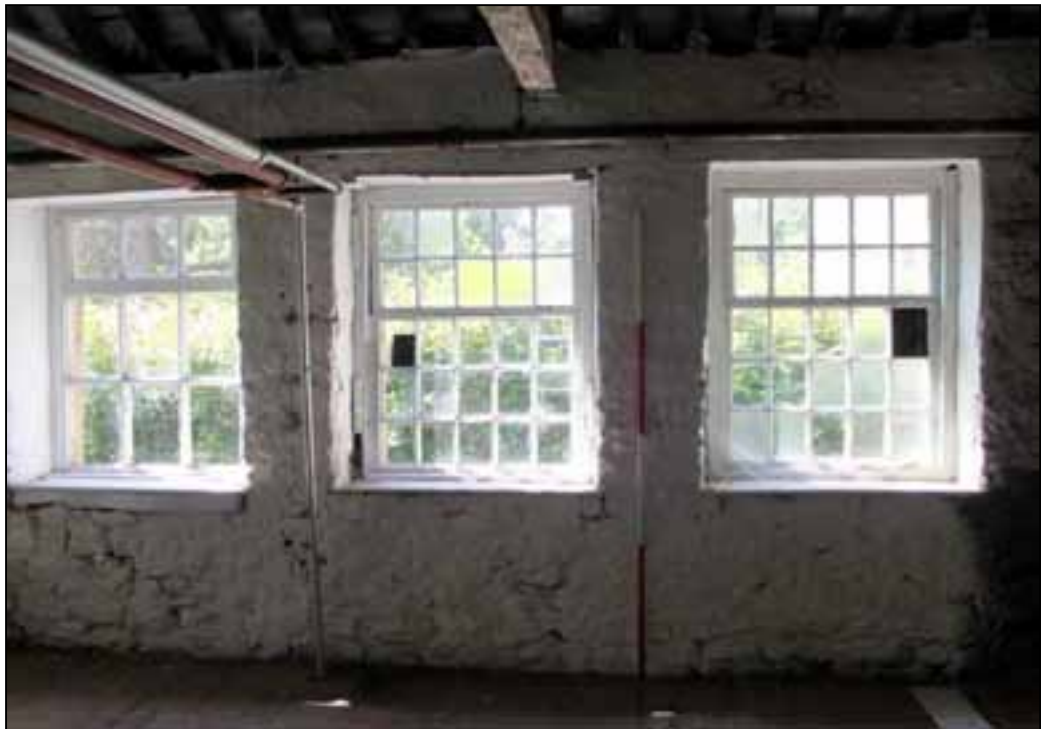
3.3.38 Windows were similar to those on the floors below, with the exception of those in the north wall, which matched those elsewhere, rather than extending to wall-head height (Plate 78). Many housed nine-light, top-vent windows, although some timber 25-light vertical sash windows also survived (Plate 80).

*Plate 80: Second-floor windows*

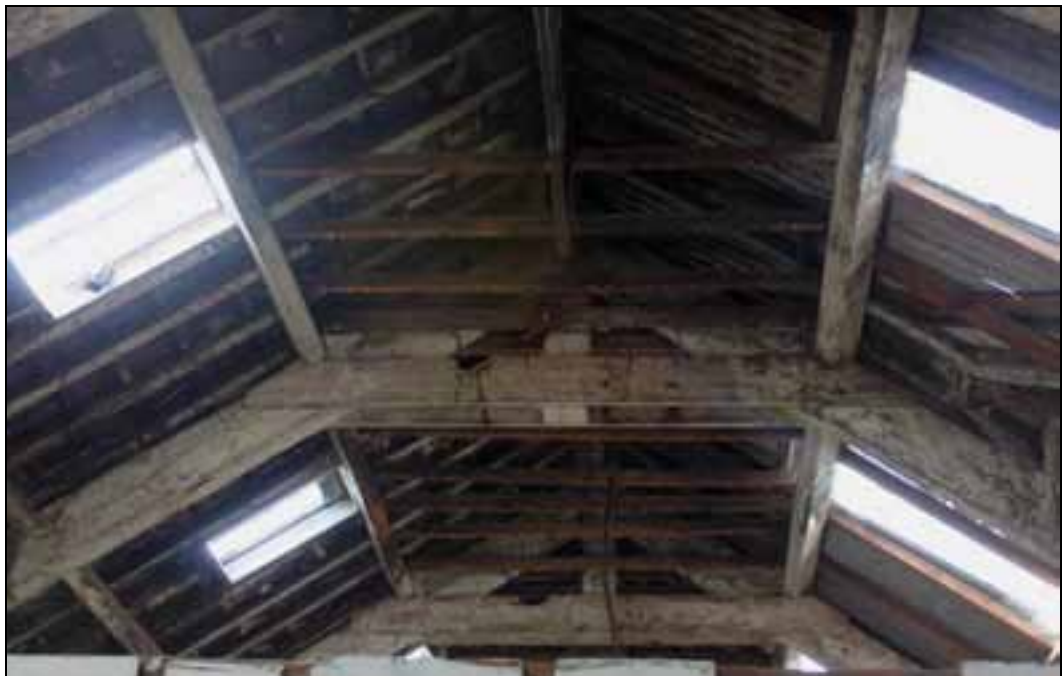
3.3.42 The earliest extant element of the roof comprised king post trusses, with clasped ridge purlin and sandstone roof tiles, carried on three purlins to each pitch (Fig 4; Plate 83). The purlins were butt-ended above the trusses which have chiselled roman numeral assembly marks on their eastern faces (Plate 84), and originally had angled braces from the angled king post foot to immediately below the central purlin of each pitch, as demonstrated by blocked or redundant sockets in this position on each principal rafter (Plate 77). The king posts of each truss were cut subsequently, and the angled braces removed, with collar planks placed across each truss, at the height of the upper purlins (Plates 77 and 83). This created an open loft, and dovetail housed sockets in the tie beams (Plate 77), demonstrating that the loft formed was floored at this time. The new collars also have semi-circular cut-outs in their upper faces (Plate 83), almost certainly to carry a pipe for the sprinkler system, rather than a timber line shaft, which would have generated too much friction and heat in a weight-bearing timber housing.

*Plate 83: Remodelled king post trusses*

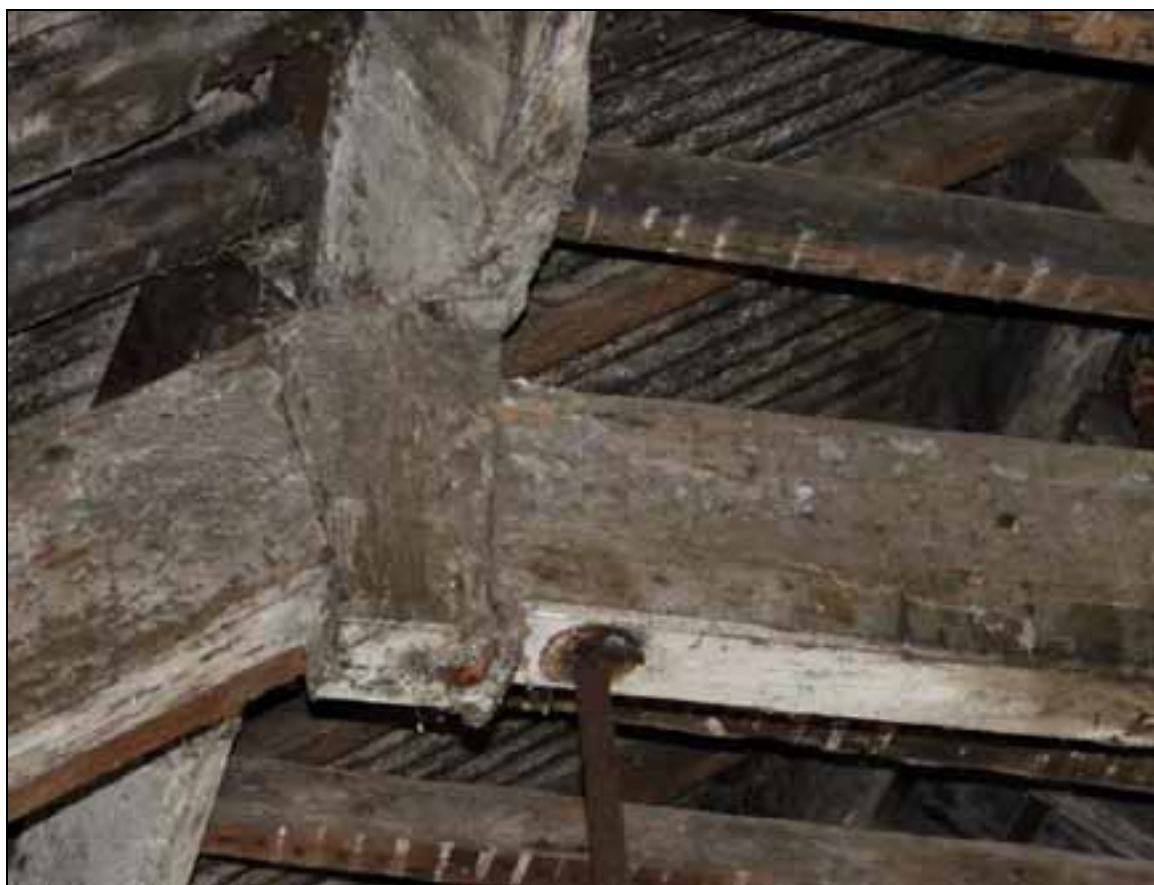
- 3.3.44 The western end of the roof was presumably originally hipped, and thus a new truss needed to be installed to carry the ridge from the original roof to that of the perpendicular extension, in order to avoid a valley between the two roofs. The truss installed was of queen post type, with two vertical members having a jowled head (Plate 87), carrying the shorter principal rafters, a straining beam placed between the two posts, and the weight of the upper purlin, which was housed in a notch within the head (Plate 88). These queen posts were also cut subsequently, and replaced with a pair of iron rods, placed immediately on their inside (Plate 87).

*Plate 88: Jowled head of queen post, carrying side purlin, with adjacent replacement rod*

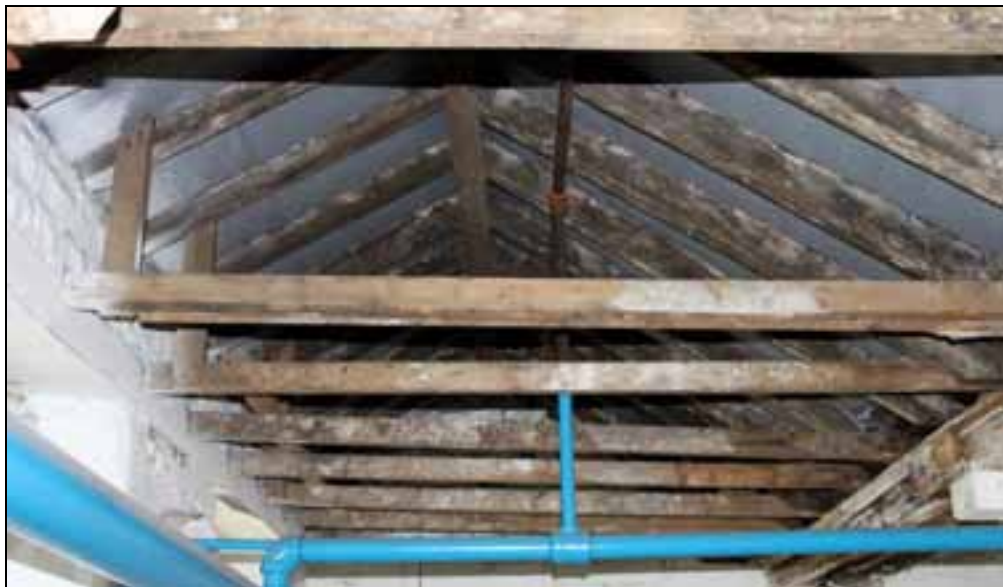
3.3.46 The extended north bay of the original mill had a separate low pitched roof of common rafters over a square-section ridge purlin (Plate 90). The valley between the two roofs was carried on the northern ends of the original tie beams, and presumably drained through the external wall at the eastern end. The stair tower had a perpendicular pitched roof comprising simple coupled trusses, with the southern principal rafter oversailing that of the north pitch, and having the ridge purlin trenched into its apex (Plate 91). A single purling to each pitch was also trenched into the trusses (Plate 92). The joint between the stair tower roof and had an end wall panel of lath and plaster (Plate 92), creating a separate room above the stair tower. This had a doorway in its southern face, into the loft (Plate 92), with an apparent original corridor above the roof of the north bay to a second, now removed, doorway into the main loft. The stair tower also retained fire hoses in the roof space, and at second floor landing level, manufactured by EJAY Walker brothers of Preston and Chester (Plate 93).

*Plate 90: Common rafter roof of extended northern bay of main mill*

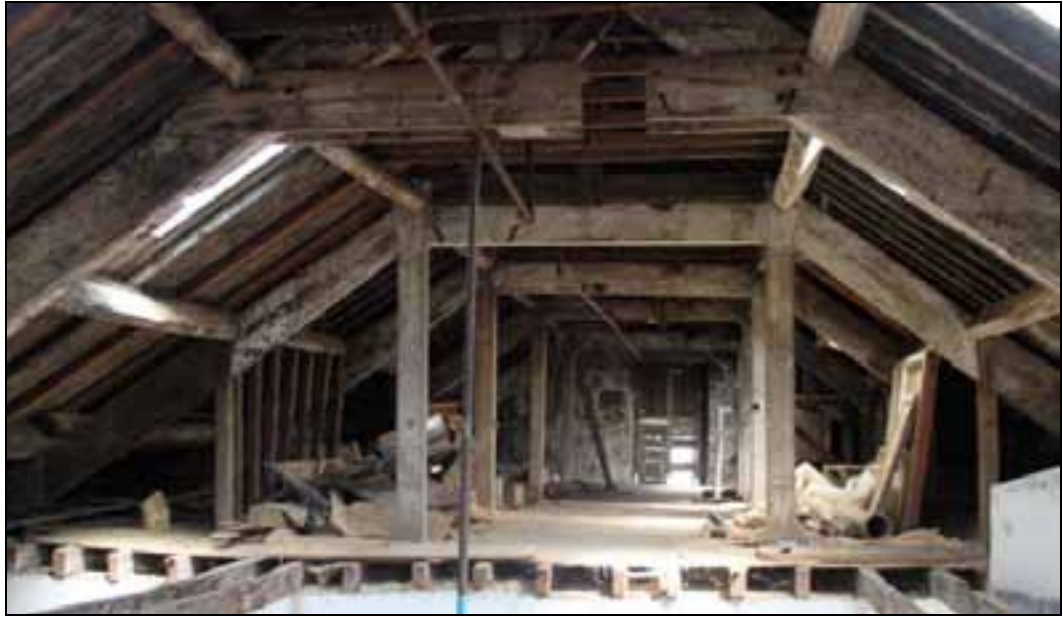
3.3.47 The roof structure above the engine and wheel houses differed from the main roof, comprising two queen post trusses (Plate 94), with jowled feet (Plate 95) and each post carrying the upper of two rectangular-section purlins to each pitch. Posts below the lower purlin do not form part of the truss, but instead form studs for a former partition to the eaves (Plate 94), which appears to have been a relatively recent addition, and certainly post-dates the extension of the mill to the east, as it is also present within this part of the roof.

*Plate 94: Queen post trusses above engine and wheel houses*

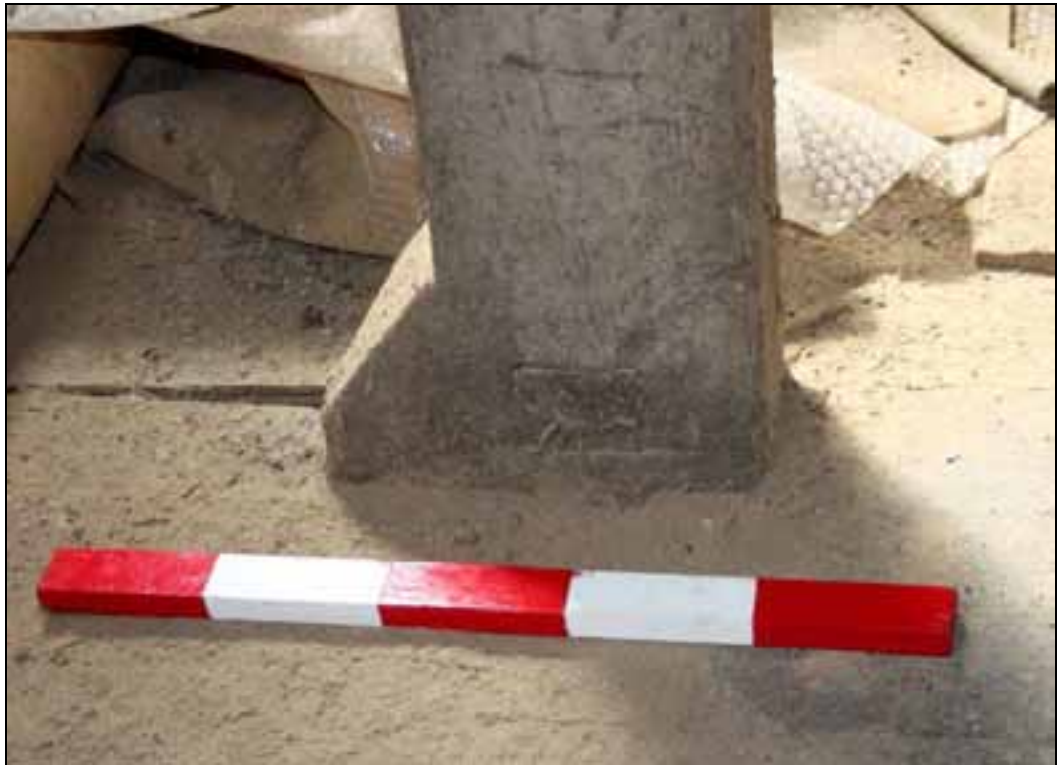
*Plate 95: Jowled foot of queen post*
