# **Kirk Mill, Chipping, Lancashire**

## **Archaeological Building Investigation**

**Oxford Archaeology North**

August 2013

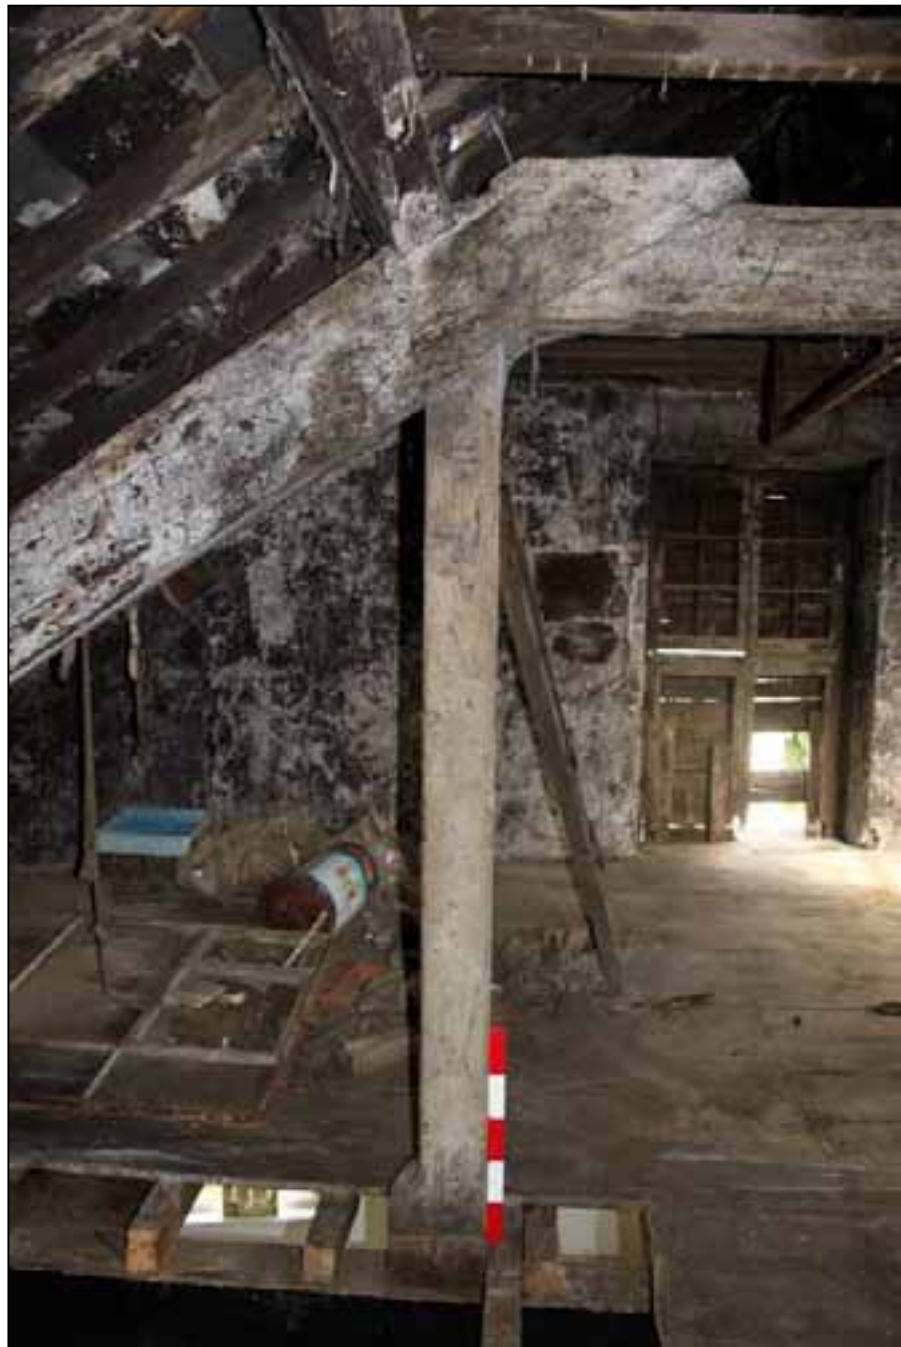
3.3.48 The roof of the eastern extension appears similar to that above the engine and wheel houses, having open bays within the attic. However, the trusses comprise queen struts, rather than queen posts, with the vertical members supporting the principal rafters of the truss (Plate 96), which extend only as far as the collar (kerb principals). The struts have similar jowled feet to the earlier examples to the west (Plate 96), suggesting that angle braces to the lower purlin may have been utilised in the original construction of both phases of the roof. The collars of each truss, and the straining beams of the earlier trusses to the west have semi-circular cut-outs, similar to those of the king post trusses to the west, and almost certainly relate to a pipe for the sprinkler system, rather than for a line shaft (Plate 94).

Plate 96: Queen strut truss above east extension

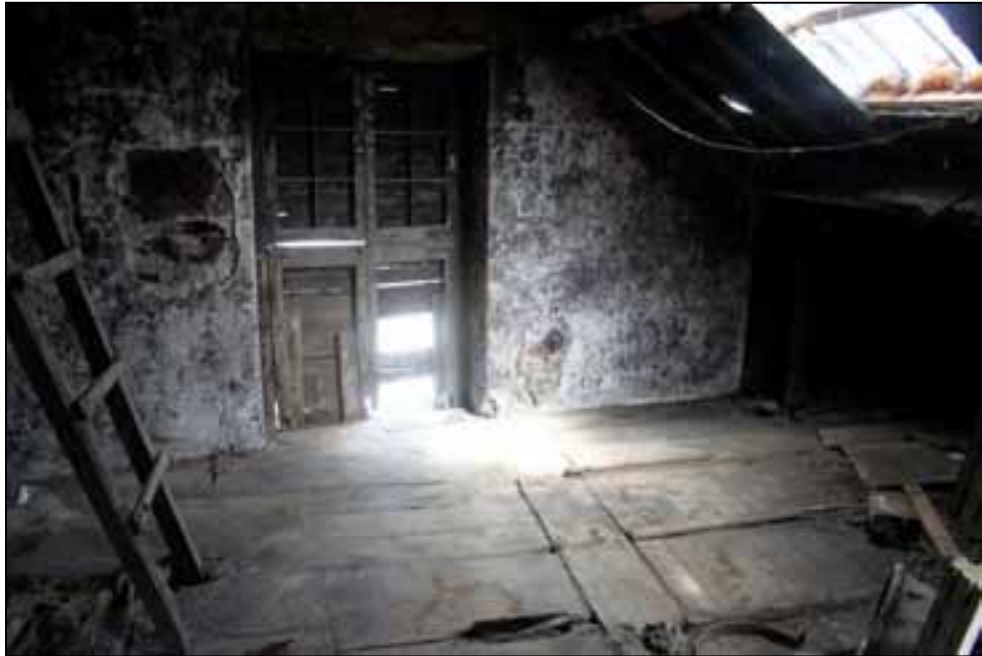
- 3.3.49 The eastern gable of the extension has a double door, forming the upper floor of a loading loophole (Plates 94 and 96), with direct access to the road (Plate 19). It retains no evidence for a hoist, but has an associated trapdoor in the planked timber floor (Plates 94 and 97).

*Plate 97: Loading door and associated trapdoor above east extension*

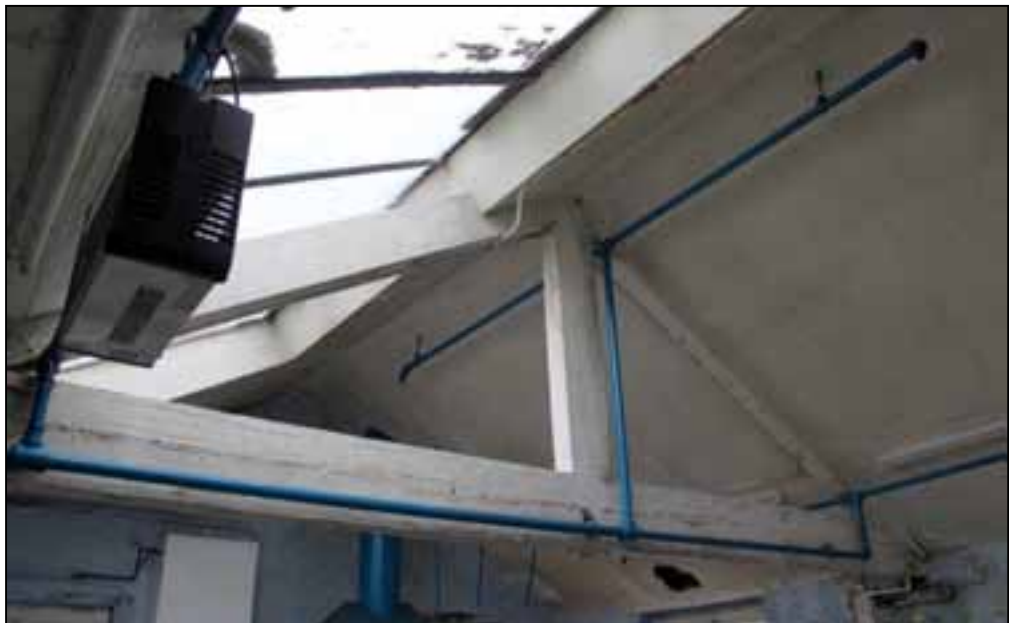
- 3.3.50 The brick extension to the south of the eastern extension of the mill has a separate pitched roof. This is carried on a solitary king post truss with a skylight band on the north pitch (Plate 98). Smaller, timber-framed skylights to both pitches of the earlier roofs (Plates 83 and 97) probably also represent insertions. The southern extension also has a corbel projecting from the chimney stack in its north-east corner, which possibly carried an external gutter on the earlier extension.

*Plate 98: King post truss and glazing band above raised south extension*

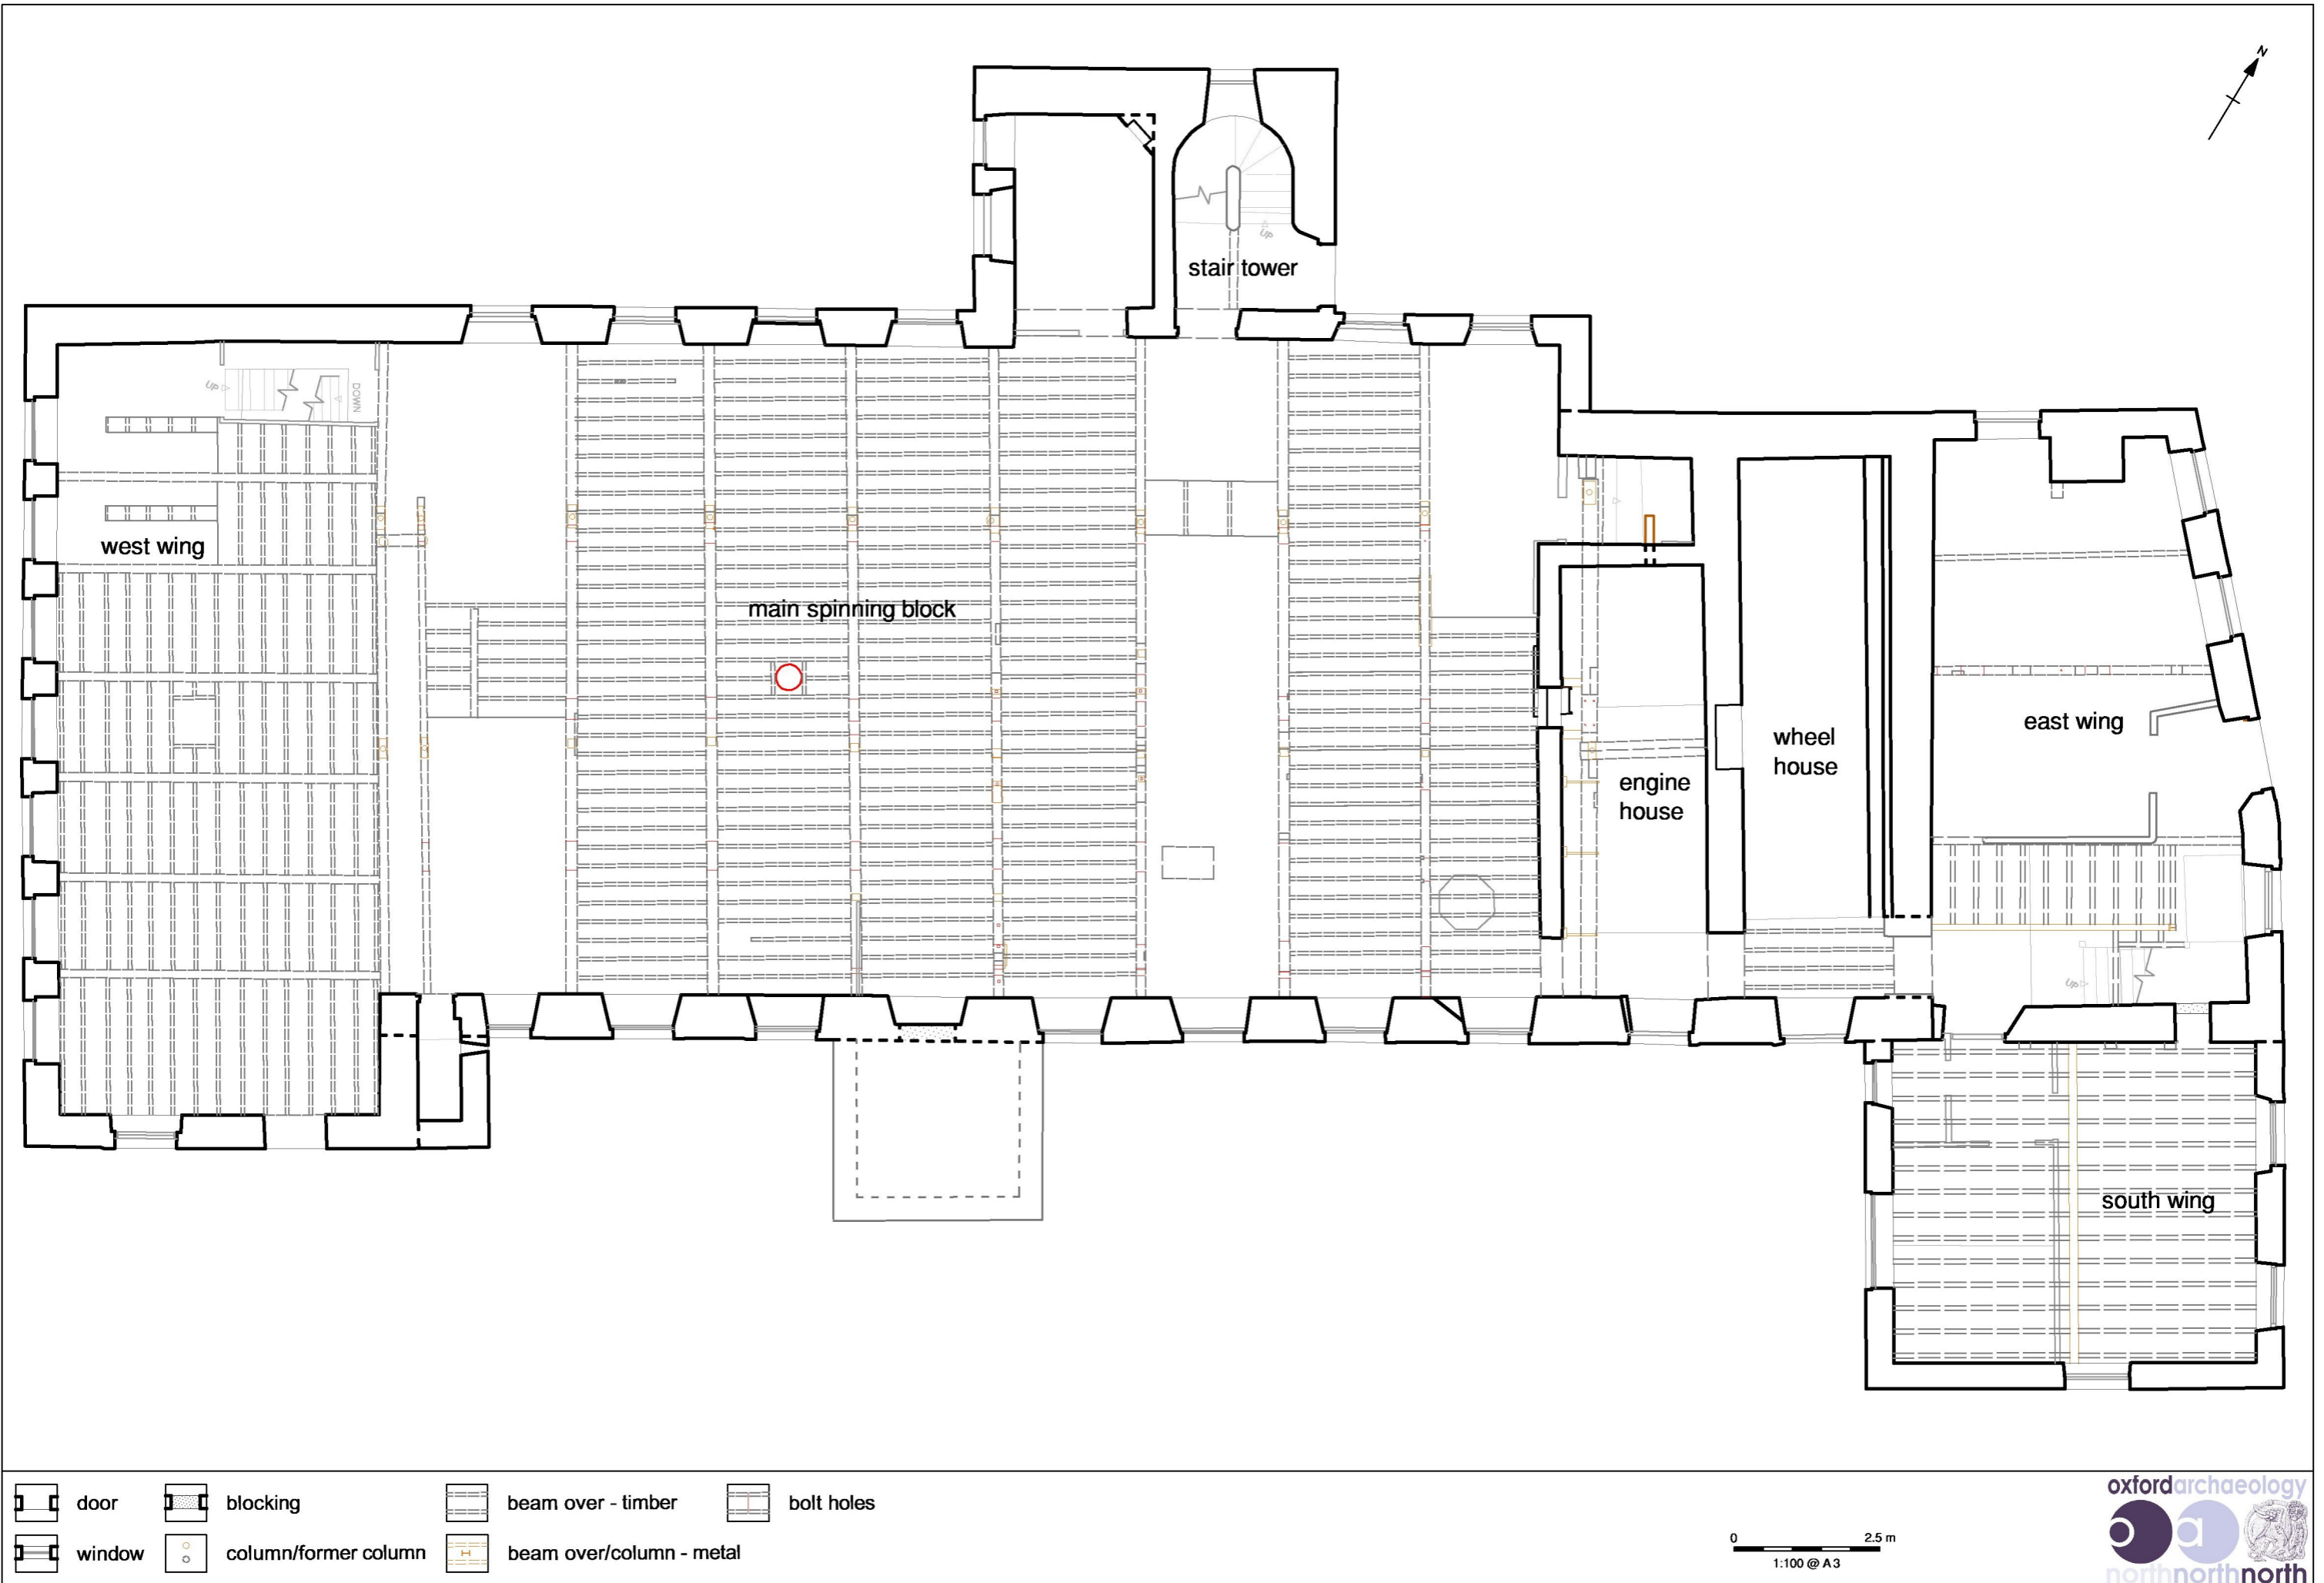
Figure 3: First-floor plan

3.3.25 The east wall of the spinning block does not continue to the repositioned north wall, instead having an eastward return 7' from the extant north wall (Fig 3). This is of coursed-rubble construction on its northern face, and probably represented the face of an engine house, partitioned within the enlarged mill. It was punctured by a ceiling-level beam (Plate 57), which appears to have been used to extend the original mill into the position of the external waterwheel, once the new waterwheel had been installed within the enlarged structure. This is supported by a column below a butt-joint at its north end (Plate 58), similar to the beams in the main spinning block, and demonstrating that it predated the repositioning of the north wall. This area was timber panelled latterly to create a store. A vertical aperture in the east end of its south wall presumably carried a shaft or belt from the adjacent gearing associated with the waterwheel.

- 3.3.34 A stone-built extension to the east of the wheel chamber had only a low narrow passage, affording access to the waterwheel axle bearing at ground-floor level, where it was terraced into the hill slope. At first-floor level, the extension was erected to the same width as the earlier waterwheel chamber, and infilled the space to the edge of the lane to the east. It appears to have originally comprised a single large room, with windows in each of its three external elevations, and probably represented a preparation room or warehouse, with cut-outs in the soffit of the timber ceiling beams suggesting it had two line shaft positions (Plate 73). The north wall was repositioned subsequently to the level of the expanded waterwheel house, apparently coinciding with its conversion to an office. A chimney breast was included in the repositioned wall, with a projecting corbel carrying a ceiling beam inserted in the position of the original wall (Plate 74). A stud partition wall was almost certainly contemporary, and separated the probable office from the southern part of the floor, with an entrance lobby to the original double doorway in the eastern wall (Fig 3). This had a small-paned 16-light timber skylight above, similar in style to a 25-light sash window to the south (Plate 19), which was internally partially overlain by an inserted half-turn staircase, placed in the south-east corner of the extension (Fig 3).

- 3.3.36 At first-floor level the extension comprised a lobby, adjacent to the earlier extension, with three doors to a privy and two further offices (Fig 3). The privy had a small four-light tilt window at the top of the west wall (Plate 75), and a modern toilet suite, whilst the floor in the western of the two larger rooms was raised by 2'6" (0.75m) in the southern part of the room, above the open-fronted bay below. The larger eastern room had two nine-light top-vented timber windows in the eastern wall, both probably original to the construction of the extension. The north wall had a fireplace cut into the 2' (0.61m) thick wall of the earlier extension (Plate 76), possibly placed in a window aperture of the earlier structure. Two convex sandstone corbels below the ceiling almost certainly carried a wall plate associated with the roof of the extension, prior to a brick-built second floor being added, at which point, the ceiling height also appears to have been increased to its present level.

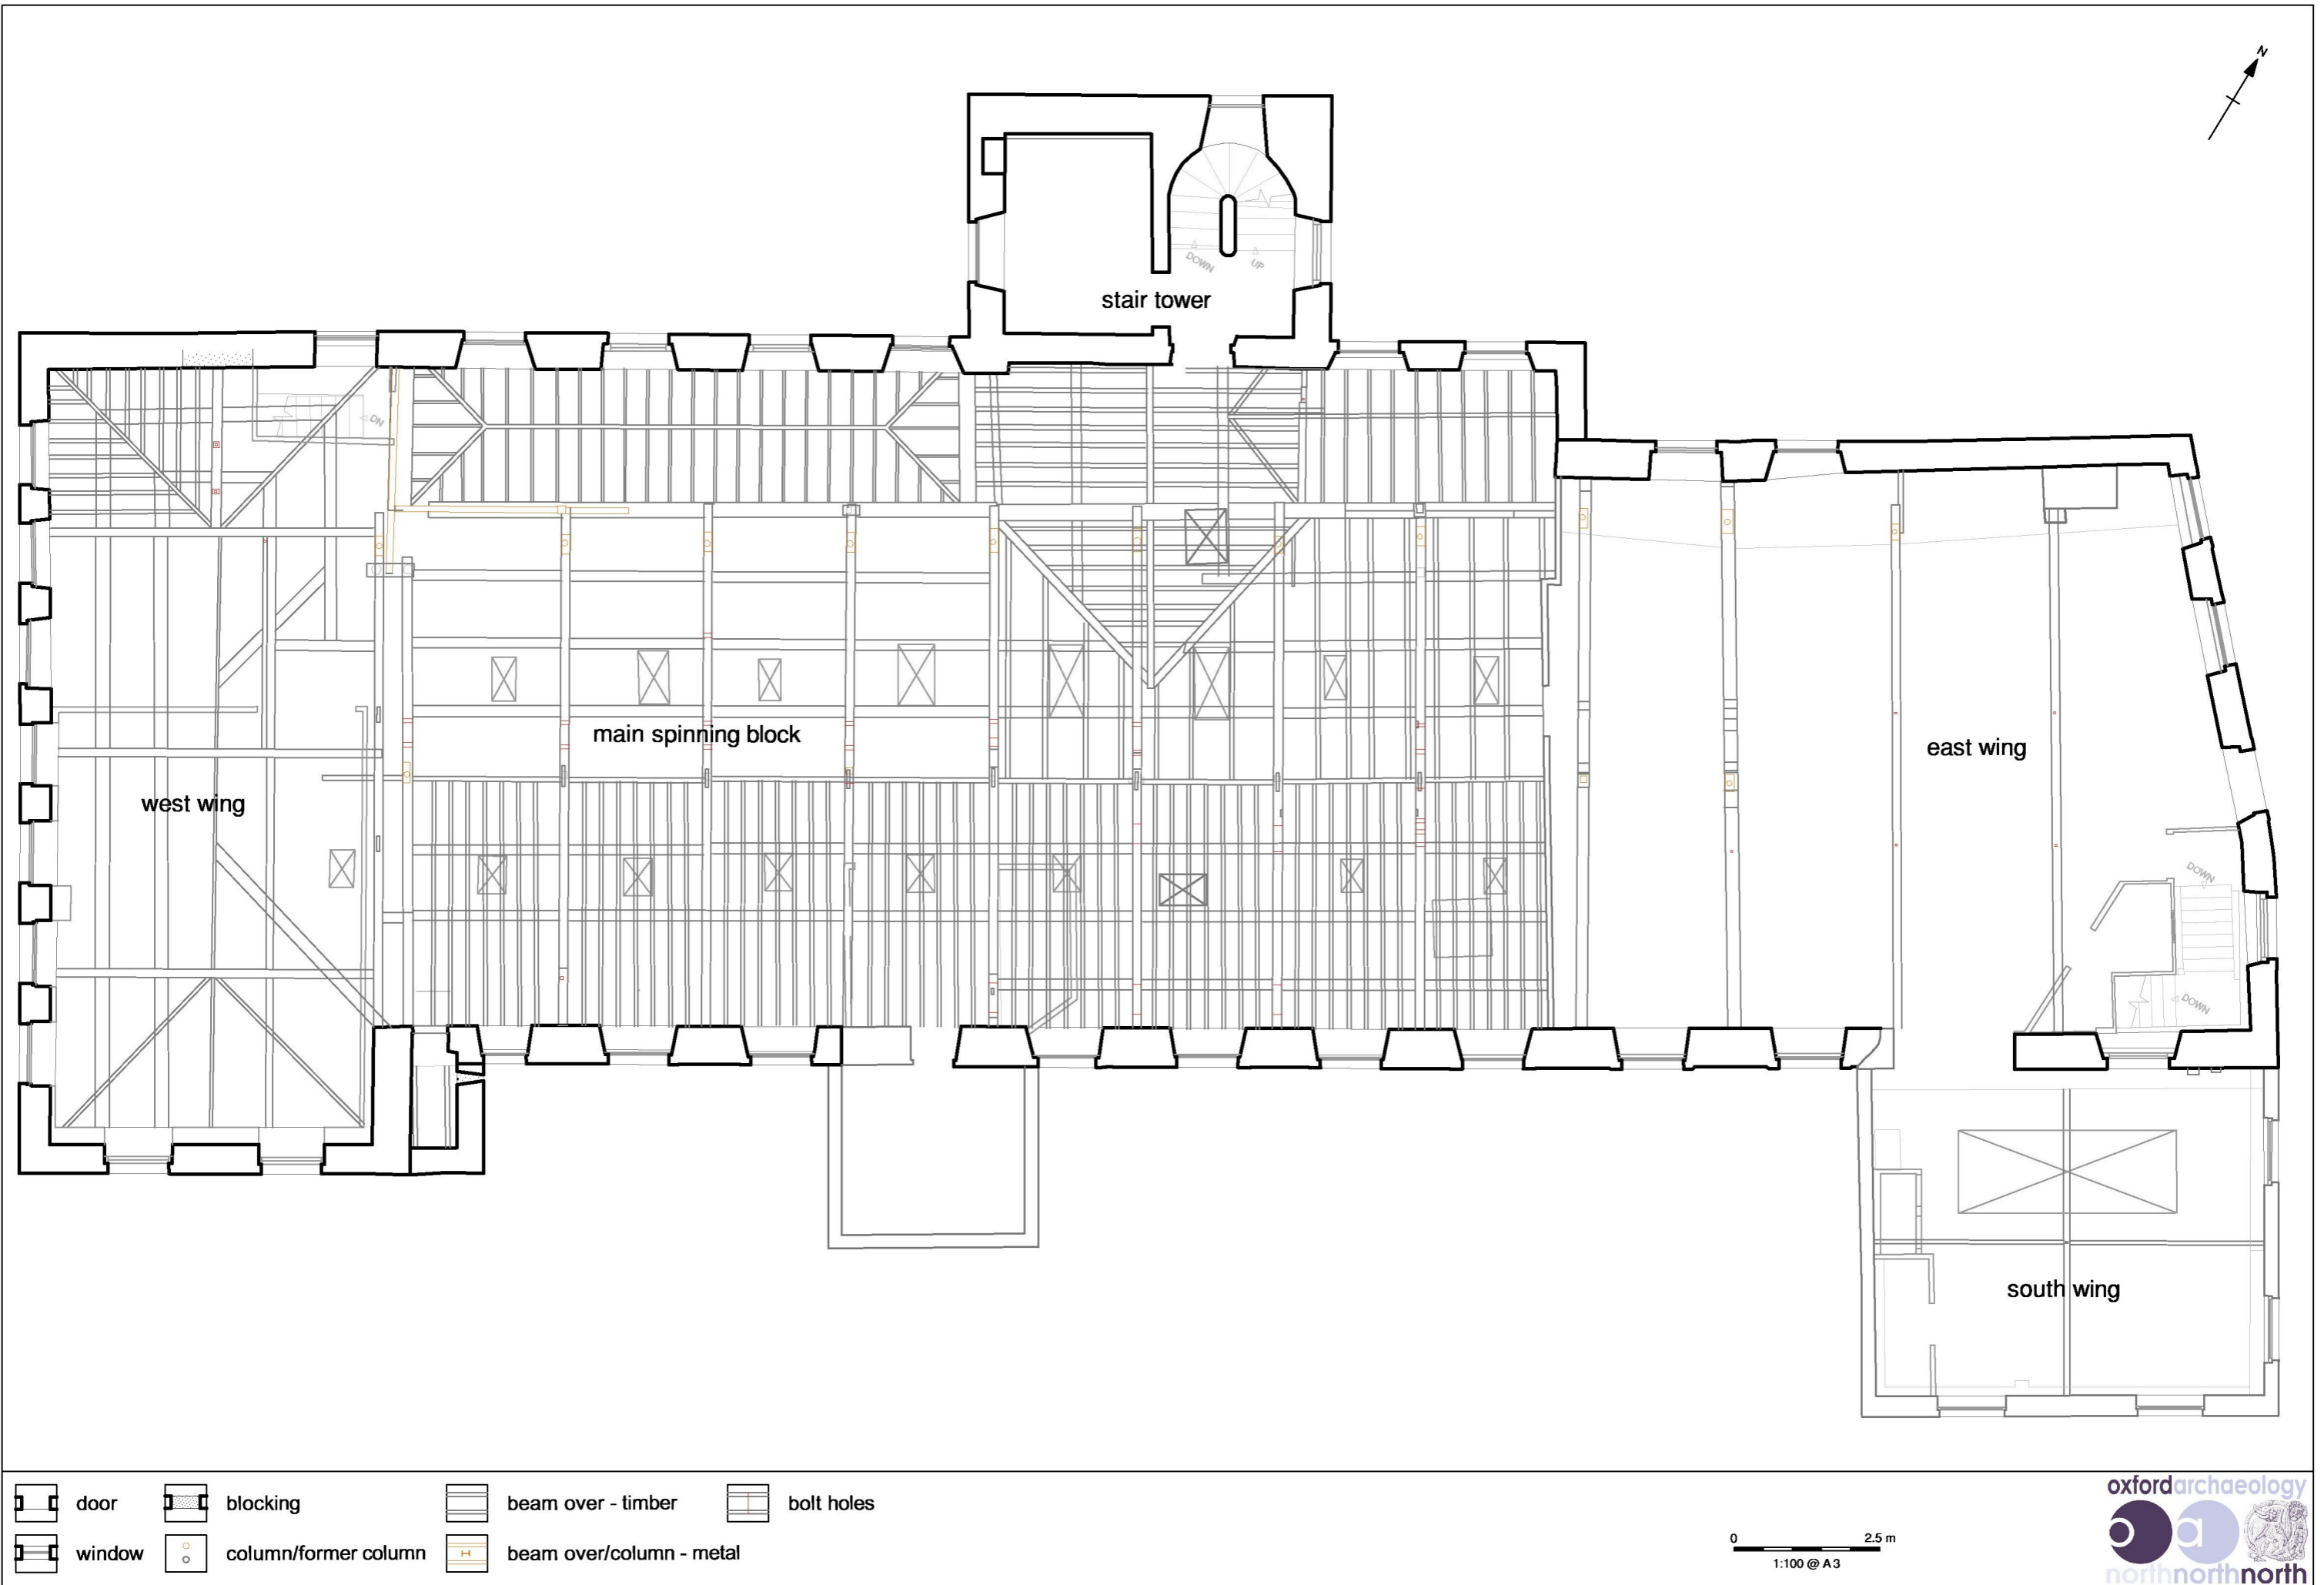
Figure 4: Second-floor plan

- 3.3.40 A timber stud partition extended to the south of the original eastern stone wall return, across the full width of the building (Fig 4). Although this followed the alignment of the partition between mill and waterwheel house on the floors below, it is probable that the area above the engine house at second-floor level was open-plan following the expansion of the mill, with the construction of an internal waterwheel house. Evidence within the roof space (*Section 3.3.31, below*), and the full height of the wheel house wall to the north (Plate 81), show that the appended wheel house was of similar height to the mill, and thus had a floor above the waterwheel, effectively making it an internal wheel, rather than being a lower, wider structure adjoining the outer face of the mill. The floors of the bay adjacent to the new waterwheel also appear to have been incorporated into the main spinning block at all floor levels.
