# LOWER HOUSE FARM, MIDDLEBROOK,

# HORWICH, BOLTON

## Archaeological Building Investigation

December 2004

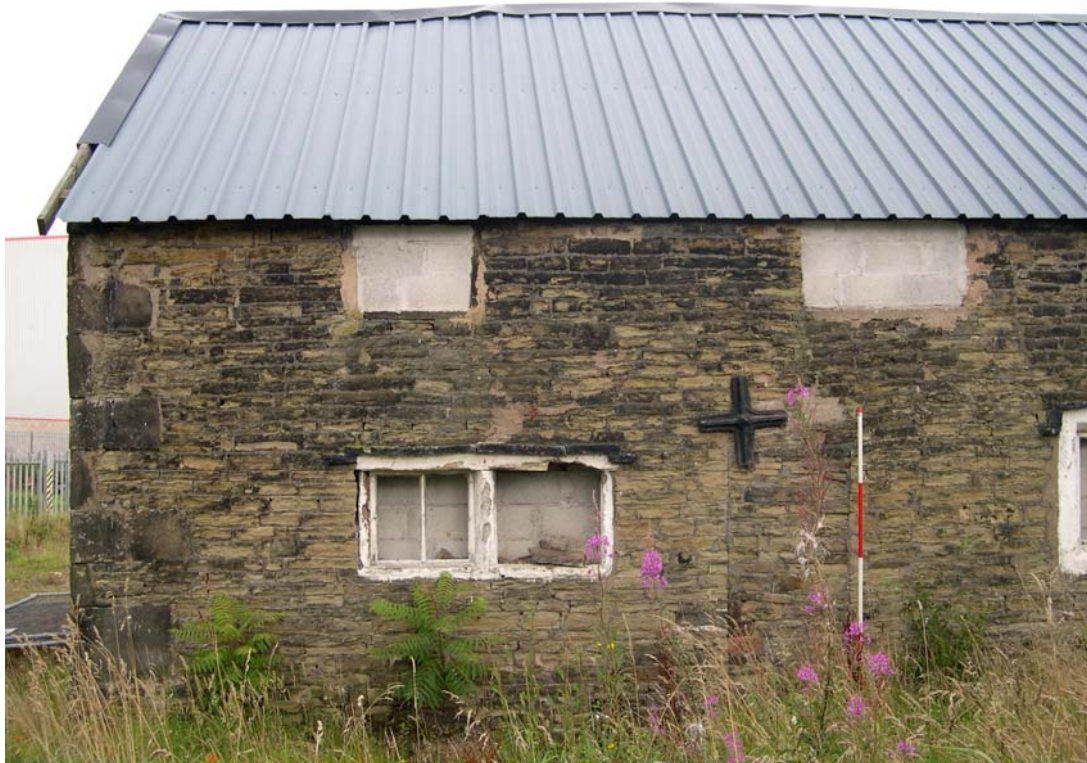
Plate 7: West end of the front (south) elevation

- 4.4.1 **Front (south) elevation of house (Fig 3):** there is a doorway at the east end with a roughly finished heavy stone lintel decorated with a stop chamfer and hood mould (Plate 6) To the west is a four-light horizontal window with a plain chamfered sill and splayed sandstone mullions and a flagstone label mould. There is a similar, albeit smaller, window to the west (Plate 7). Excavations carried out at the base of the wall, perhaps as part of the current or a previous development, reveal the foundations to consist of a plinth of four courses, which projects c0.13m. There are three inserted windows immediately below the wall head (Plates 6 and 7), all of which are filled with clinker blocks. The easternmost inserted window is situated to the west of an earlier aperture, which has been blocked with stone (Plate 6). A doorway has been inserted between the two ground floor windows, towards the centre of the elevation. This has evidently been narrowed on the east side before being blocked with stone (Plate 7). A tie-rod with a cruciform plate c0.6m across has been inserted above the top left corner of the blocking. The entire elevation has been repointed and the remains of a whitish lime plaster with gravel inclusions are visible in places. The east end has been extended with a later extension (see *Section 4.4.5*).

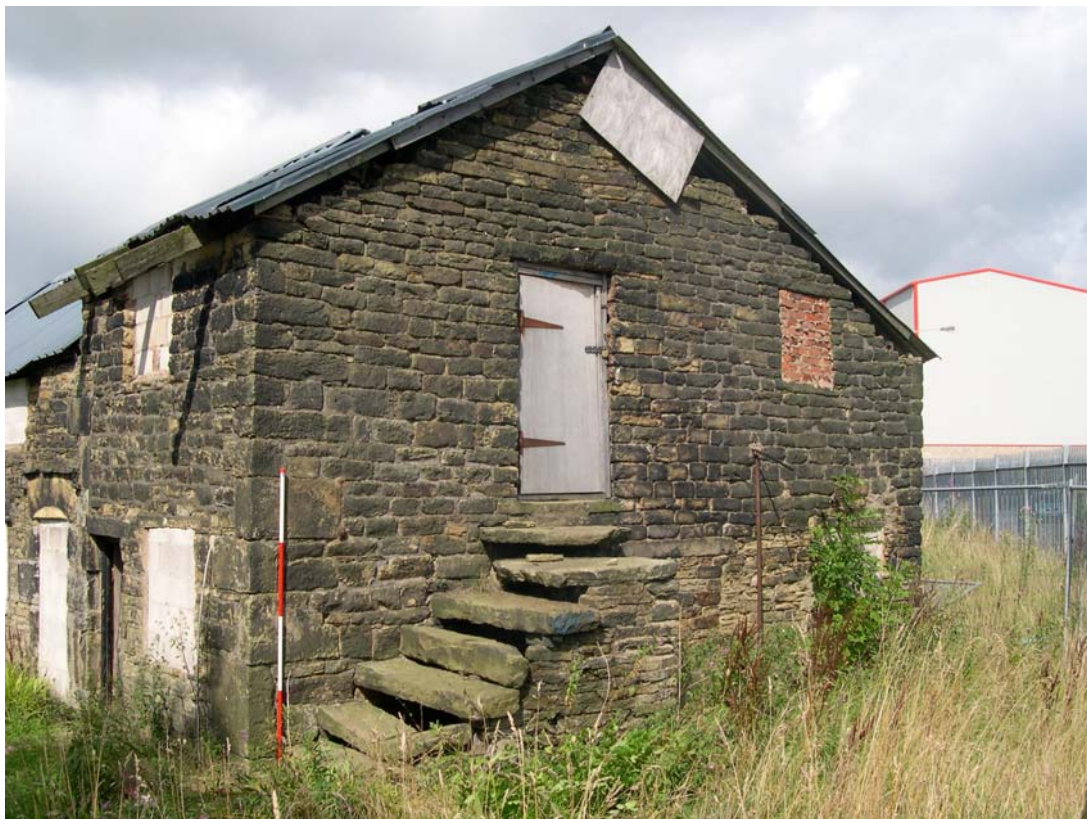
Plate 11: East gable

- 4.4.5 **East gable (Fig 5):** a single bay extension has been added to the east end of the original building, which extends to the north as far as the eastern outshut. It is 0.61m higher than walls of the main building on the south side (Plate 6) and 0.92m higher on the north, although the original roofline has been

respected. It is of a similar construction to the main elevations and has the same repointing but has smaller quoins in general and a more sandy, pinkish brown mortar. There is a doorway in the south side of the east extension with a tooled sandstone lintel (Plate 6). To the east there is a vertical window with a flush sill but no stone sill or jambs, which has been filled with clinker blocks (Plate 6). There is a larger central window at the wall head with a long sandstone sill. The east elevation of the extension forms a gable and has a doorway at first floor level accessed by a dogleg flight of flagstone steps (Plate 11). The doorway has a sandstone lintel and jambs. The present door is hung on the south side, which does not fit the stairs and the fifth step is a re-used gatepost with a drilled pintel hole. The stairs are supported by rough rubble stonework on the east side.

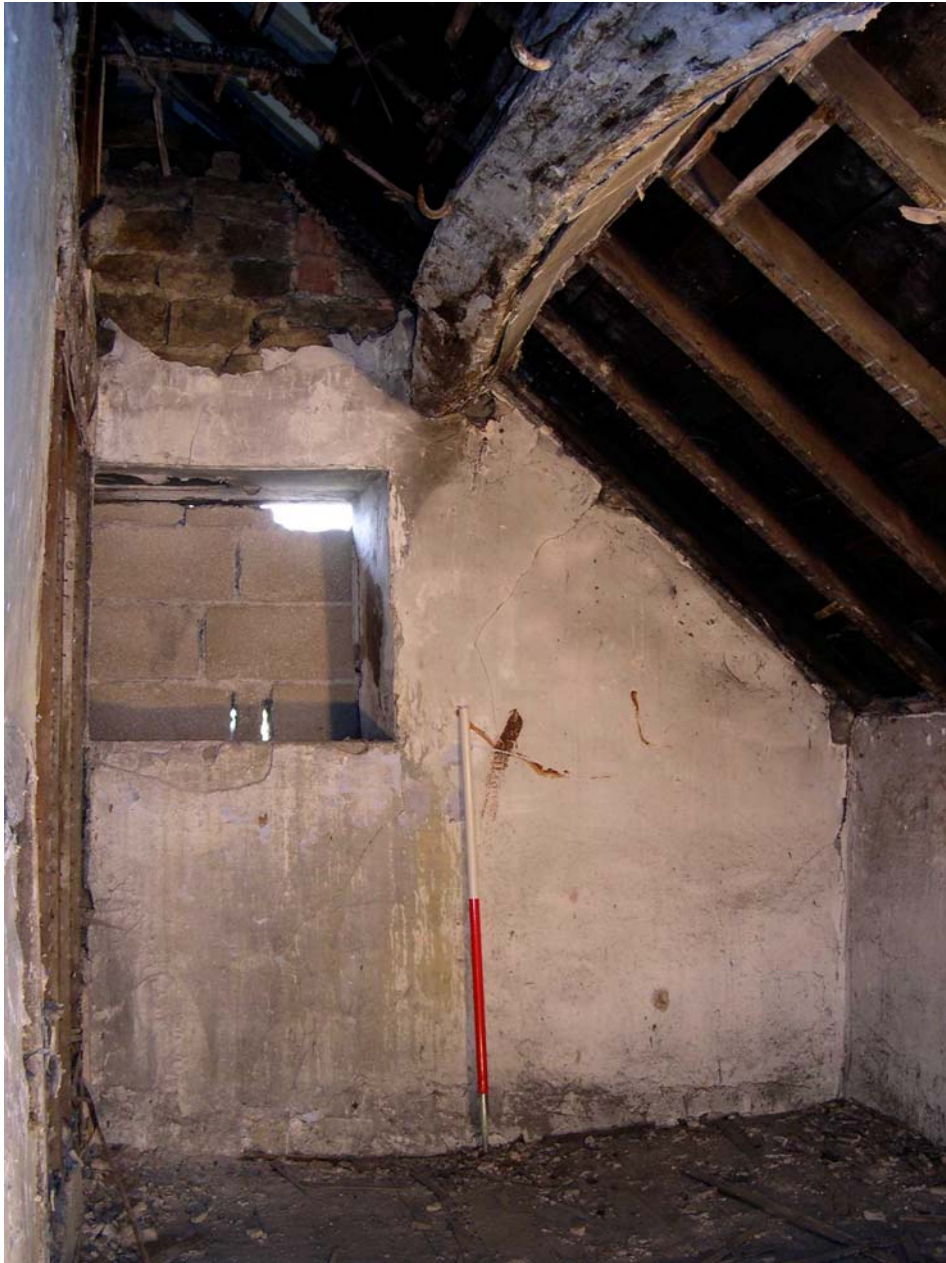
Plate 34: West elevation of first floor Room 4

4.5.17 **First Floor, Room 4 (Fig 7):** this small room is entirely finished with plaster and is lacking any detail (Plate 34), although the frame of the east wall is jointed to the lower purlin (Plate 35). It was most recently used as a bedroom.

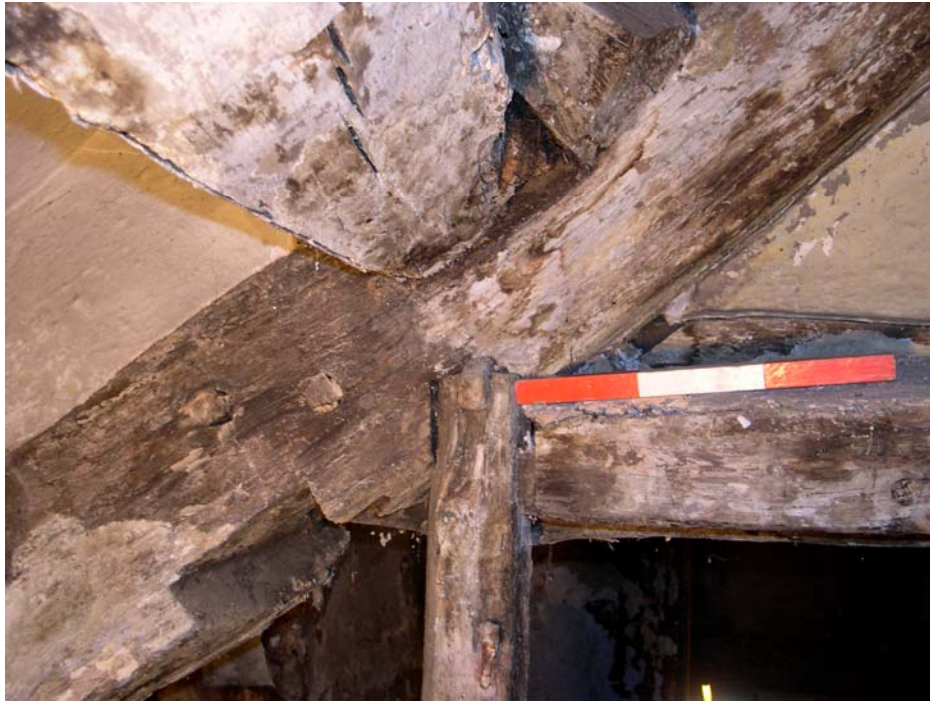
Plate 35: Joints of timbers to roof in east wall of first floor Room 4

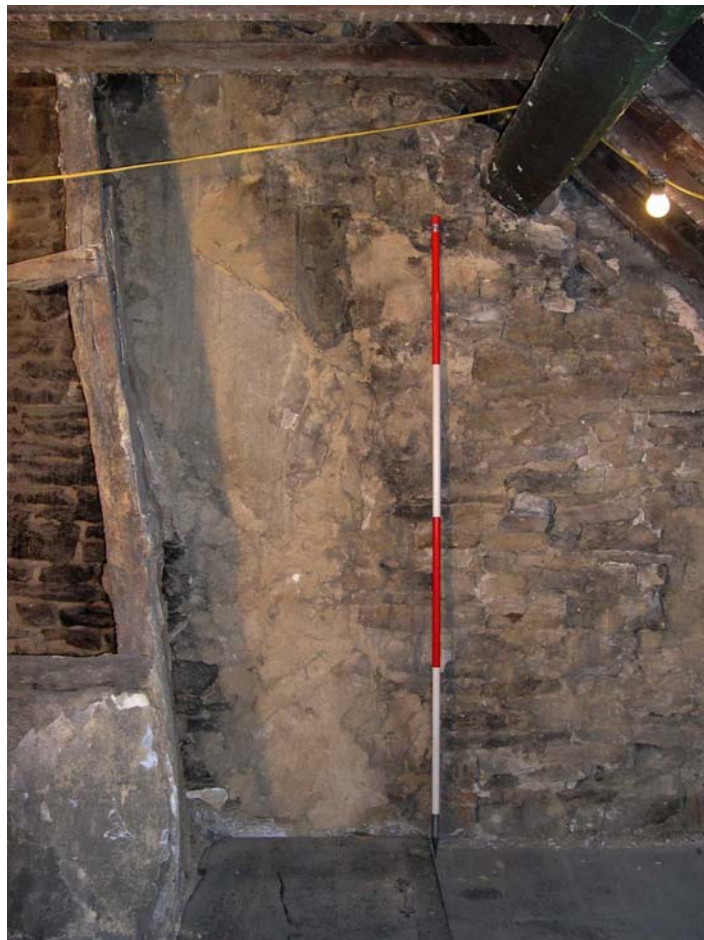
4.6.1 As the intention of the watching brief was primarily to make a photographic record of parts of the building that were not going to be retained during the redevelopment only a limited amount of additional information was gathered about the development of the building. A number of the fireplaces had had their later blocking removed, which allowed their full depths to be ascertained, and to the south of the firehood there was a possible scar for an earlier firehood evident in the wall (Plate 36). This would correspond well with the expect width of such a feature, and would mean that the original firehood would have spanned the full length between the doorway to the north of the fireplace and the heck post to the south (see *Section 5.1.12*).

5.1.12 **The Firehood:** the form and structure of the firehood is particularly interesting, as compared to other examples from similar cottages it is remarkably narrow (Watson and McClintock 1979; Brunskill 2000, 120). Miller describes a typical firehood associated with an inglenook fireplace as being ‘*almost a room in itself*’ (Miller 2002, 164) and big enough to sit inside, and they typically extend from one wall to the heck post. The narrow firehood at Lower House Farm appears to correspond closely to the existing stone-built fire surround (Fig 9-11), and is likely to be a later alteration. There is little evidence, however, for the position of an earlier, wider, firehood to demonstrate this although a possible scar was visible on the wall to the south of the firehood during the subsequent watching brief (Plate 36). It is therefore difficult to position the construction of the present firehood in the phasing outlined above. It is probable that it fits between Phases 3 and 4, and is most likely to relate to the construction of the eastern extension (Phase 3), which would have required a narrower firehood to allow access between the east end of the original house and the extension.

Plate 36: Possible scar showing the line of an earlier firehood in the east elevation of First Floor Room 1
