# **HOLLIES FARM, SCHOOL LANE, HARTFORD,**

**CESHIRE WEST AND  
CHESTER**

## **Archaeological Building Investigation**

**Oxford Archaeology North**

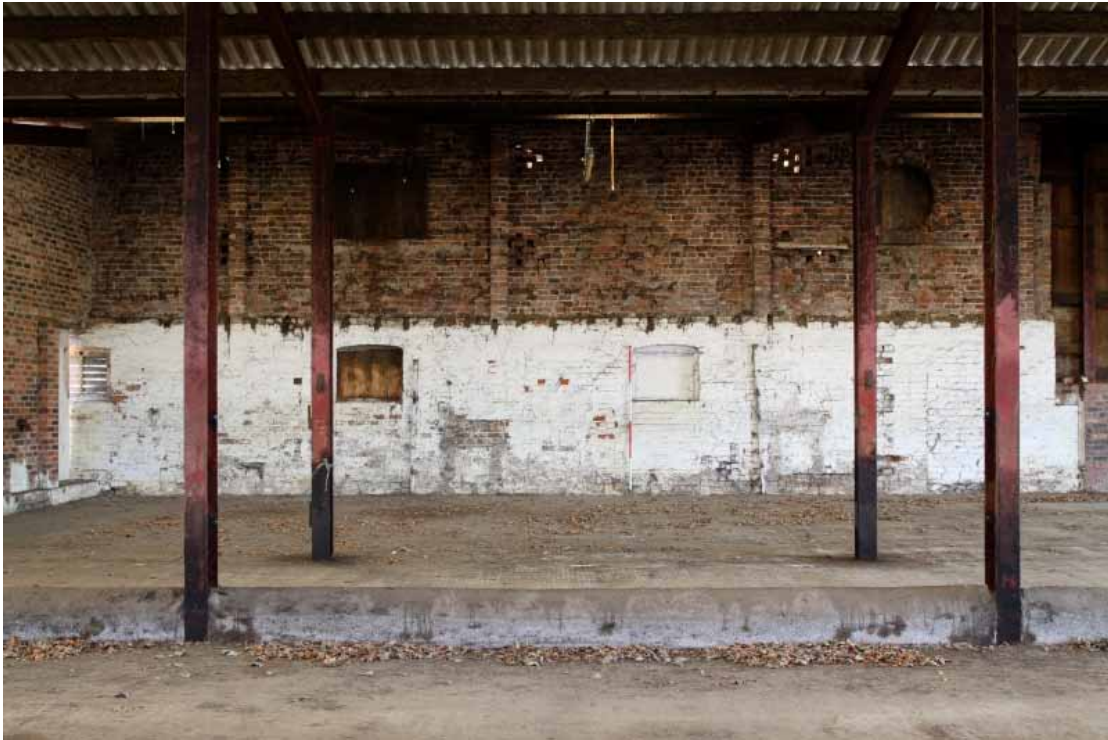
Plate 32: Internal elevation of Building 2 within Building 6, showing the sockets for the floor joists

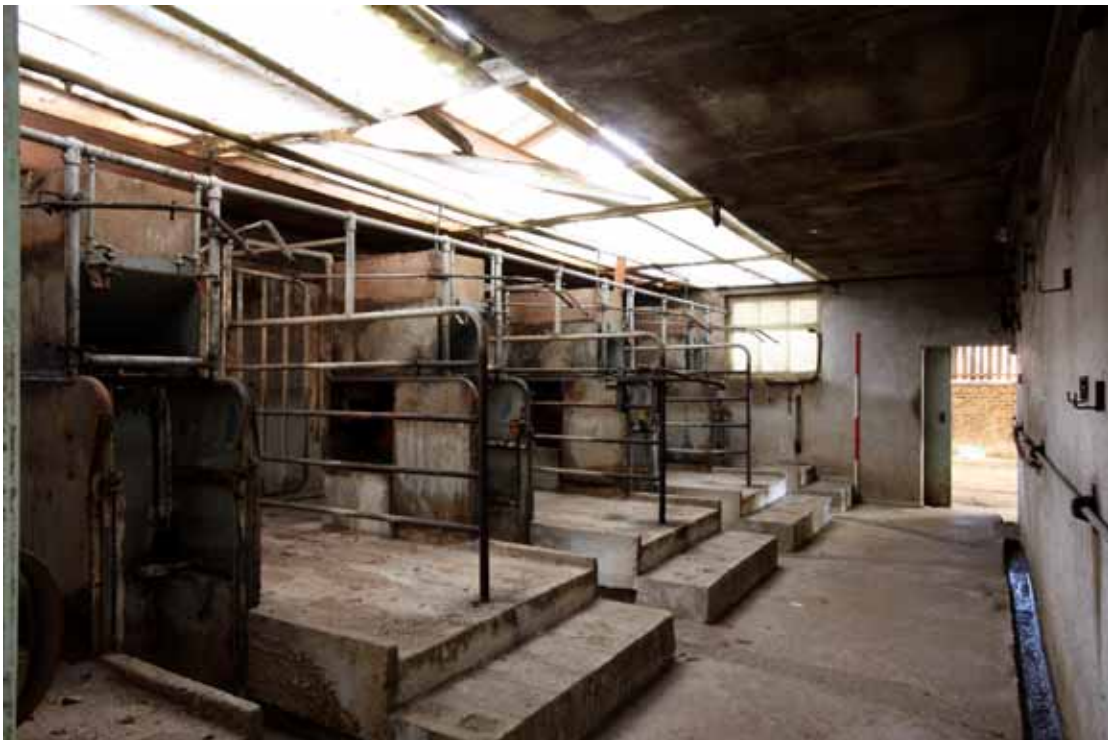
- 4.5.14 The double doors lead into a preparation room. It has rendered walls and a concrete floor, and metalwork in the floor suggests that a large table or piece of machinery has been removed. A sliding door in the right corner of the room leads through into a milking shed (Plate 33). A walkway and open drain are to the right of the room, with seven milking bays to the left. The far elevation contains a cattle entrance into the milking bays, with a further entrance at the end of the walkway, a covered window is present between these. At the far end of the building is an entrance into Building 1 with a sliding door; this appears to be a modern insertion. A window and a door in the dividing wall between this building and Building 4 have been covered, although not totally blocked.

Plate 33: Milking apparatus within the rear room of Building 3

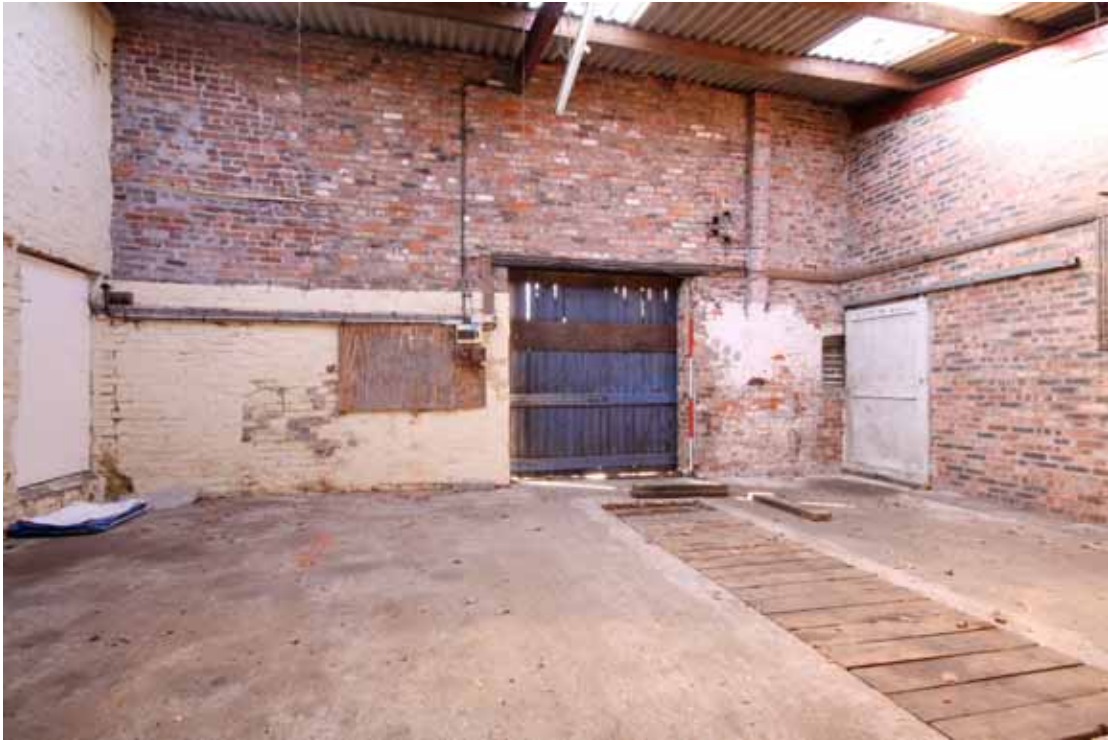
- 4.5.15 **Building 4:** is a maintenance room with a covered inspection pit in the floor, presumably for the maintenance of vehicles (Plate 34). It has an access door to every wall, with the only external face having a large timber sliding door. The majority of this building is made up from the re-used structure of Building 2. Building 2 is incorporated into the external wall, the dividing wall between Buildings 3 and 4, and also part of the rear wall of the building (Figure 11). There is a single blocked doorway on the right of the external elevation and the large sliding door has removed another. There is evidence of a door jamb in the rear elevation, although this has been abutted by modern brickwork and is only evident as a singular sandstone block in the lower door jamb.

Plate 34: Interior of Building 4 with inspection pit in floor

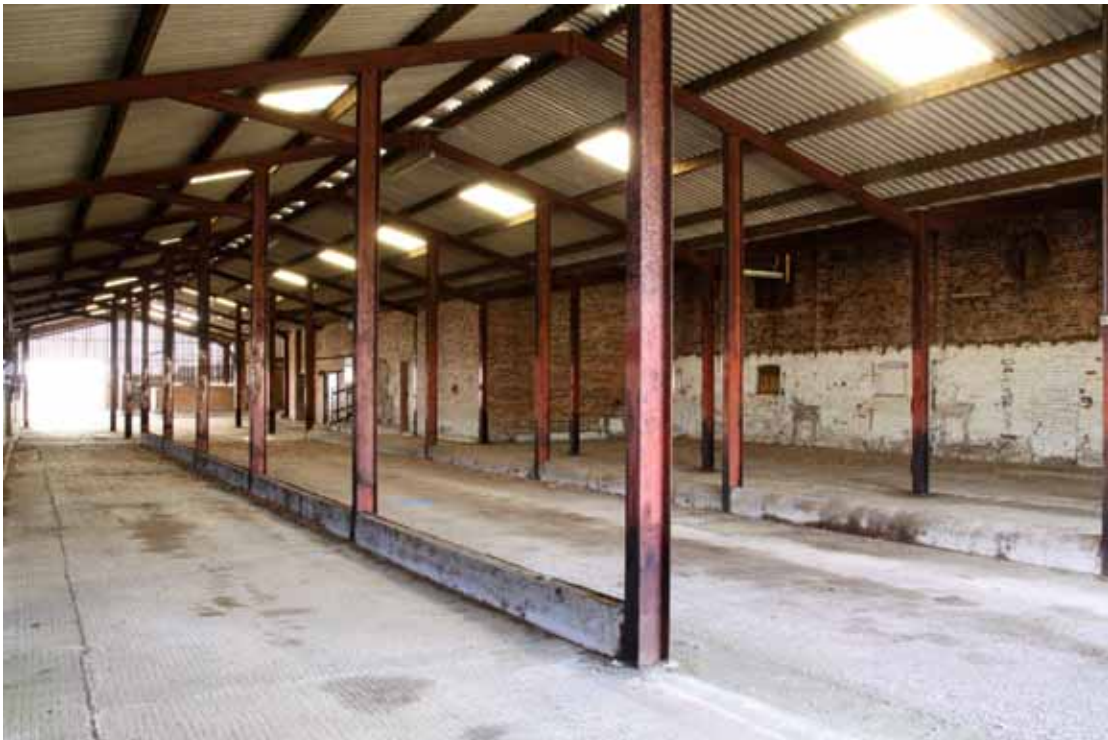
- 4.5.17 **Building 6:** the large, long, modern high-roofed cattle shed with several bays, incorporates parts of the earlier structures on site. It is supported on an I-sectioned beam frame, with an asbestos and plastic corrugated roof throughout (Plate 35). Where modern walls have been added, they are mostly of brick to half-height with wooden shuttering above. Large sliding timber doors are present to each gable end and the floors are of impressed concrete. The remnants of a row of I-section beams evident within the floor suggests that even this modern building has undergone alterations in form or function. Buildings 1, 3 and 4 all have entrances in to this building. To the south-east end are two large concrete block storage areas for either haylage or silage.

Plate 35: Interior of Building 6, a modern high-roofed cattle shed

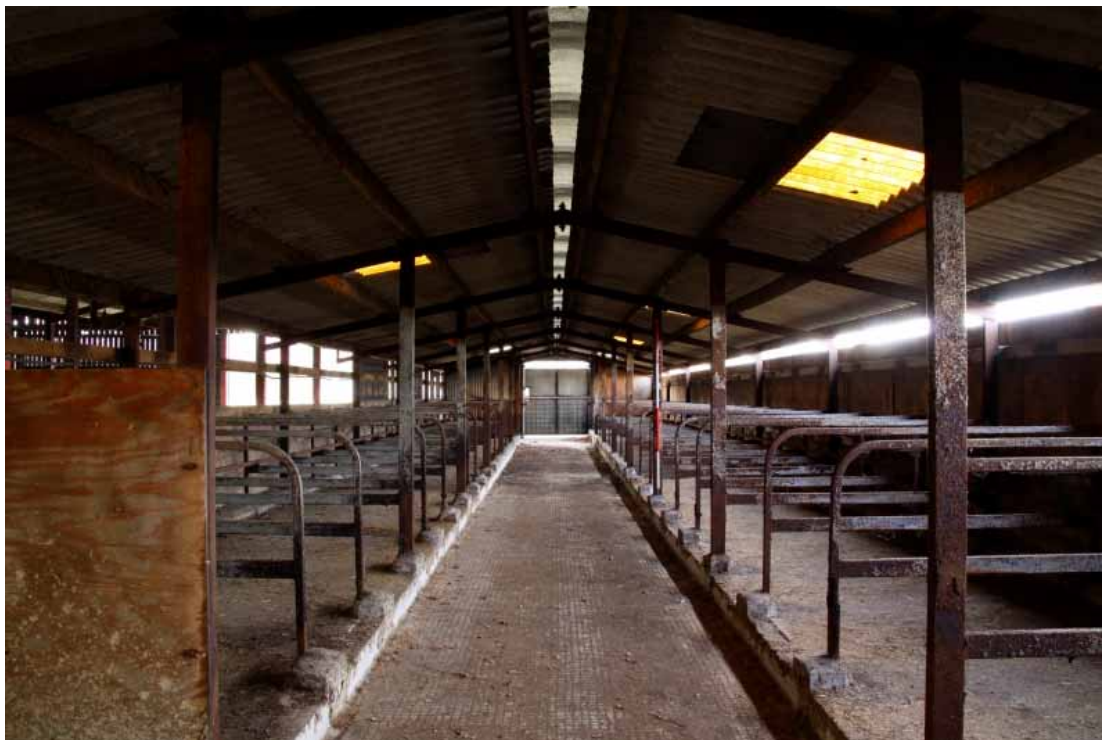
- 4.5.19 **Room 6.2:** this is a small cattle shed, an almost scaled down version of the larger cattle shed that is the majority structure of Building 6 (Plate 36). It has a metal frame with timber/woodchip panelled sides. It is divided into cattle stalls using tubular metal stall partitions.

Plate 36: Smaller cattle shed, Room 6.2
