# Montague Farmhouse Hethe

**Building Recording  
and Investigation**

March 2009

**Document Type:** Building Recording and Investigation

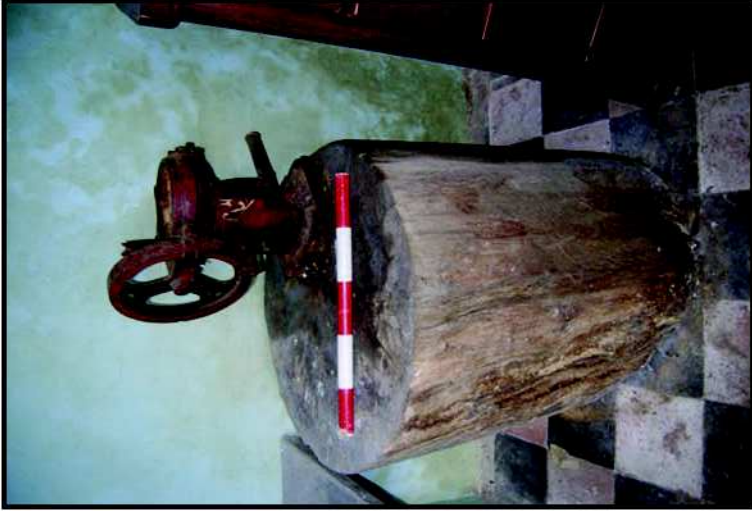
Plate 9: Room 1, 20th century  
fixtur

- 3.3.2 This room currently contains several fixtures and fittings relating to its use as a domestic dairy and for food preparation. There are two large lead salt troughs raised on low brick piers with further brick piers probably used for shelving and storage. There is a slab of marble forming a shelf on one, however this is not fixed and therefore may not be part of the original fixture. The piers are mostly painted blue and would appear to be of 19<sup>th</sup> century date. A large round timber block with metal fixture for processing meat sits adjacent to the west wall (Plate 9). The metal fixture is incomplete and is of unknown use but appears to be early 20<sup>th</sup> century in date with the words 'Now Listen' appearing in gold lettering on the side.
