# **THE THREE TOWERS, DALLAM TOWER ESTATE, CUMBRIA**

## **Management Plan**

**Oxford Archaeology North**

November 2005

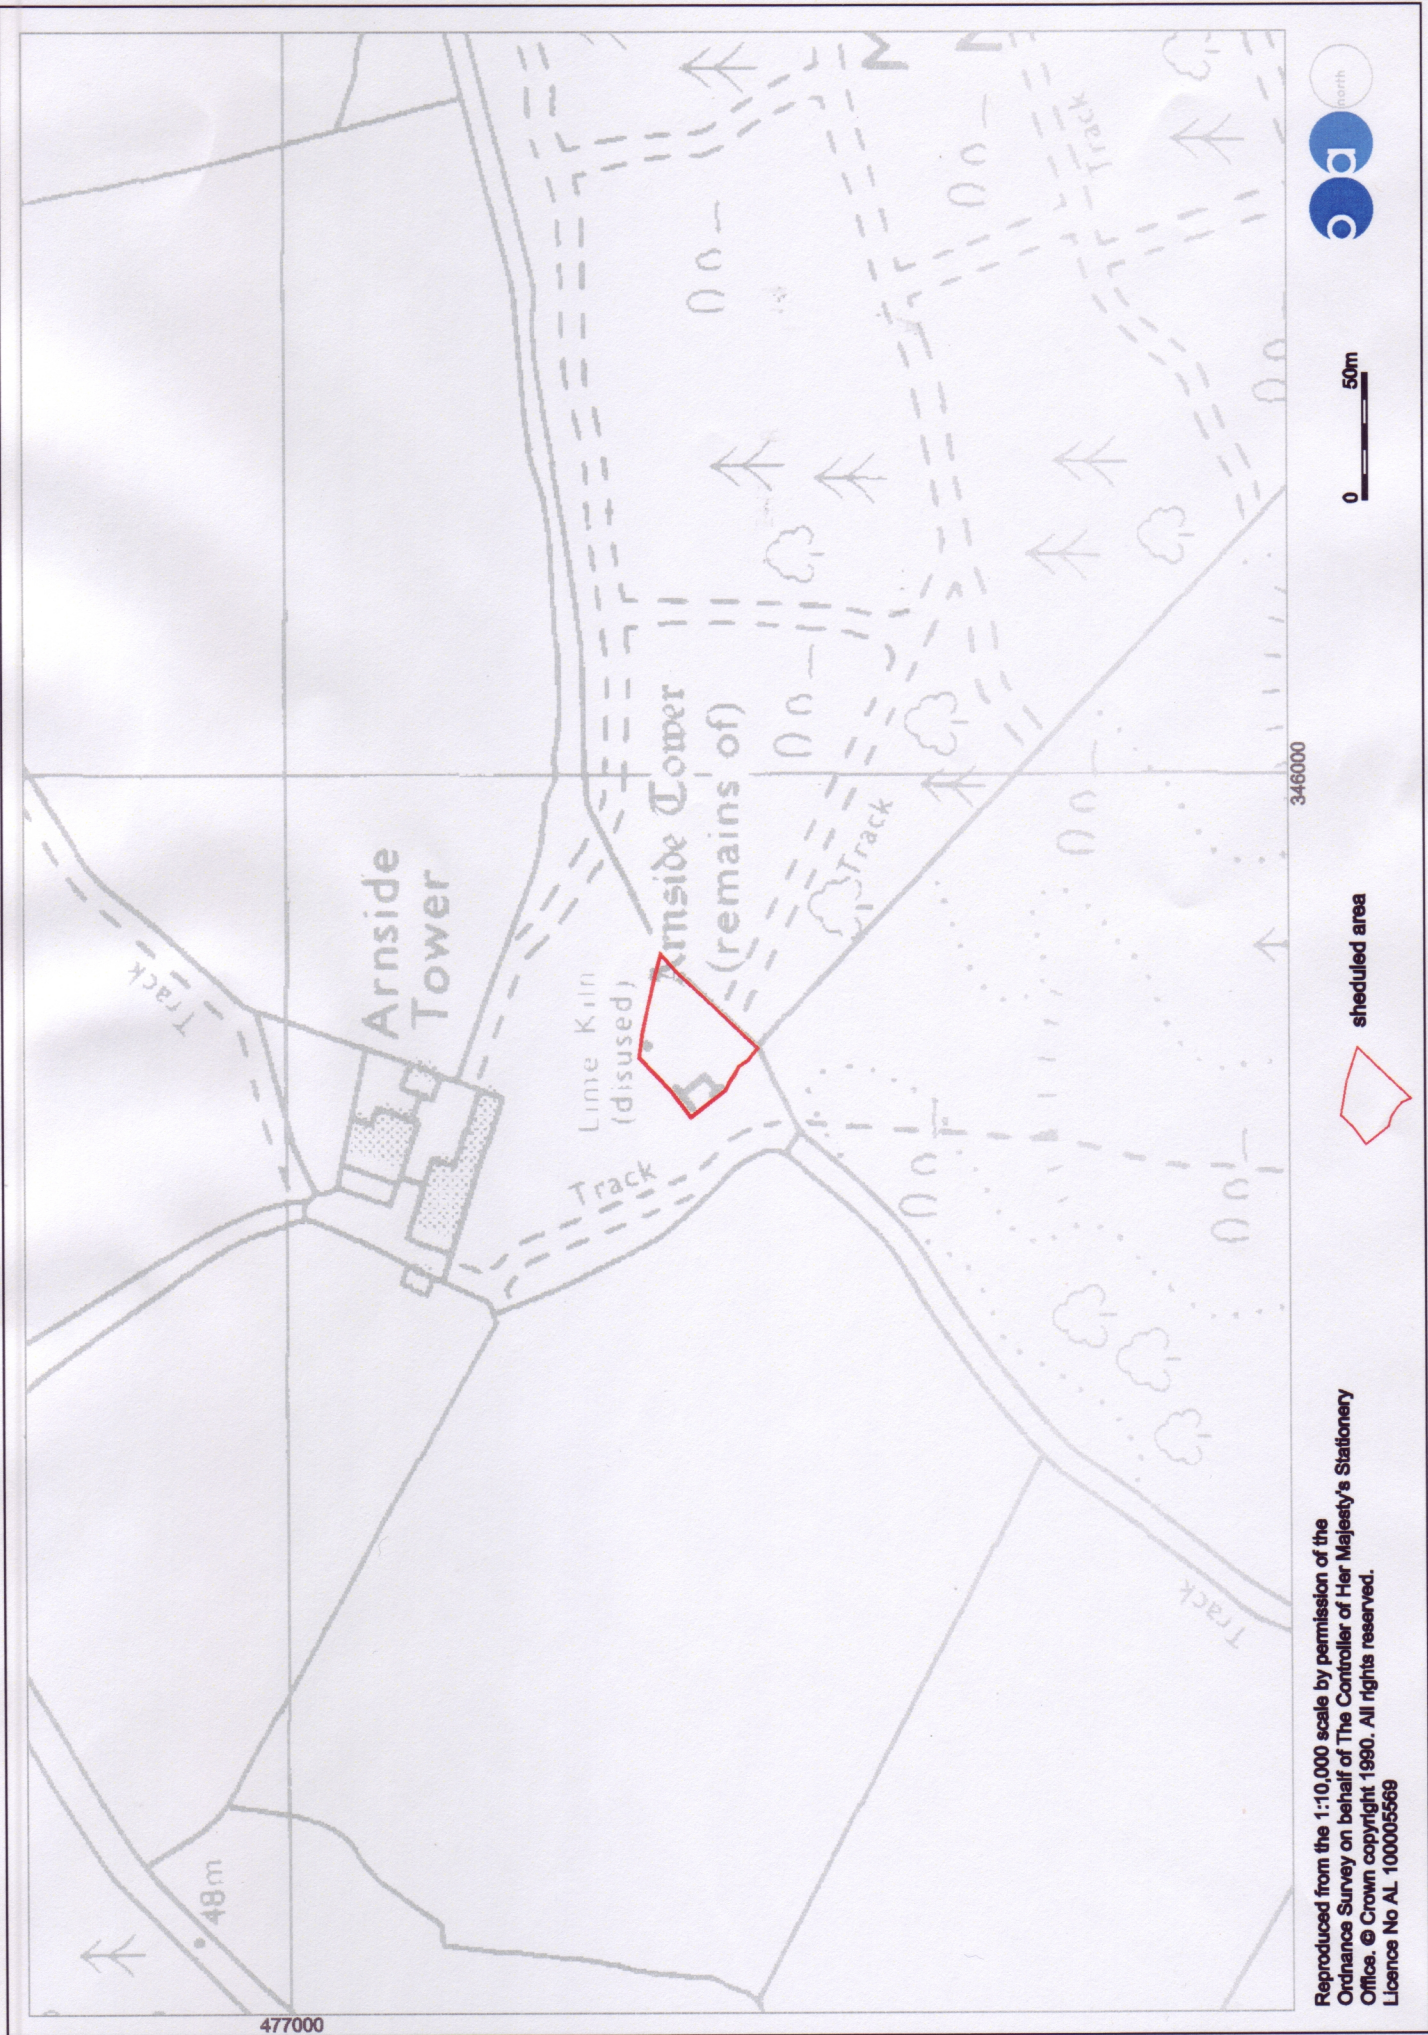
Figure 2: Arnside Tower, site plan

- 3.4.2 **Arnsdale Tower:** only two sites are recorded in the HER close to Arnsdale Tower: a limekiln to the south-east (SMR No 2523; Plate 1), which is within the limits of the Scheduled Monument for the tower (Fig 2), and a find-spot of a Norse ring-headed pin to the west (SMR No 535). Neither of these sites has any obvious relationship to the tower, although the limekiln may be connected to any demolition and re-use of materials that may have occurred. Other, largely linear, earthworks of unknown function, perhaps relating to the limekiln are also visible in aerial photographs of the site (Cumbria County Council 1987). The ring-headed pin might suggest that earlier activity should be expected in the area, although few detailed conclusions can be drawn from this single find. Other material dating from the early medieval period have been recorded in the Arnsdale area, much of it as part of the Portable Antiquities Scheme (Clement 2003, 235). The significant amount of early medieval metalwork from this area perhaps indicates that it was relatively densely occupied during this period.

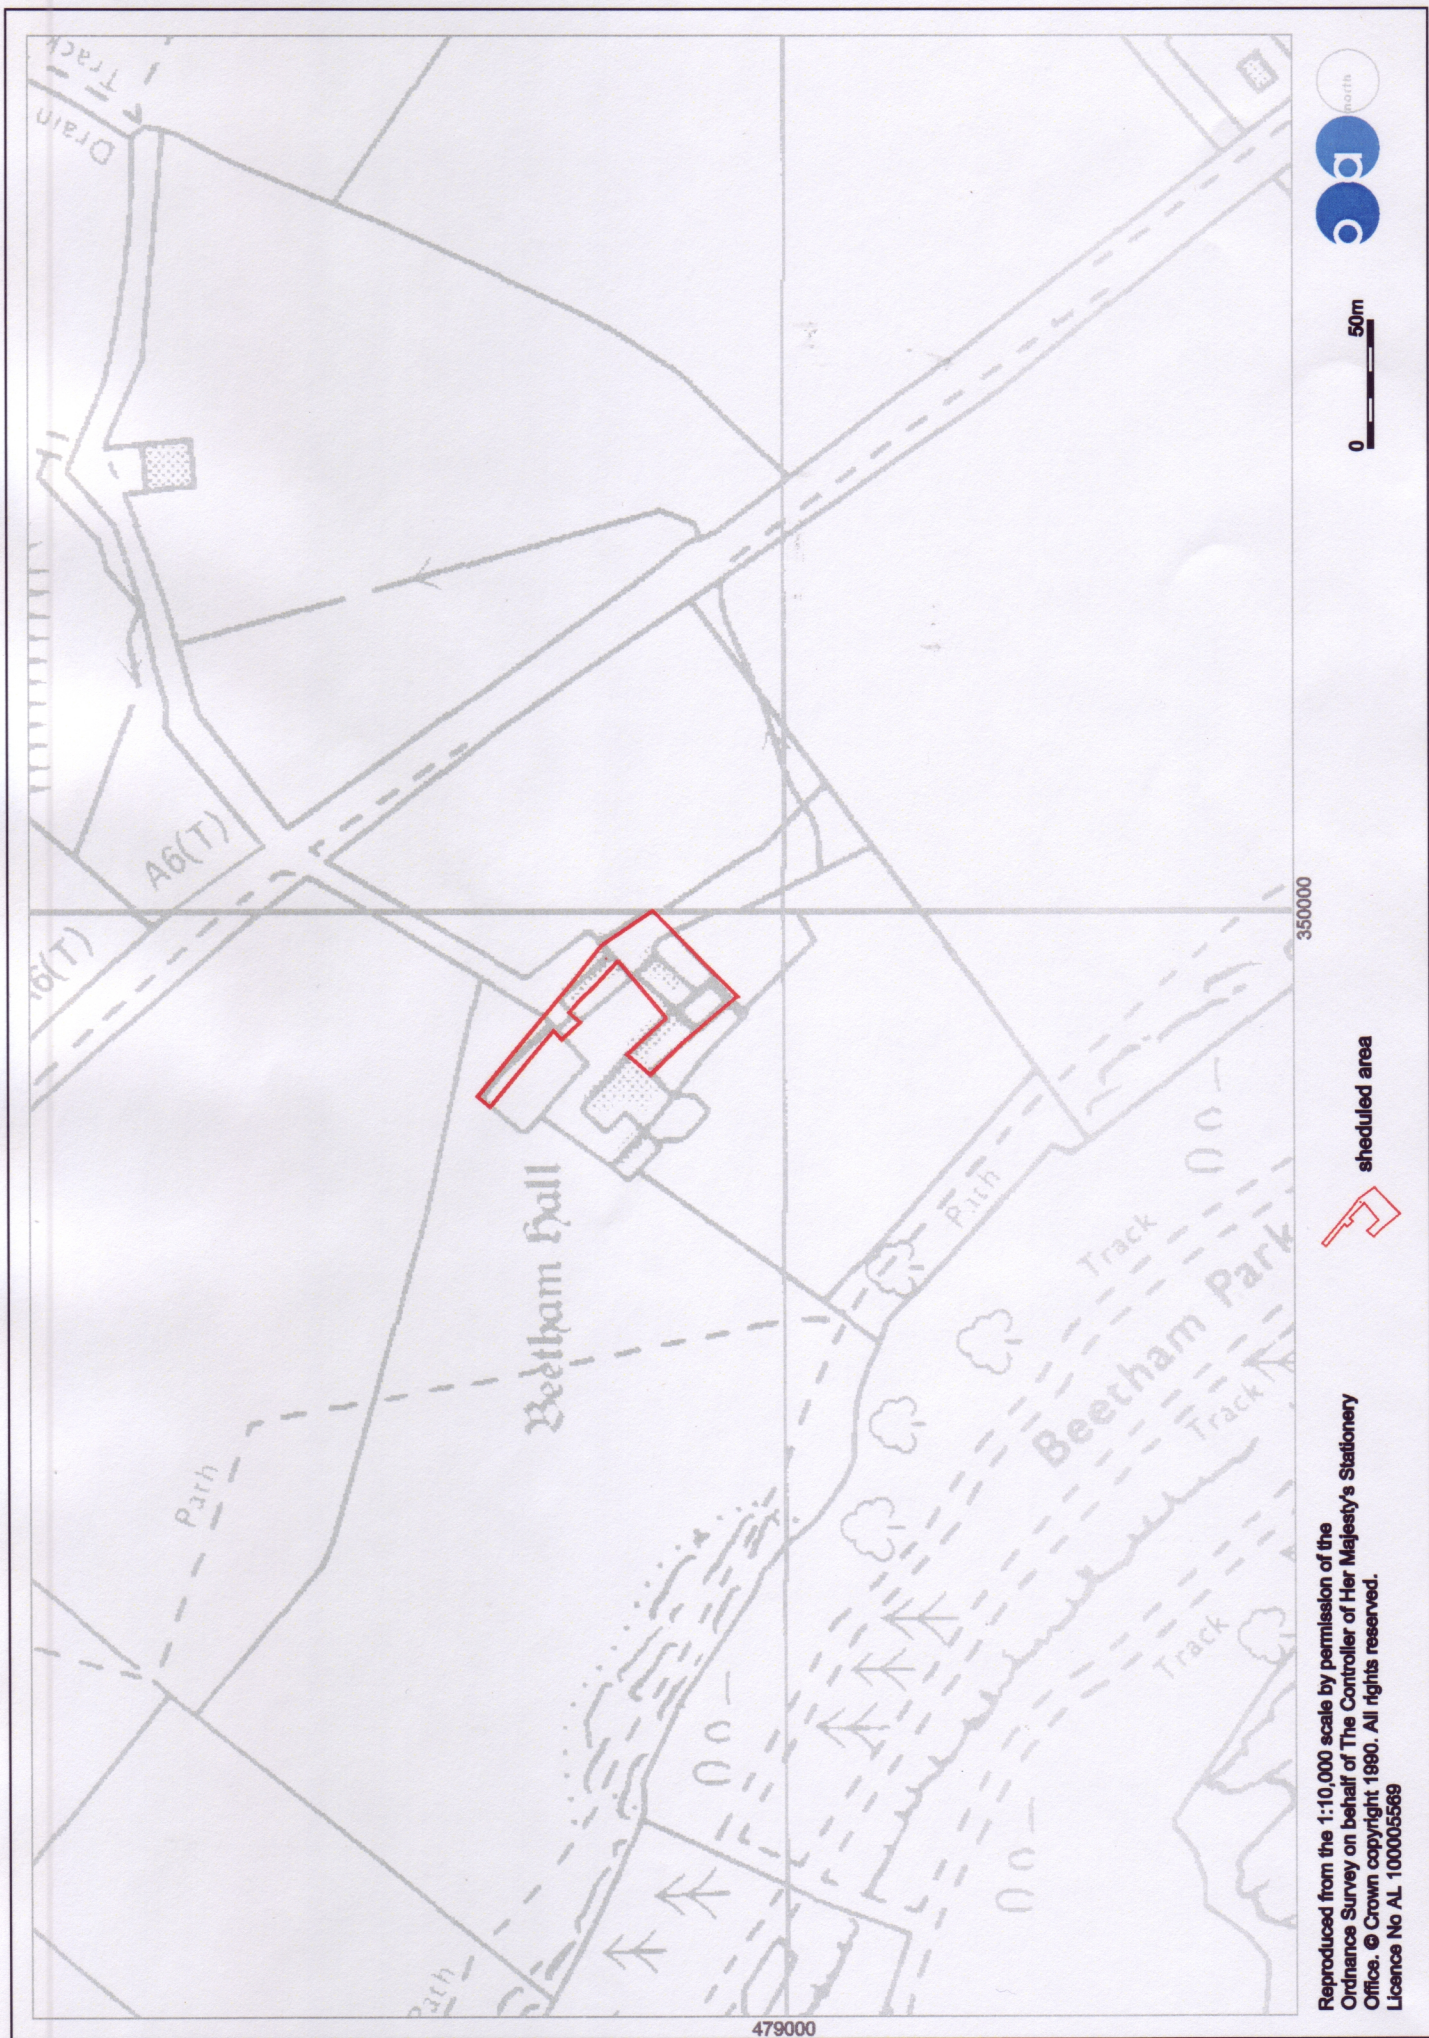
Figure 3: Beetham Hall, site plan

- 3.4.3 **Beetham Hall:** a large number of features were identified in the environs of Beetham Hall. Unlike the other two sites, the structure itself is made up of several parts, including a house, a barn and the remains of the curtain wall (all of which are included within the Scheduled Monument; Fig 3). A metal detector find of a medieval spur and belt stud was made in the surrounding fields (SMR No 16748) and there are three areas of earthworks in the

5.5.1 Beetham Hall is made up of several parts including both elements relating to the medieval hall, and buildings forming a post-medieval farmstead (Fig 3). The hall is in a poor condition, although largely still roofed, and parts of it have been incorporated into the farmstead. It is not, at present, included on the BAR Register (English Heritage 2005), but it is considered essential to add it as soon as possible (Richard Newman pers comm).

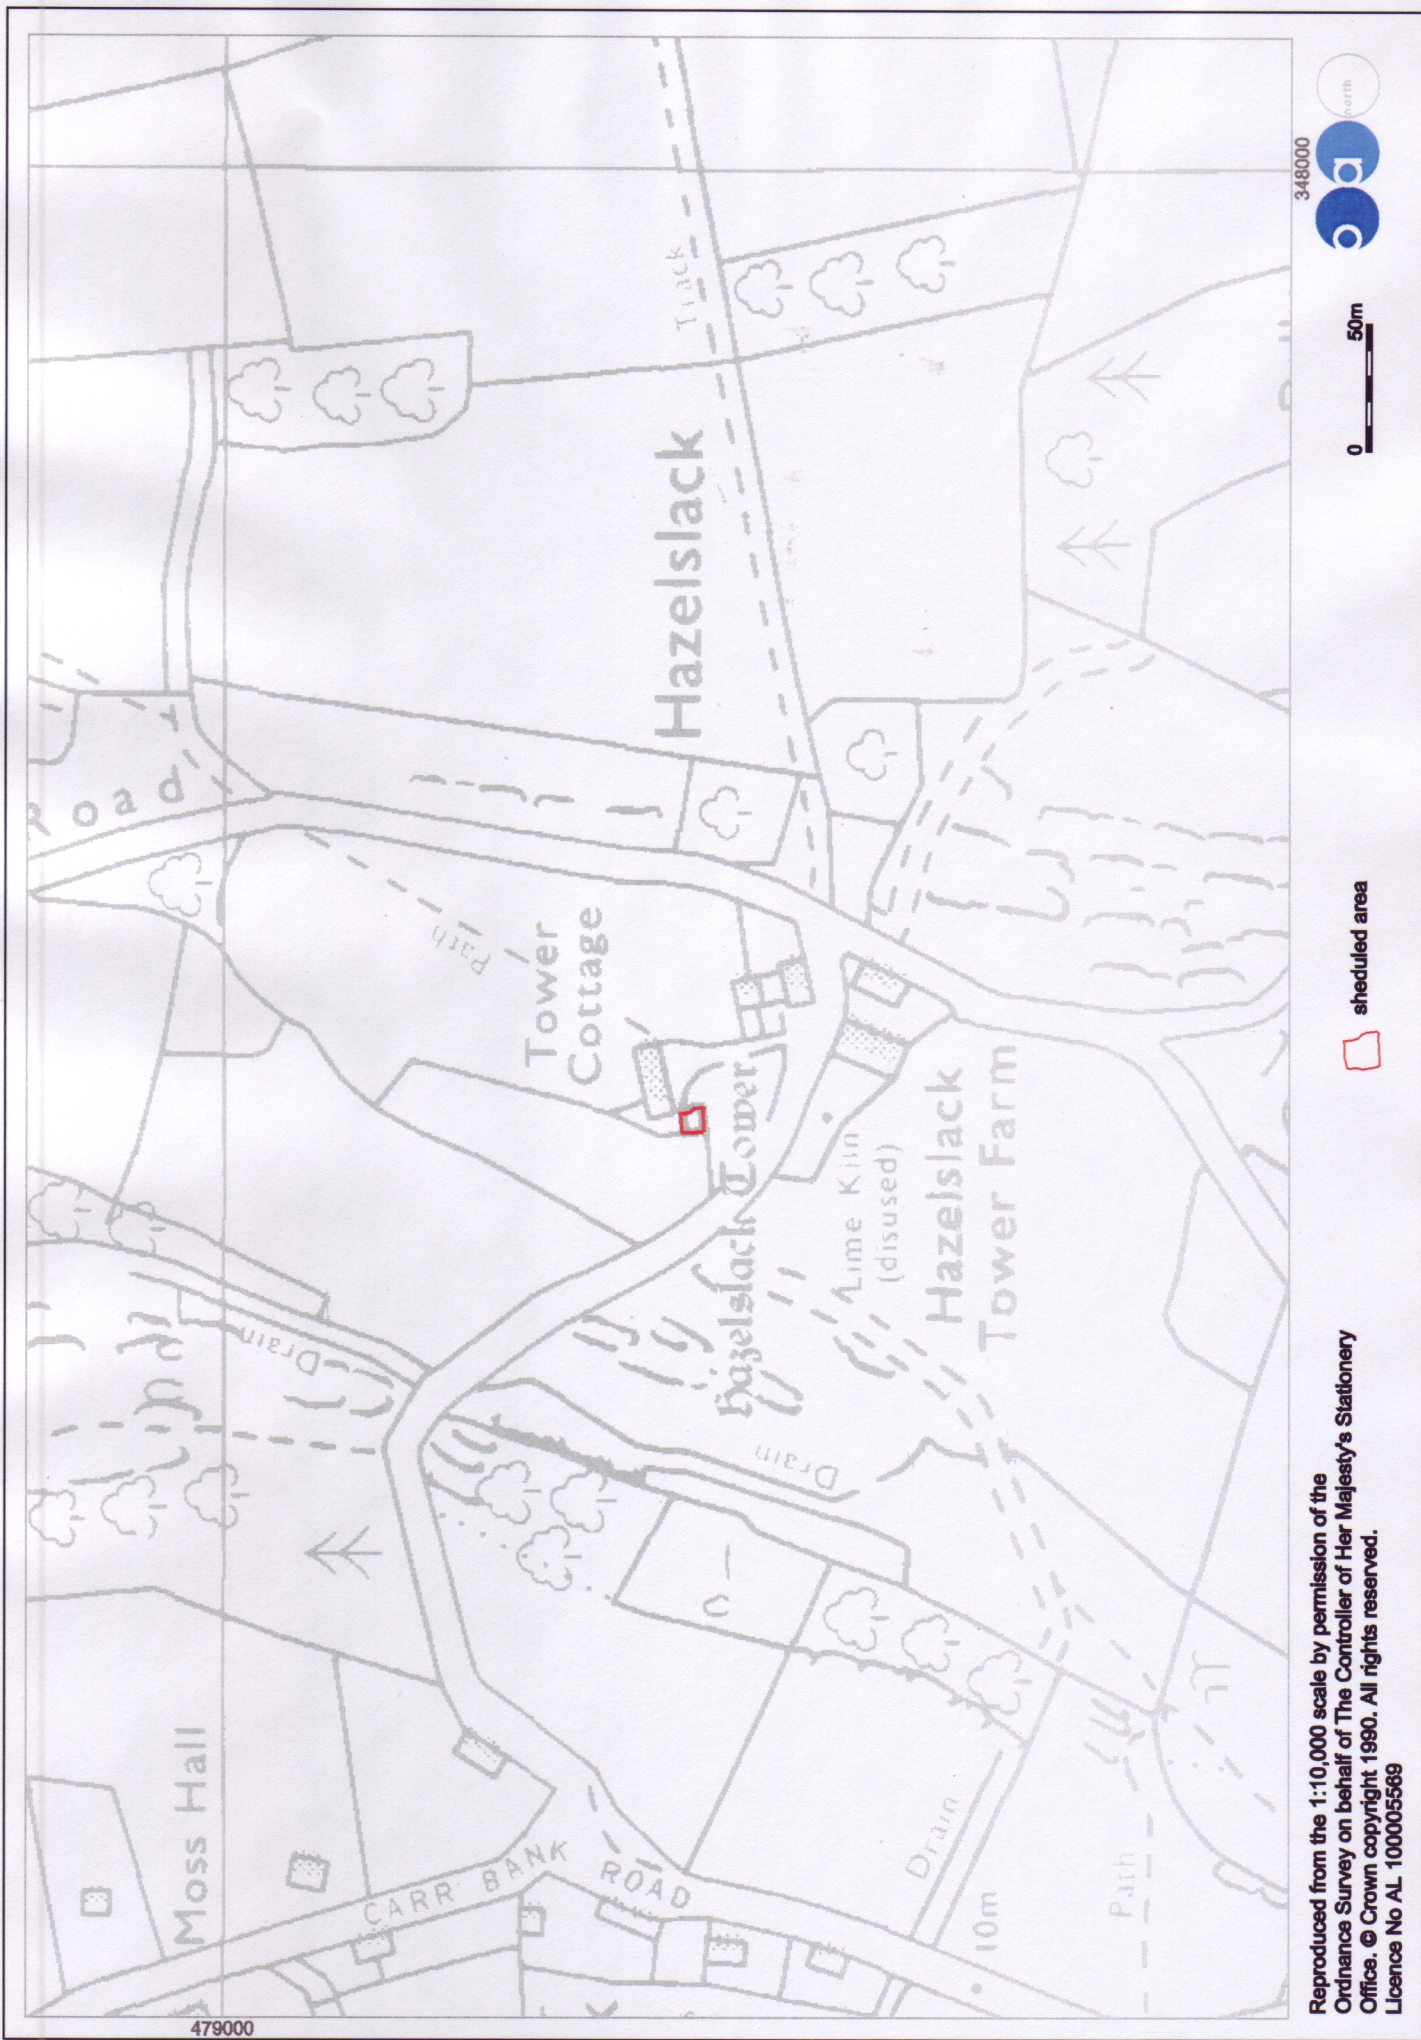
Figure 4: Hazelslack Tower, site plan

- 3.4.4 **Hazelslack Tower:** only a single site was identified close to Hazelslack Tower: a limekiln (SMR No 12557; Fig 4) possibly with associated earthworks, to the south. This is unlikely to relate to the monument itself, but may be associated with post-medieval use of the local area and possibly even re-use of the tower, which could have been used as a source of stone.
