AGRICULTURAL BUILDING, CHURCH LANE, TUNSTALL

LANCASHIRE

Documentary and Building Survey Report

August 2016

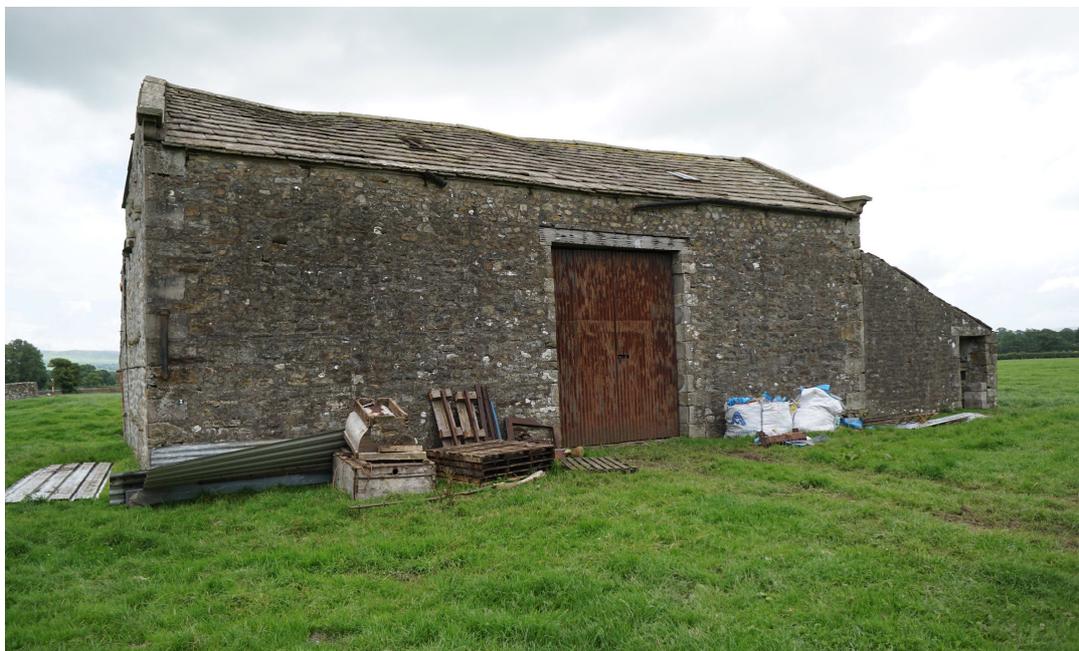
Plate 6: Western elevation of the barn

- 4.1.3 ***Western Elevation (Fig 8):*** the primary elevation of the barn lay to the west, where it faced the centre of the village across an open field (Plate 6). The only opening was a large cart entrance, off-set to the south slightly to leave two full bays to the north and only one and a half at the opposing end. The jambs were laid in alternating courses but were significantly smaller in character than those used at the corners of the building and a timber lintel lay across the head of the opening. The original double doors had been replaced with corrugated iron examples.

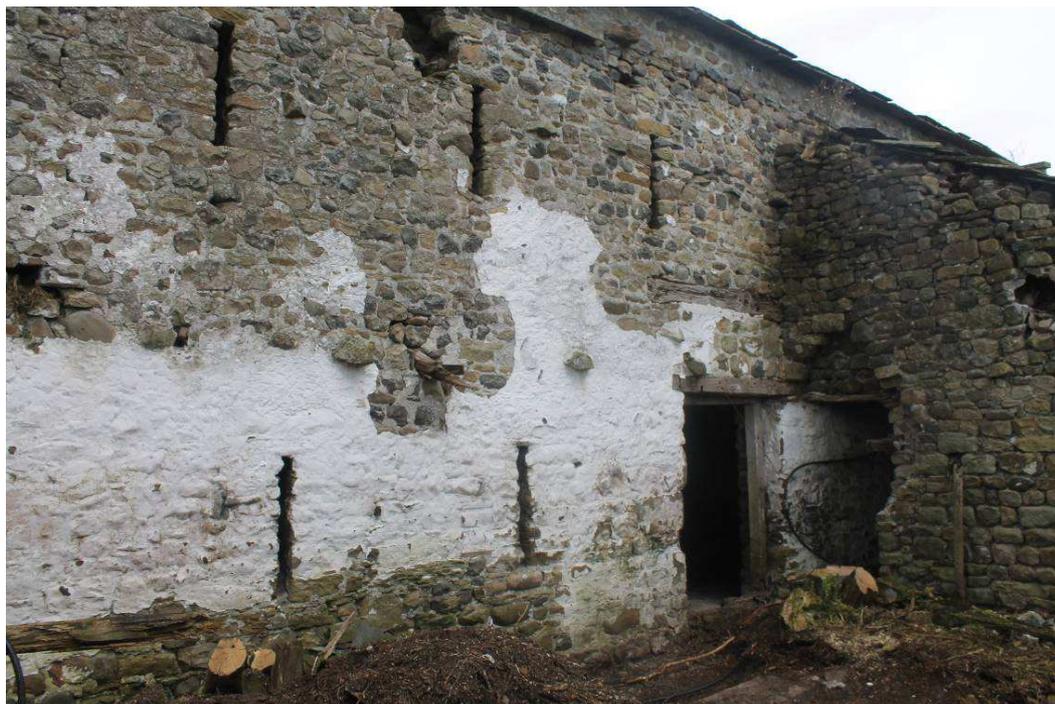
Plate 10: Southern end of the original eastern elevation of the Main Barn, facing north-west

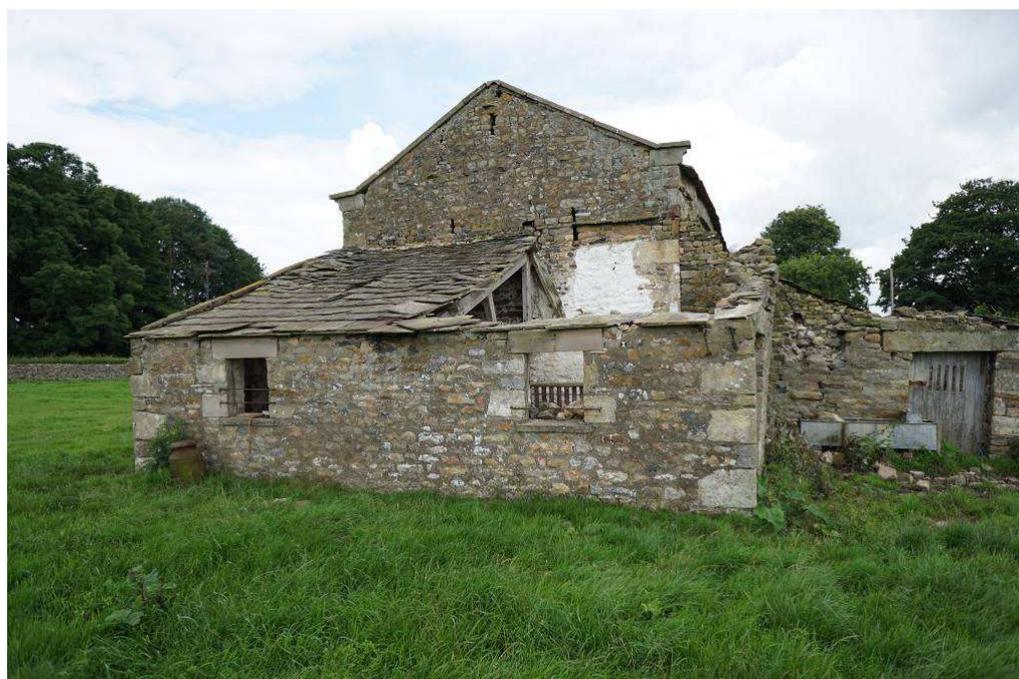
Plate 13: The southern elevation of the Main barn and southern lean-to

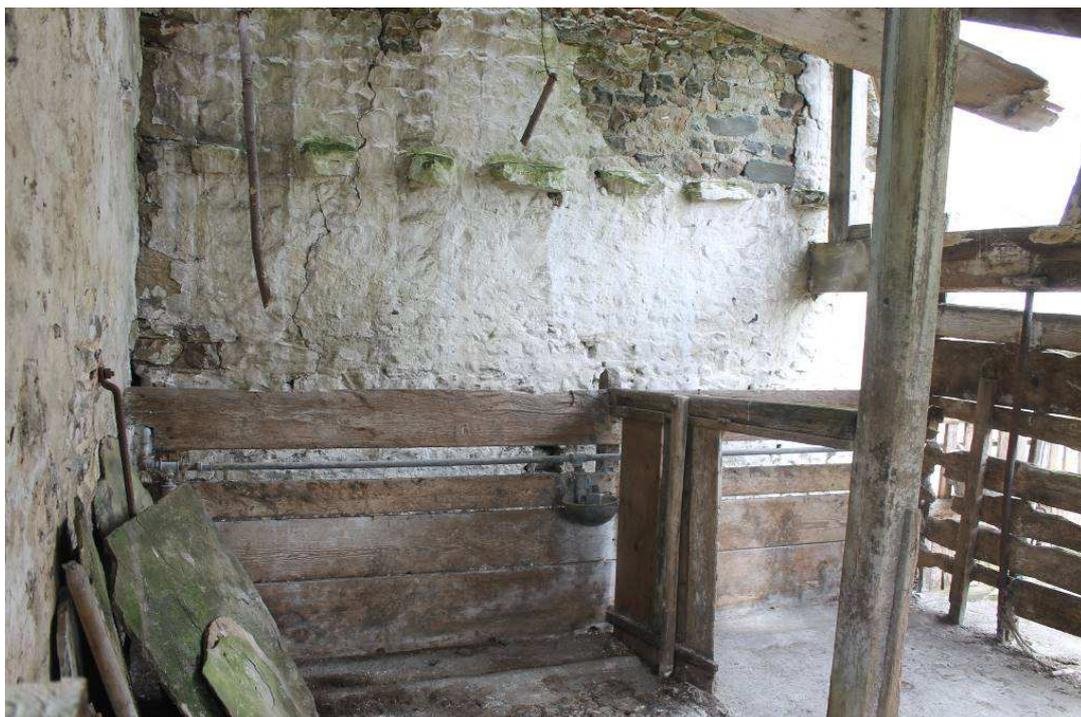
Plate 14: The southern wall of the Main Barn facing north, with the stalls of the southern lean-to in the foreground

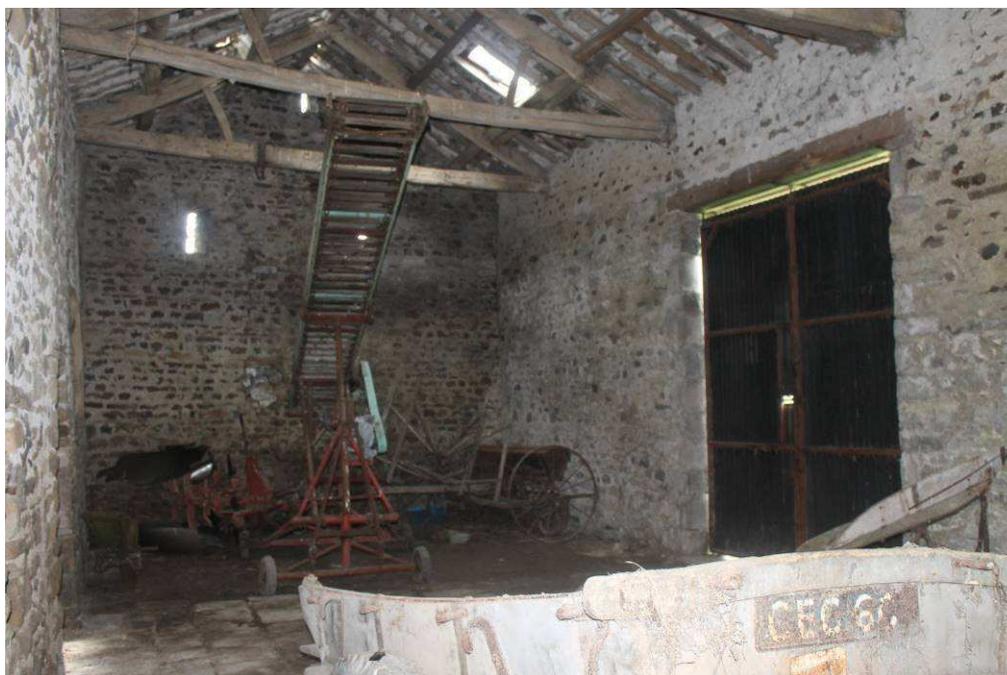
Plate 15: Interior of the Main Barn facing south

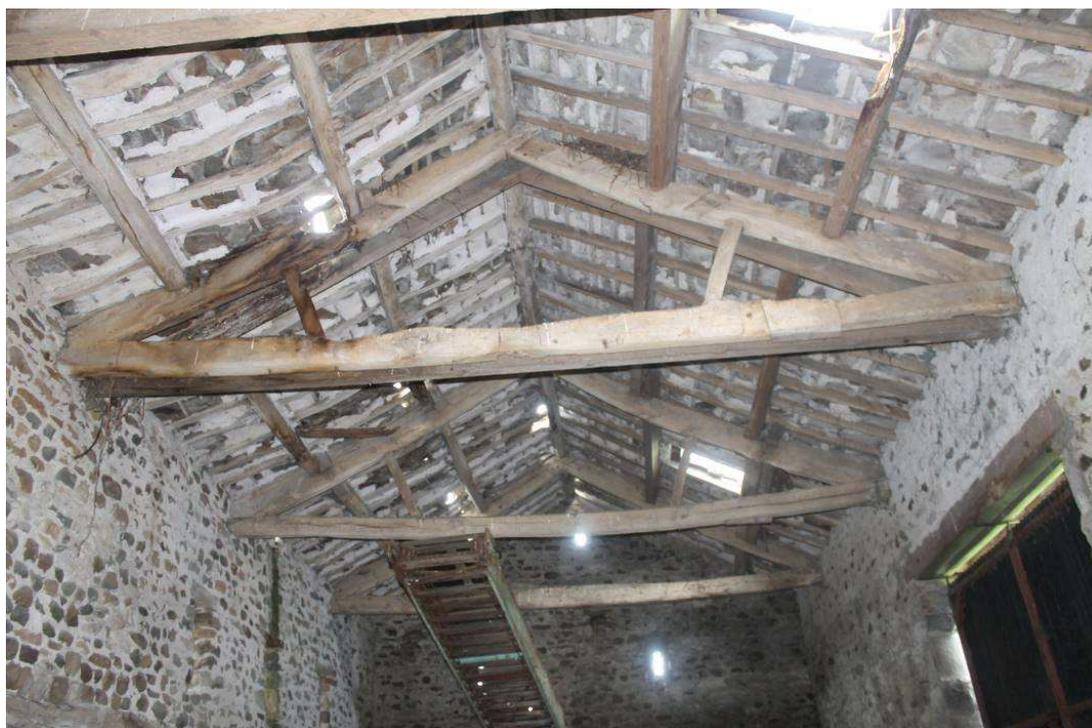
- 4.2.4 Two of the trusses were in a very poor condition and had been shored up with the addition of a matching truss immediately to the south. The original trusses were numbered on the northern face of their western joints with roman numerals from I at the southern end increasing to V at the northern end (Plate 20). Notably truss IV was not present, and again perhaps highlights the reuse of the timbers from another building. Trusses I –III were further numbered with a series of punched dots on the northern faces of their eastern joints (Plate 21).
- 4.2.5 Several pieces of wheeled farming equipment had been preserved in the barn, probably dating to the first half of the twentieth century, and a small free standing piece of equipment bearing the name ‘unchokeable’ and the manufactures name ‘J.R. Warwick’ of ‘Lancaster’ stood in one corner (Plate 22).

Plate 18: The truss design in the Main Barn

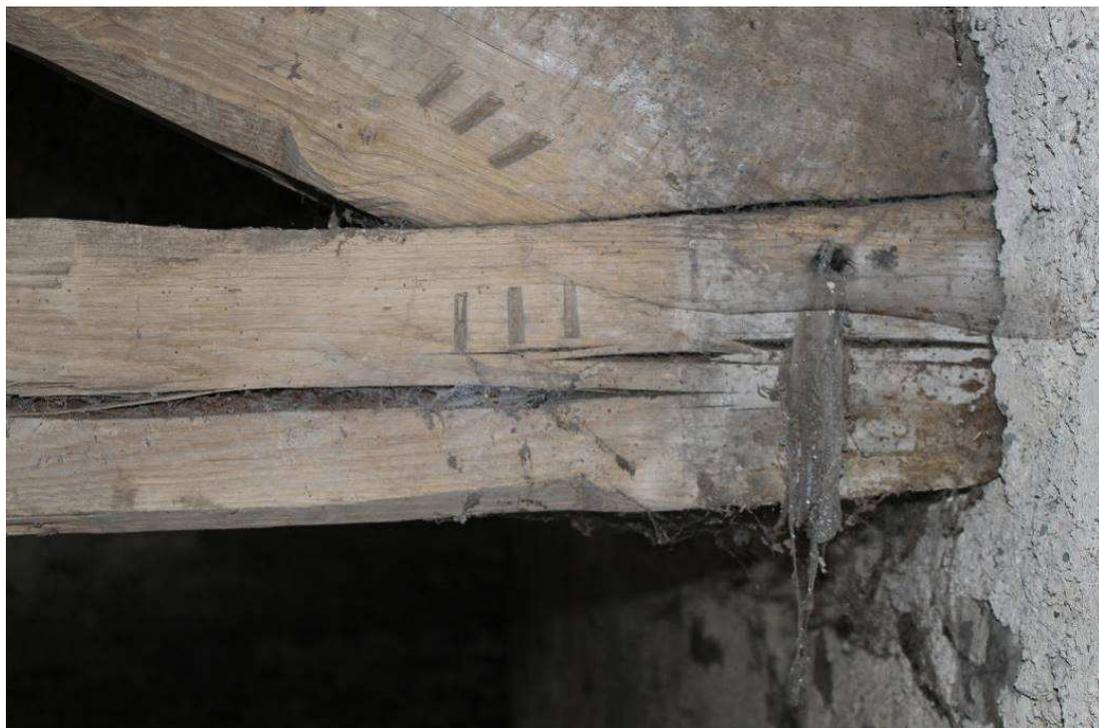
Plate 20: Roman numerals marking assembly order. Note also the chamfered stops on the underside of both beams

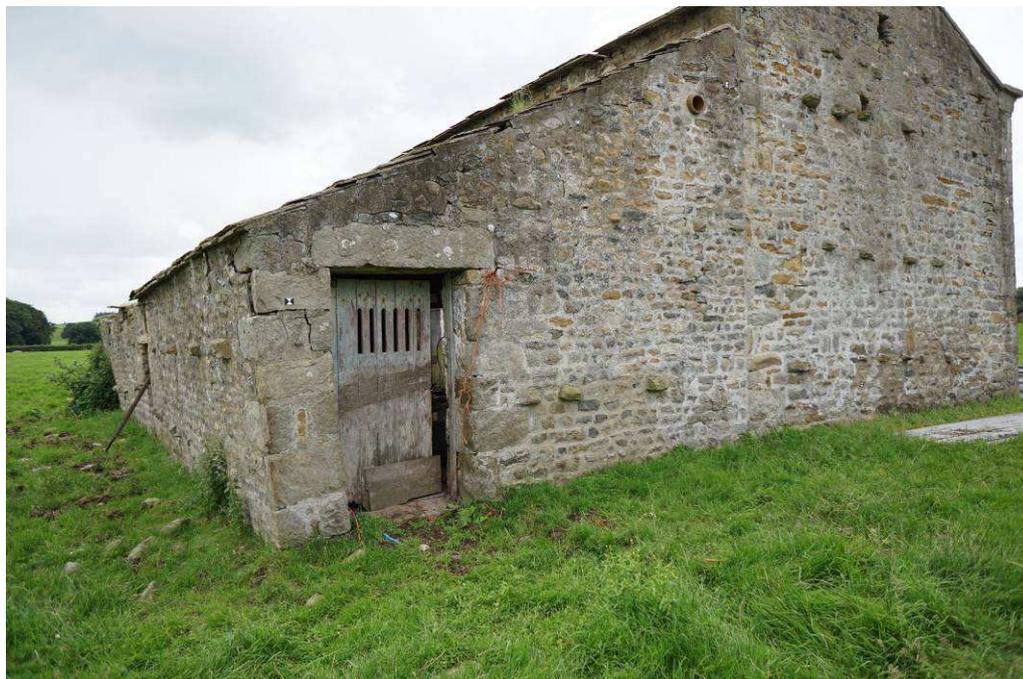
Plate 23: North wall of north-eastern lean-to, facing south

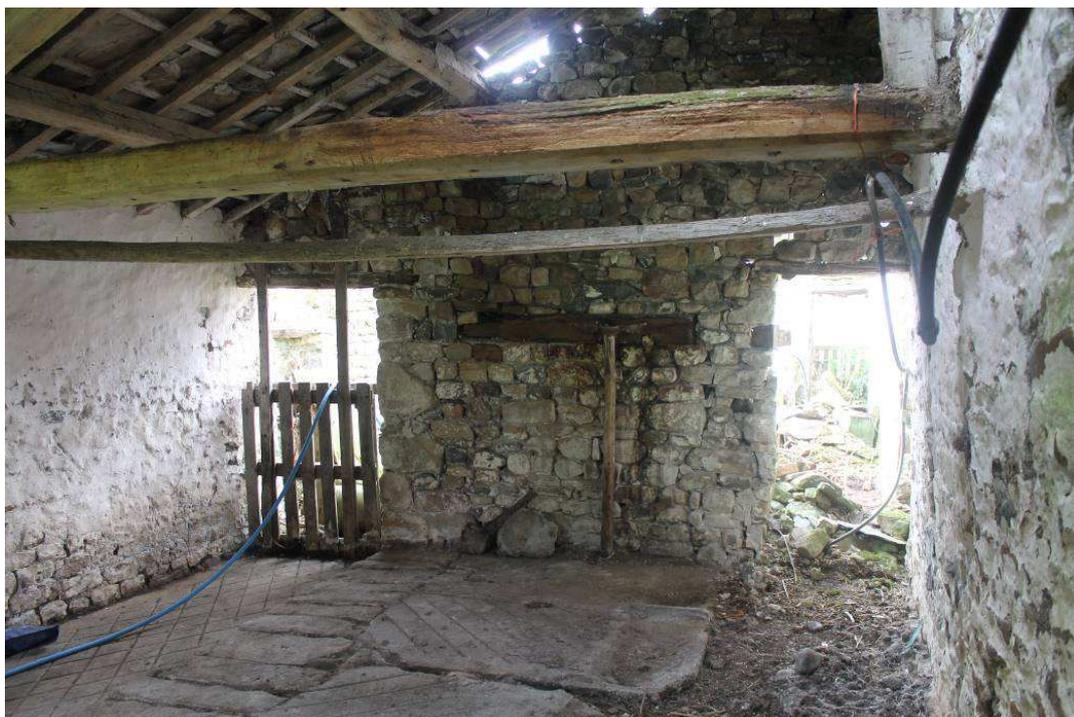
- 4.4.1 Internally, the walls had been coated in a thick white paint, although this had all but worn off on the southern wall (Plate 26). The floor was divided into two main levels with a concrete passage along the eastern side of the building connecting the two eastern opposing doors. The remainder of the floor to the west was raised approximately 0.1m higher and had a hard wearing kerb of sandstone blocks along its eastern side, edging a concrete surface (Plate 27). The western limit of this surface clearly marked the head of the cattle stalls with a feeding passage along the western wall comprised of an informal soil floor. A large upright slate at the northern end of room had formed part of the original division between the feeding passage and stalls and a pair of empty stone sockets in the floor of the stalls indicated the position of the dividing posts and the width of the stalls. A timber tethering post survived against the southern wall, complete with its iron tethering ring.

Plate 26: Interior of north-eastern lean-to facing south

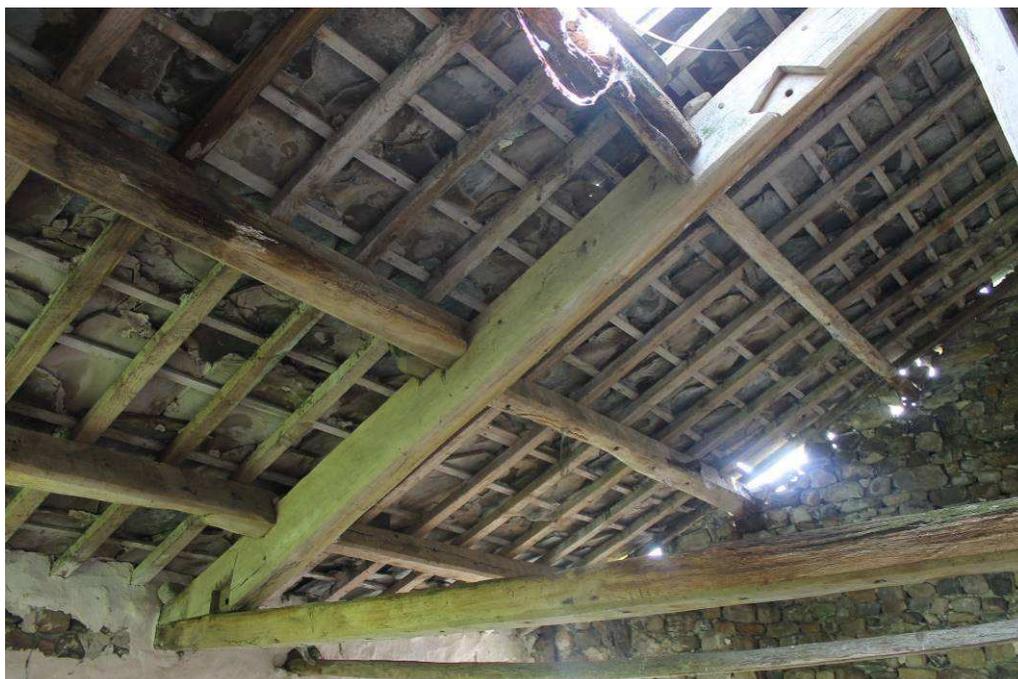
- 4.4.2 The building's roof was formed of a single half truss mid-way across the width of the room, carrying trenched and staggered purlins on the back of its principal rafter (Plate 28). The common rafters, battens and slates were arranged in an identical manner to the Main Barn, although no torching had been applied. As with the Main Barn, the principal rafter retained two empty halftings, suggesting that it was originally used as a tie beam.

Plate 28: Half truss in the north-eastern lean-to. Note the empty half-timings on the principal rafter, indicative of its original use as a tie beam. Facing south

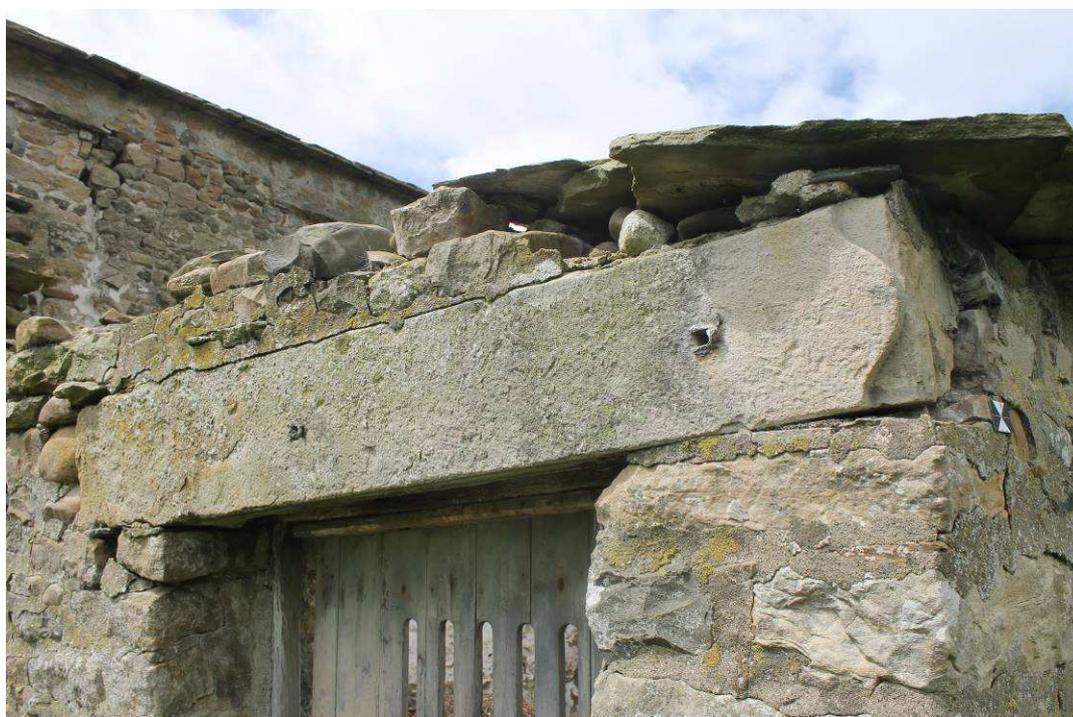
Plate 30: Sandstone gate-post reused as a lintel above the entrance into the south-eastern lean-to

- 4.5.2 ***External Appearance:*** externally, the building could be entered via a doorway at the eastern end of the southern wall, which was topped by a large, slightly trapezoidal sandstone lintel (Plate 29). It was evident from the shape of the lintel, and two small square sockets on its outer face, that it had previously served as a vertical gate post and a shallow bell curve had been carved into its eastern end in relief (Plate 30). The doorway was fitted with a timber door of narrow vertical panels similar to that described on the adjoining lean-to, and also incorporated a sliding timber vent within its upper half. The remainder of the southern wall was in poor condition, with its upper third missing and the western half partially collapsed. A steel water trough had been placed against the base of the wall to the west of the doorway, partially obscuring the wall behind.

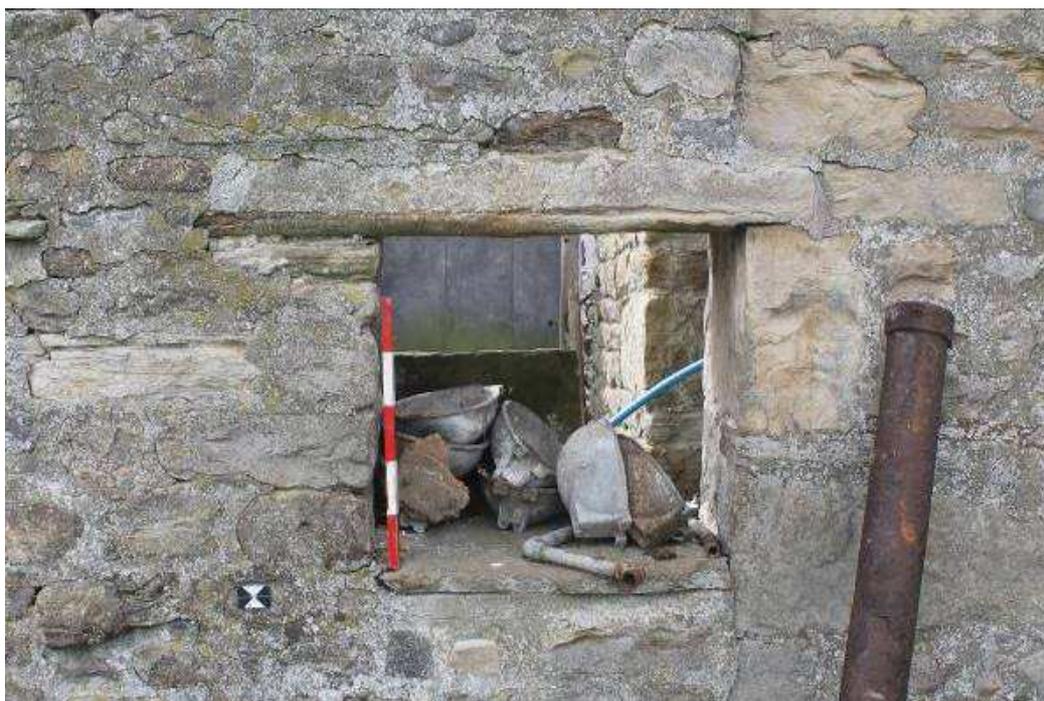
Plate 31: Window at the northern end of the eastern wall

- 4.5.3 The eastern wall was partly obscured by vegetation but two narrow openings just beneath the height of the eaves indicated the former position of a pair of principal rafters which must once have supported the roof. Where the wall abutted the northern lean-to there was a small square window at mid-height with a narrow stone sill below a substantial stone lintel (Plate 31). The northern end of the lintel

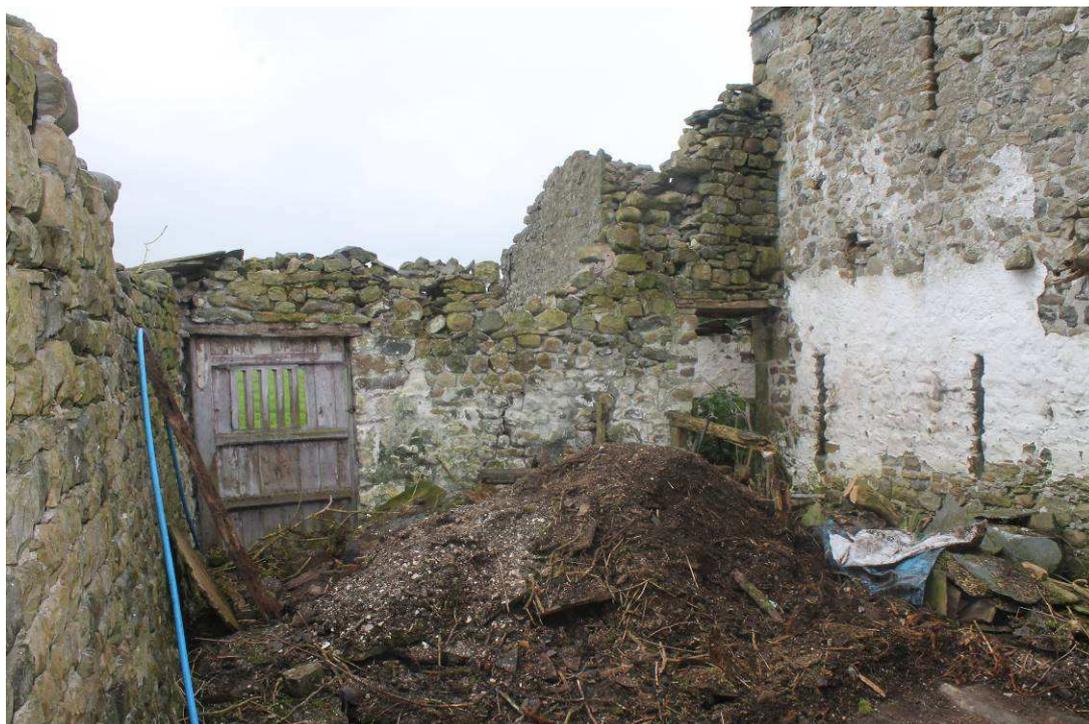
Plate 32: Interior of the south-eastern lean-to facing south

- 4.5.4 **Internal Appearance:** internally, the southern wall retained traces of its coating of white paint, although this was almost completely lost from the face of the eastern wall. A narrow doorway with a timber lintel lay at the western end of the southern wall, leading into the southern lean-to. The collapse of the roof had resulted in an accumulation of rubble, soil and other debris which obscured the ground surface but the rubble had been cleared across a central section of the floor. This revealed a similar basic arrangement to that described in the north-eastern lean-to, with a passage along the eastern wall, defined by a raised step along its western edge. Unlike the northern lean-to, the centre of the floor retained its original cobbled surface and there was a cement drain running along its western edge. A lateral feeding passage ran along the western side of the building, with the remnants of a timber partition surviving at the southern end alongside a wooden tethering post attached to the southern wall.

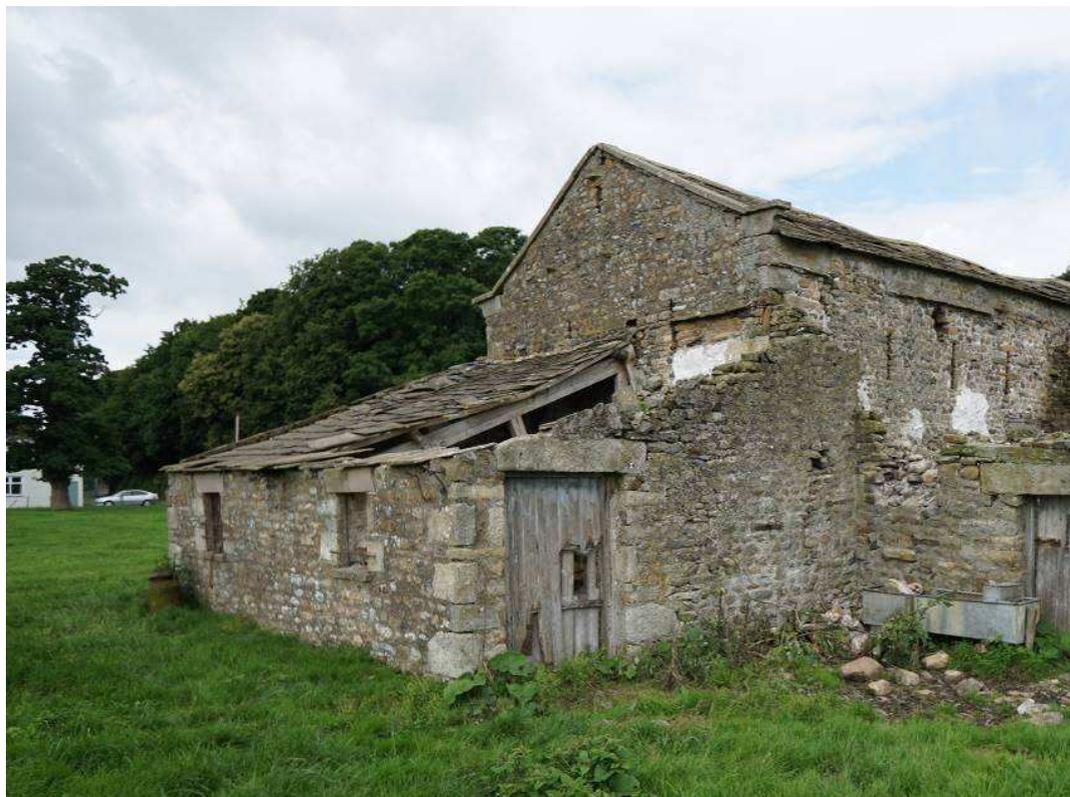
Plate 34: Eastern elevation of the southern lean-to, facing north-west

- 4.6.3 The eastern elevation was a reflection of that to the west, although it retained its internally opening timber door at the southern end. Additionally, the masonry at the northern end of the wall was slightly disturbed at about mid-height, perhaps indicating a blocked opening of some kind (Plate 35). The loss of the roof from this

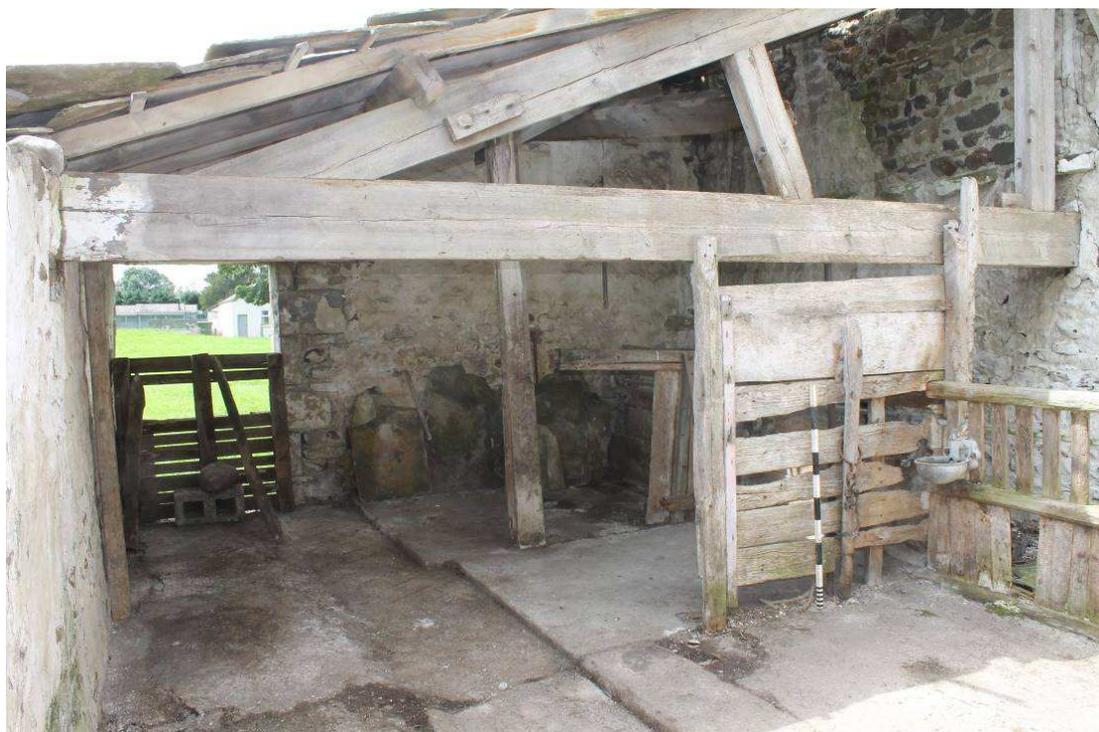
Plate 36: Interior of the southern lean-to facing west

- 4.6.4 **Internal Appearance:** the internal walls were coated in thick white paint, with the exception of the eastern wall where the weather had stripped this away but the layout of the interior was perhaps the best preserved of any of the three lean-to's (Plate 36). A cobbled feeding passage ran along its northern side defined to the south by a half-height timber partition that denoted the head end of the stalls (Plate 37). Additional partitions extended at right angles from these at regular intervals along the buildings length, indicating the width of the stalls, which would have been further sub-divided by intermediary posts. The positions of the intermediary posts were revealed by a series of empty sockets in the concrete floor, indicating stalling for up to eight animals. Timber tethering posts survived against the eastern and western walls, with a third at the centre of the room, all retained their tethering iron. A stone kerb defined the rear of the stalls, beyond which there was a step down to a concrete drain running along the length of the building. An access passage located against the southern wall between the two opposing doors retained its original cobbled floor to the east but this had been replaced in concrete to the west.

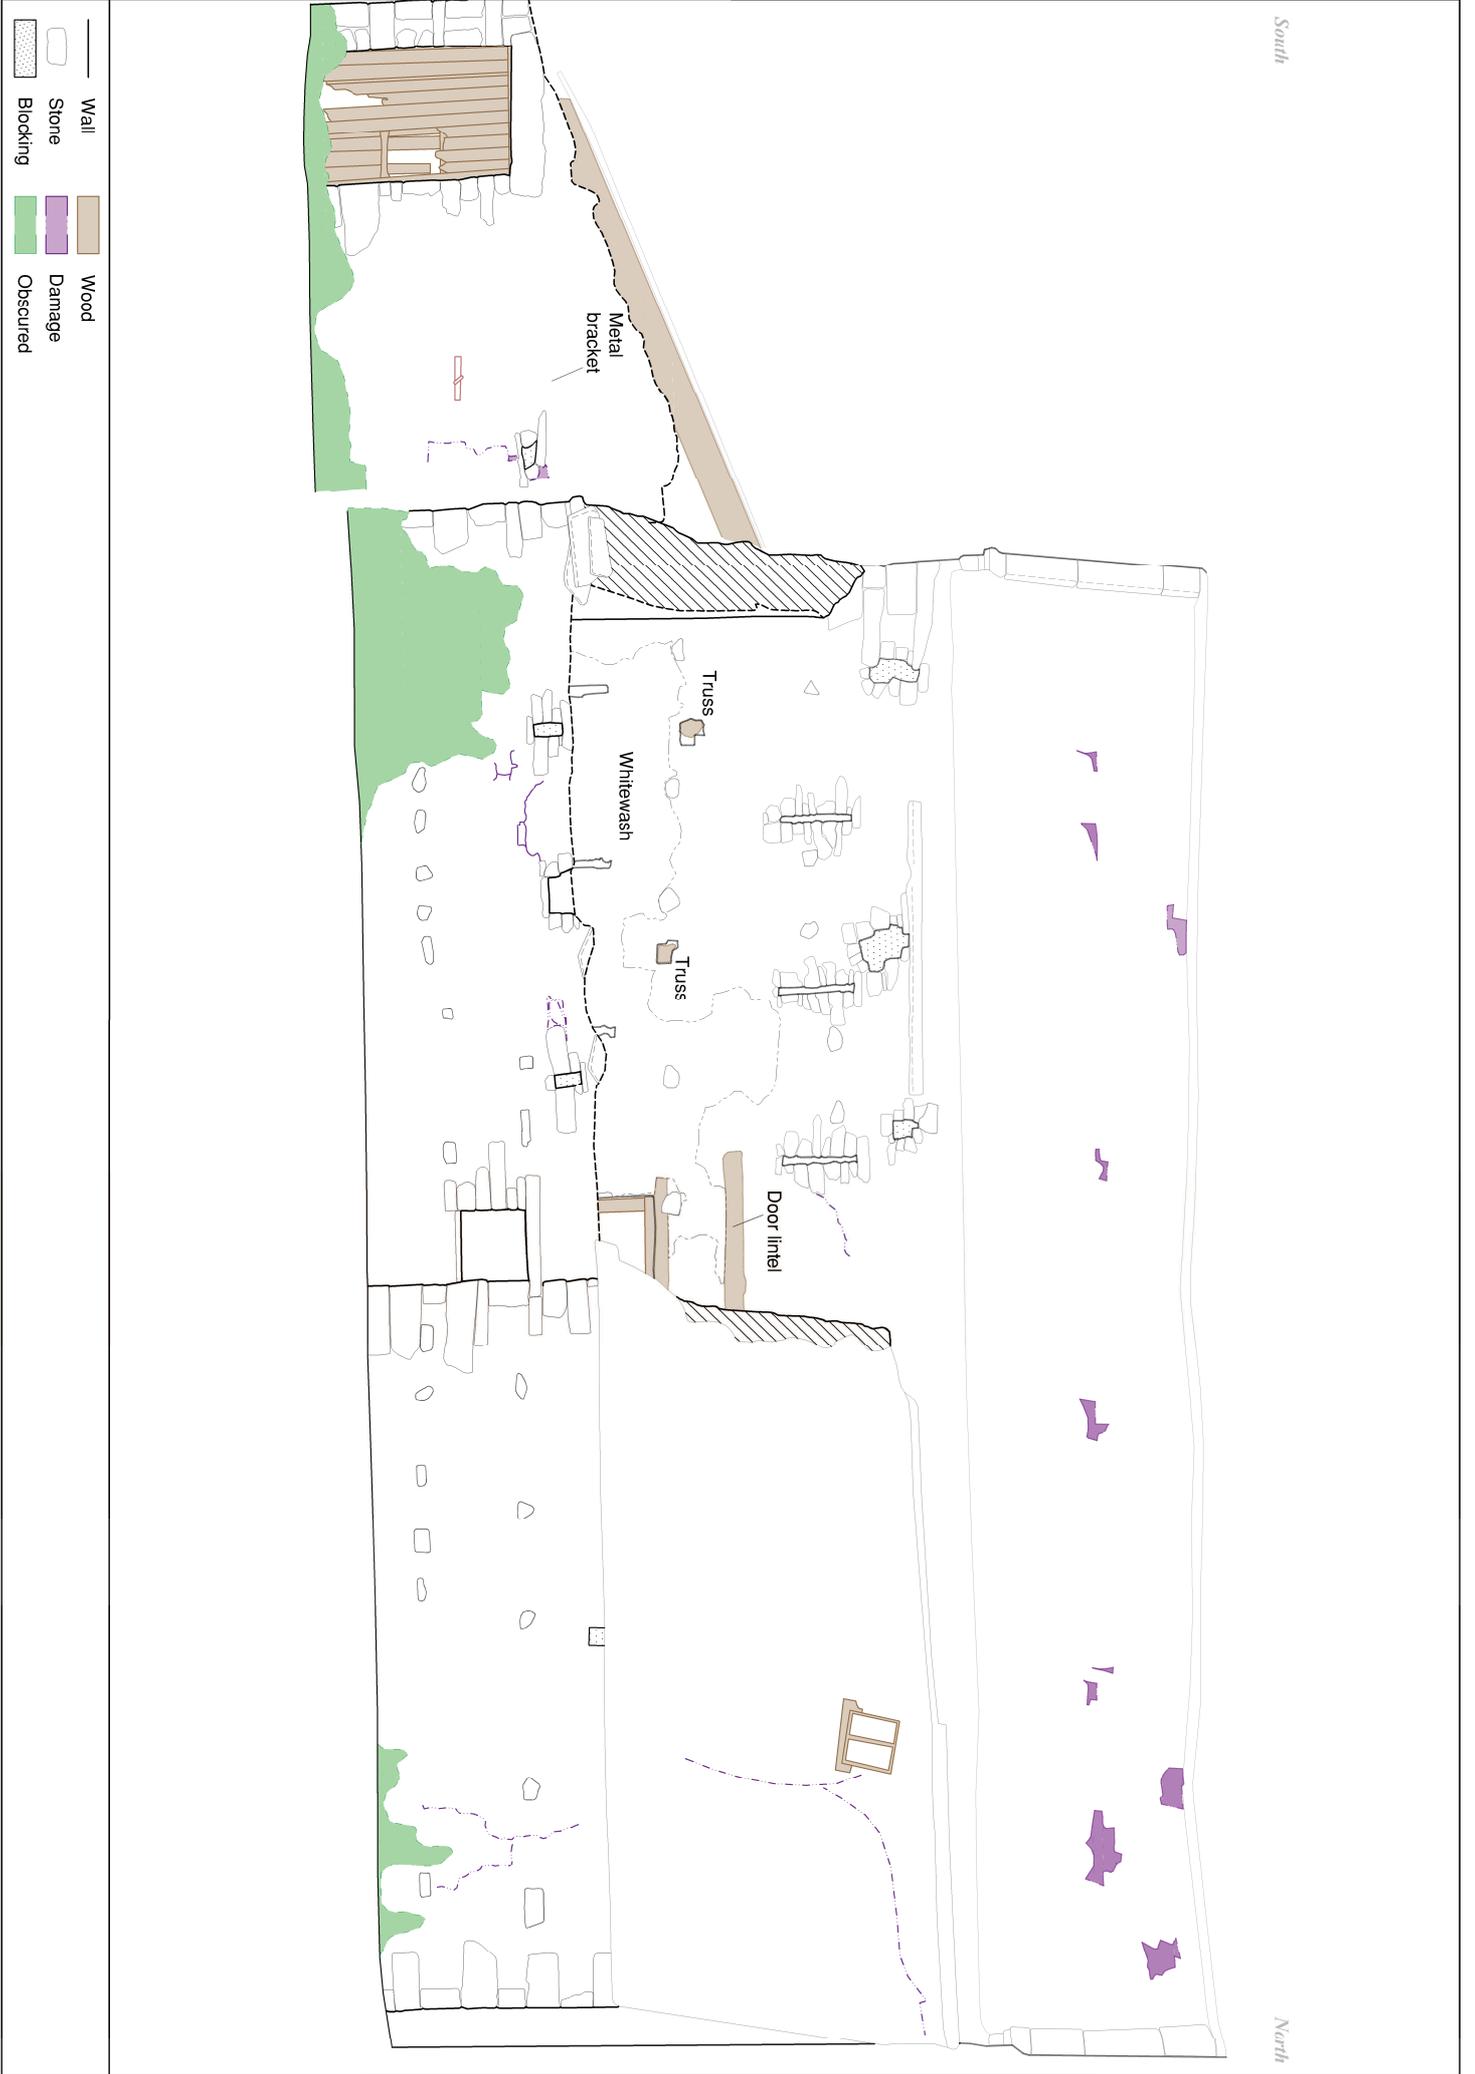
Figure 6: East-facing elevation

- 4.1.7 **Eastern Elevation (Fig 6):** the eastern elevation had been completely enclosed by the addition of two projecting lean-to structures but the collapse of the roof of the southern of the two lean-tos had once again revealed the original elevation and is described here in full.
- 4.1.8 Its construction mirrored that described on the northern gable, with regular courses of sporadic through-stones projecting from the wall face (Plate 10). A wide double

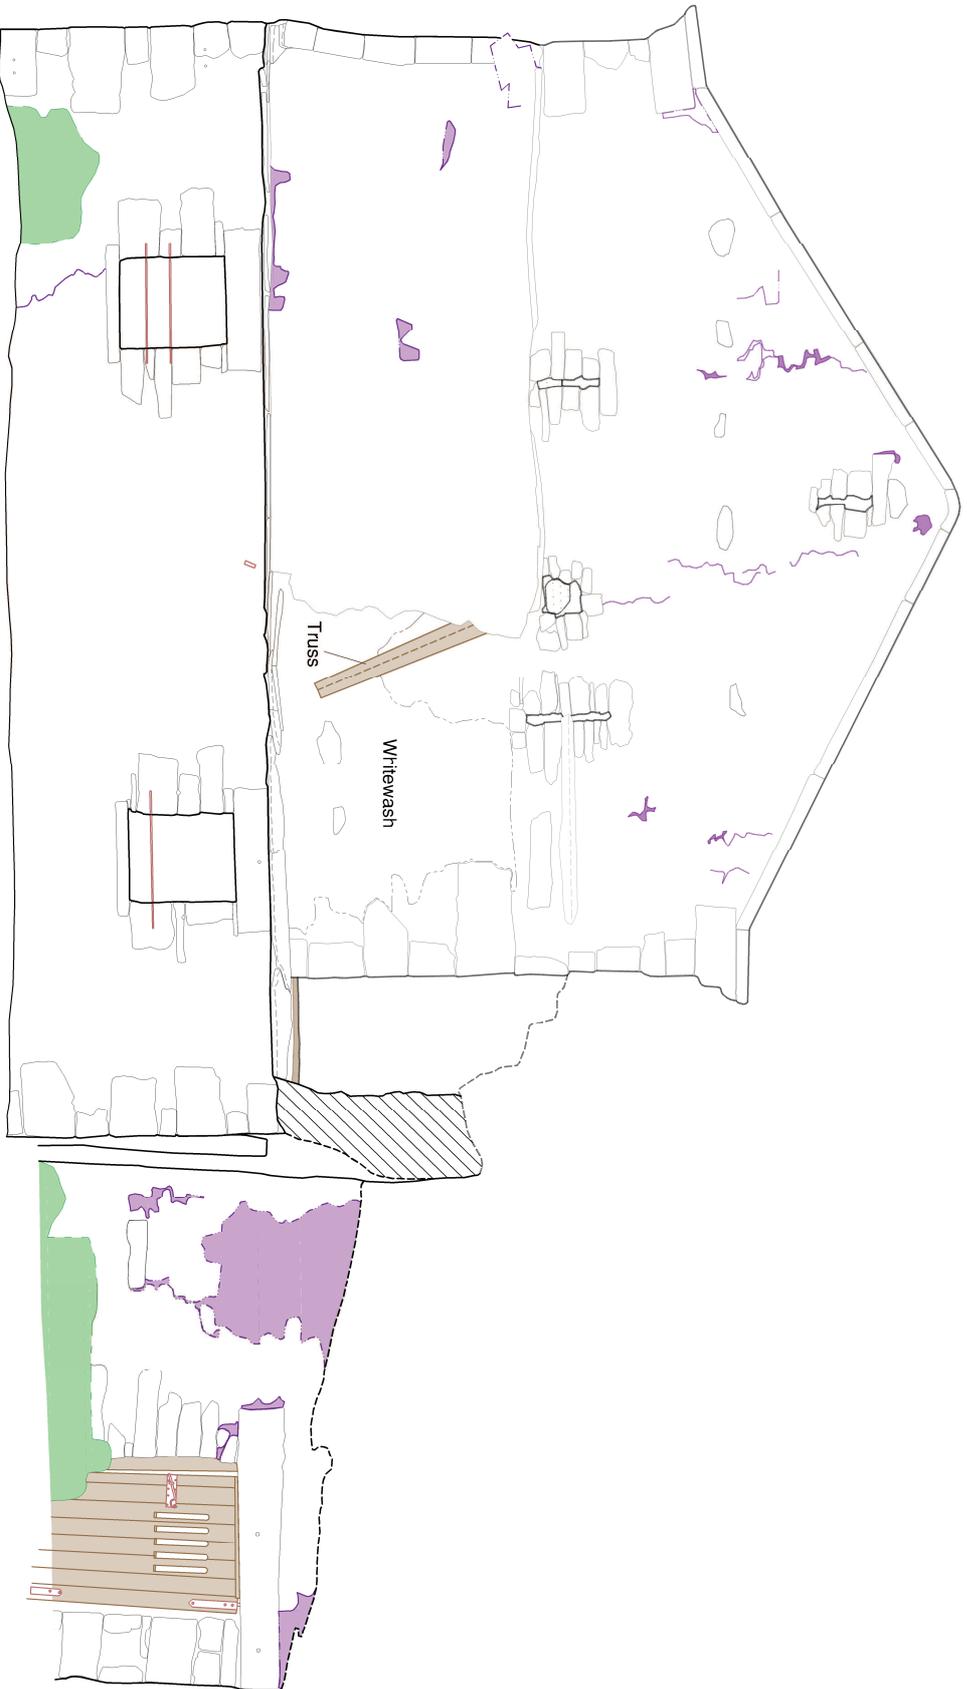
Figure 7: South-facing elevation

- 4.1.11 ***Southern Elevation (Fig 7)***: the southern gable wall was also enclosed by a later lean-to structure but its upper third was visible above the roof line and the remainder is described from within the lean-to (Plates 13 and 14). Its quoins, kneelers and raised parapet were identical to those described on the northern gable wall and it too had a narrow ventilation loop immediately beneath the apex; however, this elevation omitted the pitching hole and instead included an additional two ventilation loops at first-floor height arranged at thirds across the length of the wall. The remainder of the wall was coated in thick white paint and no ground floor openings were visible with the exception of a small square niche or large empty socket at the eastern end which may have housed one end of a beam. At least three courses of the projecting through-stones were visible arranged at broadly regular intervals across the height of the elevation.
