The Temple Bar Hertfordshire

Report on the Archaeological Investigation of Temple Bar During its Dismantling

Oxford Archaeology

February 2005

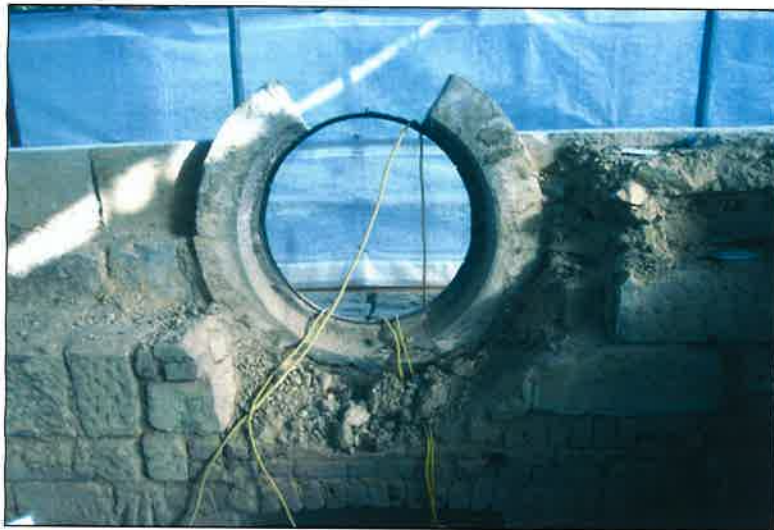
Plate 25: Back of the eastern round window, the upper inner window stones have been removed (OA 2004, F7/9)

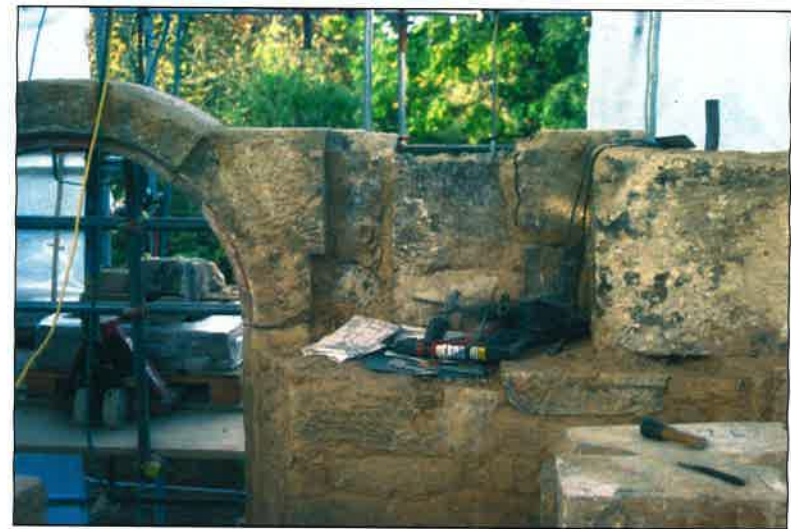
Plate 26: The back of the central window on the south side of the bar (OA 2004, F7/21)

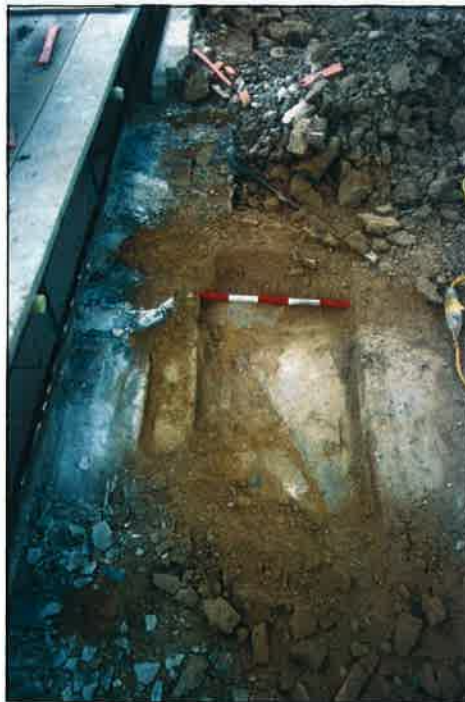
Plate 28: Floor construction on the north side of the bar, the top floor abutted the inner brick walls, at the right hand end of the scale bar (OA 2004, F8/7)

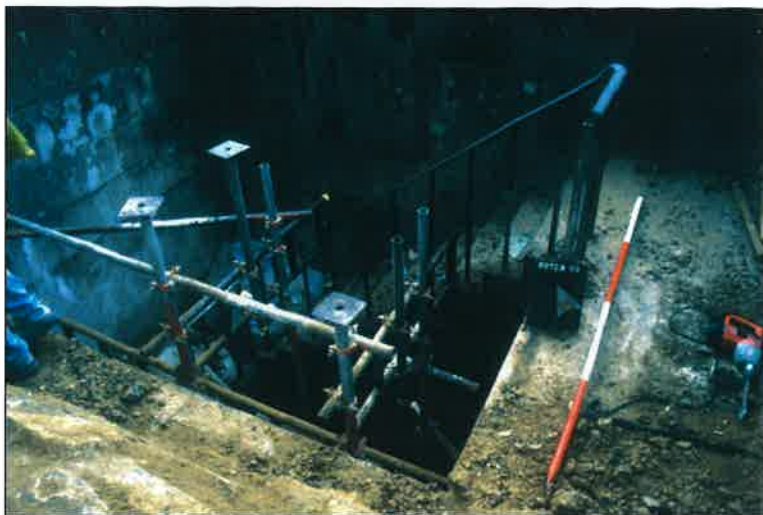
Plate 29: Stair well during dismantling (OA 2004, F10/29)

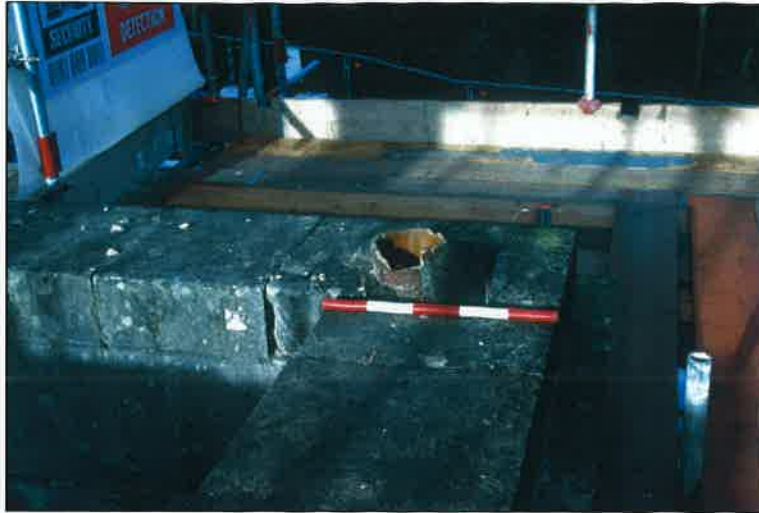
Plate 30: Flu for the boiler within the north east corner of the stair's walls (OA 2004, F11/28)

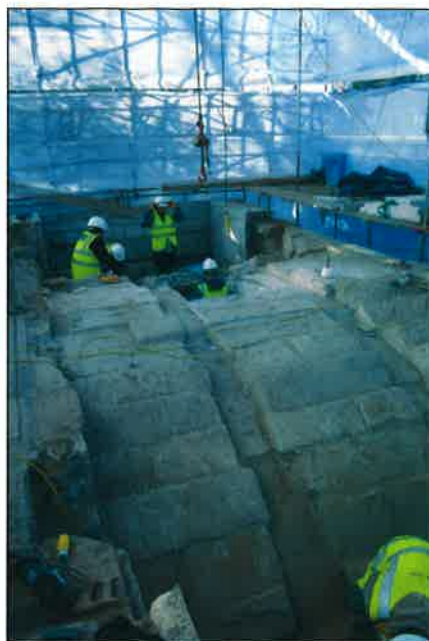
Plate 32: General shot of the dismantling work on the central arch (OA 2004, F9/3)

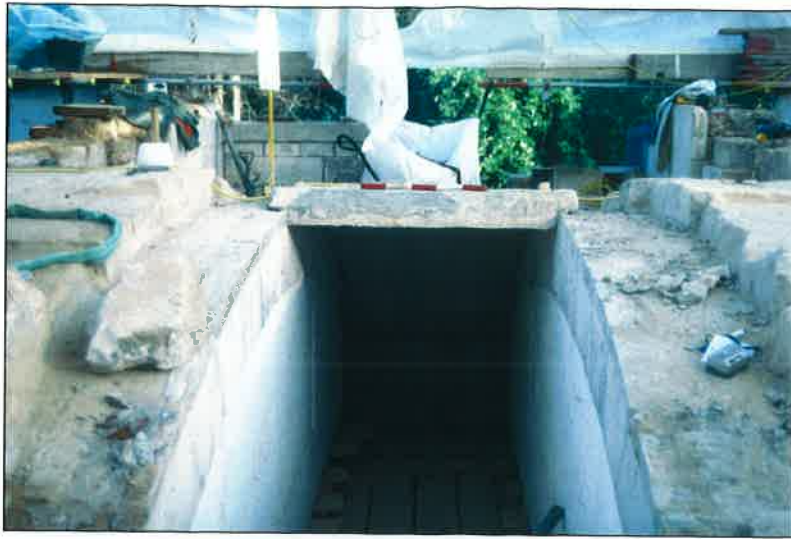
Plate 33: Partially dismantled central arch showing the soffit stones overlapping the ribs (OA 2004, F9/10)

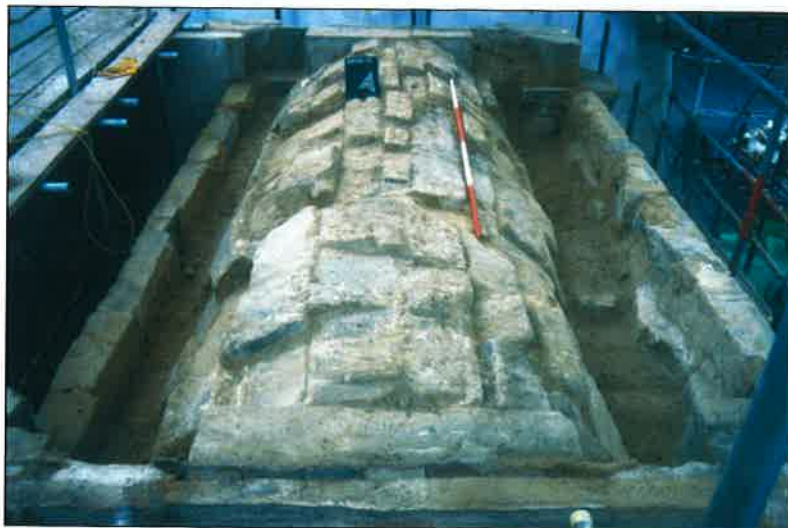
Plate 35: The western postern arch before dismantling, note the much smaller stones used and the lack of distinction between the arch and the soffit stones (OA 2004, F10/16)

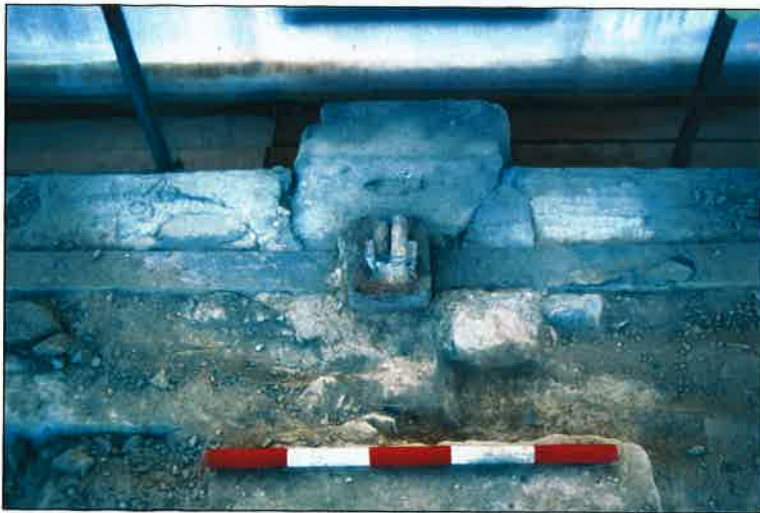
Plate 37: Square iron ring securing the bar chain over the keystone on the southern side of the bar (OA 2004, F9/21)

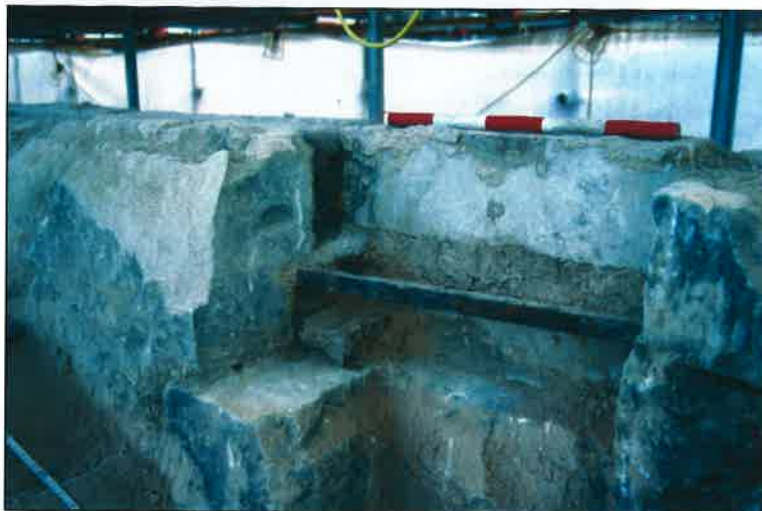
Plate 38: Square, iron tie between pilasters and voussoirs on the south-eastern side of the arch (OA 2004, F9/26)

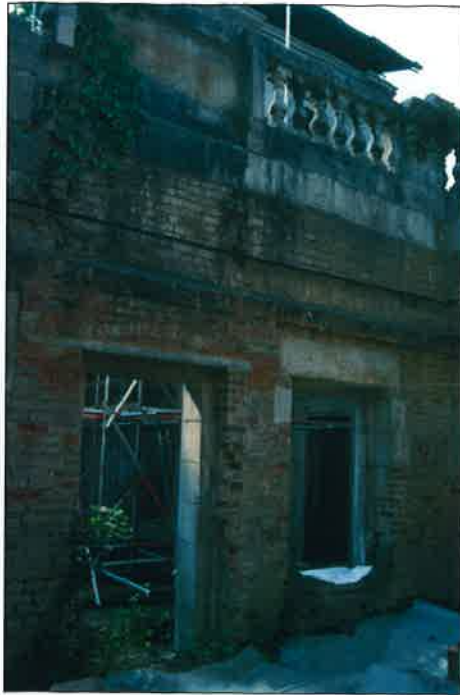
- 7.5.2 The interior walls have had all plaster or facing removed and are mostly yellow stock bricks (Plate 48). The interior brickwork was shown to be approximately 220 mm thick - or two bricks wide. There are patches of red stock bricks, for example mid way up the western side of the south wall, but these do not appear to be blocked features, rather patches where another brick was used in the original build. Below the ledge interpreted as indicating ceiling level, two to four courses of brick have been re-pointed, this was done when the ledge was capped with cement and is probably part of remedial repair works once the Lodge was empty.

Plate 48: Interior wall of lodge, the west wall containing the front door (OA 2004, F1/16)

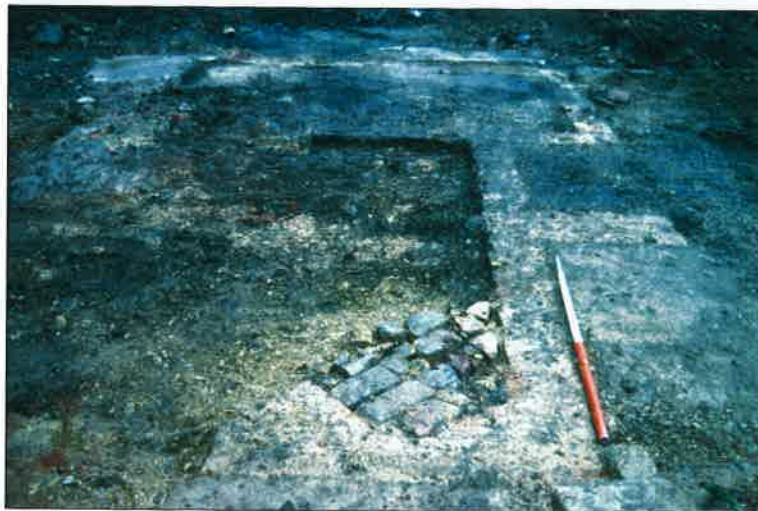
- 7.5.6 The north room (left of the front door) had had its flooring partially truncated away in the northern part of the room. The southern half of the room was covered with a hard concrete surface. Patches of ashy material were visible on this surface, and particularly within the fireplace (Plate 50), which was located approximately in the centre of the house. There was a blocked door in the eastern wall leading out to the extension at the back of the Lodge. There was no clear indication of where the door adjoining the two rooms was although it is perhaps most likely to have been immediately east of the front door.

Plate 50: View of the central part of the house with the ashy floor of the fireplace to the right of the picture beyond the scale bar (OA 2004, F14/10)

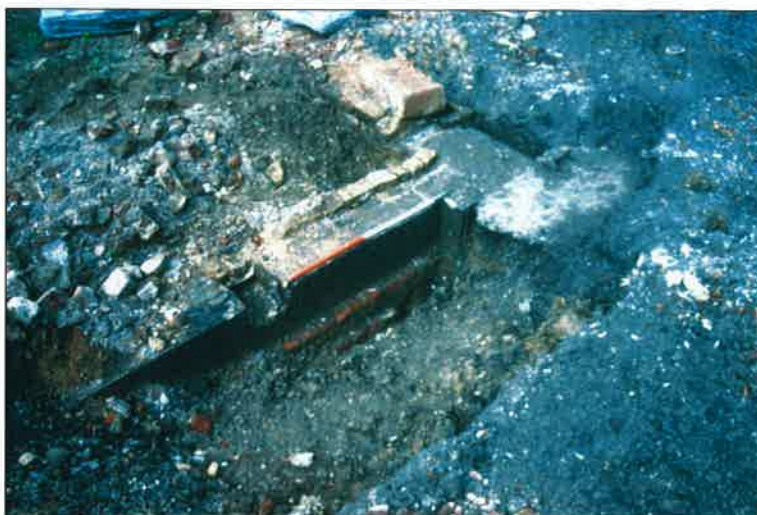
8.3.1 Test Pit 2 (Figure 15) (Plate 53) was opened to investigate the construction of the foundations underneath the south-east corner of the Lodge building. Here the lowest course of ashlar and the floor platform of the Lodge itself was still in situ although again time constraints did not allow the full depth of the foundation to be revealed.

Plate 53: Test pit 2, general shot looking north-east (OA 2004, F13/2)

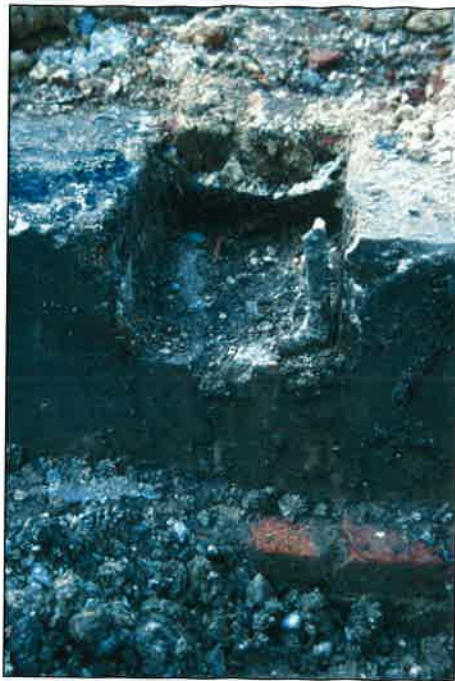
- 8.3.4 At a distance of 1.78 m from the corner along the southern wall, traces of an iron ventilation grate in the lowest course of the building's ashlar were seen although the grille itself did not survive. Fragments of the sides of the grill remained at the edges of a shallow gap between two of the stones (Plate 54). It is likely that ground level at the time of the Lodge's use was at the base of or just below this grill, again suggesting a slightly higher ground level at the rear of the Lodge. This is further confirmed by an iron fitting for the base of a drainage down-pipe, 0.70 m along the eastern side of the Lodge, which was presumably at ground level, flush with the top of the first ashlar course of the rear wall. There was no indication of which way this drainage run continued away from the Lodge although it seems likely that it may have joined up with the drain heading south west from the extension on the east side of the Lodge.

Plate 54: Test pit 2, remains of iron grill in base of the lodge's southern wall (OA 2004, F13/8)

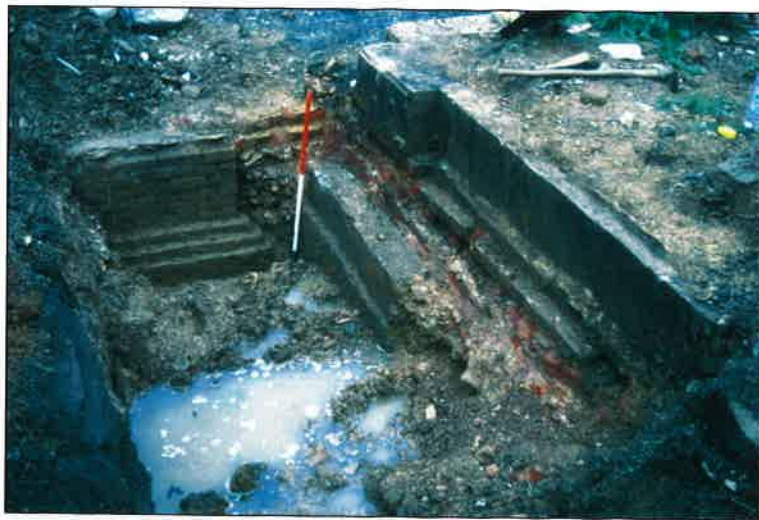
- 8.4.1 Test Pit 3 (Figure 16) (Plates 55 and 56) was opened in the corner formed by the southern wall of the stair up to the Bar's upper room and the front, west wall of the Lodge, in order to investigate the relationship between the Bar and the Lodge at foundation level.

Plate 55: Test pit 3, general shot looking north-east (OA 2004, F13/15)
