Winchester City Mill Hampshire Historic Building Investigation and Recording

September 2018

Client: National Trust

Historic Building Investigation and Recording

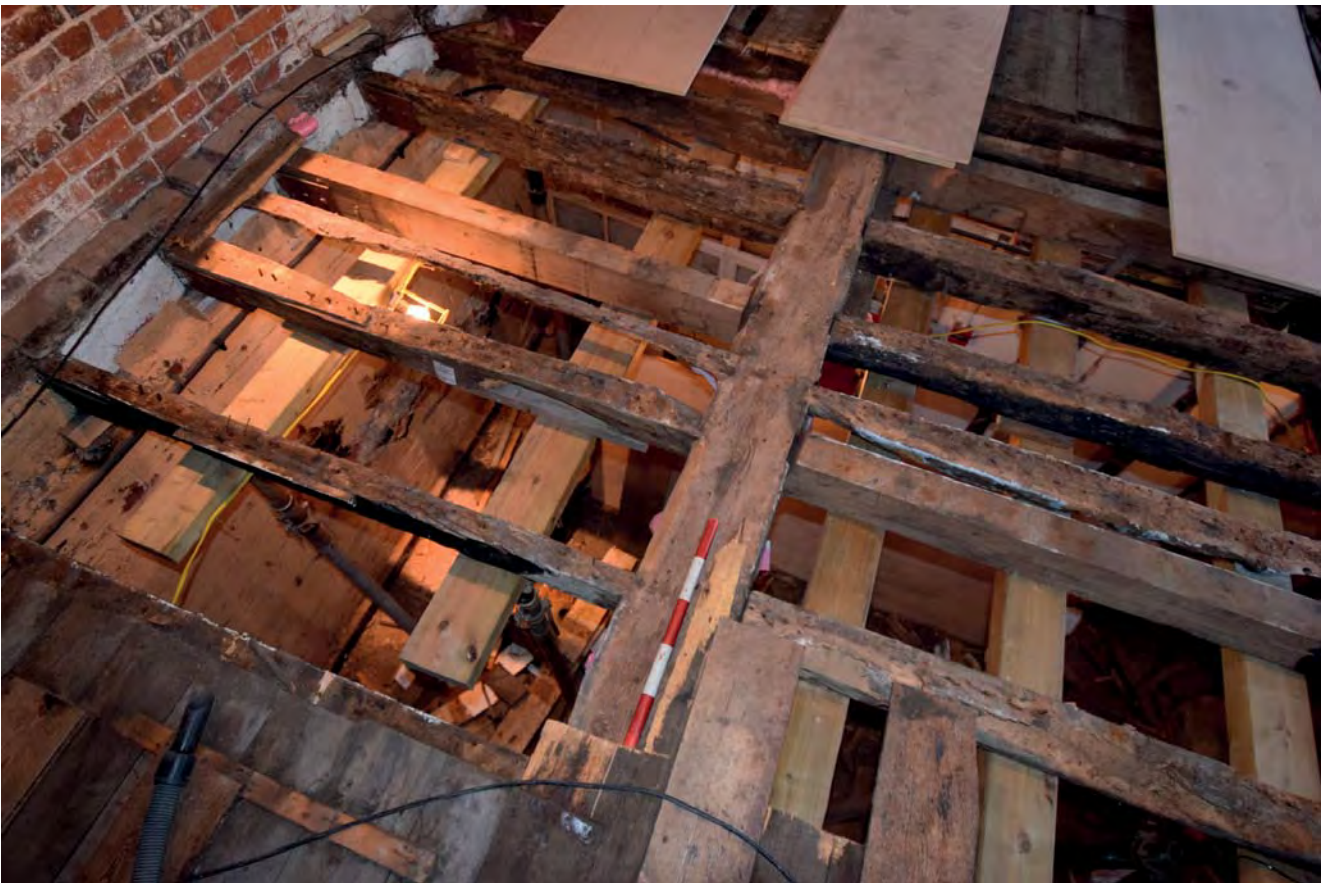
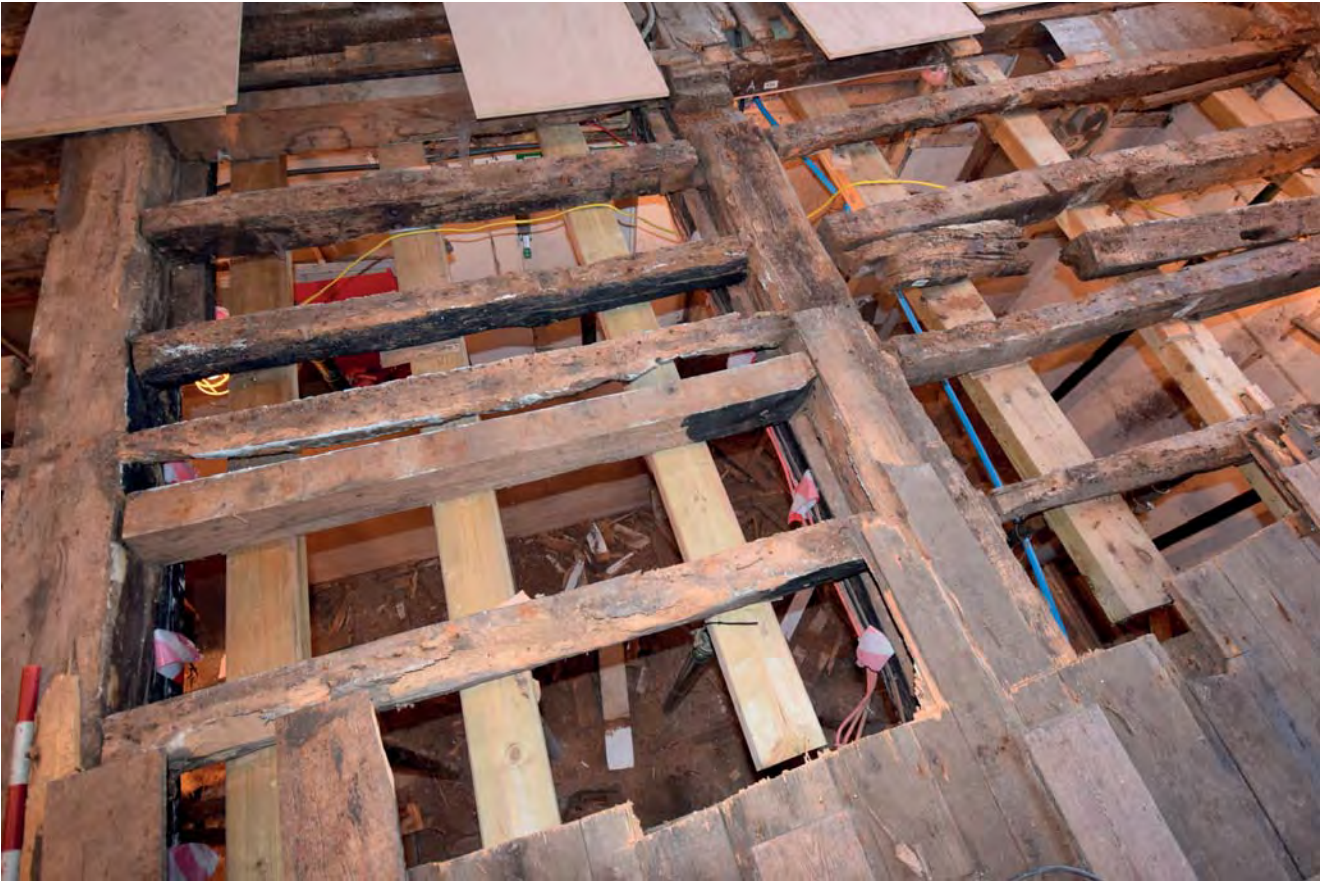
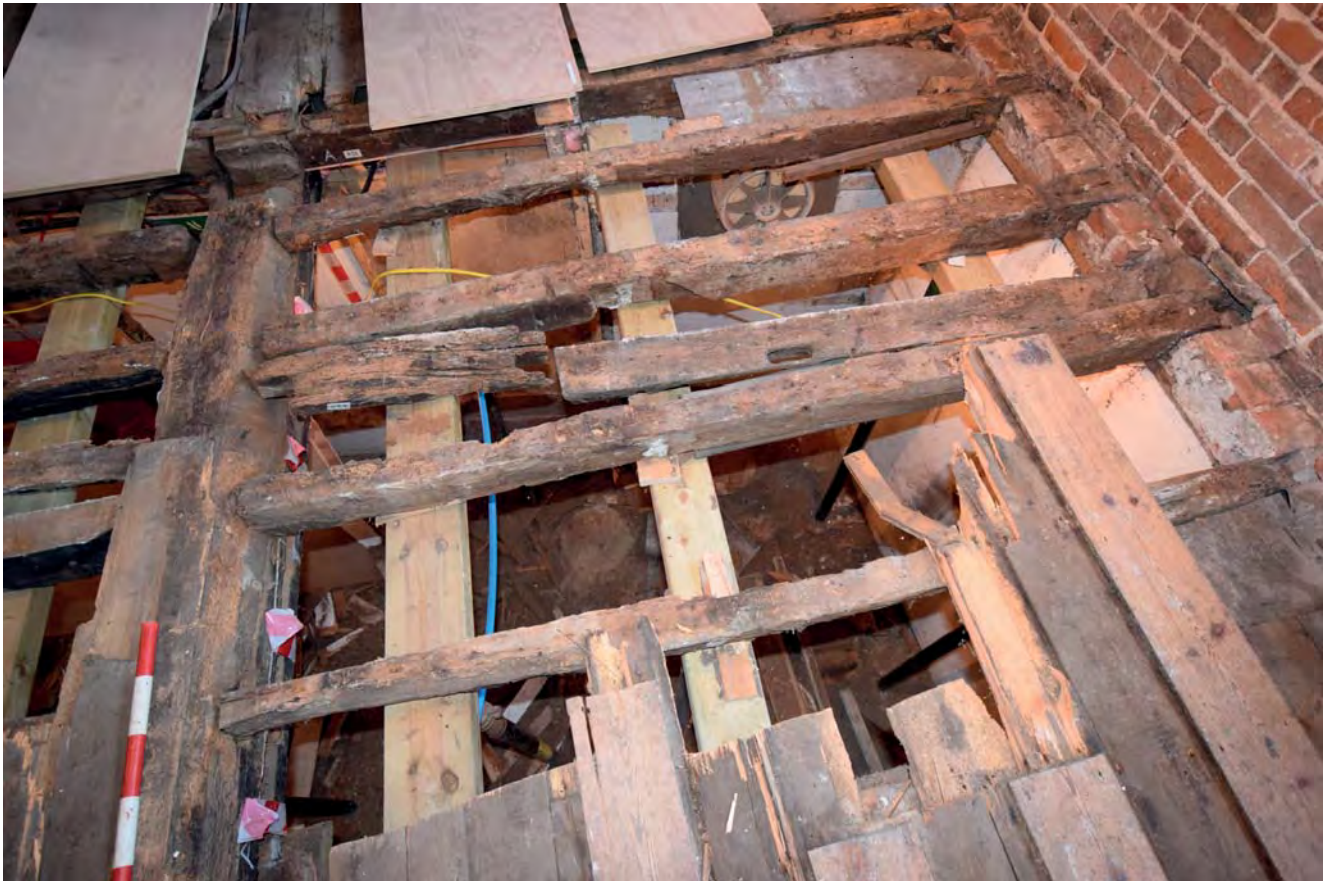
- 3.2.20 The main areas of the floor which were monitored and recorded when the joists were exposed were Areas K and Q and parts of M, N and P (as defined in MOLA's 2016 report). The upper faces of the old joists were generally heavily worn and although there were many marks which could have been from carpenter's marks they were too indistinct to interpret or clearly identify. As previously noted in the MOLA report many of the joists were reused (See Fig 5 and Plates. 4-6, 17-30).

Plate 4: Joists at west end of floor looking west

Plate 5: Joists at west end of floor looking west

Plate 6: Joists at west end of floor looking west

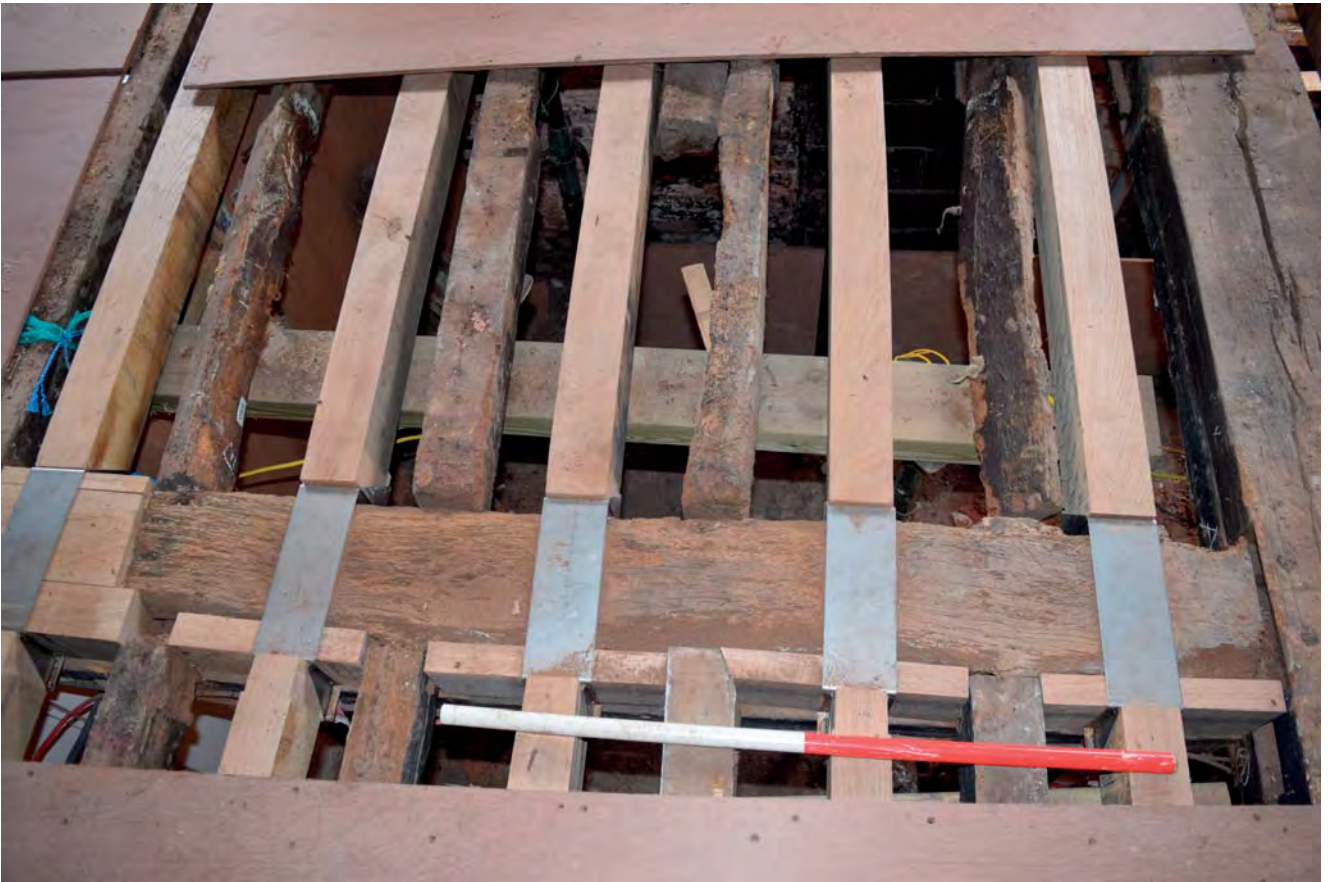
Plate 18: Joists in Area N during works looking north

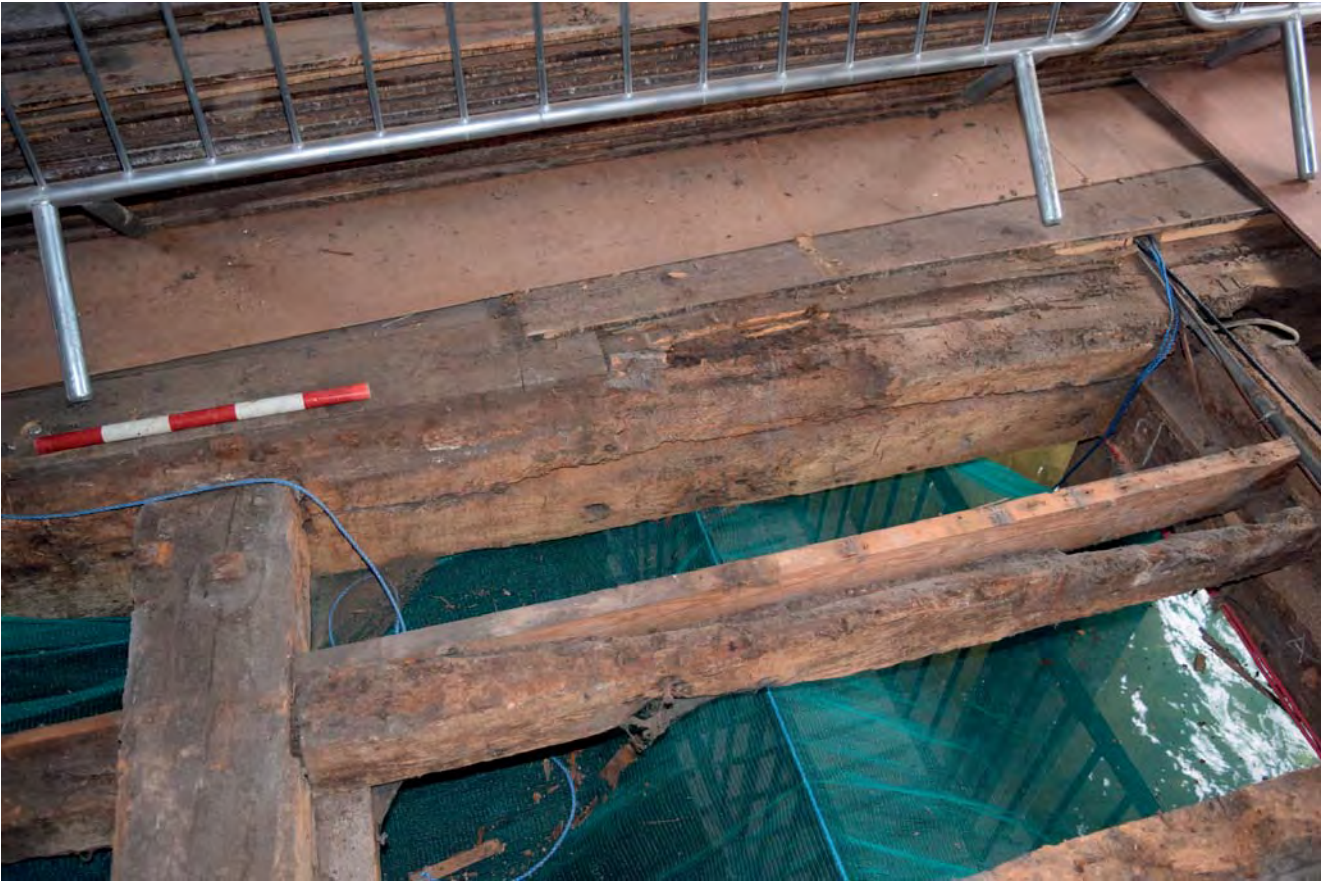
Plate 23: Trench mortice in beam III (Area Q) looking west

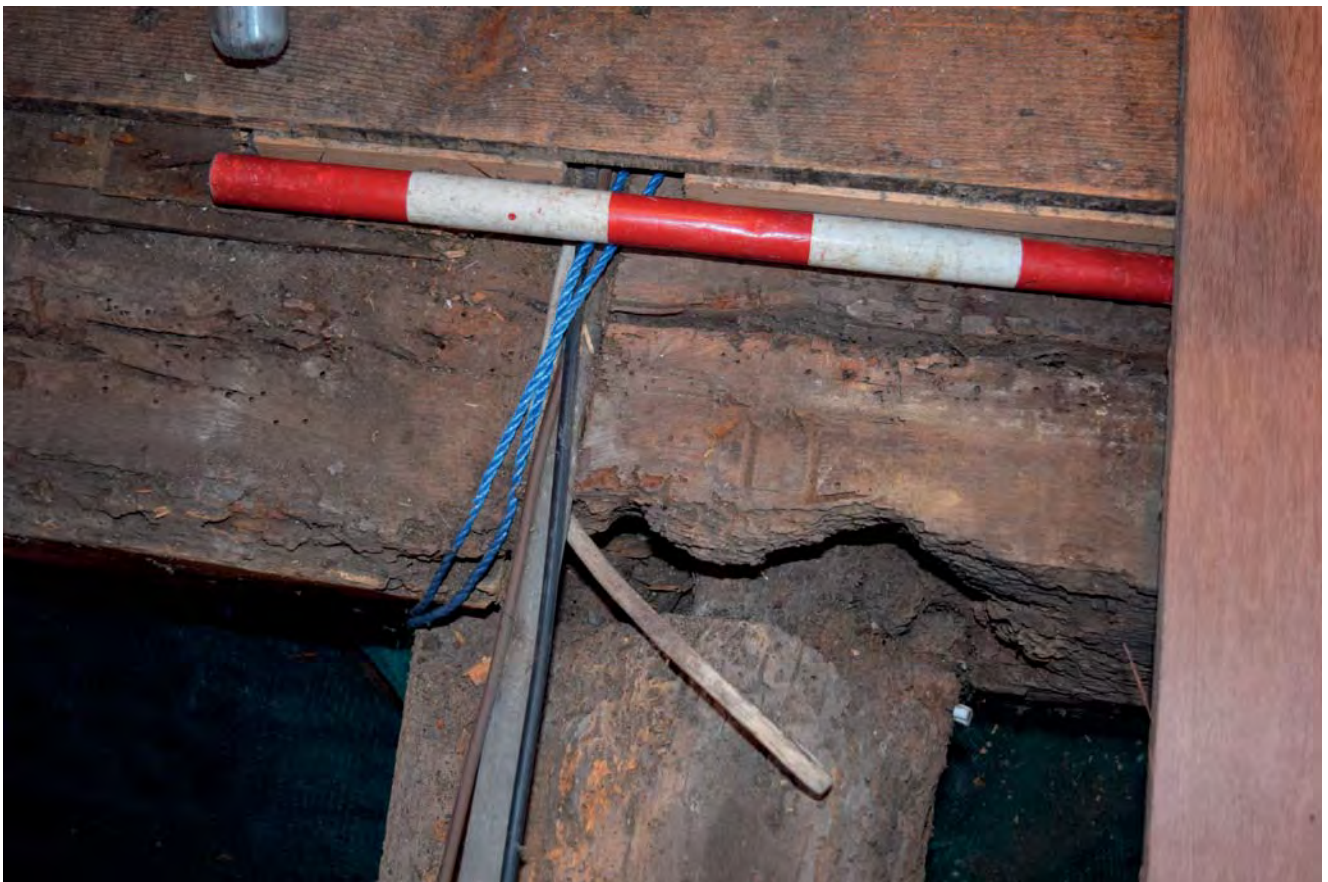
Plate 26: Marks on joist 111 (Area G) looking west

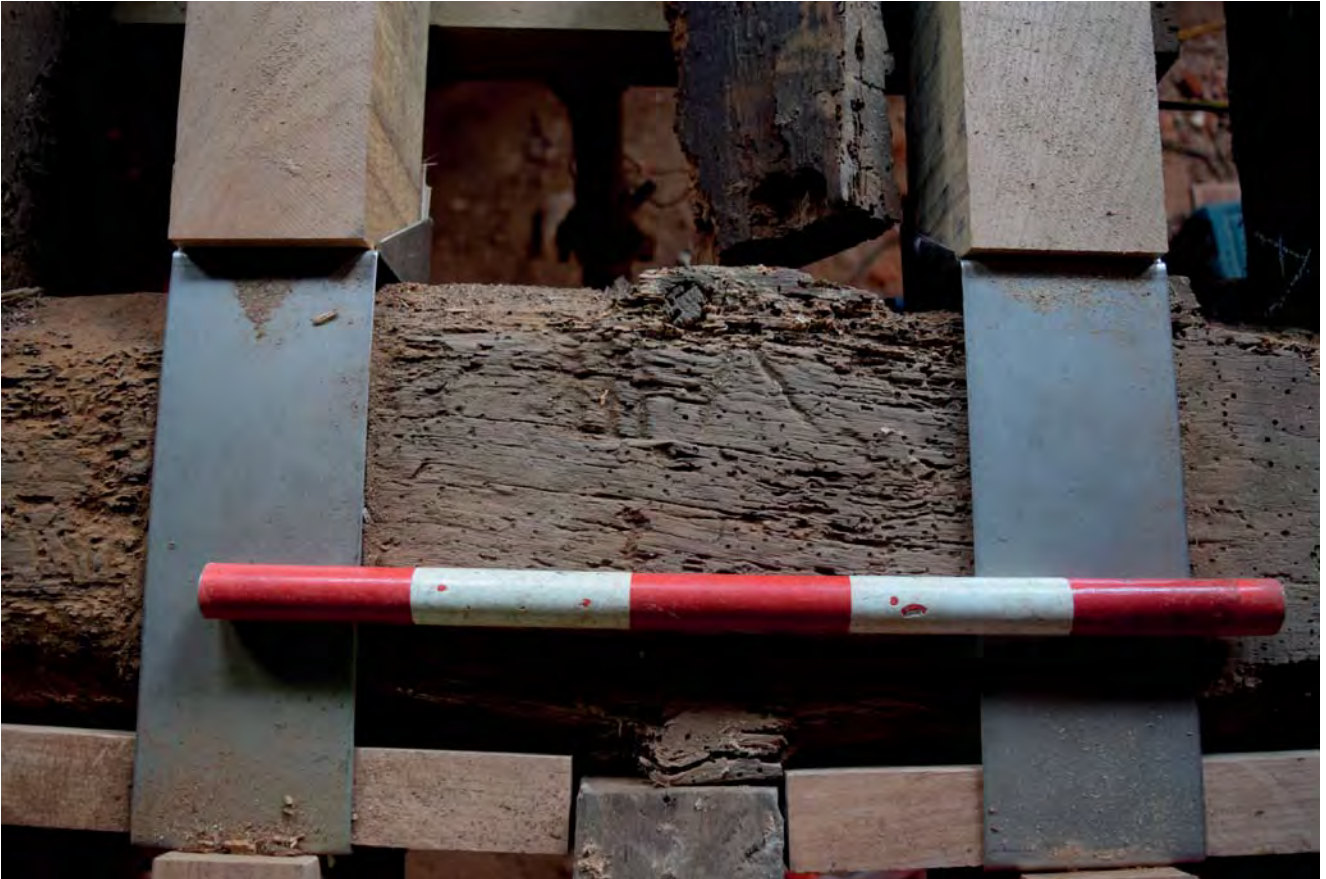
Plate 29: Mark on joist 110, by joist 70, in Area N

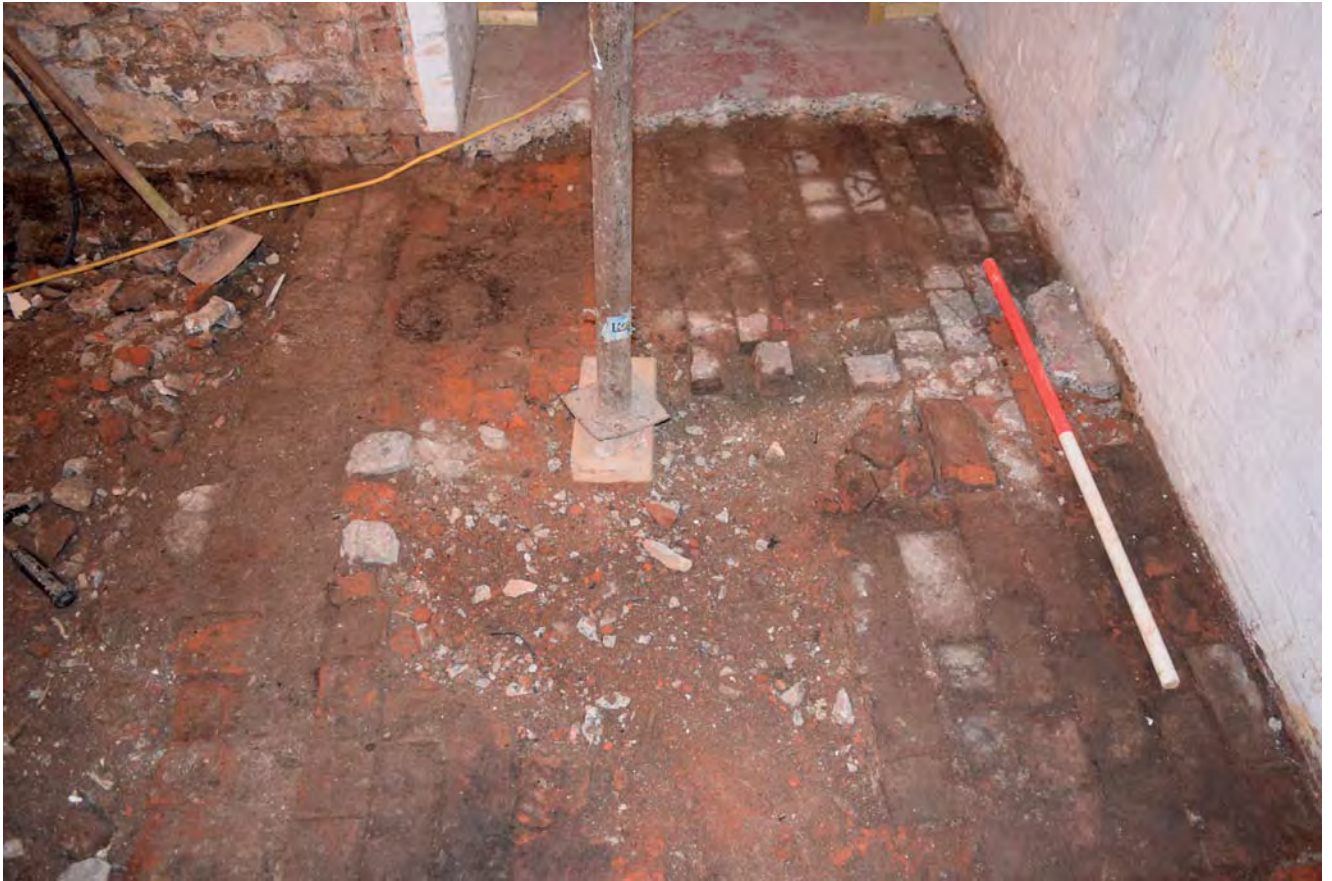
Plate 31: Exposed basement floor looking east (Feature 1)

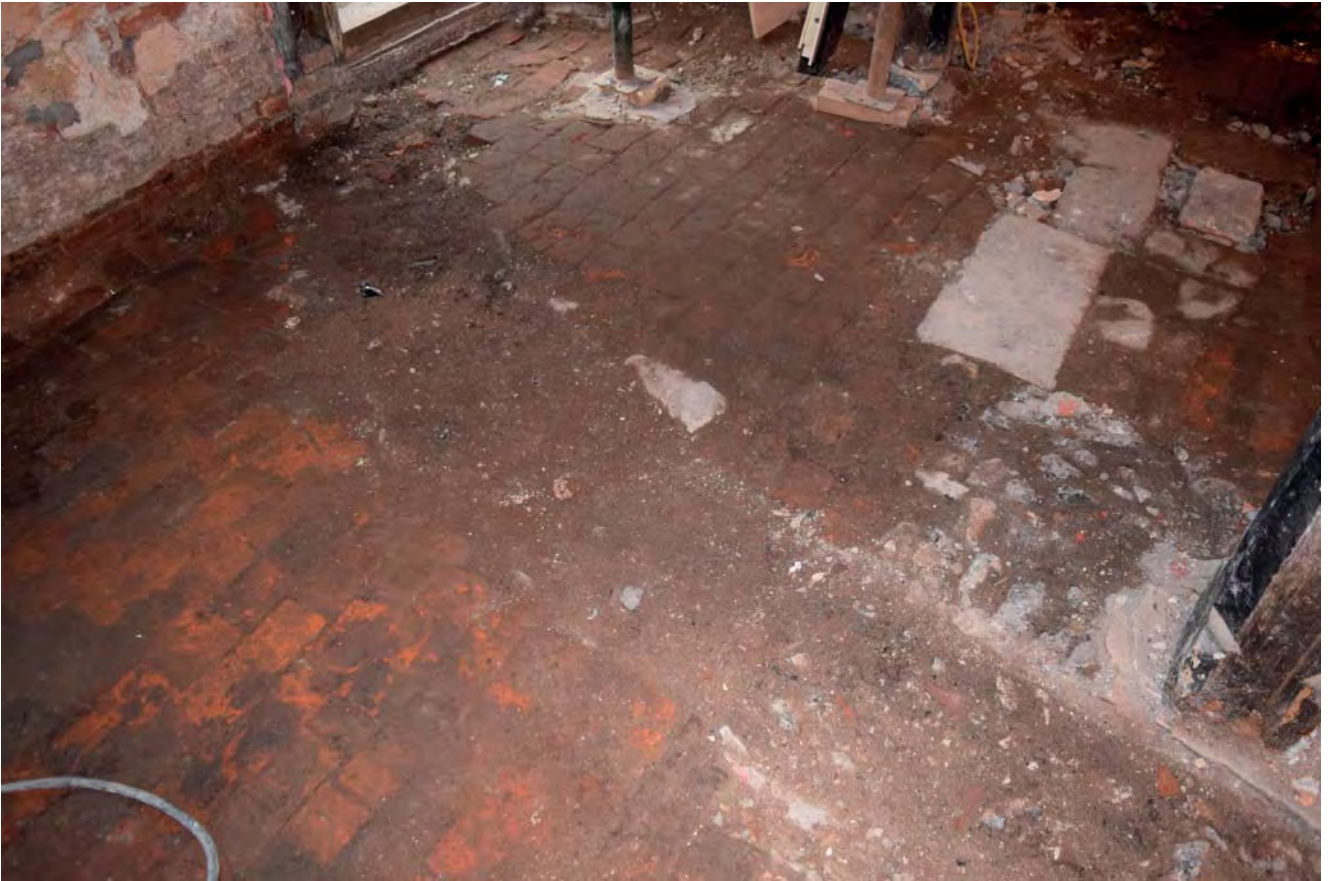
Plate 33: Infilled channel in basement looking SW

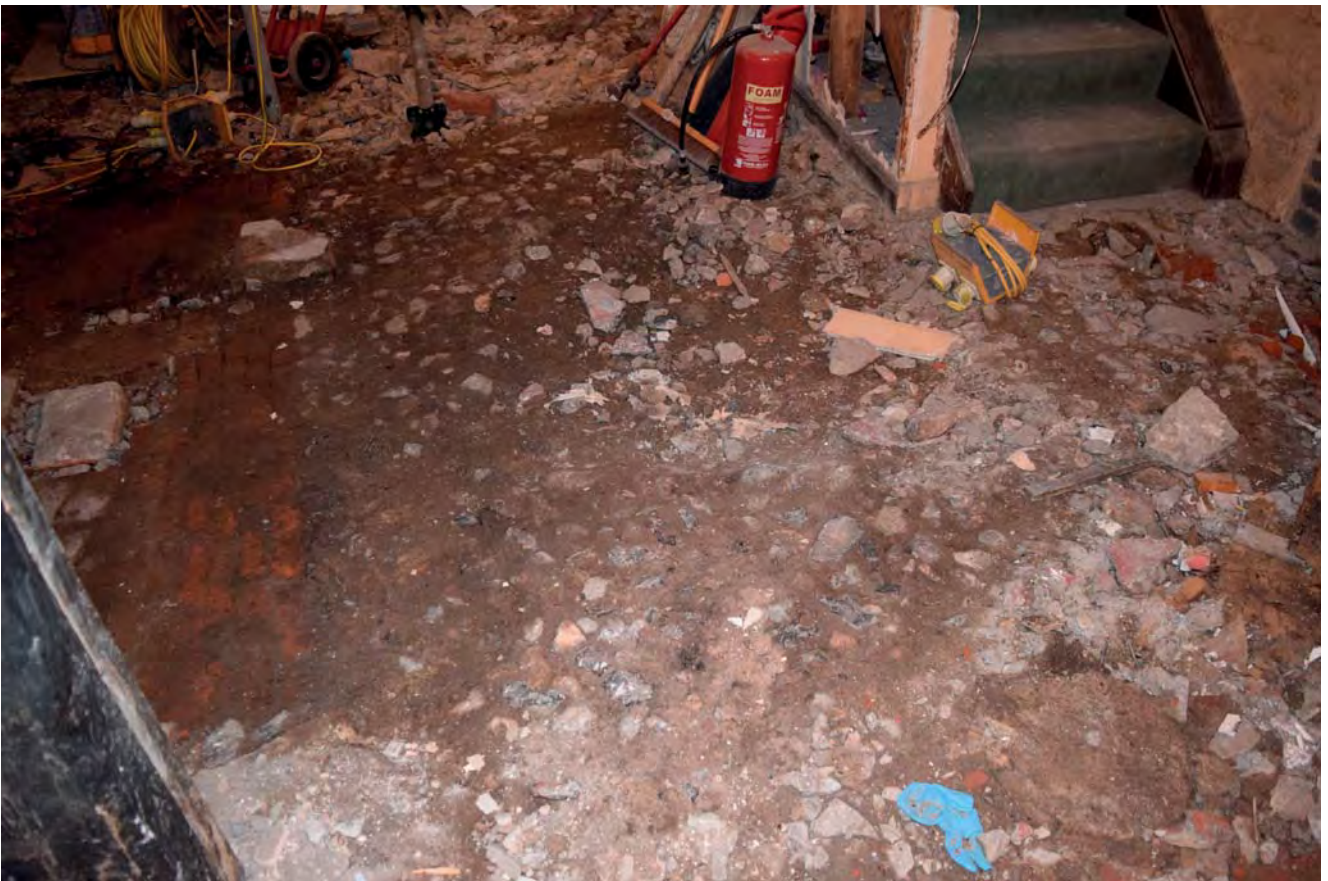
Plate 34: Flint in floor of basement

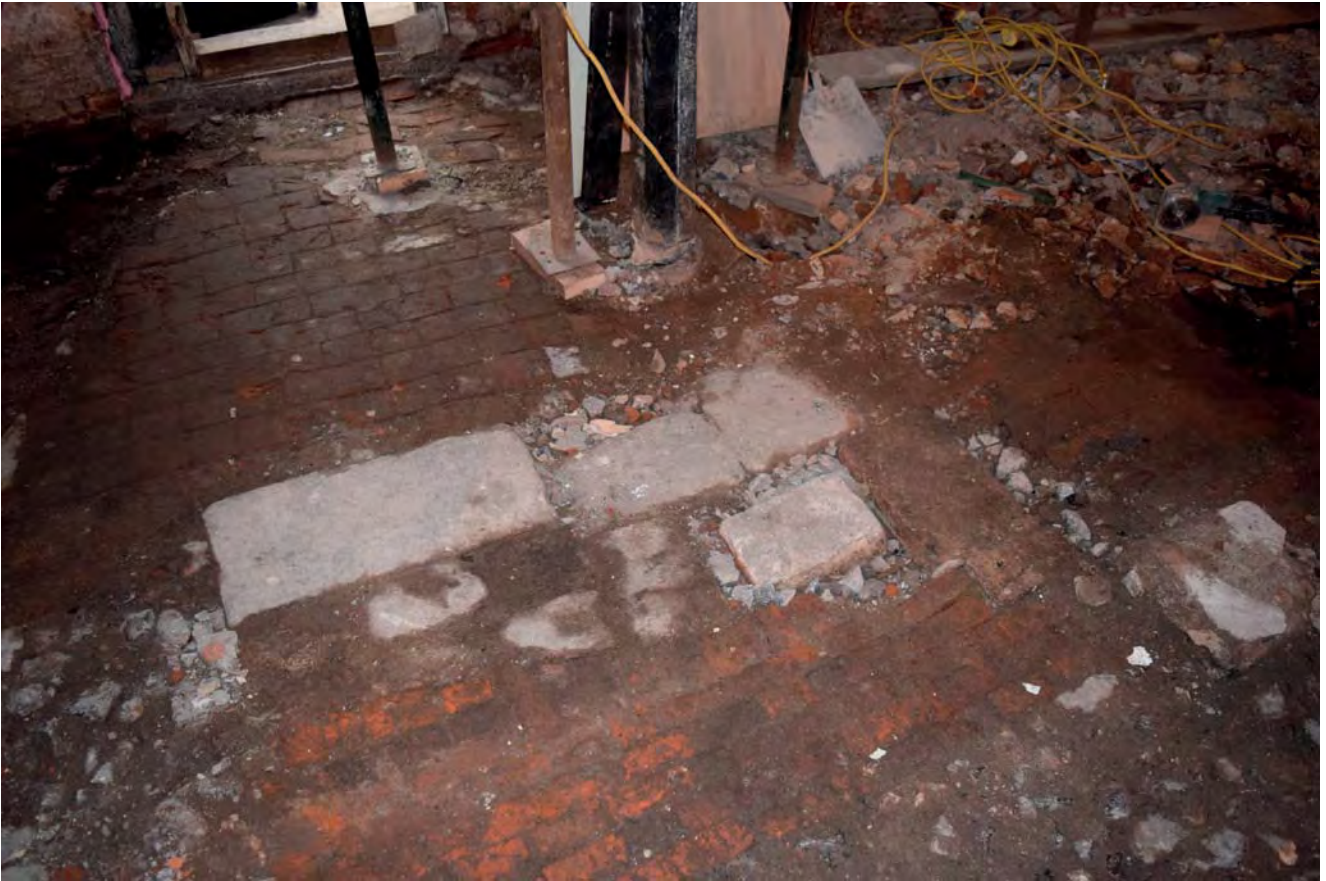
Plate 35: Features in basement floor looking south

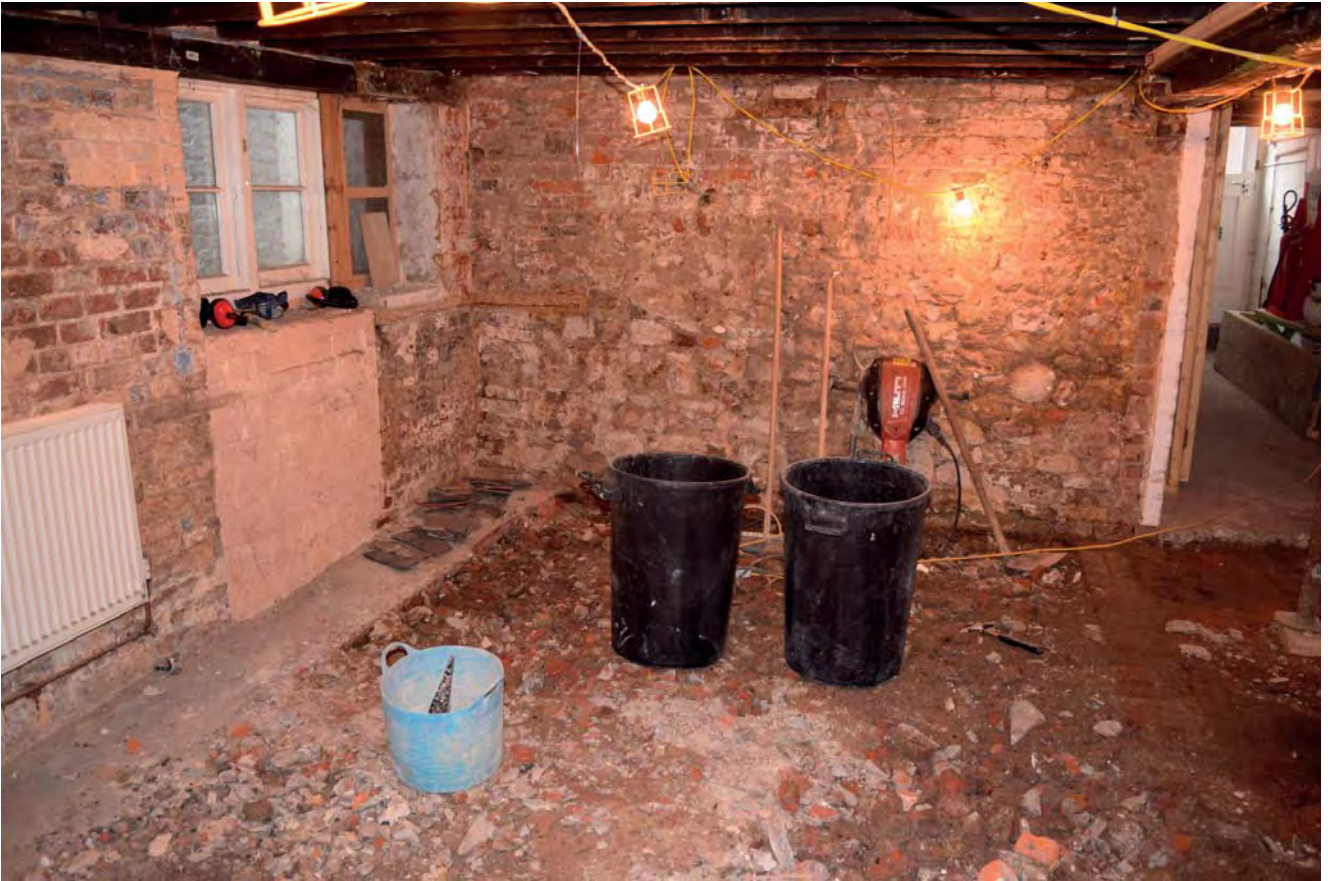
Plate 36: Features [1] in basement floor looking SE

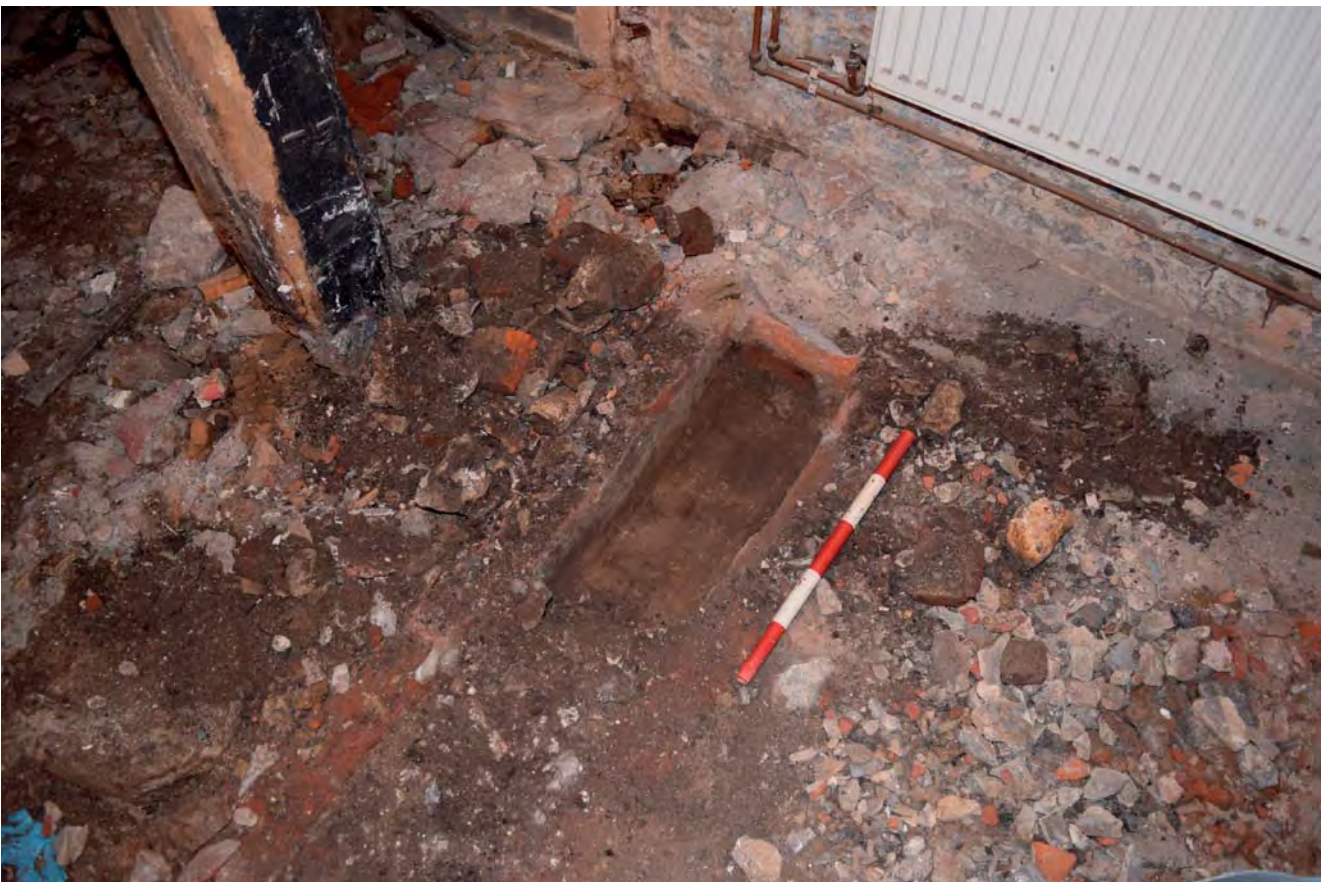
Plate 37: Basement (Area D) looking east

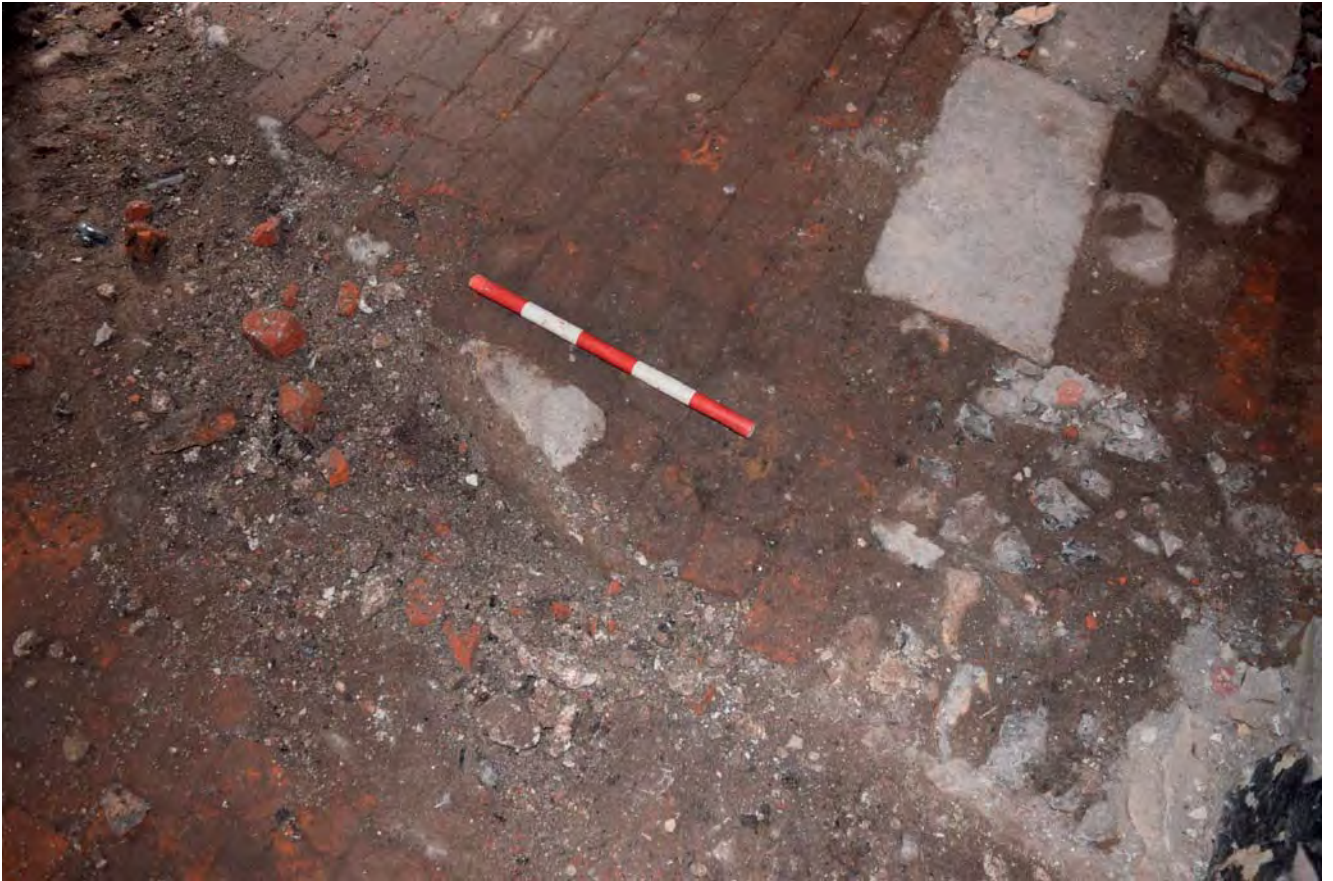
Plate 38: North end of infilled channel in basement

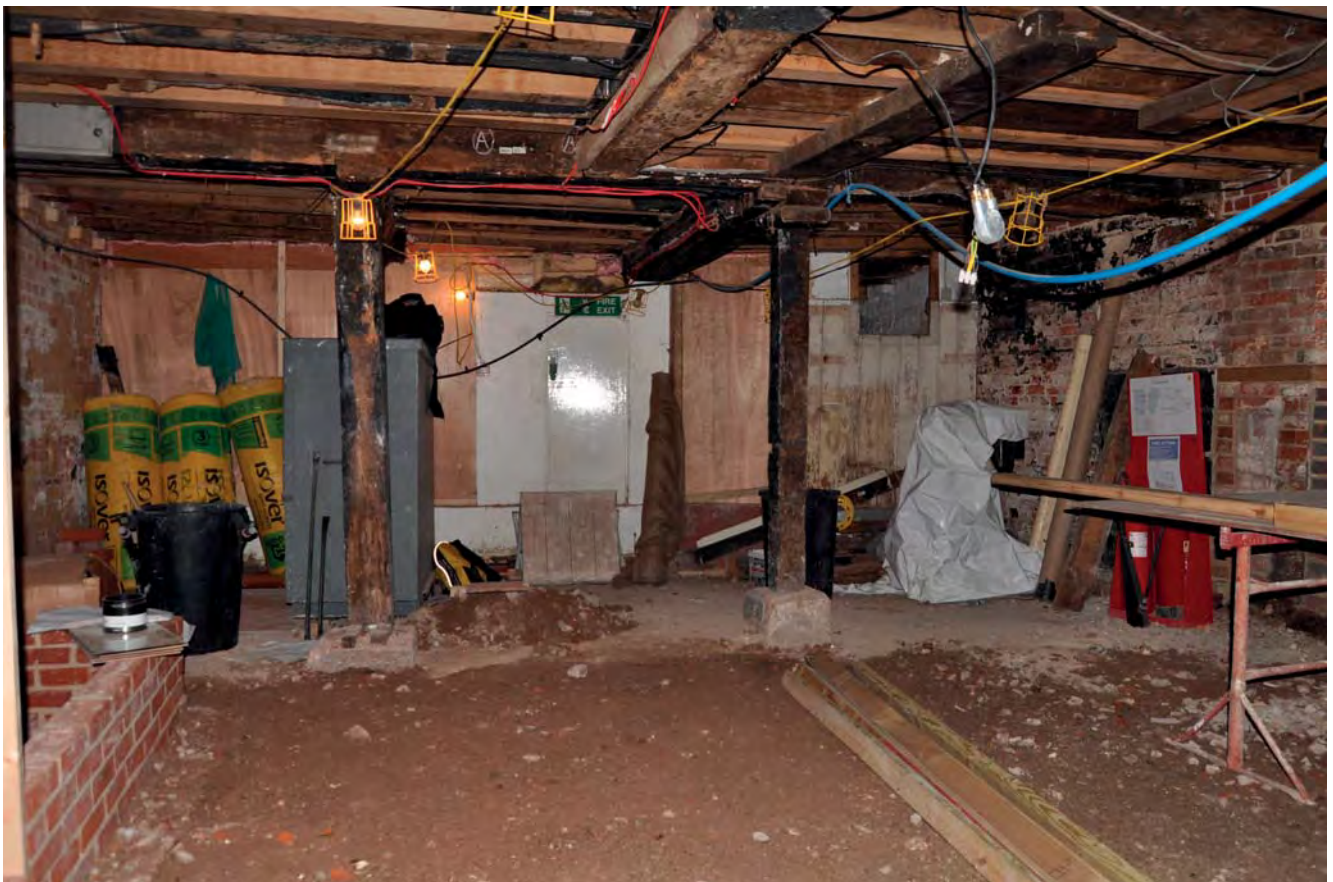
Plate 39: Detail of exposed floor in basement

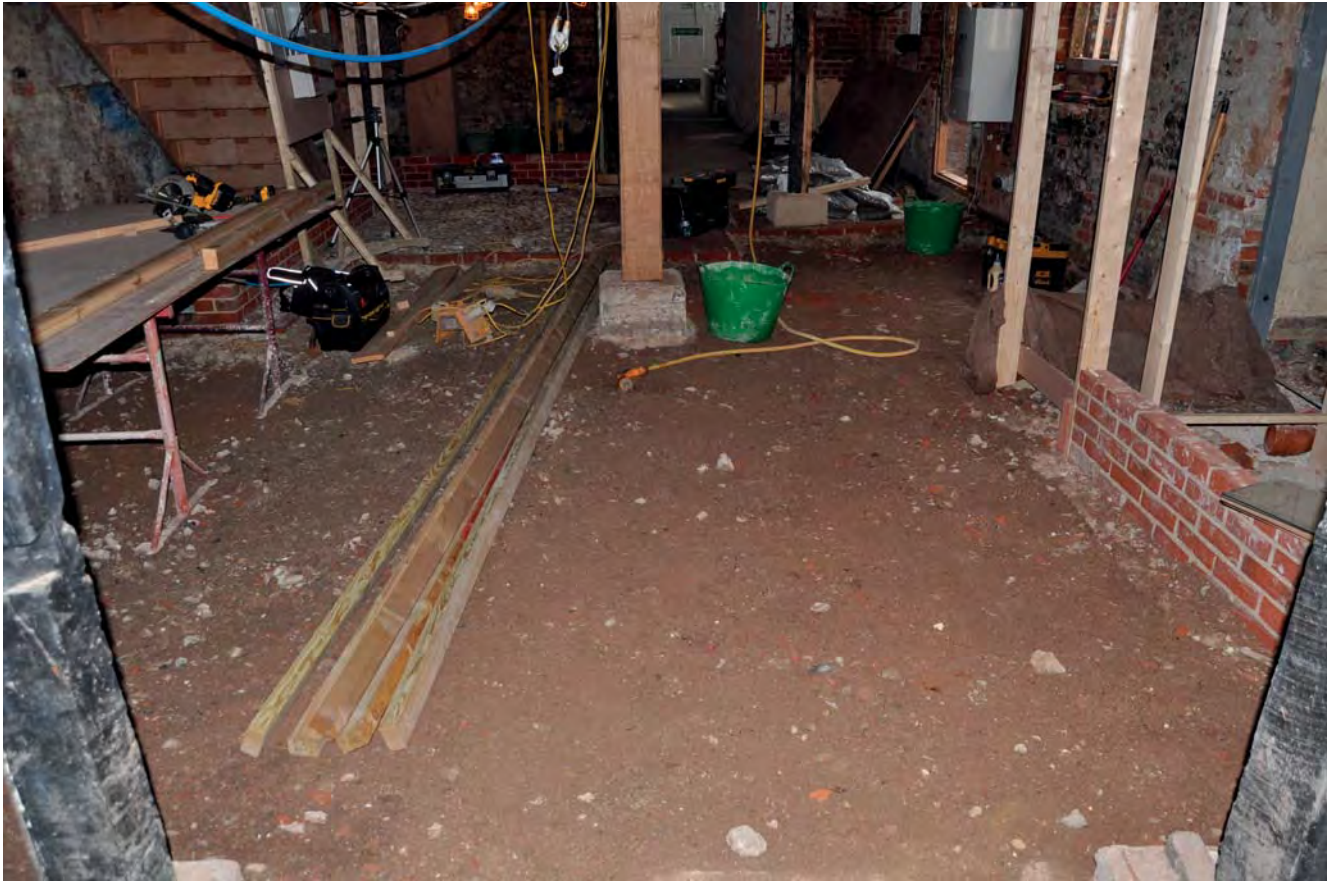
Plate 40: General view of basement looking west

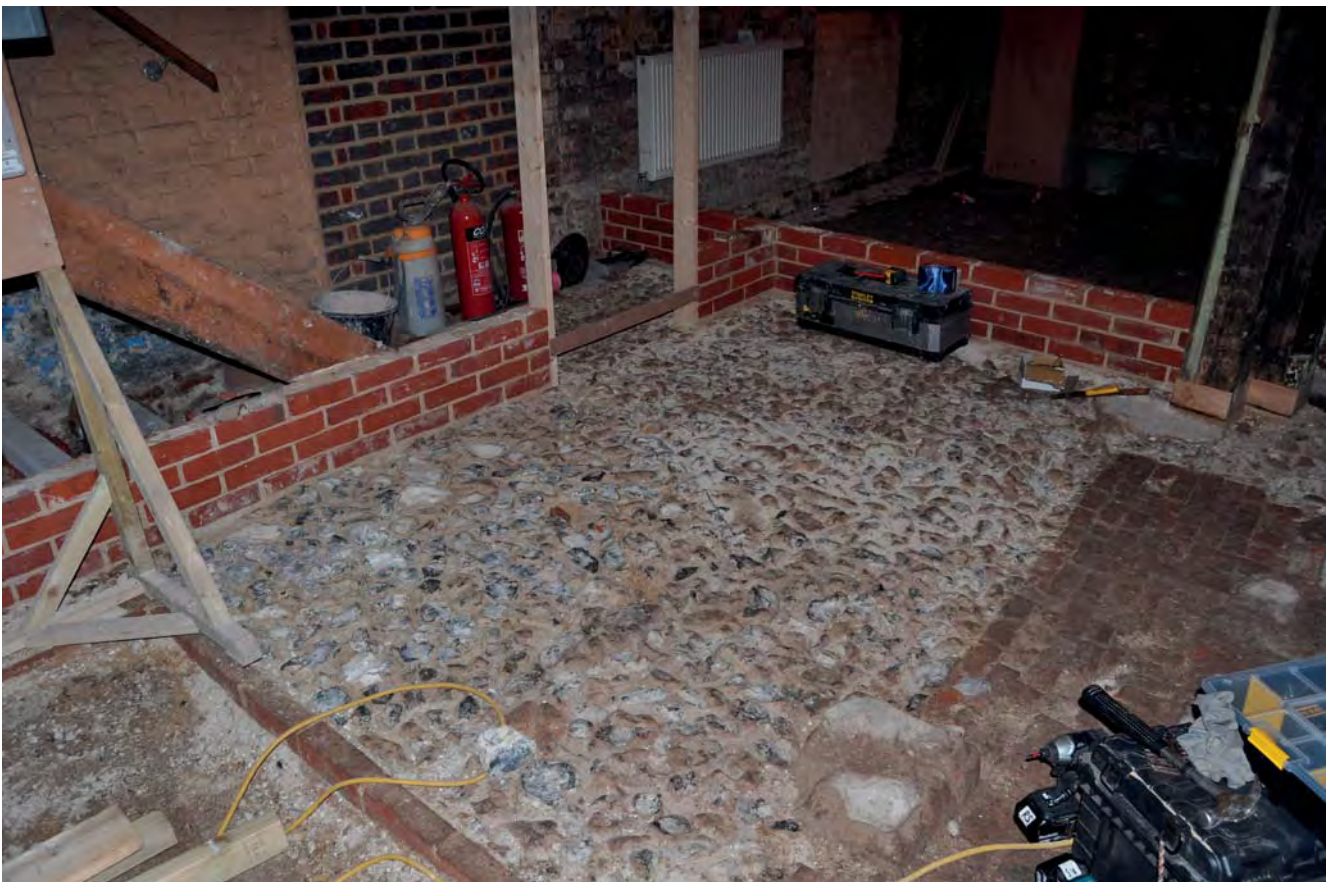
Plate 41: Floor towards west end of basement

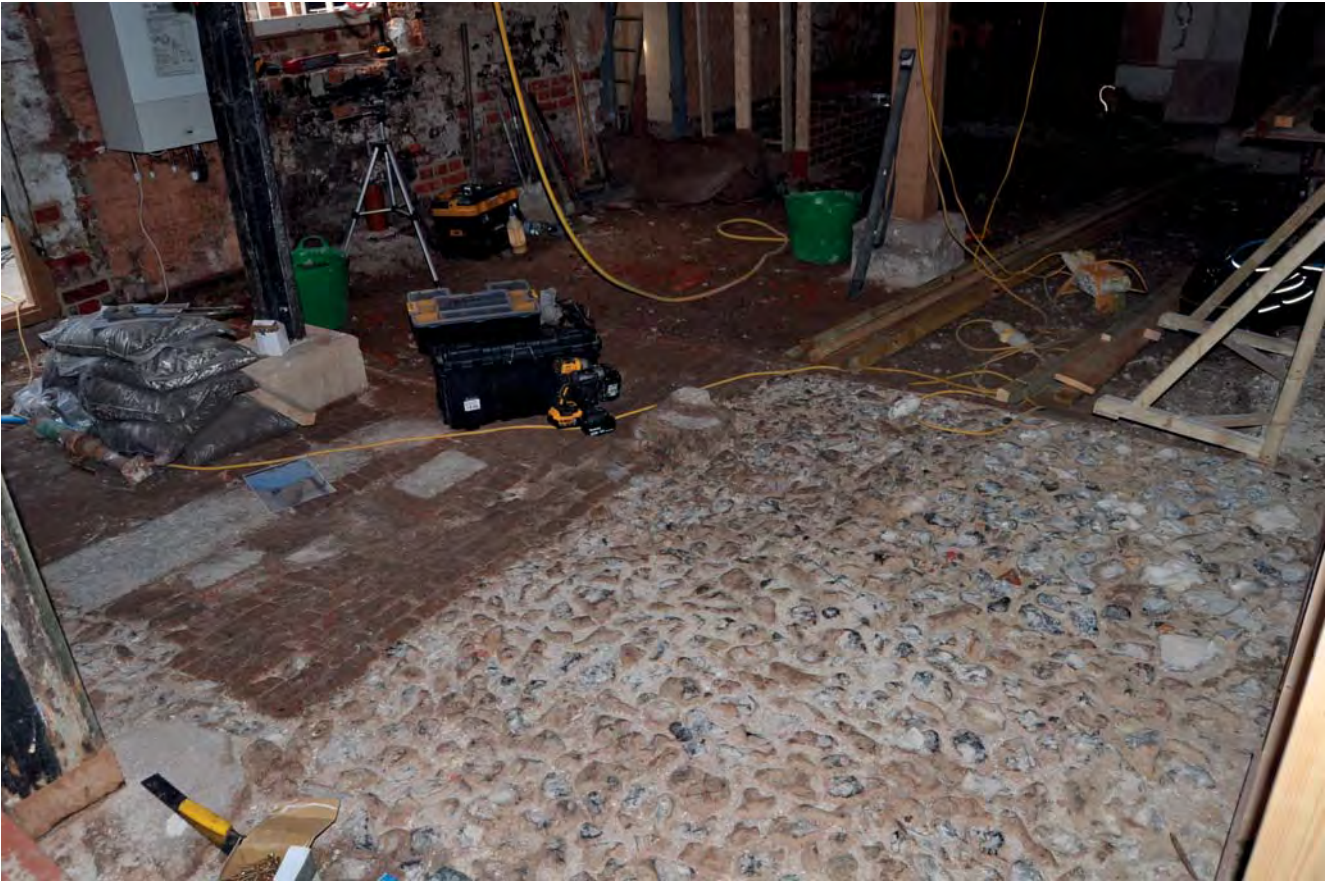
Plate 42: In-situ flint floor after repairs

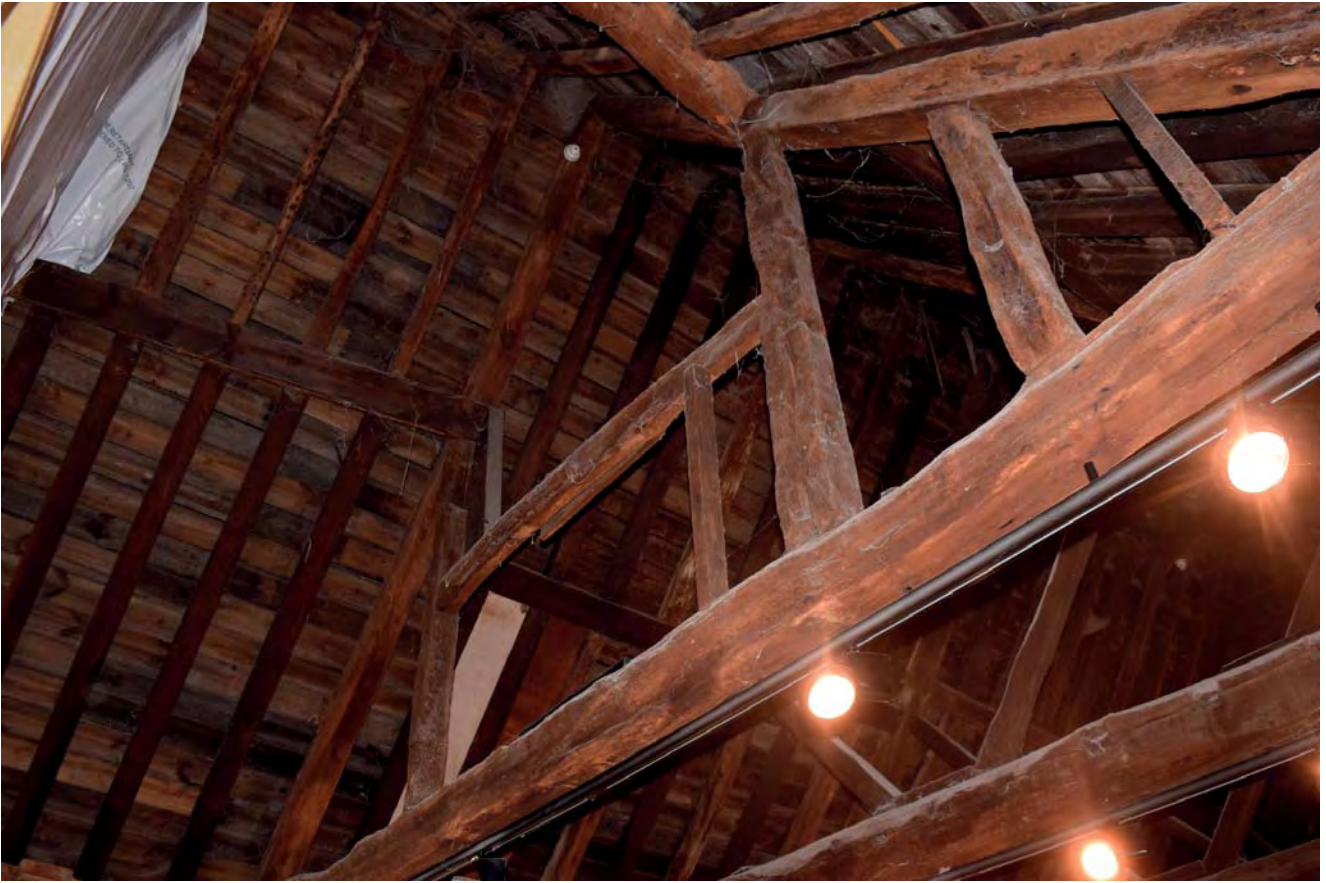
Plate 44: General view of roof looking east
