Winchester City Mill Hampshire Historic Building Investigation and Recording

September 2018

Client: National Trust

Historic Building Investigation and Recording

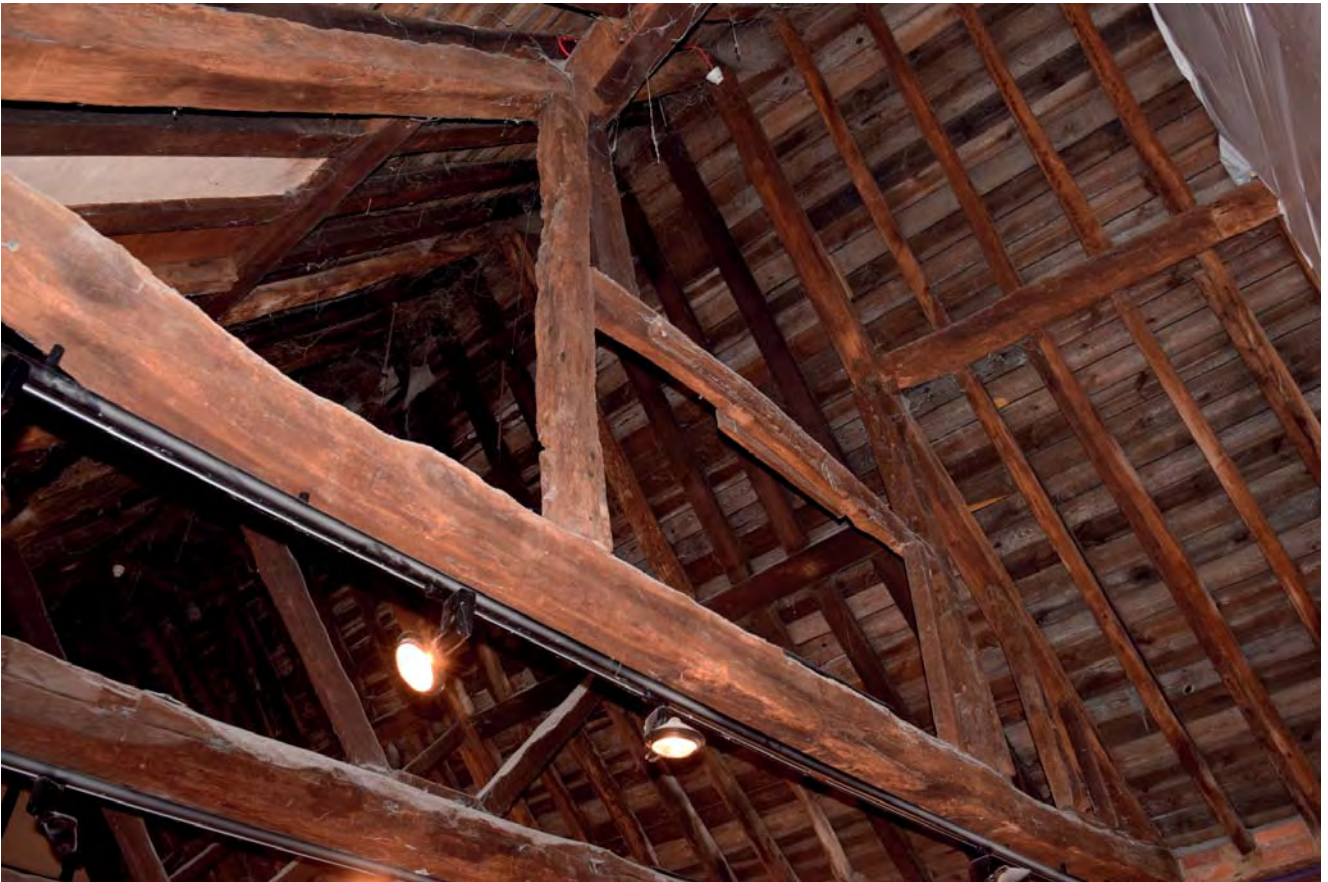
Plate 45: Truss 1 looking north-east

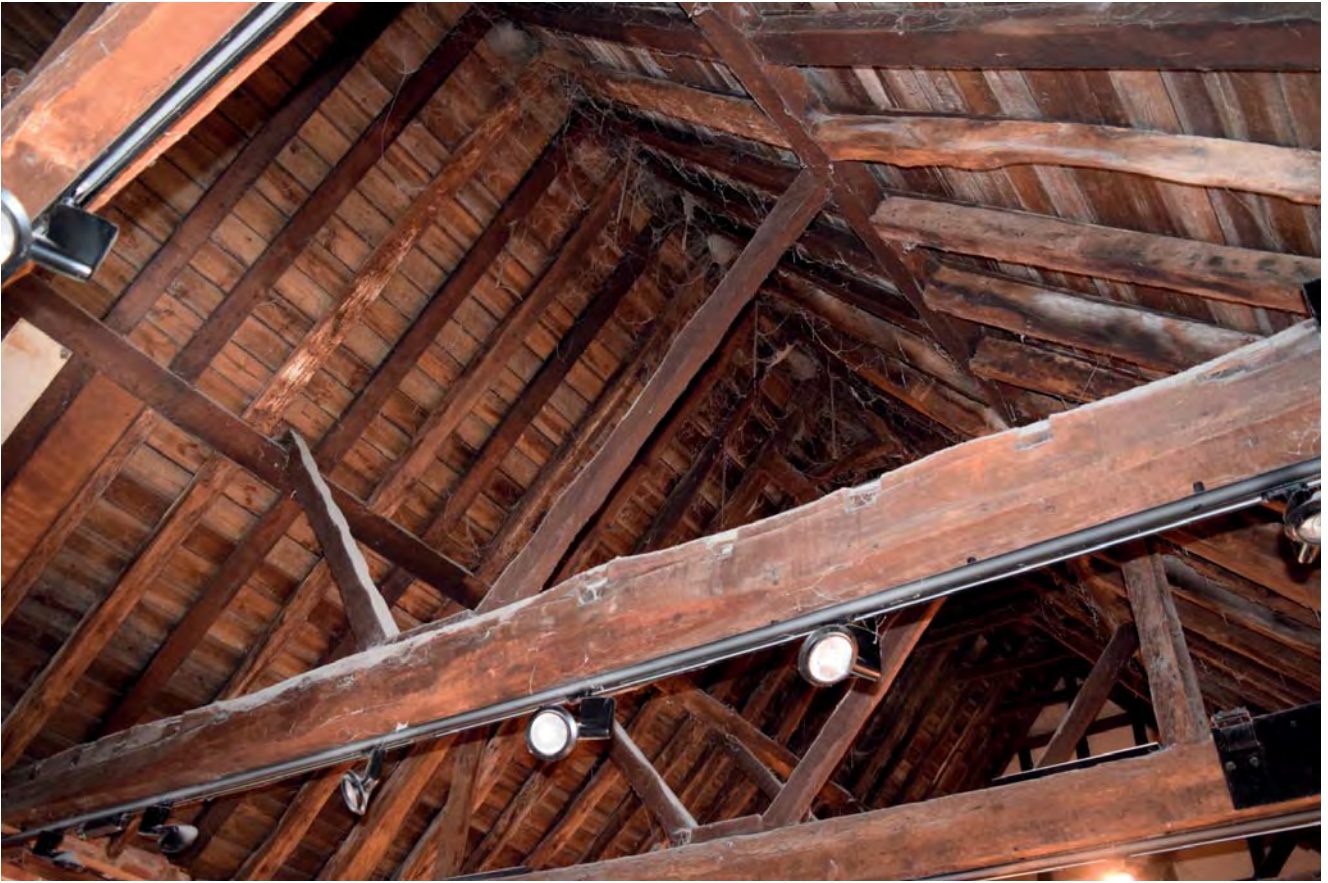
Plate 46: Truss 1 looking south-east

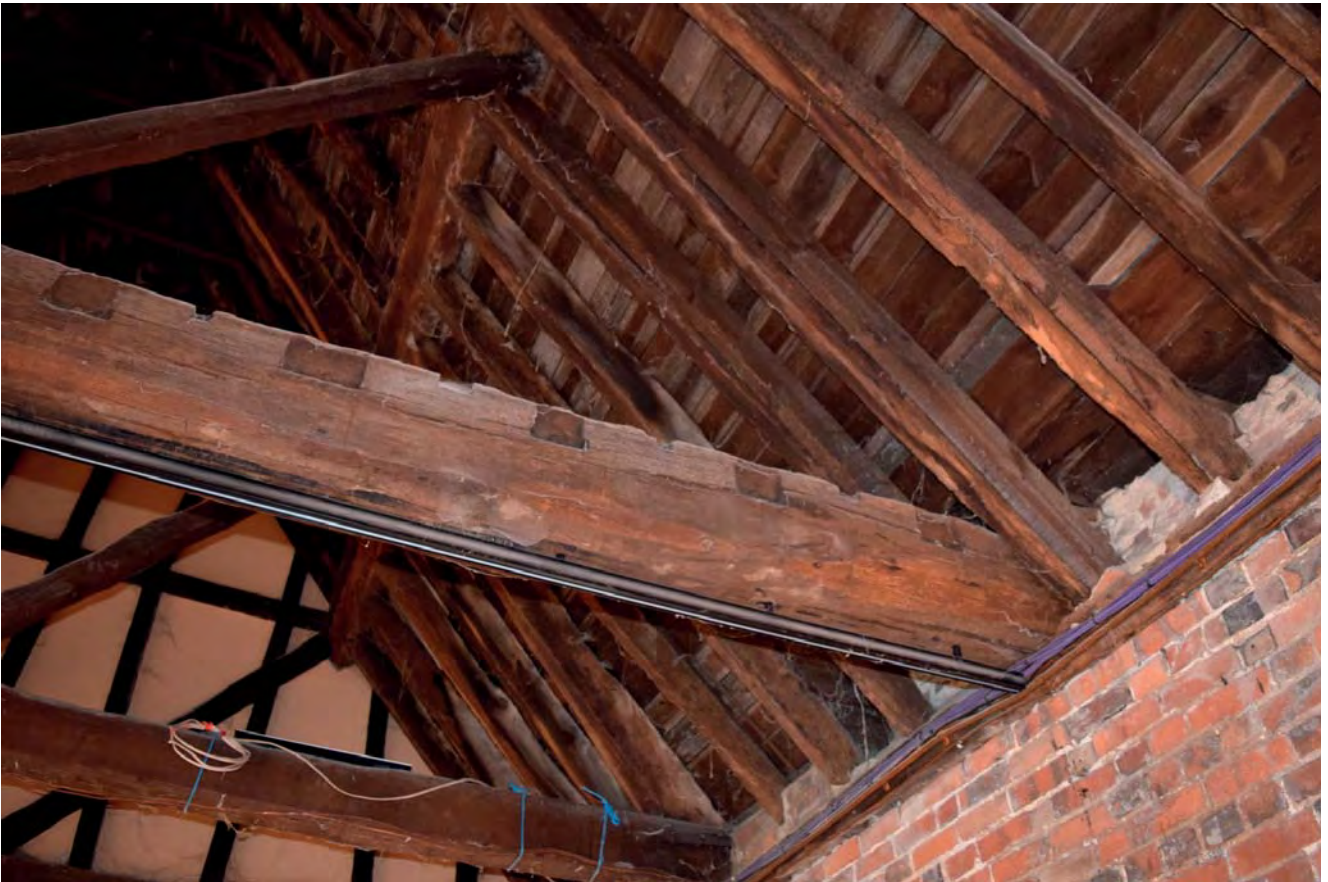
Plate 47: Intermediate truss (T.1.5) looking north-east

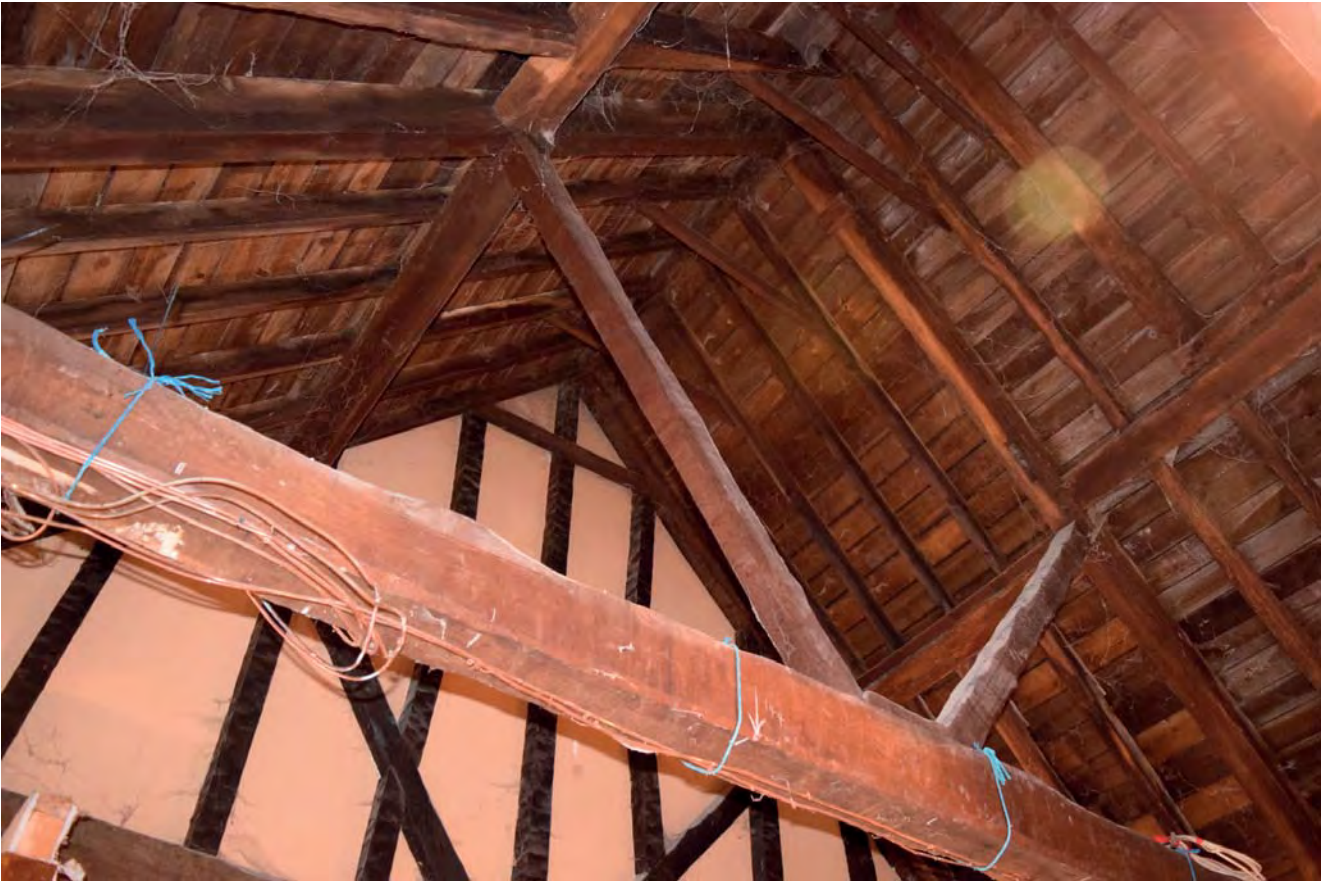
Plate 48: Intermediate truss looking east

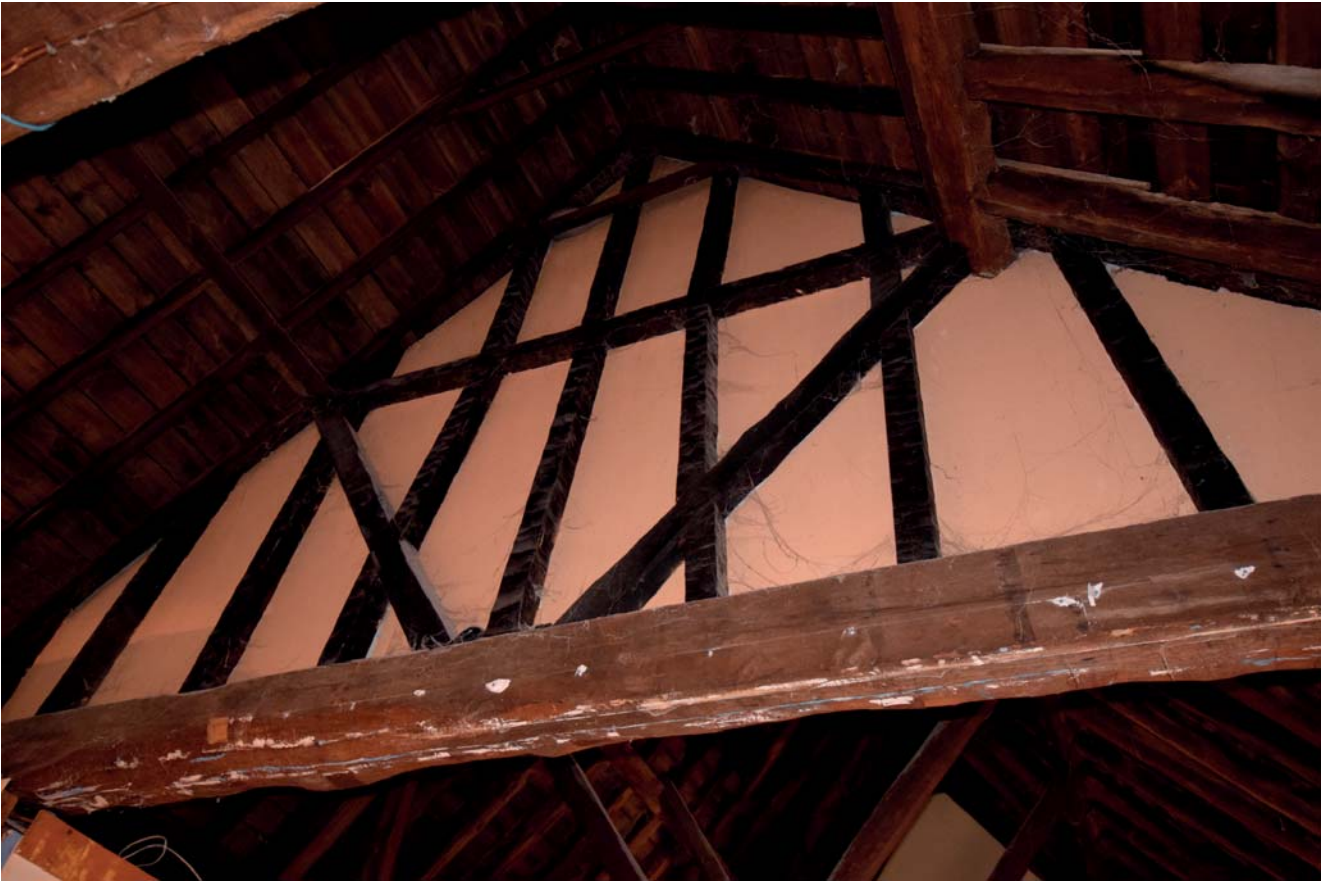
- 3.4.11 Truss 3 has simple metal straps at the ends, just securing the ends of the tie rather than the principal rafter, which could be original.
- 3.4.12 The easternmost truss in the open room (Truss 5) has a secondary tie-beam with metal straps at the end which may be early 20th-century in date (Pl. 56). The principal rafters in this truss are old however so it appears that the tie was merely replaced rather than the full truss.

Plate 50: north end of Truss 3

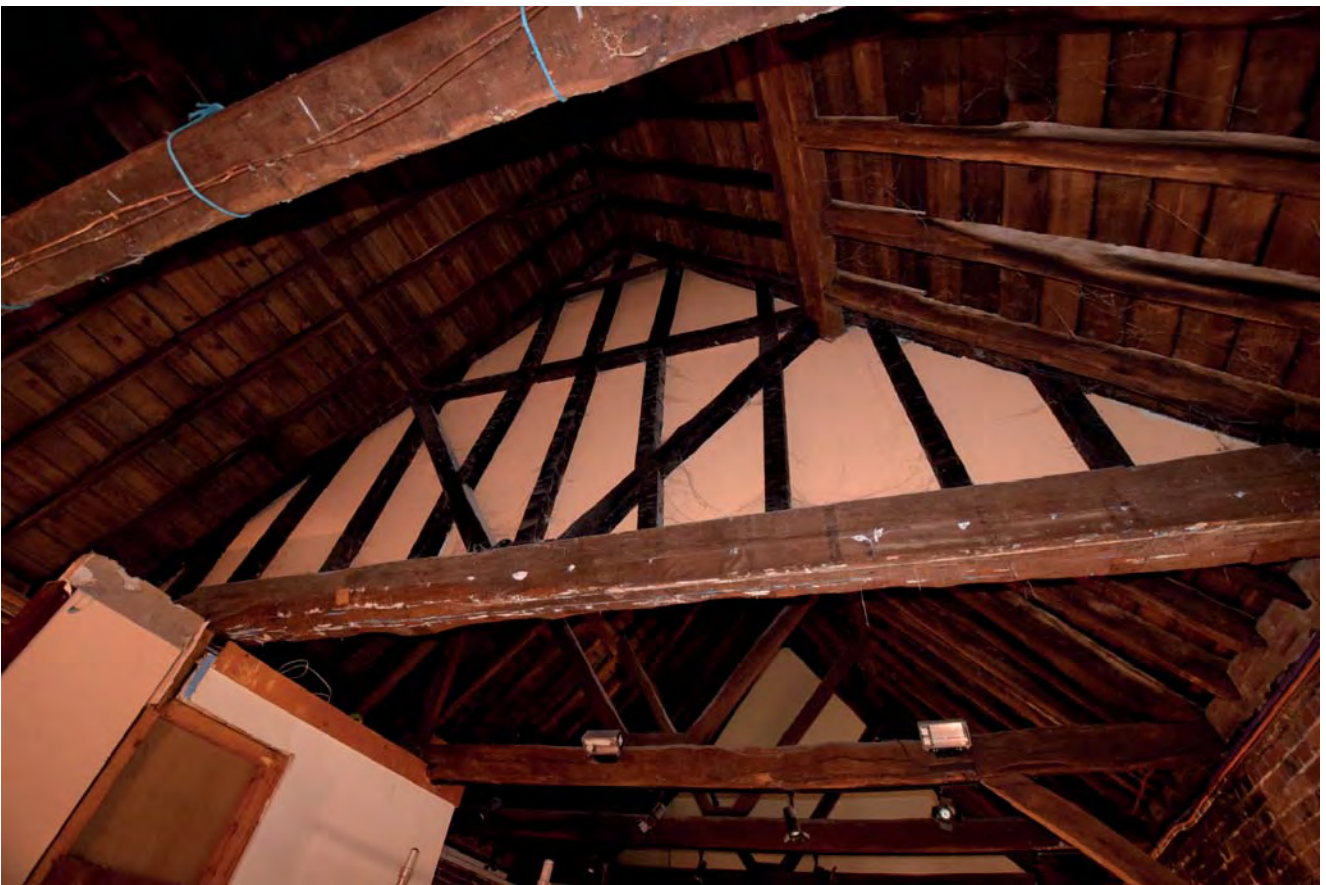
Plate 51: Closed intermediate truss at centre looking east

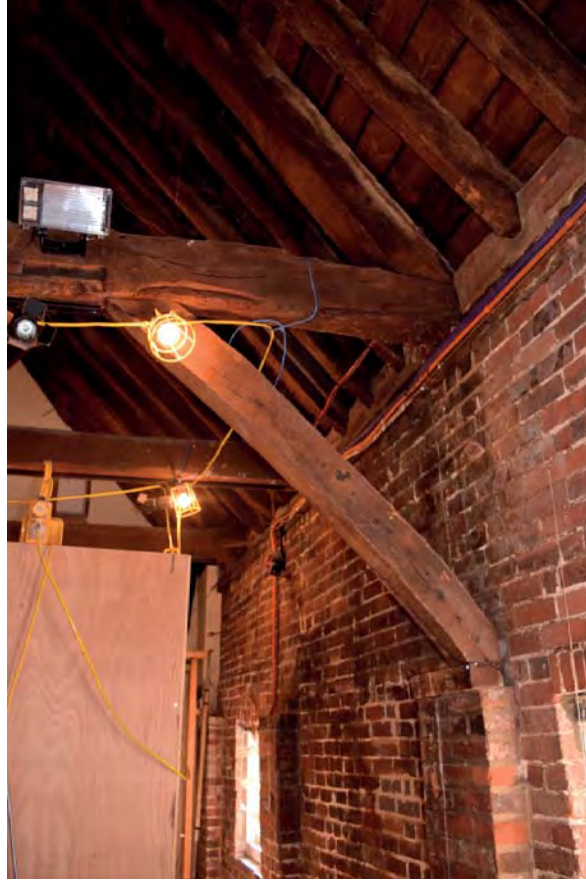
Plate 52: Closed intermediate truss at centre of building looking east

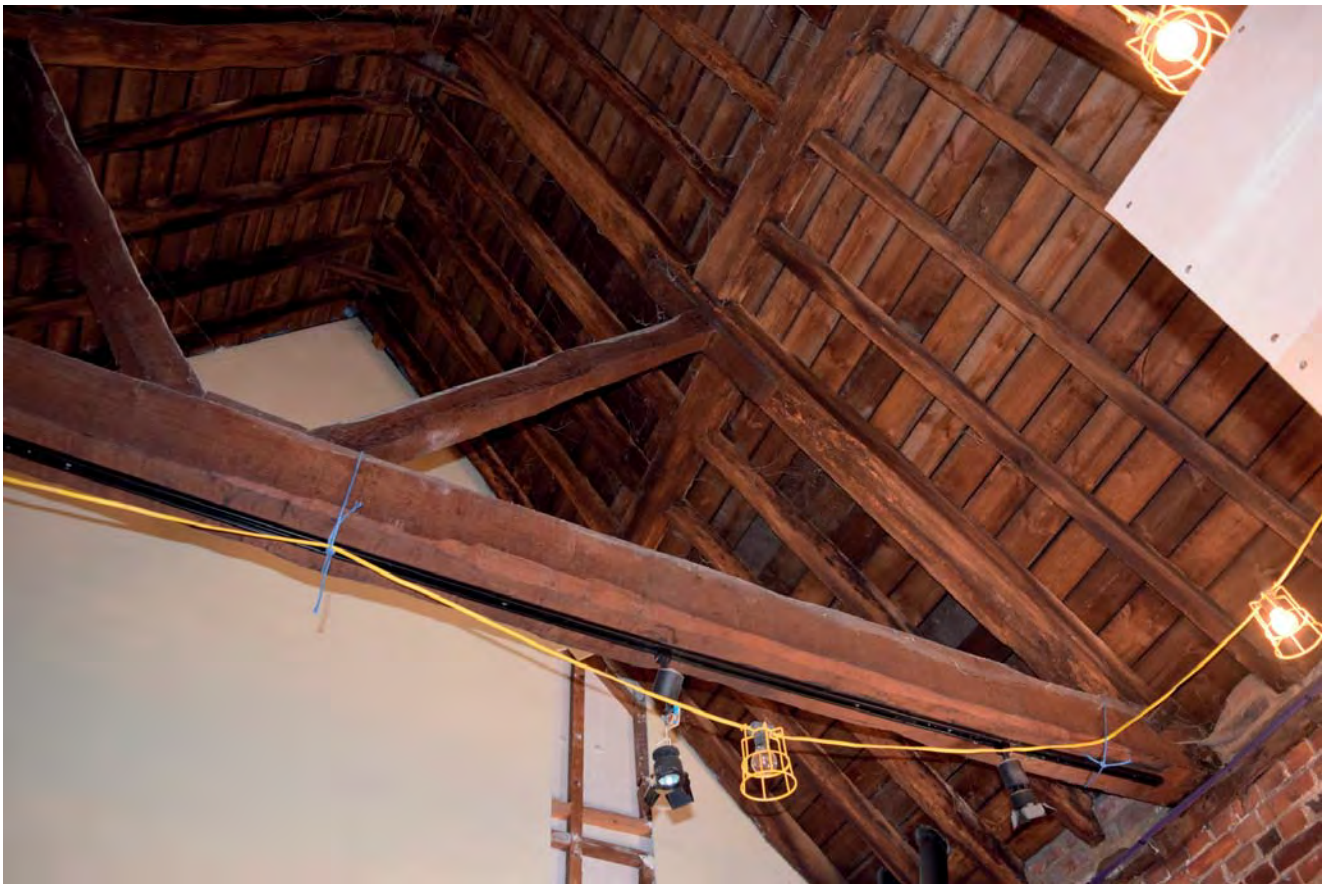
Plate 53: South end of Truss 4 looking east

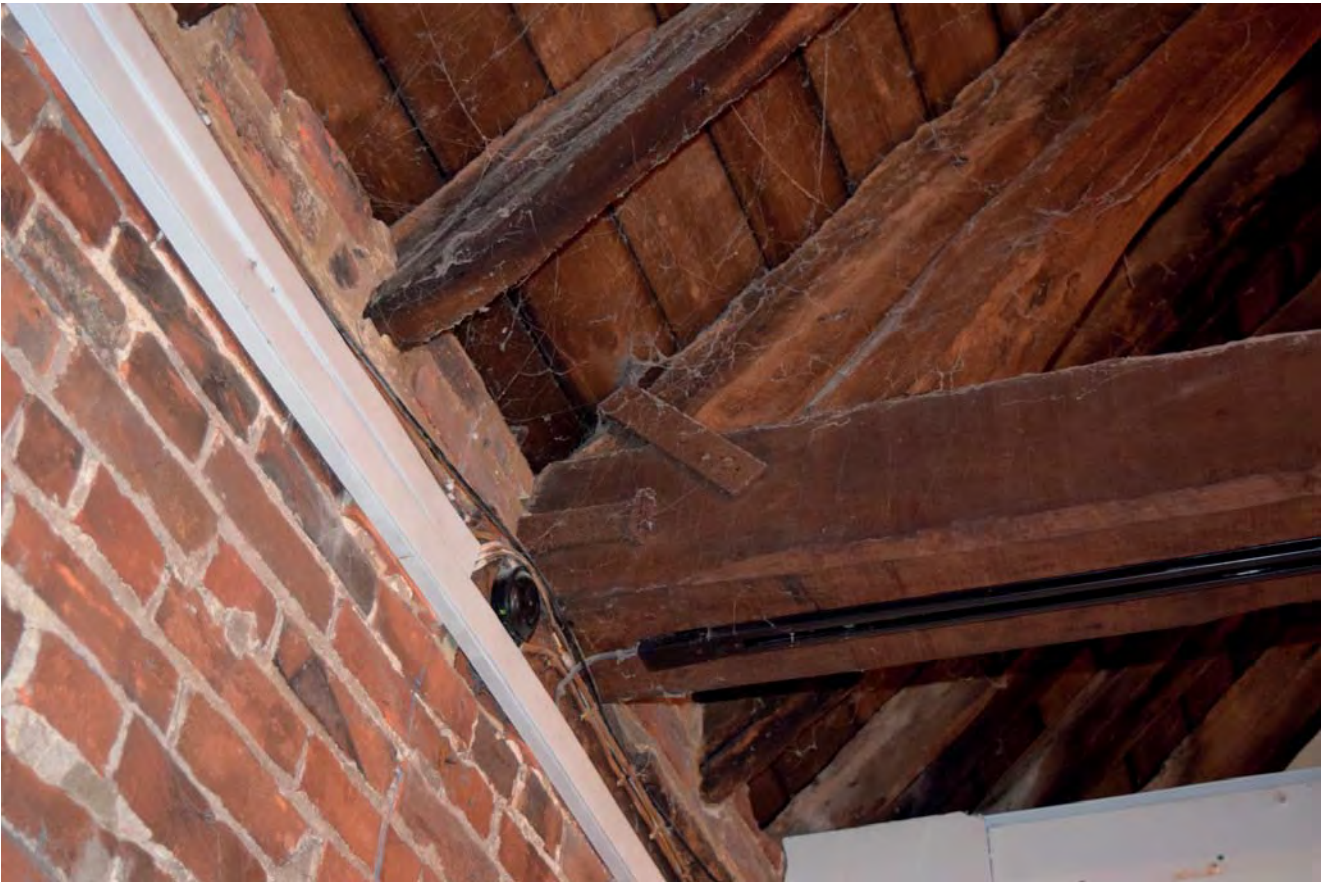
Plate 55: Truss 5 looking east

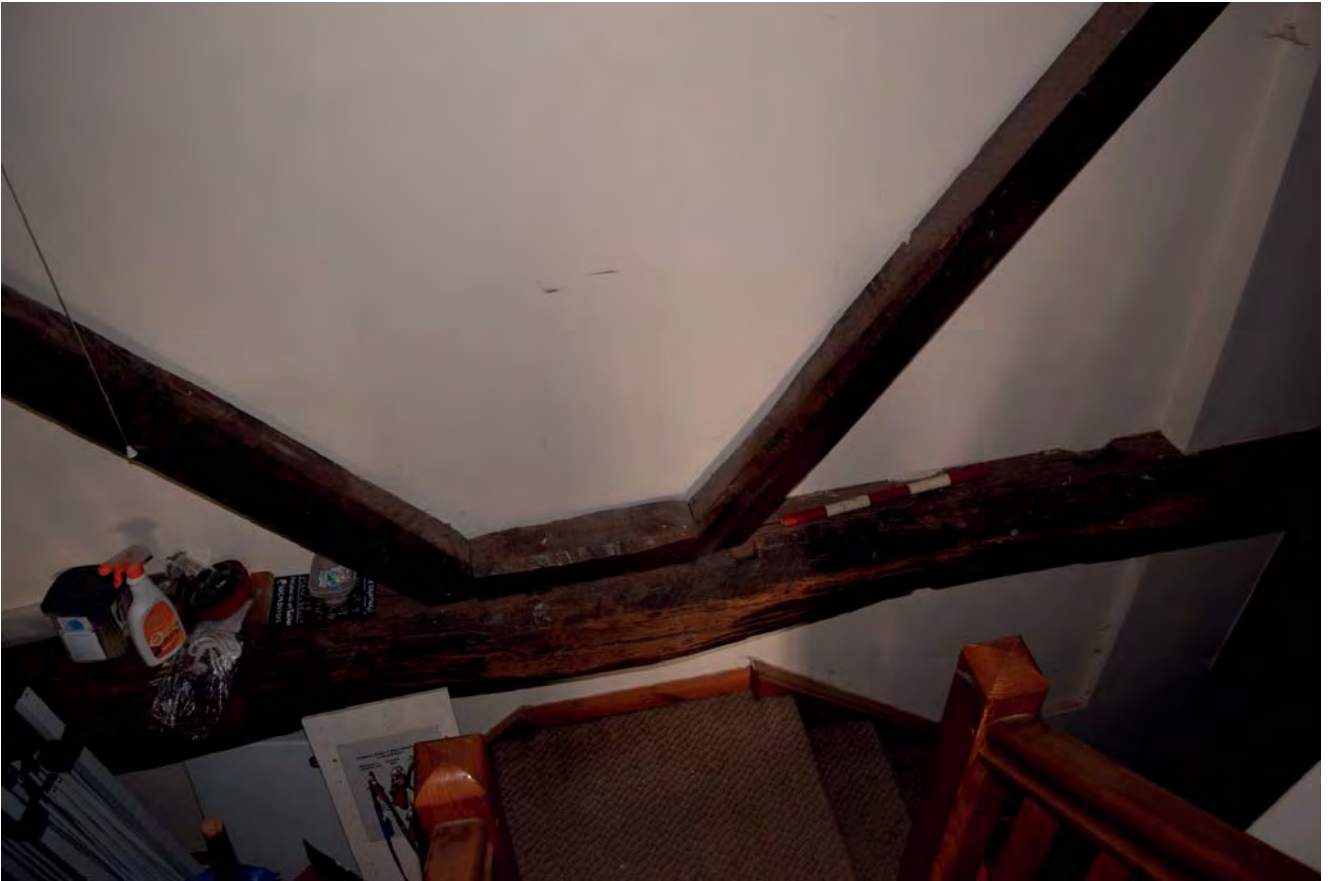
Plate 56: Detail of end of Truss 5

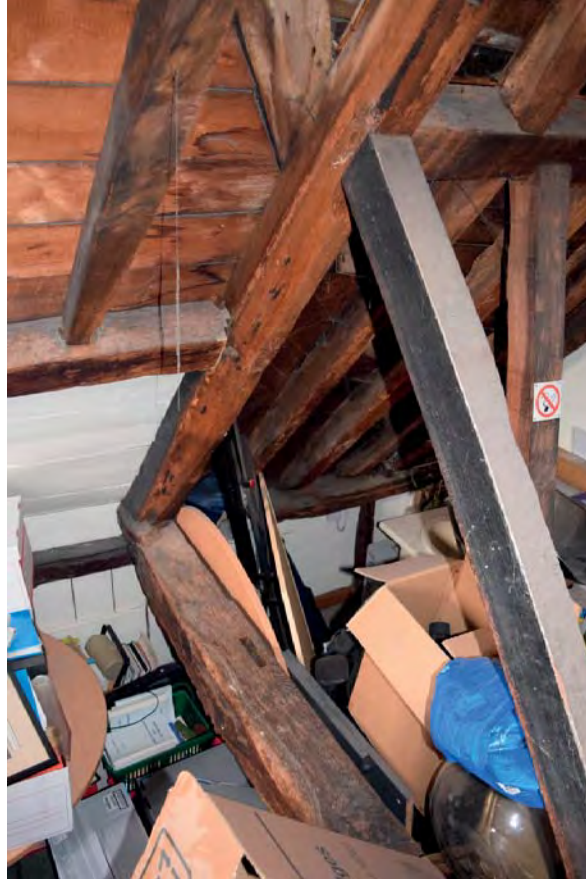
Plate 58: Roof in raised room at east end of building

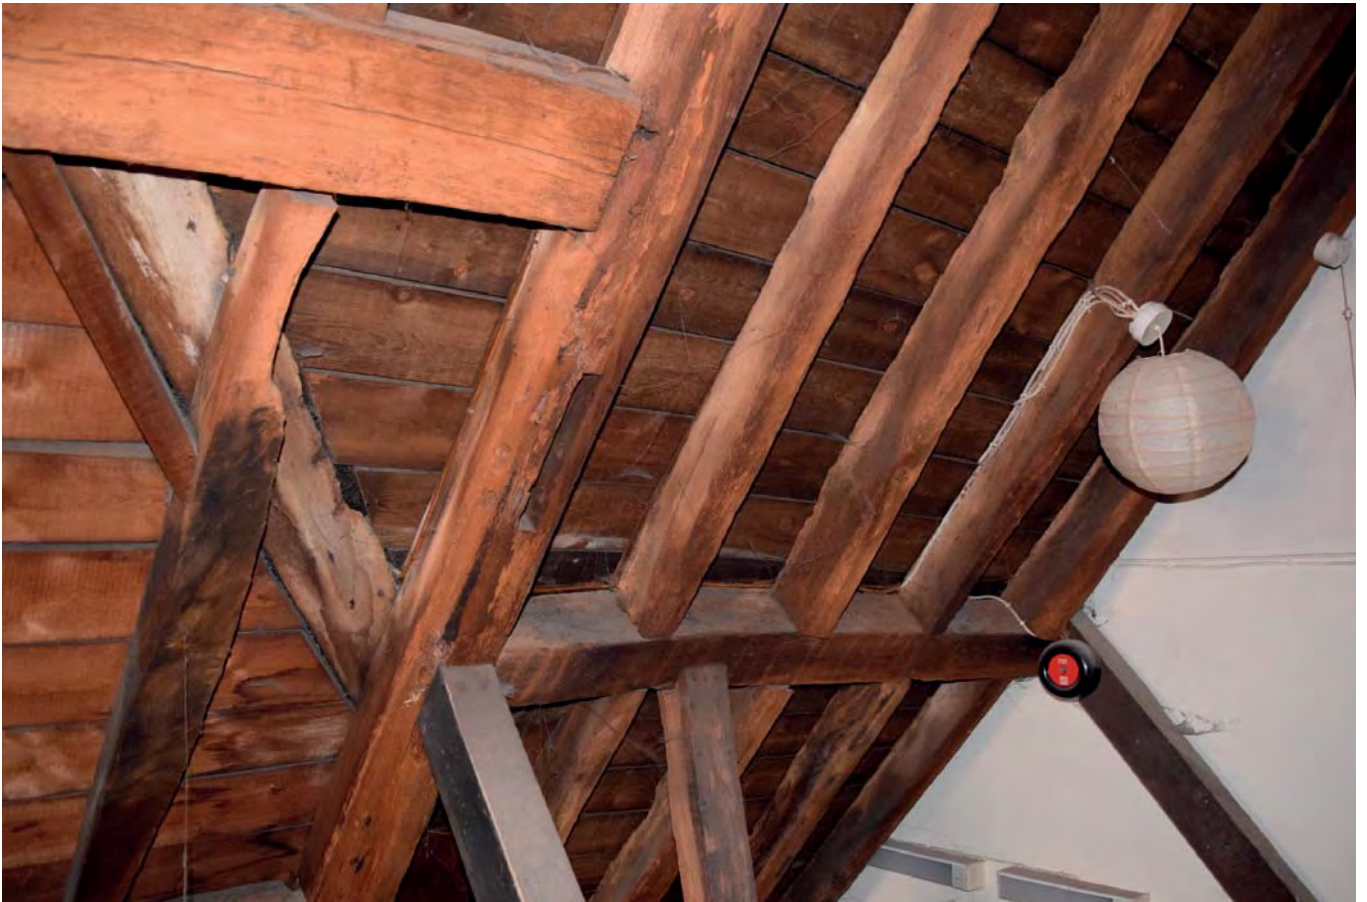
Plate 59: South end of Truss 6 at east end of building

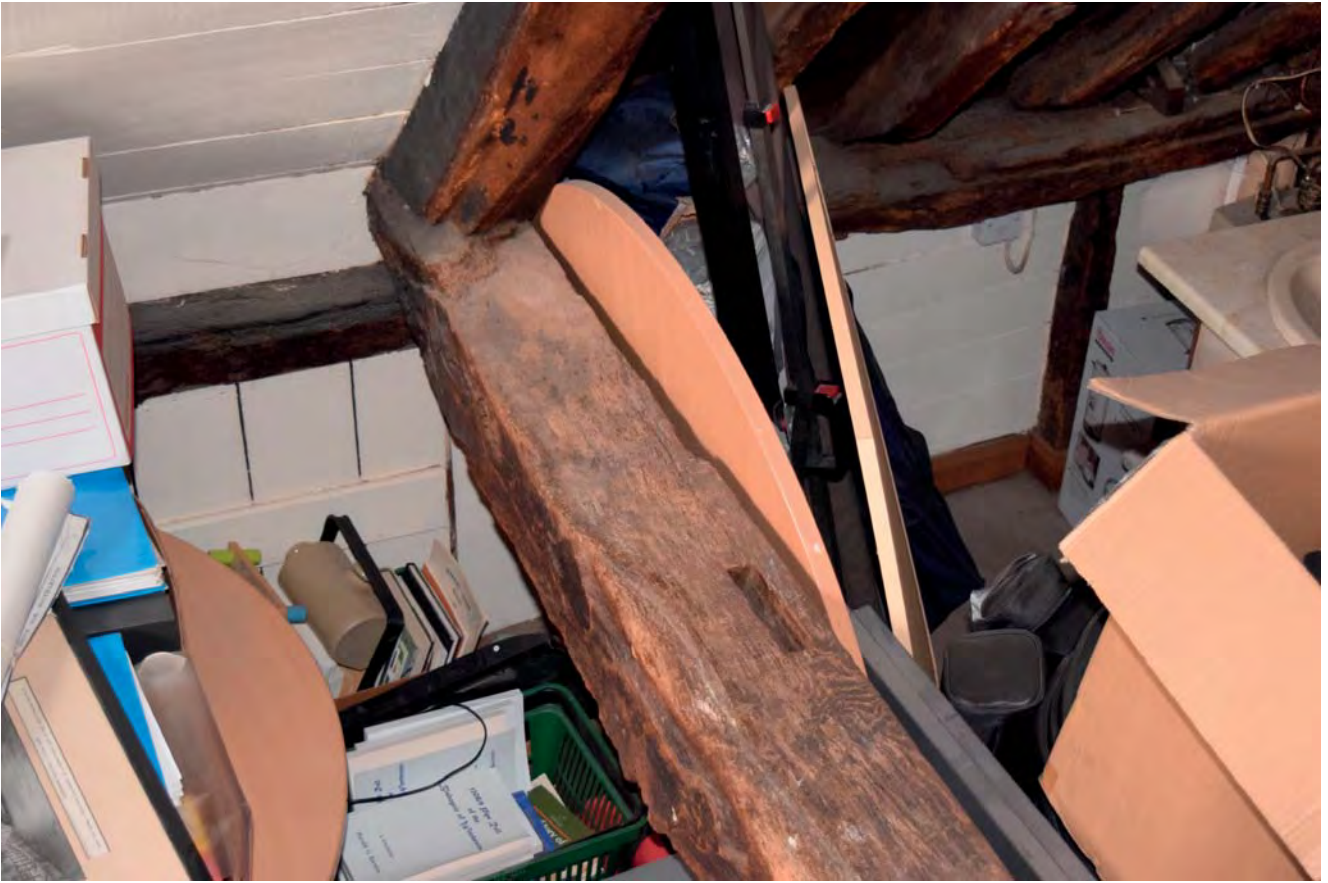
Plate 60: Mortise in principal rafter of easternmost truss (Truss 6)
