## Canons Park Harrow

**Archaeological Investigation Report**

Client: London Borough of Harrow

Date: 18th December 2003

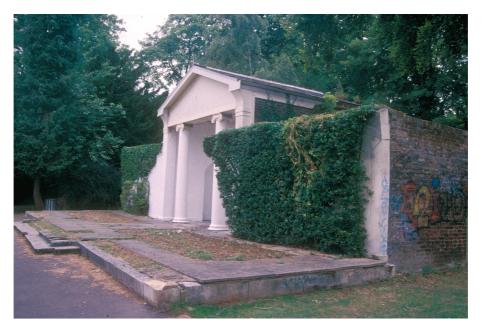
Plate 3: South elevation of Temple, looking west

- 10.2.14 The southern face of the temple is plainer and has clearly been more altered since its original construction. It consists of two free-standing Ionic columns which, together with two plain rendered pilasters, support a plain pediment with simple recessed panel (Plate 3). The pediment, columns and pilasters are in line with the rest of this face of the temple. The pediment is fully covered with a hard twentieth-century render which hides its original form together with a modern softwood bargeboard. Both the render and bargeboard were presumably added after the glasshouse was taken down and they probably hide evidence such as sockets showing how the glasshouse roof was fixed to the existing temple. To either side of the south face of the temple are brick flanking walls covered in hard render which would have formed the rear wall of the greenhouse.

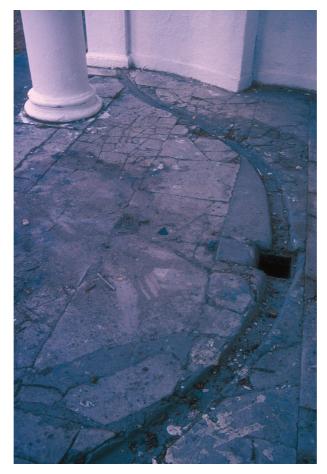
Plate 5: Drainage channel and sump on south elevation of Temple, looking west

- 10.2.15 The small south-facing room of the temple is semi-circular in plan with two small semi-circular alcoves towards each corner. The walls of this room are all covered in a hard twentieth-century render, but a small section of this was removed from within the eastern alcove and this revealed primary brickwork behind. The floor is of primary stone slabs and within this are two small drainage channels in a double curve layout meeting at a small iron lined sump towards the rear of the room (Plate 5). The channel is presumably from when the southern room was part of a large conservatory filled with exotic plants and the channels would have drained away excess water from watering the plants.

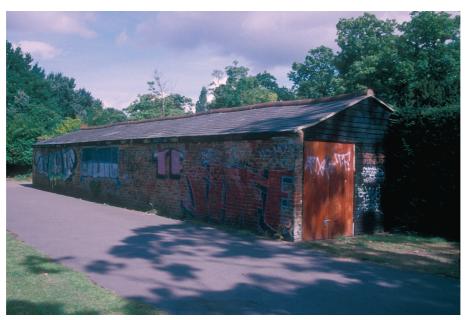
Plate 6: Structure located against south west wall of Walled Frame Yard, looking north

- north-west. However the 1935 map suggests that by that date the glasshouses had been largely cleared away and the only buildings within the yard are the small solid roofed structure at the northern corner and the longer building against the south-west wall (Fig. 17; Plate 6).
