# Chastleton House Stables Archaeological Survey

# Chastleton House Stables: Archaeological Survey

## Archaeological Evaluation of Stable/Brewhouse Courtyard

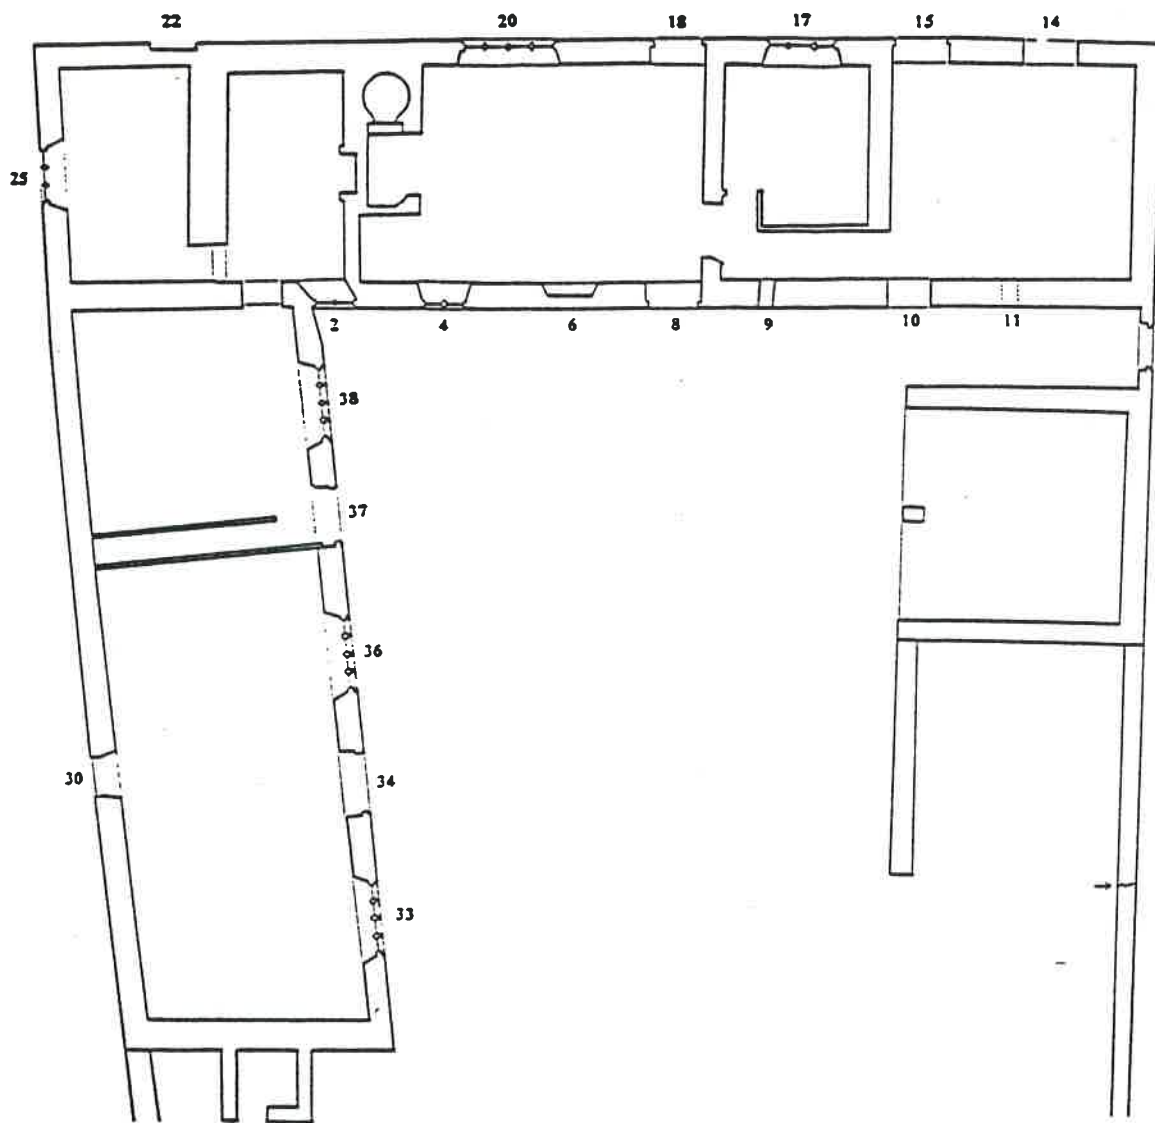
Fig. 1 Ground plan showing location of features.

On the *ground floor* there were three openings matching those above [4, 6, 8]. The first is a standard two-light window [4], though possibly secondary as below it there are breaks indicating a former door opening here. Next is a blocked window [6], whose jambs are clear externally. Then there is a door [8] of standard form (Fig. 3), with a re-used timber lintel inside and straight jambs. East of this is a small low opening [9] with a wooden frame, perhaps a hatch or an added light to the space under the stair; beyond this is a door [10] with straight jambs and a wooden doorframe, and an external wooden lintel. A masonry patch over the door suggests that the timber lintel may be a replacement for a stone one.
