English Farm Nuffield Oxfordshire

Historic Building Assessment

Oxford Archaeological Unit
December 2000

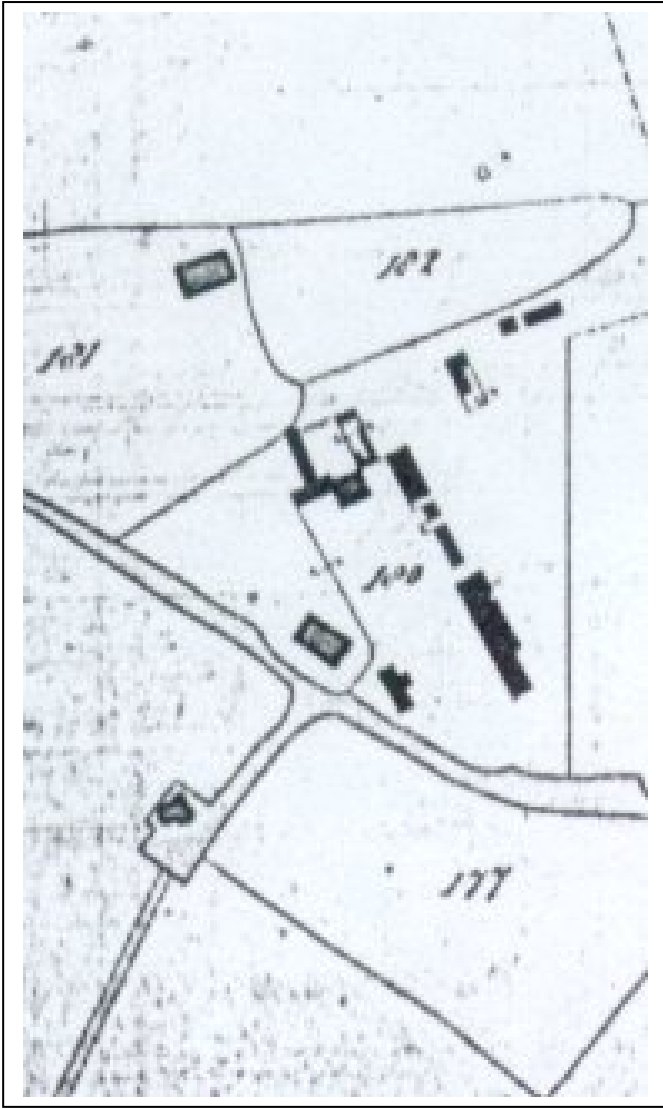
Figure 3: 1847 Tithe Map

- 2.2.4 The 1847 Tithe Map (Fig.3) confirms that the layout of the farmstead was broadly similar to that existing today but it appears to show that the coach house (Building 4) and the east-west range of Barn 11 had not yet been constructed (despite there being a date stone of 1806 on this barn). The map also shows a large building projecting west from the north-west corner of the house and a further northern range projecting from this structure. A small building is also shown between Barns 7 and 8.

- 2.2.5 The Tithe Map shows that the field immediately to the north-west of the farmstead was an orchard and that to the north-east was a paddock while the area immediately to the west was included within the general entry for the homestead. The first edition (1877), second edition (1898) and 1913 editions of the 25" Ordnance Survey maps (Figs. 4, 5) show an east-west strip of land to the north-west of the house (but to the south of the orchard shown on the Tithe Map) with trees which was probably also an orchard. It is proposed to build a tennis court partly over this area.

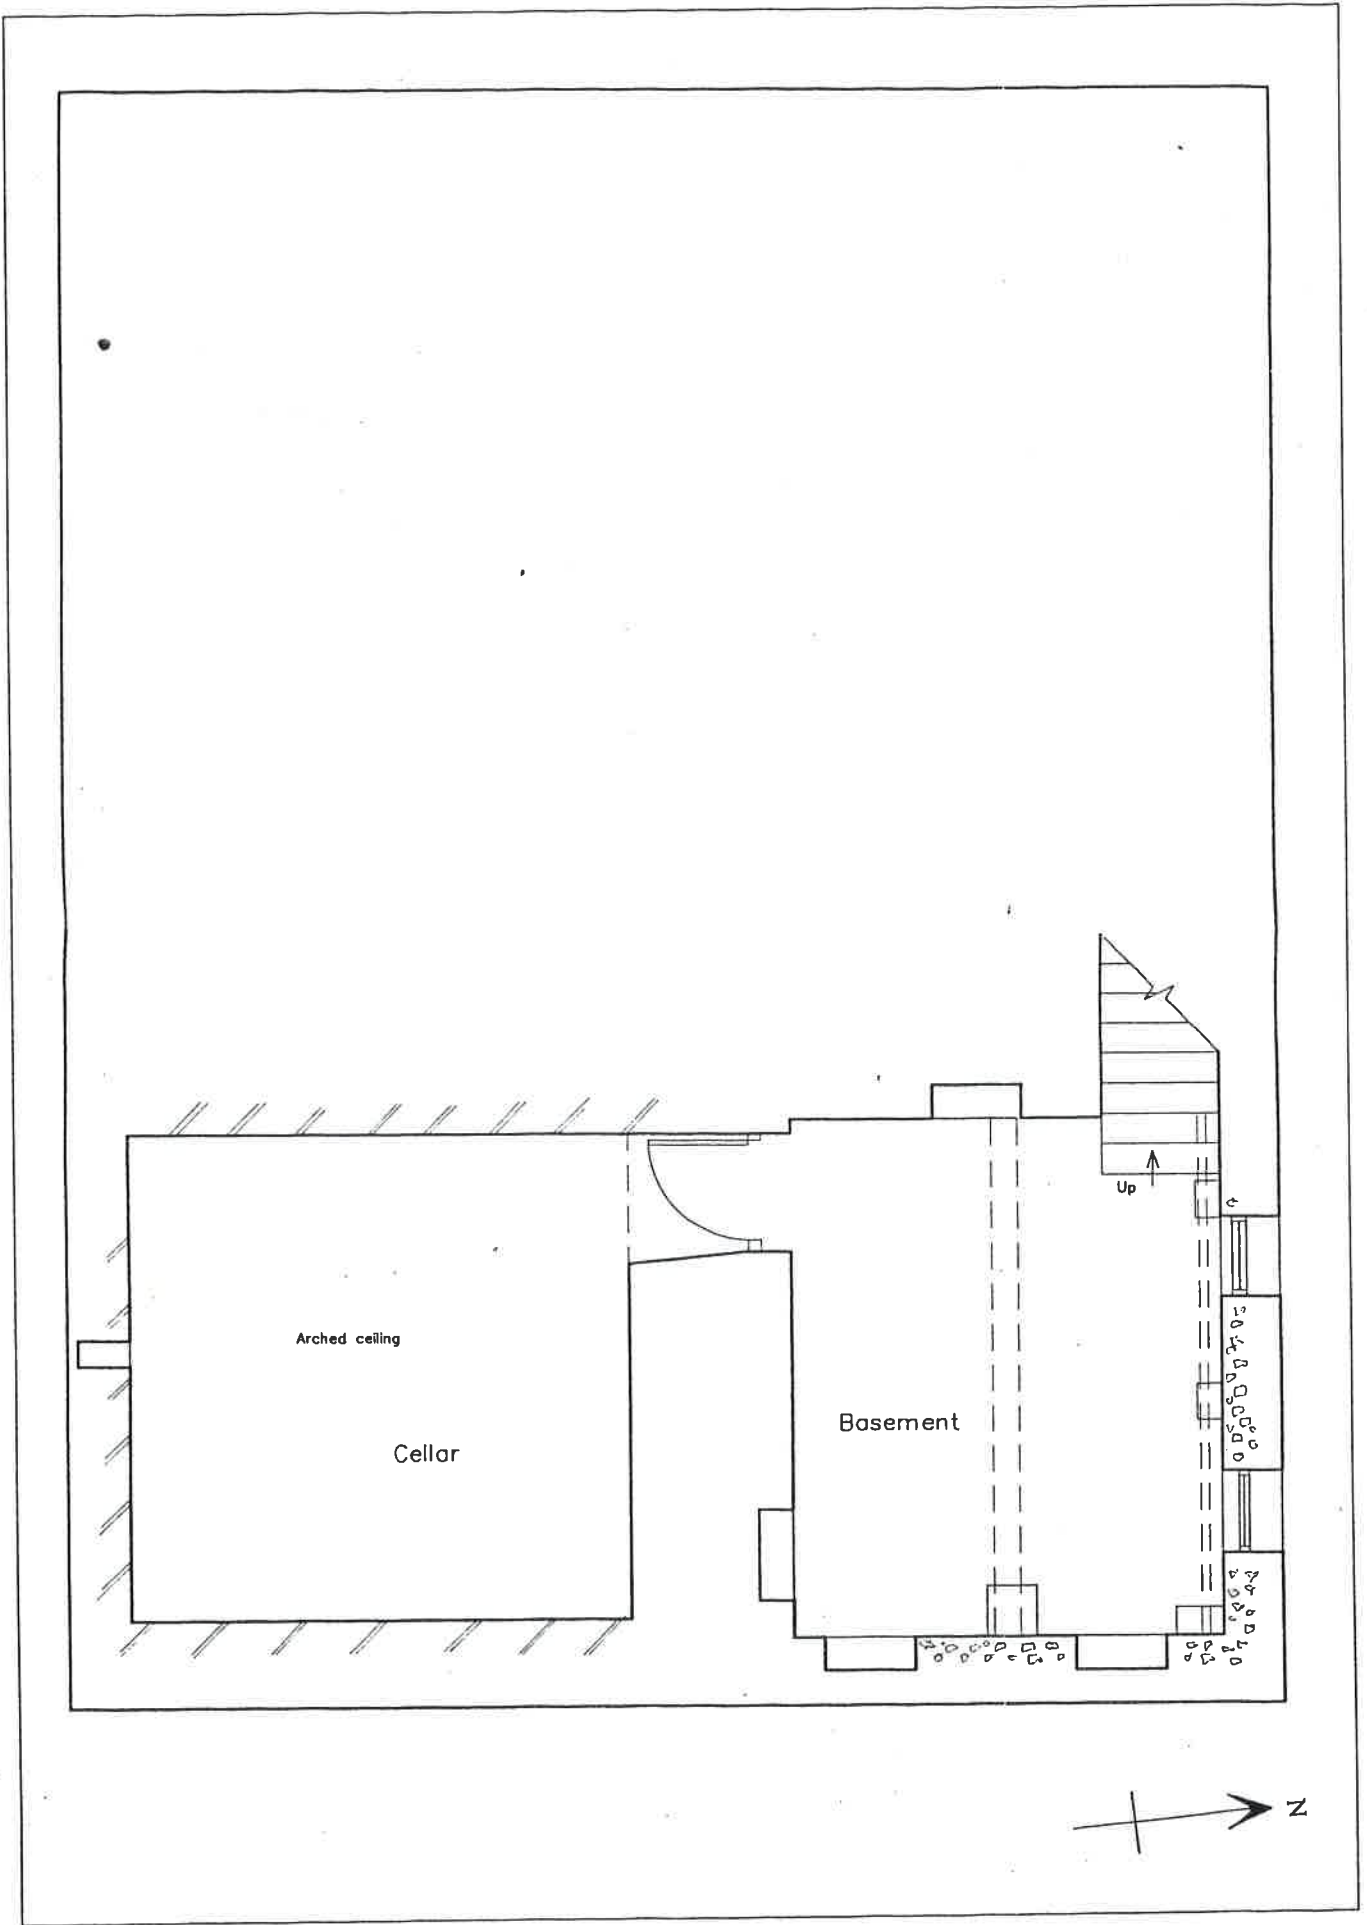
Figure 7: Basement plan

- 3.2.7 **Basement** (Fig. 7): there are two distinct areas of basement in the building which are accessed via a set of stairs (formed of small bricks) against the north wall of the building. Beneath the parlour at the north-east corner of the house is a room with flint walls covered by rough plaster and paint, and a floor above with chamfered principal joist (E-W), common joist and formerly with a lath and plaster ceiling. The floor is of stone flags and there are arched recesses with ledges within the south, west and east walls. Two small stone-lined windows in the north wall provide a small amount of light into the basement. To the south of this, beneath the lounge (small lounge before the reduction in size of entrance hall - see below) is a basement with a wide, shallow brick-vaulted ceiling (Plate 9). The brickwork is painted and the room probably used as a wine cellar.

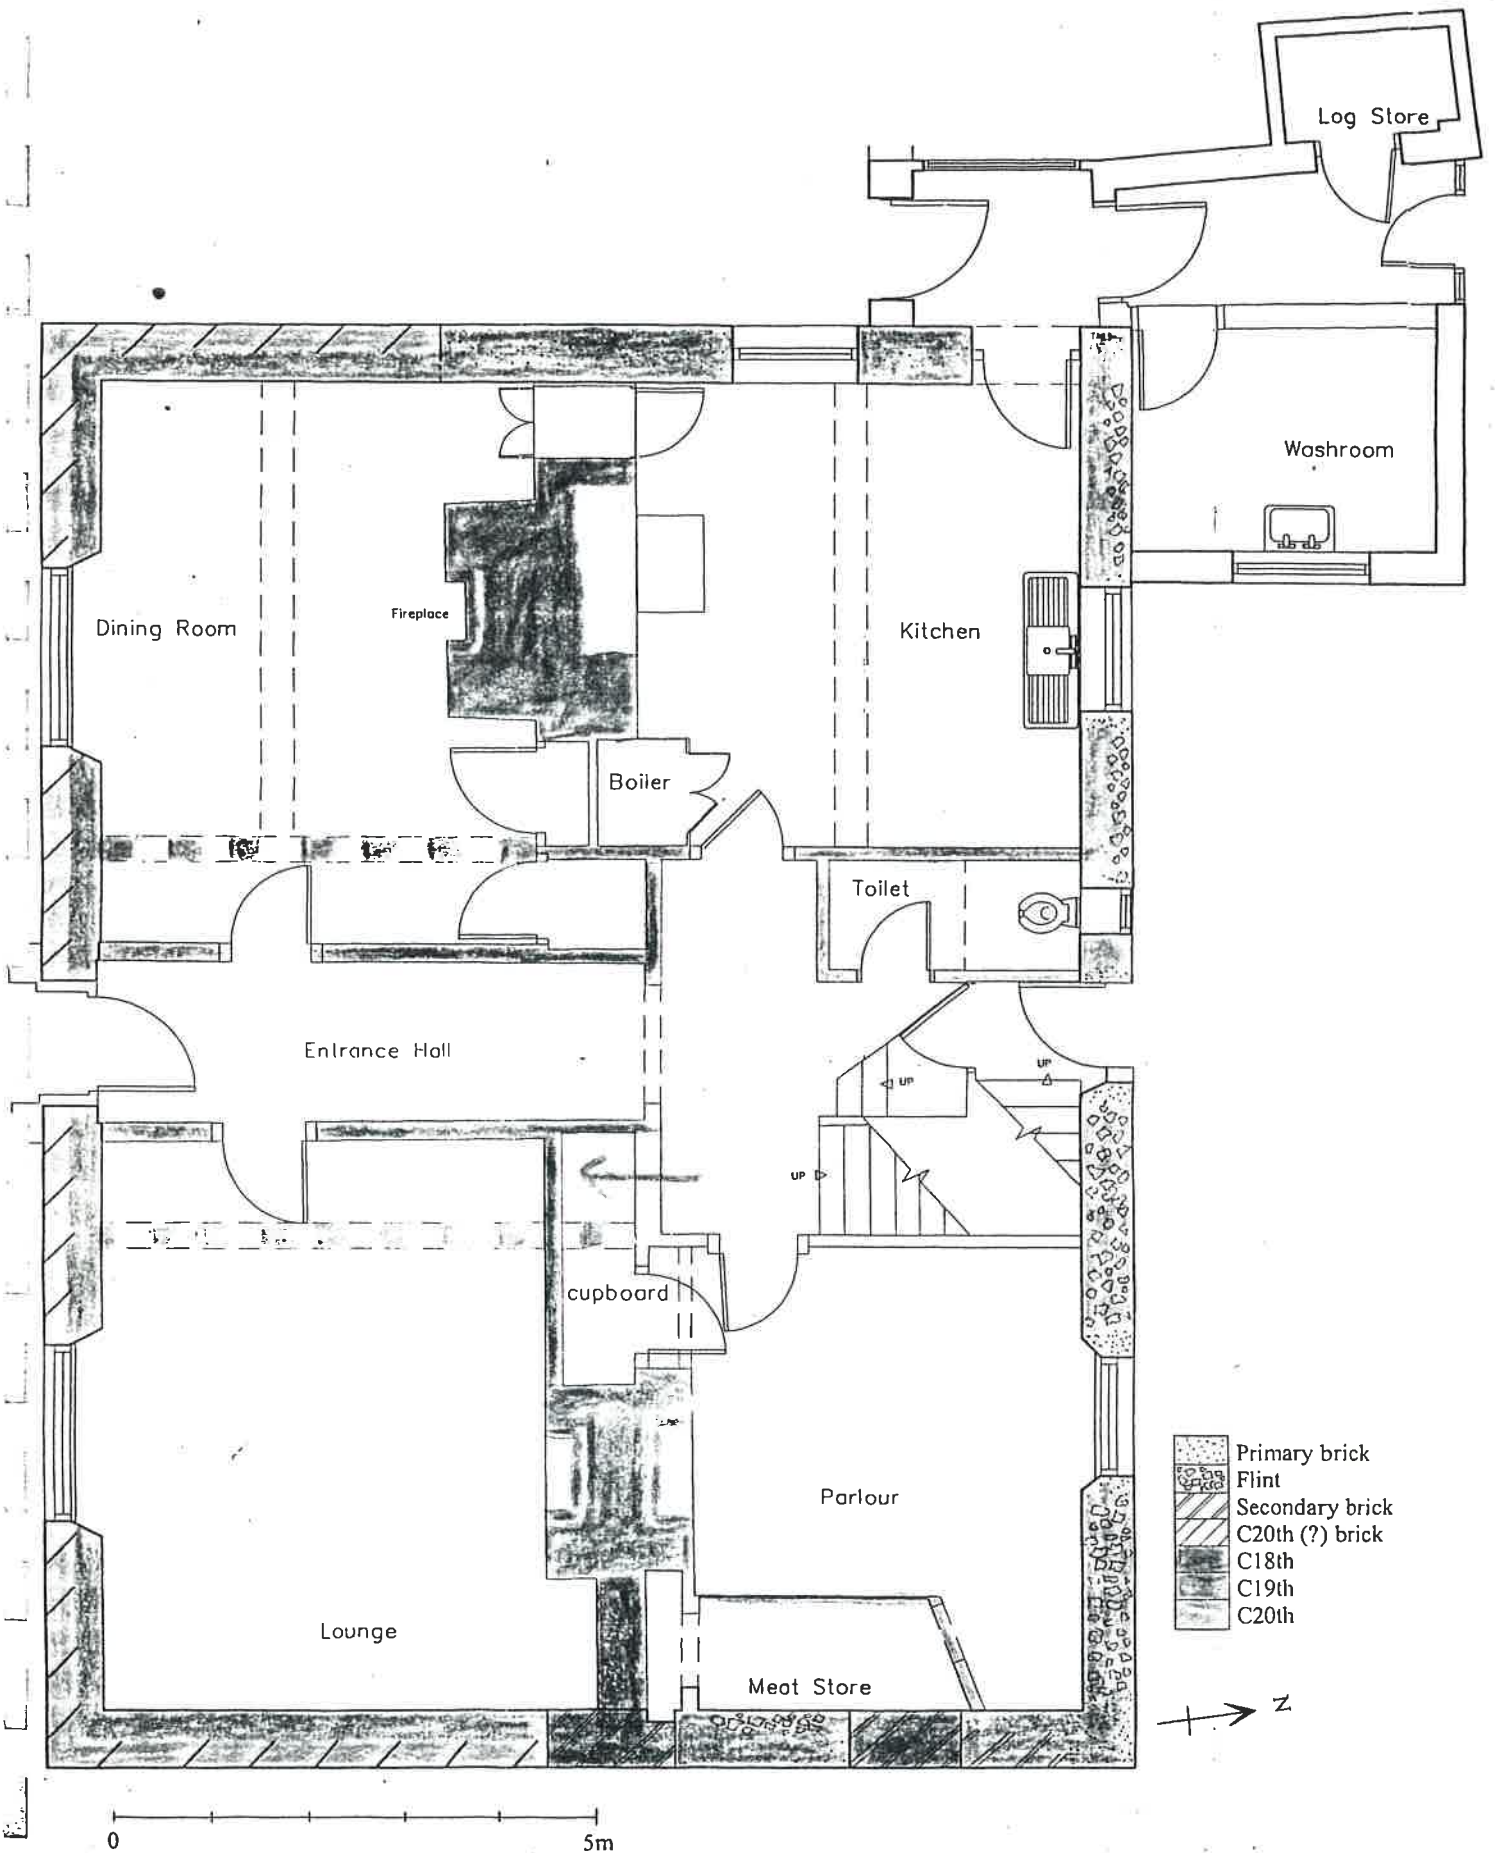
Figure 8: Ground floor plan of house

- 3.2.9 **Ground floor** (Fig. 8): The building is entered through a central doorway in the west elevation into a narrow **entrance hall** at the centre of the southern half of the ground floor. This was formerly wider on both sides and would have formed a grand hall the same width as the staircase.

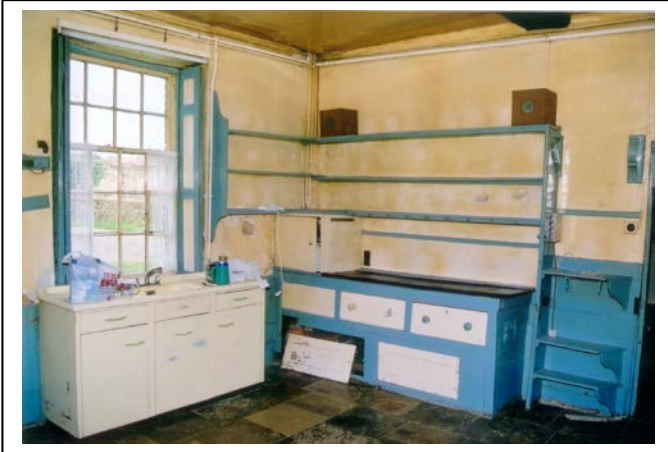
Plate 11: dresser within kitchen

- 3.2.12 The **kitchen** is at the north-west corner of the building and has a Purbeck Marble floor, a dresser against the east wall and a large primary fireplace to the south of the room (Plates 11, 12). The walls have a simple panelling (largely covered by 20th-century boards) beneath plastered walls. The window has probably primary shutters and an E-W chamfered principal joist which projects beneath the ceiling.

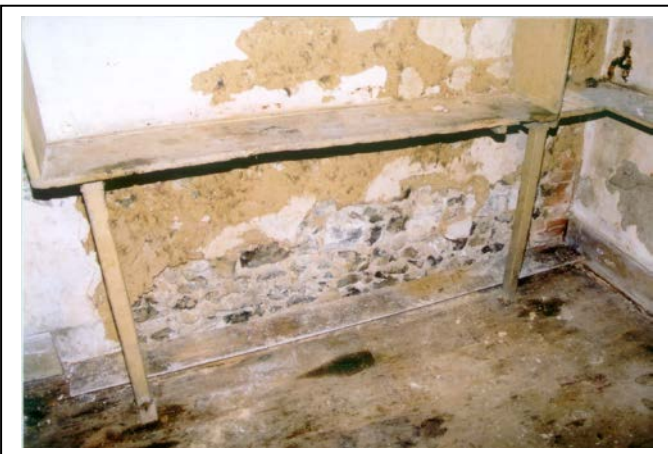
Plate 13: Flint in north wall of parlour

- 3.2.13 At the north-east corner of the ground floor is the **parlour** which has a boarded floor (wide possibly primary boards) and plastered walls although in several areas the plaster has been recently removed to confirm the construction beneath (Plate 13). A large patch immediately above floor level has been removed from the north wall which confirms that the inner face of this wall is of flint (same as outer face). Of more significance are two smaller areas of plaster removed from the east wall, one immediately above the floor and the other about 1.5 m above ground which reveal flint construction beneath. Further openings to the north of this, also in the east wall, reveal brick beneath and confirm that the straight joints visible on the outer face continue through the wall. This evidence appears to confirm that the primary construction of the wall was of flint with brick dressings around openings, the same as the existing north wall, and that it was subsequently refaced in brick.
