Wardington Manor Wardington Oxfordshire

Historic Building Investigation: Roof Structure - Southwest Wing

November 2004

Document Title: Wardington Manor, Wardington: Examination of surviving elements of south west wing roof structure

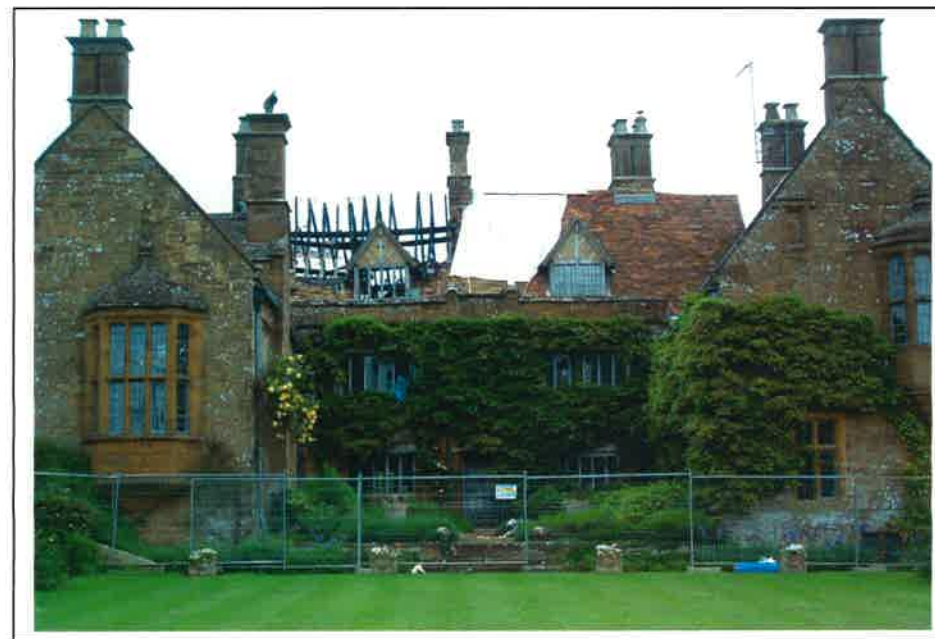
- 1.3.3 During April of 2004 fire destroyed approximately 90% of the roof covering and timber structure below. As a result of the fire (Plates 5 - 12), an extensive programme of restoration and conservation work has been proposed by RM&P, details of which are currently being finalised and are likely to run until the latter part of 2005.

Plate 3: View north east - fire damage to roof on south west wing
