ARCHAEOLOGICAL AND PHOTOGRAPHIC RECORD
IN ADVANCE OF BUILDING WORKS

OXFORD ARCHAEOLOGICAL UNIT
AUGUST 1998

Manor Farm, South Stoke, Oxon

ARCHAEOLOGICAL AND PHOTOGRAPHIC RECORD IN ADVANCE OF REFURBISHMENT

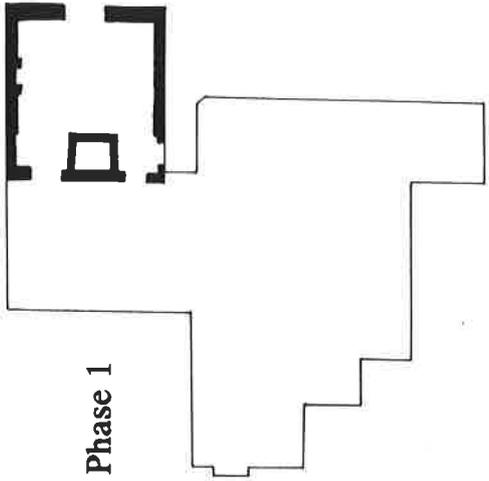
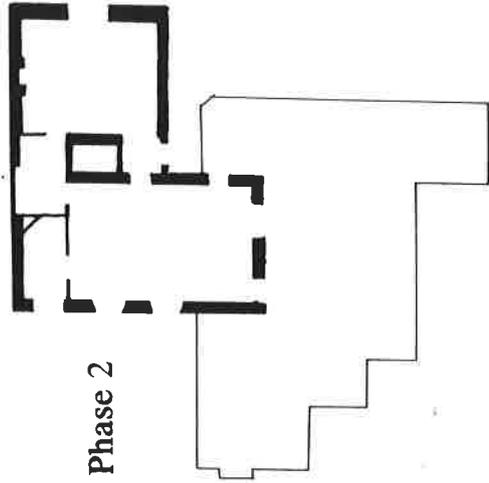
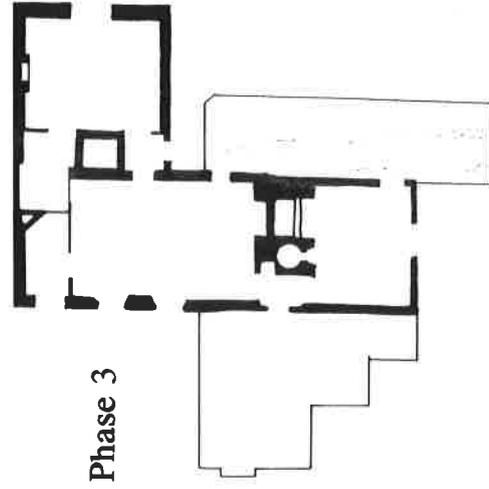
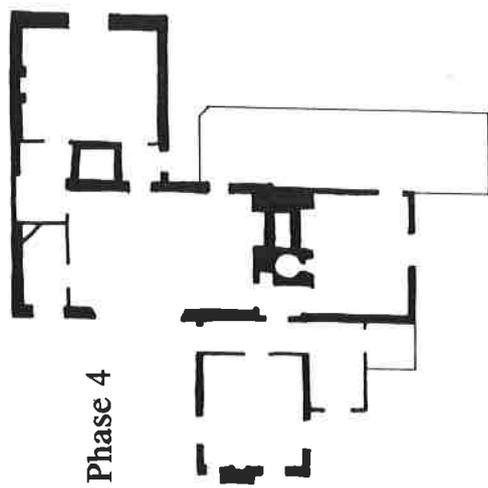
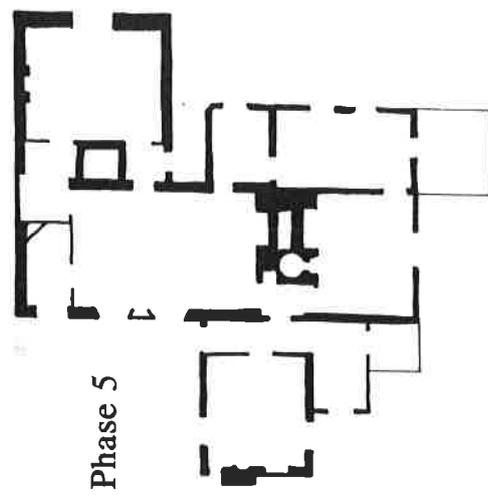
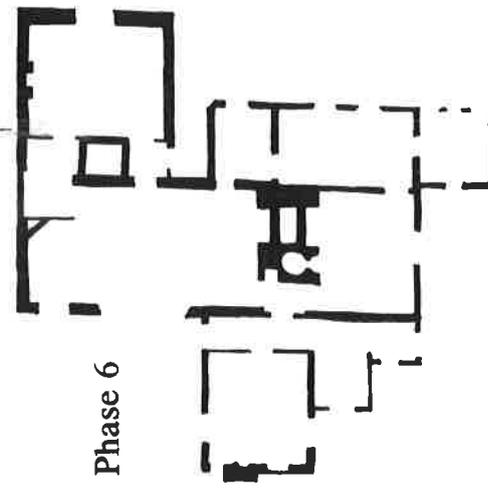
Oxford Archaeological Unit
 Manor Farm, South Stoke, Oxfordshire
 Figure 3: Phasing diagram

create Phase 4 (C18th). The lean-to was then added to create Phase 5 and the small extensions to create Phase 6, the building's present form.
