**St Marys Church, Bletchley
Buckinghamshire**

Report on Watching Brief

THE OXFORD ARCHAEOLOGICAL UNIT

January 1996

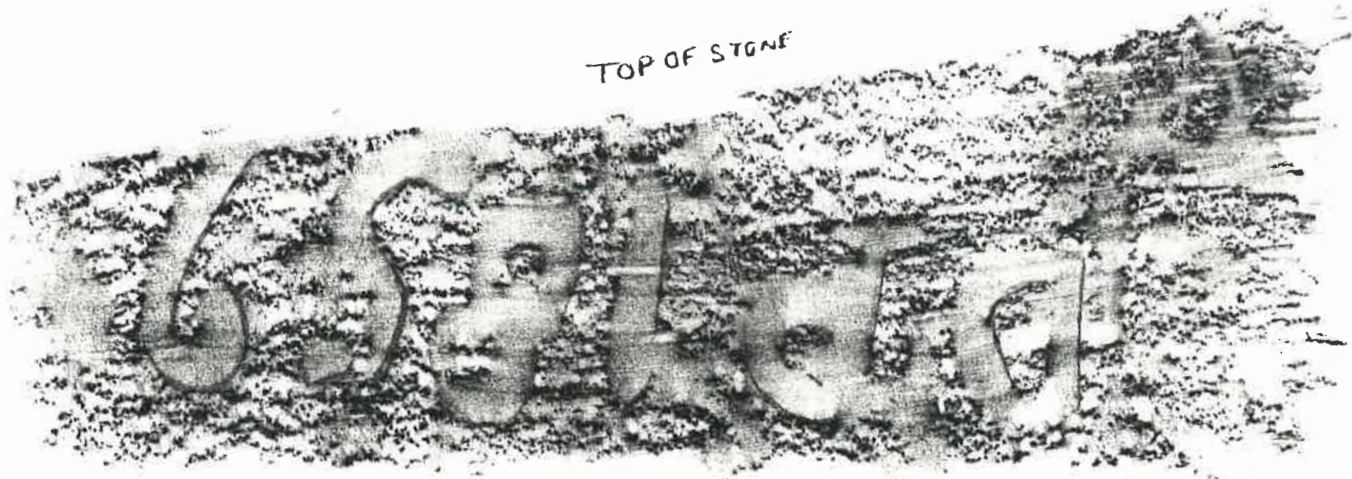
Only a single layer of lime plaster containing horse hair was observed in these four holes and no architectural features other than rubble wall core were revealed. However, a reused architectural fragment was retrieved from the wall core in padstone hole 6.
