LEEDS PRIORY DOVECOTE ABBAY FARM, LEEDS, KENT

ARCHAEOLOGICAL BUILDING RECORDING AND
WATCHING BRIEF DURING CLEARANCE WORKS

Oxford Archaeological Unit
December 2000

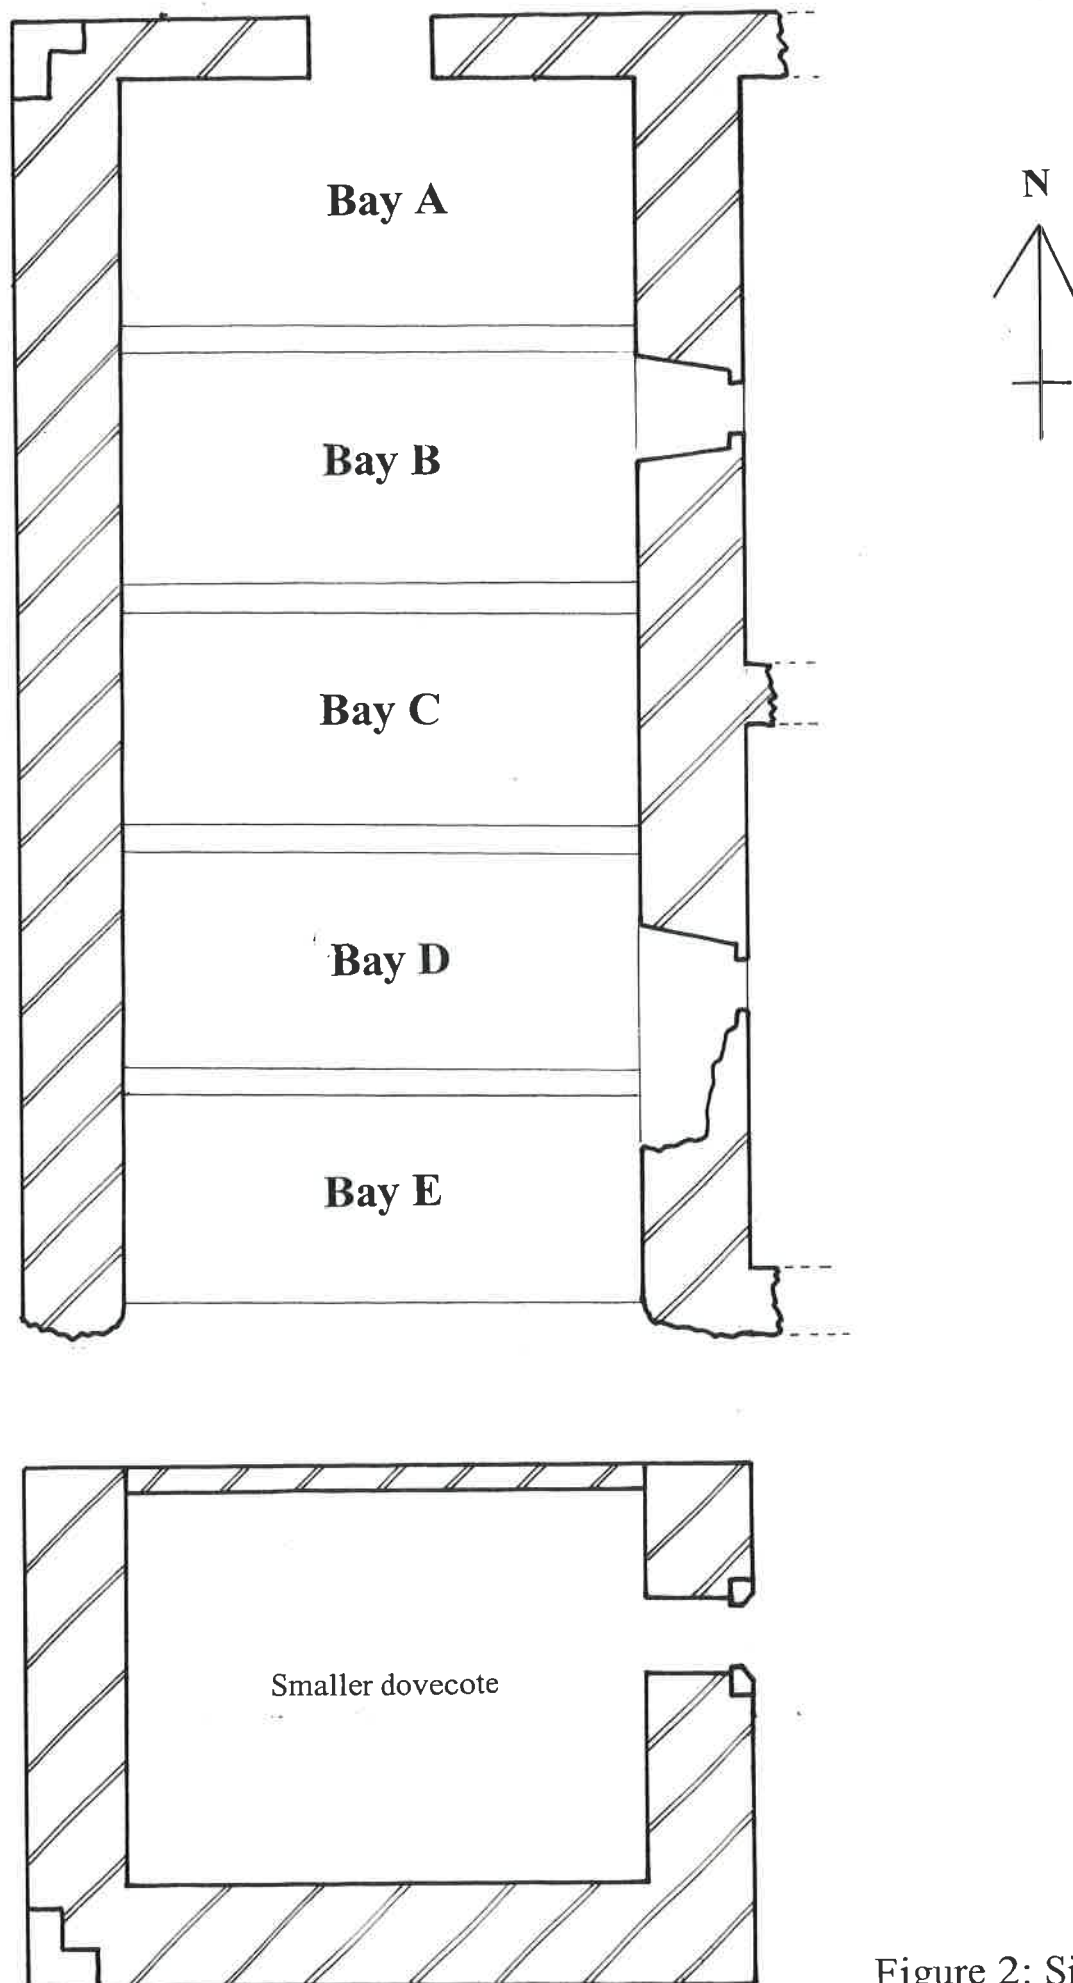
Figure 2: Site plan

- 2.2.1 Leeds Dovecote consists of two sections: a small building to the south and a larger rectangular building to the north (See Fig. 2). The two buildings are of the same width and previously adjoined each other but a cross passage has been formed between them at the north end of the smaller structure. The north wall of this passage, which was formerly the division between the two buildings has now largely collapsed although it partially survives at low level, buried before the start of the current works. The later wall of the cross passage, within the smaller dovecote, remains.

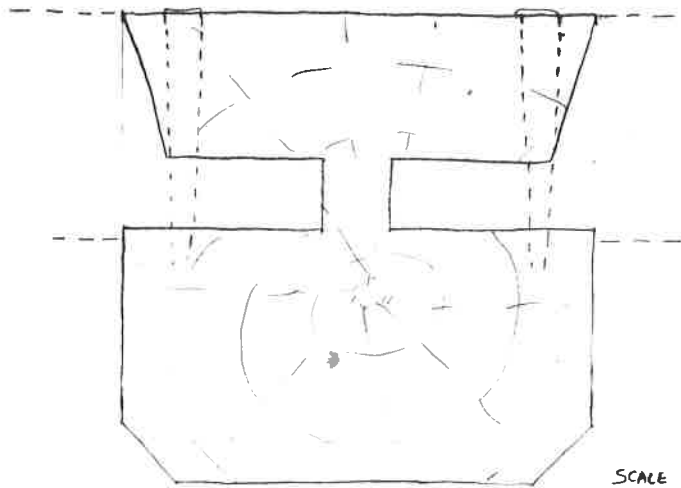
FIGURE 5: FIRST FLOOR PRINCIPAL JOIST

- 2.5.12 The only **first floor principal joist** to remain fully in-situ was that between Bays C and D, although one end of each of the others remained in place with the other end fallen to the ground. They were 31 cm by 31 cm and had mortices and peg holes for 13 common joists at 39.5 cm centres. The lower edges of each principal joist were chamfered and had moulded stops (scroll stops with bar; see Fig. 5). The first floor common joists were 13.5 cm high by 11 cm wide and also had chamfered lower edge with plain stops (Fig.7).

FIRST FLOOR PRINCIPAL JOIST
OAK, PEGGED

COMMON JOISTS AT 39.5 CTR

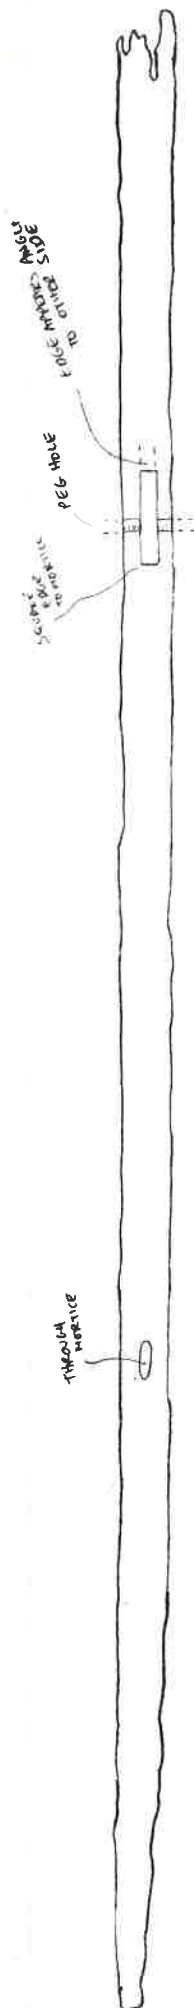
F1

FOUND OUTSIDE DOVEJOINT, TO E.
515 LONG
RAFTER(?)

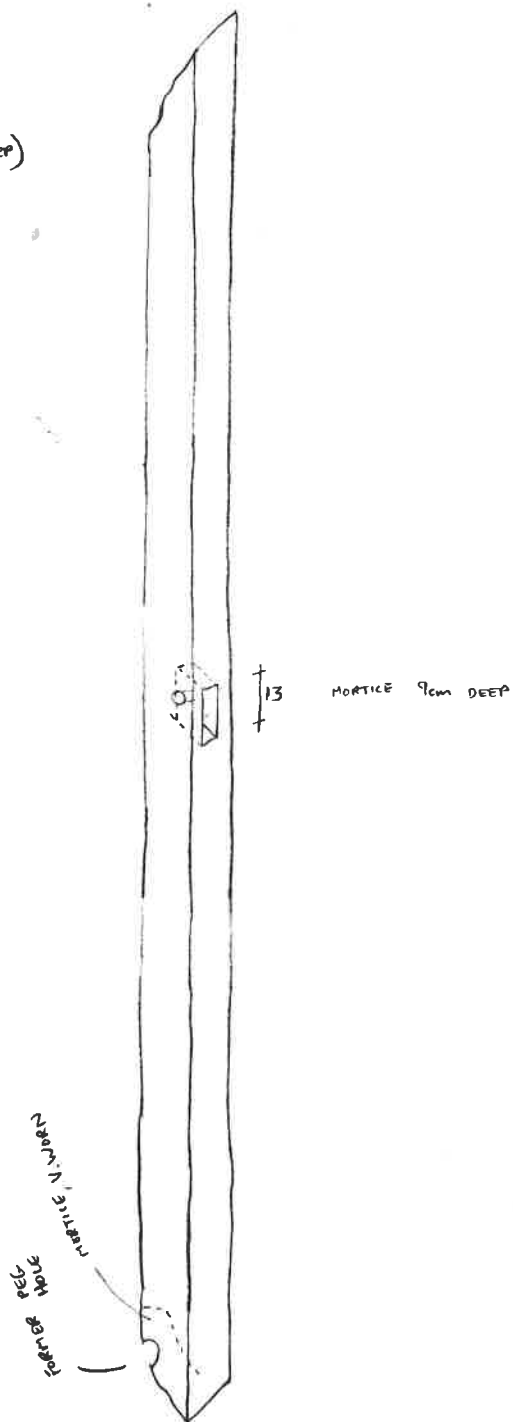
C2

14 CM DEEP
SAME CAMBOR
AS COLLAR
NO MORTICES

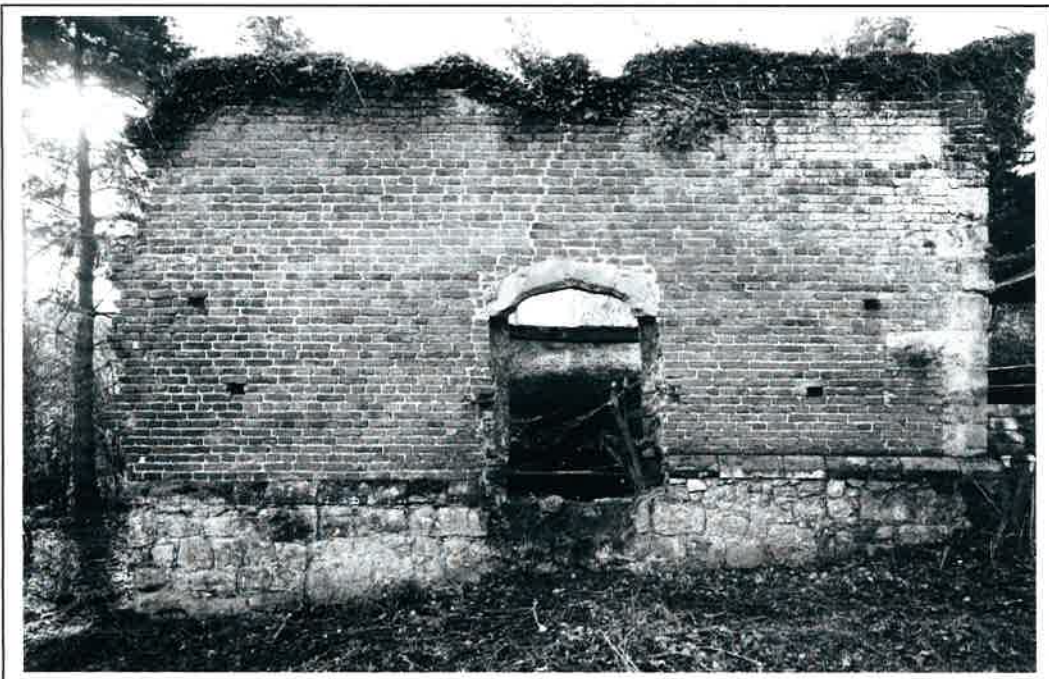
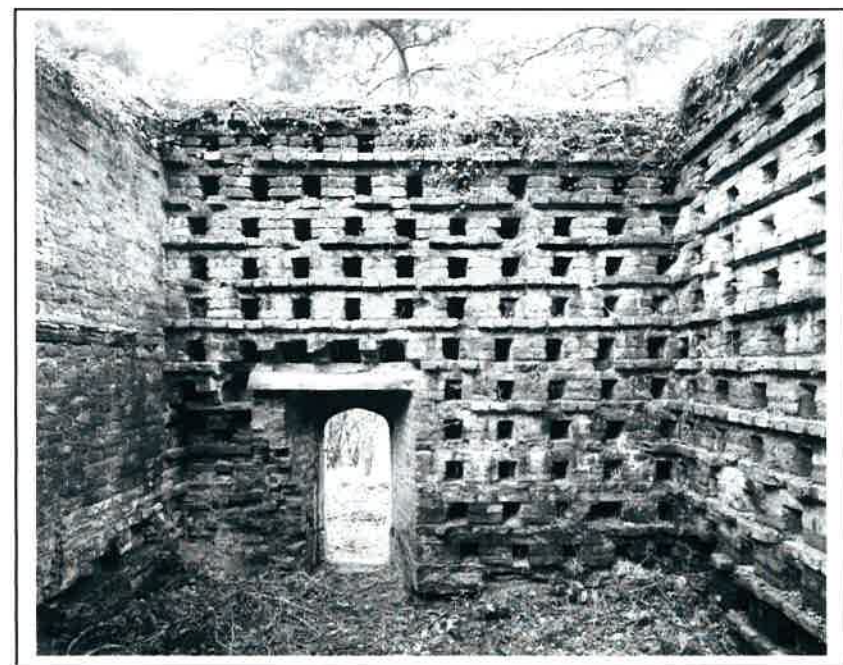
Plate 2: East elevation of smaller dovecote. Note rebuilt corner to left.
Plate 4: Interior of smaller dovecote. Secondary wall to left
