CLAYTON HALL

Archaeological Evaluation and Fabric Survey

Oxford Archaeology North

January 2002

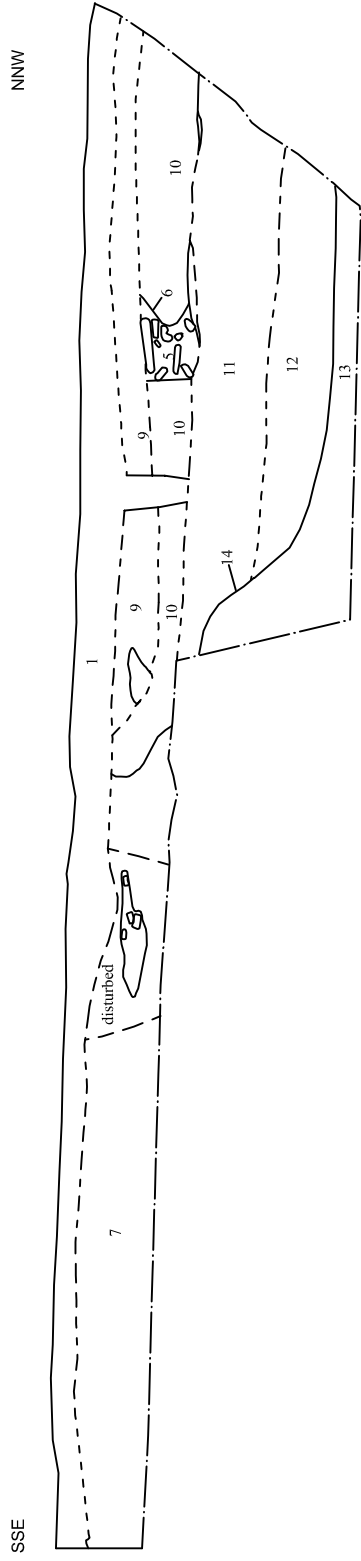
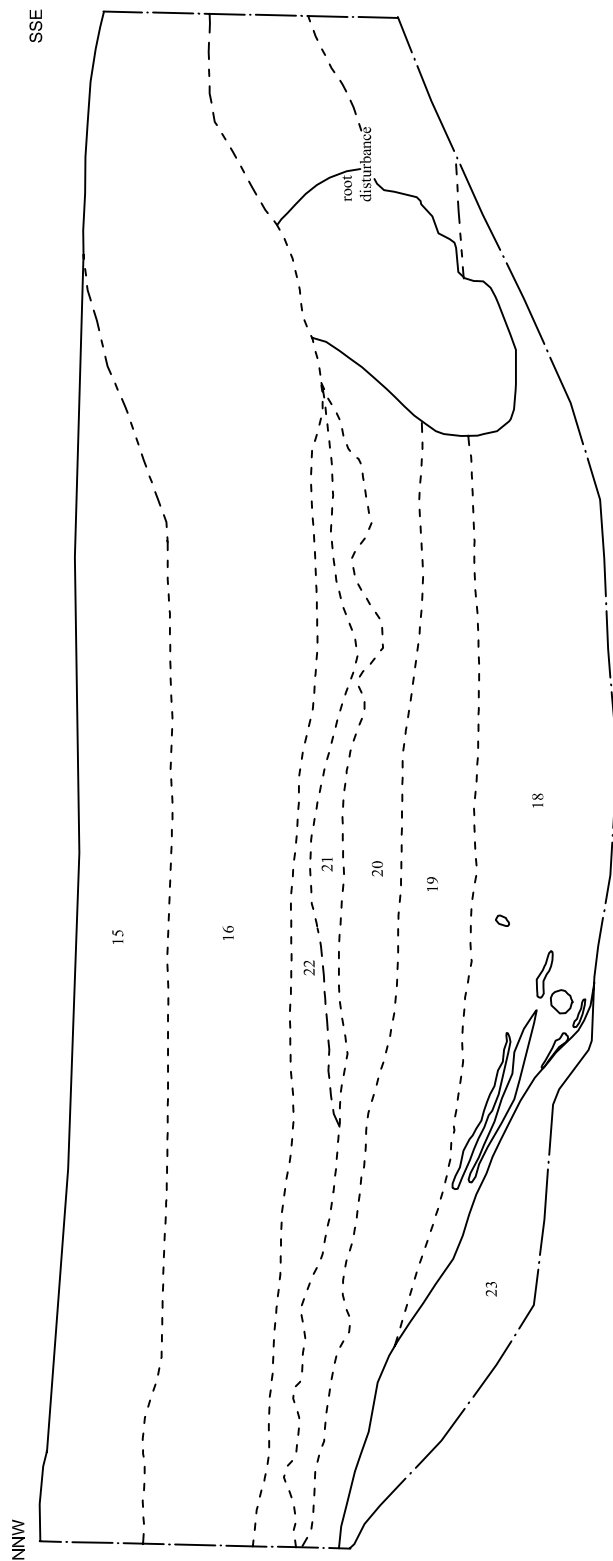
Figure 5: North-east-facing section of Trench 15 and south-west-facing section of Trench 16

- 5.2.2 Trench 15 was positioned in the field to the south of the fence forming the boundary to the site, as it was anticipated that an element of the moat would extend into this area on the basis of the first phase of evaluation. In addition, this area of pasture had previously been noted to have contained a shallow depression (WYAS 1998, 20), which was then interpreted as evidence of the moat. The evidence from Trench 15 has confirmed the presence of the moat in this position (Fig 3); the width of the moat was there seen to be at least 4m, and it appears to have been of similar dimensions to the northern arm, as revealed in the Phase 1 evaluation (LUAU 2000, 22-3). Although the fills did not have the distinctive humic element, **18**, as recorded in Trench 16, this may have been due to the construction of a stone culvert to drain the area in the post-medieval period. The levelling and backfilling seen in the south end of the trench were probably undertaken in the eighteenth and/or nineteenth centuries, as pottery (1001) from this period was recovered from the rubble make-up below the topsoil. This could be interpreted as an attempt to reclaim the land for farming.

North-east-facing section of Trench 15 at 1:25

South-west-facing section of Trench 16 at 1:25

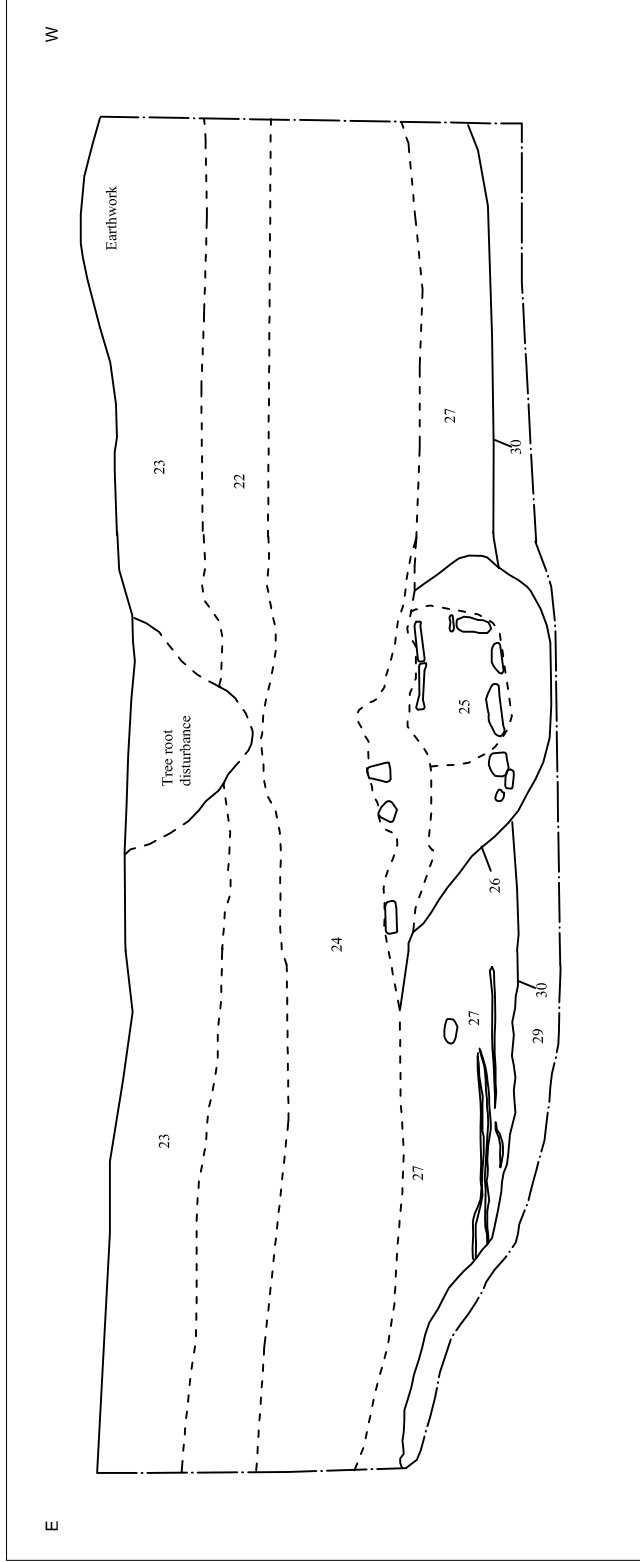
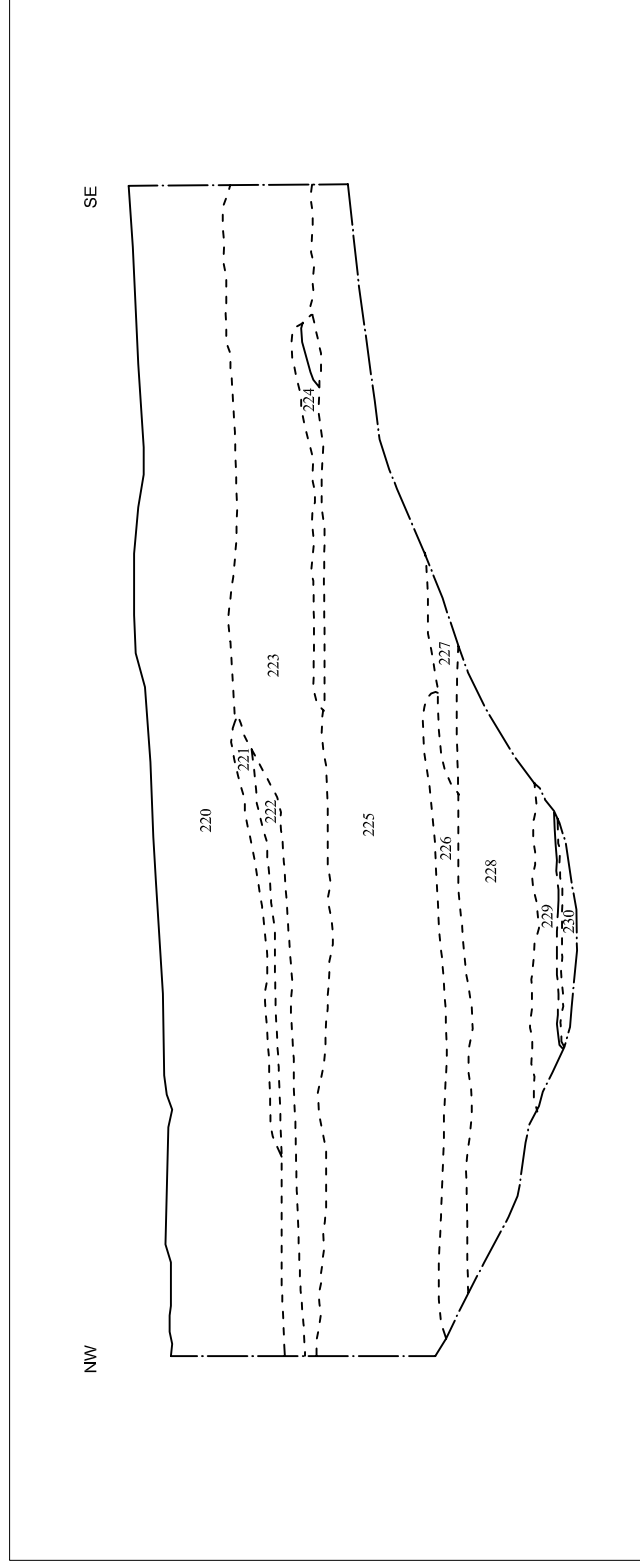
Figure 6: North facing section of Trench 17 and South-facing Section of Trench 18

Schematic North-facing section of Trench 17

South-facing section of Trench 18

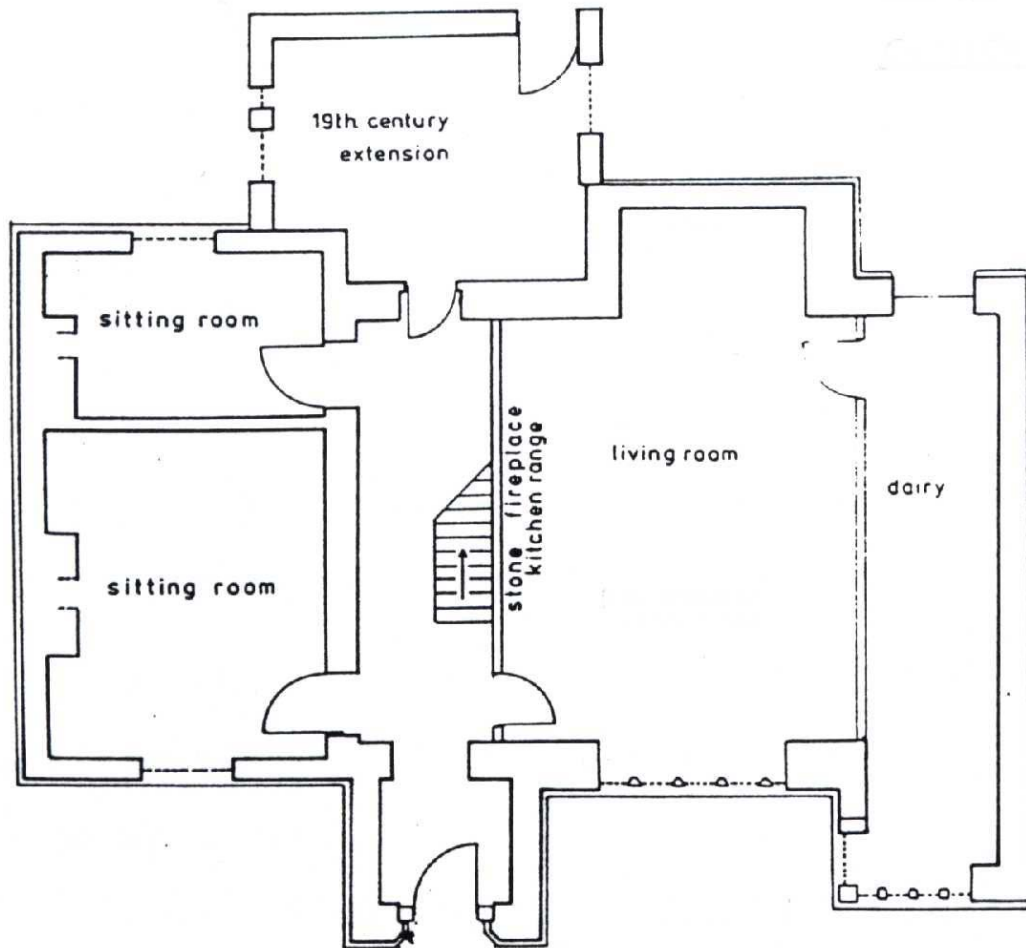
Figure 7: Plan of Clayton Hall c1910 (after Hallam 1983)

internal skin of brick. There is limited evidence of a rear, westerly extension, shown as a nineteenth century extension on a 1910 map (Fig 7; Hallam c1983), but, this was not exposed as part of the present clearance programme. However, the 1975 photograph (*ibid*) shows that this extension had no stone cladding / foundation, and clearly butted onto the ashlar-clad former rear wall of the hall. To the north of this later extension, a further section of ashlar masonry was recorded by the survey, but there was no brickwork extant on the internal side. At the west end of the north wing is a rear entrance, with an ashlar stone surround, and this is clearly shown on the 1975 photograph (*ibid*). Opposite the main entrance on the east elevation, and on the line of the former external western wall, is a pair of large ashlar moulded door surrounds which are similar in style to those on the main entrance. This entrance provided an internal access into the nineteenth century extension, but, prior to the construction of the extension, was the main rear external entrance.

- 5.4.2 Clear indications of rebuilding around the internal jamb on the south side of the porch indicates that the southern part of the building was added from this point. Extending west from the porch is a very thin internal wall, made of machine-made bricks, but the 1910 plan (Fig 7; Hallam c1983) clearly shows this as a thick wall comparable to the present external walls of the building; it would therefore appear that this may have been the former southern external wall of the hall, which was subsequently replaced in brick at some date between 1910 and its demolition in 1976.

- 5.4.3 The rear, western extension was not exposed as part of the present programme, but it was evident from both the observed fabric, and photographs taken prior to demolition (*ibid*), that this had an entirely brick foundation and was distinct from the ashlar-clad foundation of the rest of the building. It was clearly a later rebuild, and was not depicted on the OS 1st edition 6" map (1848), although the southern extension was in place by that date. By 1910 (Fig 7), the westerly extension was in place and it therefore probably dated from the second half of the nineteenth century.

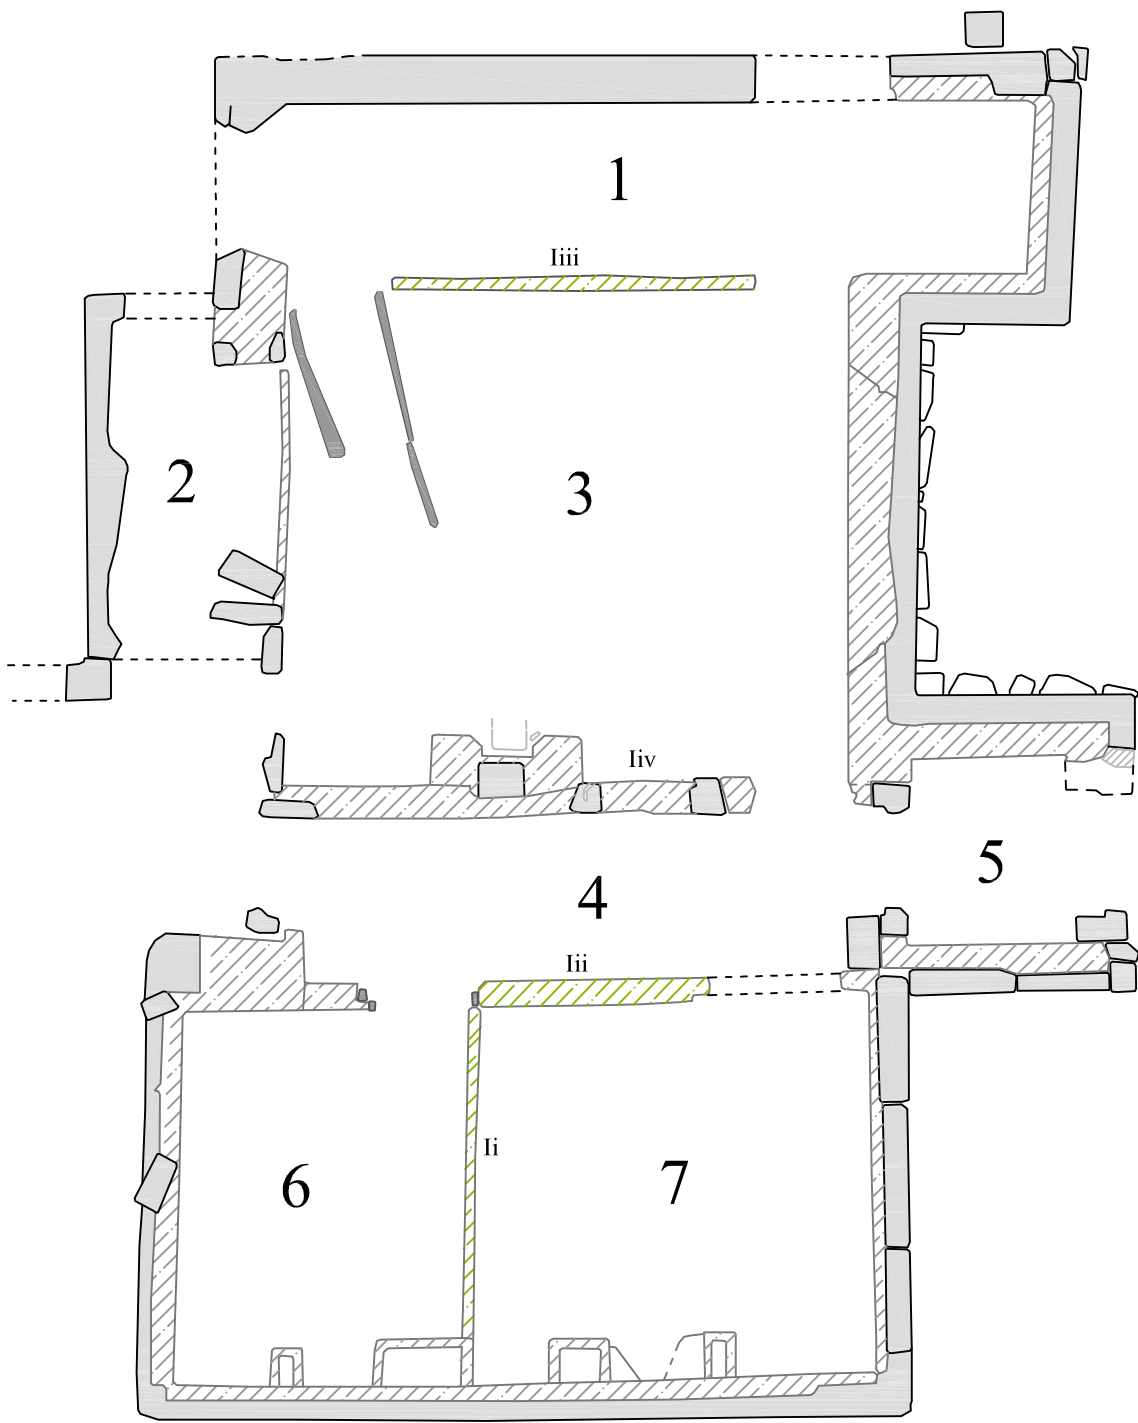
Figure 9: Eastern and Southern External Elevations of Clayton Hall

East-facing elevation (Fig 9)

South-facing elevation (Fig 9)

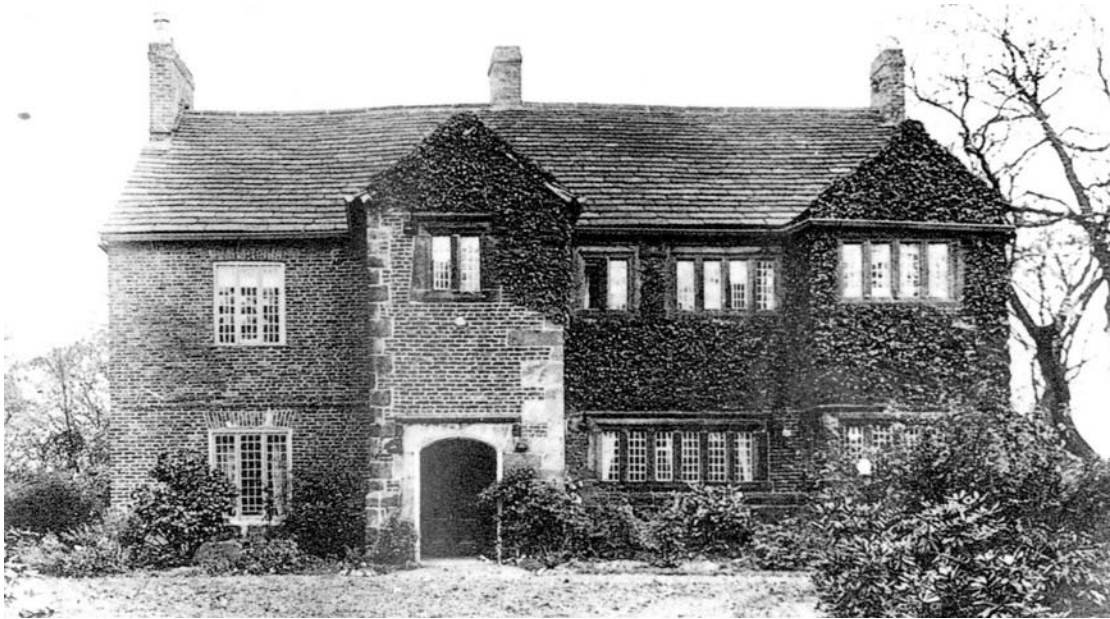
Plate 5: Clayton Hall looking west, taken in c1900

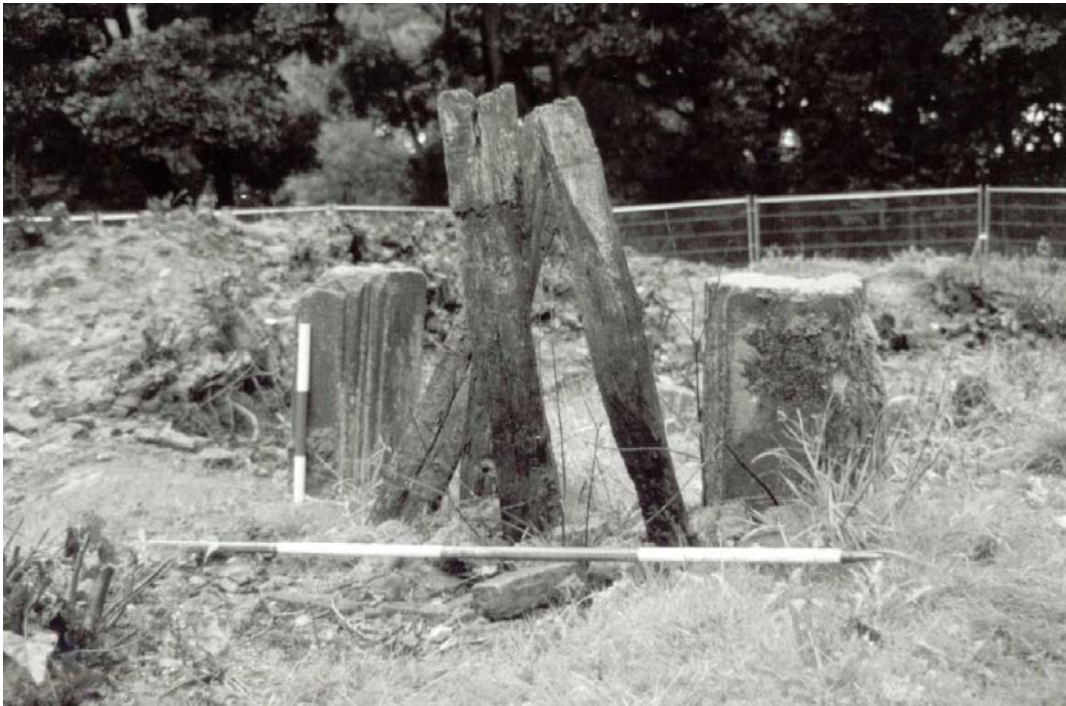
Plate 6: Main eastern entrance prior to clearance excavation, looking west

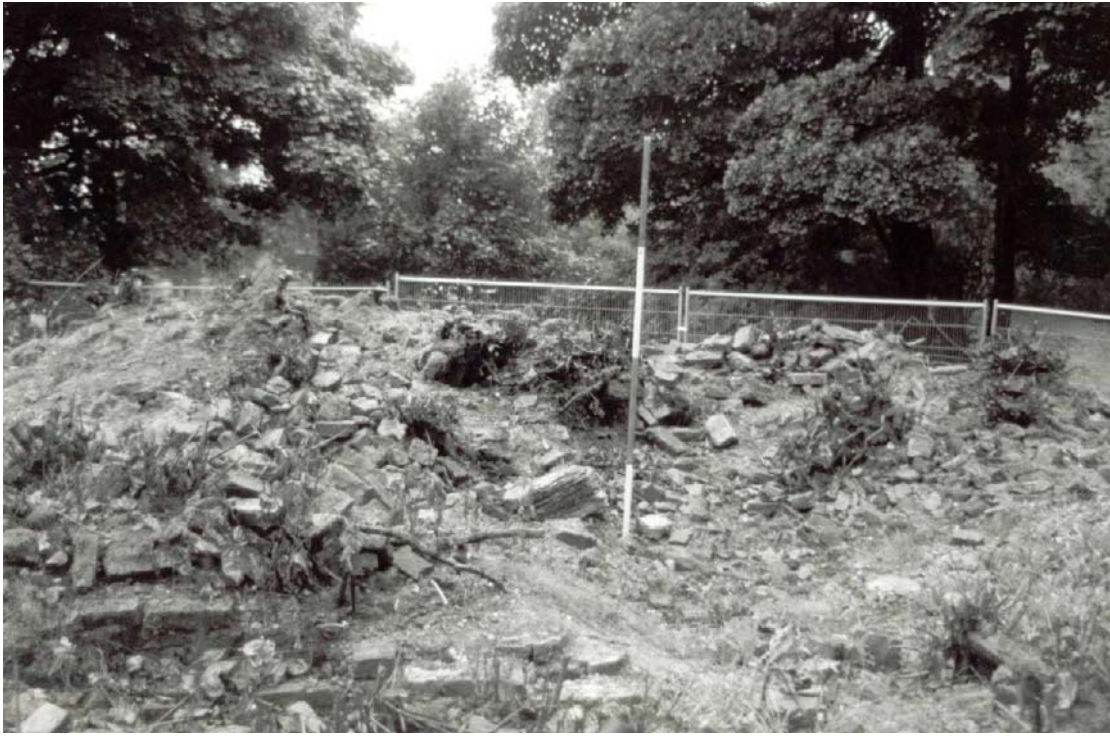
Plate 7 General view of Clayton Hall, looking north-west
