20 – 22 College Lane, Liverpool Fabric Survey - Interim Report

November 2005

Oxford Archaeology North

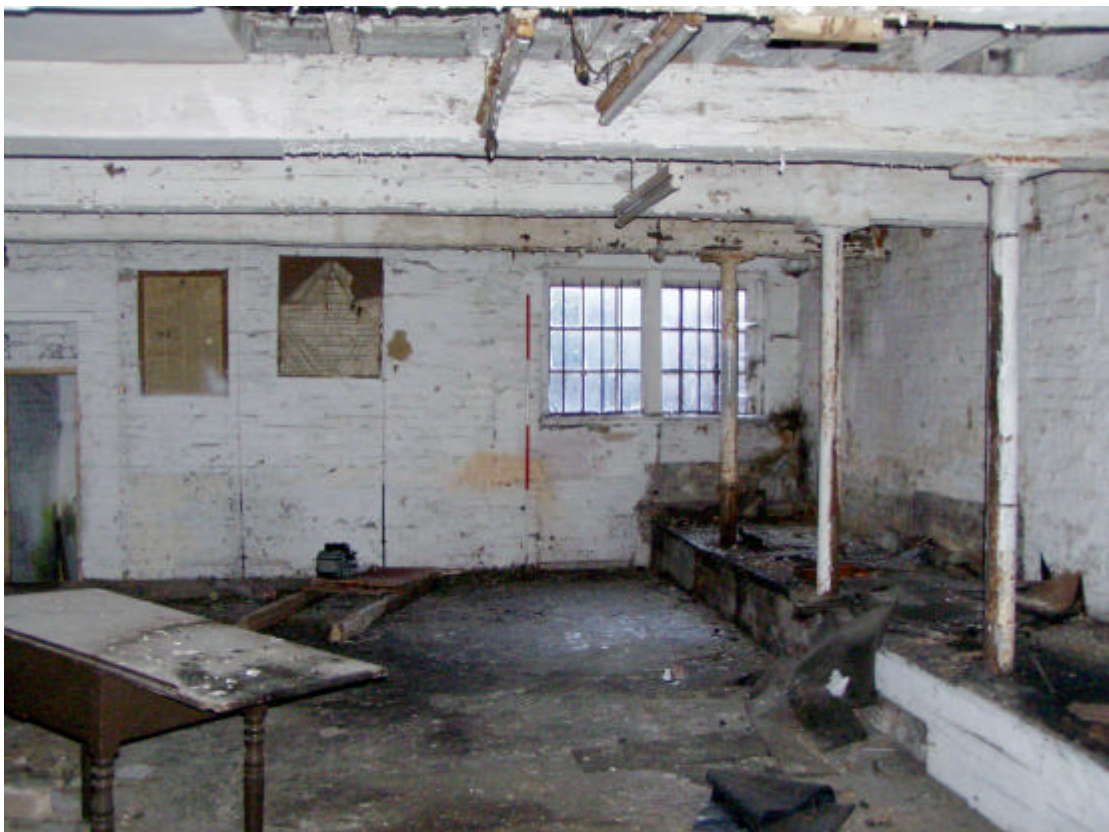
Plate 17: General Shot of 22.G1 at the Northern End

- 3.5.6 The floor is not level throughout, and along the western side is a raised platform section (0.4m higher) which corresponds to the adjacent passage which is vaulted (Plates 17 and 18). The fabric of the floor varies and includes concrete and flags laid over timber boards; in the northern half of the room, closest to the street, the floor remains as timber boards.

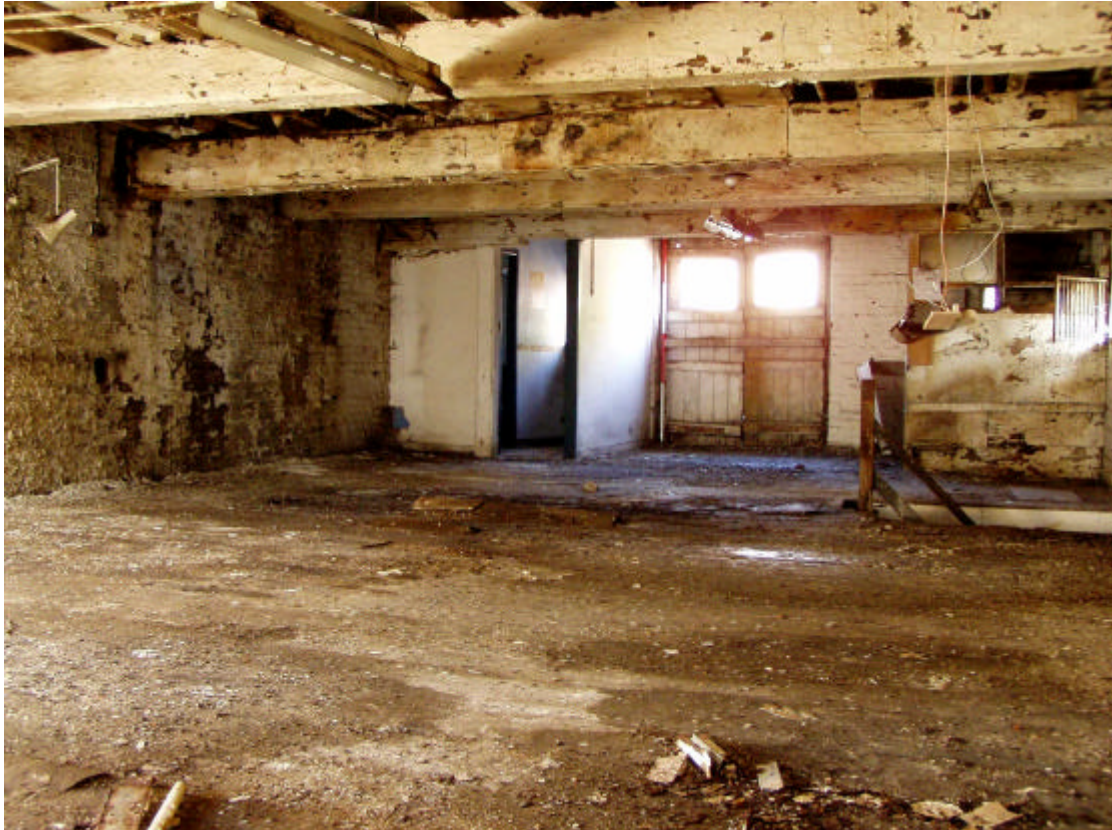
Plate 20: Shot of The Fire Escape From the First Floor to the Ground Floor

- 3.5.10 The toilet, attached to the south-west side of Room 22.G2, appears to be a later addition and is a small single storey building with stairs to the first floor running over the top (Plate 20).
