Nos. 1-7 Longwall Street, Oxford

Historic Building Investigation and Recording

February 2022

Client: Magdalen College, Oxford

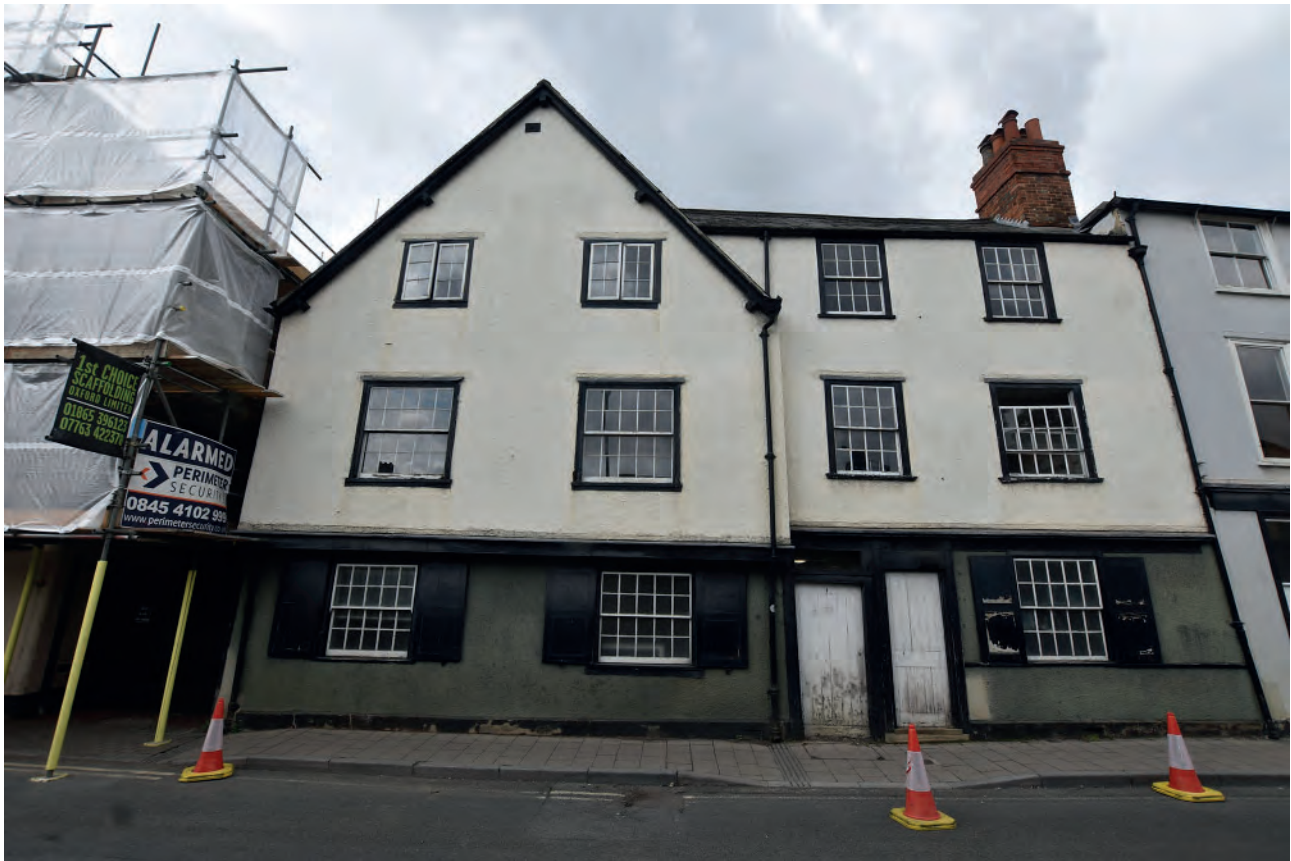
Plate 1: East elevation of Nos. 1-3 Longwall Street before work commencing

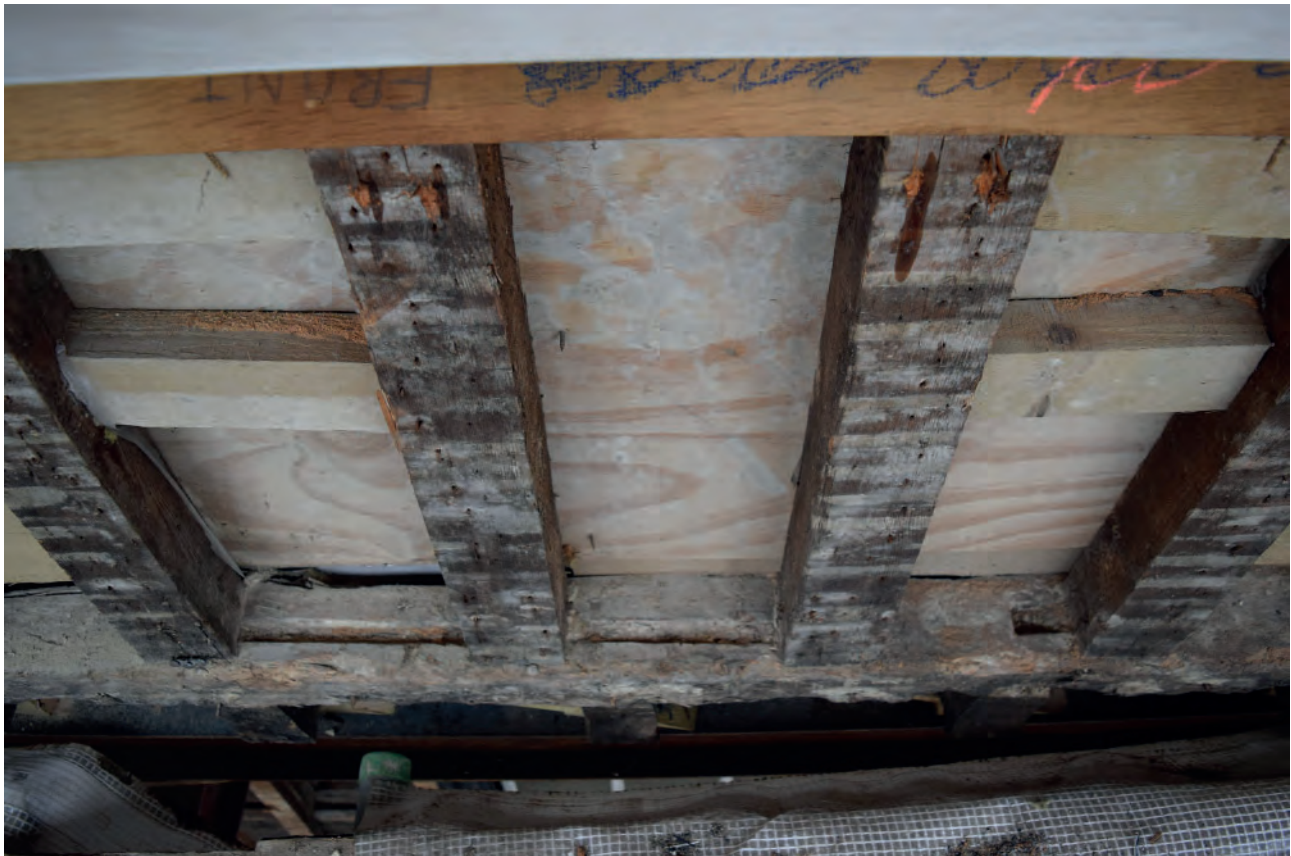
Plate 2: Studs fixed into a groove at first floor level of Nos. 1-2

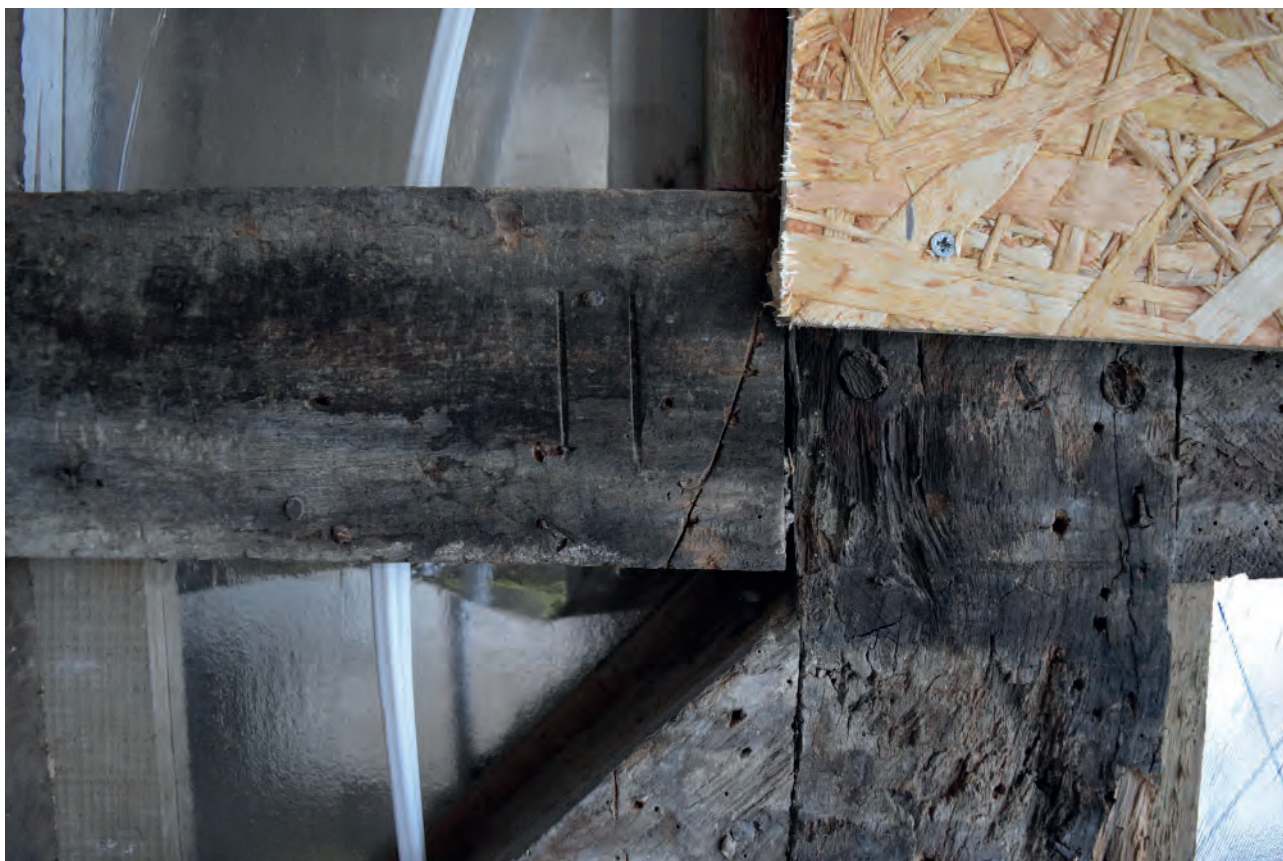
Plate 3: Carpenters' mark on the south elevation of Nos. 1-2 at first floor level

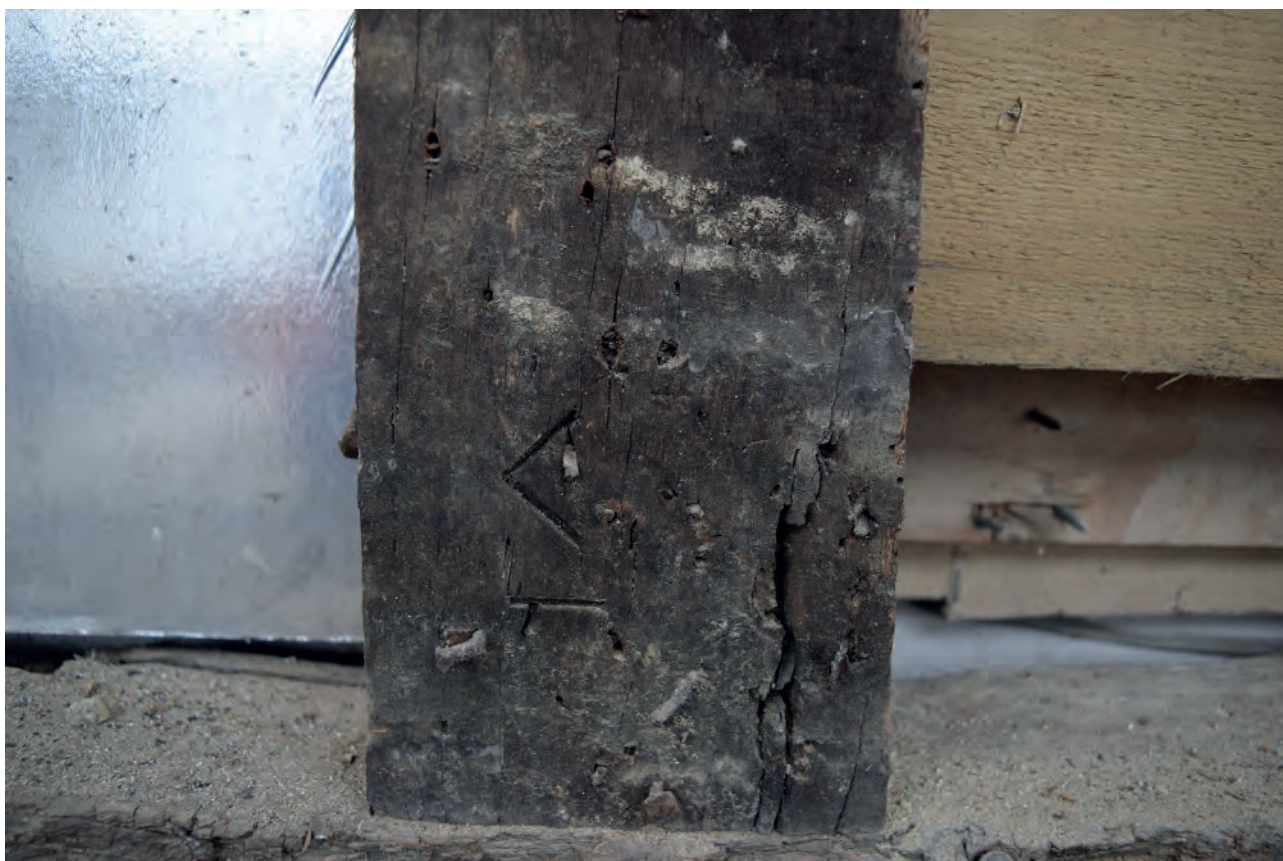
Plate 4: Carpenters' mark on the east elevation of Nos. 1-2 at first floor level

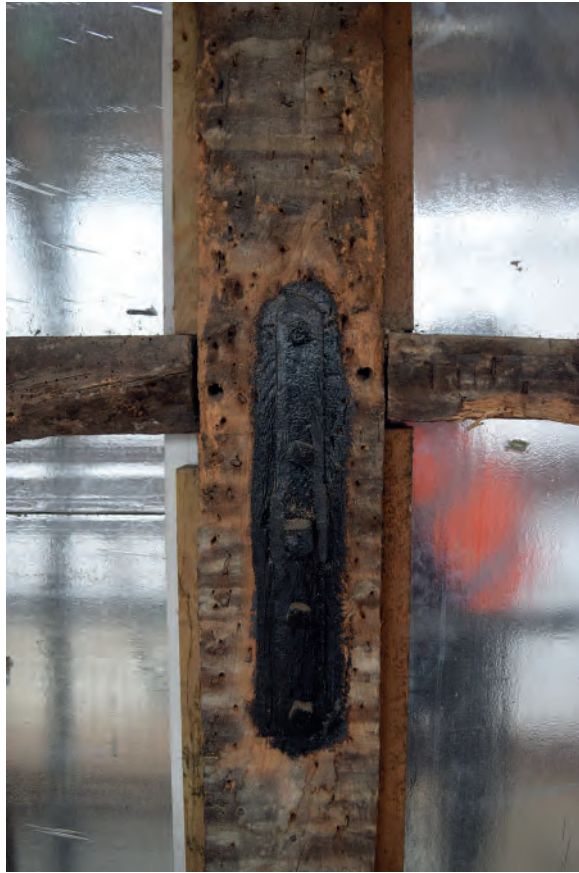
Plate 5: Strap and carpenters' mark on east elevation of Nos. 1-2 at first floor level

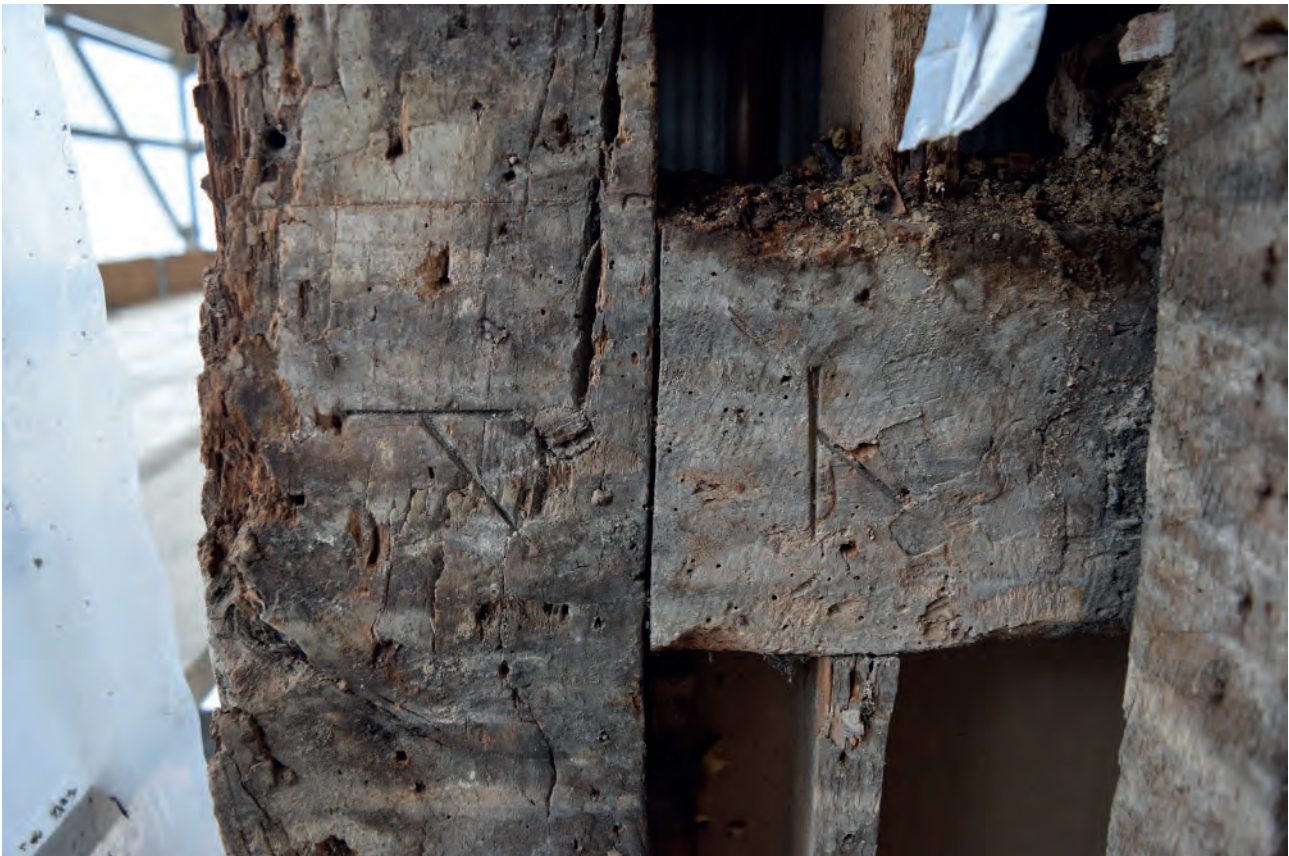
Plate 6: Pair of carpenters' marks on the north elevation of Nos. 1-2 at first floor level

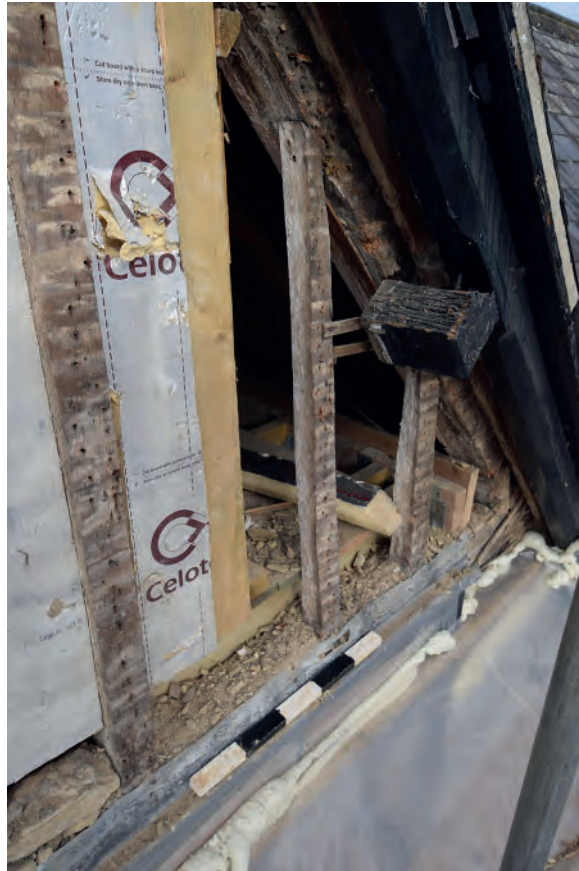
Plate 7: Fake purlin on the gable of Nos. 1-2

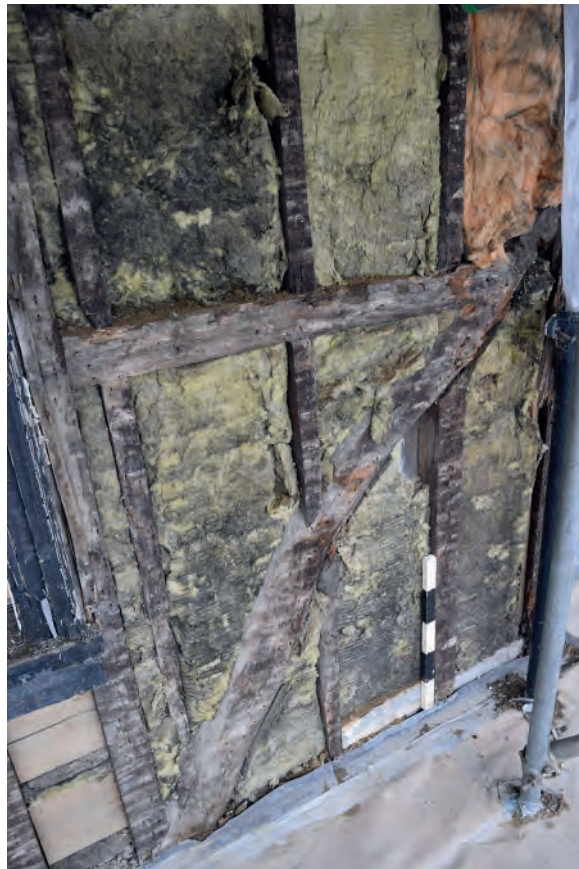
Plate 8: Northern brace on the east elevation of Nos. 1-2 at first floor level

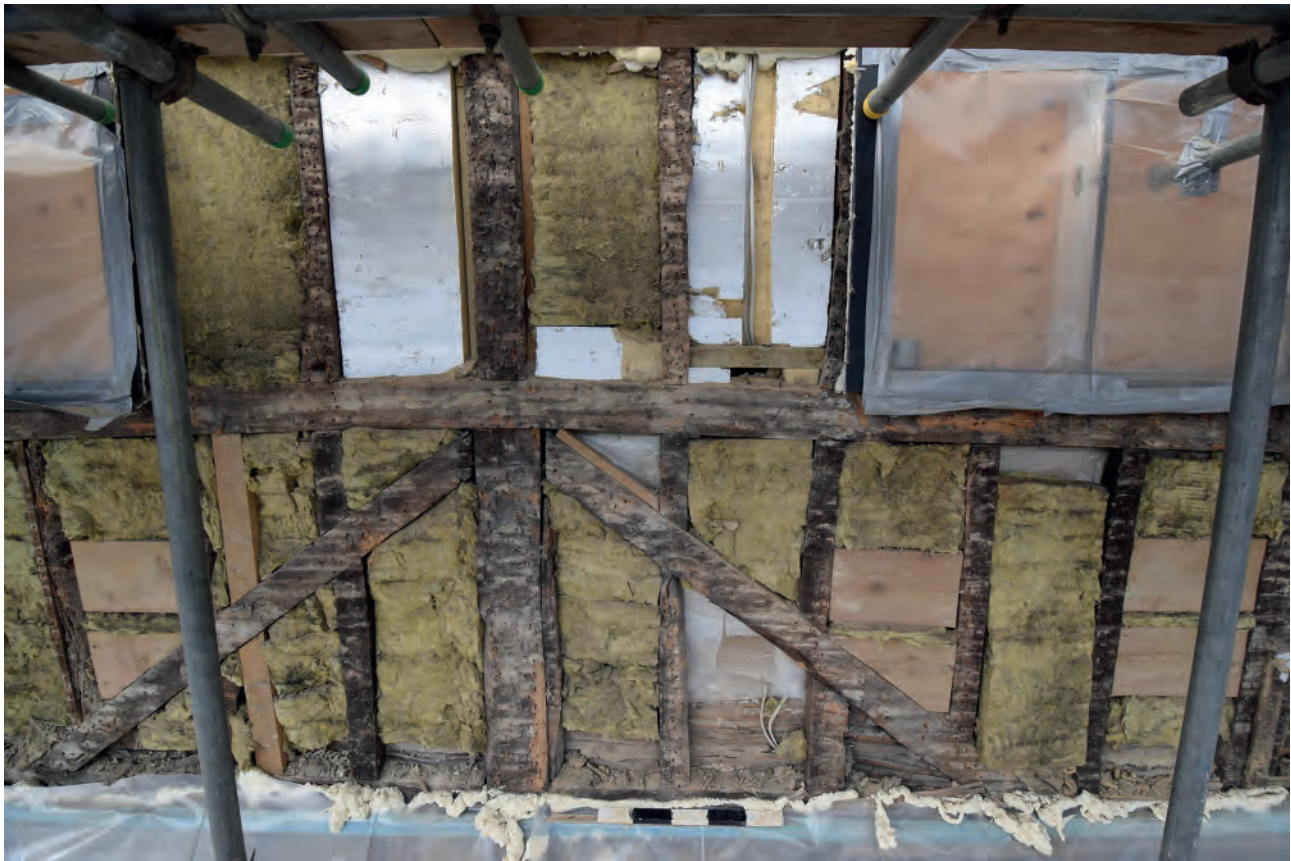
Plate 9: Braces on the east elevation of Nos. 1-2 at second floor level

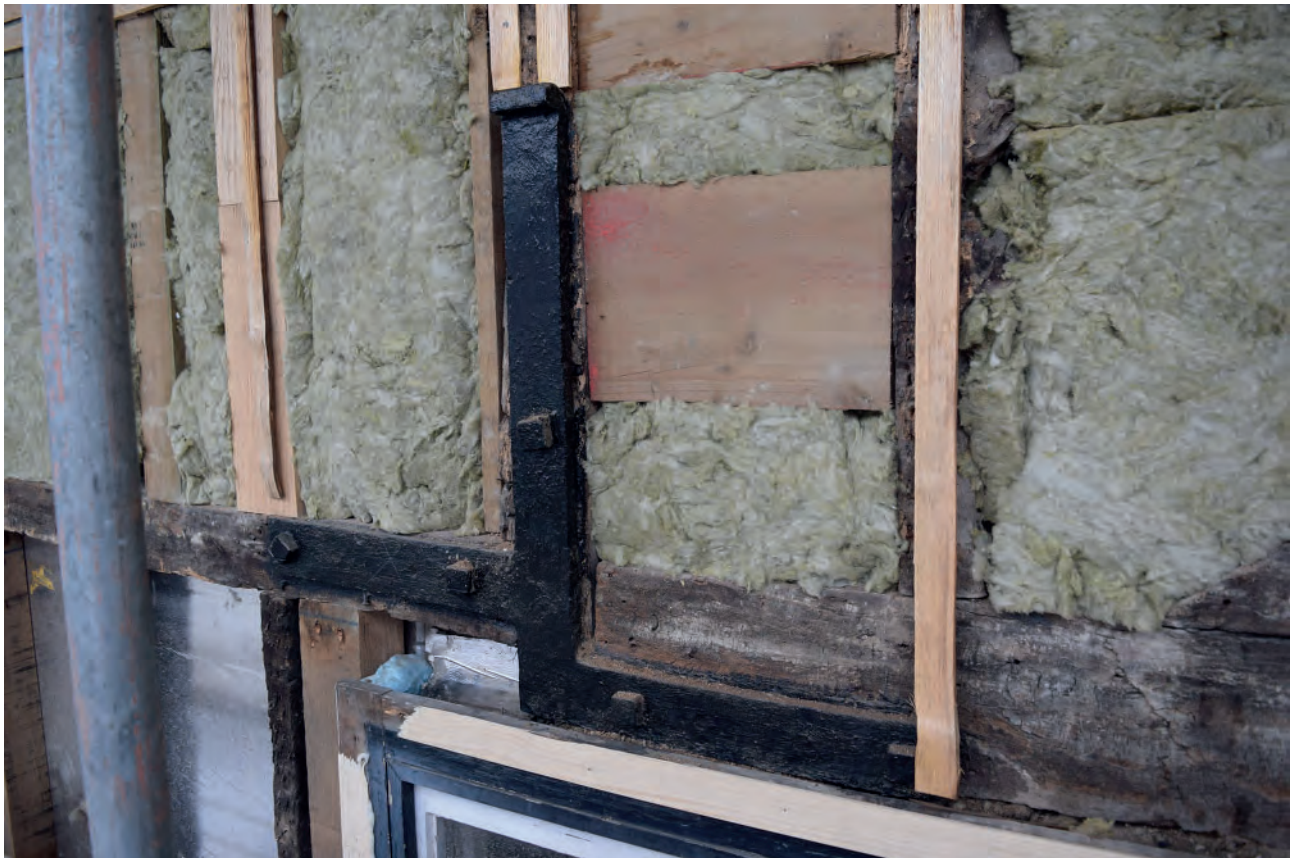
Plate 10: Strap above the southern first floor window of Nos. 1-2

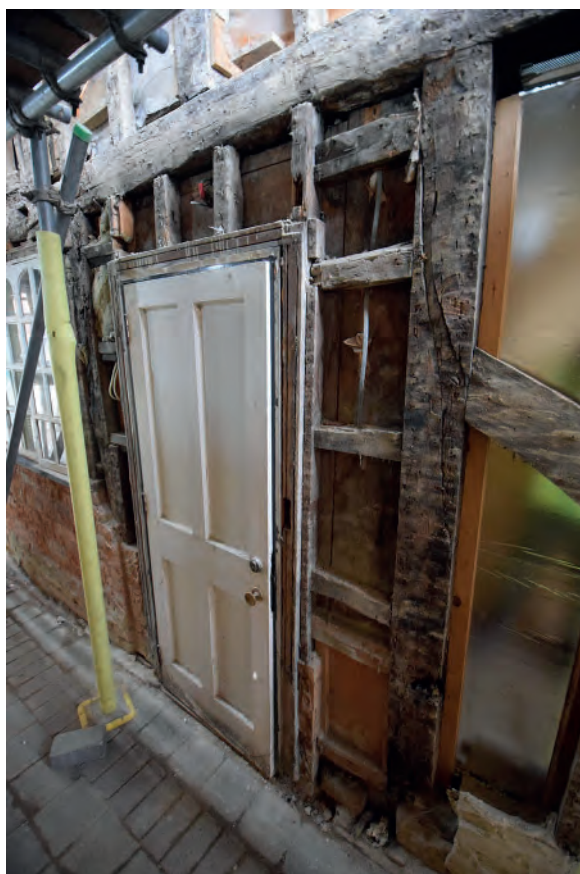
Plate 17: Entrance to Nos. 1-2 on the south elevation

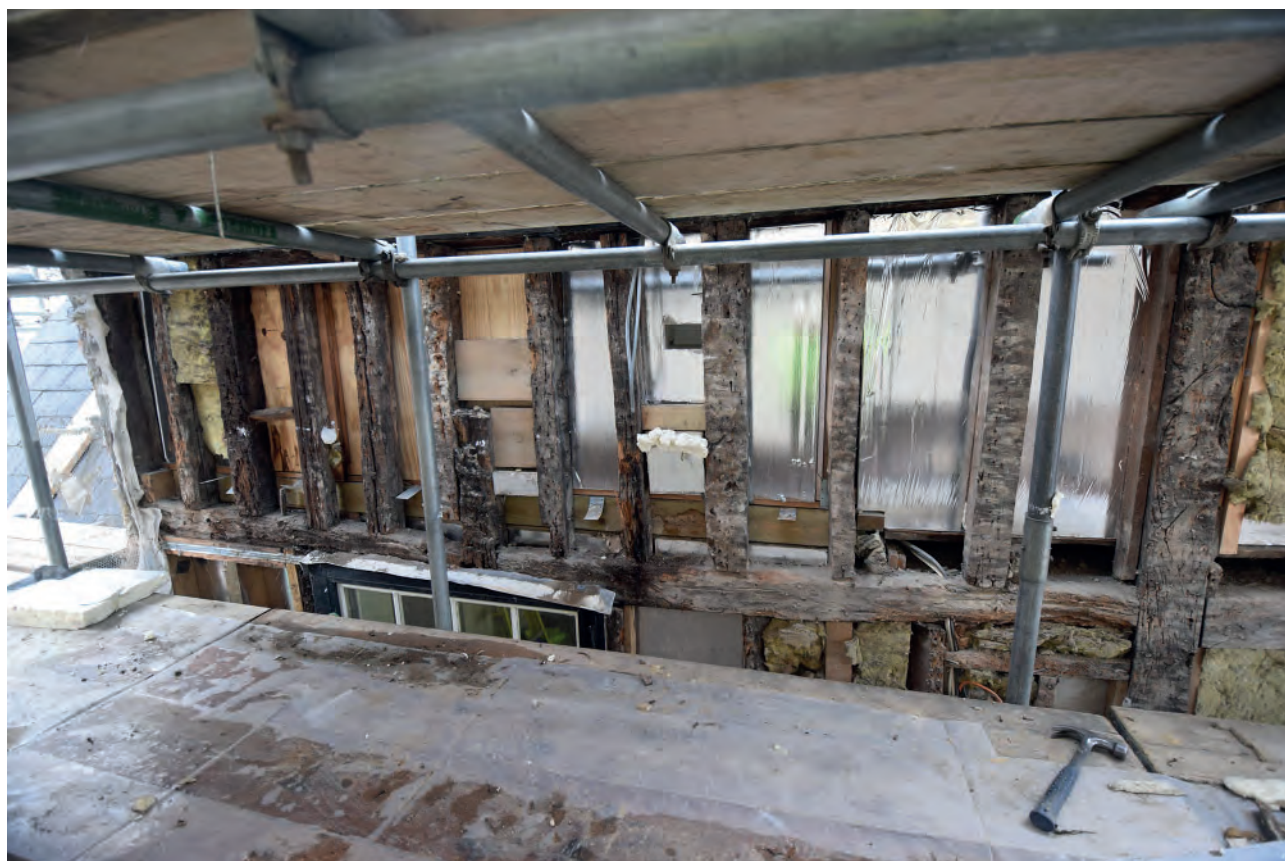
Plate 18: East elevation of Nos. 1-2 with truncated post above first floor window

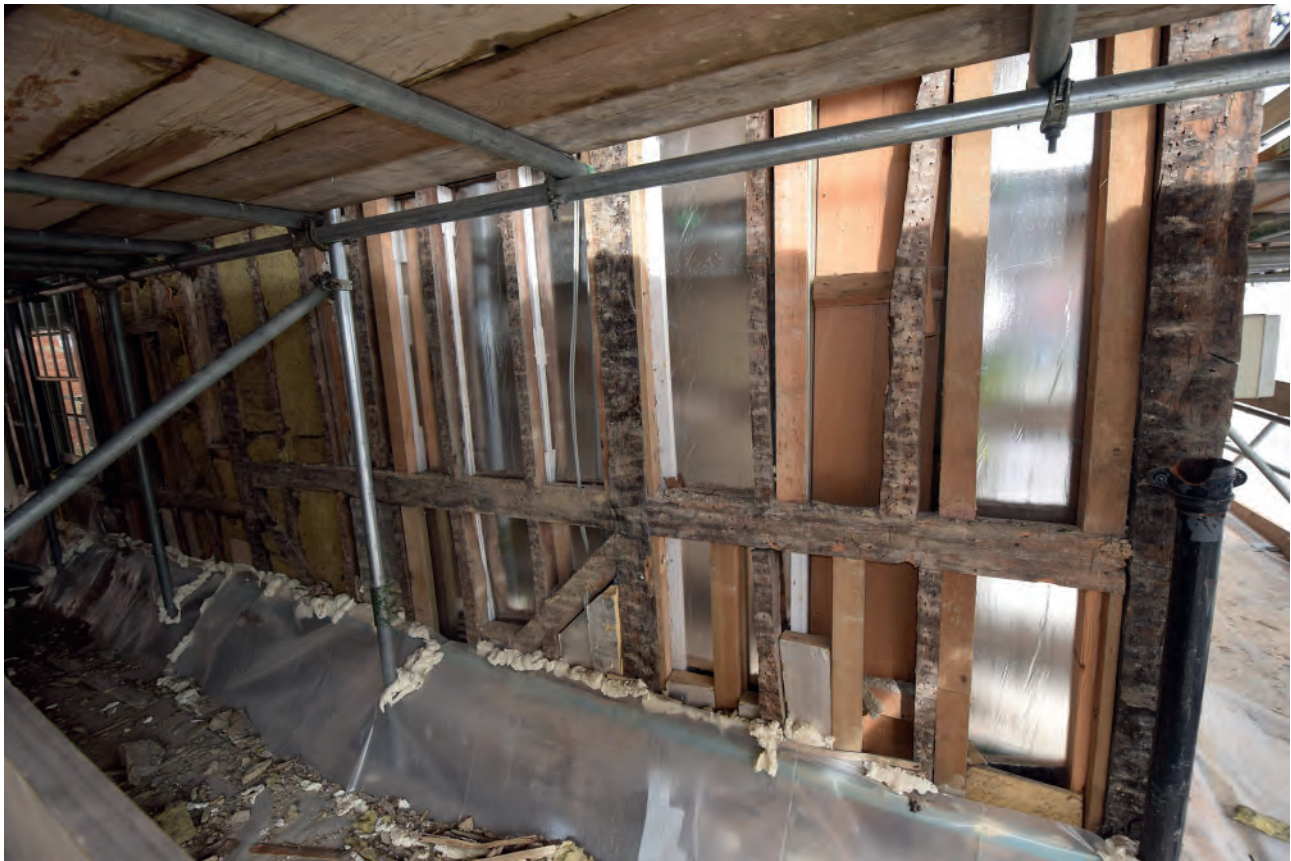
Plate 19: East elevation of Nos. 1-2 at first floor level

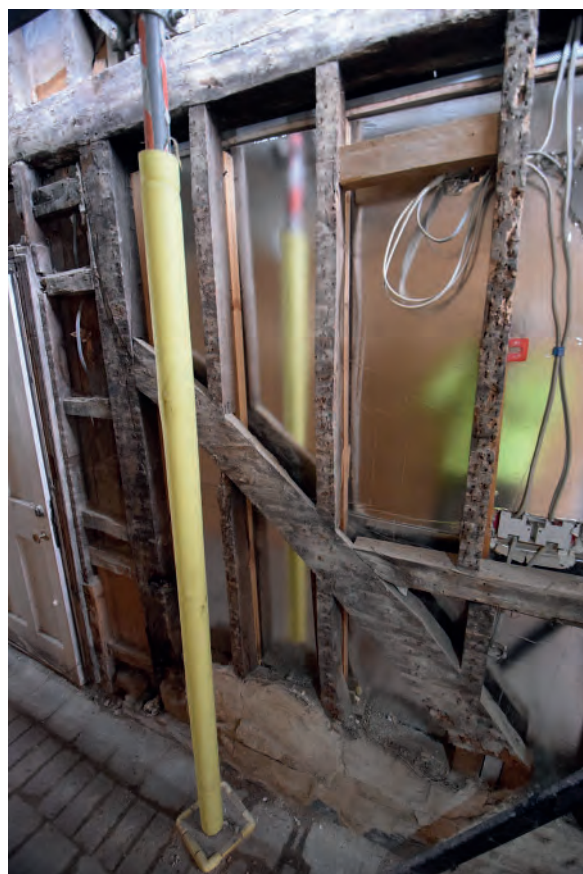
Plate 21: Brace on east elevation of Nos. 1-2

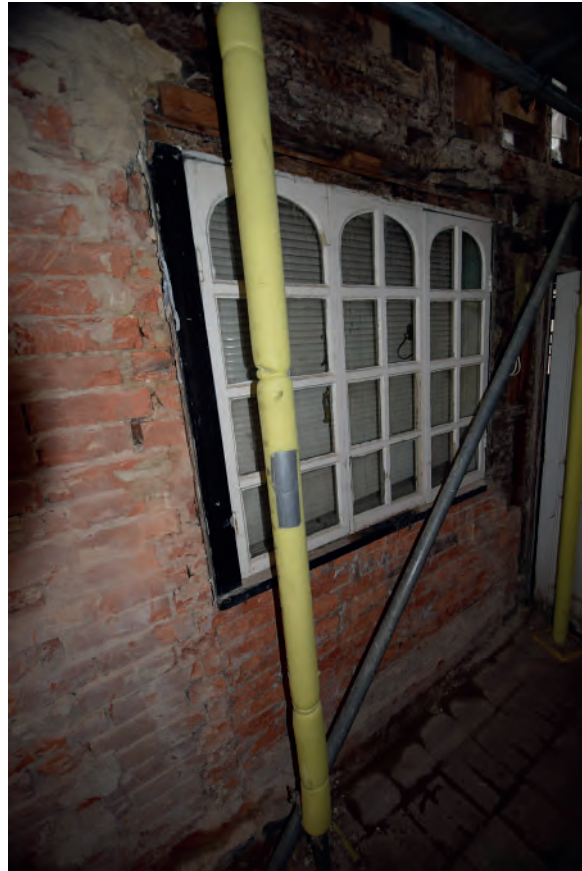
Plate 23: Brickwork on the western half of the ground floor on Nos. 1-2

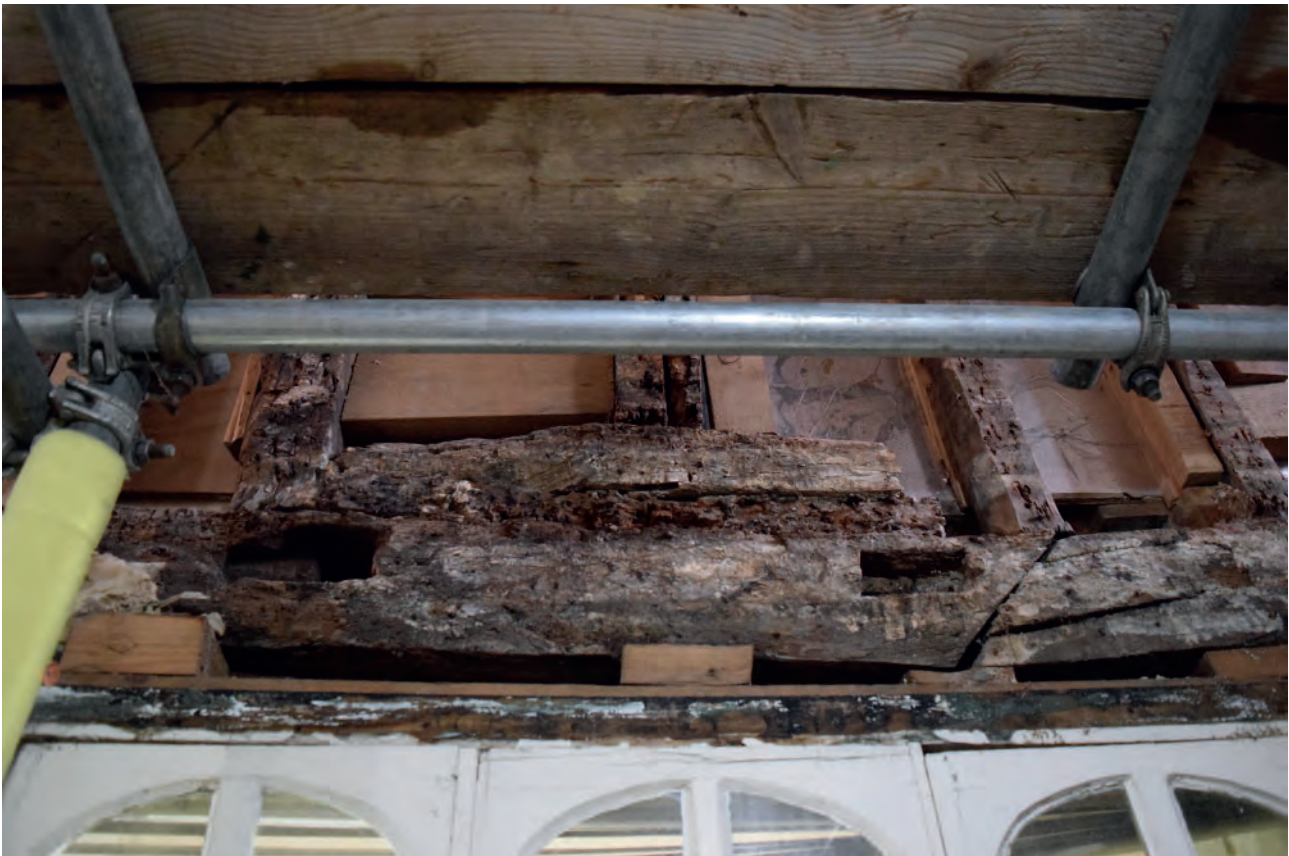
Plate 24: Scarf joint and mortices above ground floor window of Nos 1-2

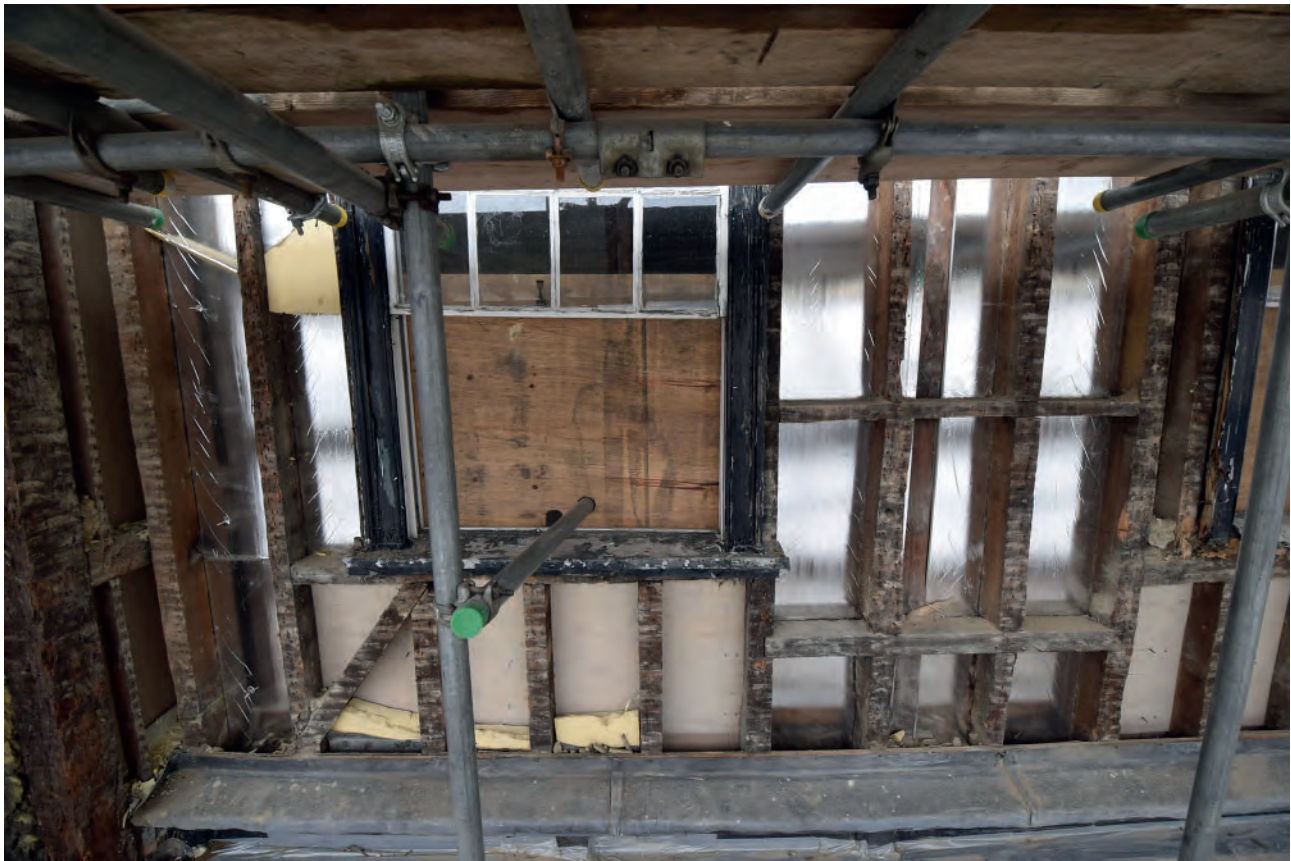
Plate 29: Southern half of the first floor of No. 3

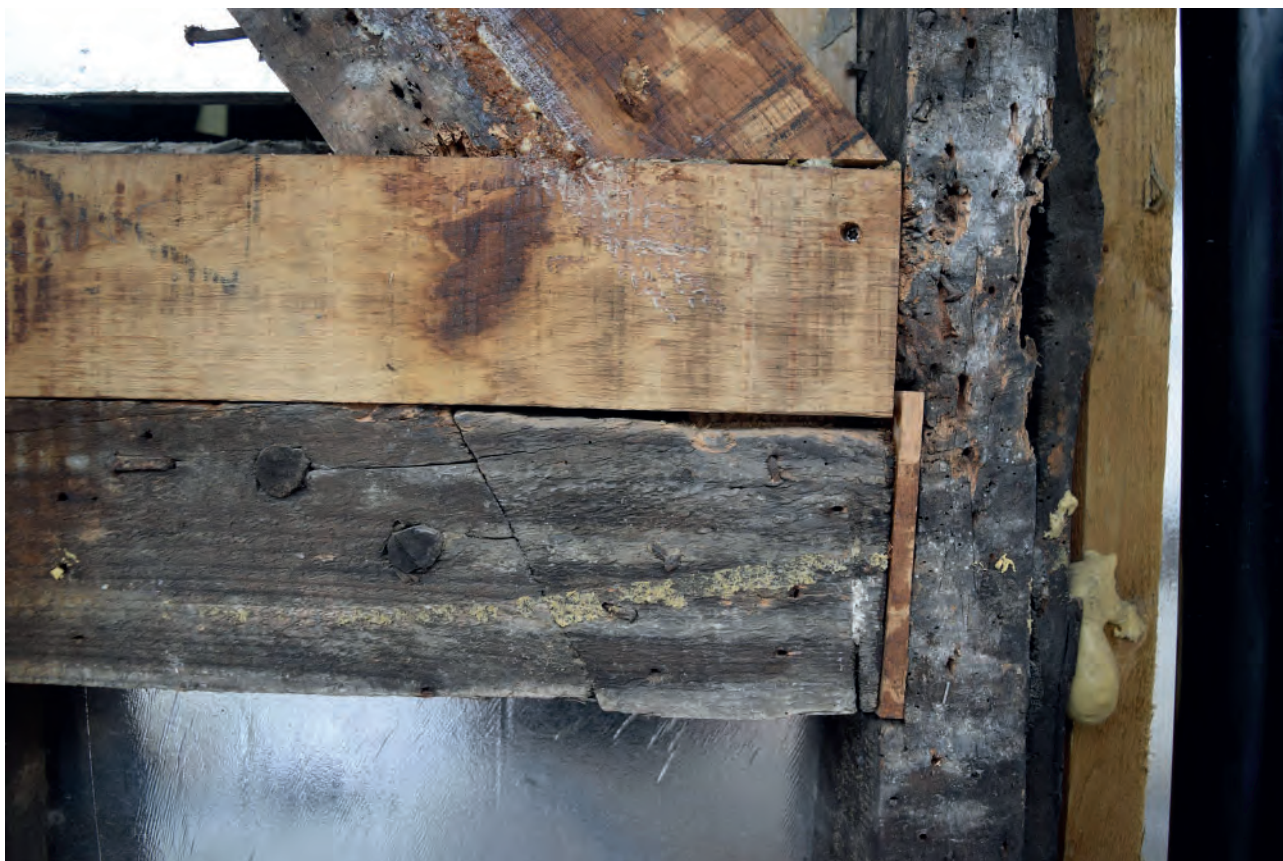
Plate 31: Scarf joint at northern end of rail on first floor of No. 3

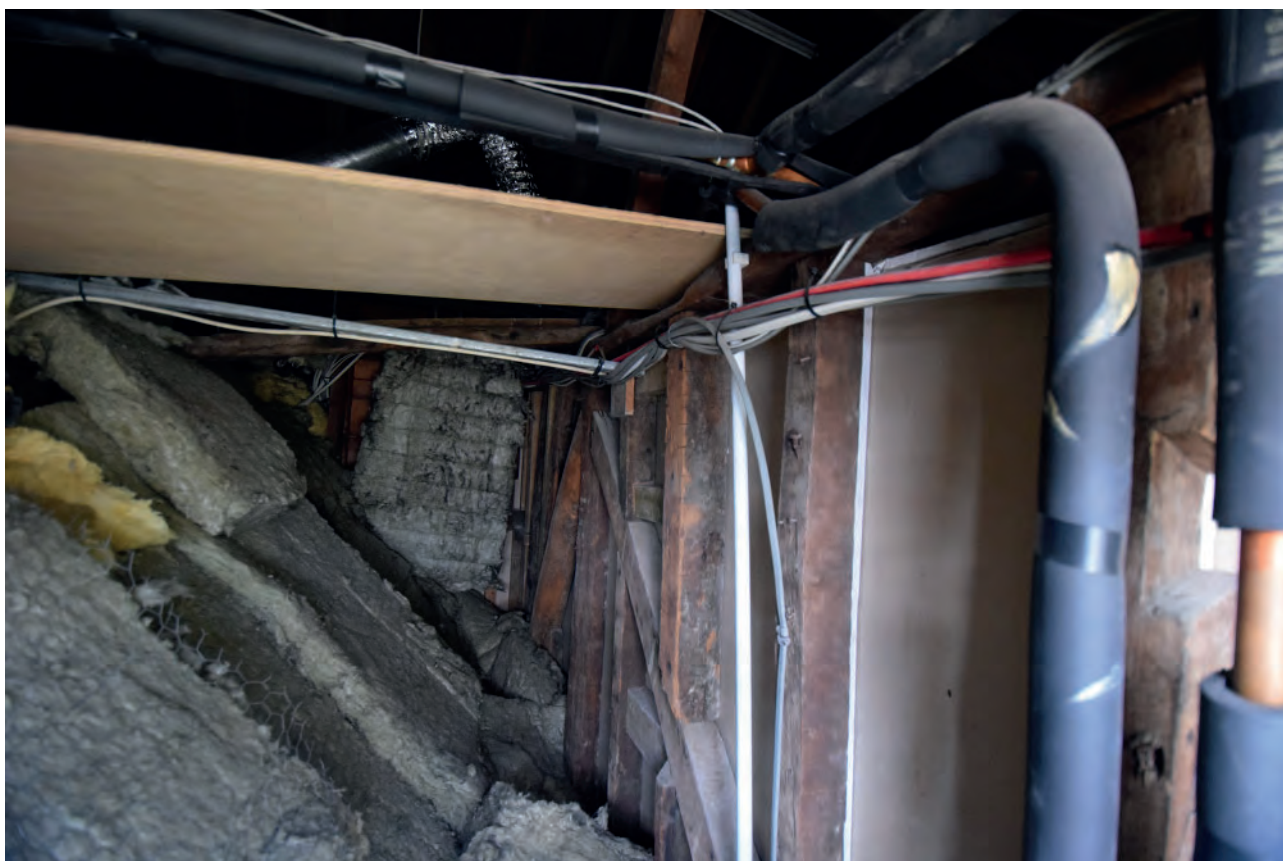
Plate 32: Wall of No. 3 overlying the roof structure of Nos. 1-2

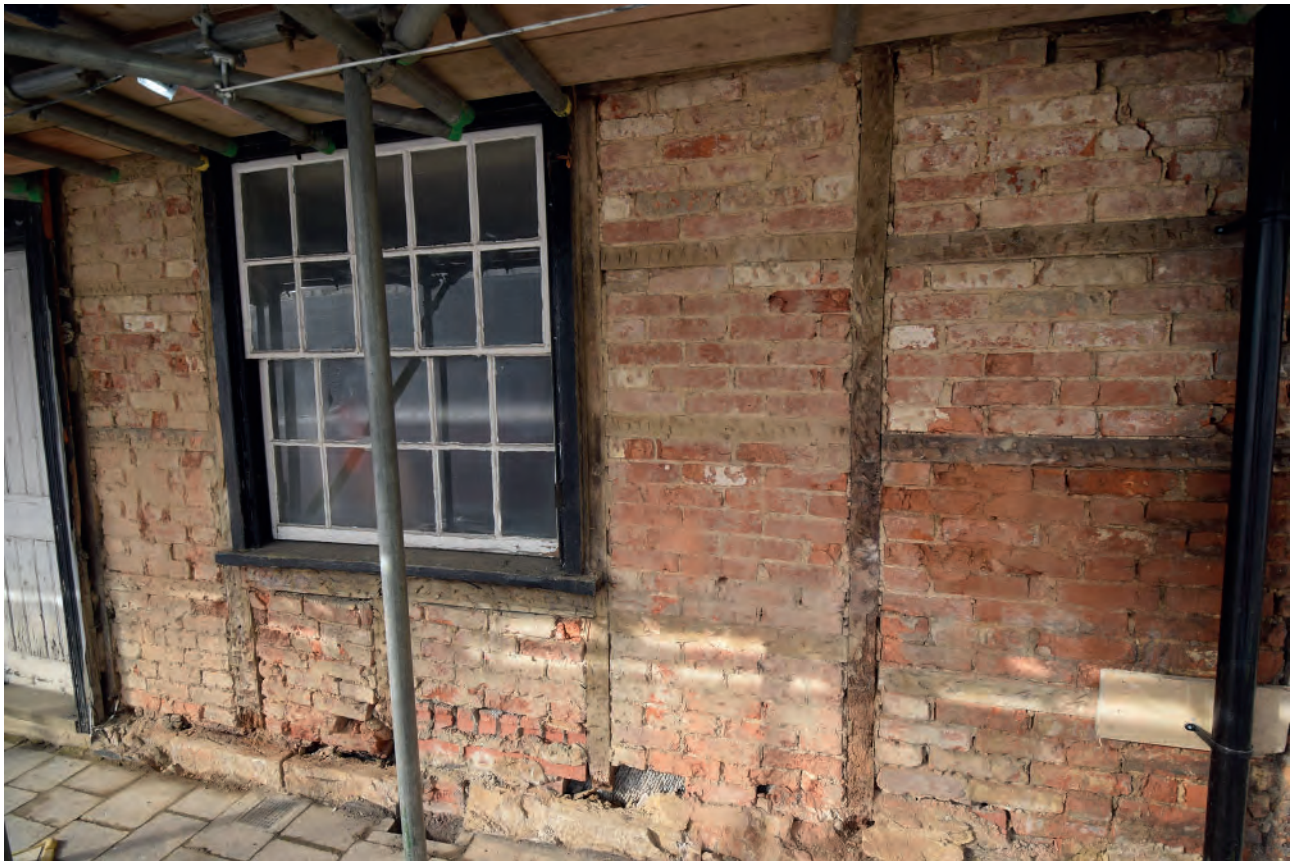
Plate 33: Brick reface on the ground floor of No. 3

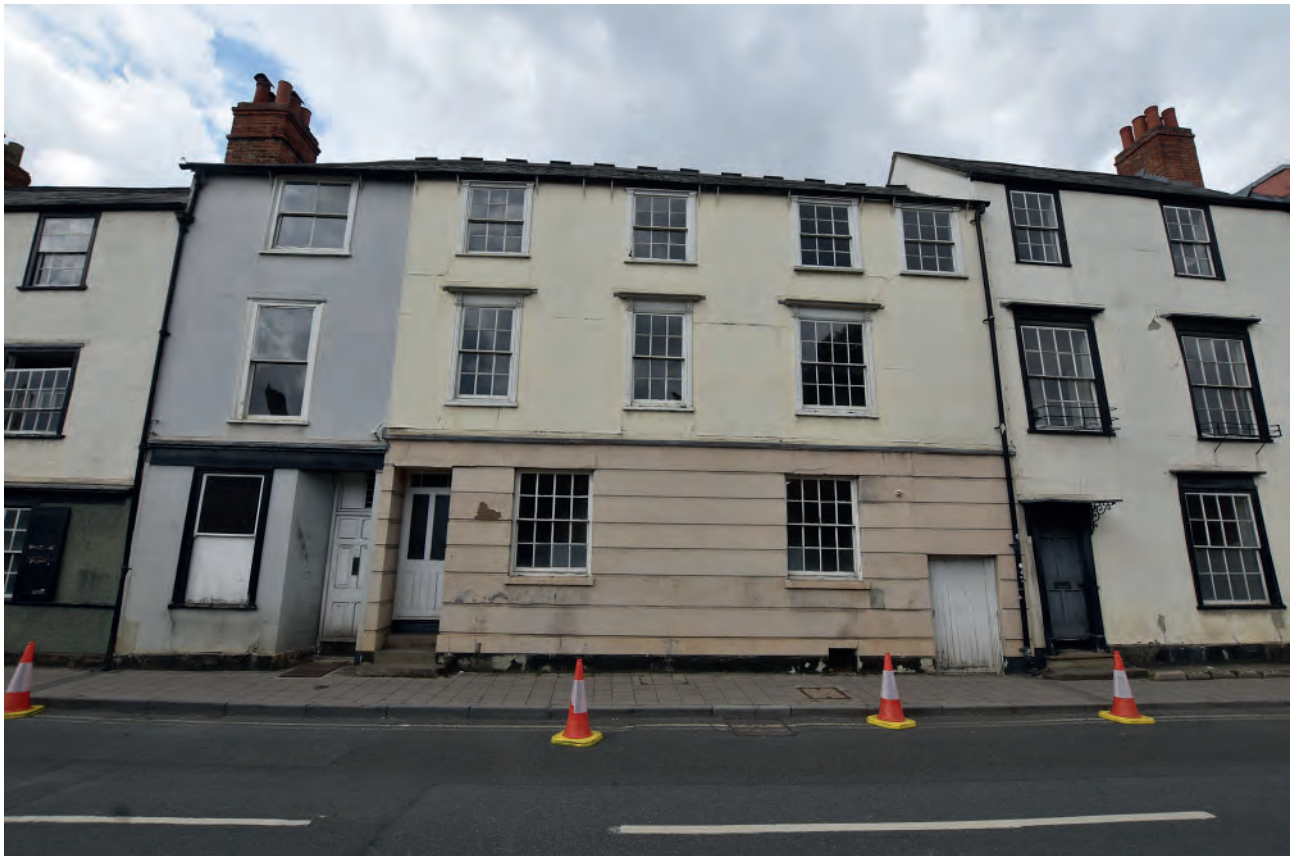
Plate 34: East elevation of Nos. 4-6 Longwall Street before work commencing

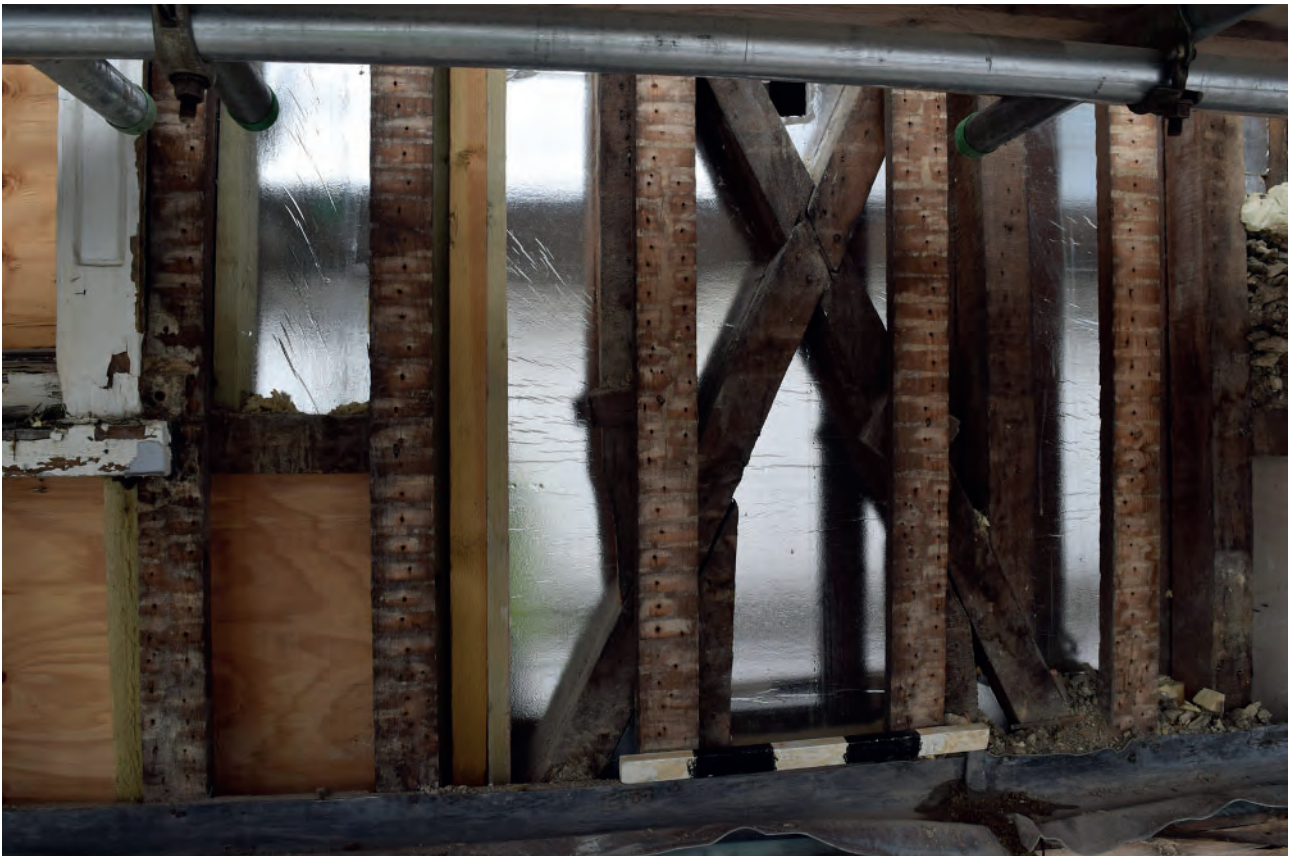
Plate 36: Cross brace on first floor of Nos. 5-6

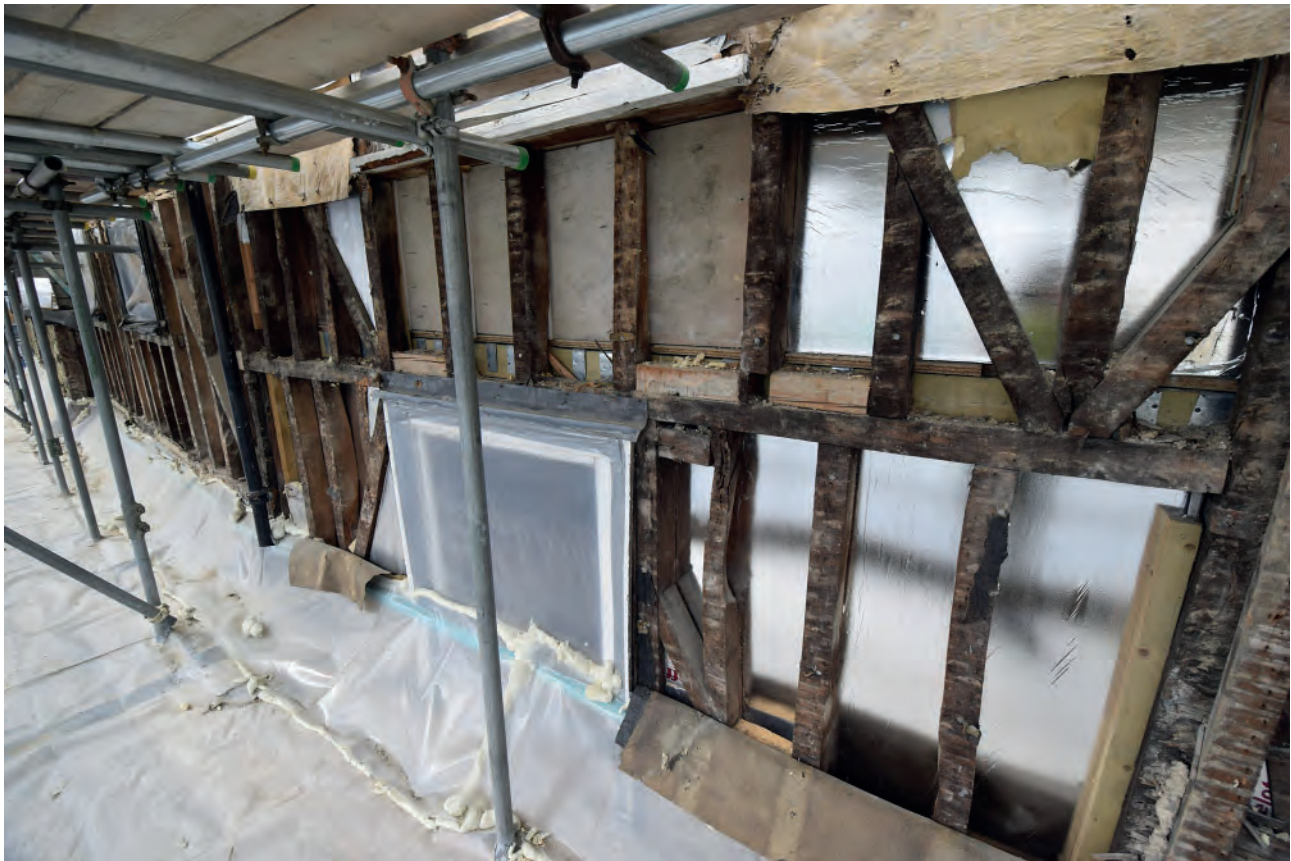
Plate 37: First floor of No. 4

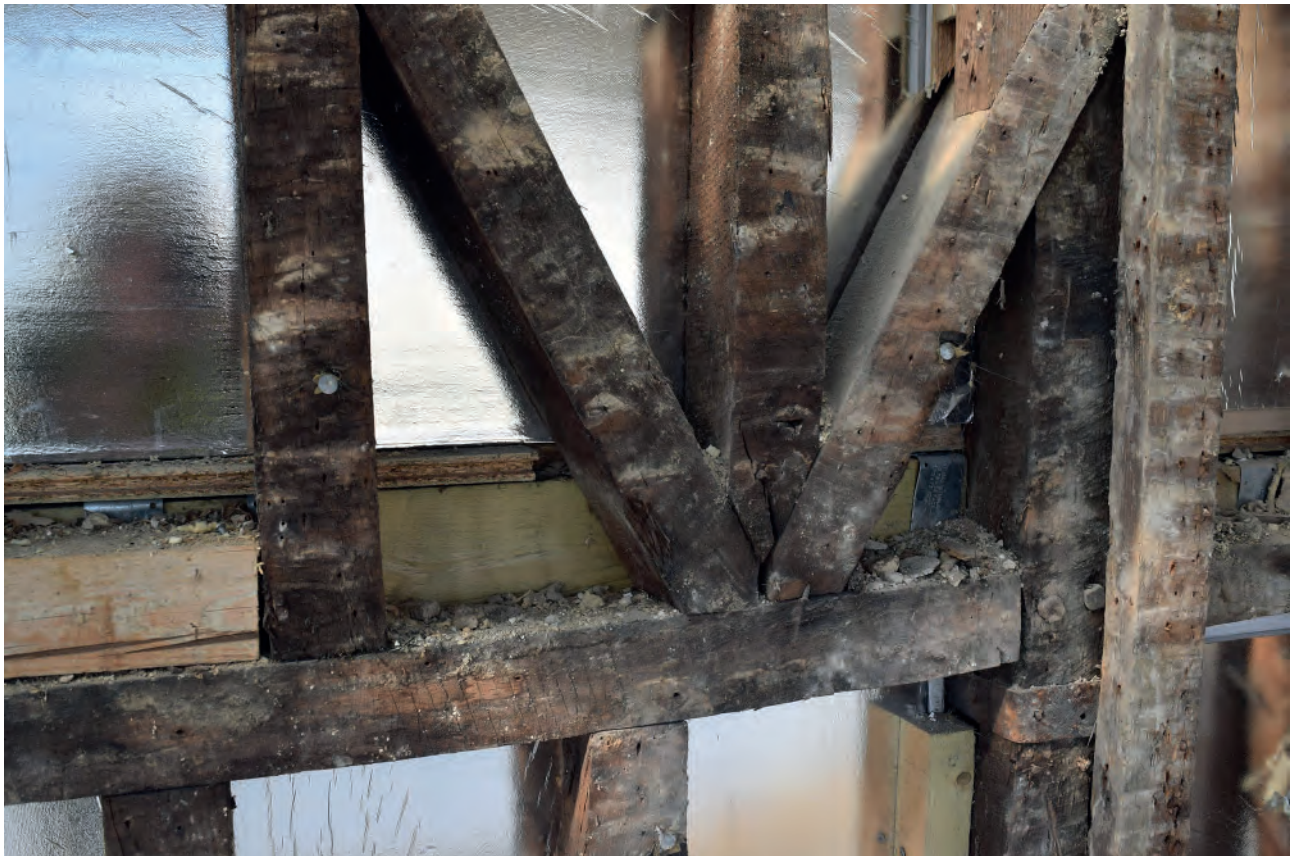
Plate 38: Bracing on the first floor of No. 4
