Nos. 1-7 Longwall Street, Oxford

Historic Building Investigation and Recording

February 2022

Client: Magdalen College, Oxford

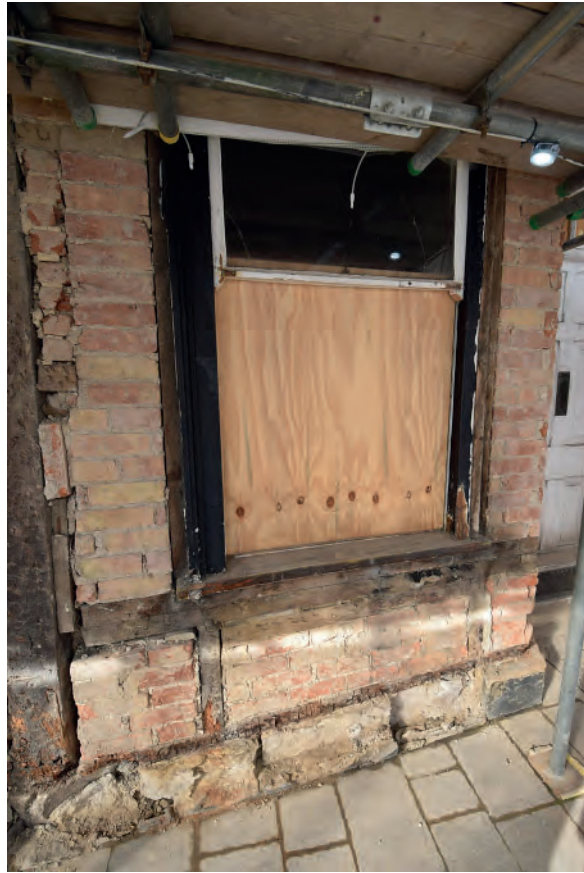
Plate 41: Brick nogging on the ground floor of
No. 4

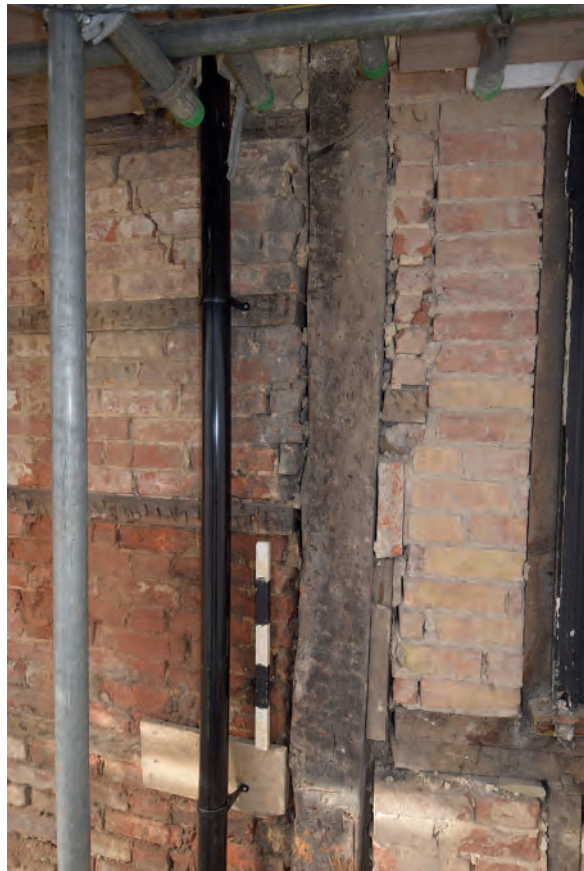
Plate 42: Rough brickwork between Nos. 3 and 4

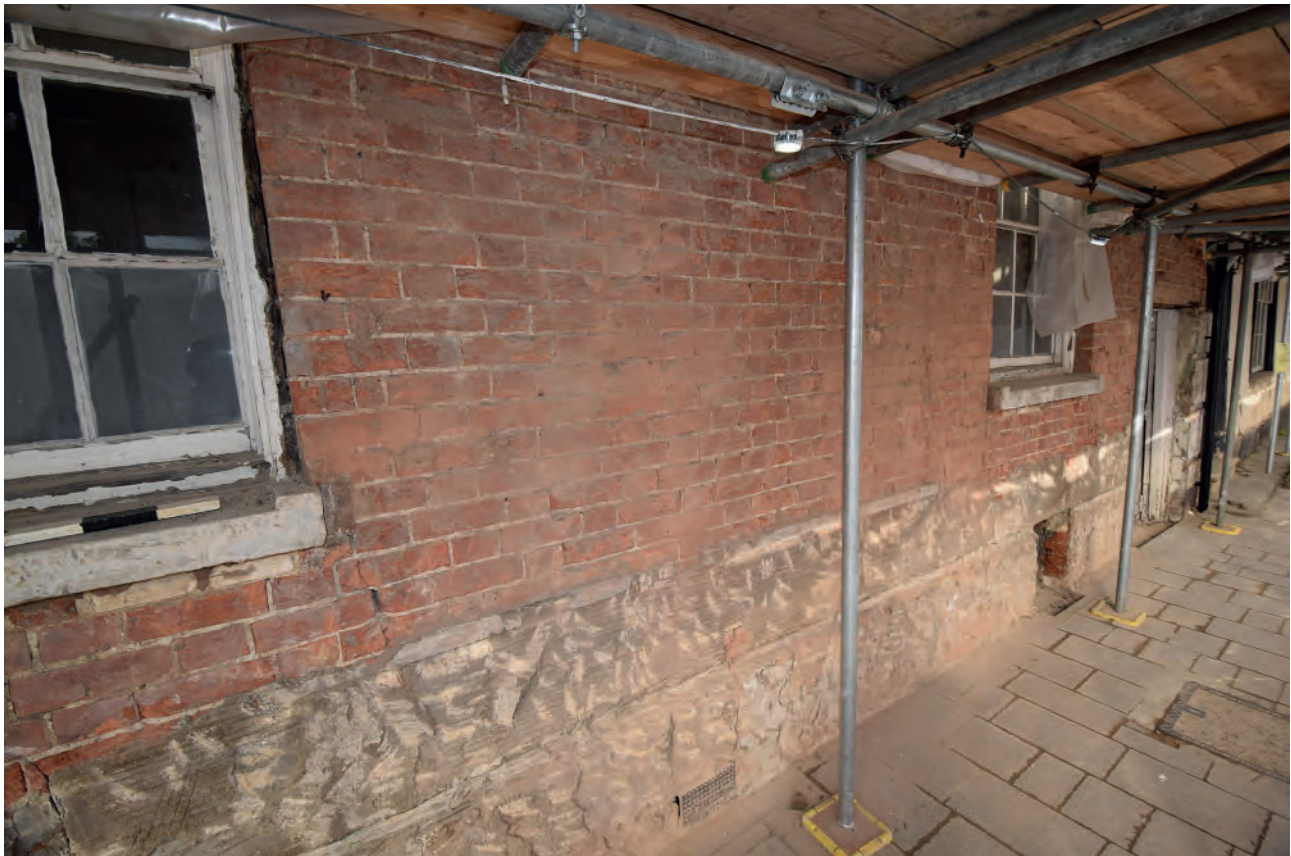
Plate 48: Ground floor of Nos. 5-6

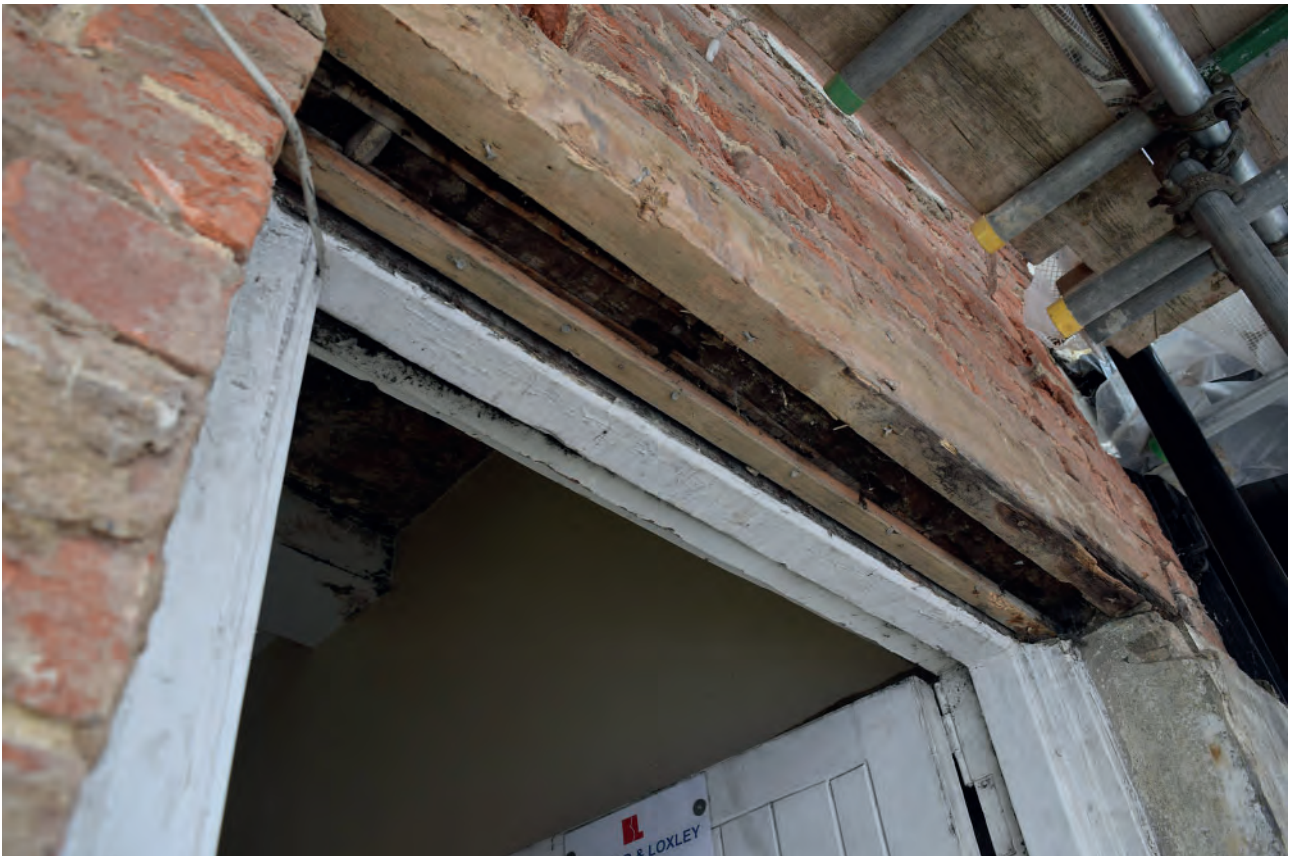
Plate 50: Original passage lintel between newer timbers on Nos. 5-6

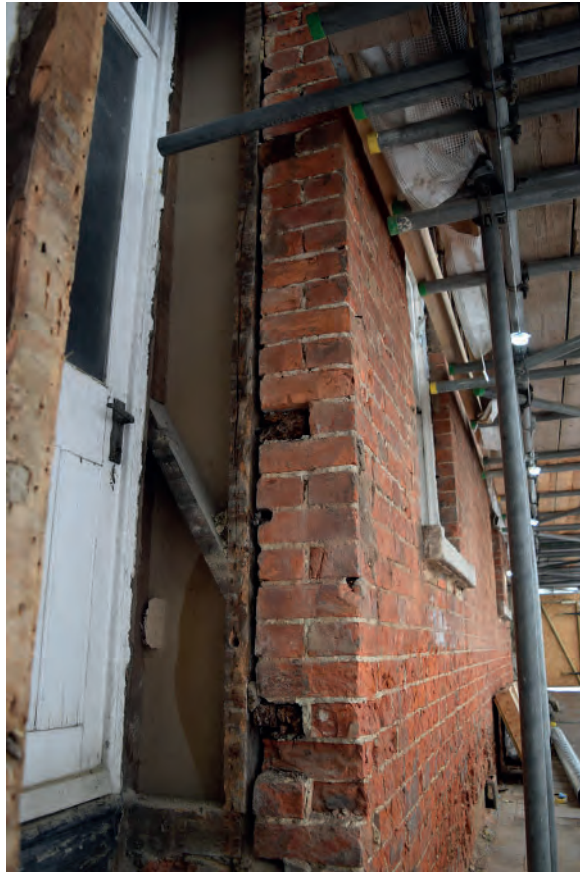
Plate 51: Framing behind the brick reface of Nos. 5-6

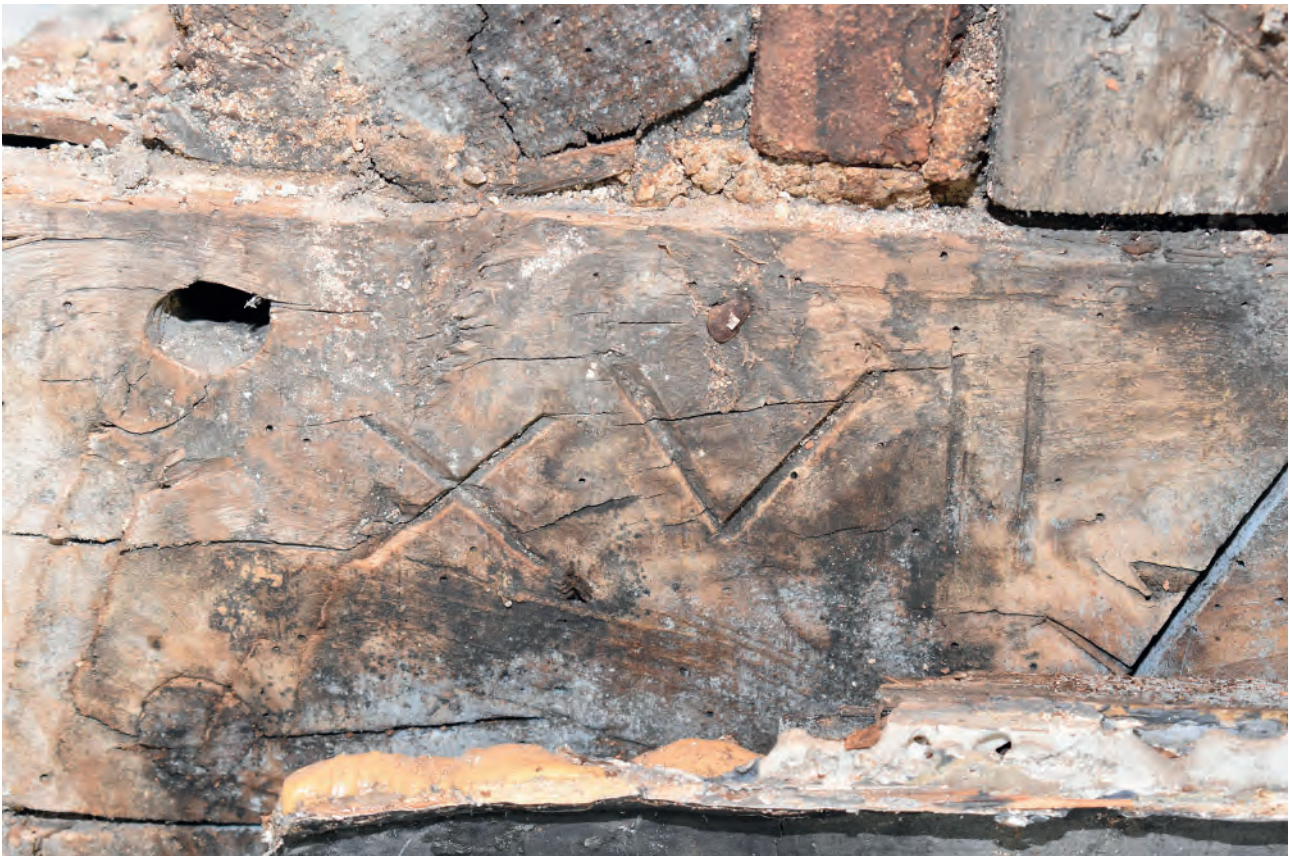
Plate 58: Carpenters' mark on the first floor of No. 7

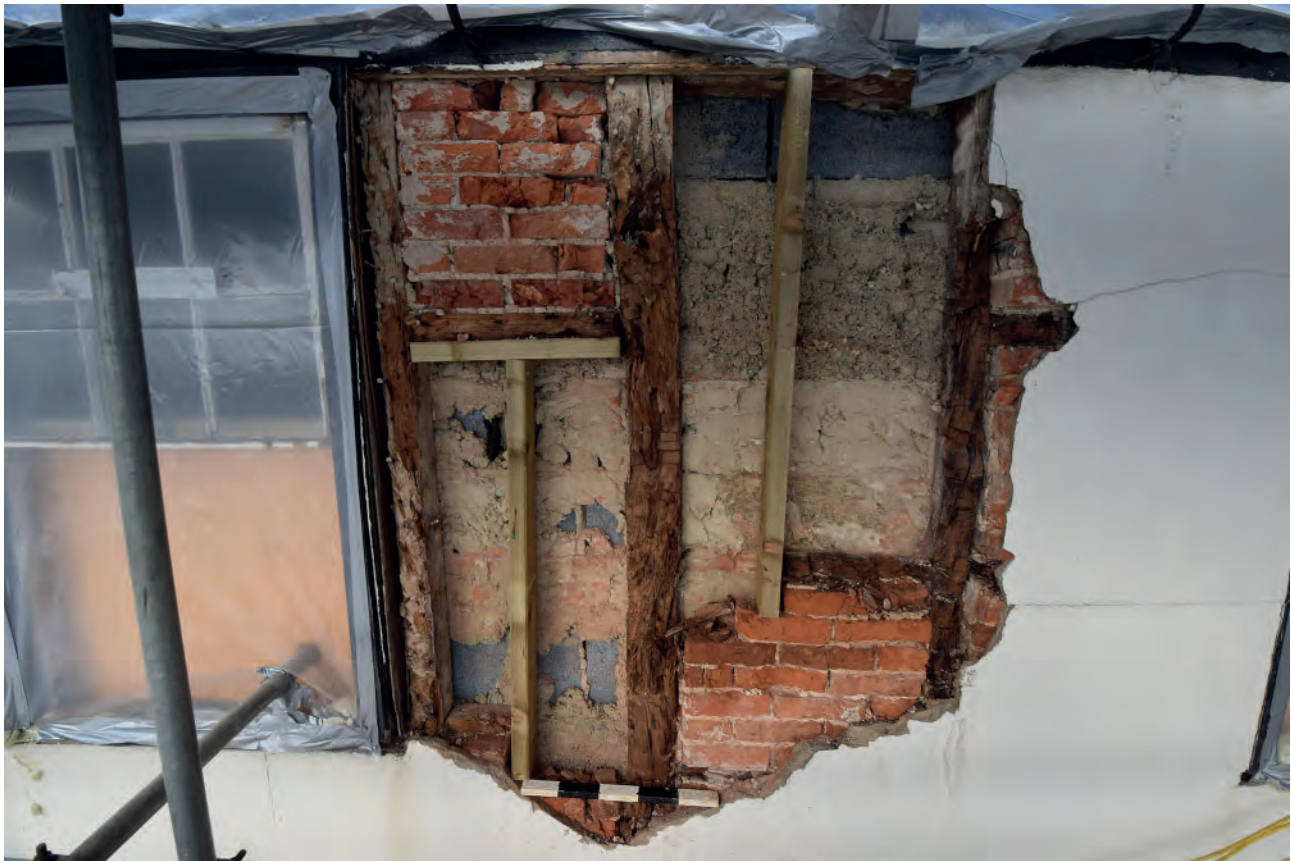
Plate 59: Brick panels on the second floor of No. 7

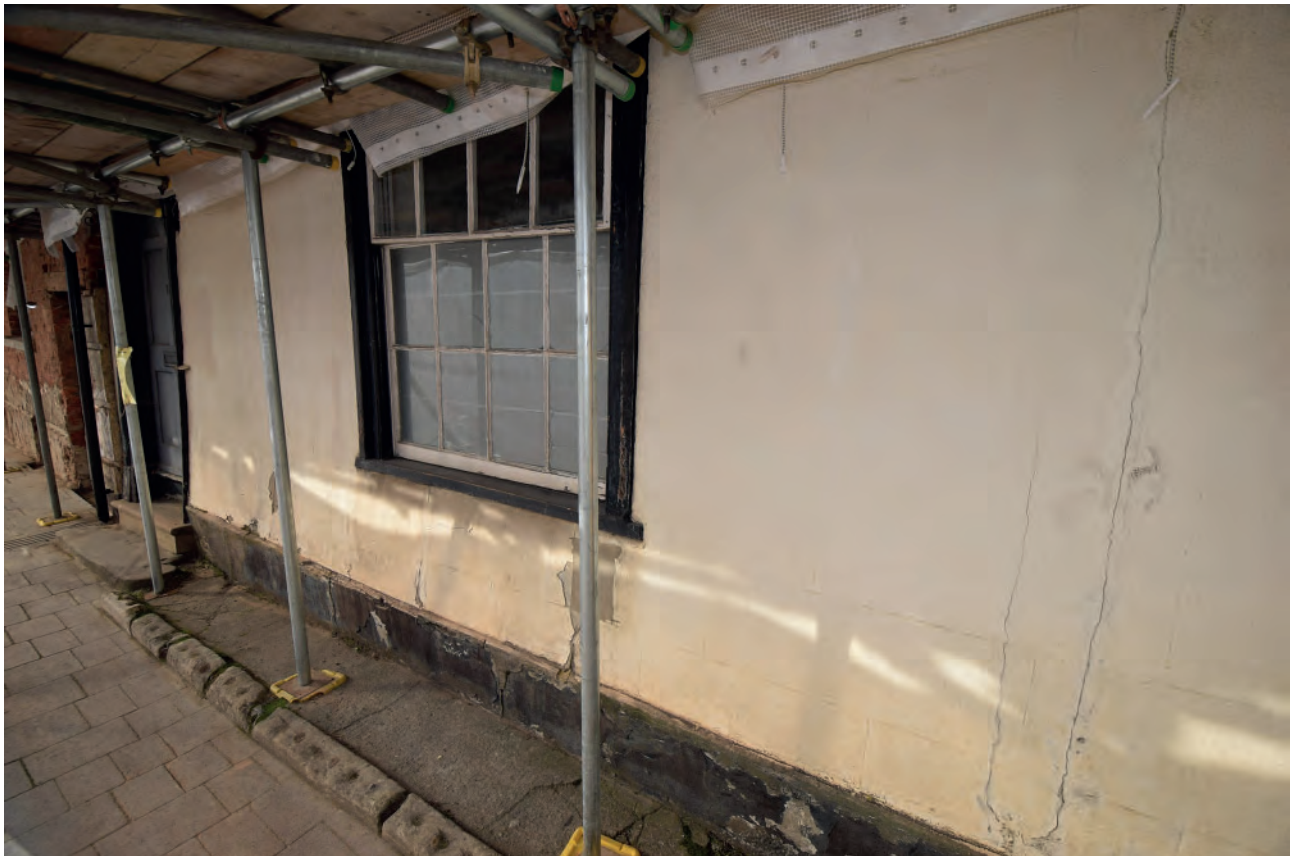
Plate 60: Stone settings for lost rails of No. 7

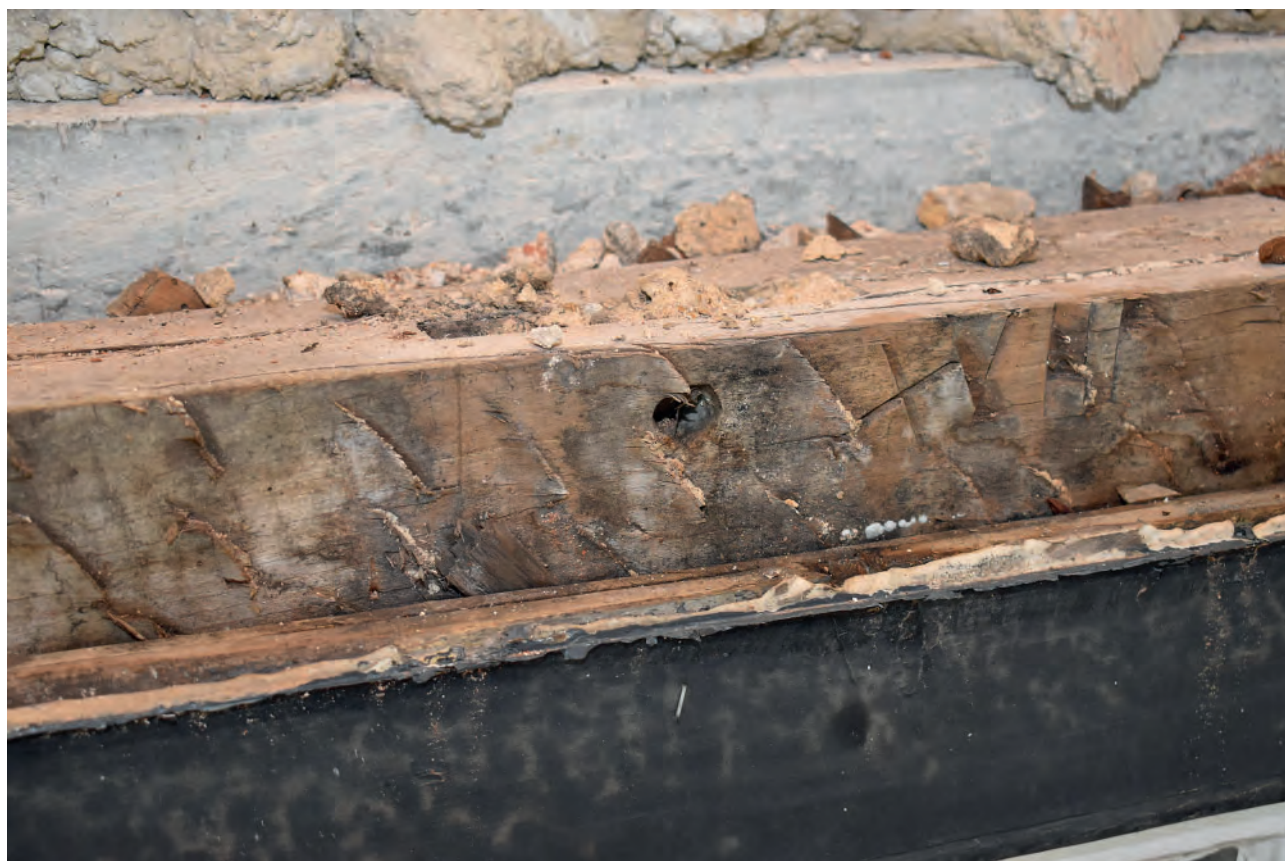
Plate 62: Peg hole, mortise and carpenters' mark above first floor north window of No. 7
