The South Terrace, Cliveden

Archaeological Investigations 2013-17

May 2018

Client Name: The National Trust
Client Ref No.: n/a
Document Title: The South Terrace, Cliveden
Document Type: Report on Archaeological Investigations 2013-17

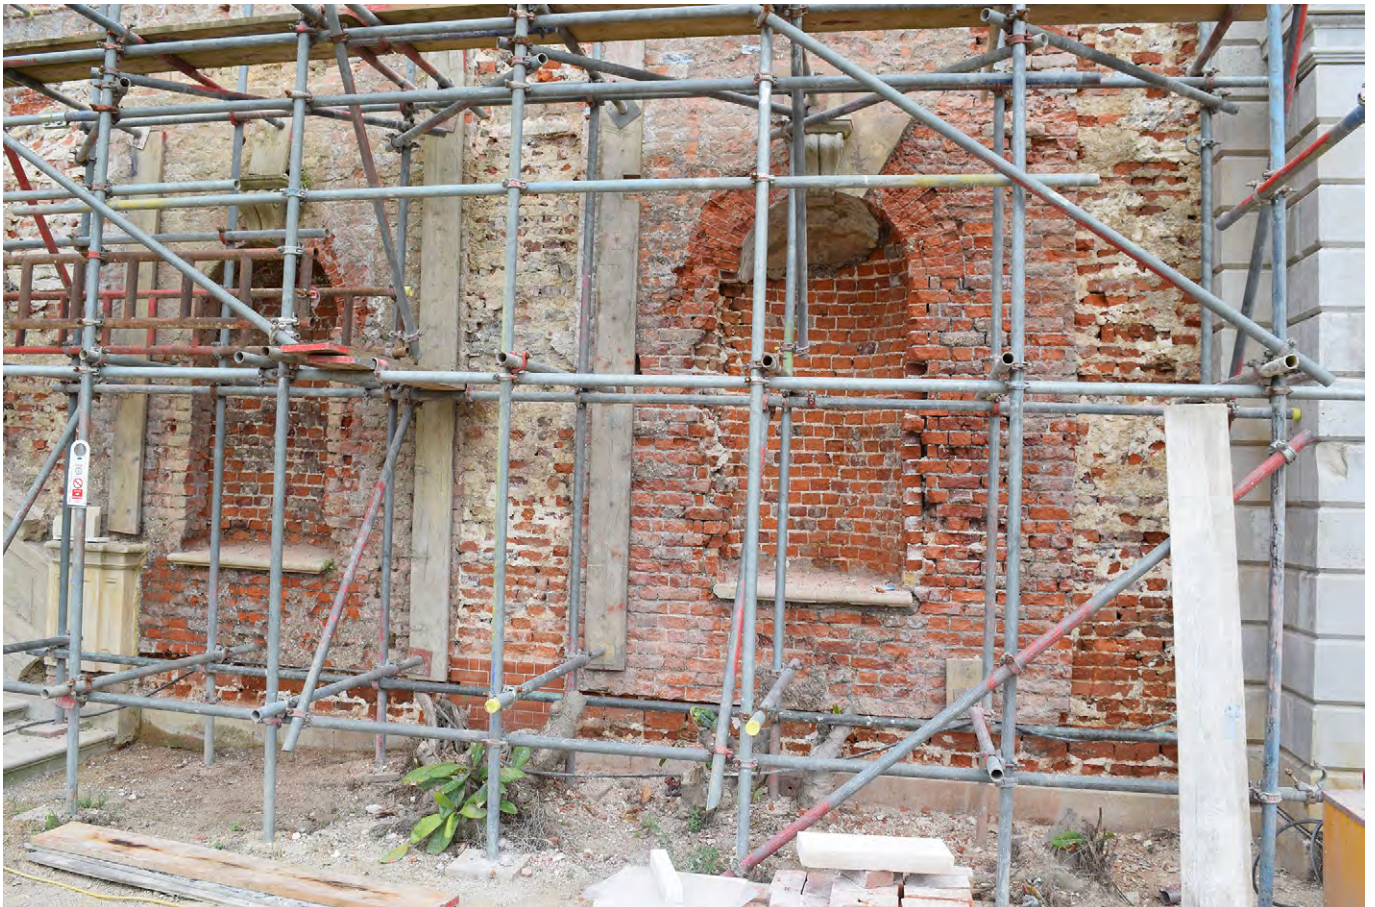
Plate A.16: Western face of stairs after removal of render

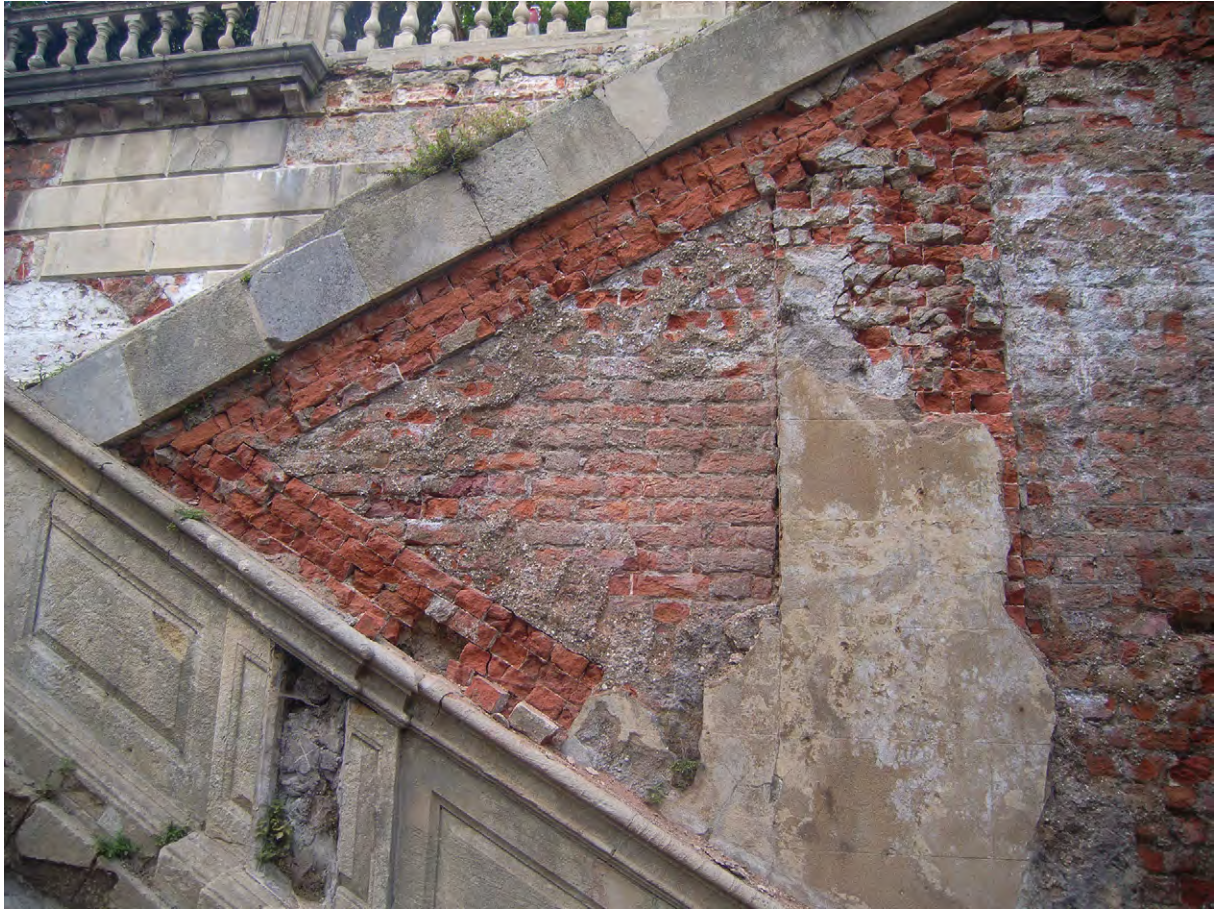
Plate A.17: Fine brickwork on west side after removal of render

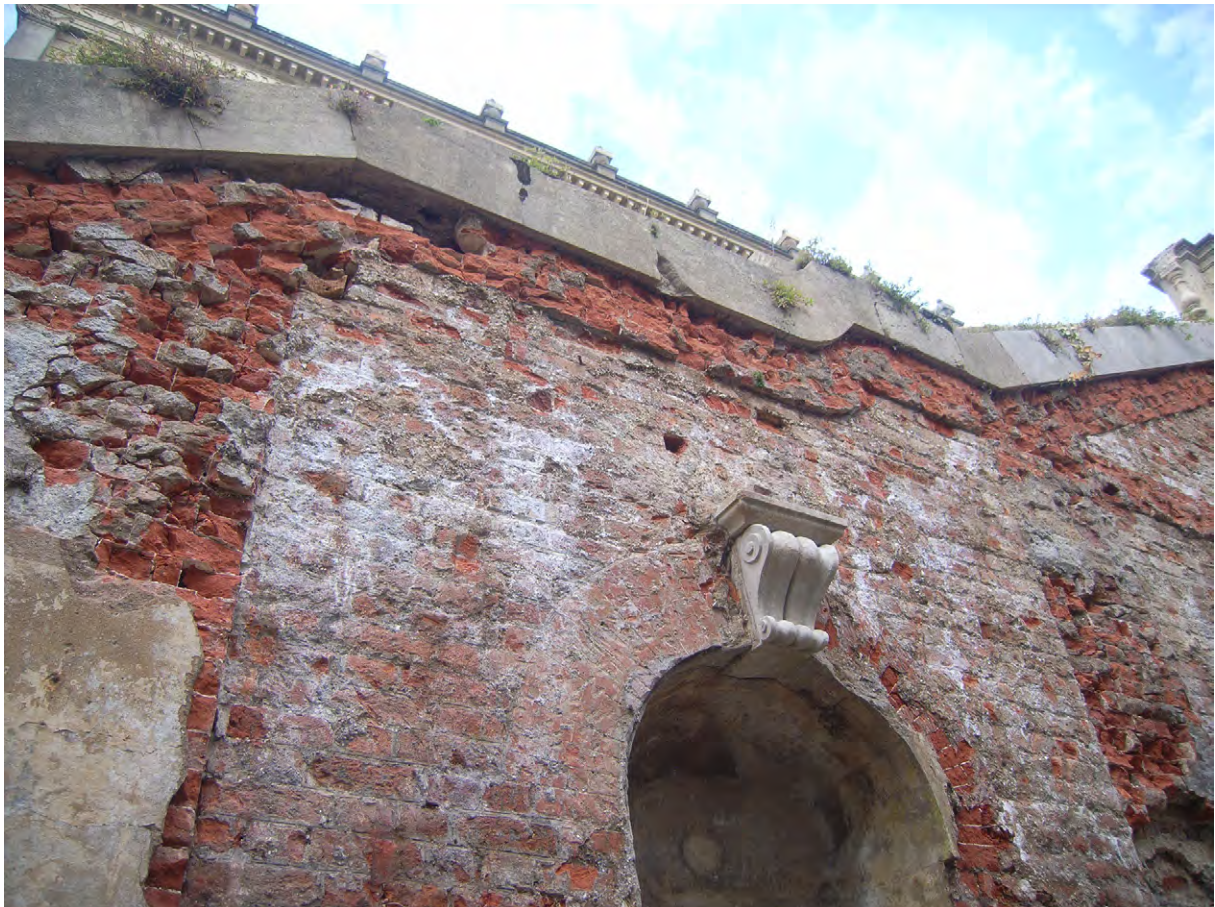
Plate A.18: Fine brickwork on west side after removal of render

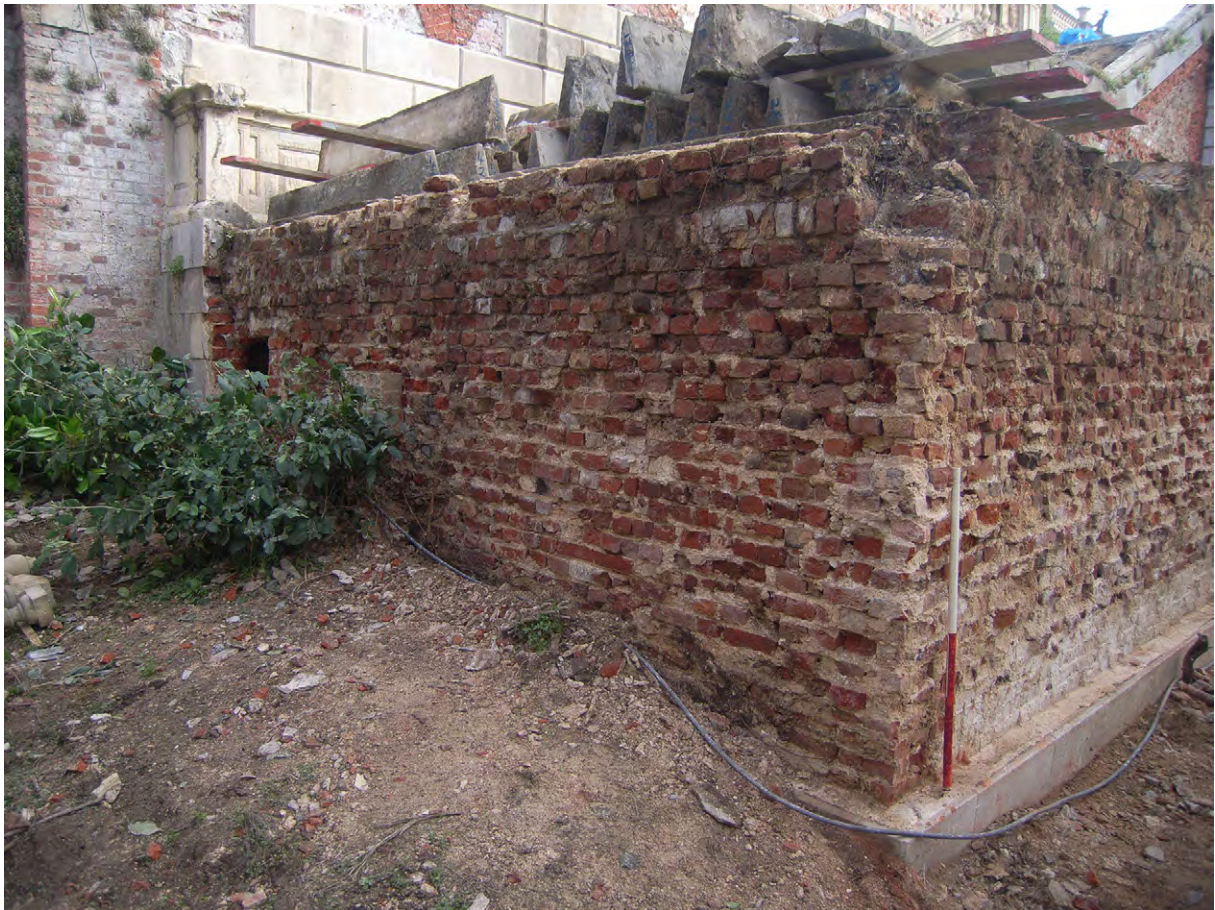
Plate A.23: West wall after removal of fine brick skin [A.4.1]

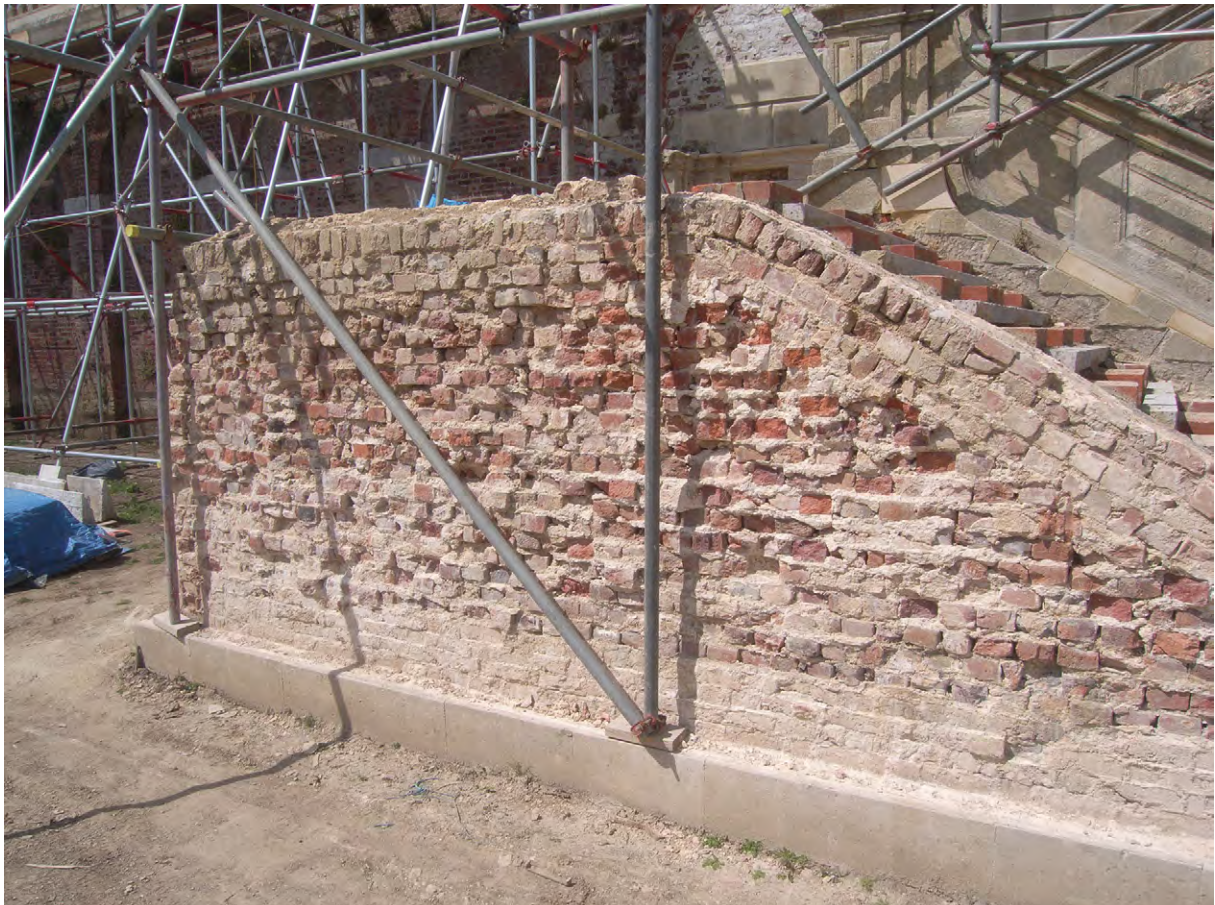
Plate A.24: West lower flight after removal of fine brick skin [A.4.1]

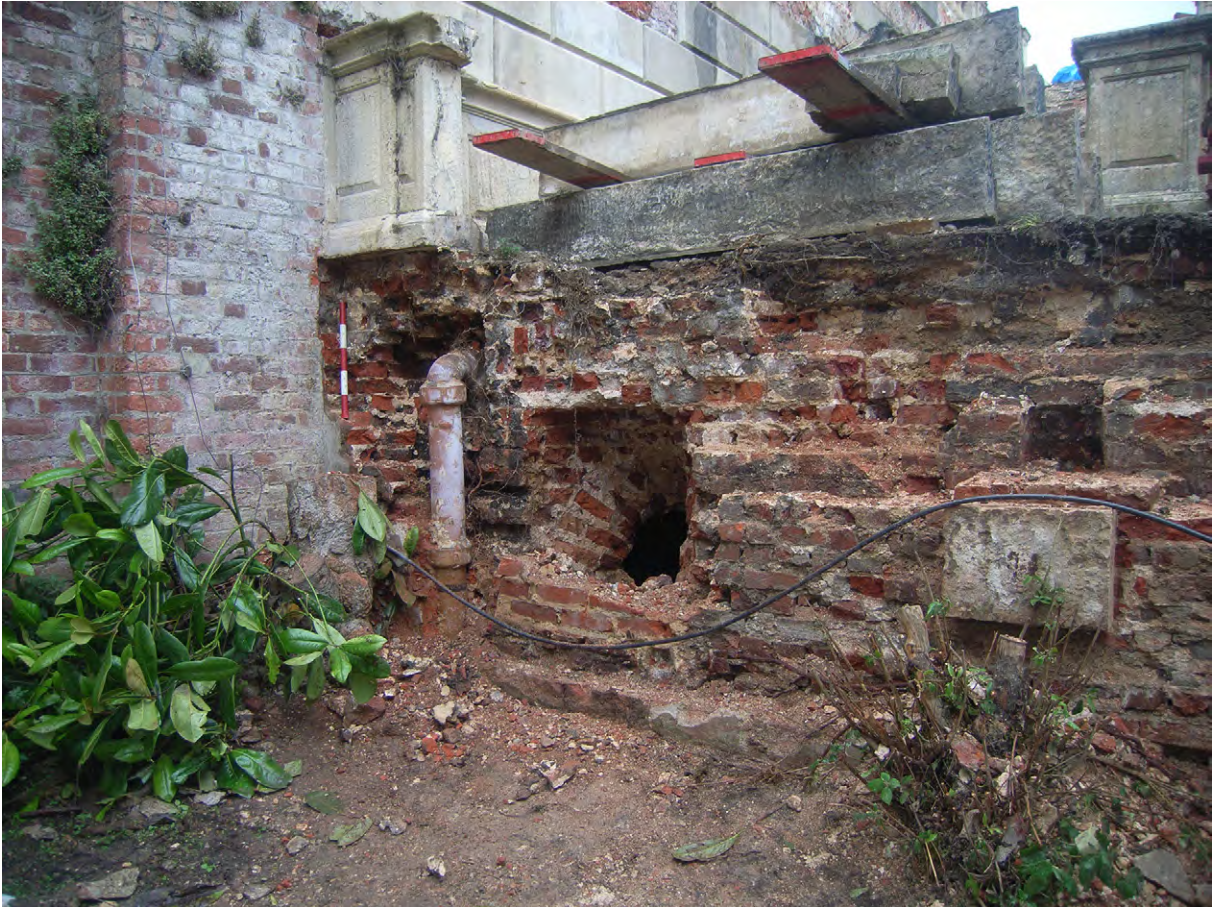
Plate A.25: Detail of west wall [A.4.1 and A.4.2]

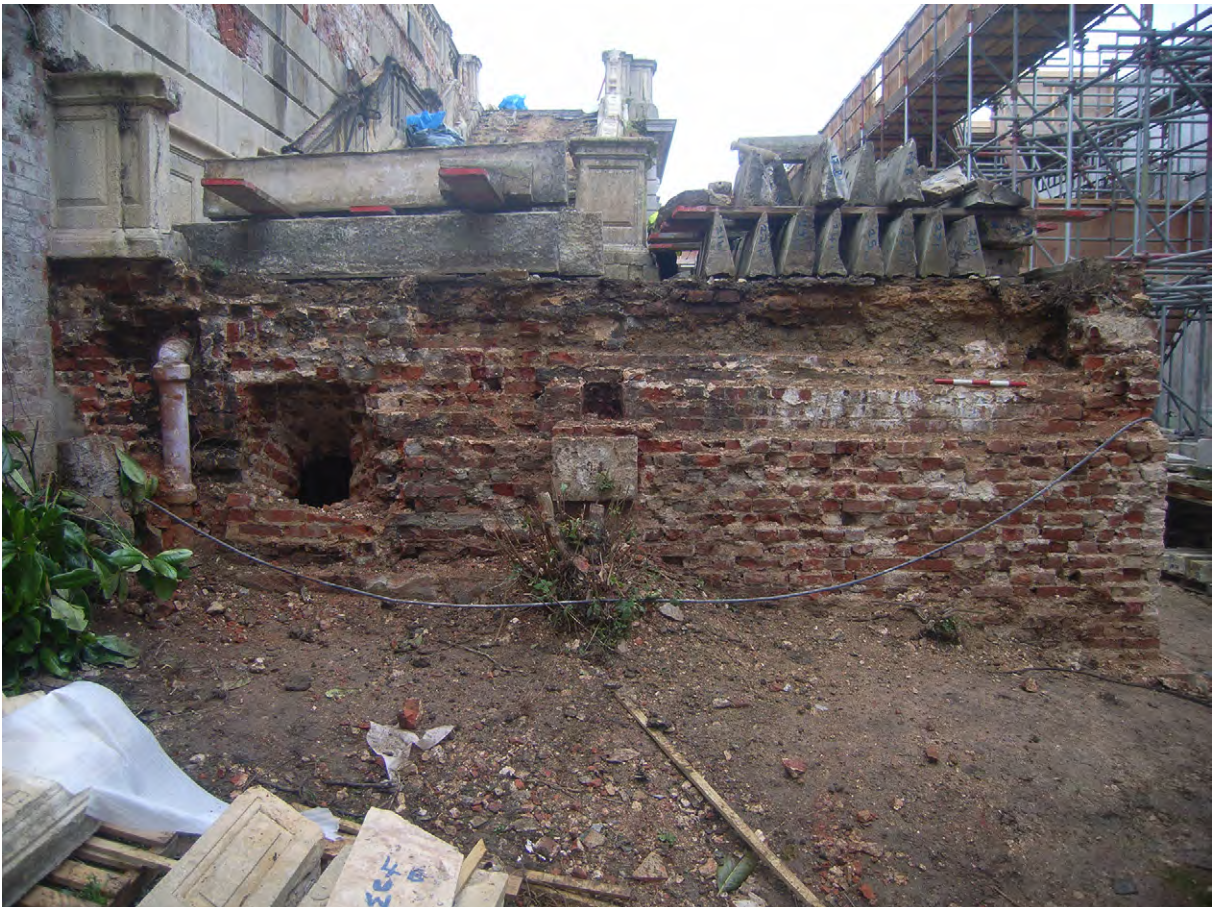
Plate A.26: Exposed core of west wall [A.4.1 and A.4.2]

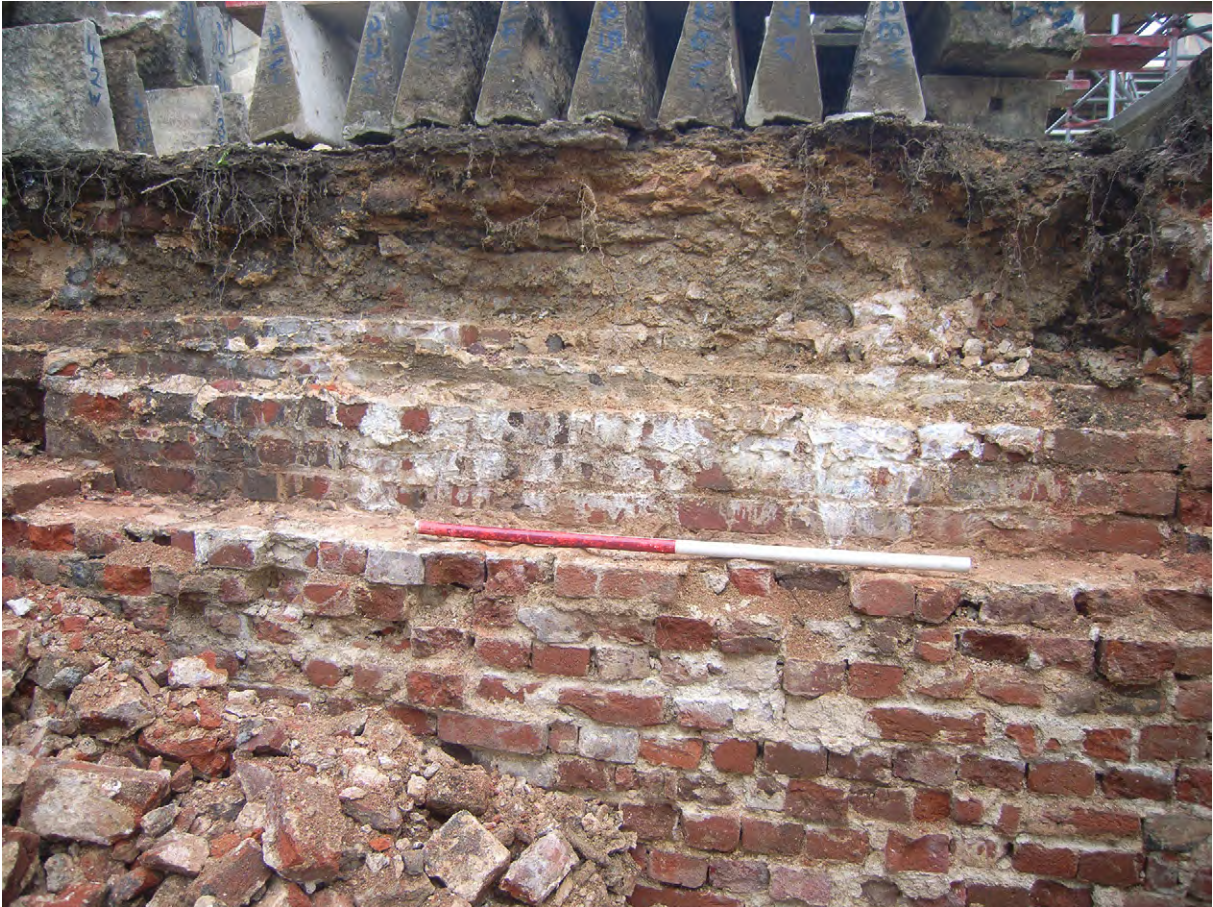
Plate A.31: Detail of west lower flight during dismantling [A.4.1 and A.4.2]

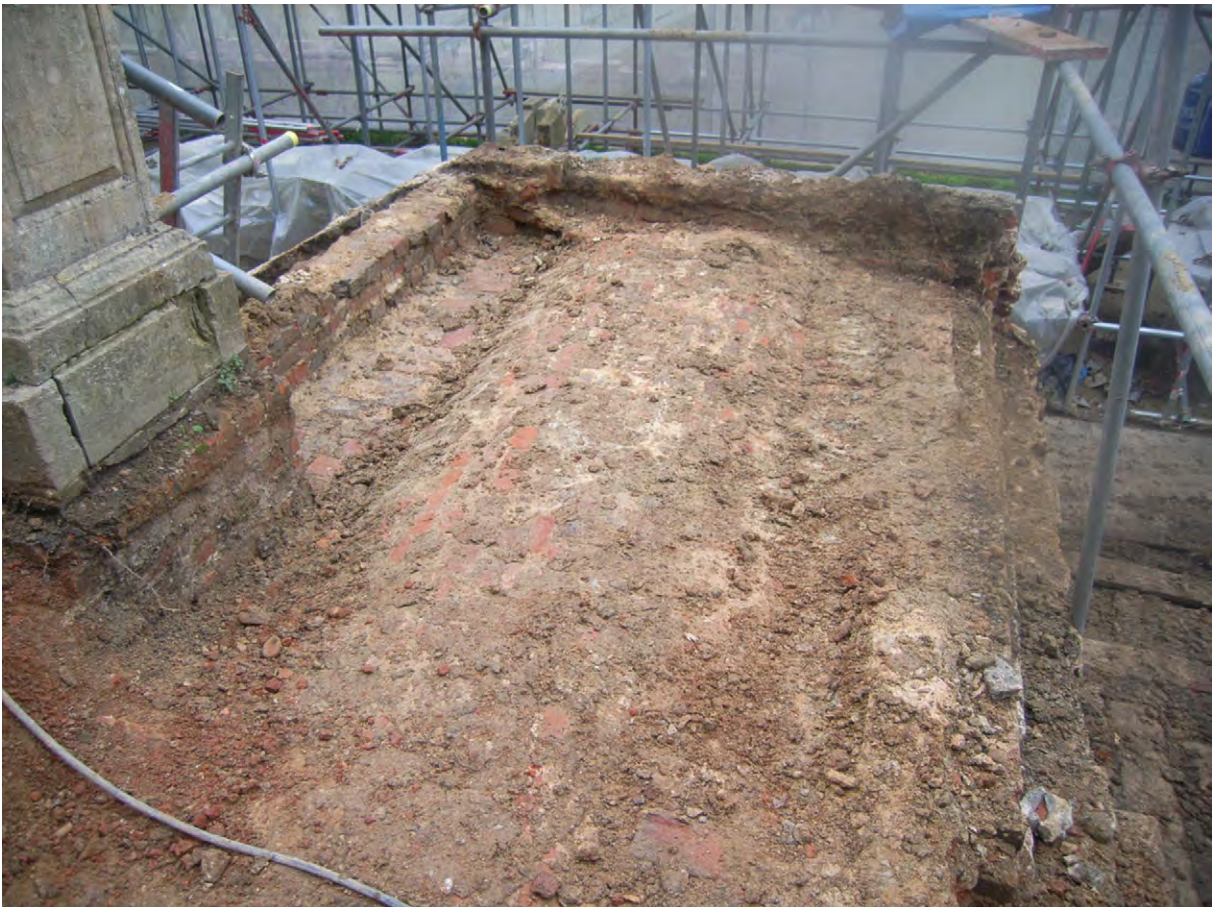
Plate A.32: Vault after removal of western lower landing

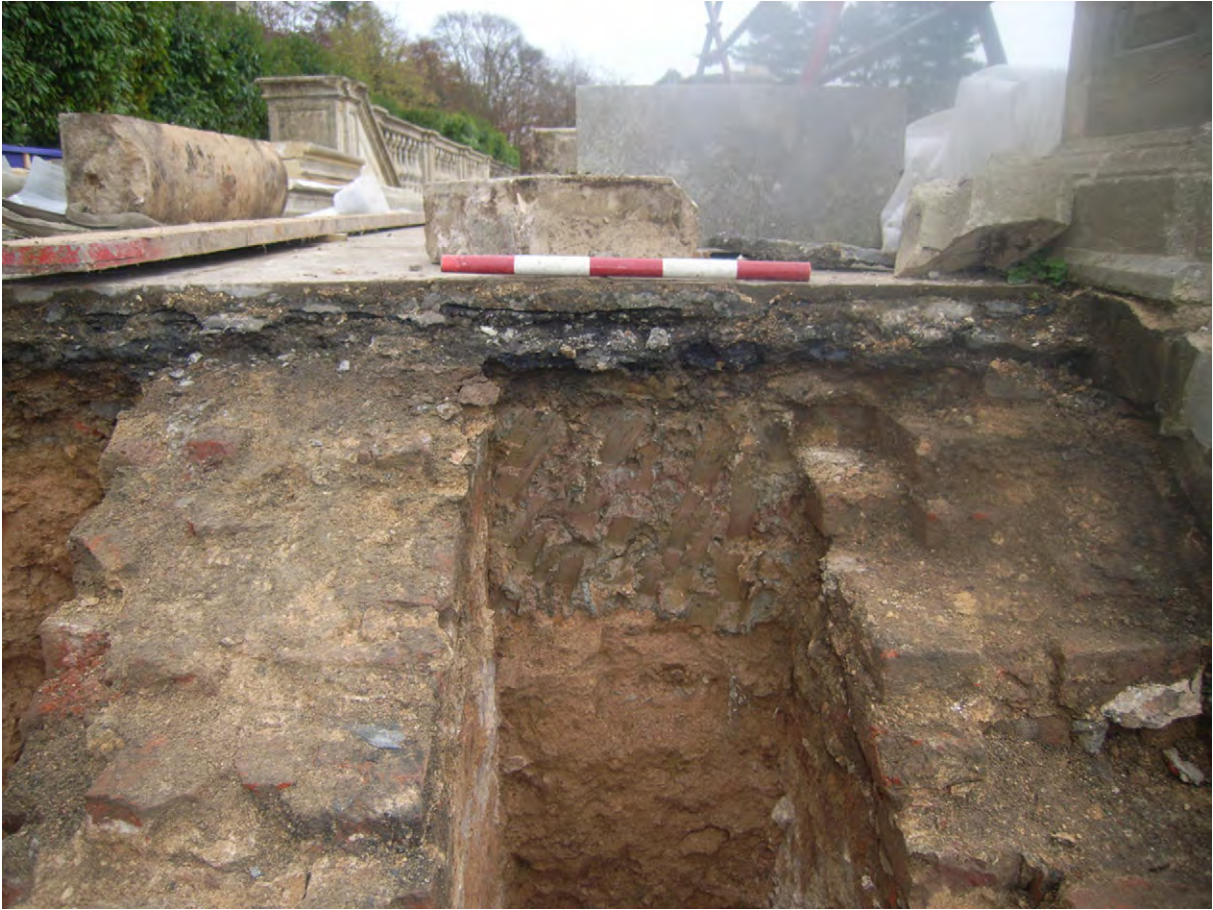
Plate A.39: Clay at top of west side of stairs

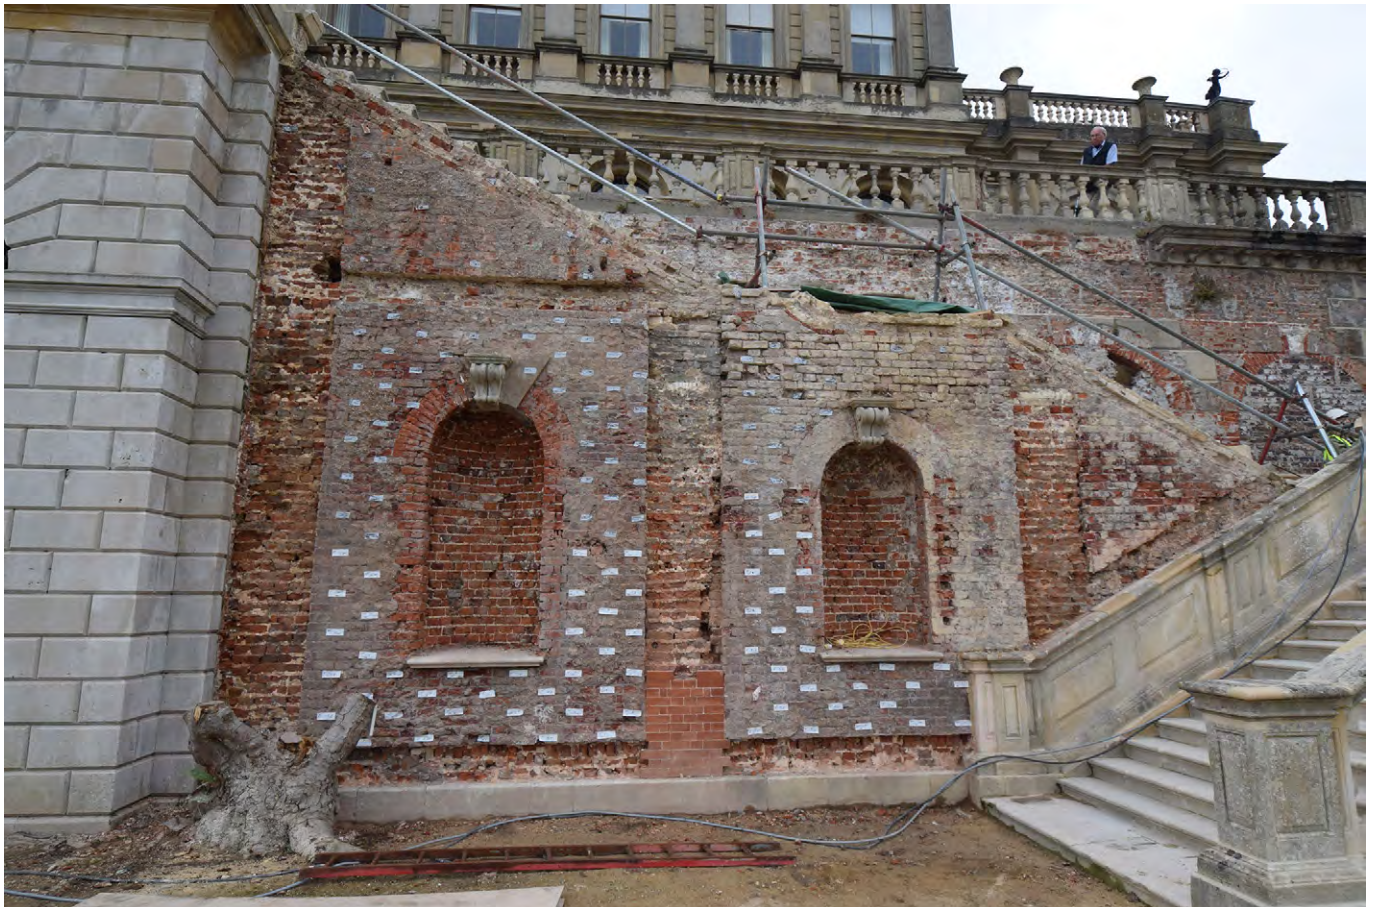
Plate A.42: East side of stairs after removal of render and pilasters

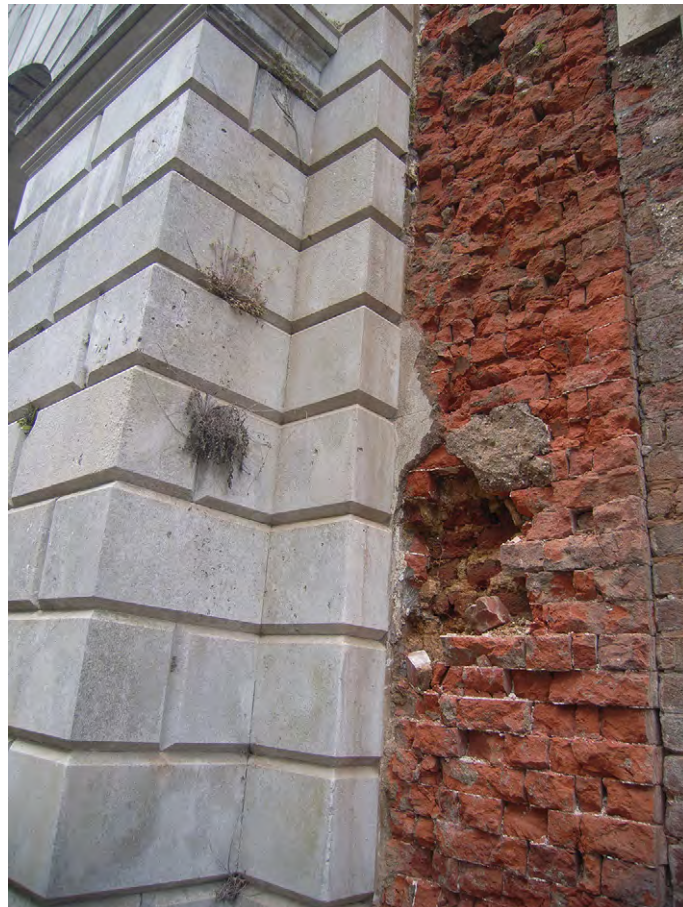
Plate A.47: RW 1739' inscription on brick in eastern niche jamb

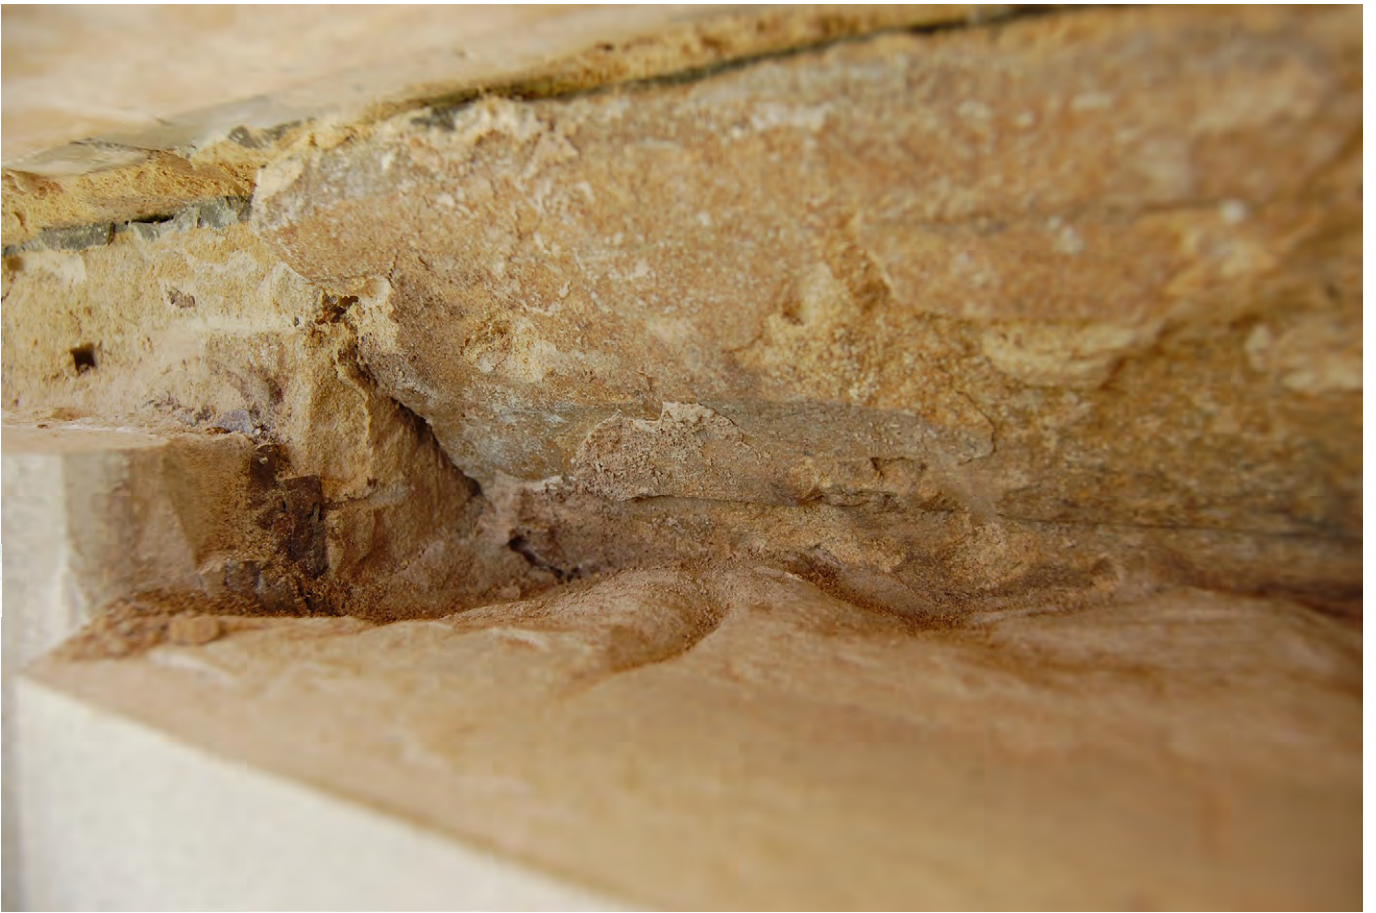
Plate A.62: Exposed fragment of older cornice behind Portico cladding [A.5.1]

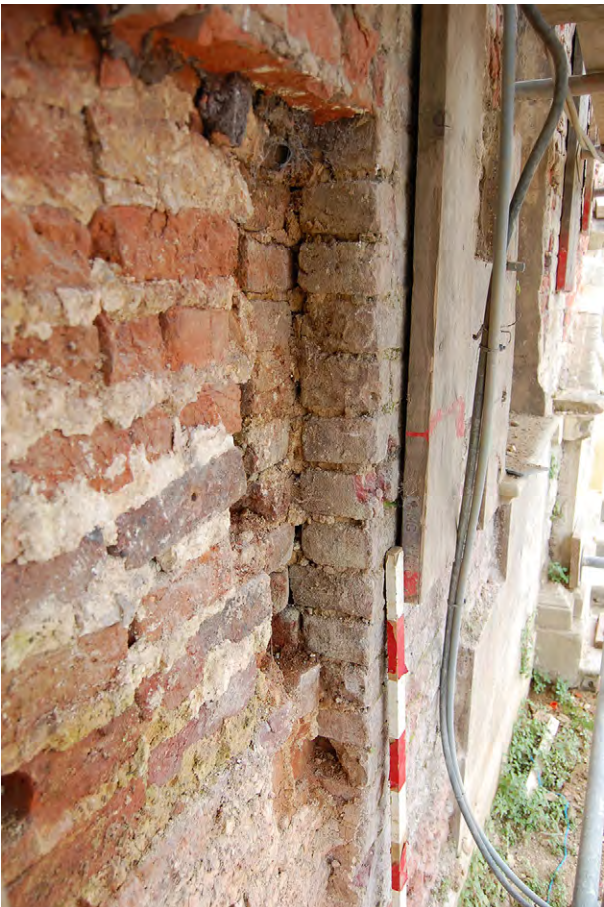
Plate A.63: Detail of exposed fragment of cornice [A.5.1]

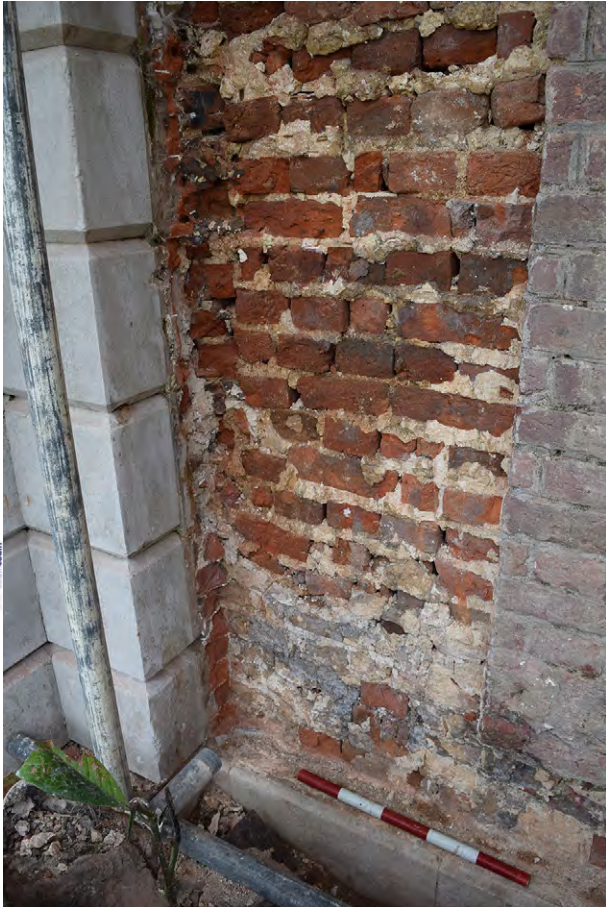
Plate A.65: Hidden brickwork exposed by removal of central pilaster to east side of stairs

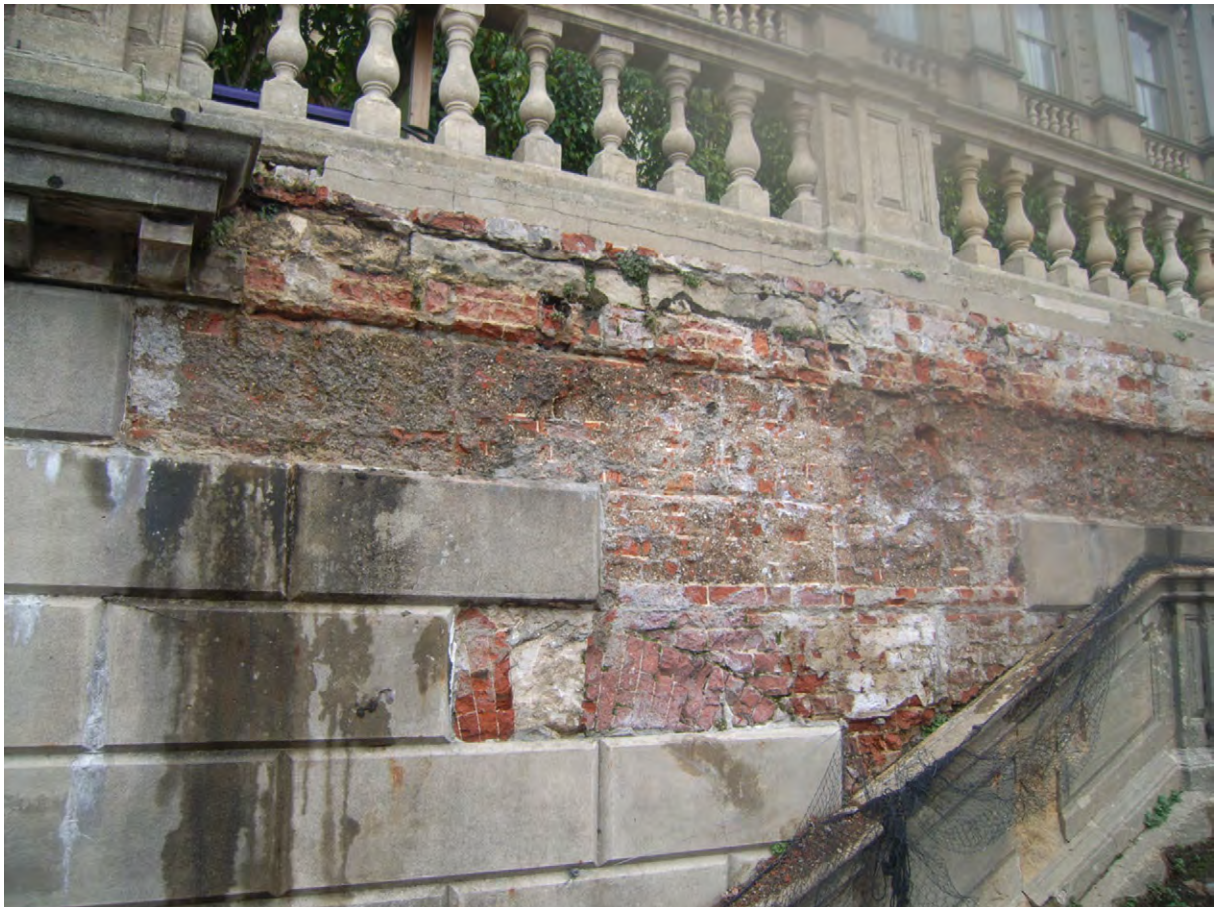
render (see Fig A3 and *Pl. B10-15*). In the current study these are numbered East Arches 10 and 11 and West Arches 10 and 11. These arches were infilled with single skin, mid 19th-century stock brick, presumably also dating from sometime between 1850 and 1866 before being rendered over. A small hole (c.30 cm long by c.12 cm wide) was made by removing some of the bricks from the blocking of the innermost visible arch on the east side (East Arch 11) and this exposed the recessed stucco (Roman cement render) face of the blind arch which would have been visible prior to the addition of the rusticated render (*Pl. B15-16*). This hidden recessed face was 19 cm behind the front of the later brick face and the hard, light brown stucco had scour marks to give the superficial appearance of ashlar. This stucco was a yellow colour and where it was broken the core of this stucco was a chocolate brown colour, with white inclusions. This corresponds with the early 19th century view of the unexecuted proposal for the house which may show the terrace as it existed at that date.

Plate B.12: Area on west side of stairs where rustication removed

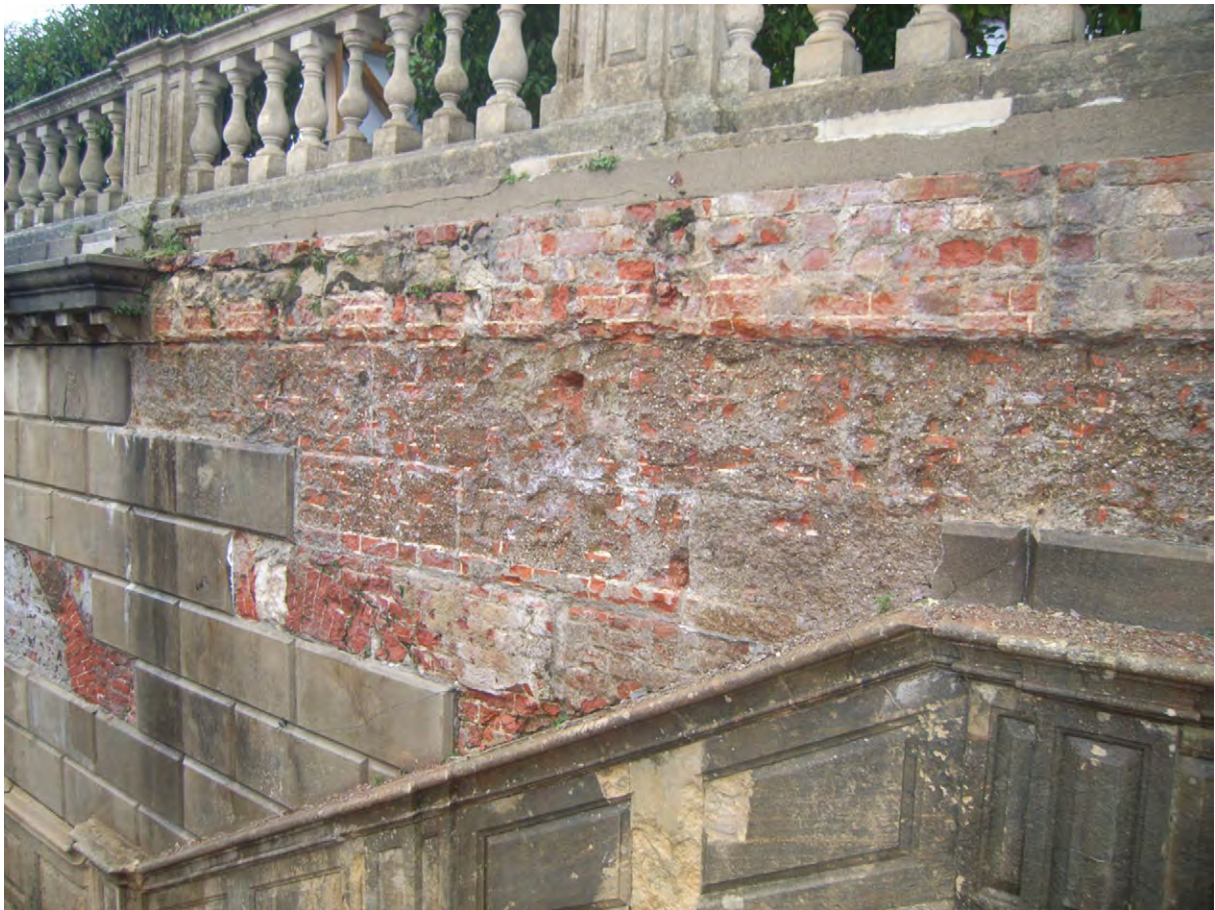
- 5.3.18 Each of the four blocked arches exposed behind the staircase had the truncated remnants of a former projecting keystone [*Feature B.2.1*] which was clearly cut off to allow for the render to be applied over this area. Similarly the stone impost band was also found to have been cut back between the arches at the point where the render covering was added [*Feature B.2.2*]. Also, the uppermost 11 courses of brickwork which formed a slightly projecting band across the length of the terrace façade had also been cut back slightly to allow for the render. Another minor feature revealed by the removal of the render were grooves cut in the brick face to allow for the deep V-profile rustication 'joints' [*Feature B.2.3*].

Plate B.13: Areas on west side where rustication removed (note B.2.3, B.2.1)

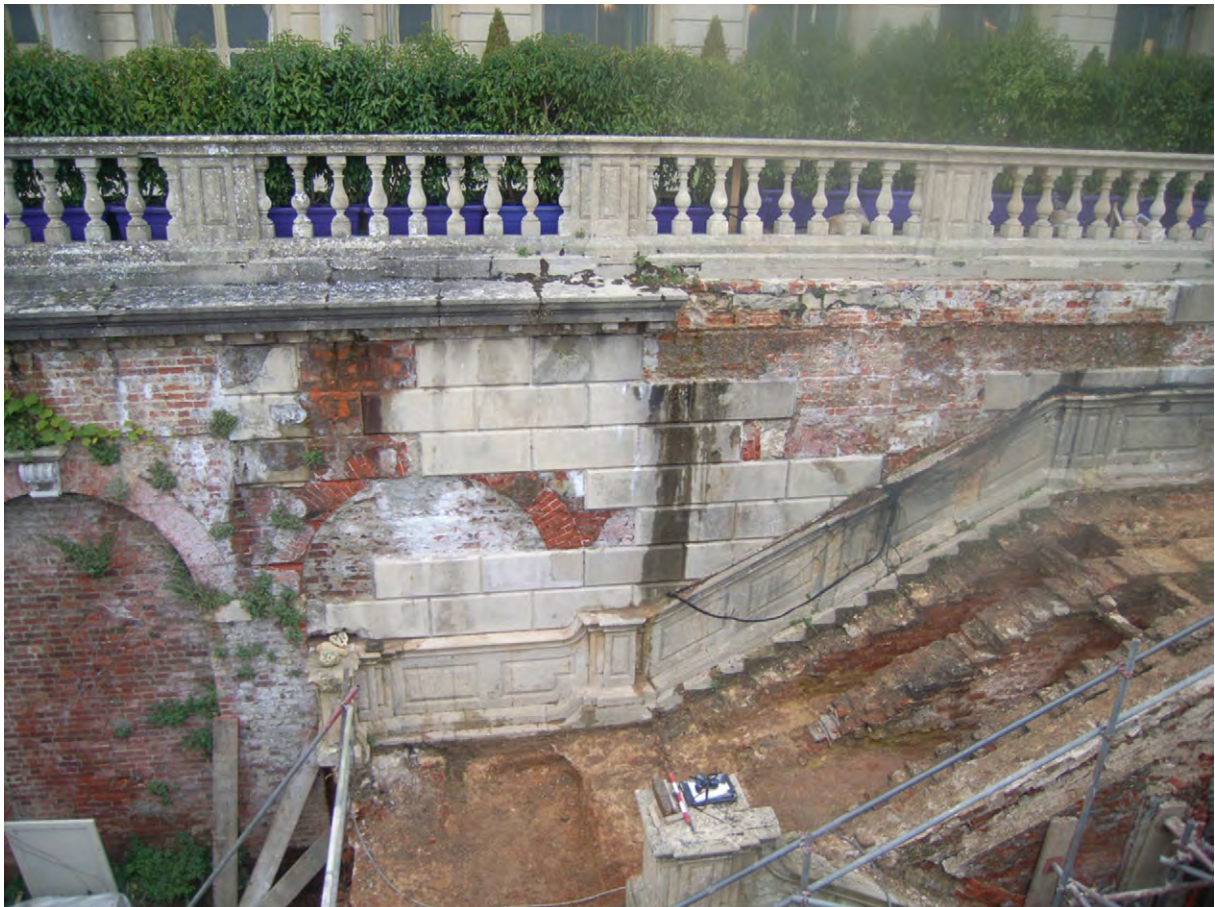
Plate B.14: General view of west side during removal of rustication

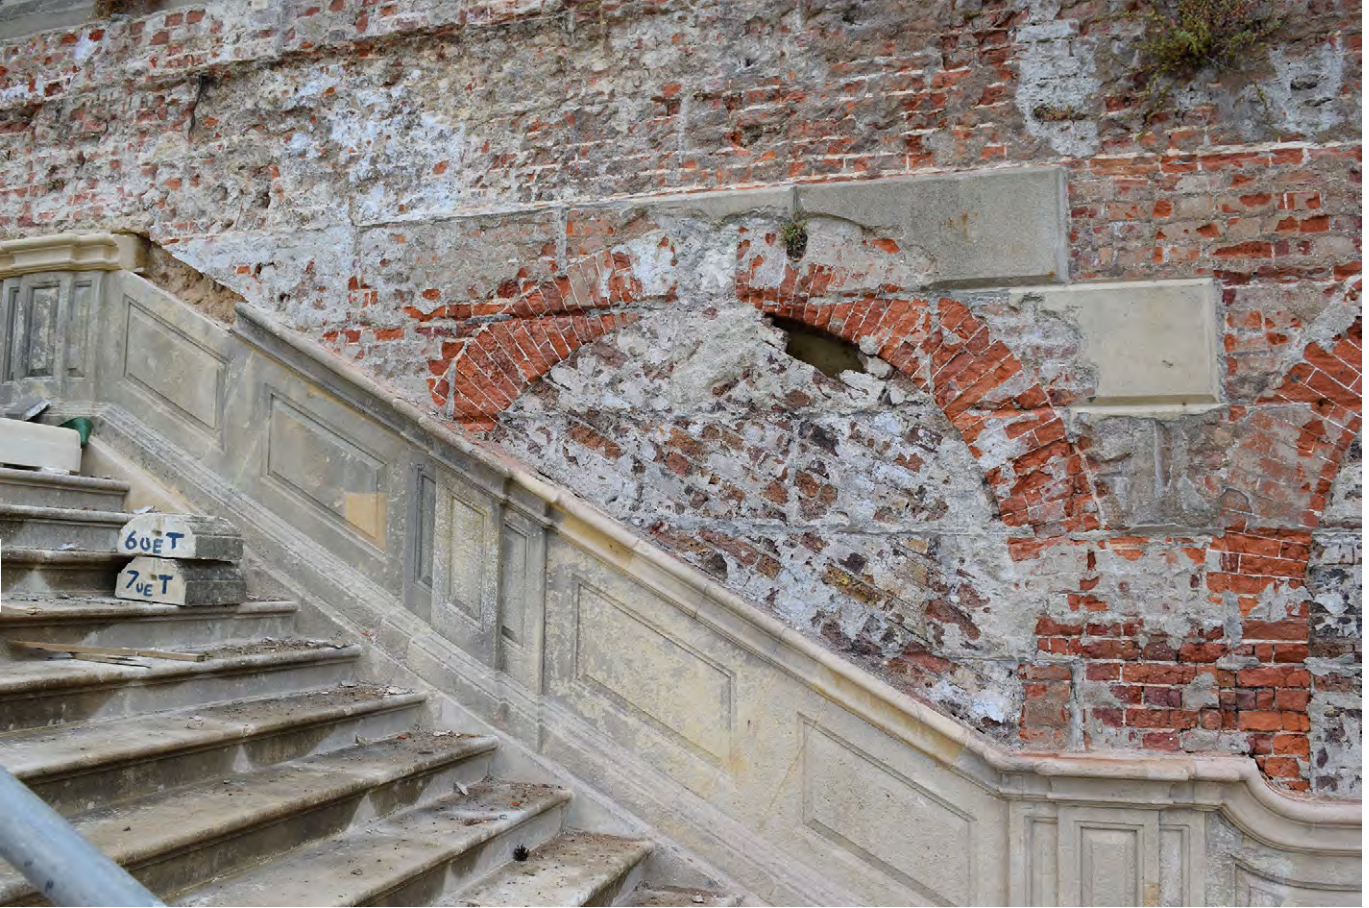
Plate B.15: Arch in east side after rustication removal

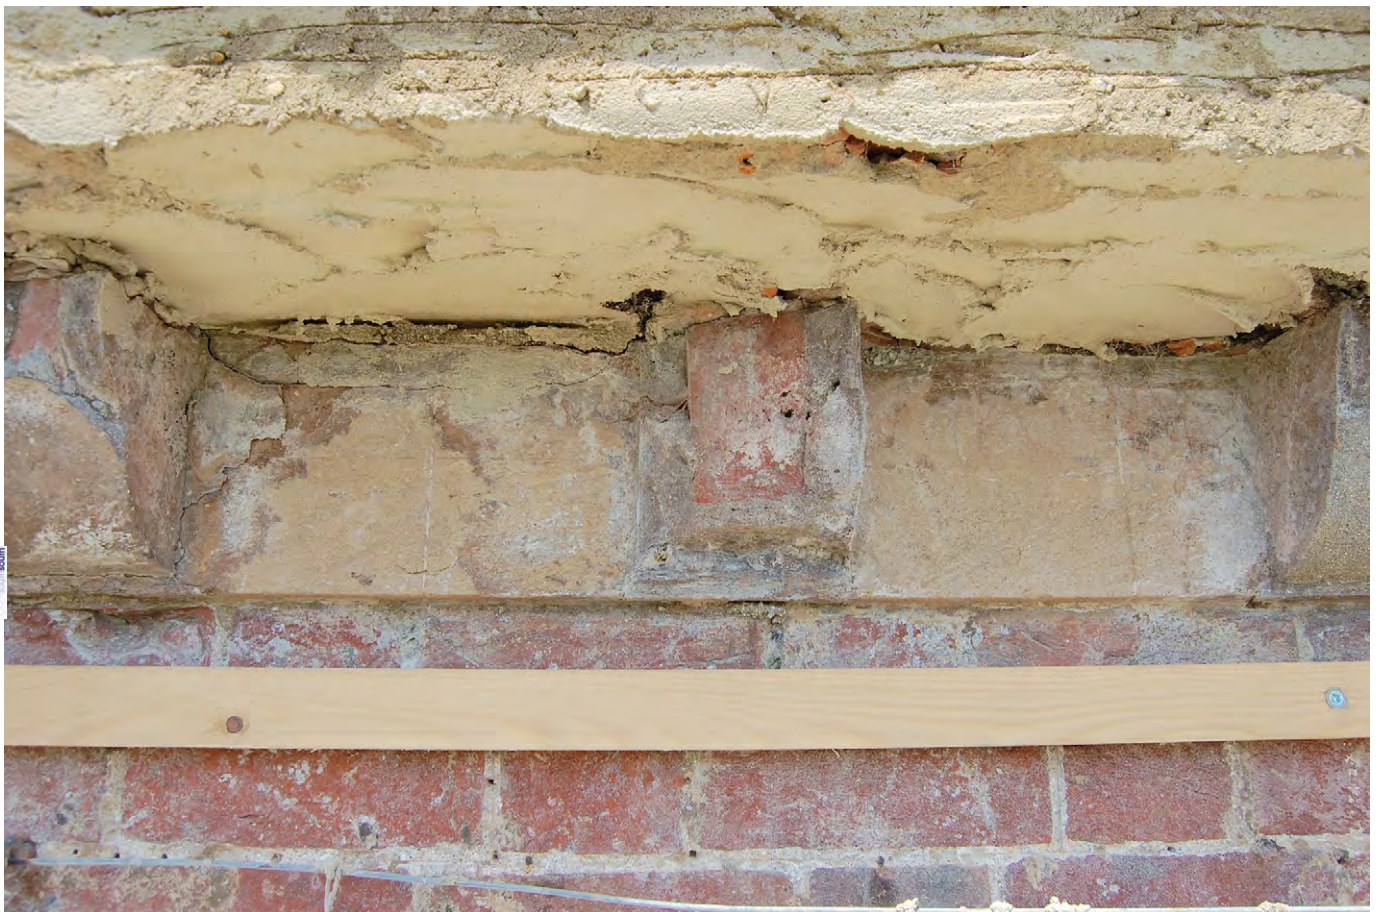
Plate B.17: Detail of cornice with ashlar grooves between brackets

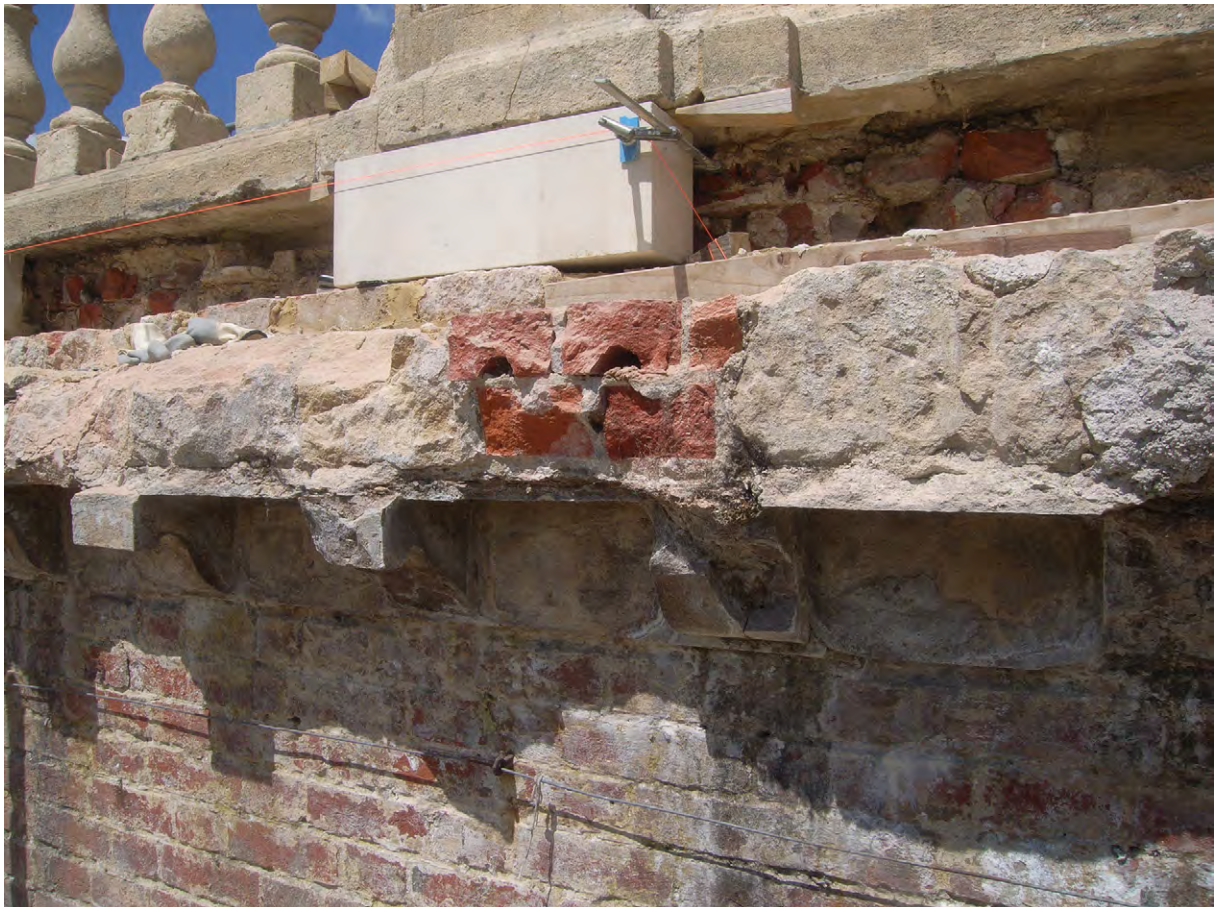
Plate B.18: Detail of cornice
